INTERGRANULAR CRACKING OF INOR-8 IN THE MSRE

H. E. McCoy

NOVEMBER 1972

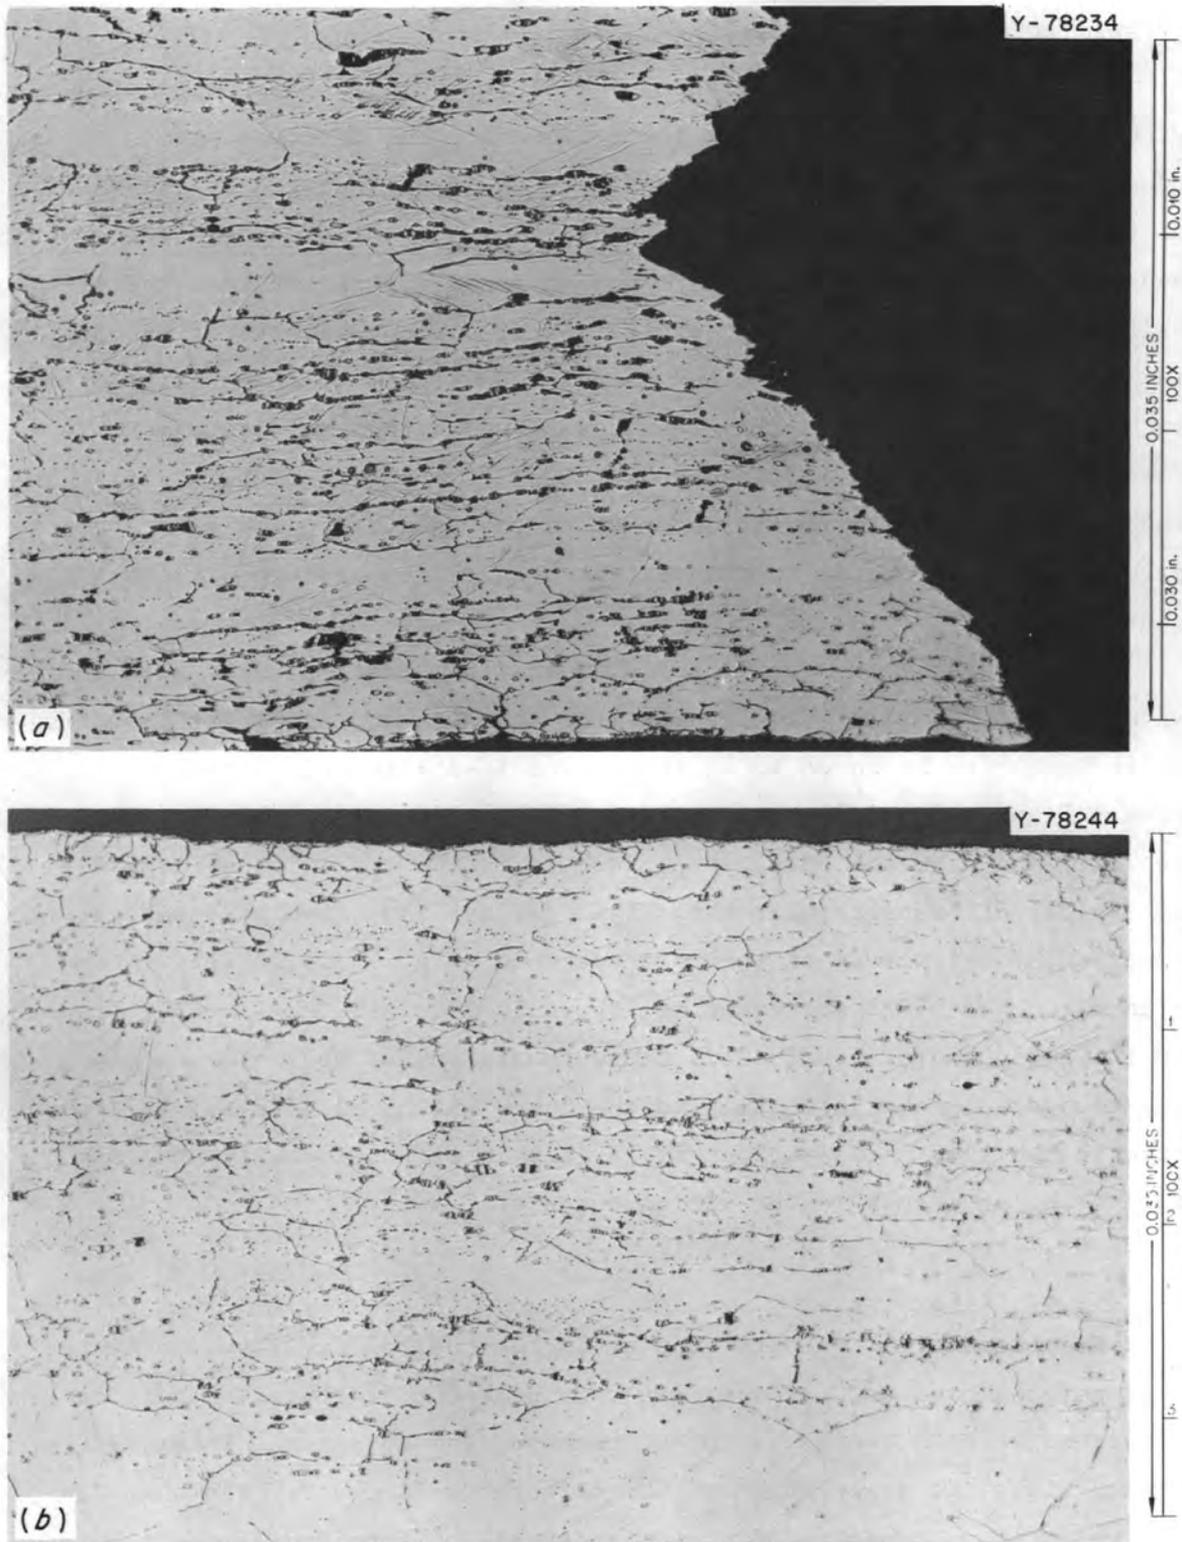
Metallography of specimens broken in tension at 25°C revealed differences in the nature of the fractures in core and control specimens. These differences are believed to be another manifestation of carbide precipitation. Figures 8 and 9 show specimens of heat 5081 from the control facility and from the core. The fracture in the control specimen (Fig. 8) is typical of transgranular shear-type failure (cup-cone appearance). In contrast, the fracture of the core specimen (Fig. 9) is largely intergranular. Heat 5085 specimens are shown in Figs. 10 and 11. The fracture in the 5085 control specimen is mixed transgranular and intergranular, with the elongated grains attesting to the large amount of strain. The fracture in the 5085 core specimen is largely intergranular with numerous intergranular cracks in the microstructure.

Fig. 8. Photomicrographs of Control Specimen AC-8 from Heat 5081 Tested at 25°C and at a Strain Rate of 0.05/min. (a) Fracture. (b) Edge of specimen about 1/4 in. from fracture. Etchant: glyceria regia.

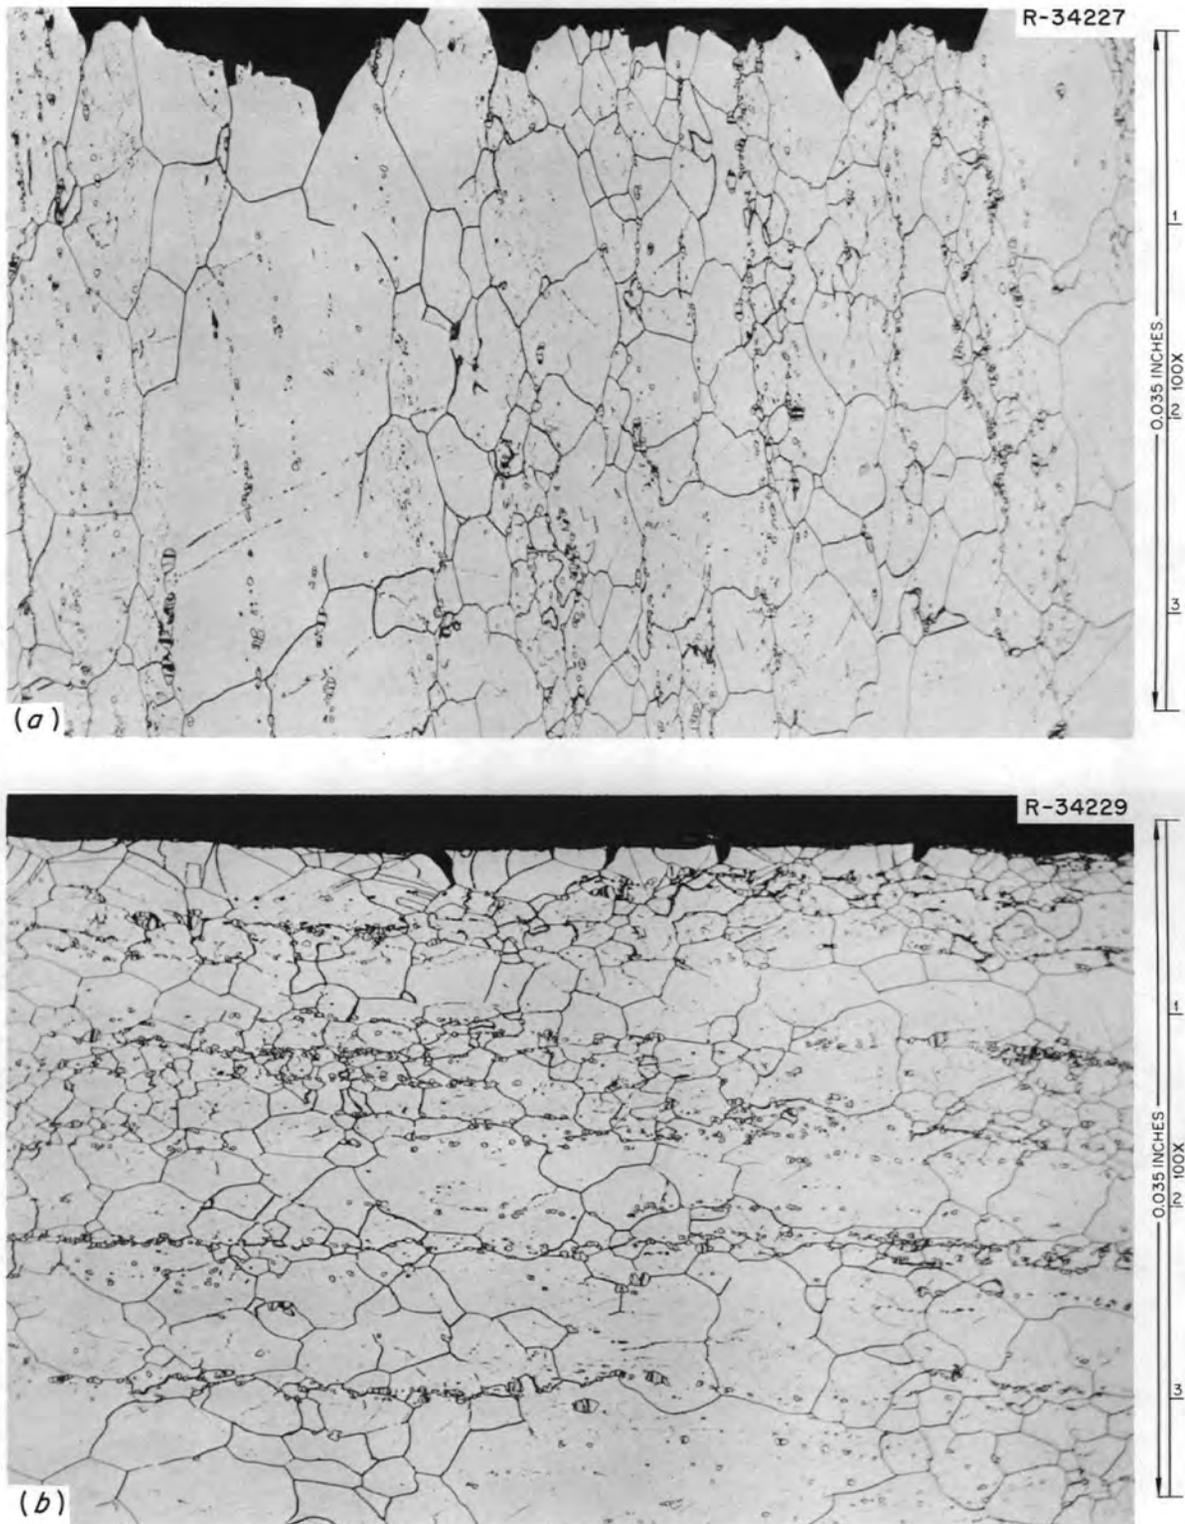
Fig. 9. Photomicrographs of Surveillance Specimen D-16 from Heat 5081 Tested at 25°C and at a Strain Rate of 0.05/min. (a) Fracture. (b) Edge of specimen about 1/4 in. from fracture. Etchant: glyceria regia.

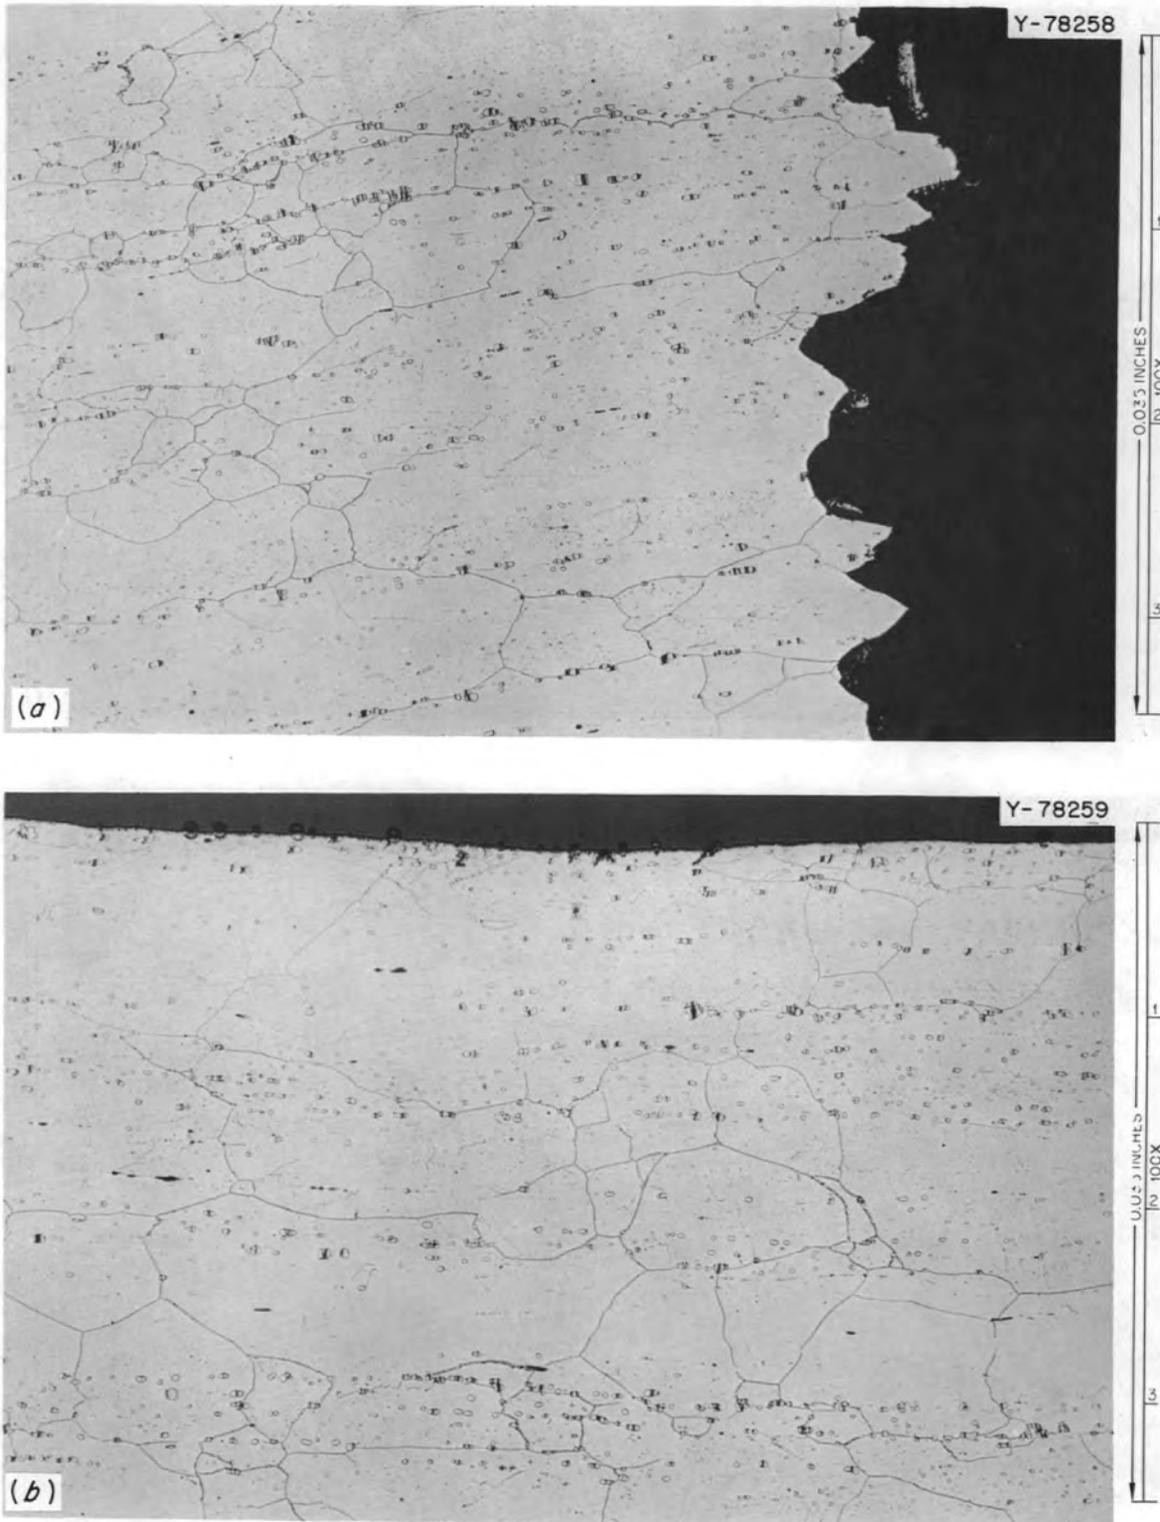
Fig. 10. Photomicrographs of Control Specimen DC-24 from Heat 5085 Tested at 25°C and at a Strain Rate of 0.05/min. (a) Fracture. (b) Edge of specimen about 1/4 in. from fracture. Etchant: glyceria regia.

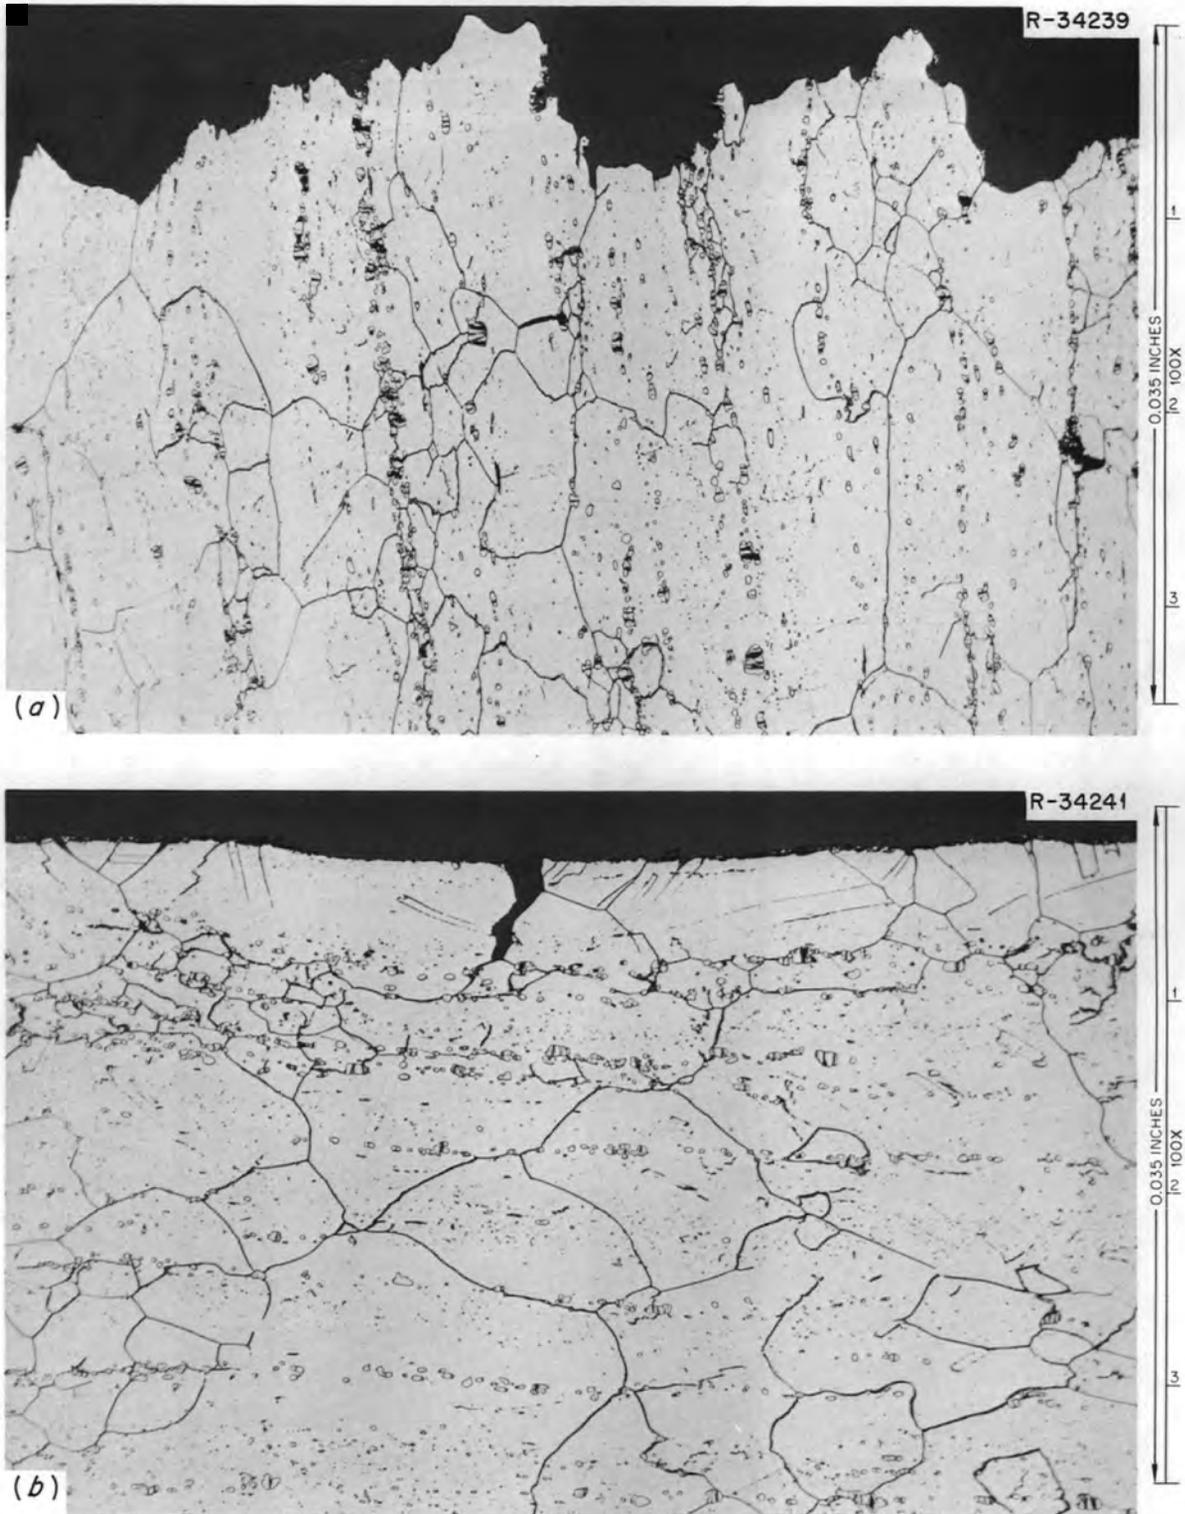
Fig. 11. Photomicrographs of Surveillance Specimen A-16 from Heat 5085 Tested at 25°C and at a Strain Rate of 0.05/min. (a) Fracture. (b) Edge of Specimen about 1/4 in. from fracture. Etchant: glyceria regia.

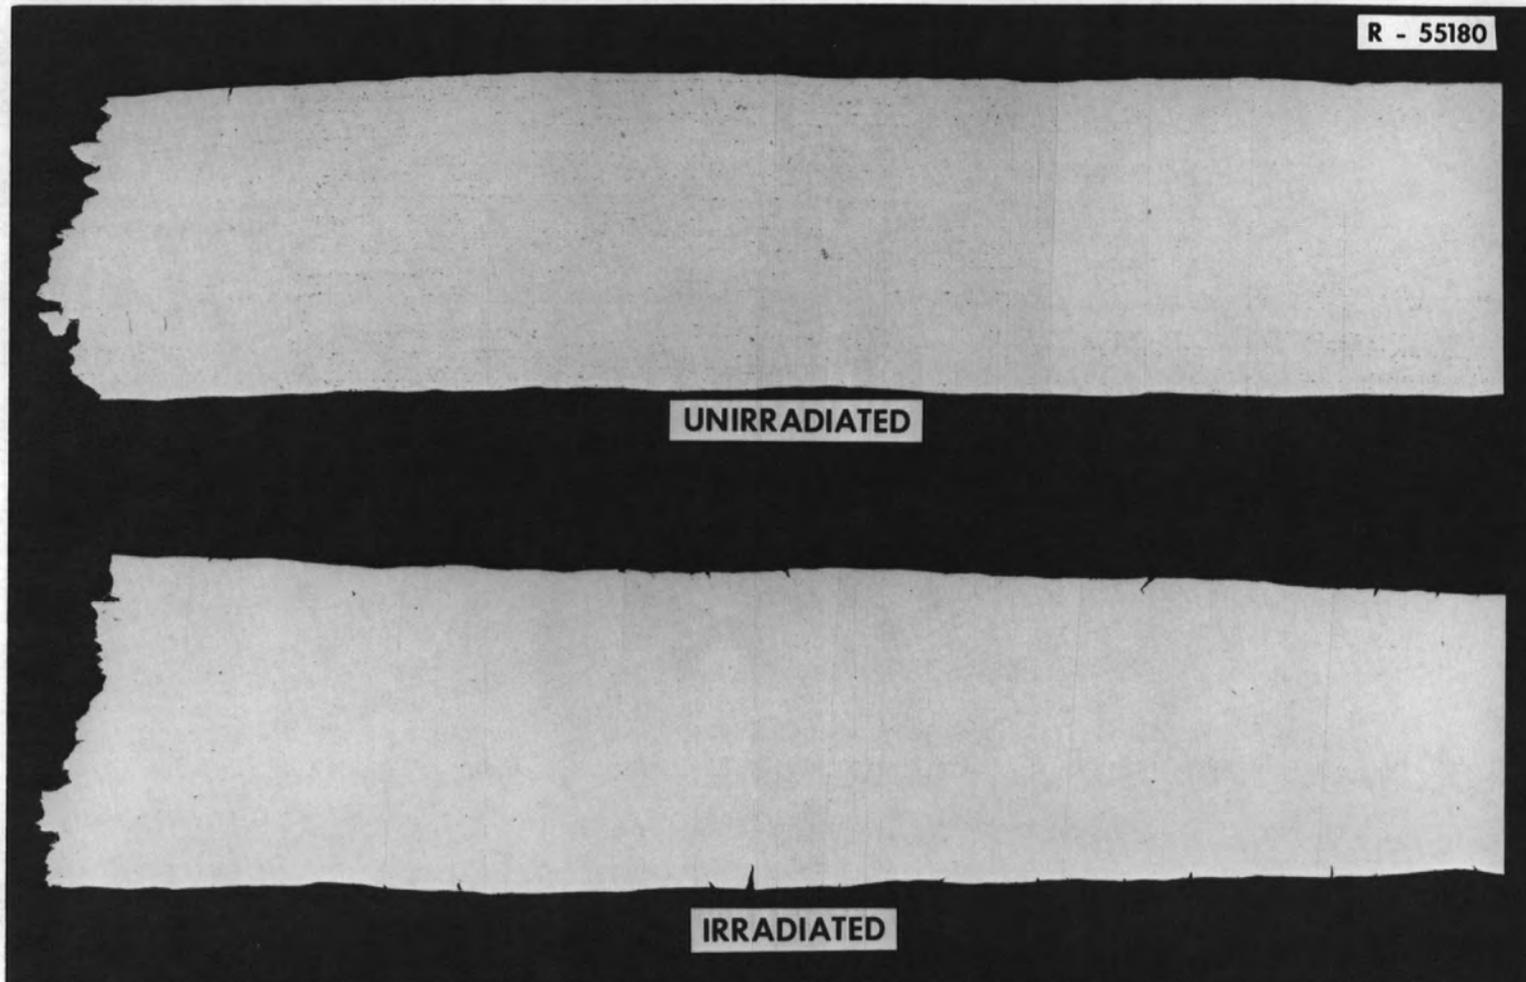
Fig. 12. Photomicrographs of Heat 5085 strained at 25°C After 5550 hr Above 500°C. The top specimen was in static fuel salt containing depleted uranium, and the lower specimen was in the MSRE core. The true specimen diameters are 0.070 and 0.090 in., respectively.

frequency and depth of cracks. In the section of the control specimen, only one surface crack was found (a frequency of about 1 per inch). Its depth was 5.7 mils. The section of the core specimen showed 19 cracks per inch with an average depth of 2.5 mils and a maximum depth of 8.8 mils. The core specimen has more surface cracks than the control specimen (and the pre-power core specimen).

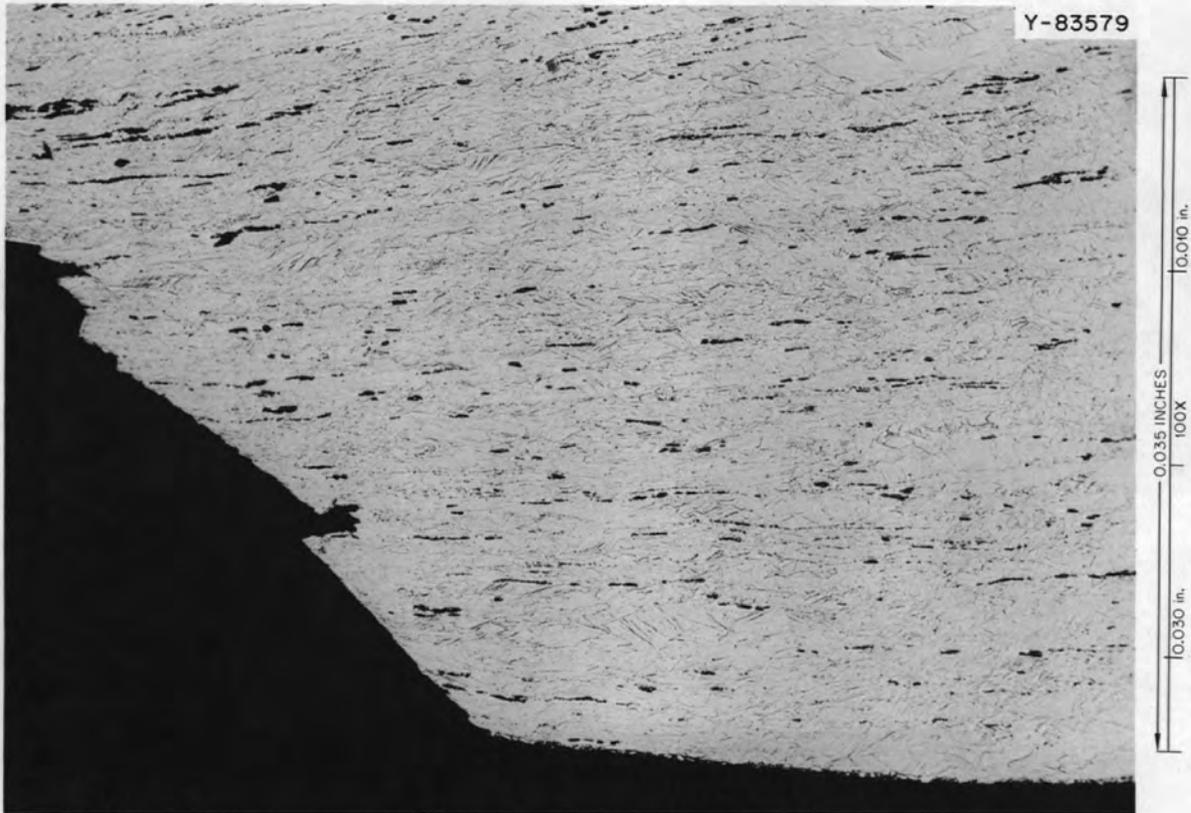
Core specimens of both heats tested to failure in tension developed numerous intergranular cracks along the surfaces, while control specimens tested similarly showed few or no surface cracks. The difference is illustrated in Figs. 15-18. Figure 15 and 16 are control and core specimens respectively of heat 21554. In the core specimen surfaces nearly every grain boundary is cracked to a consistent depth of about 2 mils. In the control specimen there is no evidence of intergranular edge cracking. Figures 17 and 18 show the same thing for heat 21545.

Fig. 15. Photomicrograph of the Fracture of a Zirconium-Modified INOR-8 Sample (Heat 21554) Tested at 25°C at a Strain Rate of 0.05/min. Exposed to a static fluoride salt for 5554 hr above 500°C before testing. Note the shear fracture and the absence of edge cracking. 100x. Etchant, glyceria regia.

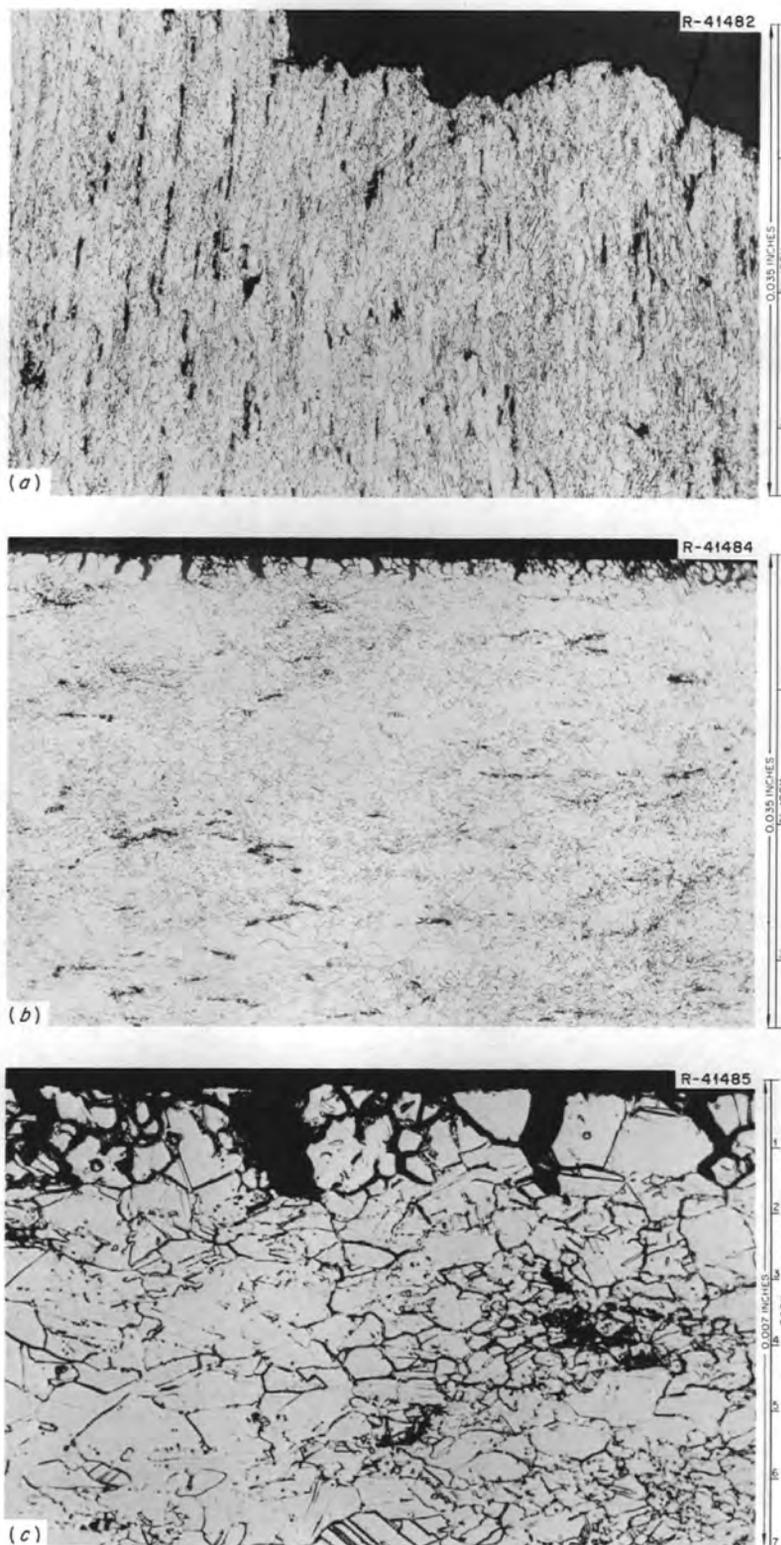
Fig. 16. Photomicrographs of a Zirconium-Modified INOR-8 Surveillance Sample (Heat 21554) Tested at 25°C at a Strain Rate of 0.05/min. Exposed in the MSRE core for 5554 hr above 500°C to a thermal fluence of 4.1×10^{20} neutrons/cm². Etchant: aqua regia. (a) Fracture. 100×. (b) Edge of sample about 1/2 in. from fracture. 100×. (c) Edge of sample showing edge cracking. 500×. Reduced 31.5%.

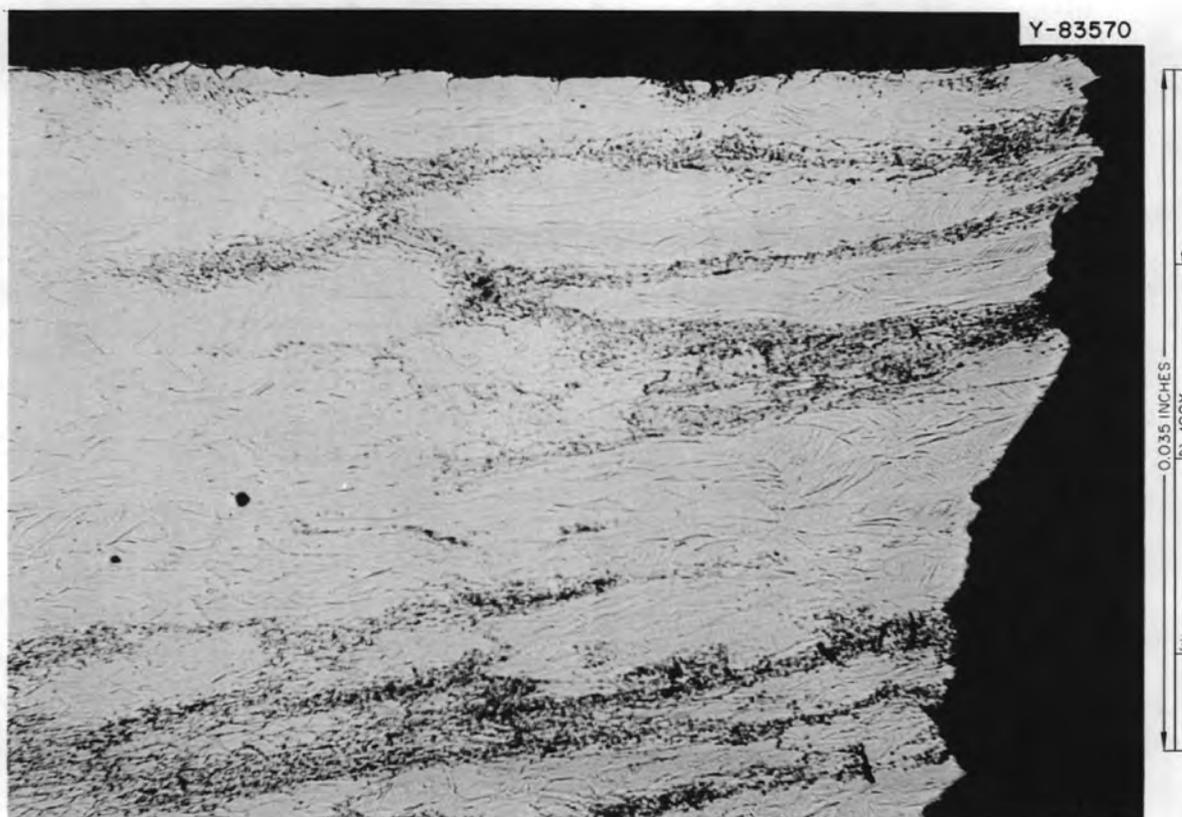
Fig. 17. Photomicrograph of the Fracture of a Titanium-Modified INOR-8 Surveillance Sample (Heat 21545) Tested at 25°C at a Strain Rate of 0.05/min. Exposed to a static fluoride salt for 5554 hr above 500°C before testing. Note the shear fracture and the absence of edge cracking. 100 \times . Etchant: glyceria regia.

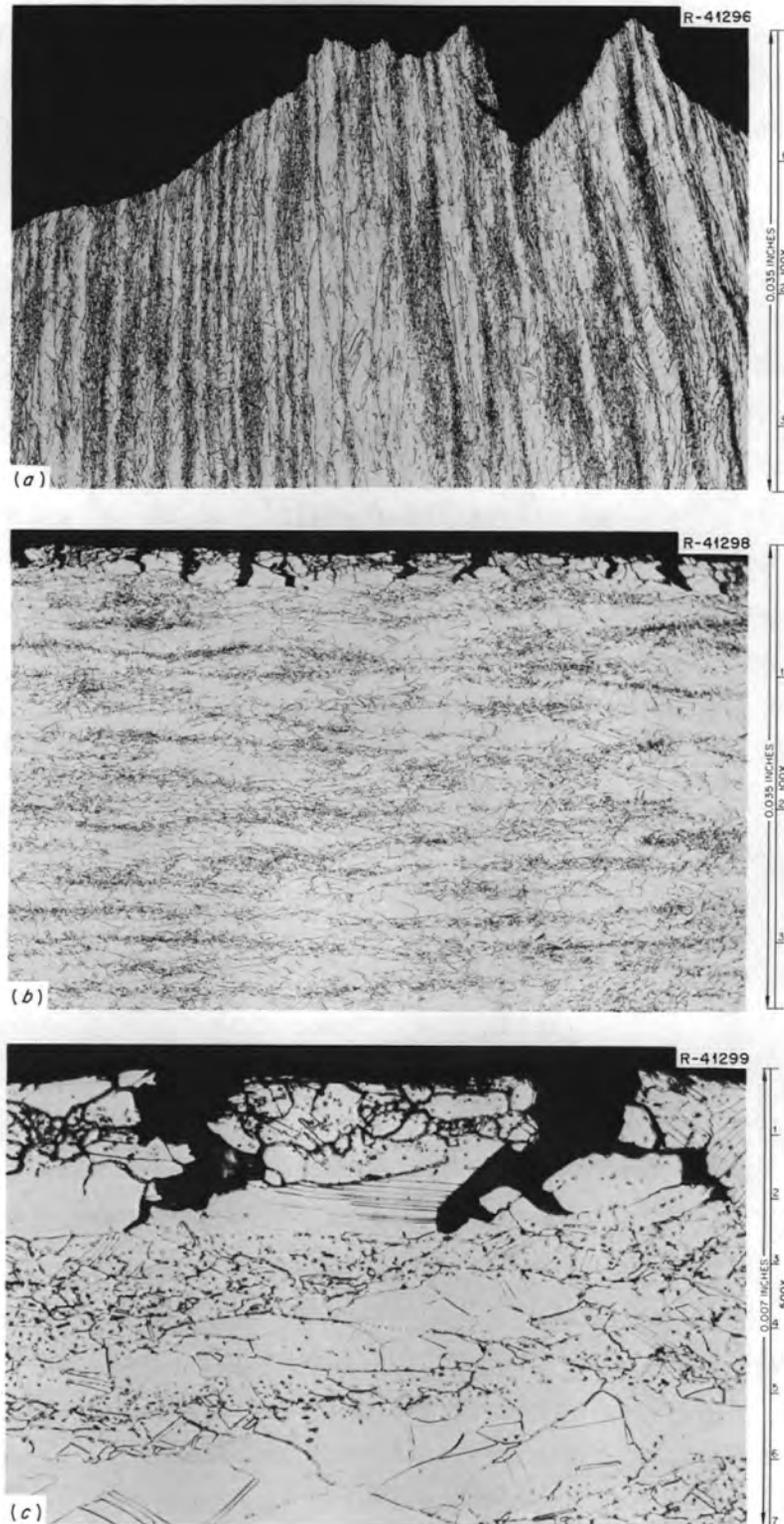
Fig. 18. Photomicrographs of a Titanium-Modified INOR-8 Surveillance Sample (Heat 21545) Tested at 25°C at a Strain Rate of 0.05/min. Exposed in the MSRE core for 5554 hr above 500°C to a thermal fluence of 4.1×10^{20} neutrons/cm². Etchant: aqua regia. (a) Fracture. 100×. (b) Edge of sample about 1/2 in. from fracture. 100×. (c) Edge of sample showing edge cracking. 500×. Reduced 32%.

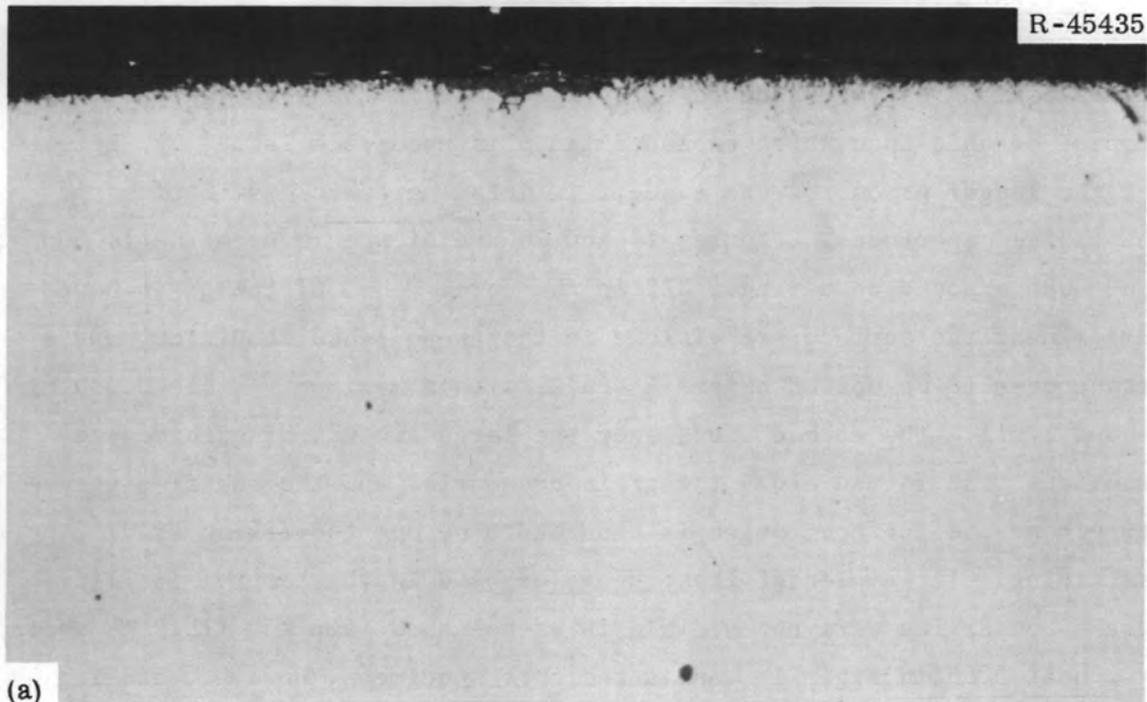
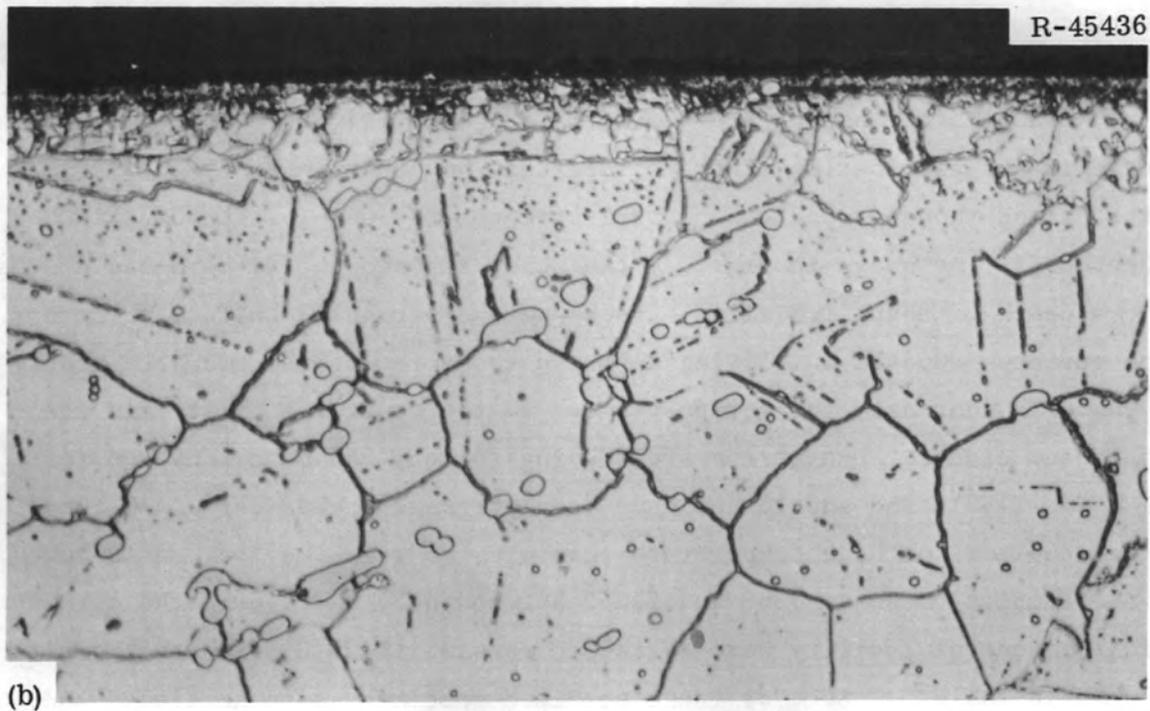
Fig. 19. Photomicrographs of INOR-8 (Heat 5065) Surveillance Specimens Exposed to Fuel Salt for 11,933 hr above 500°C, 500 \times . Shallow reaction layer is seen near surface. (a) Unetched. (b) Etched (glyceria regia).

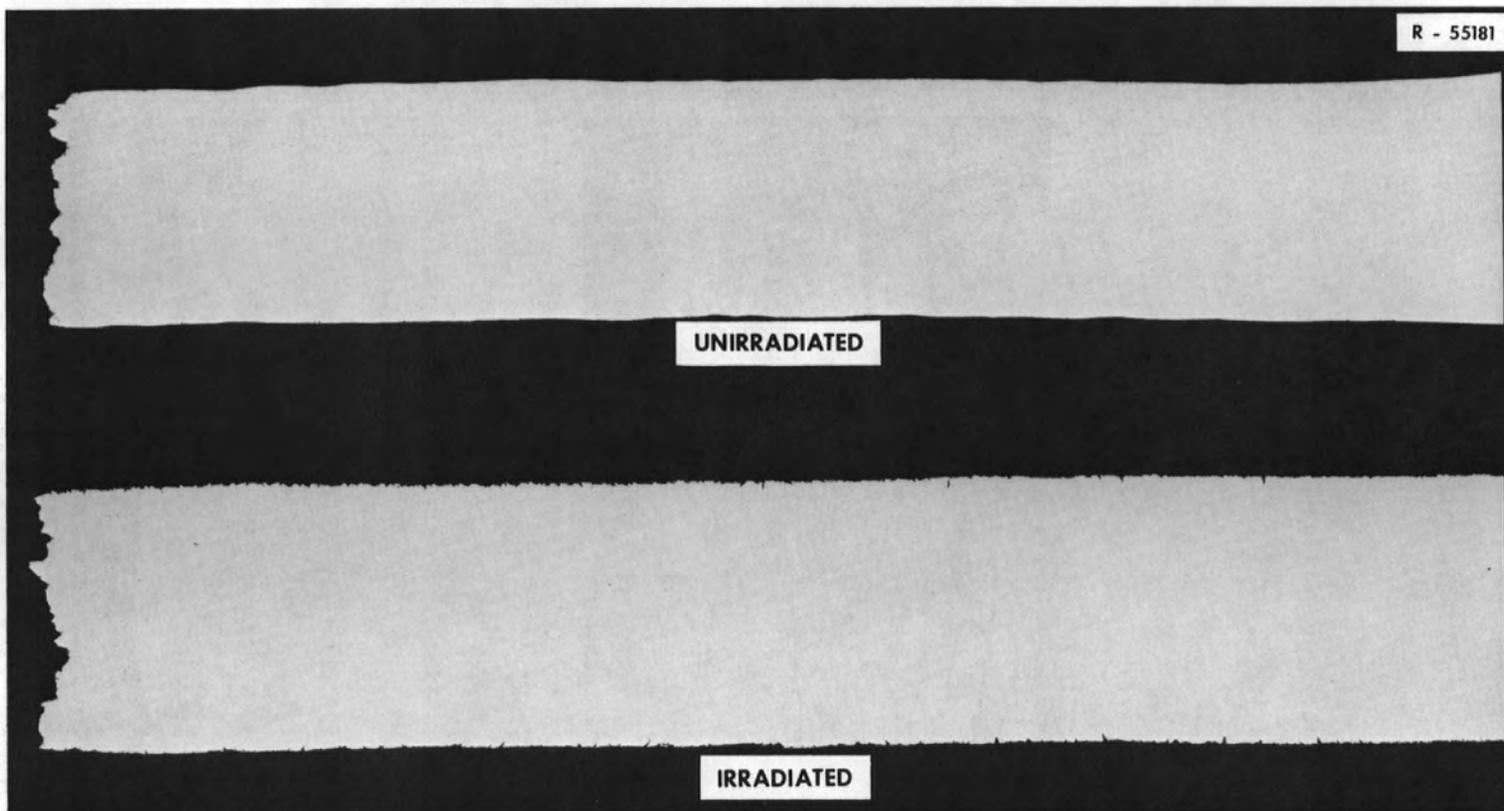
Fig. 28. Photomicrographs of INOR-8 Specimens Strained to Fracture After 11,933 hr above 500°C. The upper sample was in the control facility and the lower sample was in the MSRE core. The sample diameter is about 0.1 in.

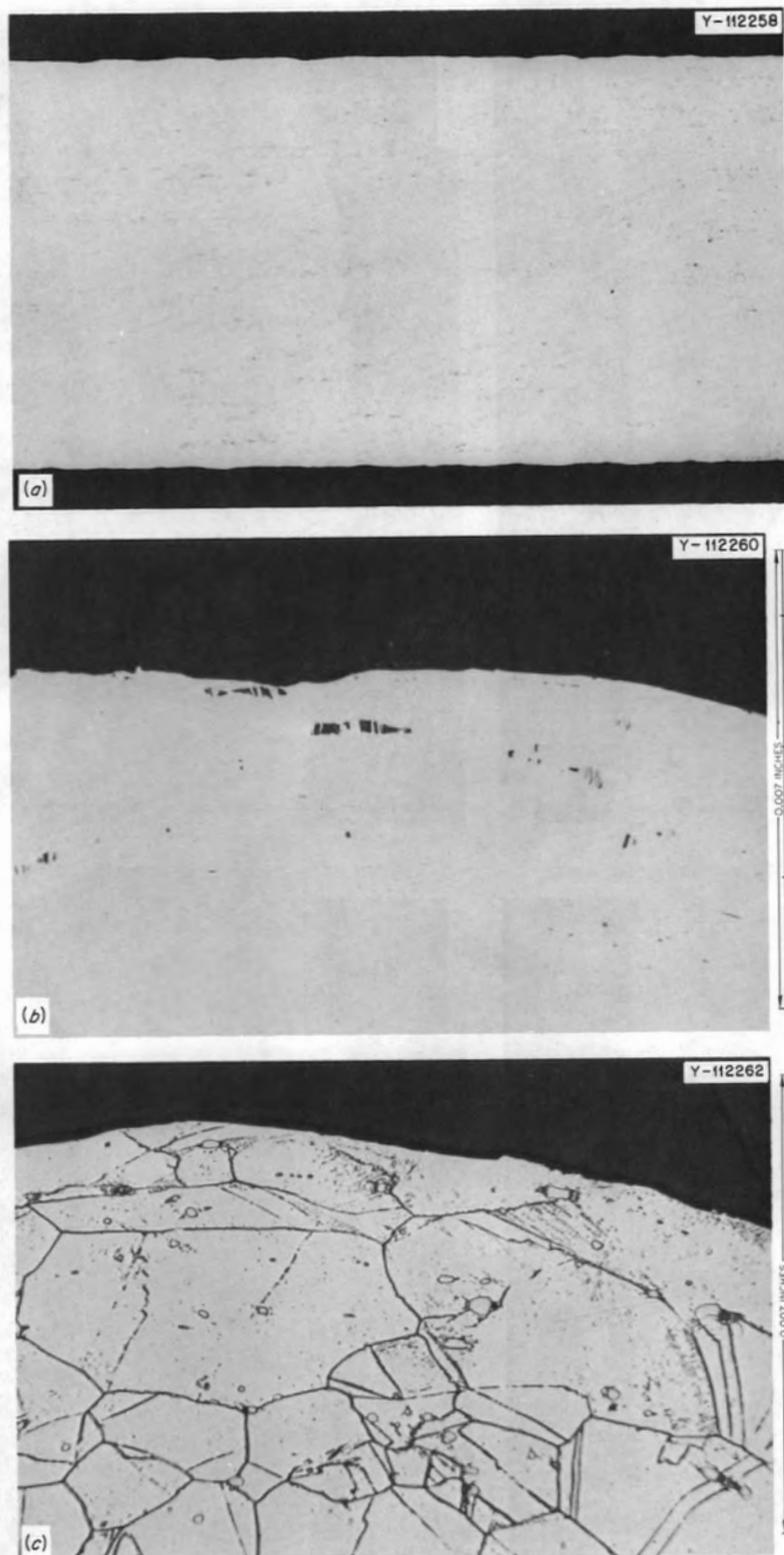
Fig. 40. Photomicrographs of INOR-8 (Heat 5055) Straps Exposed to Static Unenriched Fuel Salt 7203 hr Above 500°C. (a) As-Polished 33x, (b) As Polished, 500x, cracked regions are carbide that fractured during initial forming, (c) Etched with glyceria regia, 500x. Reduced 33%.

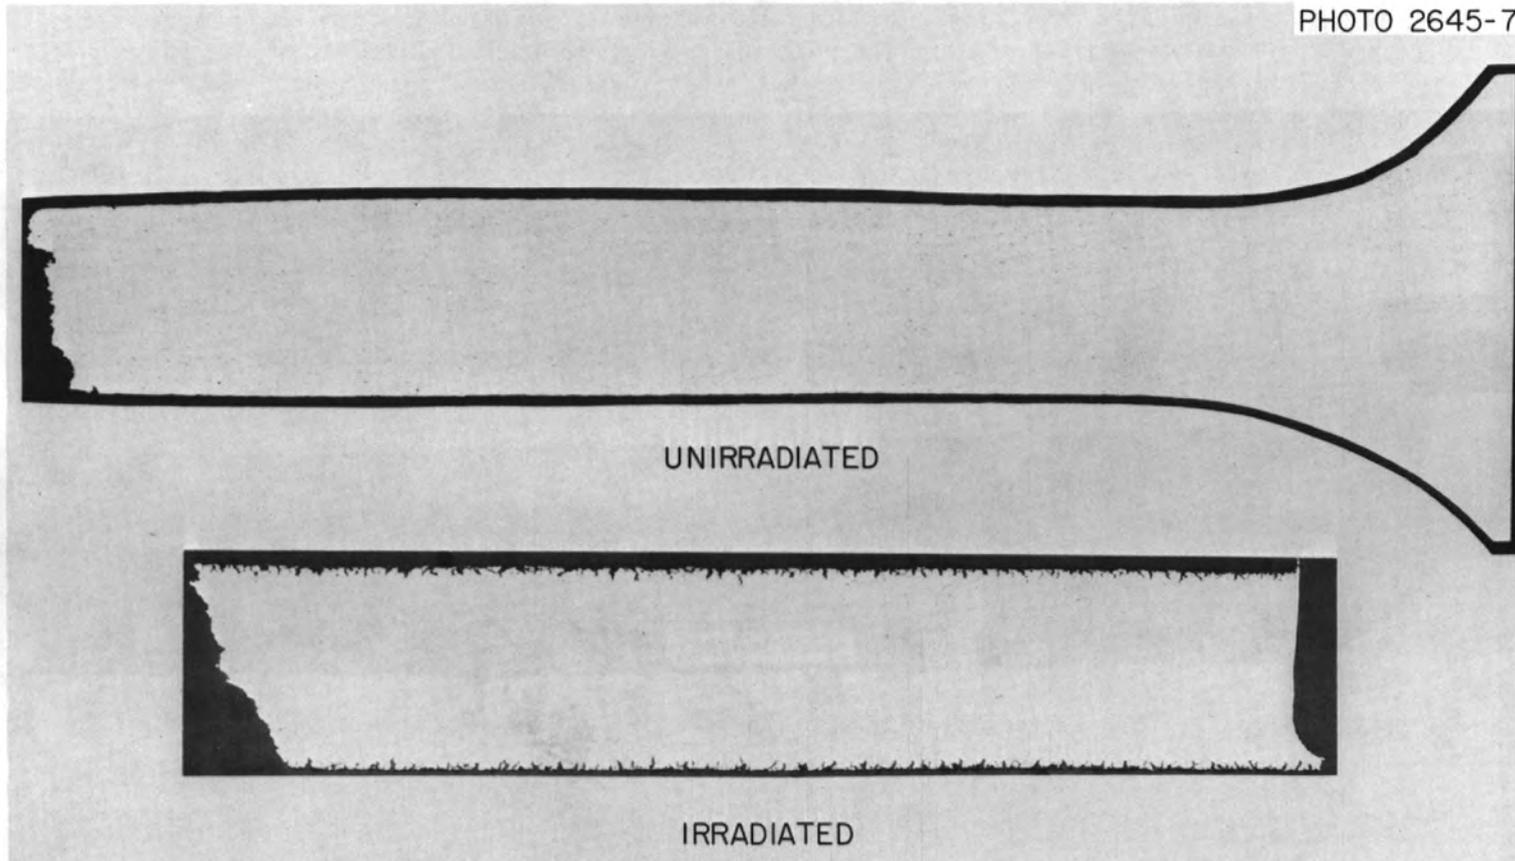
Fig. 47. Photomicrographs of INOR-8 (Heat 5065) Strained to Fracture at 25°C. Top specimen was exposed to static unenriched fuel salt for 19,136 hr above 500°C and the lower specimen was exposed to the MSRE core for the same time. The diameters are about 0.1 in.

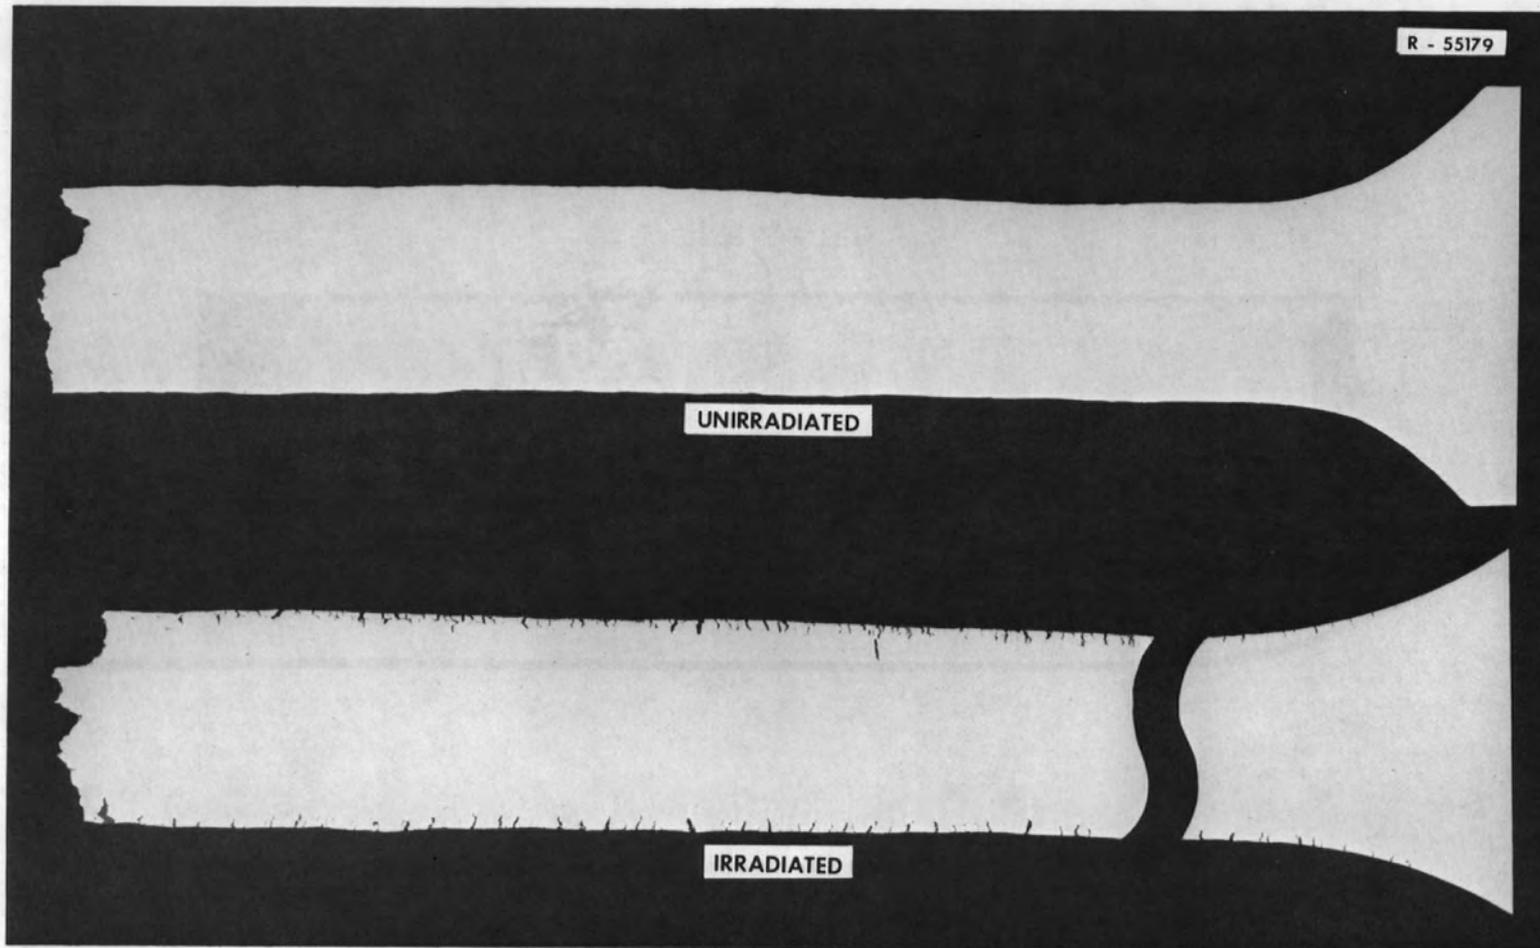
Fig. 48. Photomicrographs of INOR-8 (Heat 5085) Strained to Fracture at 25°C. The top specimen was exposed to static unenriched fuel salt for 19,136 hr above 500°C and the lower specimen was exposed to the MSRE core for the same time. The diameters are about 0.1 in.

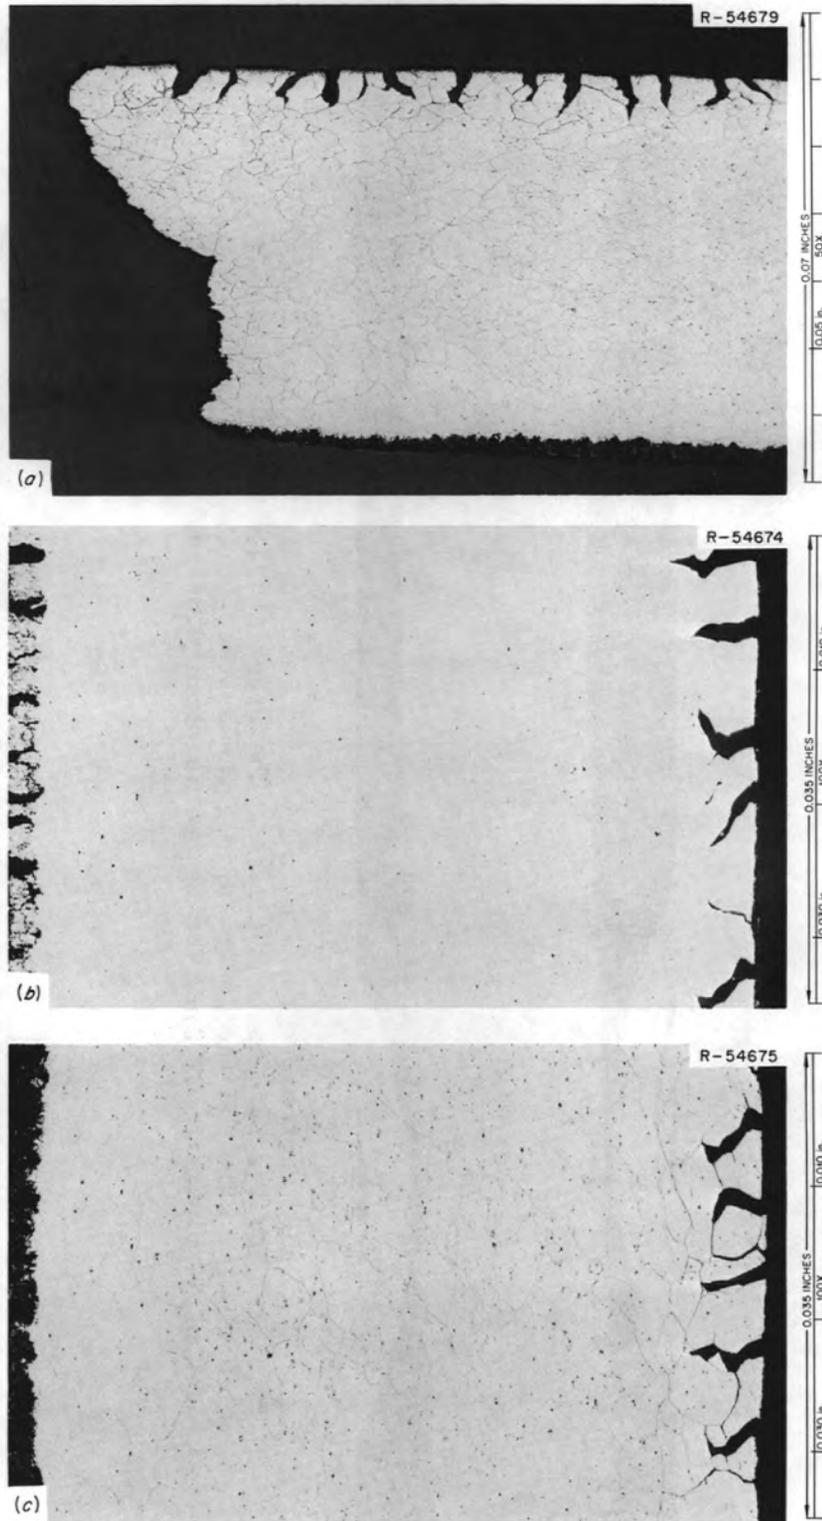
Fig. 68. Photomicrographs of Control Rod Thimble Specimen Exposed to Flowing Salt and Tested at 25°C. (a) Fracture - dark edge is oxide on inner surface of tube, and cracks formed on the outer surface; etched. (b) Cracks in outer surface of tubing as polished. (c) Cracks in outer surface of tubing etched. Etchant: Aqua regia. Reduced 30.5%.
