INTERGRANULAR CRACKING OF INOR-8 IN THE MSRE

H. E. McCoy

NOVEMBER 1972

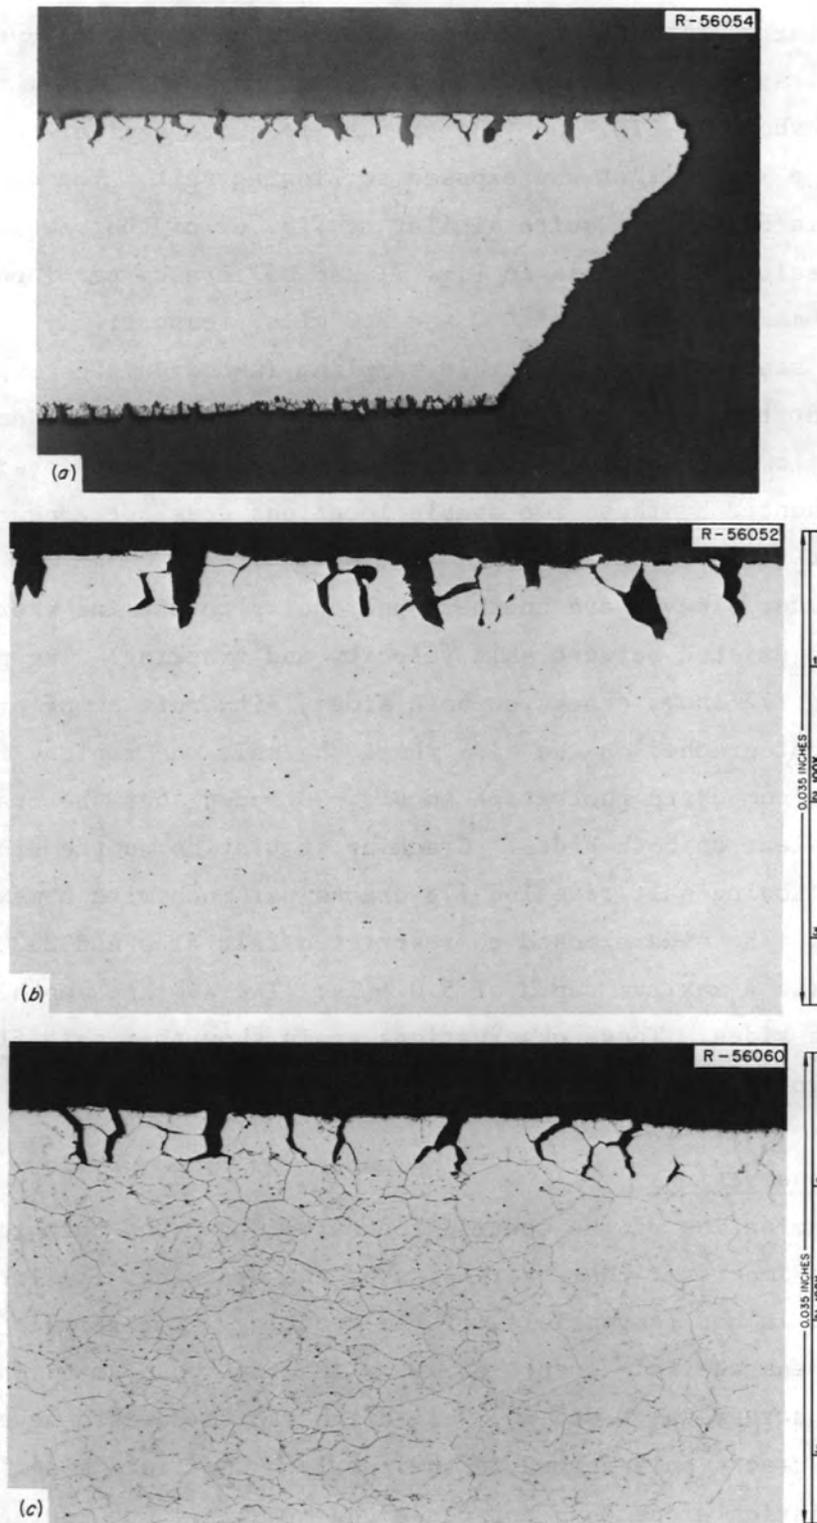
Fig. 70. Photomicrographs of Control Rod Thimble Exposed to Fuel Salt Under a Spacer Sleeve and Tested at 25°C. (a) As-polished view of fracture. 40x. (b) As-polished view of cracks. (c) Etched view of cracks. Etchant: Aqua regia. Reduced 30.5%

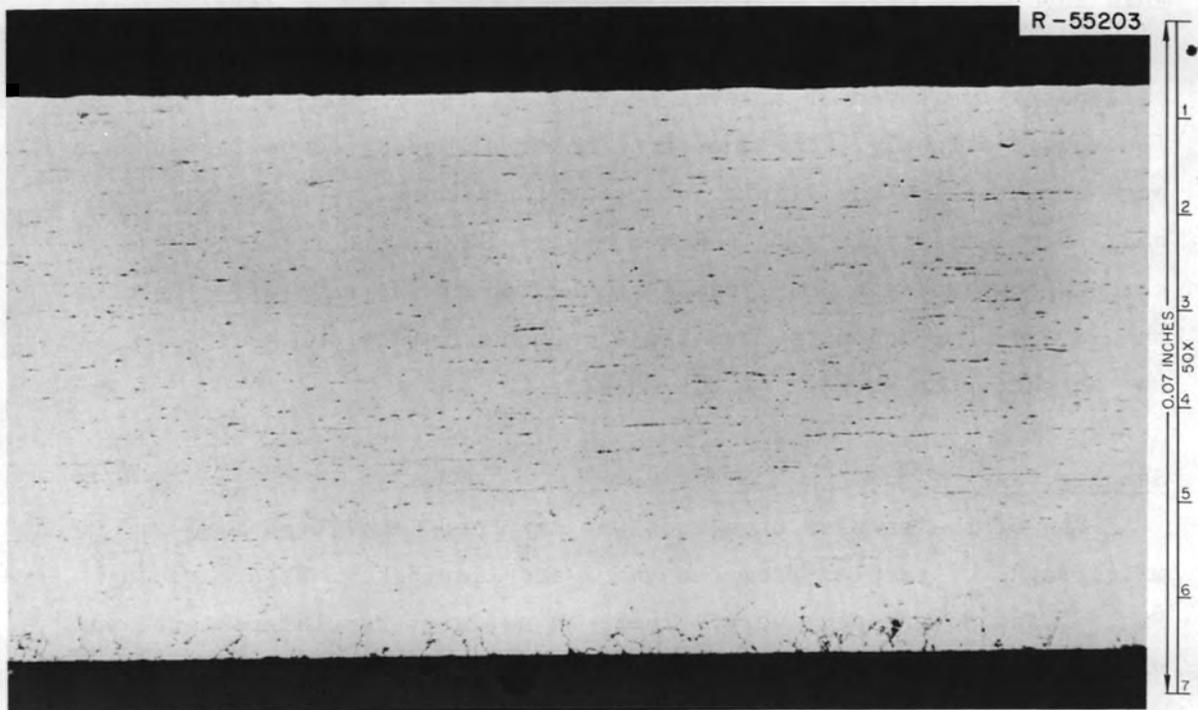
Fig. 82. Photomicrograph of Heat Exchanger Tubing in the Unstressed Condition. The side with the small cracks was exposed to fuel salt and the other was exposed to coolant salt.

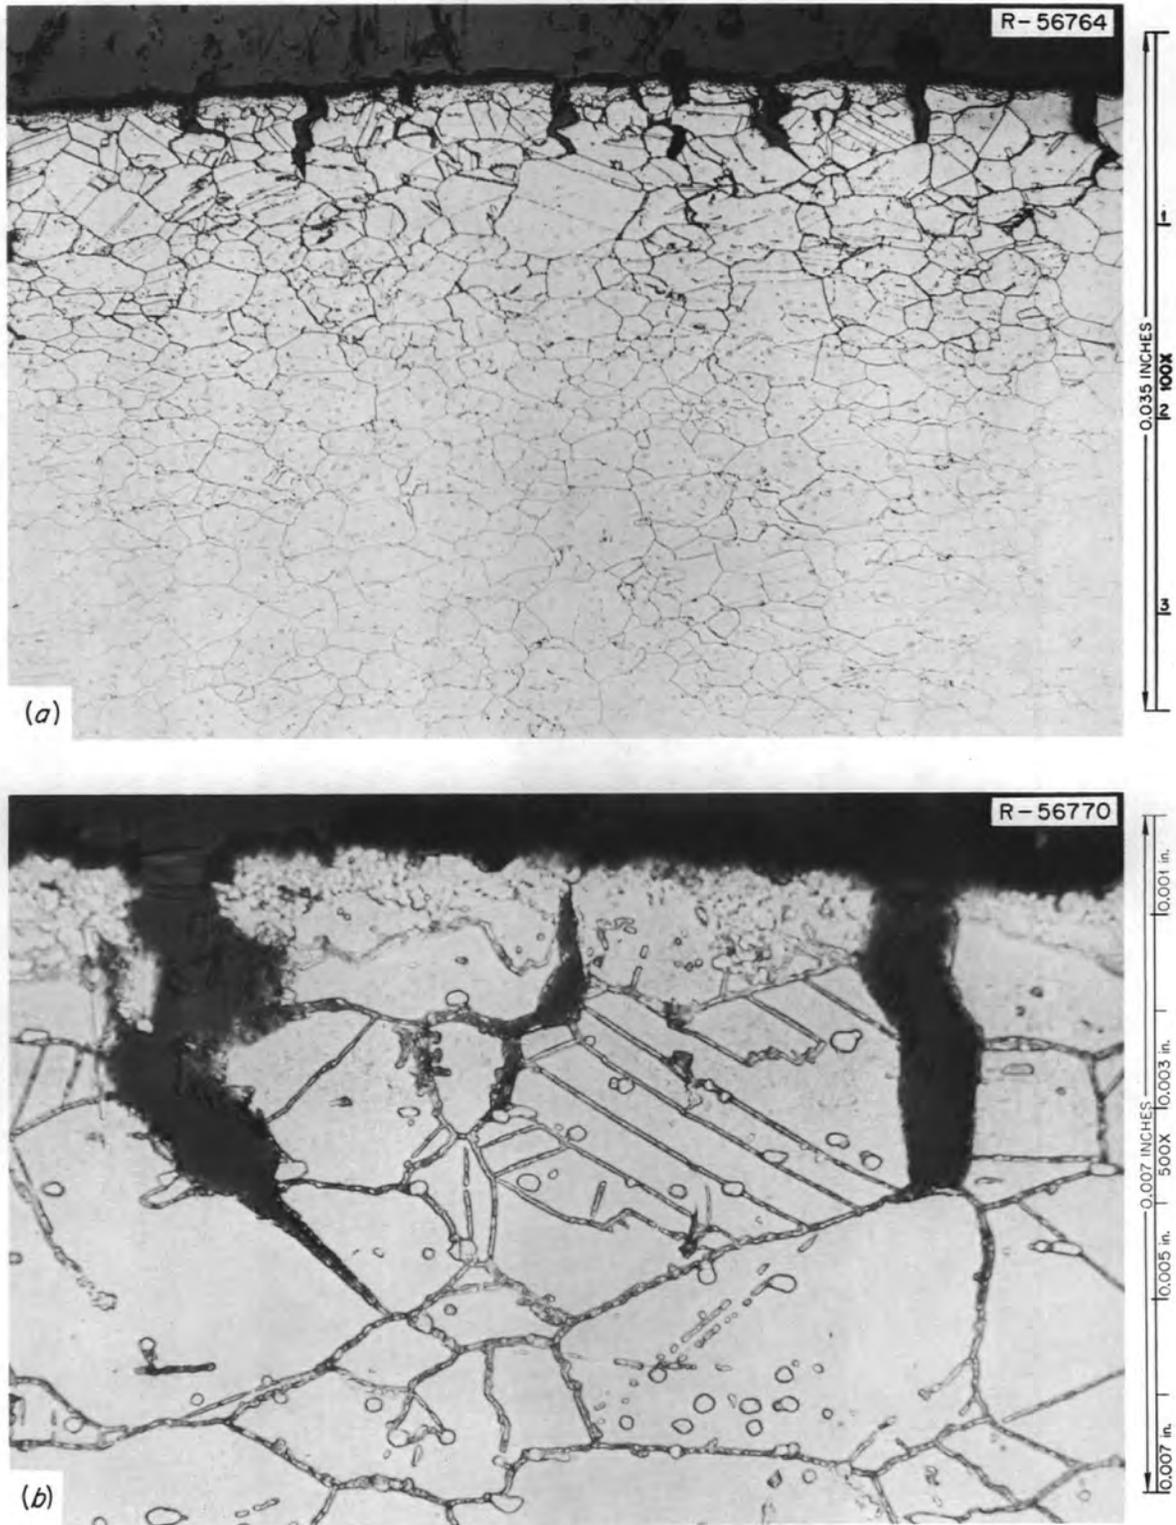
Fig. 97. Photomicrographs of the Tension Side Near the Fracture of a Bend Specimen from the Outside Liquid Region of the Mist Shield. (a) 100 \times . (b) 500 \times . Etchant: lactic acid, HNO_3 , HCl .

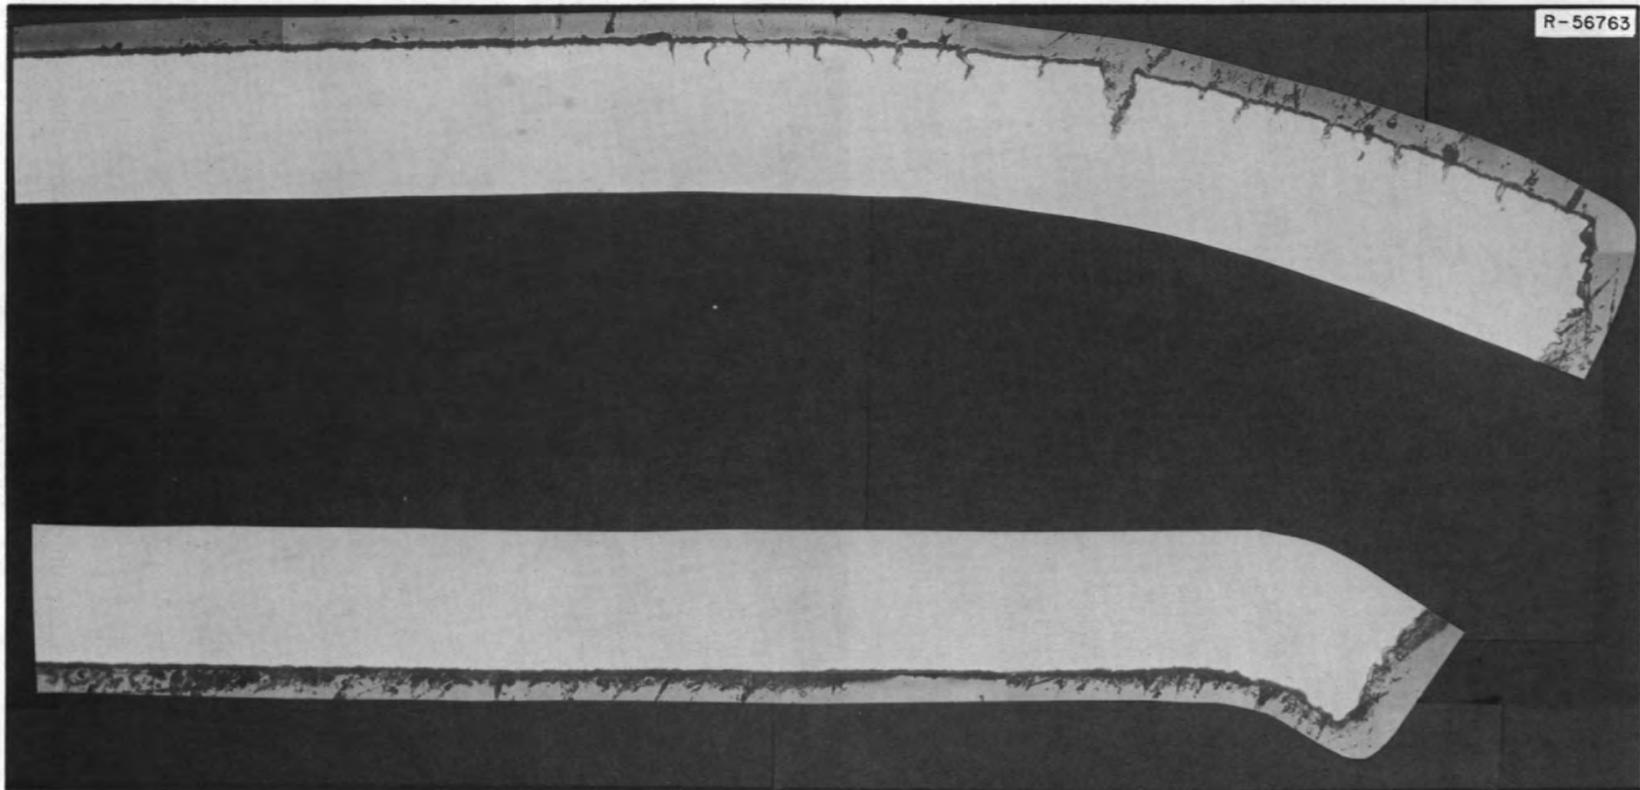
Fig. 98. Composite of Several Photomicrographs of a Bend Specimen from the Outside Liquid Region of the Mist Shield. Top portion shows the tension side and the lower portion shows the compression side. 24x.

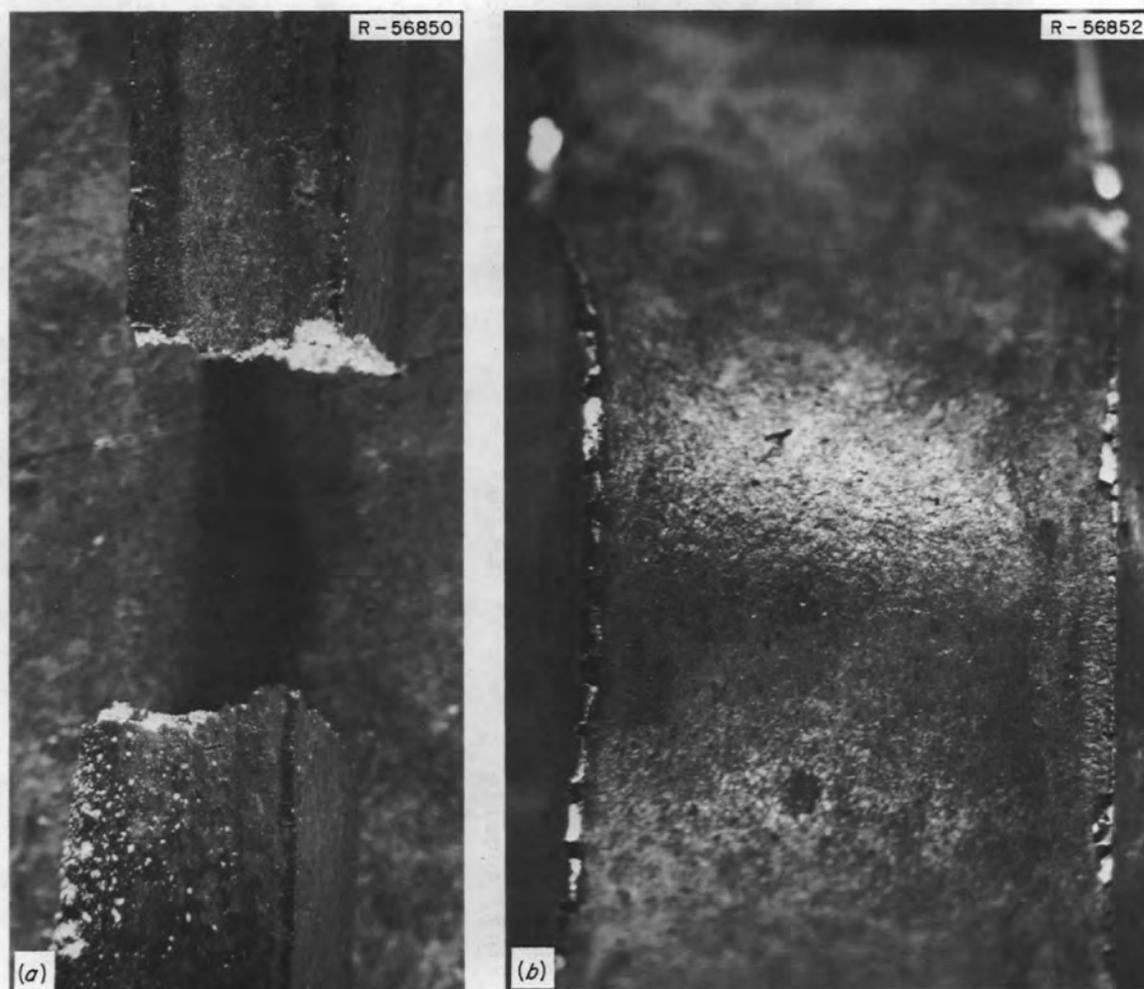
Fig. 102. The Surfaces Exposed to Salt in Freeze Valve 105 After Deformation at 25°C. (a) Fracture of ring specimen pulled in tension. Note surface cracks near the fracture. 4 \times (b) Surface of bend specimen. Note some cracks on surface and edge cracks. 7 \times . Reduced 18.5%.
