ORNL/TM-11318

Inspection of Contaminated Hot Cell Ductwork

Publication Date: August 1989

This ductwork requires decontamination prior to release of the facility to resume sterilization activities. Due to the small size (20-in. × 24-in. cross section) and the long runs embedded in the cell roof, it was determined that remote visual inspection and preliminary radiation mapping of this ductwork was necessary. This report covers the inspection effort and evaluation of the results.

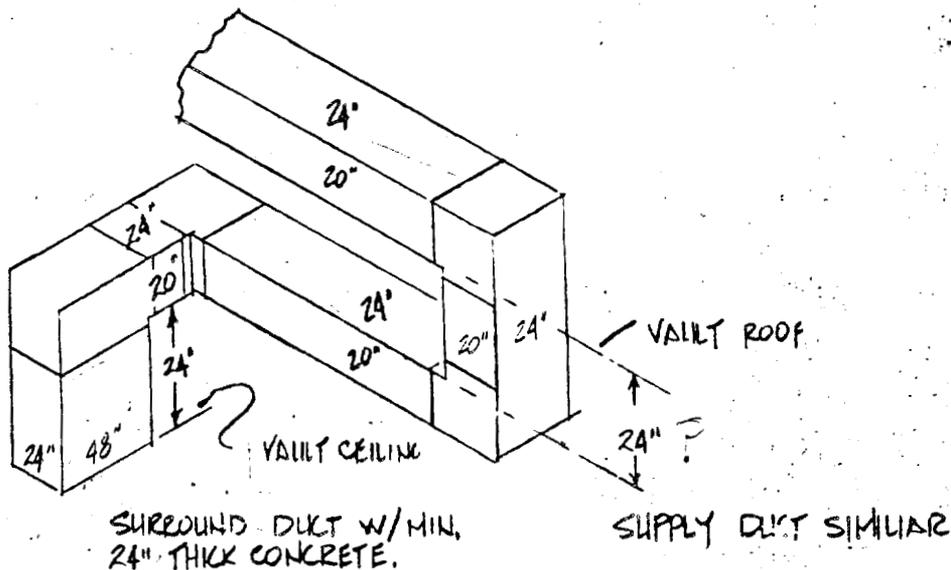
Fig. 1. Original 1983 drawing of duct.

At the beginning of the inspection effort, little was known about the internals of the heating, ventilating, and air conditioning (HVAC) ductwork at the RSI facility. The original assumptions regarding the physical layout were taken from a 1983 drawing (Fig. 1), which shows the expected duct details. No as-built drawings of the facility were available to confirm this layout. In addition, the levels of contamination were unknown, and it was possible that personnel barriers were installed within the ductwork. Consequently, it was decided that the inspection should be performed by a remotely controlled vehicle with integral television camera and lighting.

This CCA system utilizes dual track drives for skid-steered control during operation. It is designed to inspect pipes and ducts up to 450 ft from a single entry, giving continuous distance measurements as it travels. It is remotely powered from batteries in the van that also houses the inspection personnel. A remotely controlled mirror attachment enables inspection of the entire inside of the duct or pipe as it is traversed. Figure 3 is a cutaway view of the actual duct, showing the CCA in the fourth section (counting from the bottom to the top). Figure 4 is a block diagram of the system. It should be noted that there is an additional section of ductwork (shown in Fig. 3) not shown in the original design depicted in Fig. 1. The difference is discussed in Sect. IV.

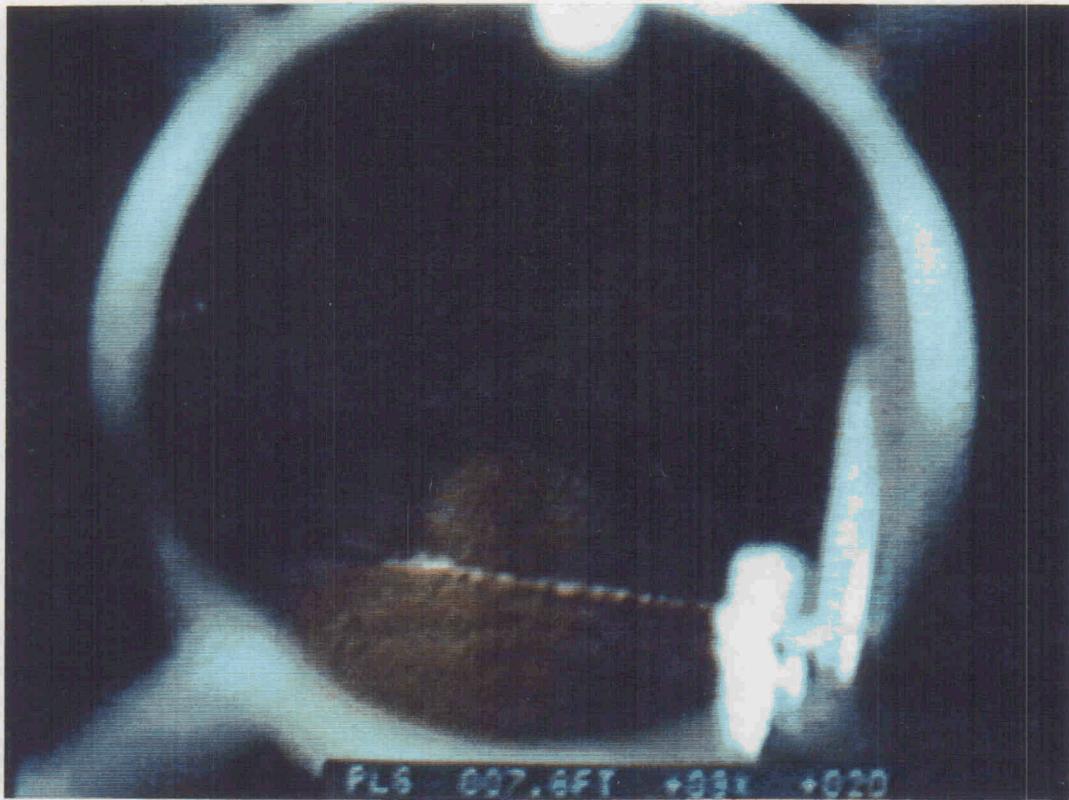
Fig. 5. Welded seam on duct corner in Sect. 3.

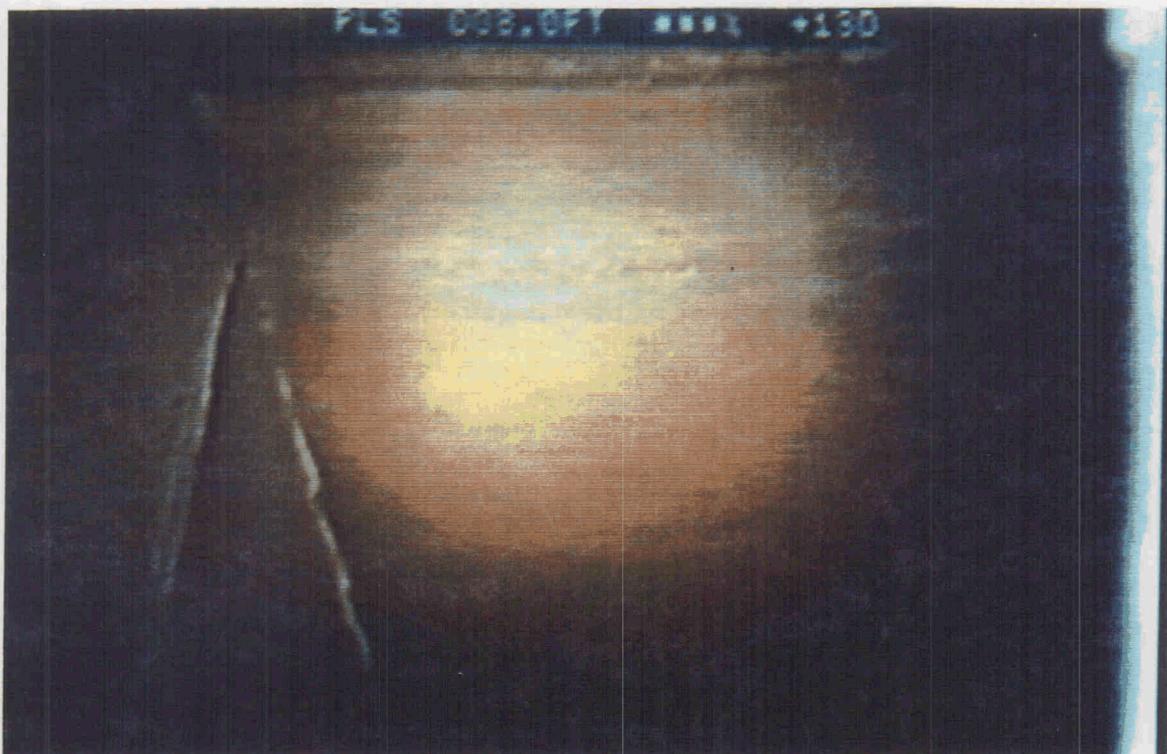
Fig. 6. Inside view of welded seams on Sect. 3 wall and roof.

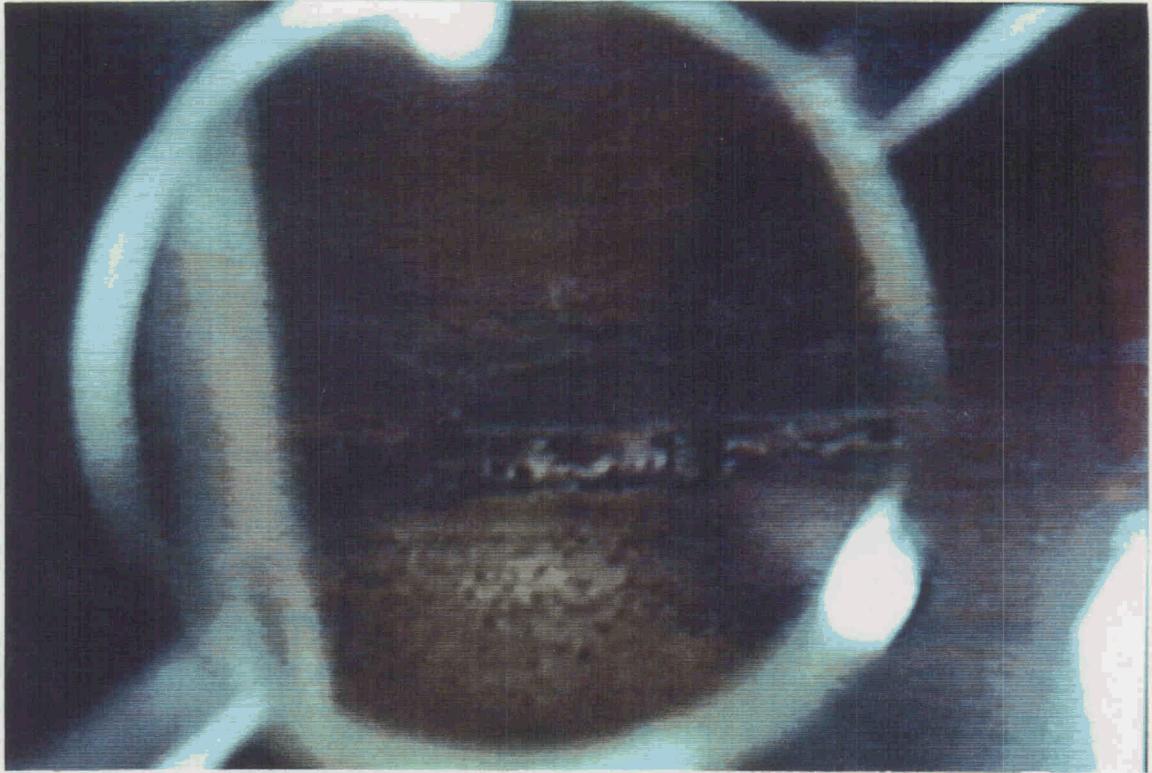
Fig. 7. Welded seam in roof corner of duct with caked dirt on wall.

The duct appeared quite rough (see Figs. 7 and 17) when viewing at it through the TV camera. For this reason, some personnel concluded that the duct wall surfaces might be concrete, not metal. When the magnet showed that it was indeed metal, it became apparent that what was being observed was a buildup of dirt caked onto the lining. This was further substantiated when the 2x4s were moved, pushing the dirt aside and showing in places a shiny metal lining beneath (see Figs. 18-20). Also, dirt buildup could be seen at the turns at the end of the third section of duct, as shown in Fig. 21.

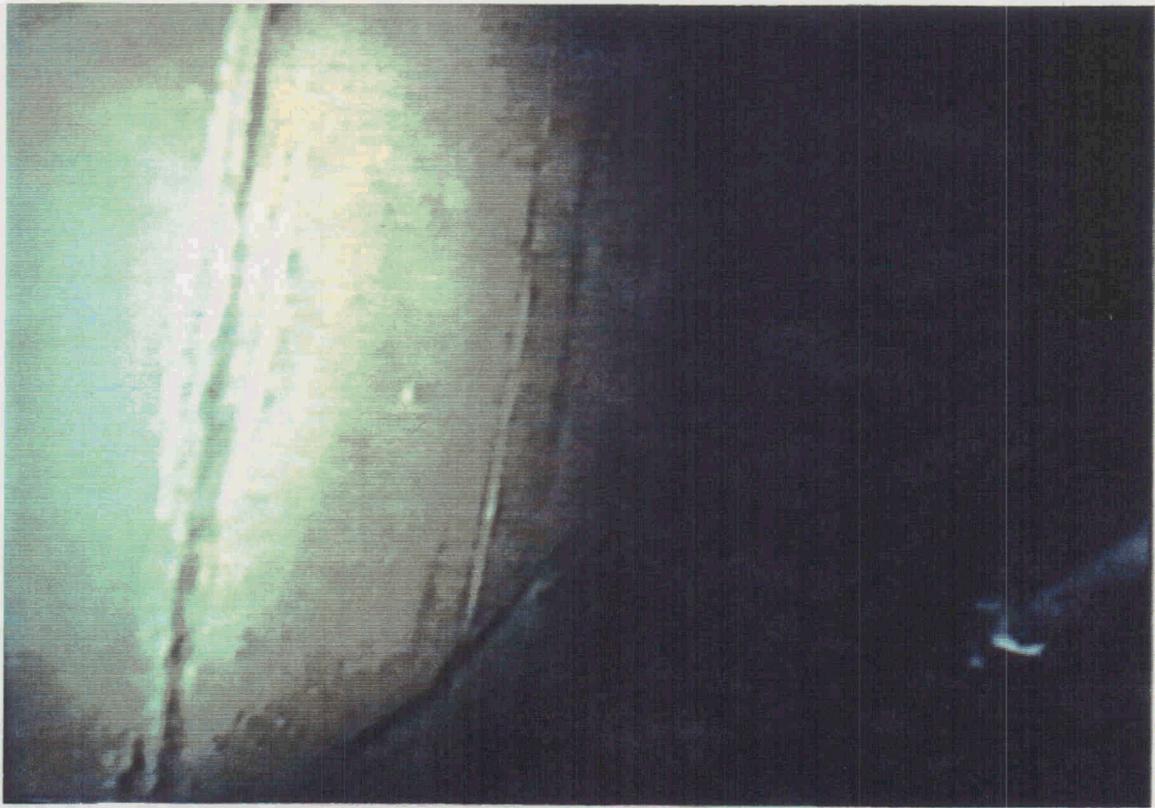
Fig. 8. Welded seam with zinc coating melted back from joint.

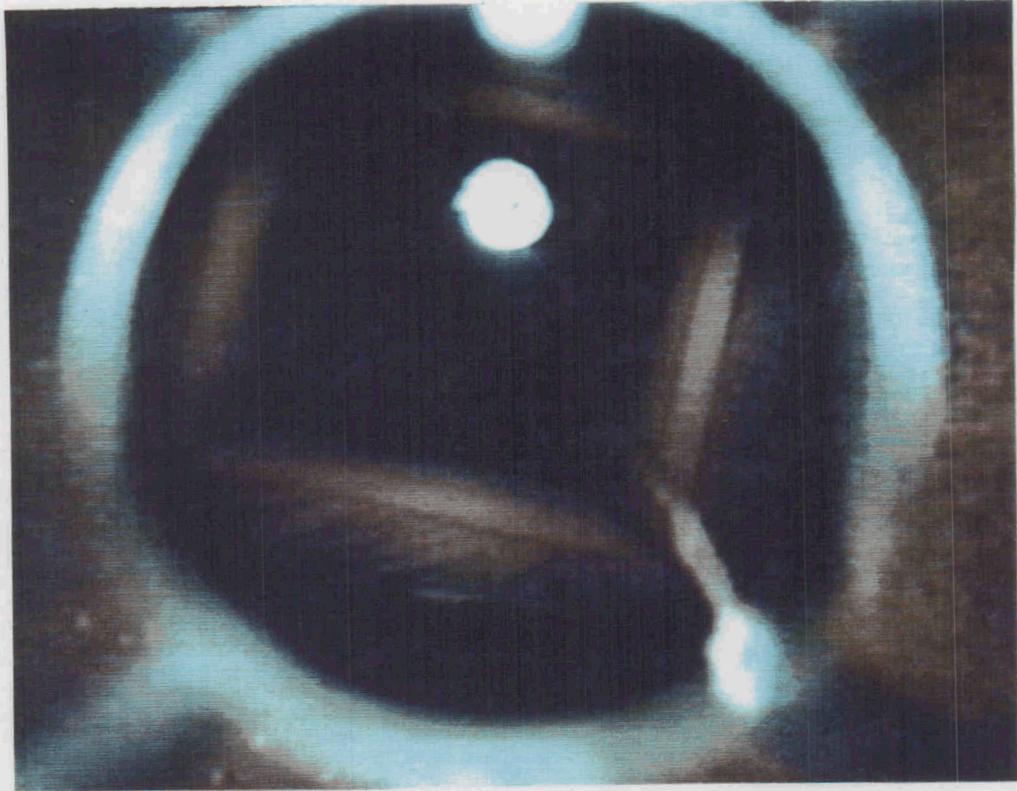
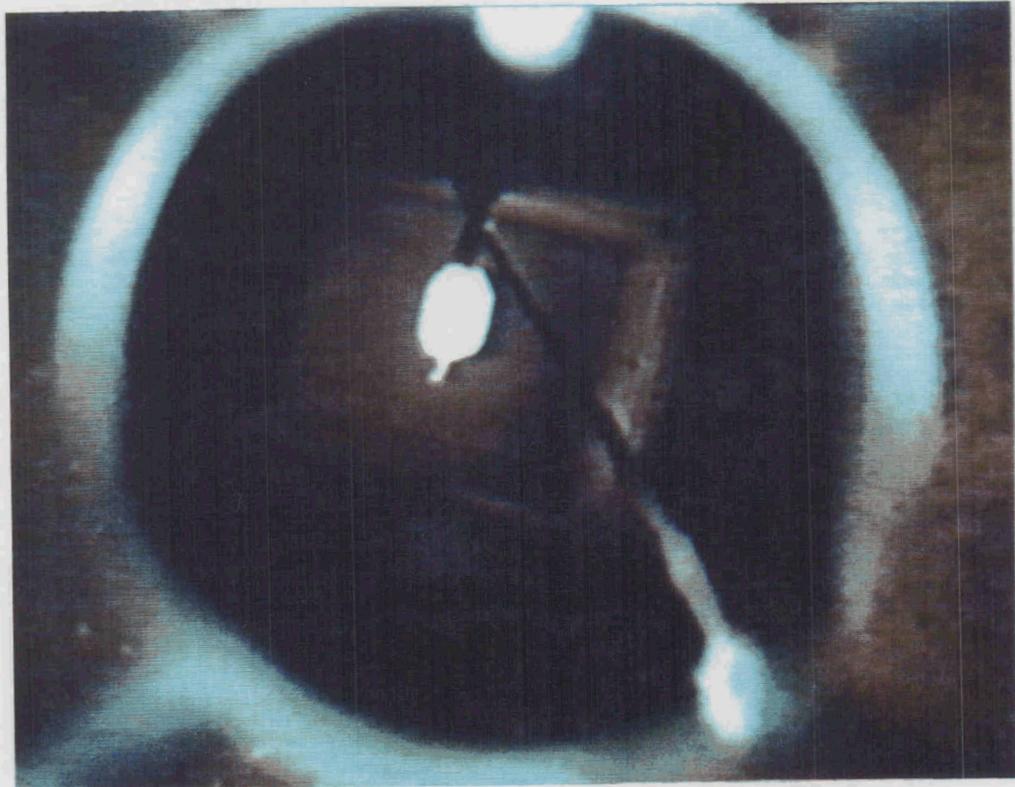
Fig. 9. Two views looking upward into Sect. 5.

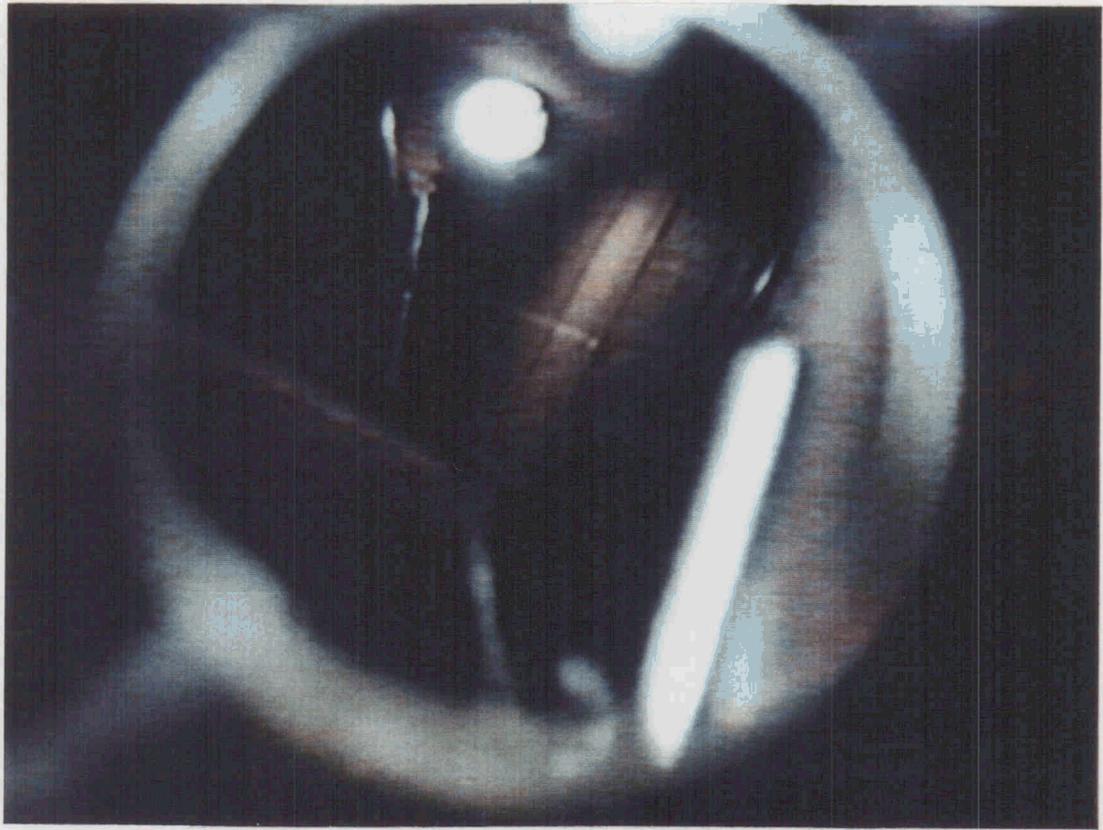
The CCA was equipped with a remote-controlled mirror attachment with the mirror mounted at a 45° angle to the direction of travel. This feature enabled the mirror to rotate so the camera could "see" in any direction perpendicular to the direction of motion so as to inspect the duct wall. It was found that the welded seams in the ductwork looked uniformly satisfactory (see Figs. 5-8). Some small surface rusting was seen where the welding had melted the zinc away from the weld junctions (see Fig. 8), but no other problems were seen. The mirror was also used to look upward in the vertical section of the duct (see Figs. 9a and 9b). A magnet was lowered on a string through that section of the duct to check its four sides for ferromagnetism (see Fig. 10). That duct also was found to be uniformly ferromagnetic.

Fig. 10. Magnet sticking to side of Sect. 5.

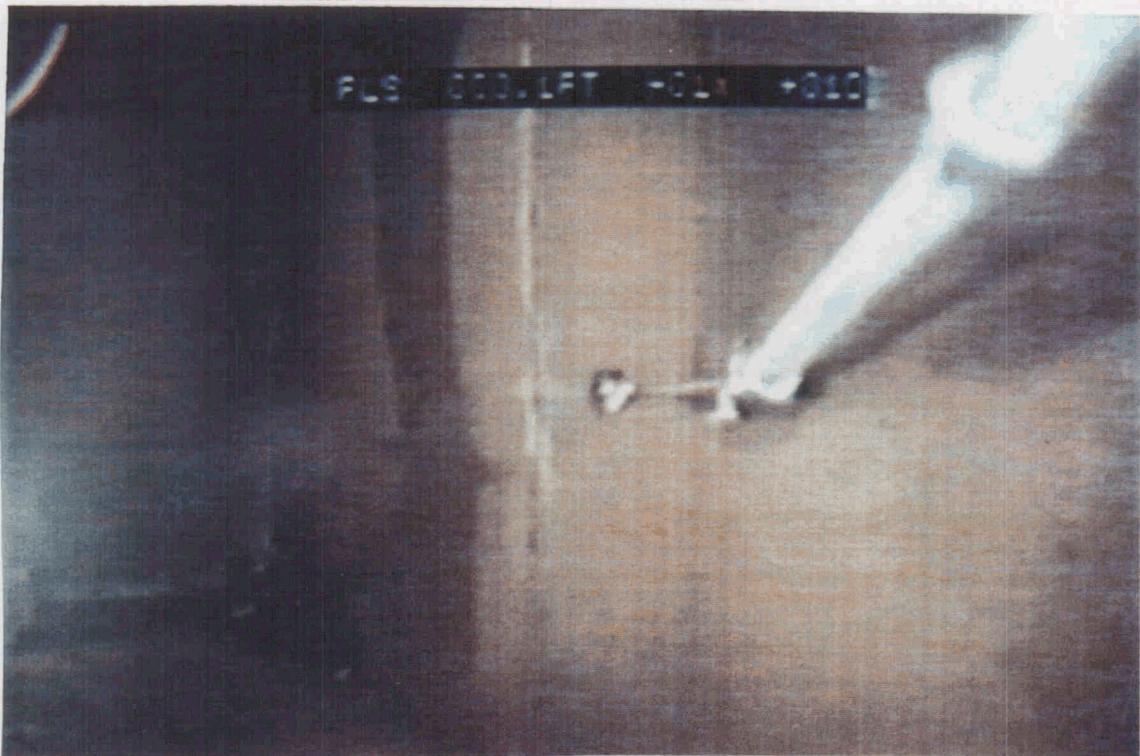
A rod was fastened to the CCA with a magnet tied to it such that the magnet was visible to the video camera. The sides and bottom of the duct were inspected by watching the magnet stick to the ferromagnetic sides (see Figs. 11-14). The top of the ductwork was not directly inspected in this way but, as noted previously, the roof was partially inspected by the worker who crawled into the ductwork. Visual inspection established continuity of the ceiling with the sides (see Fig. 15), showing the uniform metallic nature of the ductwork.

Fig. 11. Magnet being dragged along metallic wall of Sect. 4.

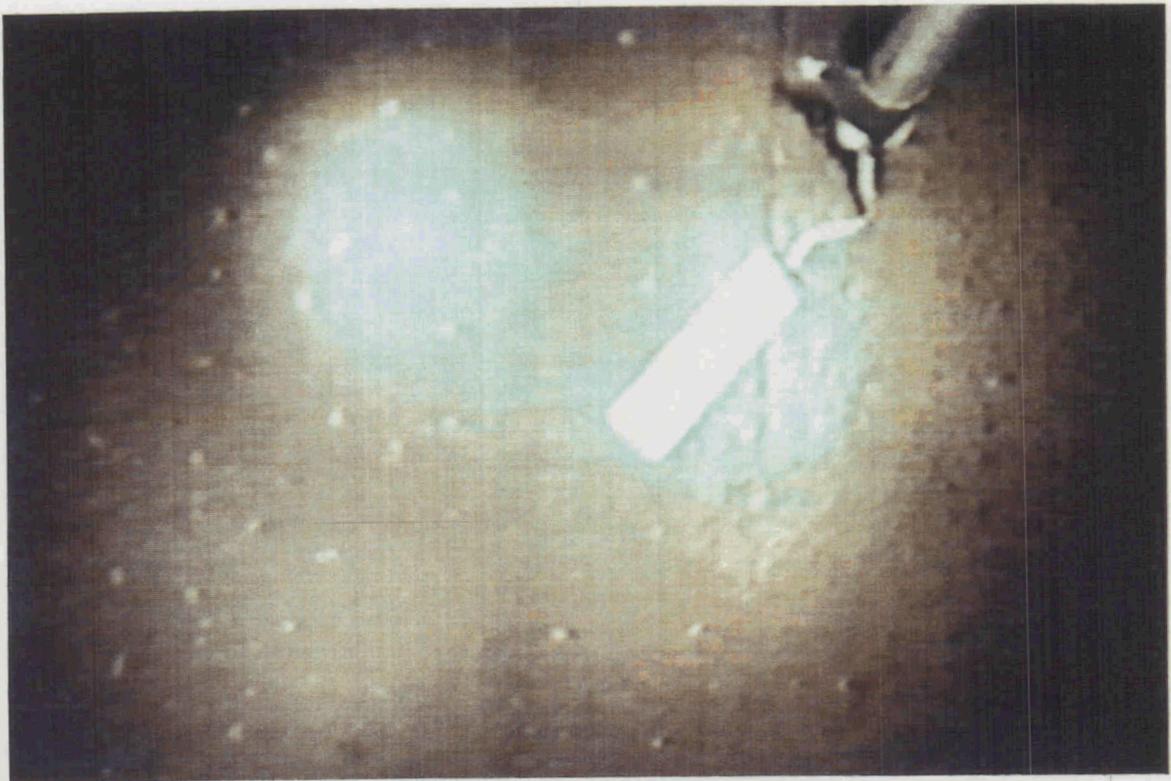
Fig. 12. Magnet sticking to wall at end of Sect. 3.

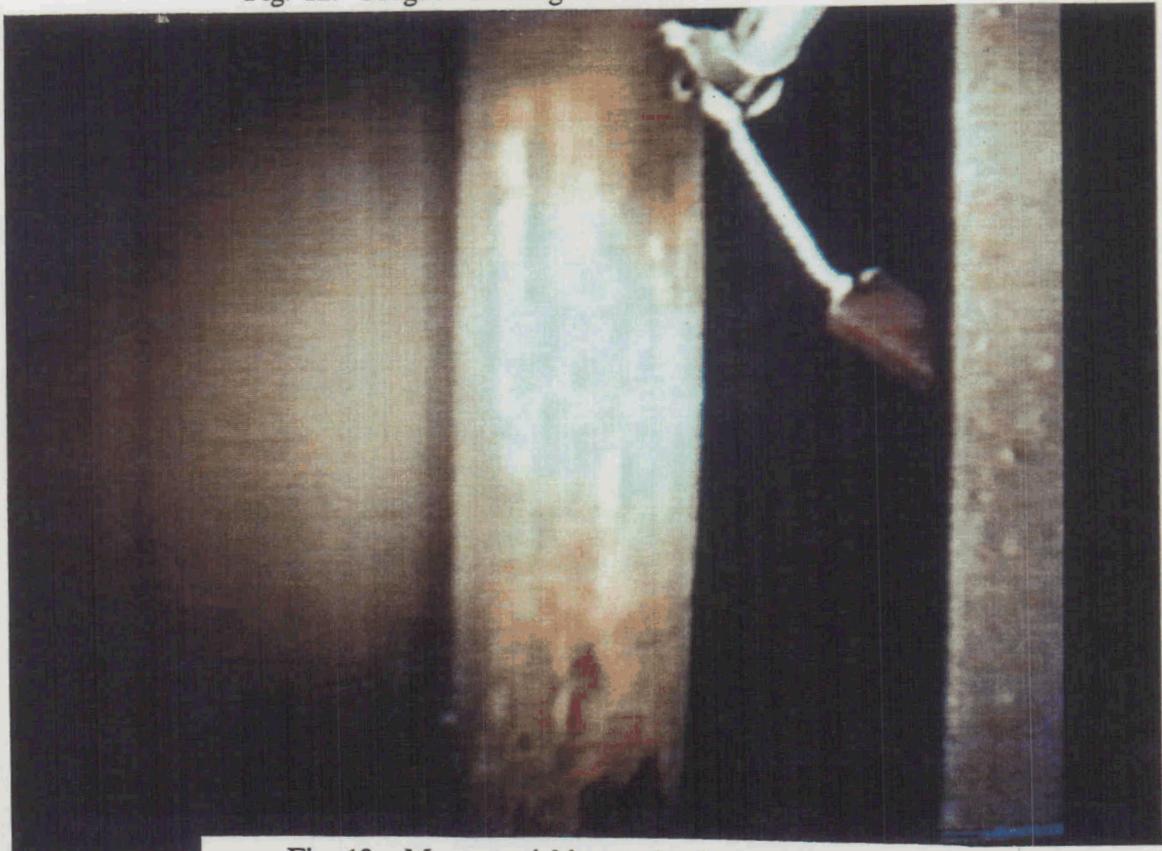
Fig. 13. Magnet sticking to beginning of Sect. 4.

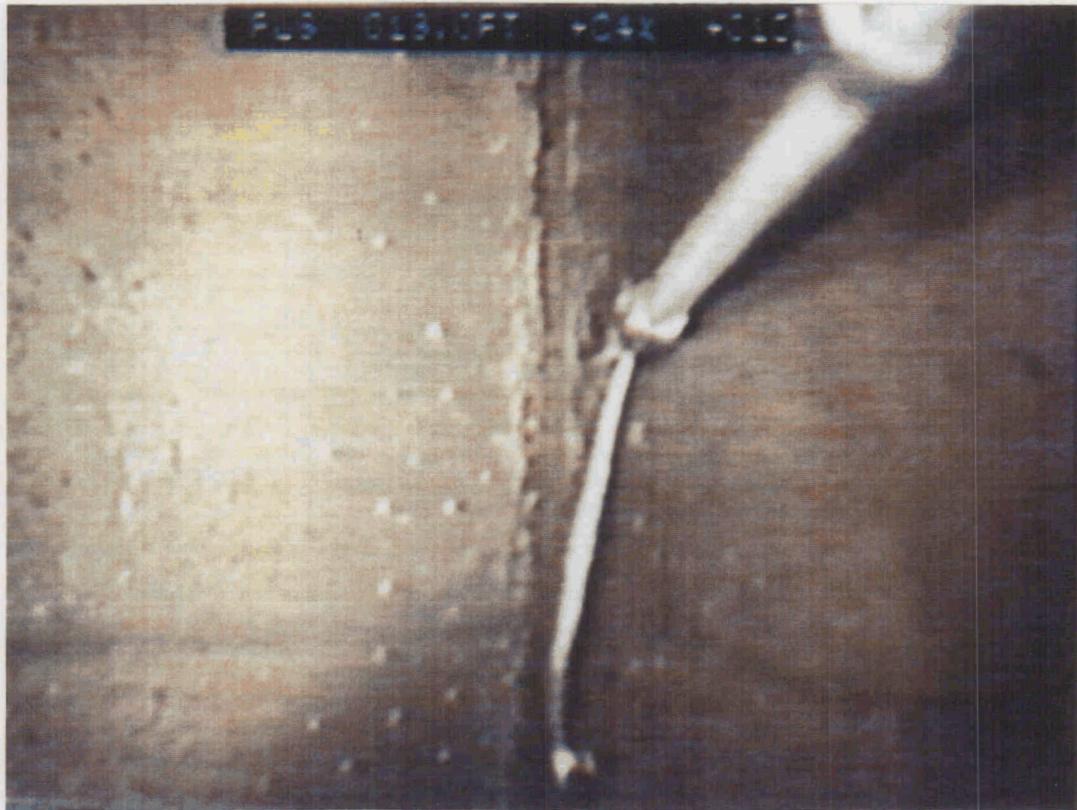
Fig. 14. Magnet sticking to end of Sect. 4.

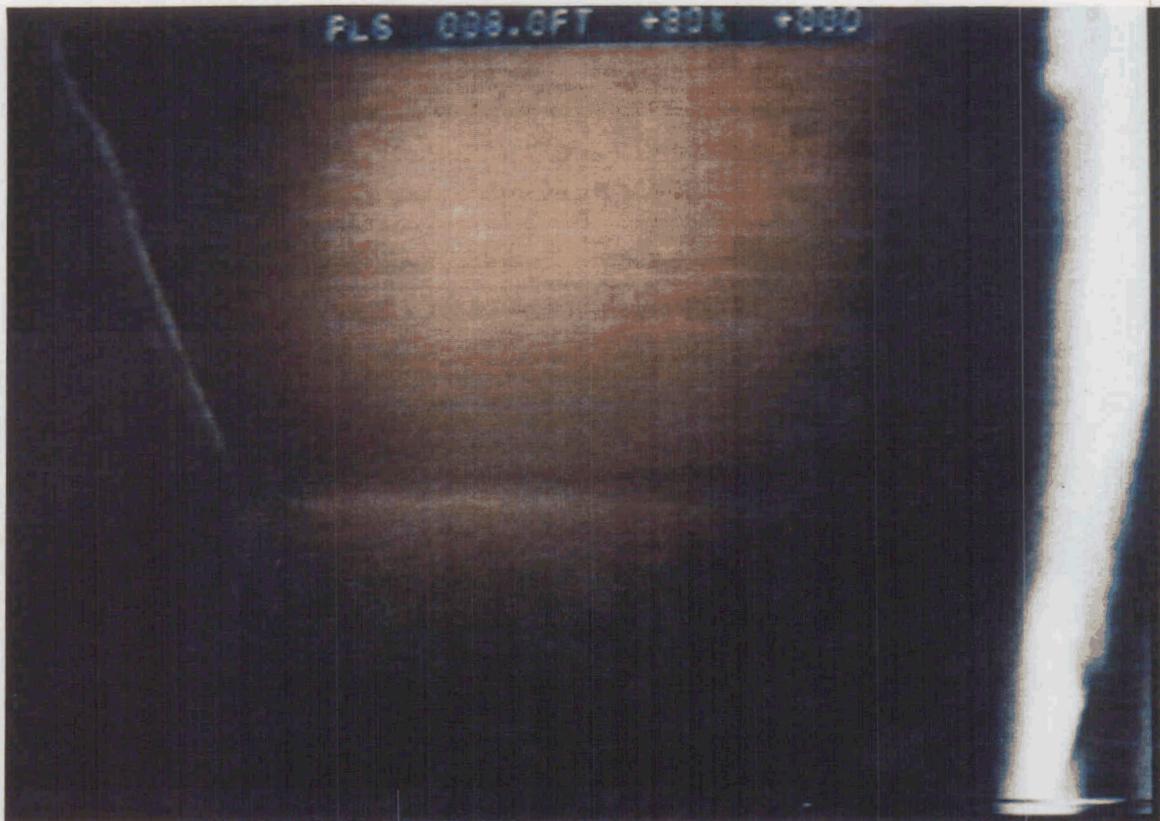
Fig. 15. View of Sect. 3 roof showing metal continuity.

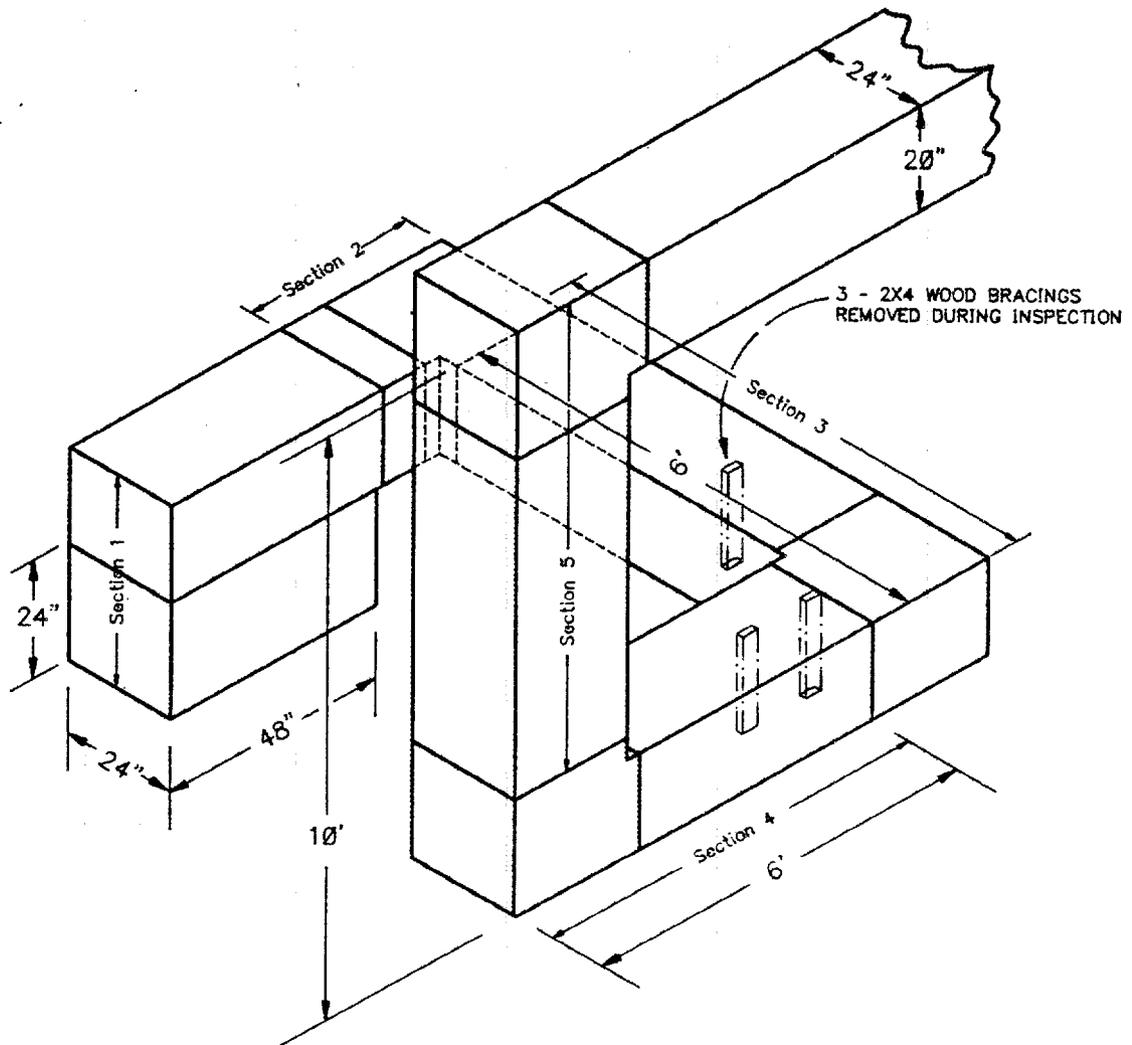
Fig. 16. Drawing of actual duct.

With the detector fastened to the crawler as shown in Fig. 2, the ductwork floor and right-hand wall were inspected for beta and gamma radiation. The detector was ~0.5 in. from these surfaces during the inspection. Of course, the detector was repositioned from that shown in Fig. 2 for inspection of the wall. The readings taken are presented in Tables 2 and 3. All of the readings shown in these tables were taken in section 3 of the duct as shown Fig. 16.

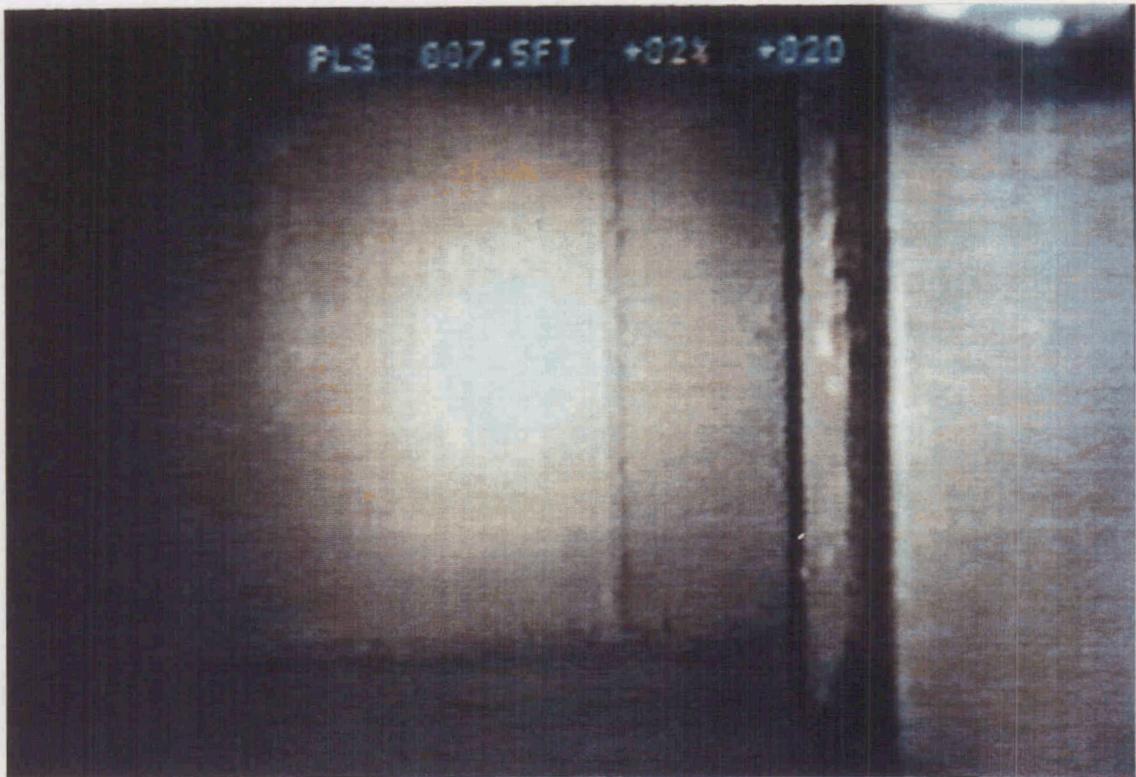
When the crawler was initially inserted into the duct, one of the first things observed was a piece of 2x4 (probably used for bracing during construction) standing vertically in the path of the CCA in the third section of the duct, as shown in Fig. 22. It was a standard wooden 2x4, and from the coarseness of the grain it appeared to be made of pine. The 2x4 had to be removed to allow the inspection to proceed. Because concrete had been poured on the top of the duct, the 2x4 was wedged in quite tightly. A suited person leaned into the duct and rapped the 2x4 sharply with a crowbar to dislodge it. It moved, splintering at the bottom end as it did so. This was visible from the camera. When the 2x4 was removed, it was found to be covered with dirt. When the fourth section of the duct was investigated, two additional 2x4s were noticed (see Figs. 17, 23a, and 23b), and these also were removed. The approximate original positions of all removed 2x4s are shown in the drawing of the actual duct (see Fig. 17). A summary of this manual removal operation follows.

Fig. 17. End of section 3 showing 2x4 in beginning of section 4.

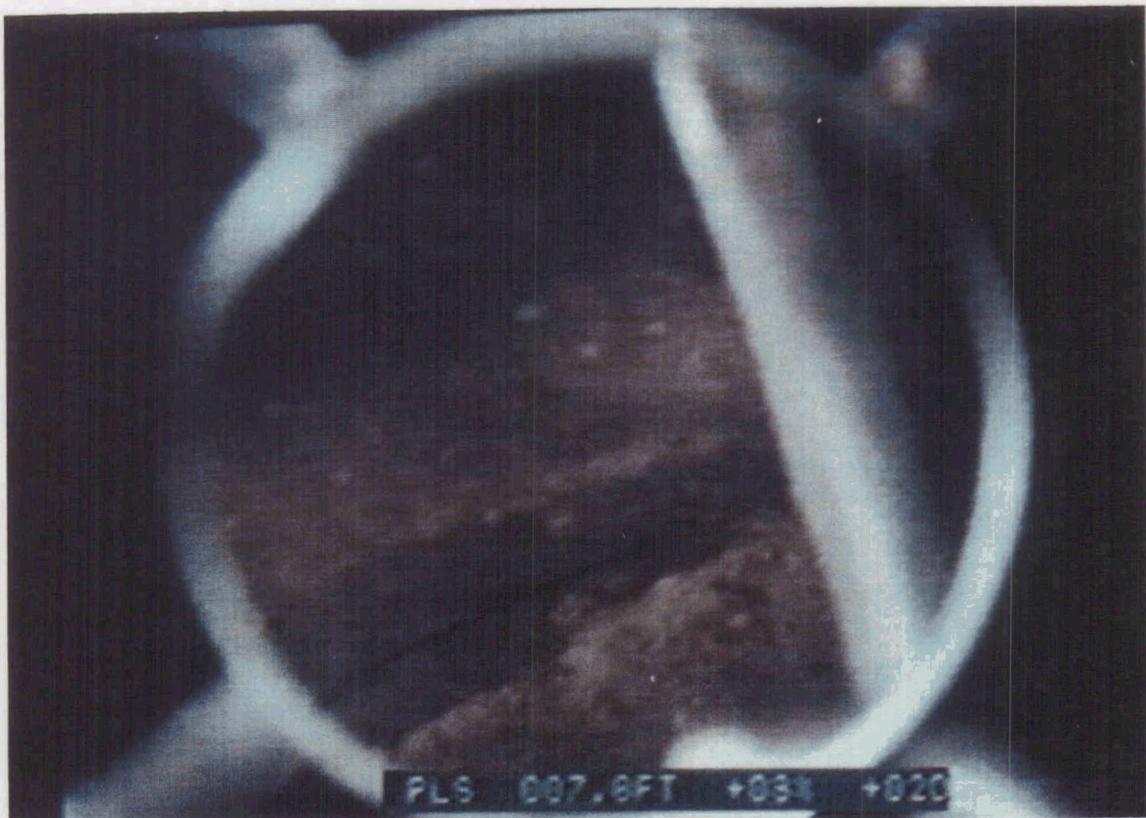
Fig. 18. Spot where 2x4 was dragged on floor of section 3.

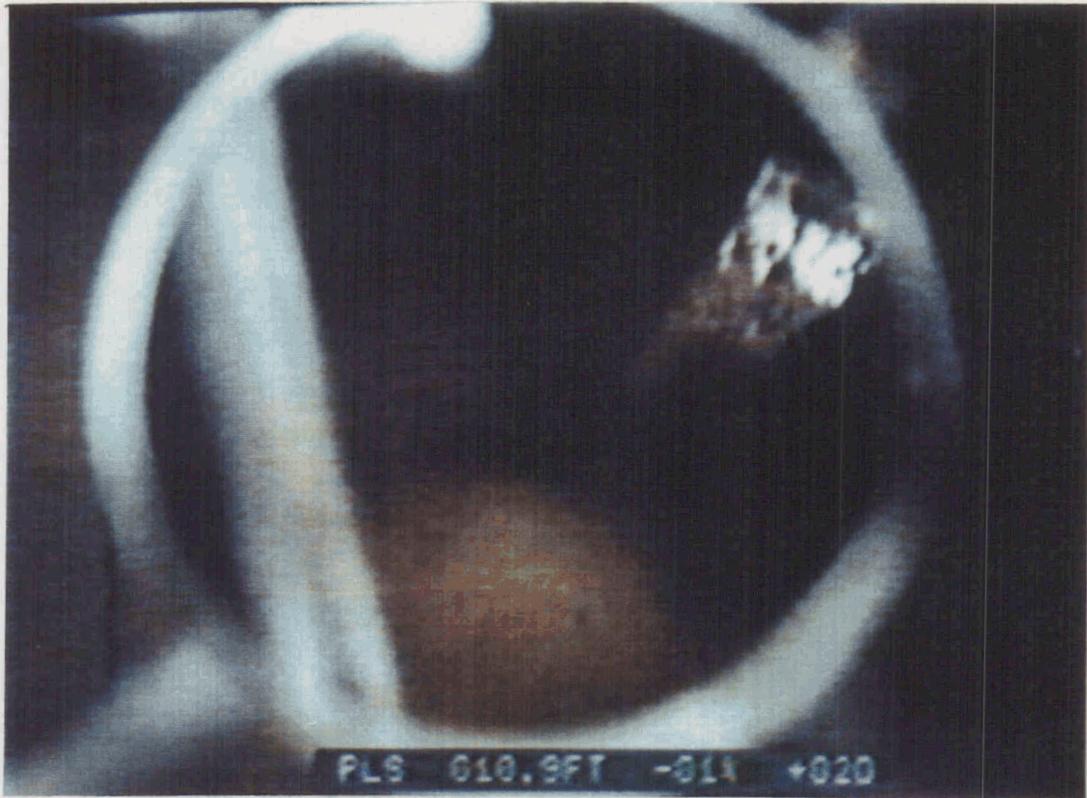
Fig. 19. Bright metal surface on roof of duct in section 4 where wedged 2x4 was removed.

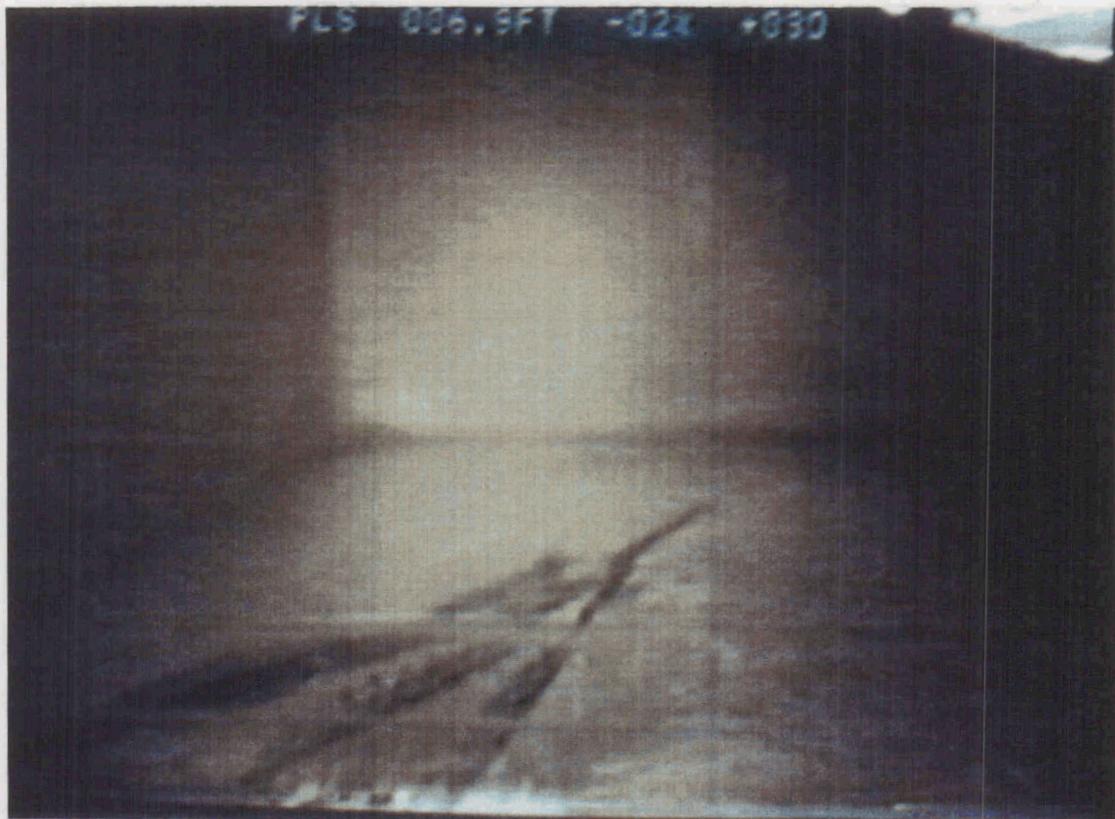
Fig. 20. Section 3, showing skid marks where 2x4 was removed.

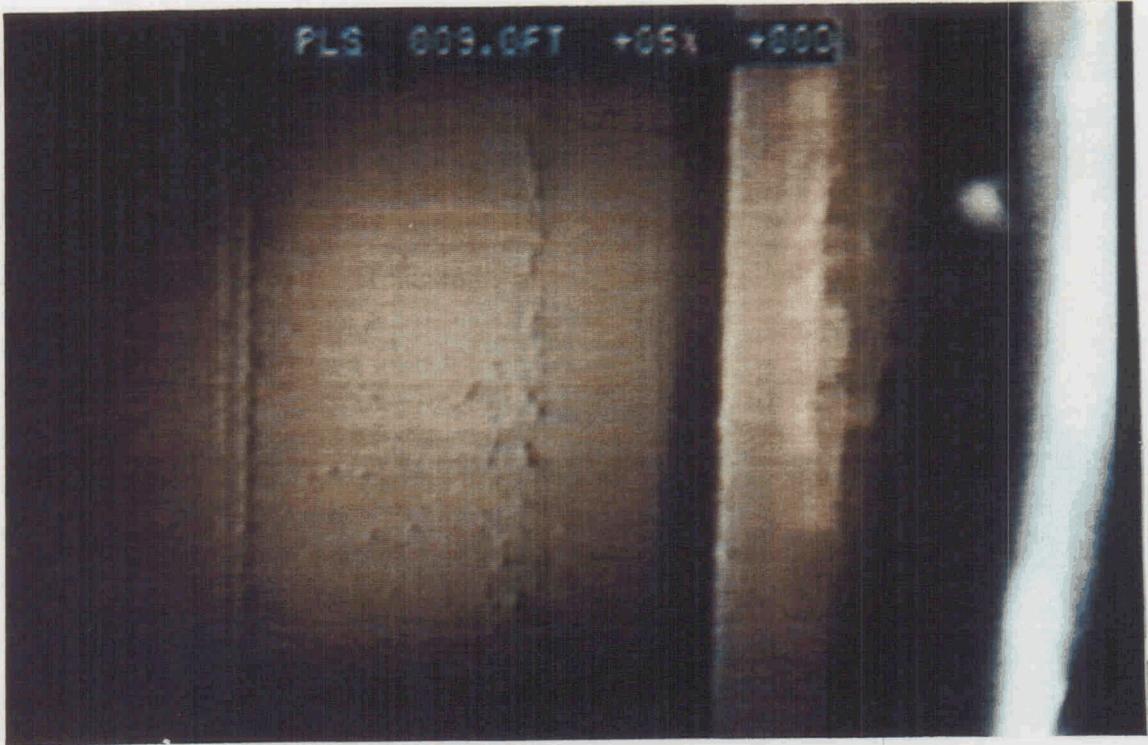
Fig. 21. Dirt buildup at end of section 3.

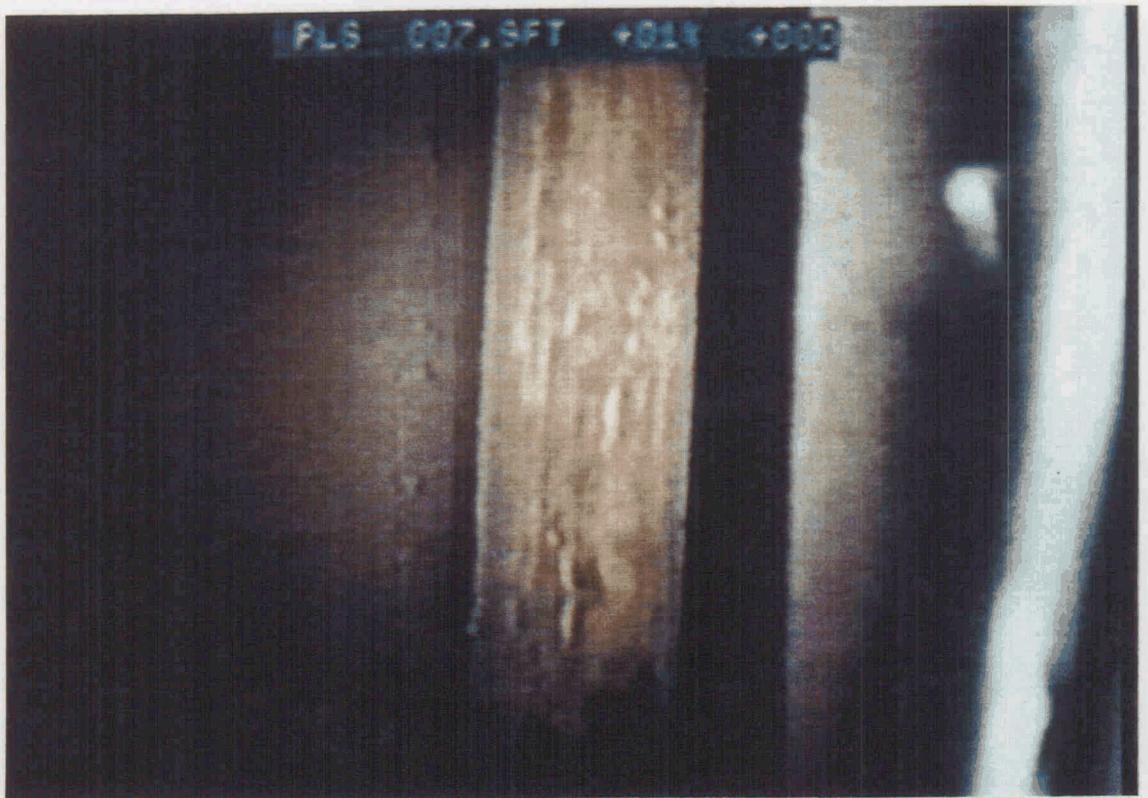
Fig. 22. View of 2x4 at beginning of section 4.

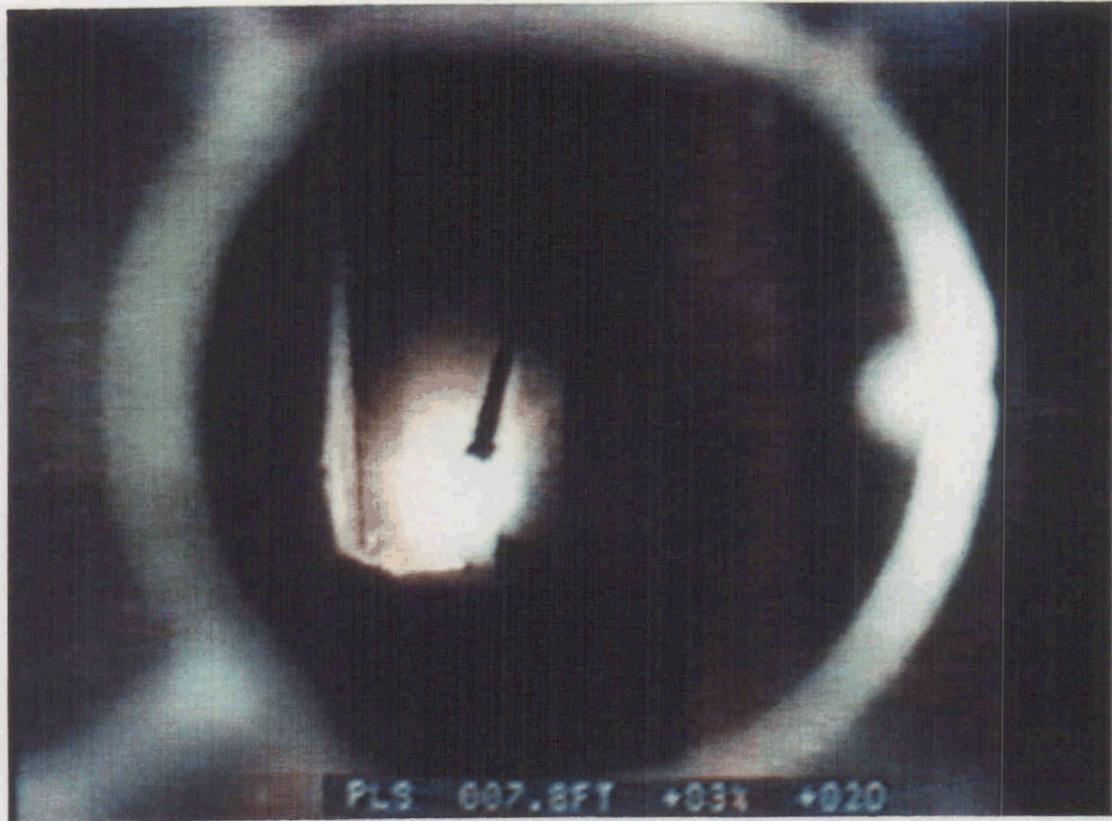
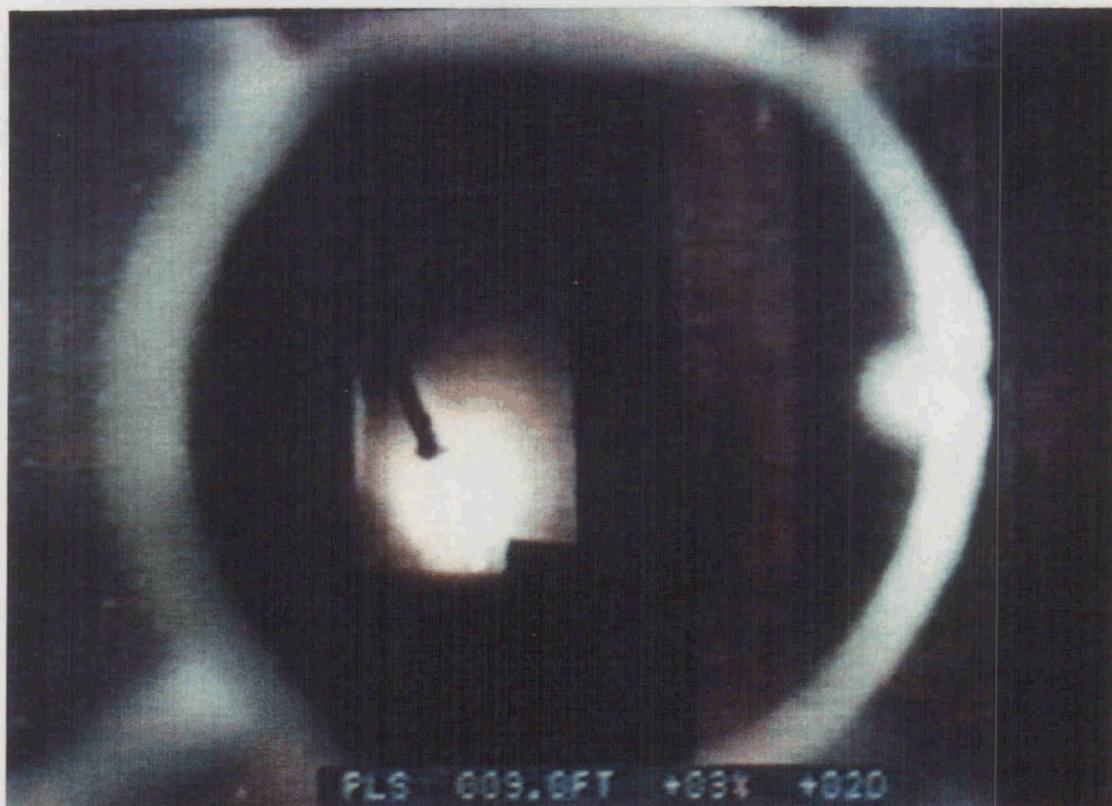
Fig. 23. Two views of unexpected portion of section 4 as viewed with mirror attachment looking right from vehicle showing lamp on cord.
