ORNL/TM-12626

**MERCURY AUDIT AT
ROCKY MOUNTAIN ARSENAL**

DATE PUBLISHED - FEBRUARY 1994

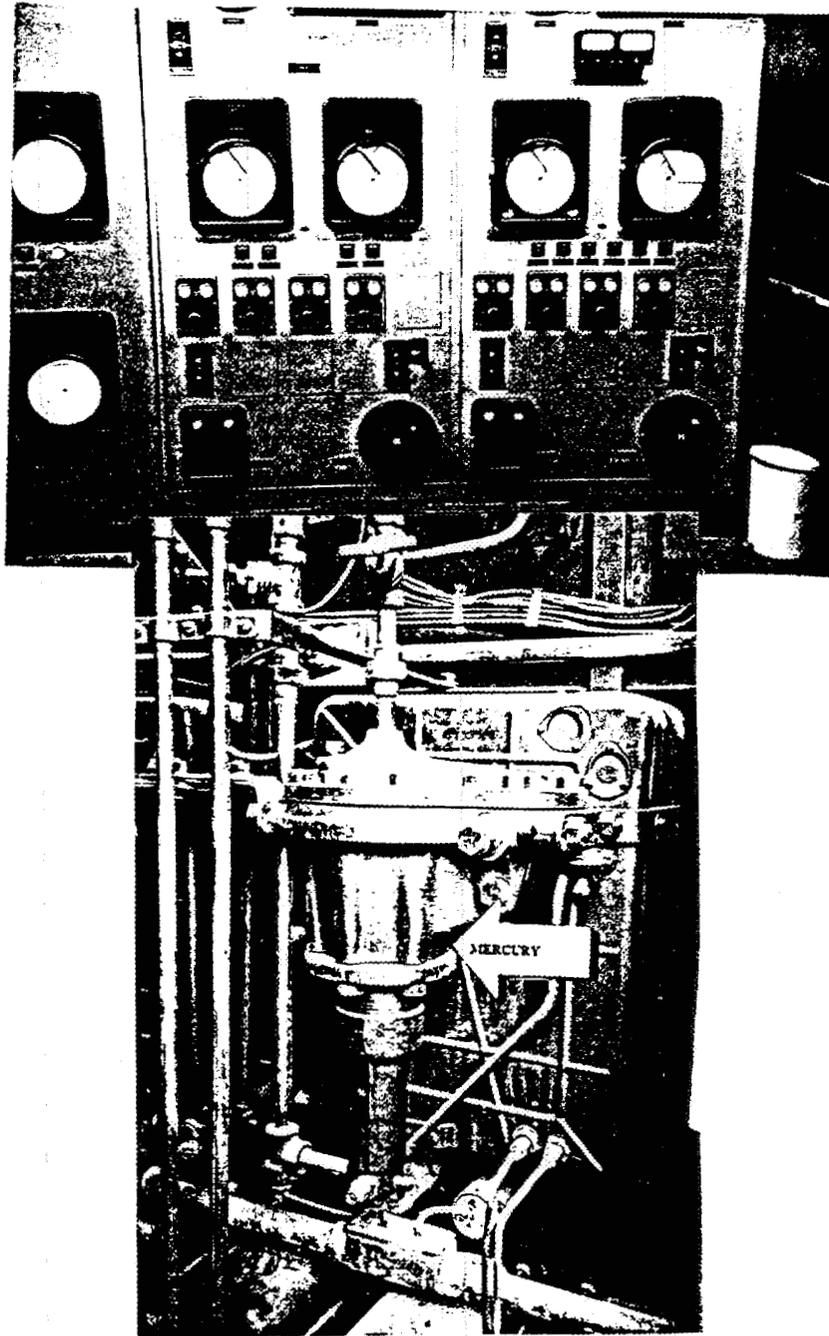
Visible mercury spills were found in Buildings 321, 346, 411a, and 1706. The spills in Buildings 321, 346, and 411a were from instruments with leaking mercury pots. Figure 1 top shows a typical instrument control panel utilizing mercury pots; Fig. 1 bottom shows a back view of a portion of the same instrument panel with the mercury pot attached to the back of a round chart recorder. The spill detected in Building 1706 was the result of a broken thermostat. In addition to these four mercury spills, there were two buckets in Building 346 containing bottles of mercury drained from old mercury pots. Mercury vapors were leaking from these containers.

Fig. 1. Front view of instrument control panel and rear view showing mercury pot.

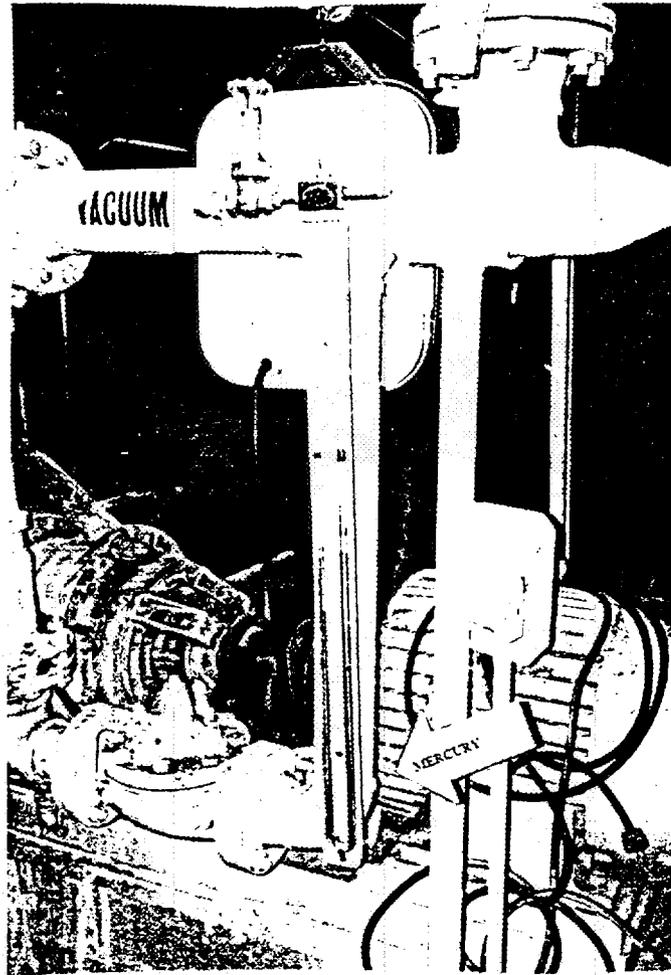
The remaining detection was at an old manometer located in Building 243. A similar mercury-containing manometer is shown in Fig. 2.

Fig. 2. Mercury-containing manometer.

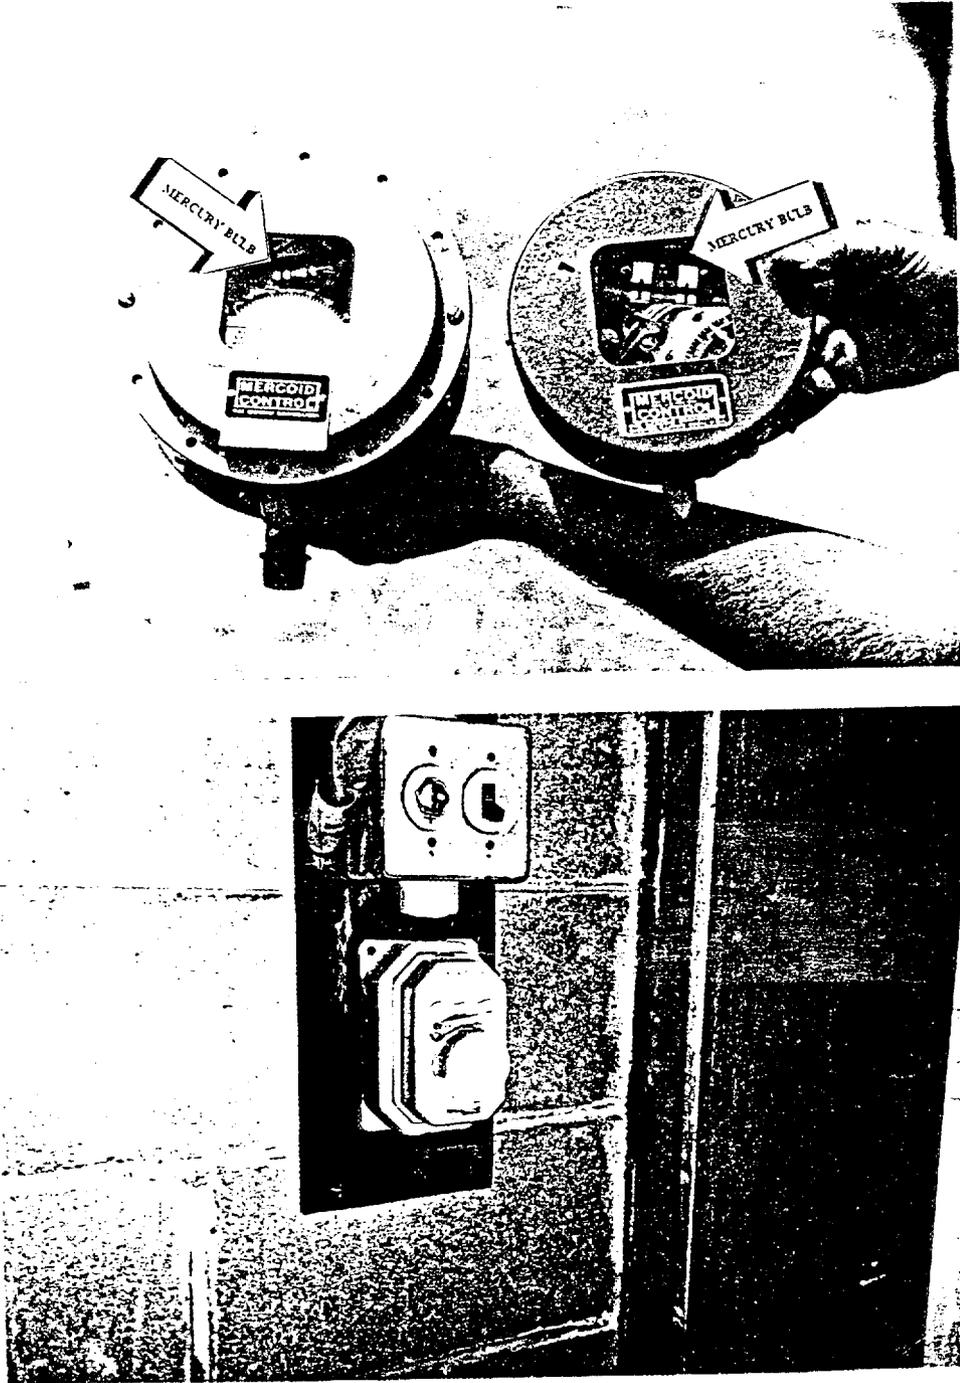
In addition to the mercury-containing instruments shown in Figs. 1 and 2, several other commonly found instruments containing mercury bulbs were photographed to aid with any remedial action that may follow. Figure 3 shows two Mercoid controls and a Mercoid thermostat, both commonly found on machinery at the RMA. The color of the controls varies from black to green. All are round, with mercury bulbs visible through a glass window. A Mercoid thermostat was found in Building 1706 with a broken mercury bulb. Another common mercury-containing thermostat is the round Honeywell™ thermostat (no picture available). Not all of the thermostats used at RMA contain mercury.

Fig. 3. Mercoid controls and Mercoid thermostat.

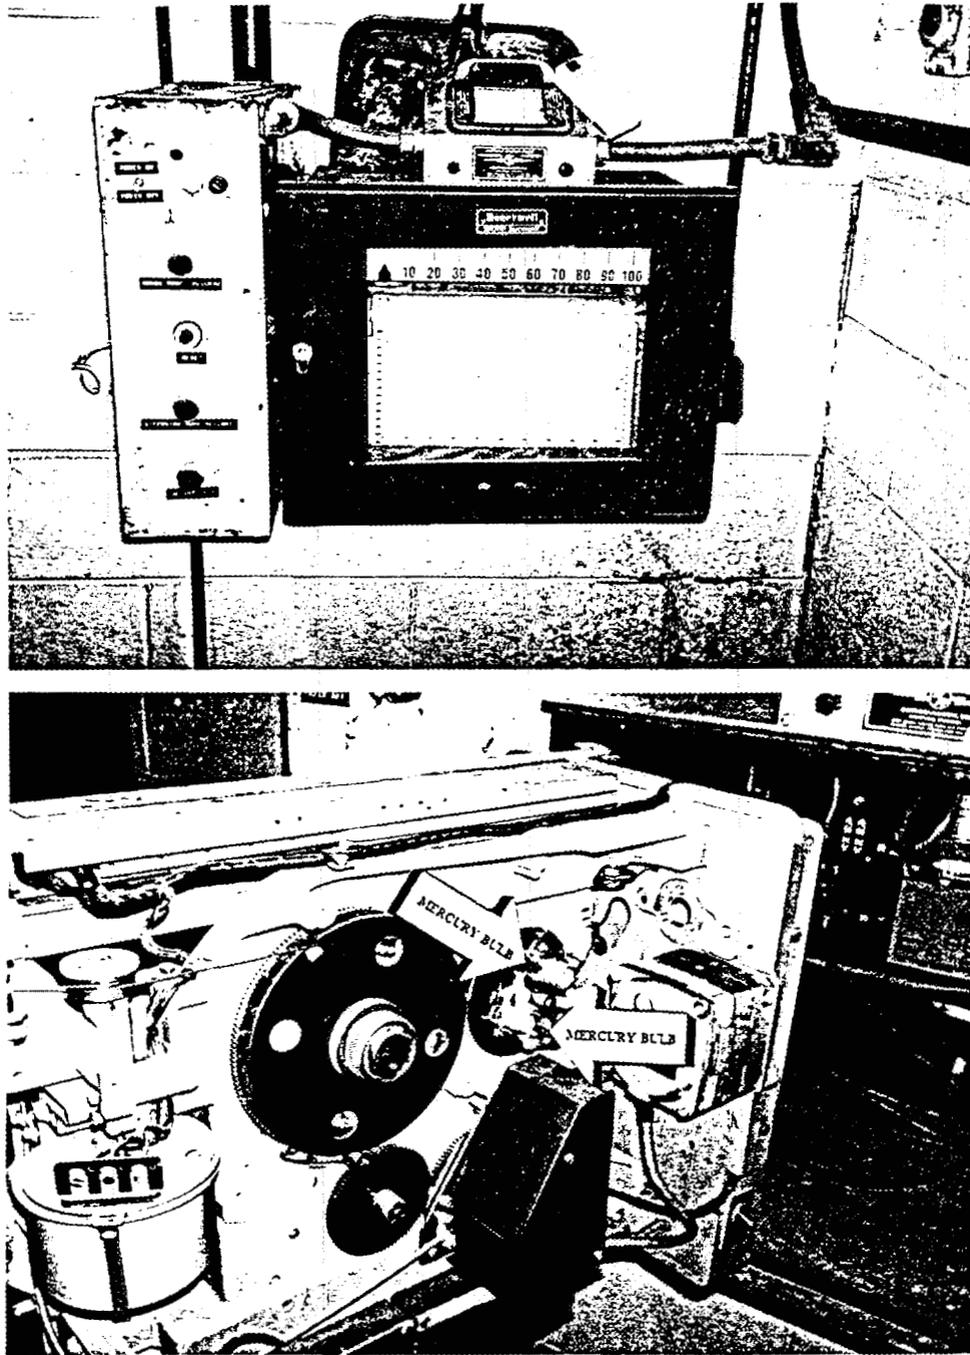
Figure 4 shows the front and back of a Honeywell™ chart recorder and the locations of the mercury bulbs. These recorders typically had two to four mercury bulbs.

Fig. 4. Honeywell™ chart recorder with inside view of mercury bulbs.

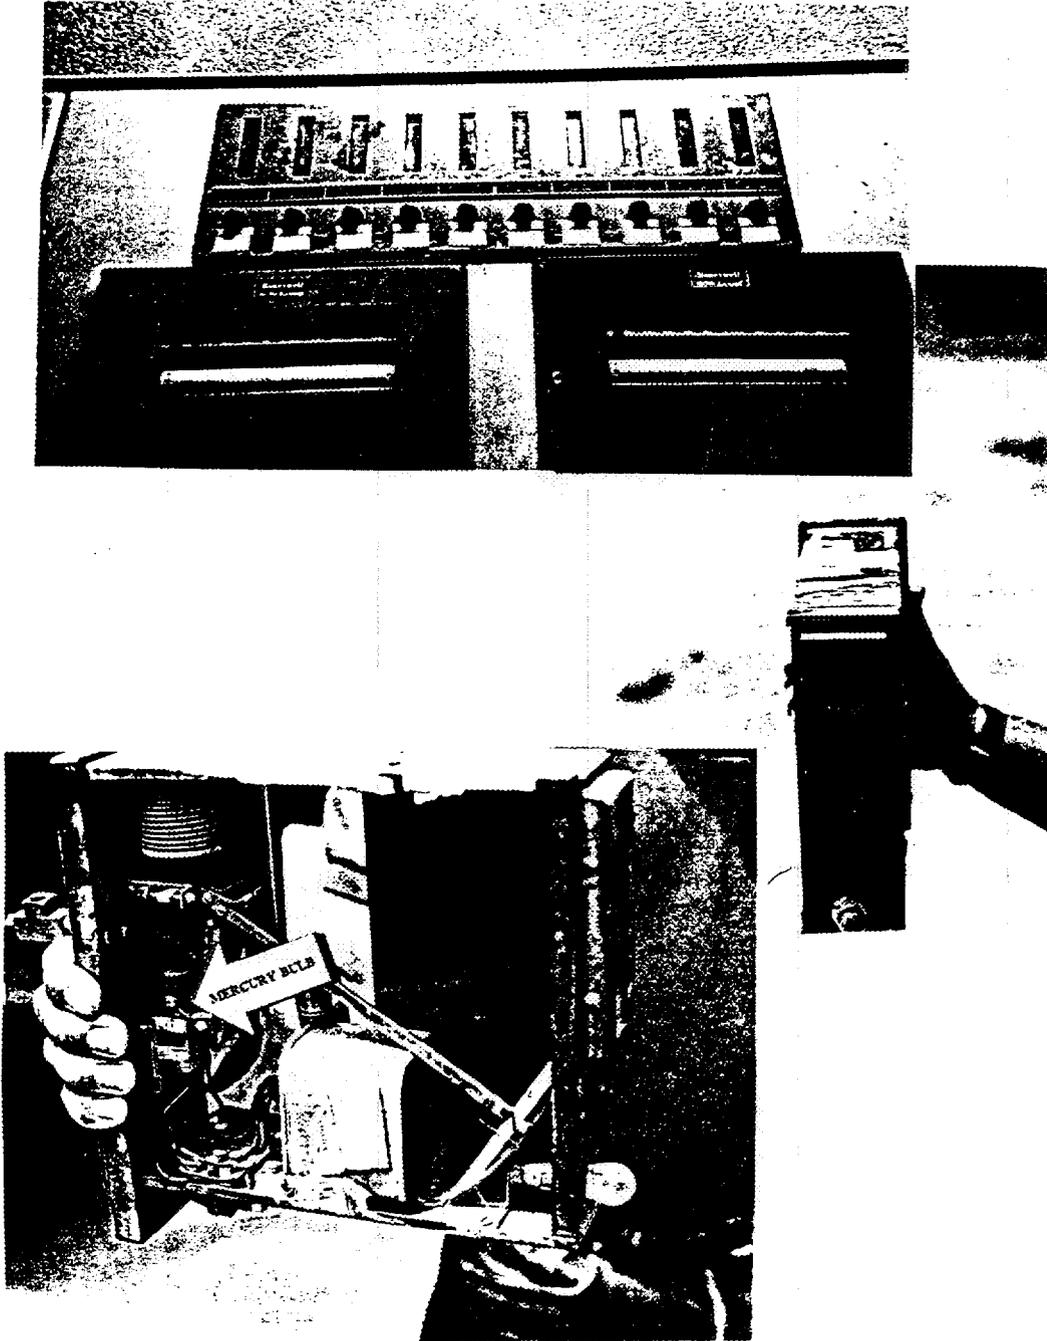
Figure 5 shows a control panel with 10 Panalarm™ controls. Also shown are an individual Panalarm™ detached from the control panel and a side view of the instrument.

Fig. 5. Panalarm™ gauge, front and rear view.

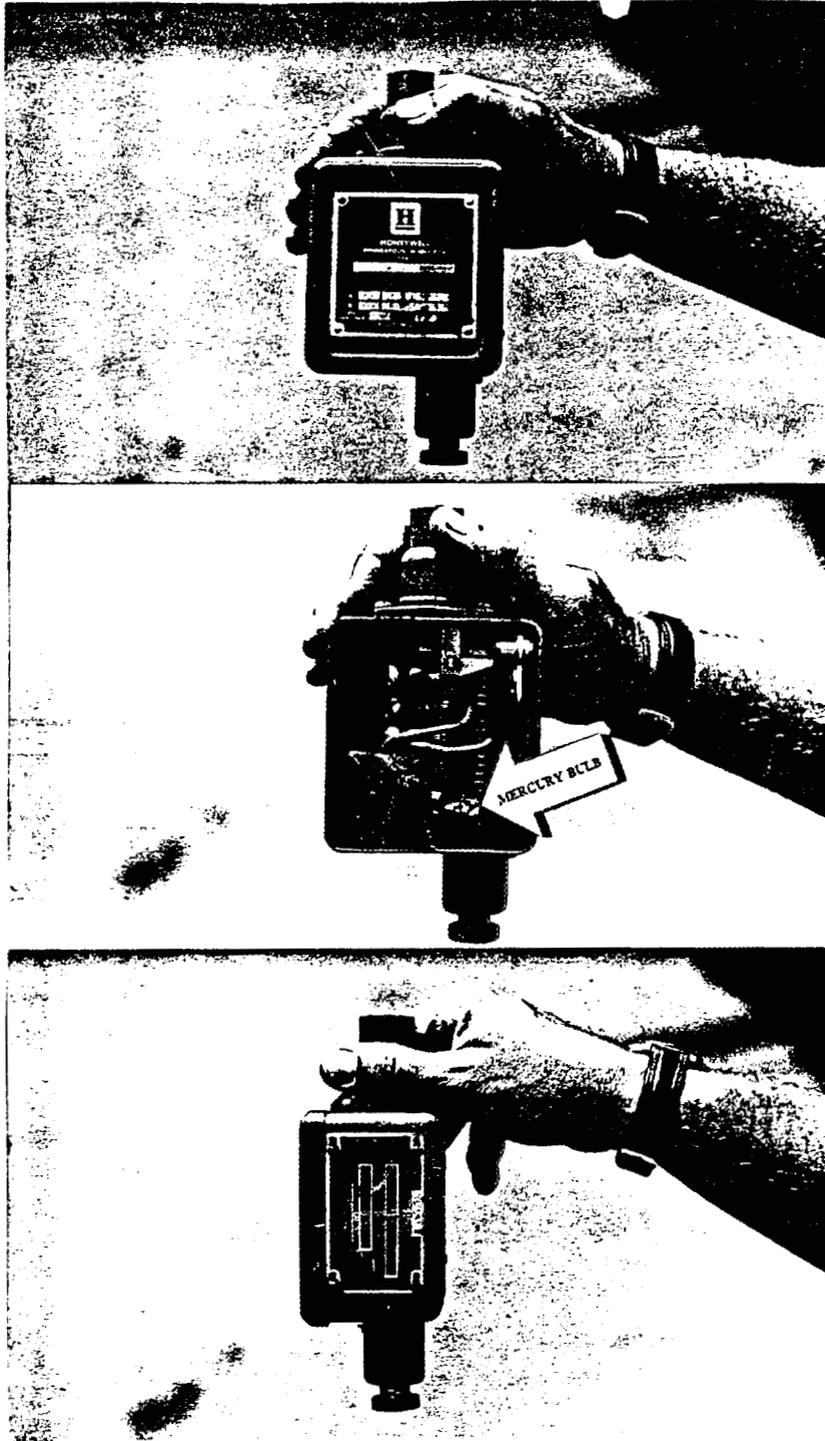
Figure 6 and the top of Fig. 7 are pictures of Pressuretrol™ instruments. Several different types of these instruments were located at the RMA, some appearing to be newer than others. Mercury bulbs are indicated.

Fig. 6. Honeywell™ Pressuretrol™ switch with mercury bulb.

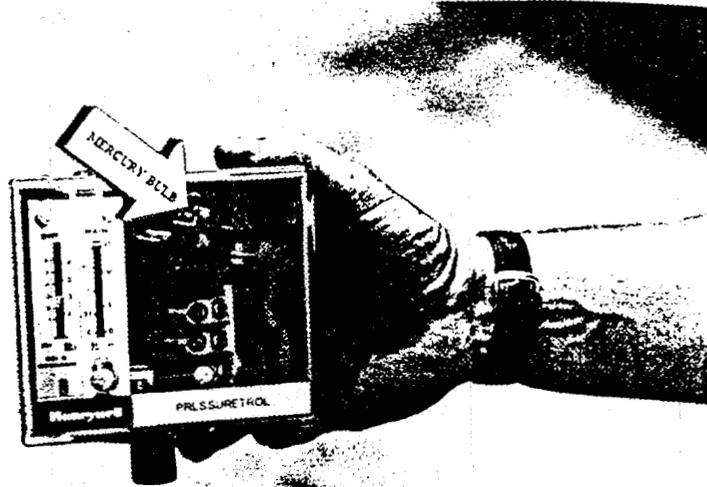
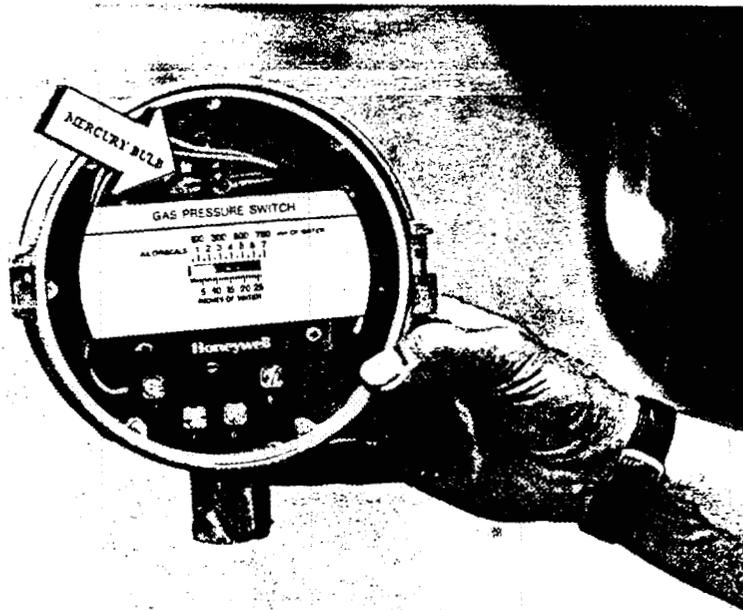
A Honeywell™ gas pressure switch appears as the bottom picture in Fig. 7. Many of these switches are located in boxes in storage areas and supply cabinets; however, none were located on machinery.

Fig. 7. Honeywell™ Pressuretrol™ switch and Honeywell™ gas pressure switch.
