Timber-Frame Walls: Feasible with a Damaged Vapor Barrier?

Ernst Jan de Place Hansen, PhD

Erik Brandt

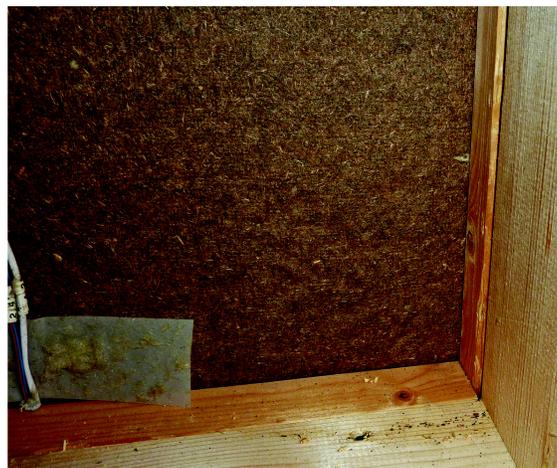
In general, inspection of elements with an intact vapor barrier showed a moisture content behind or in the wind barrier below the critical level, although the moisture content in the

Figure 9 Inner side of the wind barrier after four years of exposure: element 14, facing north (vertical weatherboard, no cavity, wind barrier: asphalt-impregnated wood fiberboard).
