*Evaluation of Mechanical Reliability of  $\text{Si}_3\text{N}_4$   
Nozzles After Exposure in an Industrial Gas Turbine*

*H. T. Lin and M. K. Ferber*  
**Metals and Ceramics Division**  
**Oak Ridge National Laboratory**  
**Oak Ridge, TN 37831-6068**

*Mark van Roode*  
**Solar Turbines Incorporated**  
**San Diego, CA 92186**

**7th International Symposium on Ceramic Materials and Components for Engines**  
**Goslar, Germany, June 19-21, 2000**

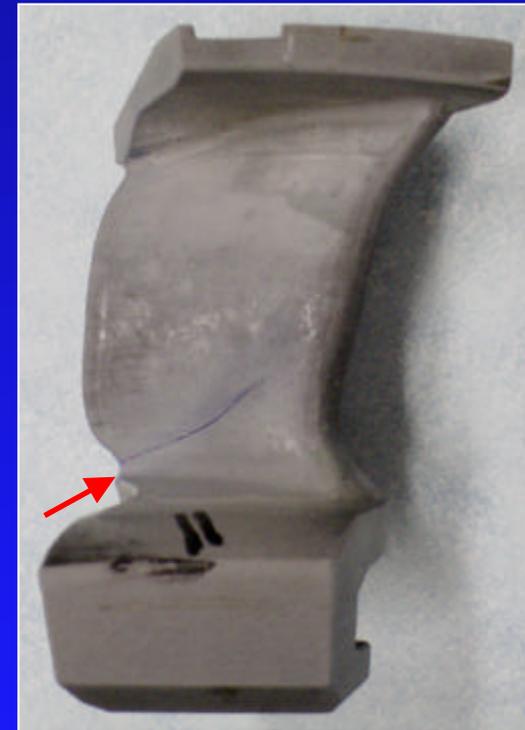
68 h test

**Crack observed after 68 h engine operation with 15 start/stop cycles**

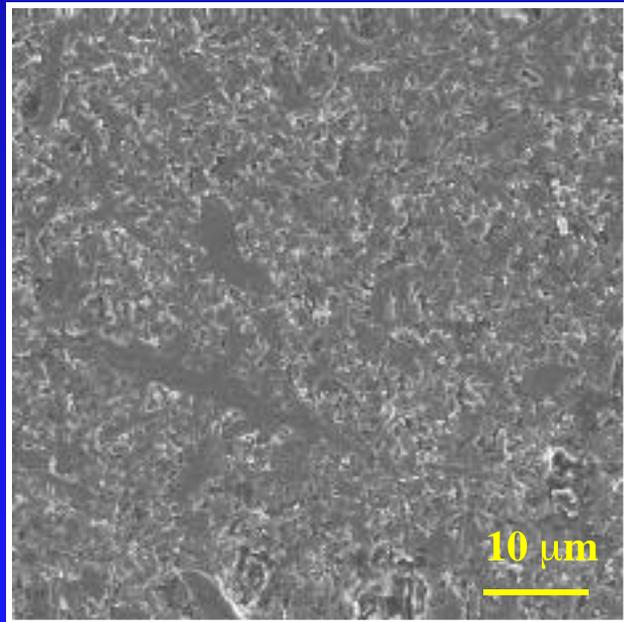
**Non-pressured side**

# *Minor Surface Pitting Observed on Airfoil Surface of SN88 Nozzles After 10 h Engine Exposure*

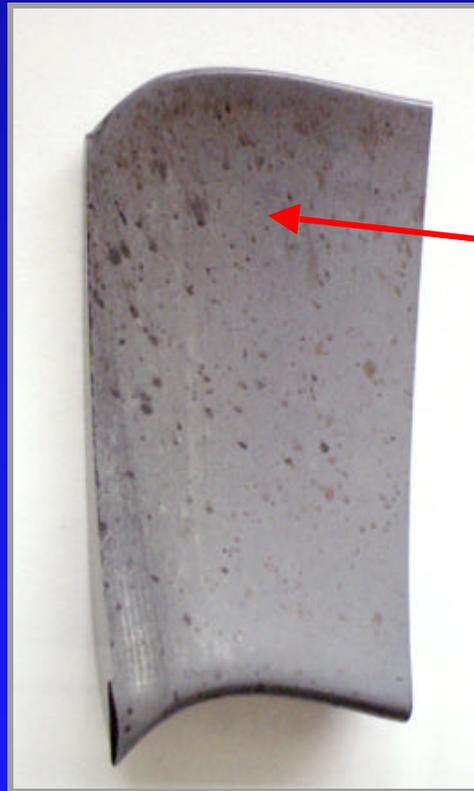
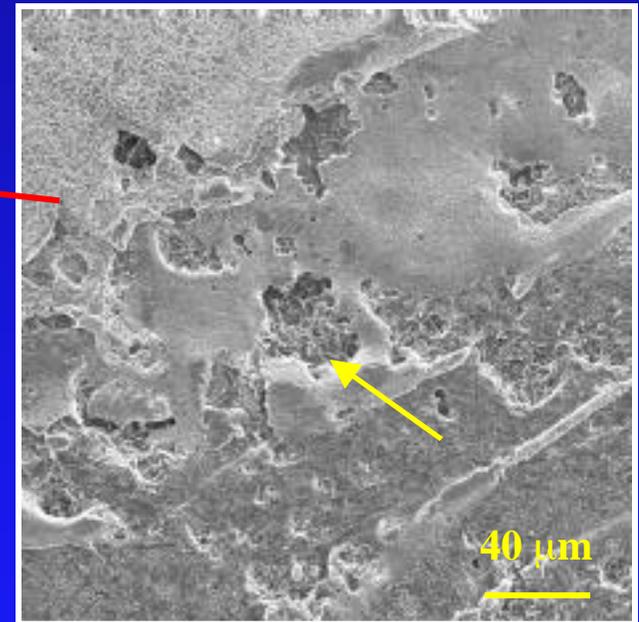
**N768\_16 after 10 h field test**

**Pressured side**

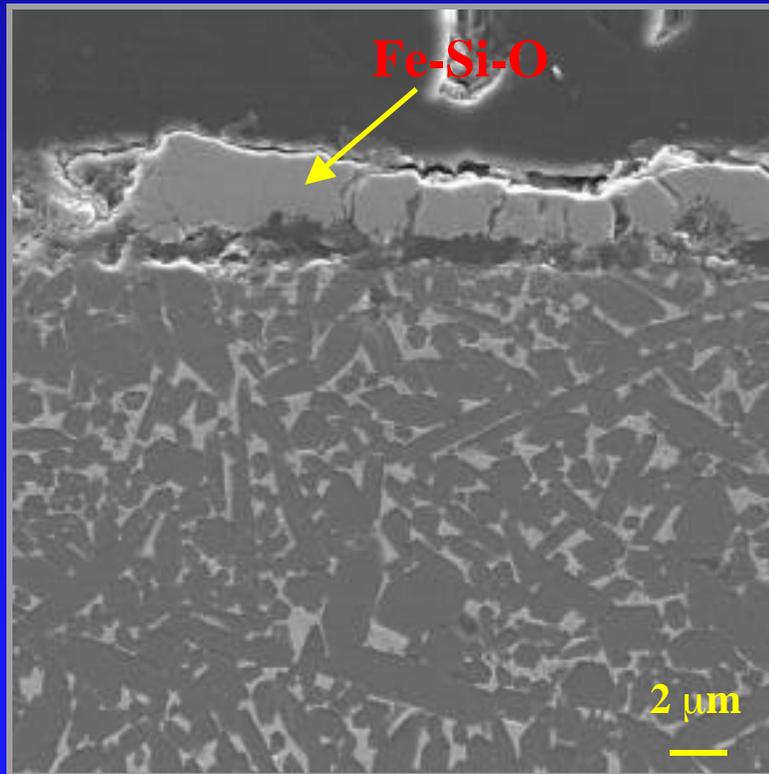
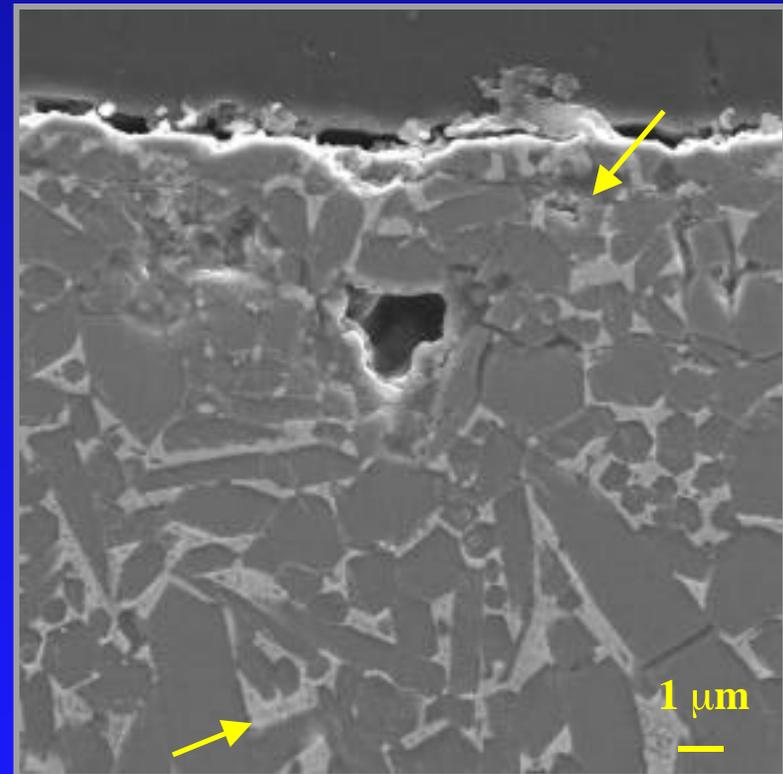
N768\_16 after 10 h field test

# *Fe-oxide Deposit and Limited Subsurface Damage Observed in Nozzle Airfoil*

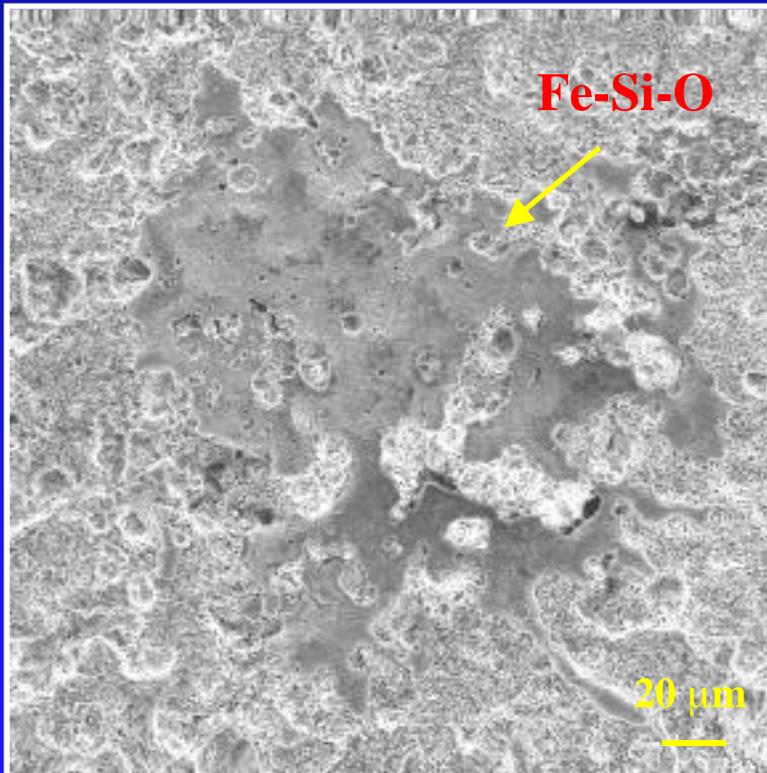
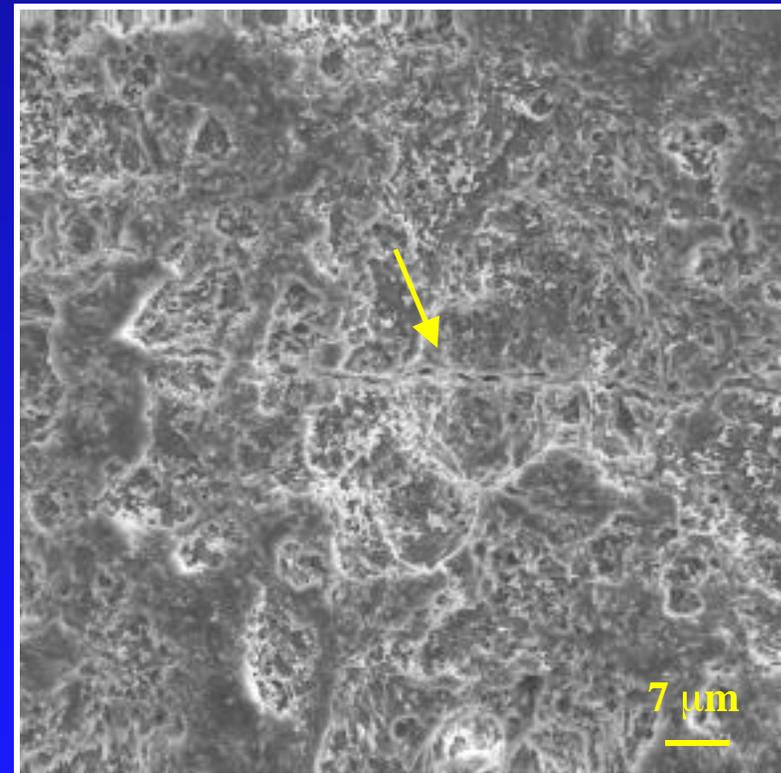
**N761\_15 nozzle after 68 h field test**

# *Metal Oxide Deposits and Sever Pitting Observed on Airfoil Surface of SN88 Gas Turbine Nozzles*

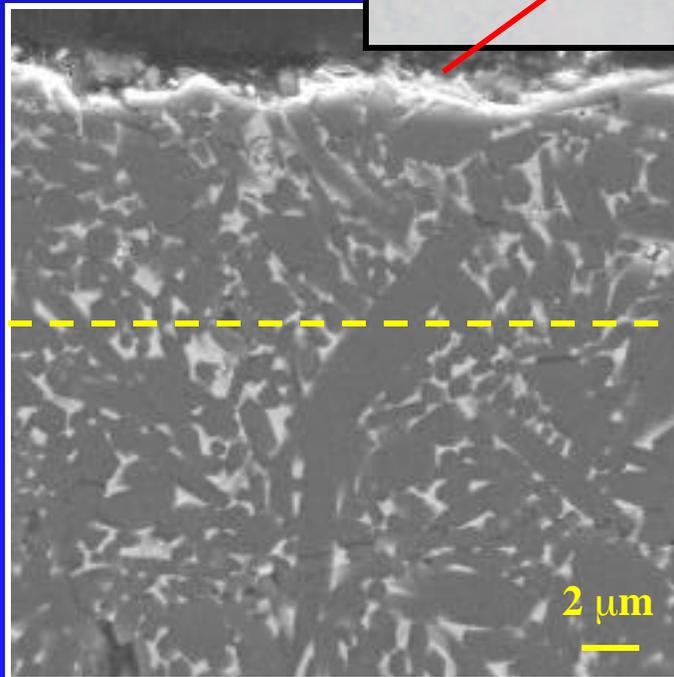
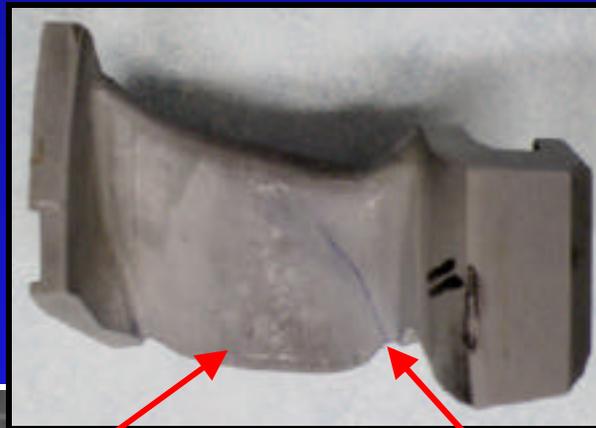
Middle Surface  
Region

# *Extensive Crack Generation and Pores in Secondary Phase Observed in Airfoil/Platform Region*

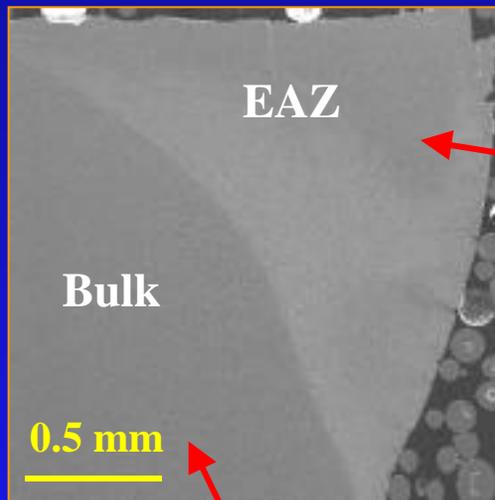
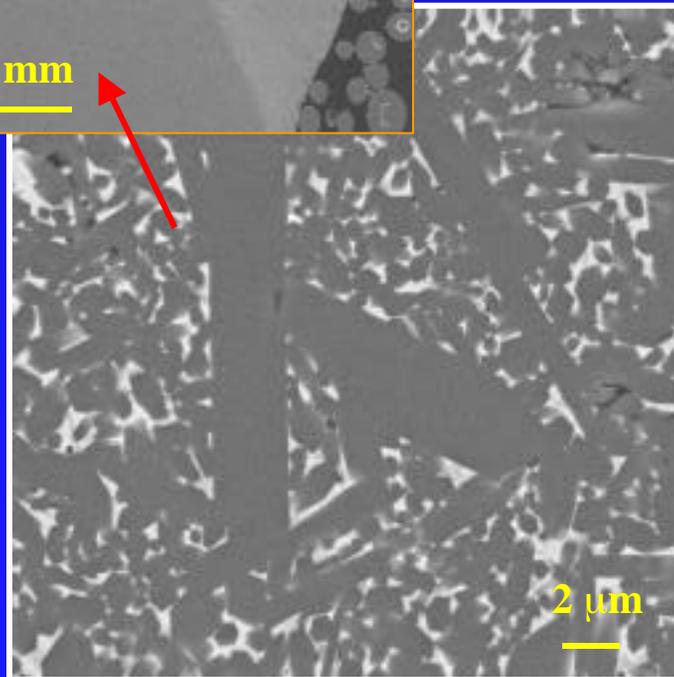
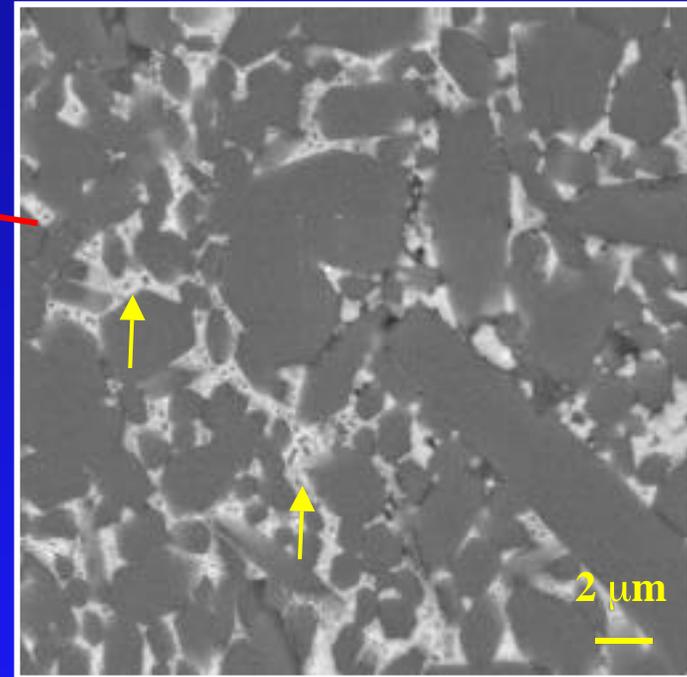
# *Phase Change Occurred in Intergranular Phase in Environment-Affected Zone (EAZ)*

$\text{Yb}_4\text{Si}_2\text{O}_7\text{N}_2$  (J-phase)  
∅  $\text{Yb}_2\text{Si}_2\text{O}_7 + \text{Yb}_2\text{SiO}_5$

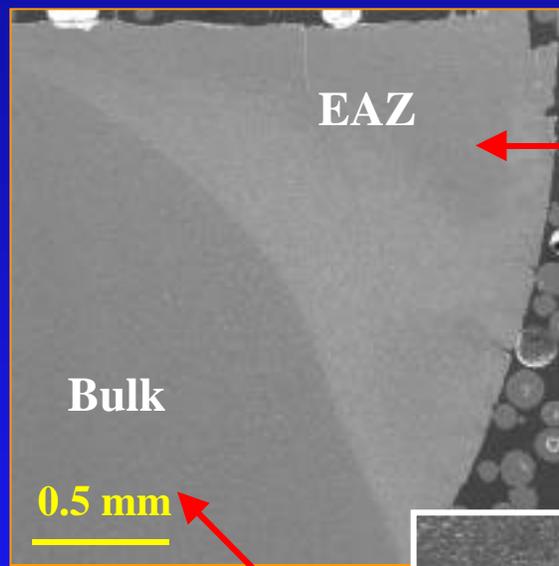
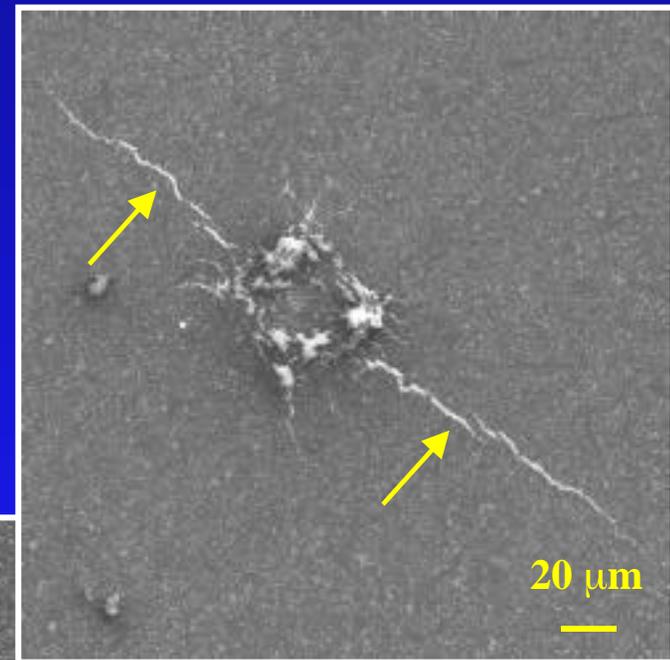
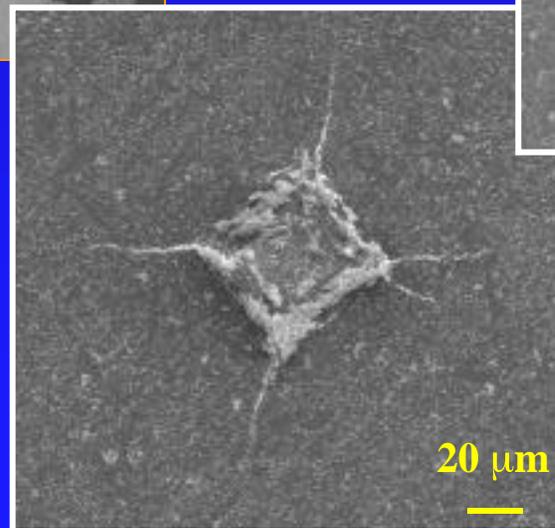
# *Vickers Indentation Indicated a High Residual Stress Developed in Environment-Affected Zone (EAZ)*

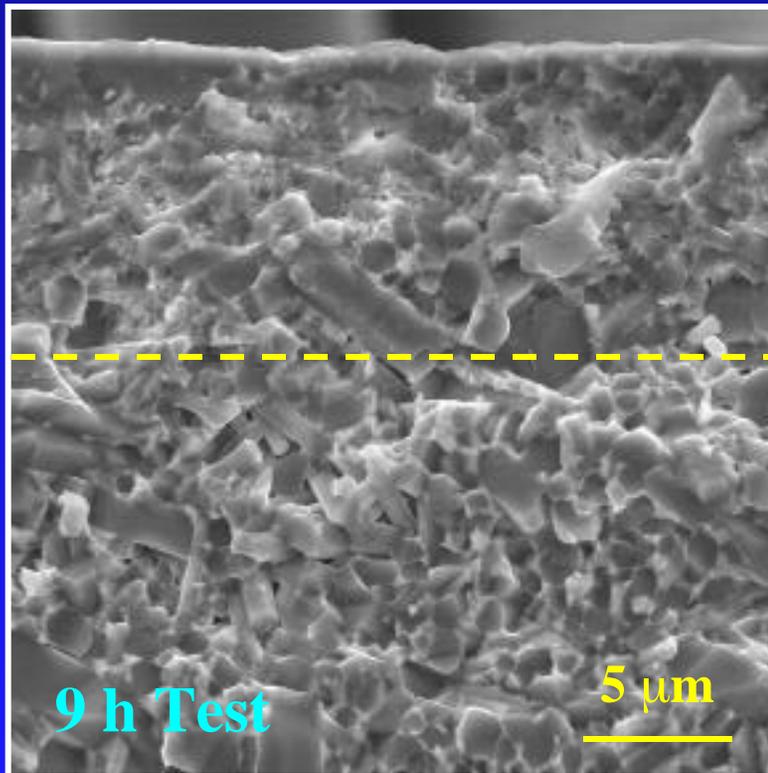
*EAZ* ~ 10  $\mu\text{m}$   
from airfoil surface

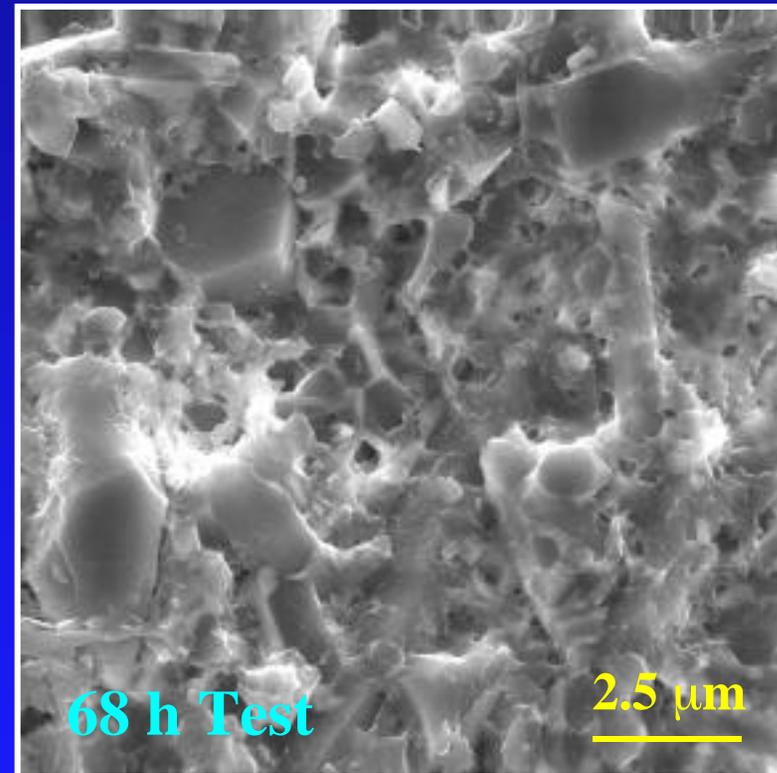
## *Larger Environmentally-Affected Zone (EAZ) Observed in 68 h Test Airfoil Specimens*

*EAZ* ~ 70  $\mu\text{m}$   
from airfoil surface

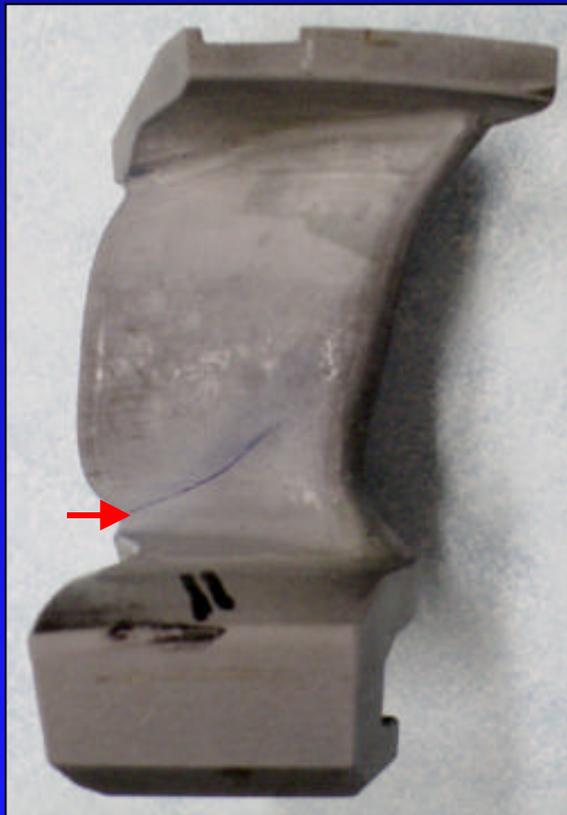
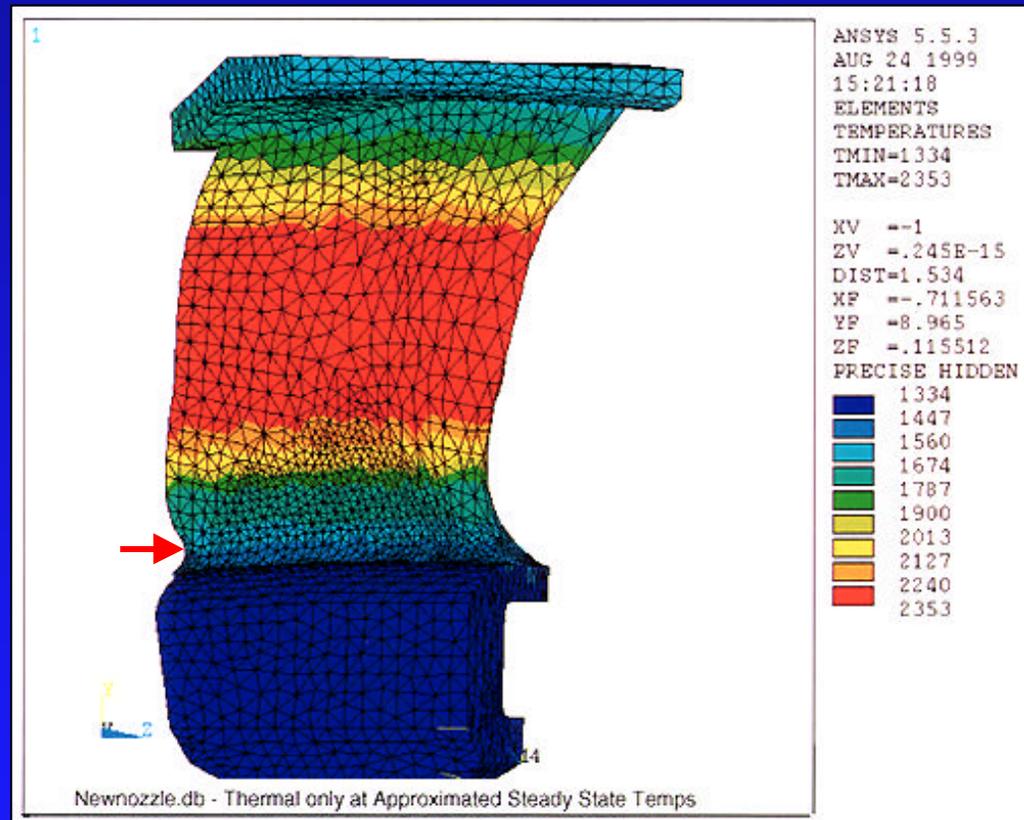
# *Critical Crack Initiated at Low Temperature (< 920°C) Airfoil Trailing Edge Region*

Temperature distribution based on steady state temperature of 1120°C
