## **Test Results and Description of a 1-kW Free-Piston Stirling Engine with a Dashpot Load**

Jeffrey Schreiber  
National Aeronautics and Space Administration  
Lewis Research Center  
Cleveland, Ohio 44135

Prepared for  
Eighteenth Intersociety Conversion Engineering Conference  
Orlando, Florida, August 21-26, 1983

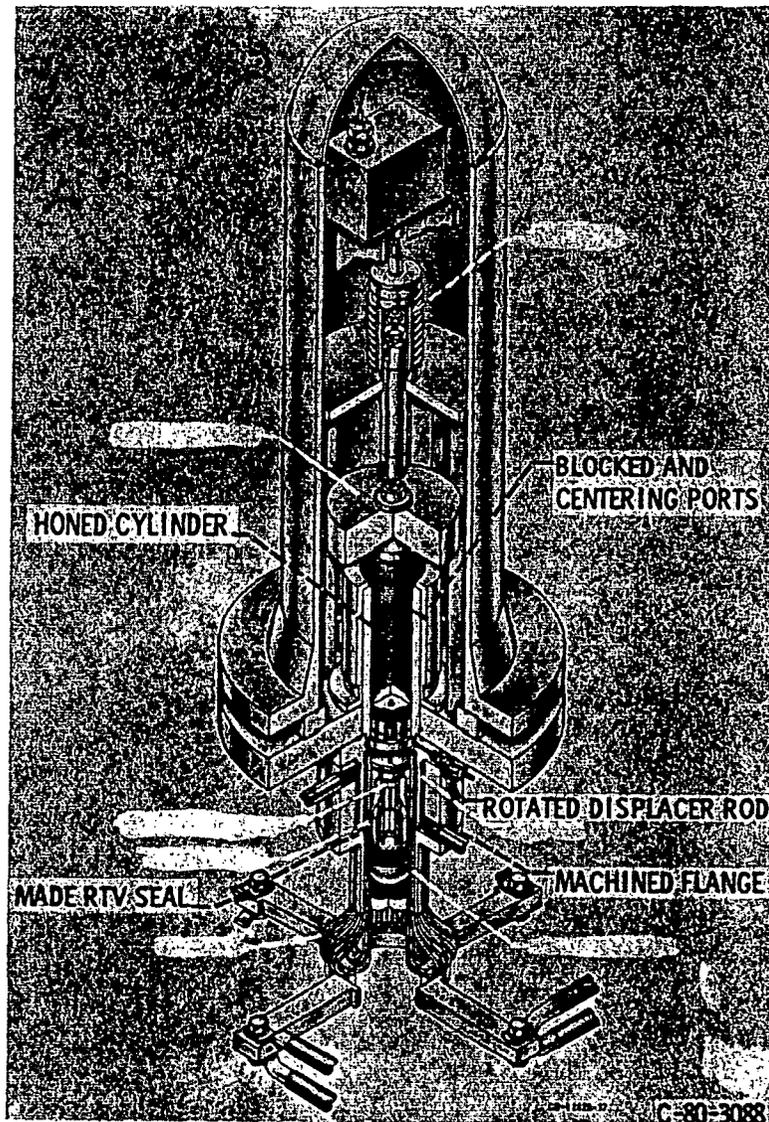
From past experience in the assembly of the RE-1000, it was known that at some point in the stack up of the heat exchangers, some amount of misalignment existed. Careful inspection and measurements taken showed that the problem originated at the mounting flange of the heater head. At this point the centerline of the heater head deflected at a slight angle from the centerline of the cooler assembly. The flange at which this misalignment originated is indicated in Figure 5.

Figure 5. - RE-1000 free-piston Stirling Engine problem areas corrected.

The first step taken to refurbish the engine was to remachine the mounting flange of the heater head to insure a truer stack up of the heat exchanger assembly. Prior to this remachining process, the displacer would very lightly rub on the cylinder wall. The rub was light enough that the engine would still run smoothly. The effect of the rub, however, was to cause some amount of damping to the displacer motion.

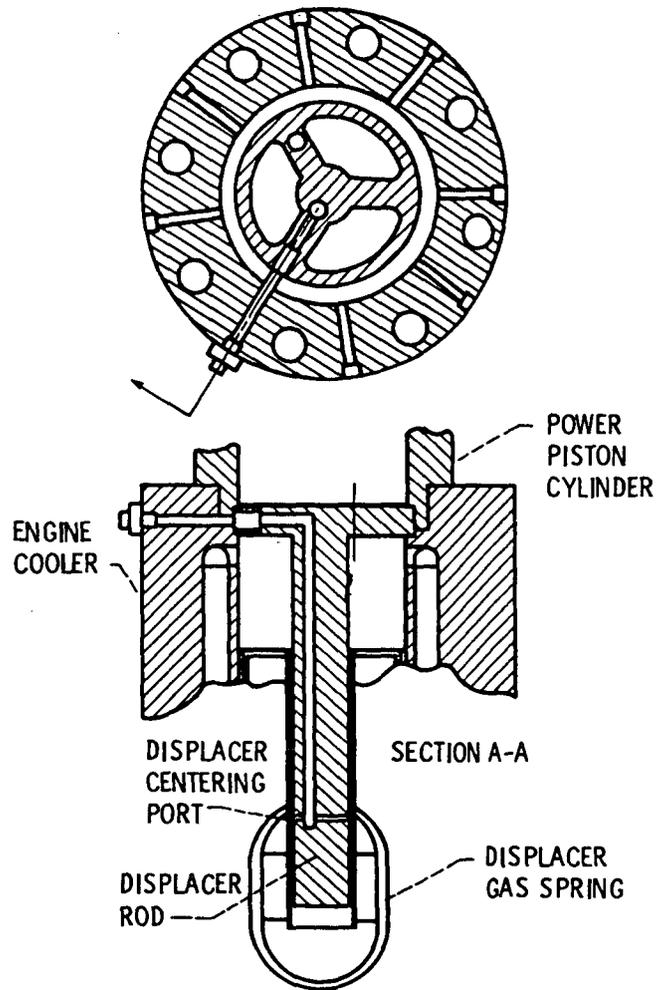
displacer line up with the ports in the displacer rod, the displacer gas spring is able to communicate with the main bounce space or buffer space in the pressure vessel atop the engine. The volume in the pressure vessel is large enough that it has almost no pressure variation throughout the engine cycle. The displacer centering port system is therefore able to reference the displacer gas spring to a steady pressure, the engine mean operating pressure, when the centering ports open. This system is needed to make up for any leakage of gas into or out of the gas spring from the compression space. The system is shown in Figure 8.

It was found that the centering ports in the displacer were rotated  $60^\circ$  from the centering ports on the displacer rod. Although the circumferential groove in the displacer bore allows for this condition, it was felt that if the ports were aligned so as to not need the circumferential groove, a stronger centering system would exist. Because of provisions in the engine for some future instrumentation, it was possible to assemble the engine in a configuration which would permit the centering ports to be aligned.

Figure 8. - Displacer rod mounting and communication ports for RE-1000 engine.

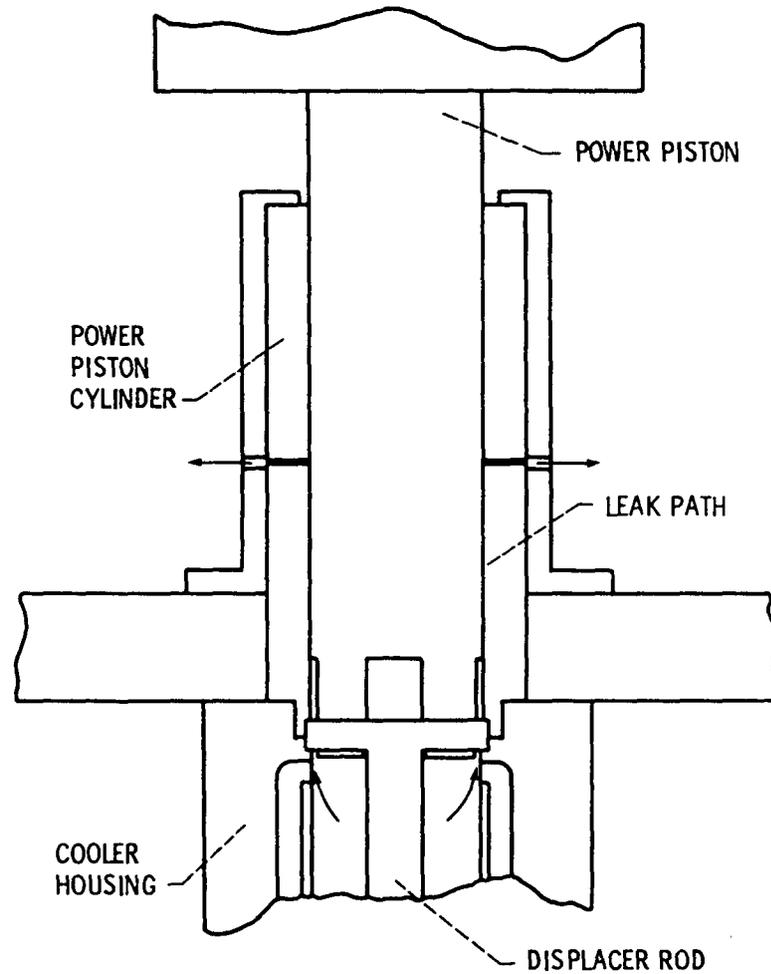
A pressure decay half-life pressure test was then performed to check the level of leakage past the power piston. This test is performed by clamping the power piston at some desired position. The pressure vessel of the engine is removed so as to expose the back side of the power piston to atmosphere. The working space is then pressurized with helium to a pressure of 1200kPa. The amount of time for the pressure in the working space to decay to 600kPa is measured. For the engine to be able to run as designed, the half life of the pressure should be about 15 seconds or more. The half-life tests showed the measured time to be approximately 2 seconds. At some time during earlier tests the half life was measured to be 15 seconds. Since the gas leaking out of the working space travels out the annular gap between the piston and cylinder to the centering ports and then out through the centering ports, it was theorized that honing away the high spots that surrounded the centering ports allowed the leak rate to increase. Figure 9 showed the leak path being investigated during the half life tests.

To see if the leak rate could be slowed without rechroming the cylinder wall to minimize the gap between the piston and cylinder, 2 of the 4 centering ports drilled through the cylinder wall were plugged with epoxy. Half-life pressure tests were run to see if this lessened the leak rate, but the half life was still about 2 seconds. This indicated that even with 2 of the 4 centering ports blocked, the major restriction to leakage was the piston to cylinder wall clearance, and therefore the piston to cylinder clearance must be reduced to control the leak rate.

Figure 9. - Power piston leak path of RE-1000 engine.

Based on the results of these leak tests it was determined that the radial clearance between the power piston and the cylinder should be reduced. Since the cylinder had recently been honed and was therefore known to be round and true, it was thought that the best solution would be to recoat the power piston and grind it to provide 0.020 mm diametral clearance instead of the original value of 0.036 mm. The displacer bore was honed and the displacer rod was recoated with chrome oxide at this same time to bring all of the close tolerance parts back to the original level of quality. The power piston,

however, was coated with a fluorocarbon-based, low-friction substance. This coating was applied and ground to size such that it provided the 0.020 mm diametral clearance desired.

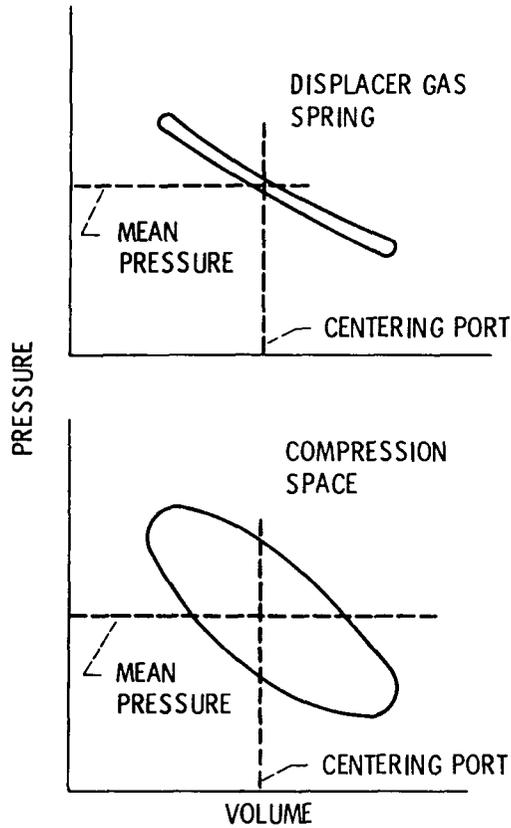
It is interesting to note that the design of the centering ports for the displacer is less critical than the design of the centering ports for the power piston. In the case of the displacer gas spring, the centering ports will flow enough gas to make up for any leakage into or out of the gas spring. If the gas spring pressure had no hysteresis there would be very little flow through the displacer centering port system and therefore very little power loss. The power piston centering port system, however, will yield large losses if too much gas is allowed to flow. Since there is a much larger P-V diagram in the compression space, the working gas will try to flow to the buffer space or bounce space when the piston is on the expansion part of the cycle. Similarly, the gas from the bounce space will try to flow into the working space on the compression part of the cycle. P-V diagrams are shown in Figure 10.

Figure 10. - RE-1000 engine centering port pressure drop for displacer gas spring and compression space.

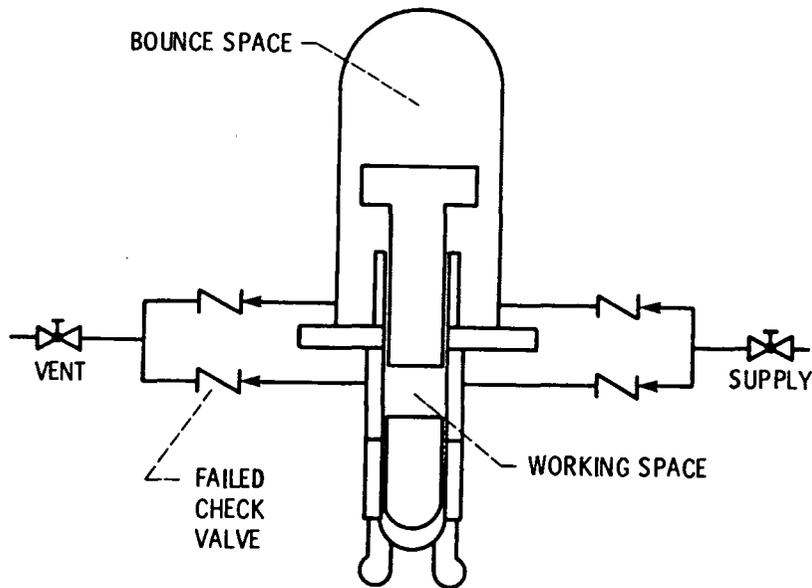
differential pressure transducers were removed. A valve known as the short circuit valve was removed. The short circuit valve existed to connect the working space to the bounce space when charging the engine or venting the engine. Check valves to allow gas from a supply system to be introduced to the working space and to allow gas to be vented from the working space were removed. With these two check valves removed, the engine would be brought up to full operating pressure after operation has started by slowly bleeding gas into the bounce space and letting the piston centering ports equalize the mean pressure across the power piston. These valves are shown schematically in Figure 16.

Subsequent tests showed that the Validyne differential pressure transducer and the short circuit valve had no effect on engine performance. It was found that the working space venting check valve was not sealing properly although it is not known exactly when this valve began to fail. The method used at LeRC to check piston leakage would not show a leak problem in that check valve.

Figure 16. - Supply and vent check valve system.
