FLOOD-DAMAGE-RESISTANT HOUSING

Results from Field Testing of Envelope Materials and Systems

Work performed by Oak Ridge National Laboratory and Tuskegee University for the U.S. Department of Housing and Urban Development
September 2004

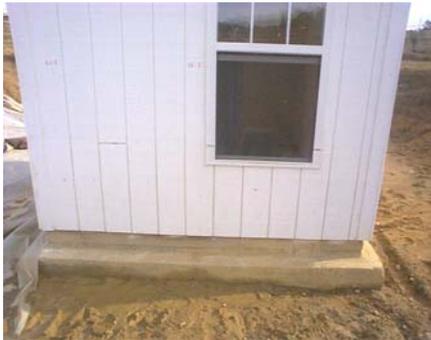
We found that water does not evaporate quickly from behind plywood siding. Therefore, we do not consider the combination of plywood siding and wood sheathing a good flood-damage-resistant system. Lap siding with more joints than plywood allows moisture to escape more quickly and reduces the potential of long-term damage to the sheathing.

Plywood T1-11 siding survived flooding with minor checking, but retained excessive moisture in the adjacent plywood sheathing.

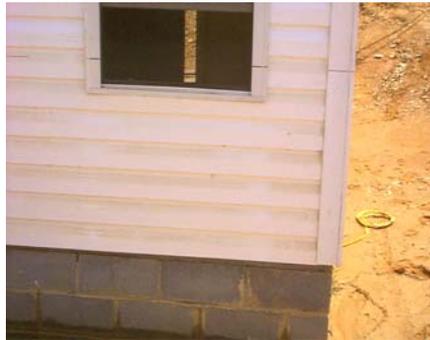
Vinyl lap siding survived flooding with no physical damage other than needing to be washed. Its joints permitted the adjacent plywood sheathing to dry.

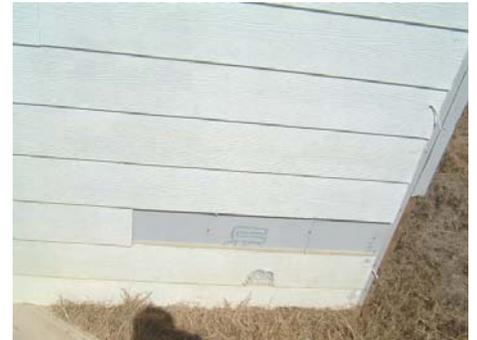
Fiber cement lap siding survived flooding with no physical damage other than needing to be washed. Its joints permitted the adjacent sheathing to dry.

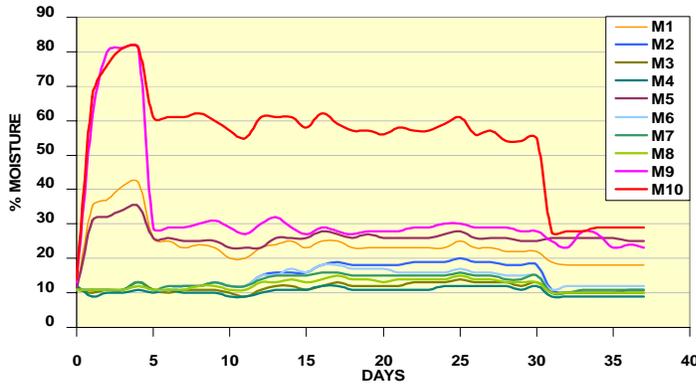
This graph shows the impact of flooding on the relative moisture content of various framing members above and below flood level. The percentages should be viewed in relation to pre-flood percentages and not as absolute values. Moisture levels in most below-flood-level members dropped back toward pre-flood levels as the water receded. Moisture levels in subflooring did not drop as much until day 31, when the fiberglass floor insulation was removed. This long-term moisture retention could be a problem if the insulation is left in place.

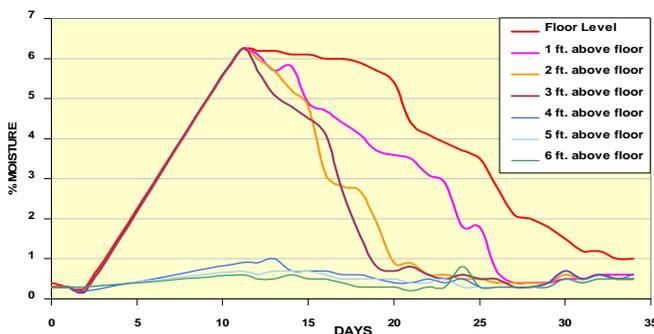
This graph shows the moisture content of the gypsum wallboard above and below water level after exposure to flooding. Readings were taken upon reentering the unit on day 11. The lower cluster of readings is from above flood level and the upper cluster of readings, from below flood level. Fiberglass insulation in this wall slowed the drying on the two lower reading locations.

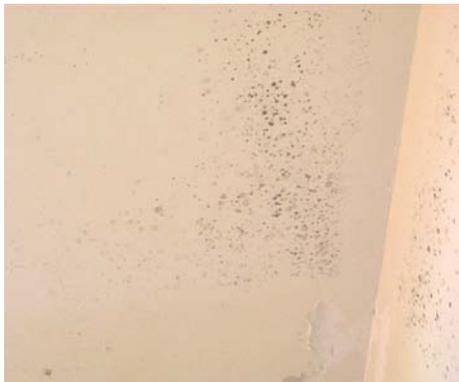
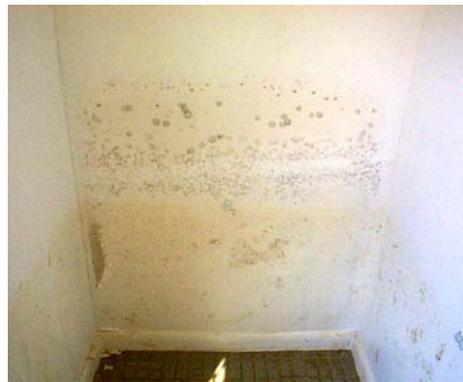
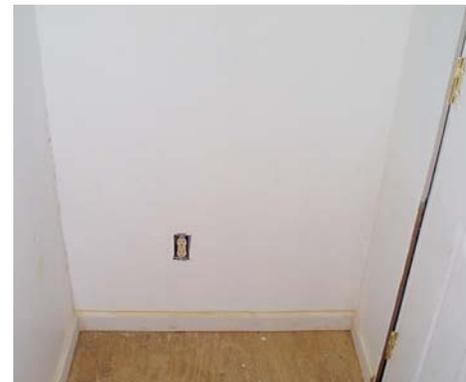
When conventional paper-faced gypsum board was used with fiberglass batt insulation on exterior walls, the gypsum board lost about 50% of its flexural strength and remained wetter than gypsum board on interior walls (without insulation). The gypsum board on interior partition walls dried out within the 28-day drying period and maintained flexural strength (see the table). We believe that if gypsum board is able to dry completely within an appropriate time, it can be restored to pre-flood condition with only cosmetic restoration. Although the board supported mold growth on the exposed painted surface, it could be cleaned, sanitized, and restored. We saw no visible evidence of mold growth from flood exposure on the backside or unexposed surface of the gypsum wall board we tested.

Conventional gypsum board (*left*) after exposure to flooding typically grew mold in a 2-ft-wide band above the flood level and was stained below flood level. Fiber-reinforced gypsum (*center*) after exposure also typically grew mold above flood level and was stained below. Water-resistant fiber-reinforced gypsum (*right*) after exposure did not support mold growth and had less staining than either of the other two materials.

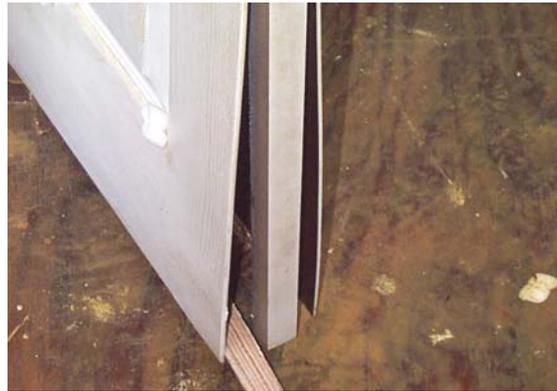
We tested the following door types: solid-wood six-panel, louvered-wood bifold, hollow-core-wood flush panel, and formed-wood-composite six-panel. All interior doors tested were severely stained, and some were warped, split, and/or peeling. Considering the relatively low cost of replacement, it is not considered economically feasible to restore such doors.

Formed wood-composite panel door delaminated after flood exposure. The low initial cost of such doors makes a restoration effort difficult to justify.

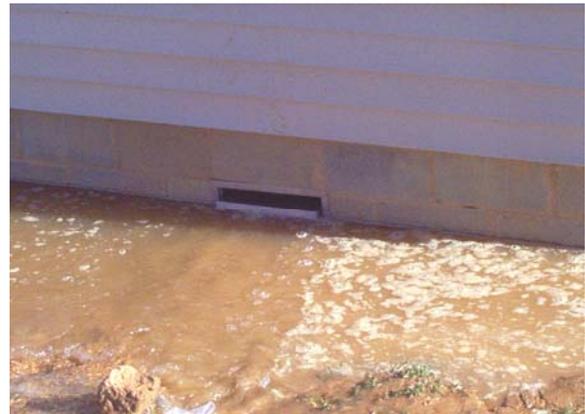
Flood vents opened and closed with the ebb and flow of the flood as designed. This action prevents hydrostatic pressure from occurring should conventional vents become plugged with debris.

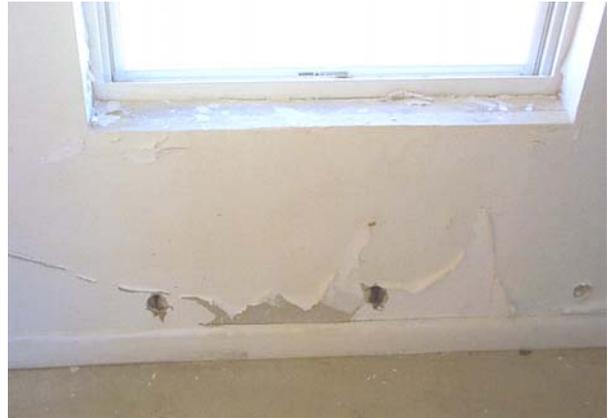
We punched holes above the floor molding of the interior walls (a commonly recommended practice) and found that these holes do not drain any water nor do they cause the wall to dry any faster, especially if floodwater has receded for several hours. We found in most instances that if holes are not punched in the walls, the gypsum board can be easily repaired and restored. As a result, the practice of punching holes in gypsum board walls to promote drainage is not recommended as an effective flood recovery procedure. Under some circumstances, restoration professionals may use holes along with special drying equipment to speed the drying process in difficult-to-dry situations.

Punching hole at the bottom of walls to promote drainage requires significant repair effort and does not contribute to drying of the wall.

- Follow recommended procedures from professional organizations such as ASCR or IICRC with regard to the treatment or removal and replacement of existing housing envelope materials. In most cases, do not punch holes in walls to promote draining or drying, as this is usually not effective.

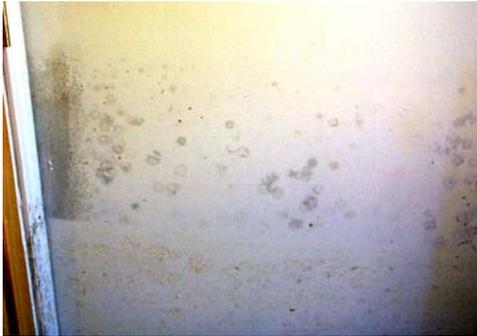
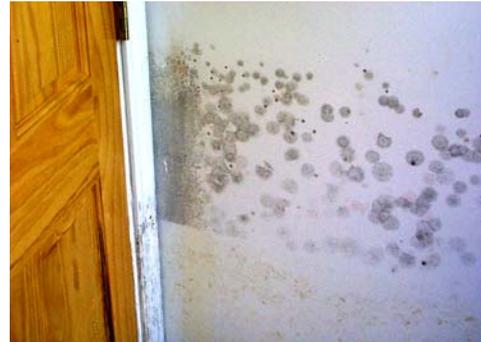
Cleaning of the walls removed some staining and dirt but did not reduce mold growth. The photos show a wall before washing (*left*) and after washing (*right*). The mold continued to grow after washing.

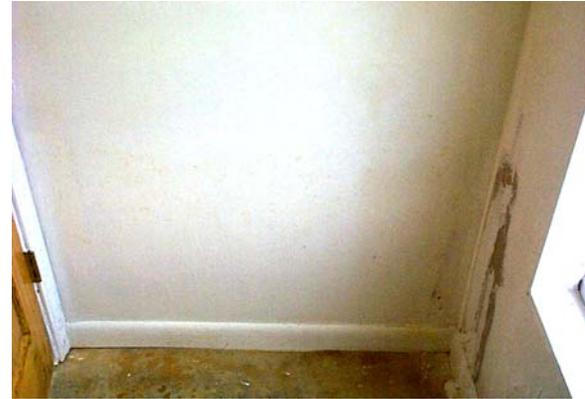
Sanitizing eliminated evidence of mold from the walls. Mold did not recur during our testing.

We found that spraying vertical surfaces in our test structures using a compression (pump-up) garden sprayer with a solution of water (70% by volume), household bleach (25%), and trisodium phosphate (5%) until the surfaces were thoroughly wetted was effective in eliminating evidence of mold. Floors were wet-mopped with the same solution. Other sanitizers and cleaner-disinfectants may be equally effective. We do not recommend treating metallic items such as hinges, fasteners, and electric outlets with this solution because of the potential for corrosion.

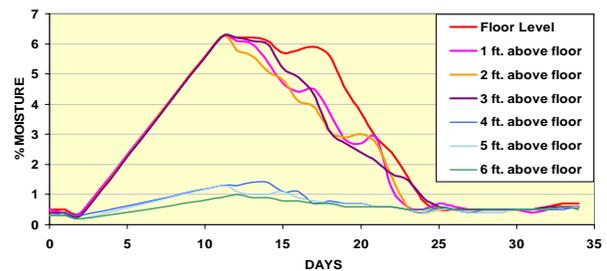
With doors and windows opened on day 11, the walls of the test module returned to pre-flood moisture levels by day 25. Larger, more complicated structures may require longer drying periods or mechanical assistance to return to pre-flood moisture levels.

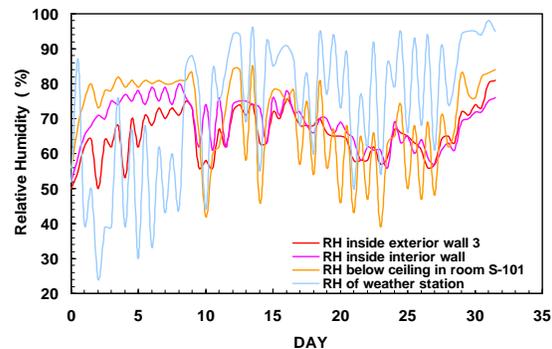
Indoor relative humidity (RH) exceeded the outdoor RH during the flood and before the opening of the test module on day 11. After opening, the indoor RH trended downward but also reflected the changes outside.

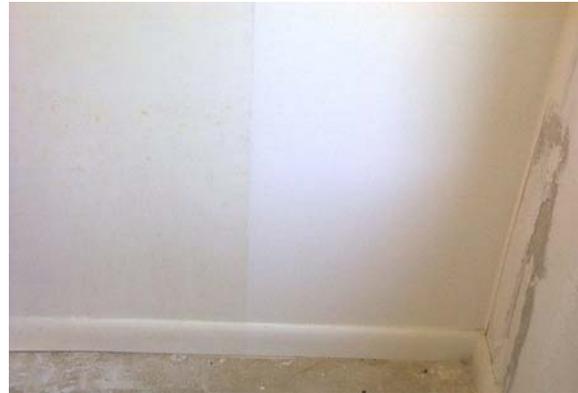
The left side of this wall is awaiting restoration, while the right side has been restored through washing, sanitizing, some resurfacing, and repainting.

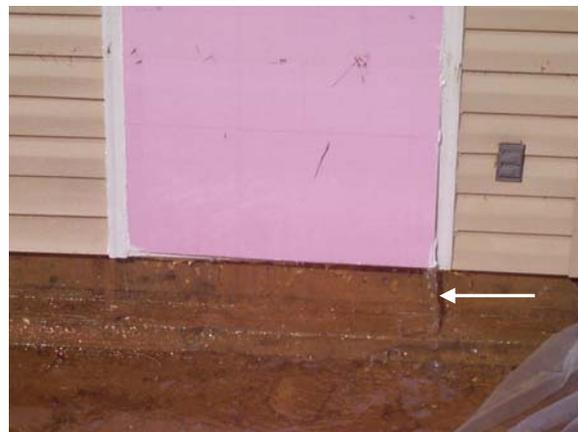
Water draining from behind flood dam (lower right corner).

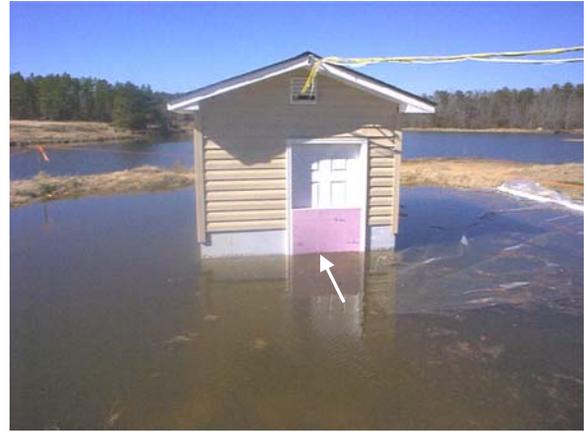
Second attempt at dry flood-proofing; note deflection of flood dam at door.

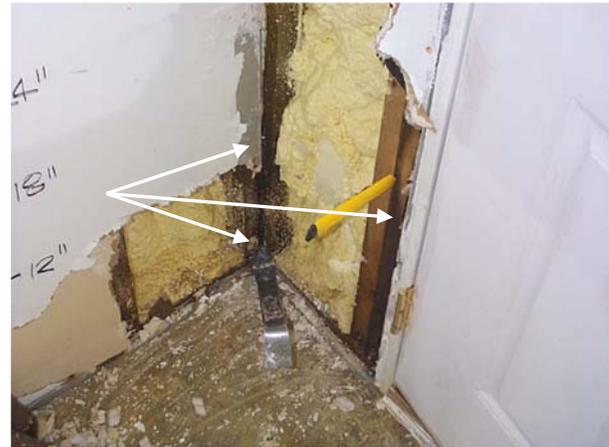
Even with our extraordinary efforts to dry flood proof, the slab-on-grade test modules still flooded. We believe our efforts to seal the outside of the modules were more thorough than the efforts homeowners and possibly contractors would make. If, after very careful efforts, we did not achieve dry flood proofing, we believe that other efforts would also not succeed.

Water came through the small cracks between stud and sill plate.
