WHY DO KRAFT RECOVERY BOILER COMPOSITE FLOOR TUBES CRACK?

James R. Keiser, Gorti B. Sarma, Xun-Li Wang, Camden R. Hubbard, Robert W. Swindeman

Oak Ridge National Laboratory
Oak Ridge, TN 37831-6156 United States

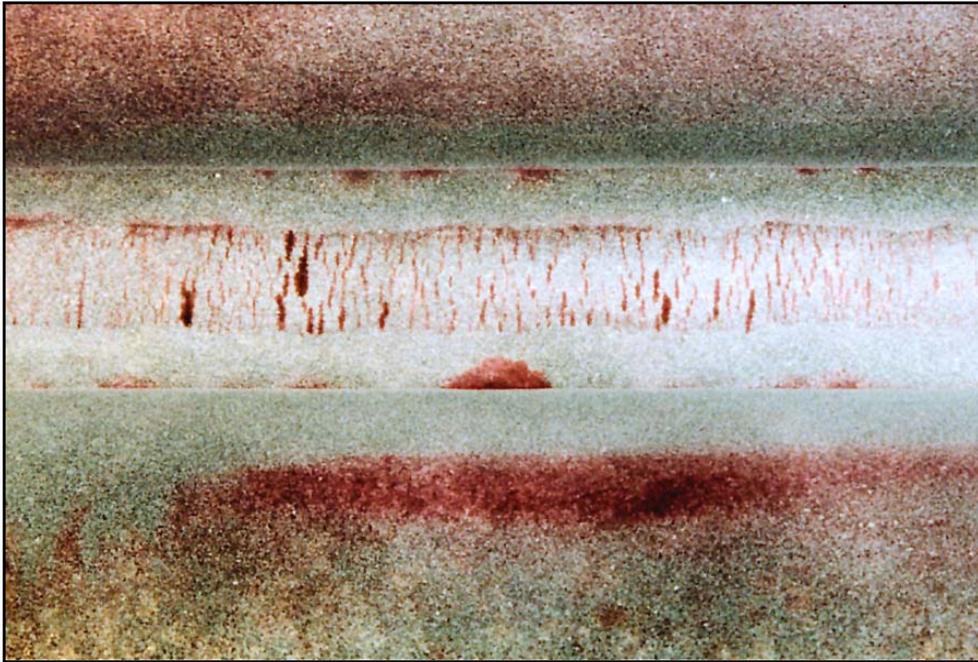
On floors constructed with three inch tubes on four inch centers, transverse cracking in the 304L clad membrane, like that shown in Fig. 1, is sometimes seen before cracking is found on the tubes. However, cracking is seen on both 2-1/2 and 3 inch composite tubes, and it is found in both slope-floored and decanting-type recovery boilers. Particularly on floors with the wider membrane, cracking can occur at the toe of the membrane to tube weld. Cracking is also found on both sizes of tubes away from the weld. This cracking sometimes is primarily circumferential in orientation (see Fig. 2) while in other cases it will consist of a series of randomly-appearing interconnected cracks sometimes referred to as craze cracking like that shown in Fig. 3. The different crack orientations most likely reflect the stress state (tensile or compressive for the axial and tangential directions) at the

Fig. 1. Transverse cracks like those shown are sometimes seen in the membrane of floor panels constructed with 76 mm (3 in.) diameter tubes on 102 mm (4 in.) centers.

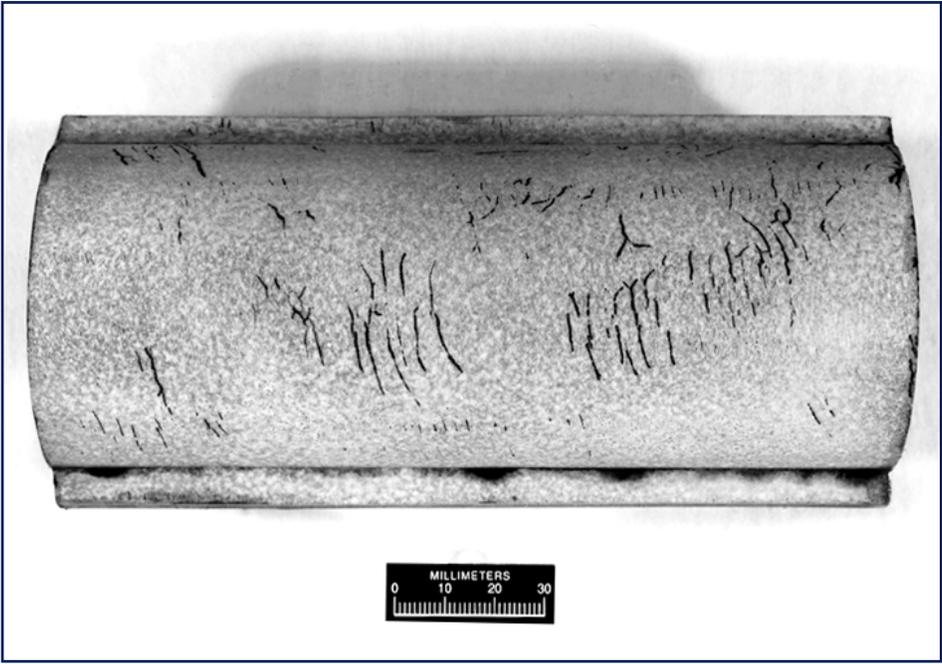
Fig. 2. Circumferential cracks are found on some tubes indicating the tensile stresses on the tube are primarily axial.

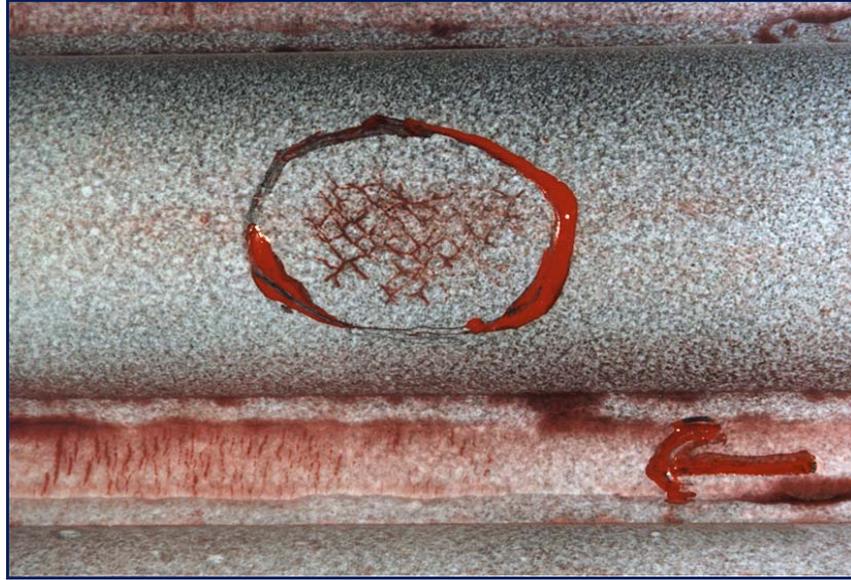
Fig. 3. The craze or interconnected cracking found on some tubes suggests that both axial and tangential stresses are tensile.

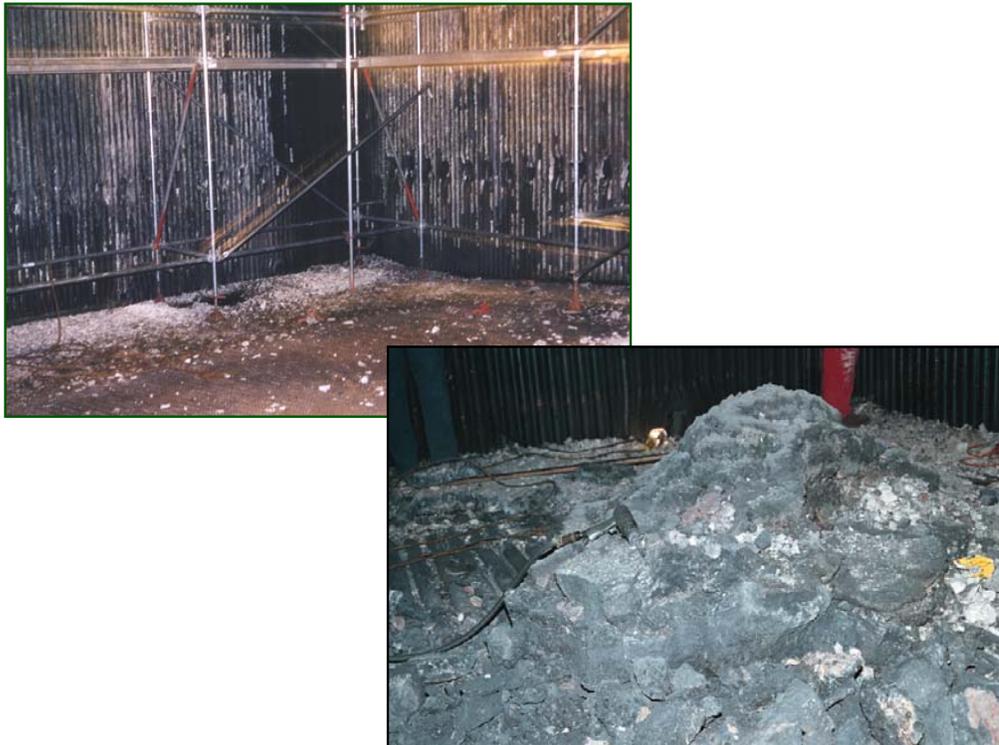
Before any inspection is performed, debris and adherent deposits must be removed from the surface of the tubes. For floor tubes, this is facilitated by taking the time to completely burn out the smelt bed as the boiler is being shut down for inspection (Fig. 4). There is an additional benefit to burning out the bed, since such action helps eliminate some of the conditions that can contribute to floor tube cracking. Some mills have used high pressure water lances inserted through the spout openings in the latter stages of a water wash to help remove the residual smelt bed from the floor.

Fig. 4. Examples of a recovery boiler where the smelt bed has been nearly completely burned-out and a boiler where little effort was made to remove the bed before shut-down.

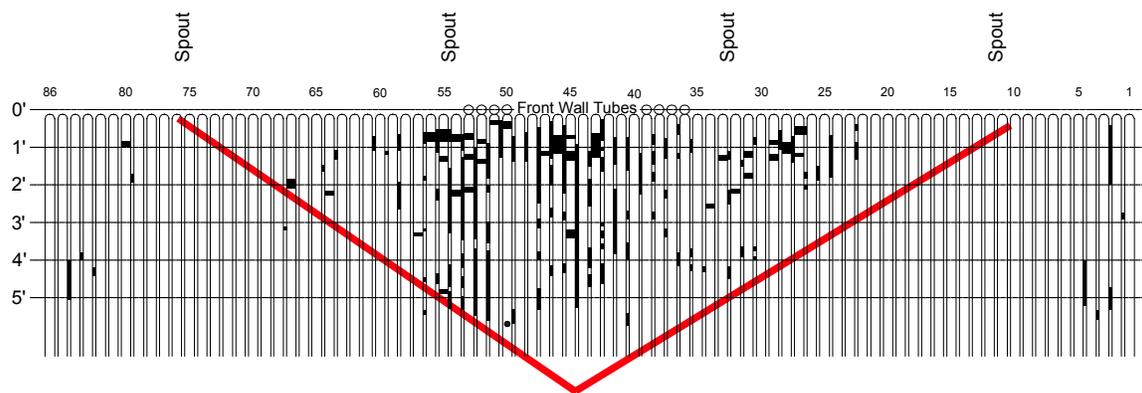
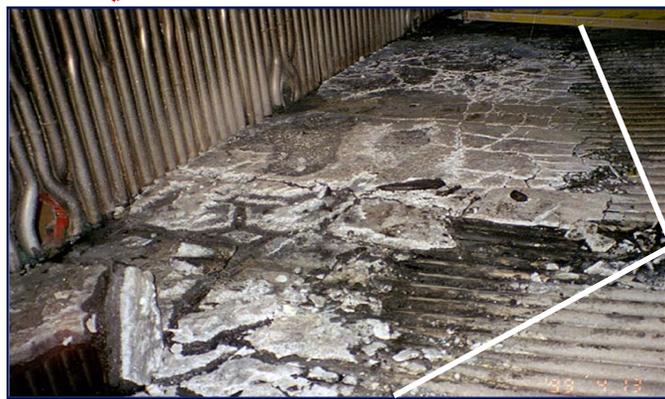
These data suggest that a narrow window of susceptibility to cracking exists when the boiler floor tubes are still hot, and covered by a relatively thick insulating layer of smelt. In the early stages of a water wash, saturated wash water will pass over the tubes, or moisten the smelt in contact with the tubes. Circumstantial evidence suggesting that the presence of residual smelt on the floor during washing plays a part in the development of floor tube cracks is shown in Figure 6. The pattern of cracking found on the floor of this boiler closely matches the location of the smelt typically left after the bed is burned down and the boiler water washed. A particularly dangerous situation for cracking exists when a residual bed of moist smelt is left on the boiler floor during a dry-out fire (Fig. 6b). Floor tube temperatures can remain within the range of maximum susceptibility to SCC for several hours during a dry-out fire [10].

Fig. 6. (a) Schematic of recovery boiler floor showing location of cracking found in the tubes and membranes and (b) photograph of recovery boiler floor showing the residual smelt bed that was present during a shut down. Note that both the cracking pattern and the residual bed have a “V” shape.

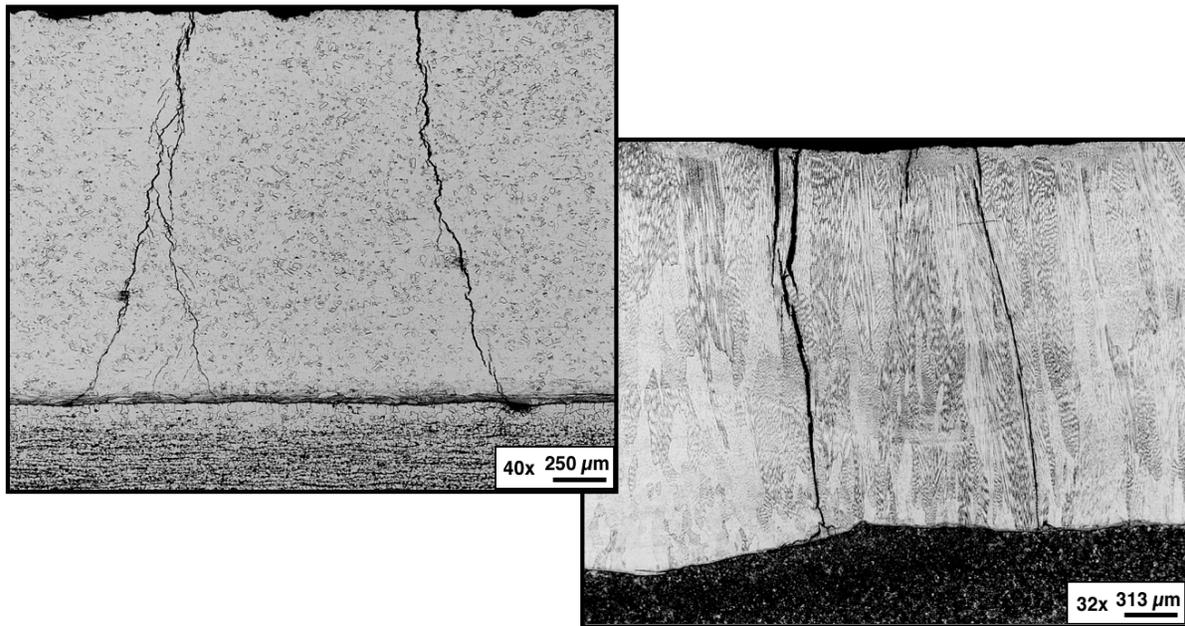
A direct comparison of three compositions of co-extruded tubes and two compositions of weld overlaid carbon steel tubes is being made in a North American recovery boiler. Operating experience from this particular recovery boiler has shown that co-extruded 304L/CS and weld overlaid 309L on carbon steel cracked during the second year of exposure (see Fig. 8) while co-extruded 825/CS, co-extruded 625/CS and weld overlaid 625 have not cracked after five years of exposure. Reports of operating experience in Scandinavian boilers also indicates that an alloy equivalent to alloy 825 has operated in a recovery boiler floor for at least eight years without cracking.

Fig. 8. Cross section of cracking in co-extruded 304L/carbon steel and 309L weld overlay tubing. Note that most cracks penetrate entirely through the stainless steel layer but do not continue into the carbon steel.
