## AN EXPERIENCE WITH DETECTION AND ASSESSMENT OF SAC IN A RECOVERY BOILER

### ABSTRACT

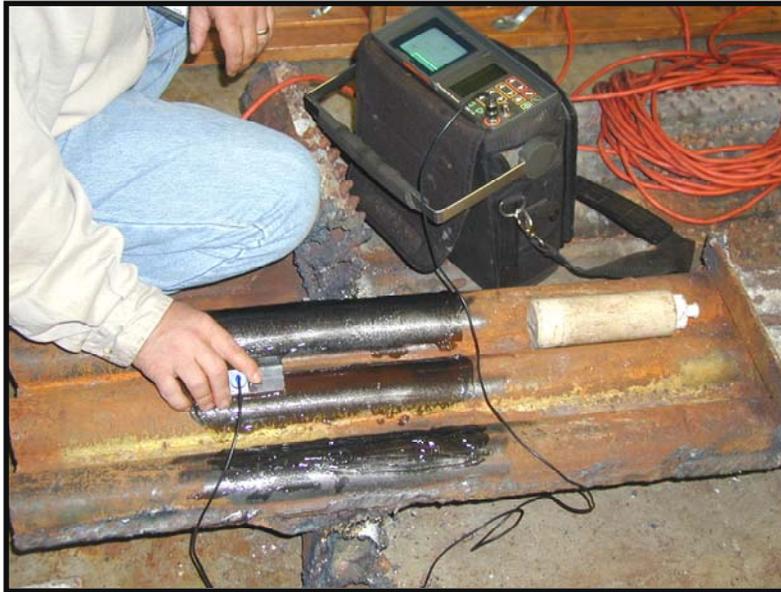
It was of course not practical to attempt to evaluate the entire lot of 300 m of boiler tubing for SAC using this technique, particularly since a large fraction of the tube specimens were studded. As a result, the operators relied on experience with related inspection efforts for SAC and concentrated on wall tubes with floor attachments (filler blocks) and on wall tubes adjacent to substantial scallop-type attachments as regions most likely to contain SAC detectable with this technique (see Fig. 1). However, following examination of approximately thirty “suspect”

locations (among perhaps sixty or more available in the lot of sample material), no significant indications of SAC were detected. Given that SAC indications were subsequently located by destructive techniques in several tubes – including a few tubes specifically examined with circumferential waves – it seems likely that a factor other than examination of an insufficient number of locations limited/prevented detection of SAC with this technique. Perhaps the extreme proximity of the SAC indications to the attachment welds tended to mask the modest and relatively infrequent SAC indications due to attenuation issues associated with discontinuous wall thickness at the weld and attachment.

FIGURE 1. Circumferential wave inspection of recovery boiler tube opposite the floor attachment locations. No indications of SAC were observed in locations represented by this type of attachment.

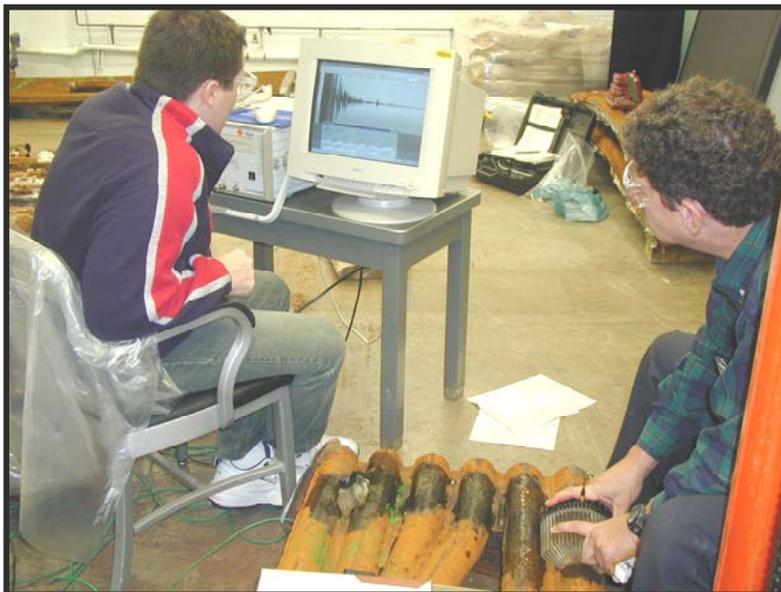
Similar to the situation for the circumferential wave technique, it was impractical to attempt to assess all of the available boiler tube specimens for SAC using this technique. Therefore, the engineers performing the test (see Fig. 2) concentrated on tubes with longitudinal weld attachments and/or tubes with a “corner” attachment resulting from the intersection of a longitudinal and a transverse weld. After considerable effort, which included detailed examination of about a dozen tube panels meeting the above criterion, no significant indications of SAC were detected. Since several tubes with SAC (found by subsequent destructive analysis) were among those examined with longitudinal waves, it seems likely that the longitudinal orientation of all of the SAC indications among the Longview boiler tubes masked these from detection with this technique.

FIGURE 2. Longitudinal wave inspection of a recovery boiler tube with a longitudinal attachment (skip weld) on the opposite side. Operators shown are Mike Quarry (left) and Jacques Brignac.

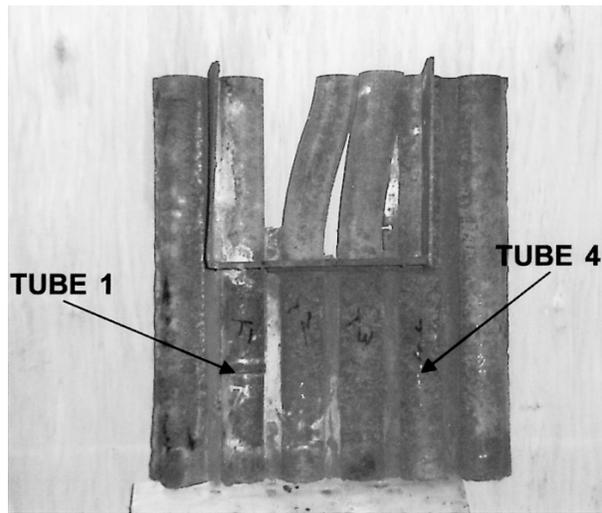
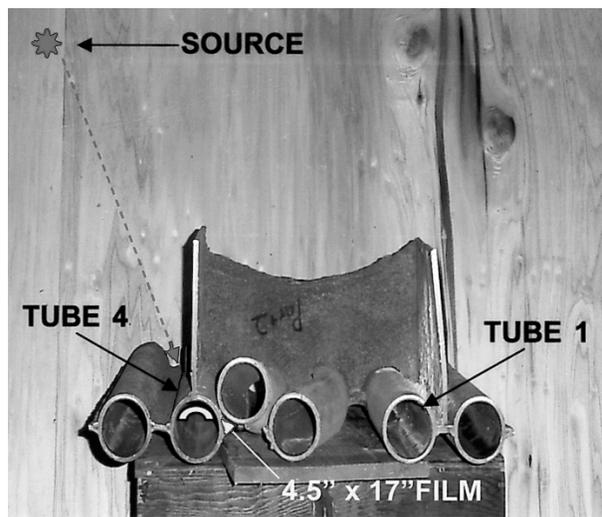
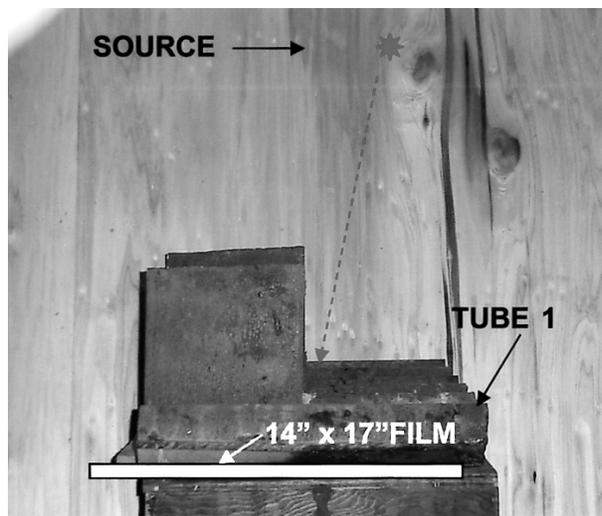
The sections subjected to radiography were selected from among those with attachment welds deemed high probability areas for SAC based on experience, but that showed no significant indications (or perhaps only a “maybe” indication) with either the circumferential or longitudinal wave techniques. In addition, a few randomly selected tube panels with substantial attachment welds were selected from among the sections that had not been inspected by either of the ultrasonic wave methods for radiography. Figure 3 contains a representative example of the radiographic technique employed.

In total, eight panels (with several tubes each) were extensively examined with these radiographic techniques. A few small indications were identified, but none were judged by the radiographer to be significant and each was associated with the external attachment weld (not the tube ID).

FIGURE 3. Representative example of radiographic inspection technique on a boiler tube panel with an attachment weld. Top: overview. Middle: film inside a tube. Bottom: external film.

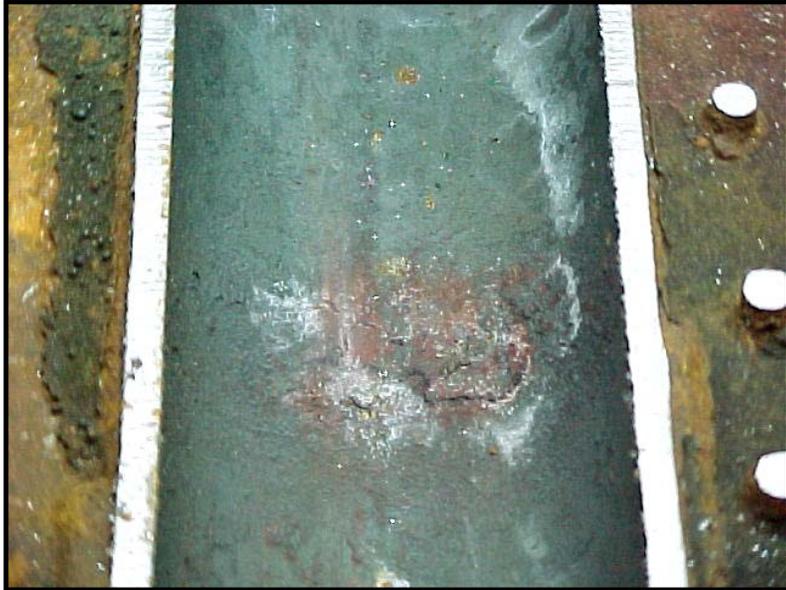
An example of the only significant exceptions to smooth/uniform oxide on the waterside of the tubes is shown in Fig. 4. Viewed at right angles (light and view port on the borescope perpendicular to the tube surface), locations like these appear slightly graveled, but with oblique lighting it is obvious that the oxide at these locations is significantly thicker than the nominal oxide thickness. Oxide accumulations almost 500  $\mu\text{m}$  (20 mils) thick were observed in a few of these positions, which invariably were located on the tube waterside directly adjacent to an external attachment weld. Not every attachment weld exhibited such an oxide accumulation on the tube waterside, but no accumulations were observed that were not immediately adjacent to an attachment weld. When several tubes from a panel were examined together (such as the four-tube panel shown in Fig. 5), oxide accumulations were observed on the ID of the tube crown associated with each attachment weld location, but the degree of oxide accumulation typically varied significantly among the attachment welds in the group.

The cause of the oxide accumulations is perhaps related to subtleties of the internal heat transfer conditions at the attachment weld locations. For example, depending on the efficiency (in the thermal sense) of the weld attachment, the attachment may act as something of a cooling fin to encourage heat transfer from the tube and thereby precipitation from the water on the internal surfaces of the tube at these locations. Alternate thermal conditions at the attachment might lead to slightly increased temperatures at the attachment locations encouraging more rapid growth of oxide. In any case, it is not apparent that the oxide accumulations directly cause SAC at these locations, but it is likely the thermal conditions that contribute to the oxide accumulation also contribute to the stress state and corrosion conditions at this location.

FIGURE 4. Typical oxide accumulation on the internal surface of a boiler tube, viewed with oblique lighting. An attachment weld (scallop-type) is located immediately adjacent to the oxide build-up on the external surface of this tube.

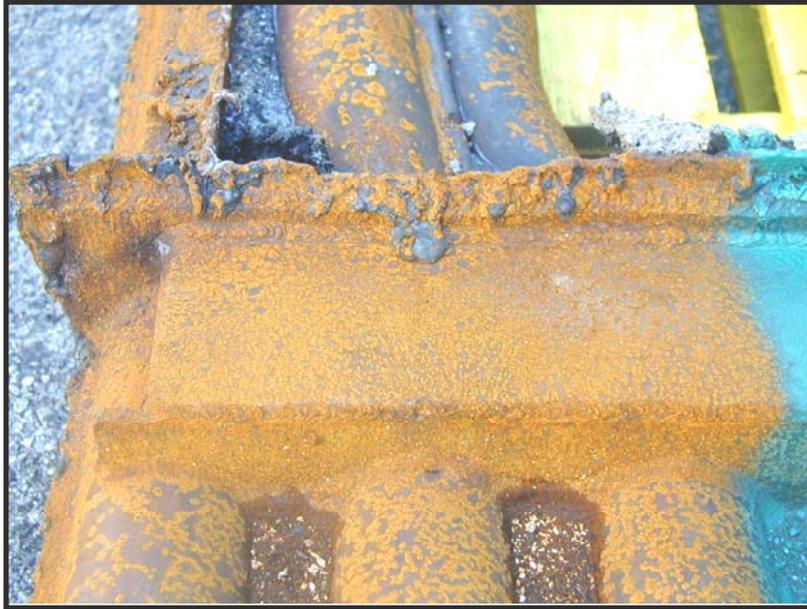
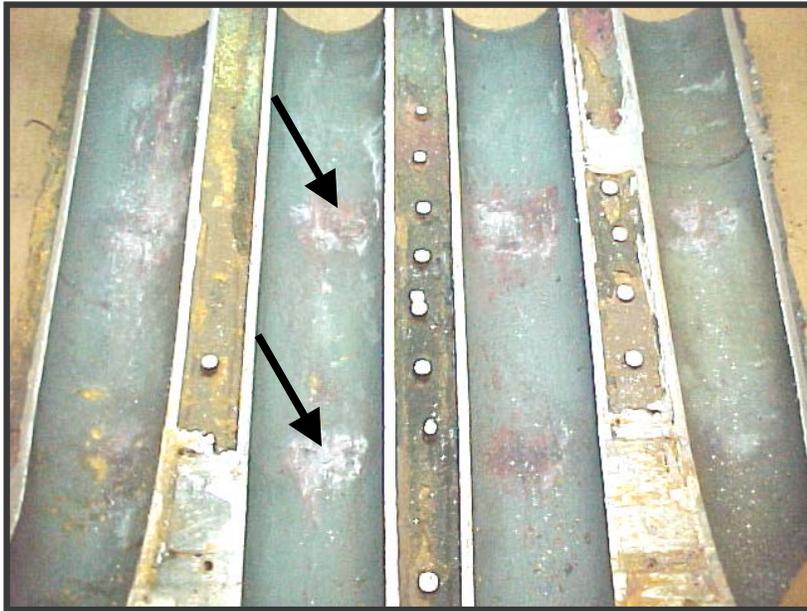
FIGURE 5. Top: Fillet welds associated with a tertiary windbox. Bottom: Internal surfaces at the fillet weld locations shown above. Note variable extent of oxide accumulation opposite each weld. One pair of oxide accumulations is marked with arrows, but a similar pair is on each tube.

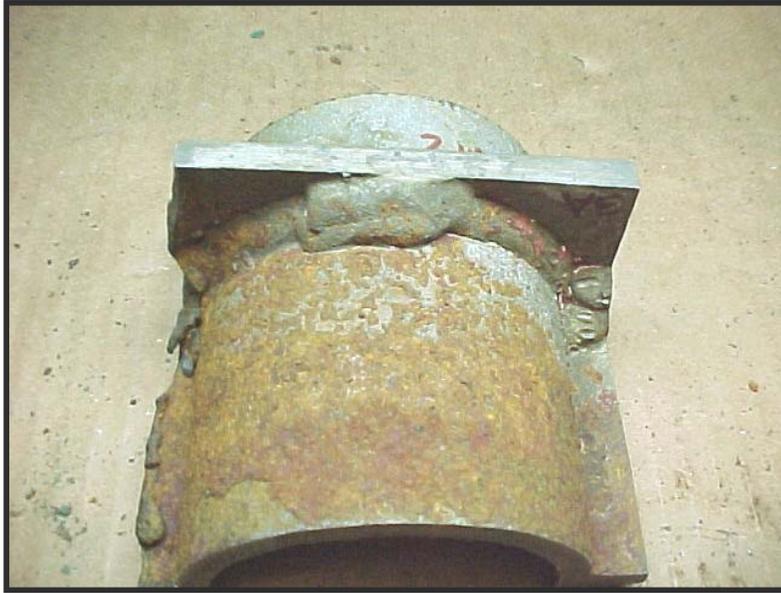
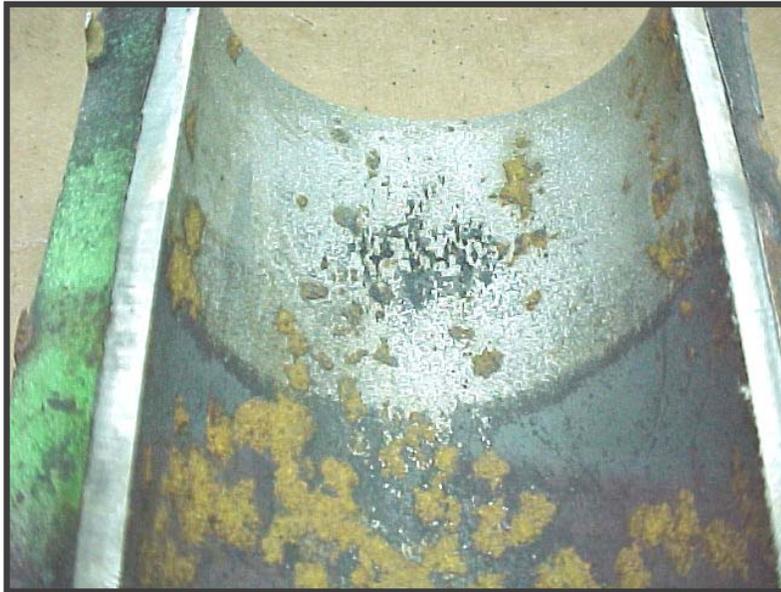
A sampling of tubes exhibiting the oxide accumulation was cut into short lengths and chemically cleaned with inhibited hydrochloric acid (ASTM G-1-1990 procedure C.3.5) to remove the oxide with no appreciable attack of the underlying steel. A representative result is shown in Fig. 6. Directly beneath every oxide accumulation, longitudinally-oriented SAC was observed. The indications in Fig. 6 are typical of all of the SAC observed among these tubes in that they appear as a cluster of short, roughly parallel indications on the ID near the tube crown, and are centered on the attachment weld location. The total longitudinal length of each cluster was less than 3 cm in every case for the tubes in this investigation.

FIGURE 6. Attachment weld (top) and appearance of the internal surface opposite the weld following acid cleaning.

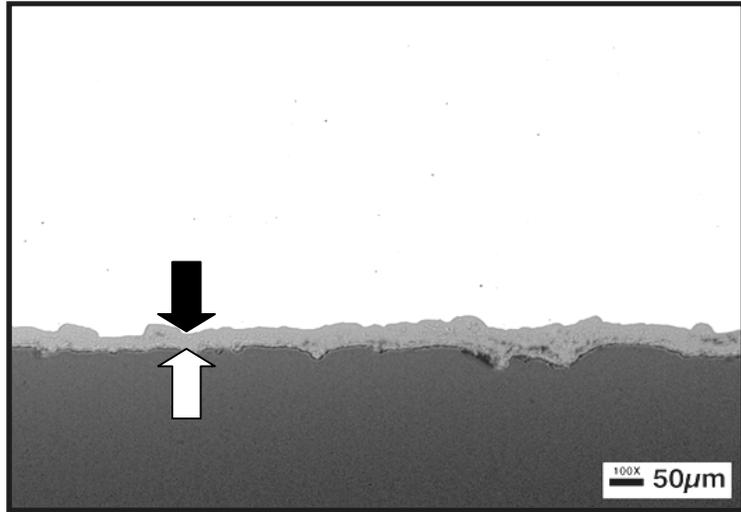
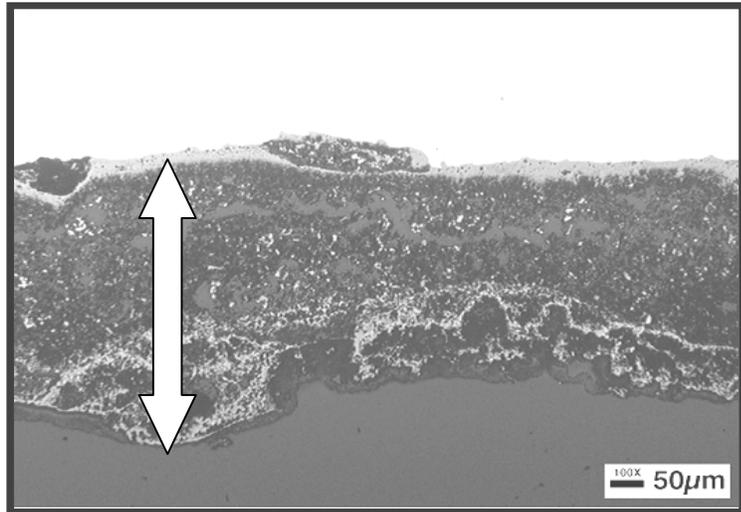
Following the discovery of SAC under the oxide accumulations, tubes were sectioned to facilitate metallographic examination in regions with and without oxide accumulations. Figure 7 compares the nominal appearance of the internal oxide layer – observed over the entire boiler tube ID except for very limited areas adjacent to some attachment welds – with an area exhibiting the oxide accumulation. Nominally, the oxide is approximately 50  $\mu\text{m}$  thick, relatively free of porosity, very adherent, and uniform in color. In locations with an oxide

accumulation, the film tends to exhibit significant porosity (contributes to poor adhesion in some areas) and irregular thickness nominally near 300  $\mu\text{m}$  but in some locations up to 400-500  $\mu\text{m}$ . In addition, the color of the thick films is not generally uniform, suggesting a range of oxide stoichiometries and compositions, including trace contaminants (Cu, Cl, P, and S were sporadically detected, generally near 0.1 at.%, but Cu and Cl occasionally were present up to almost 1 at.%).

FIGURE 7. Comparison of the nominal oxide thickness (top) with an example of an oxide accumulation (bottom). In each photograph, the oxide is marked with arrows, and unetched steel is at the top (white) and the epoxy mount material is at the bottom.

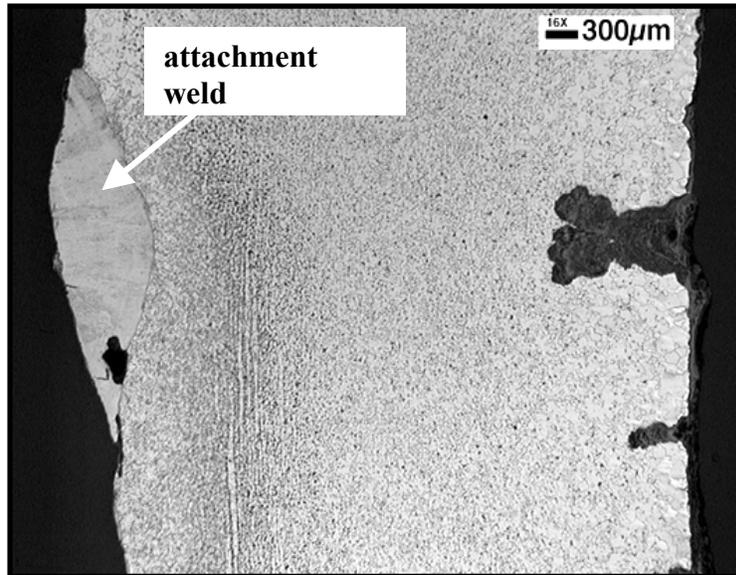
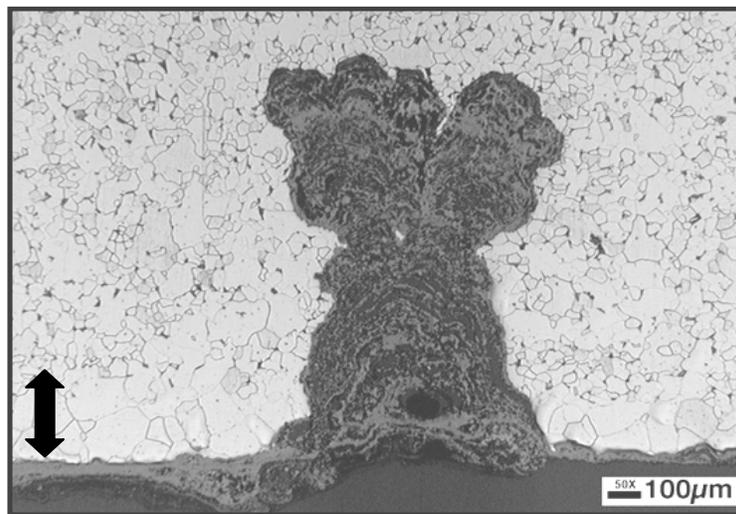
Figure 8 is representative of the most common characteristics of the SAC indications observed in this investigation. The waterside penetrations are consistently transgranular, relatively straight with bulbous features and rounded tips, and filled with an adherent, layered oxide. The relative width of the deepest penetrations varies significantly, with depth/width ratios commonly in the range 1-5. The SAC penetrations are invariably located within 1 cm or so of an attachment weld location, and the deepest penetration observed among these boiler tubes was about 30% of the tube wall thickness. In some instances, the penetrations are generally narrow with somewhat bulbous features, consistent with periodic intense corrosion events. Apparently, during periods of relatively high corrosion (probably associated with simultaneous rupture of the protective film and poor water chemistry), the penetration advances until the stress or water chemistry (or both) return to nominal levels, at which time the corrosion tends to spread laterally until full passivation is restored. In the most favorable cases, the number of “bulbs” on the penetrations can be related to the number of aggressive corrosion events<sup>4</sup> in the boiler.

Another common feature revealed by the metallography in Figure 8 is that the waterside surfaces rather routinely exhibit a decarburized layer approximately 200-300  $\mu\text{m}$  deep in which the ferrite grains have grown significantly larger than the nominal size. Microhardness scans across the tube thickness indicate that the decarburized layer with large grains (85-100 HV) is generally somewhat softer than the nominal base material (100-115 HV). For comparison, the welds examined on these tubes exhibit somewhat higher hardness at 160-250 HV, with intermediate hardness in the weld heat-affected zone. In some regions with SAC indications, the decarburized layer was not observed on the tube waterside, suggesting sufficient general corrosion/wastage at this location to remove the thin layer of somewhat softer material. In general, the external surfaces of the boiler tubes also exhibit the decarburized layer with some grain growth (see area adjacent to the weld at the top of Fig. 8), but where extensive surface preparation for an external attachment has occurred, the decarburized layer has typically been removed by grinding.

FIGURE 8. Representative photomicrographs of a tube cross section showing the attachment weld and adjacent SAC penetrations (top) and a higher magnification view of the deepest penetration associated with this particular attachment weld (bottom). The decarburized layer is marked with an arrow in the lower photograph.

If the SAC process is initiated when boiler tubes experience sufficient strain to fracture the nominally protective oxide,<sup>9-11</sup> then that process is perhaps aided by boiler tubes with a slightly weakened (decarburized, large grains) internal surface. Increased resistance to SAC might be realized by utilizing boiler tubes that do not exhibit a soft layer or, alternatively, selecting a somewhat stronger tube material in general, at least for application in areas of the boiler susceptible to SAC.

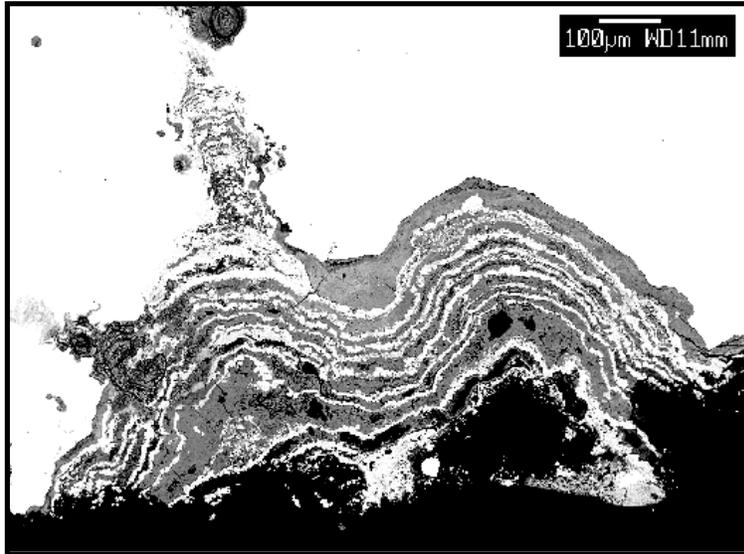
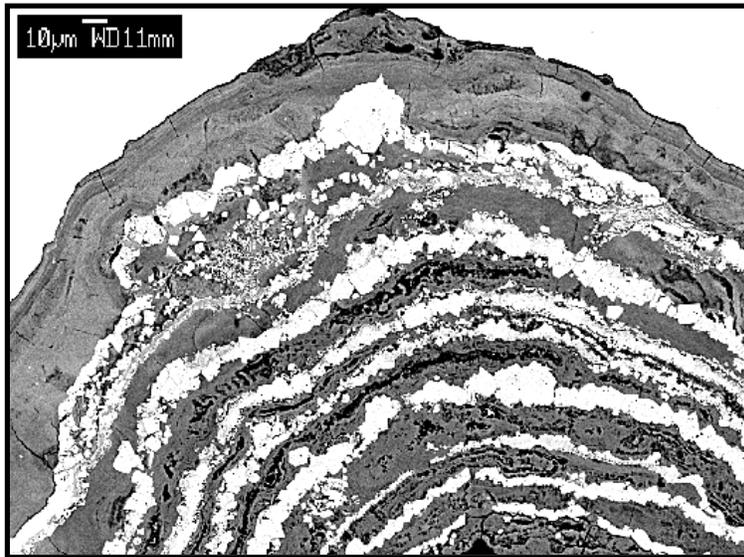
Scanning electron microscopy of representative SAC penetrations revealed a layered oxide structure within the penetrations as well as in portions of the oxide accumulations on the tube internal surface. An example of the layered oxide appearance is shown in Fig. 9. While not analytically identified, the relatively dark layers of iron oxide have a uniform Fe/O ratio consistent with  $\text{Fe}_2\text{O}_3$  and the relatively light layers have a similarly uniform Fe/O ratio consistent with  $\text{Fe}_3\text{O}_4$ . While multiple alternating layers of oxide have not been previously reported within SAC penetrations, inner and outer oxide layers (similar to that shown in Fig. 7b) have been observed following field and laboratory tests associated with SAC investigations.<sup>12-15</sup> The alternating oxide layers observed here provide visual confirmation of the concept that the corrosion conditions in the boiler tubes – and within the penetrations into the tube wall – vary periodically and that pitting/cracking is cyclic in nature.

FIGURE 9. Backscattered electron microscopy of a typical SAC indication on the tube ID. The top photograph shows the entire SAC indication, and the bottom photograph is a higher magnification view of a portion of the oxide in the penetration.
