Objective

Spark Plug Erosion is Observable

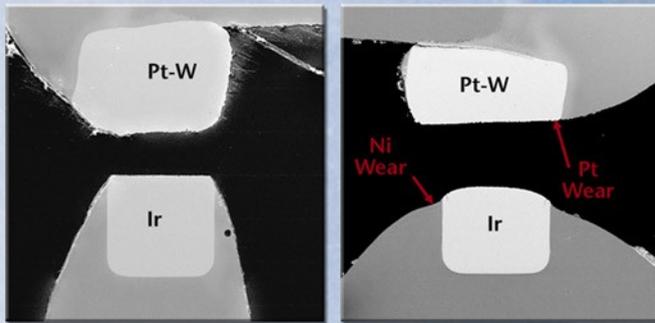
The tips of the spark plugs wear away until the gap distance is too large for the plug to fire

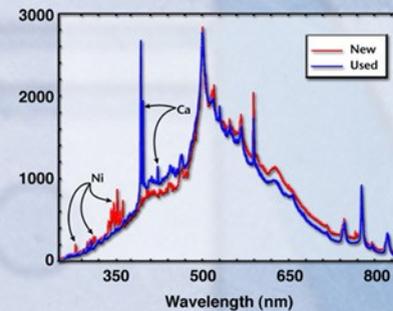
Optical Spectroscopic Analysis Detects Chemicals During Spark Process

- Ca from the engine oil
- No detection of Pt, W or Ir from electrode tips

Detection of Ni in new spark plug suggests the erosion of Ni-based electrode due to sputtering process

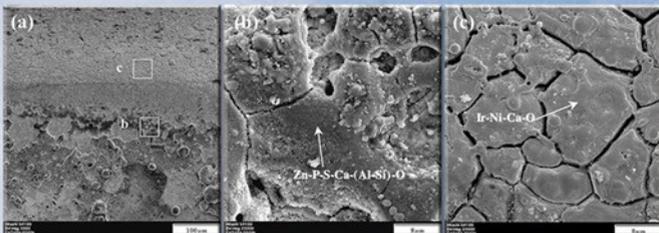
Ir Electrode Shows Glassy Phase and Cracking

SEM micrographs of Ir central electrode showing substantial formation of glassy phase enriched with Ca on electrode side surface (b) and intergranular cracking and Ir-Ni glassy phase formation on Ir tip insert surface (c).

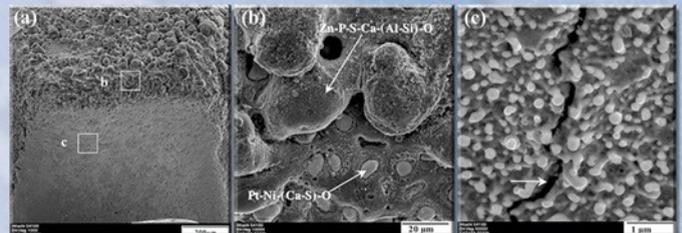
Pt-W Electrode Shows Glass Phase and Cracking

SEM micrographs of Pt-W alloy ground electrode showing substantial formation of glassy phase enriched with Ca on electrode side surface (b) and crack generation and localized melting on Pt-W alloy tip insert surface (c).
