ORNL/RASA-99/1

**Results of the Independent Radiological  
Verification Survey of  
Remediation at Building 14,  
Former Linde Uranium Refinery,  
Tonawanda, New York (LI001V)**

Date Issued—July 2000

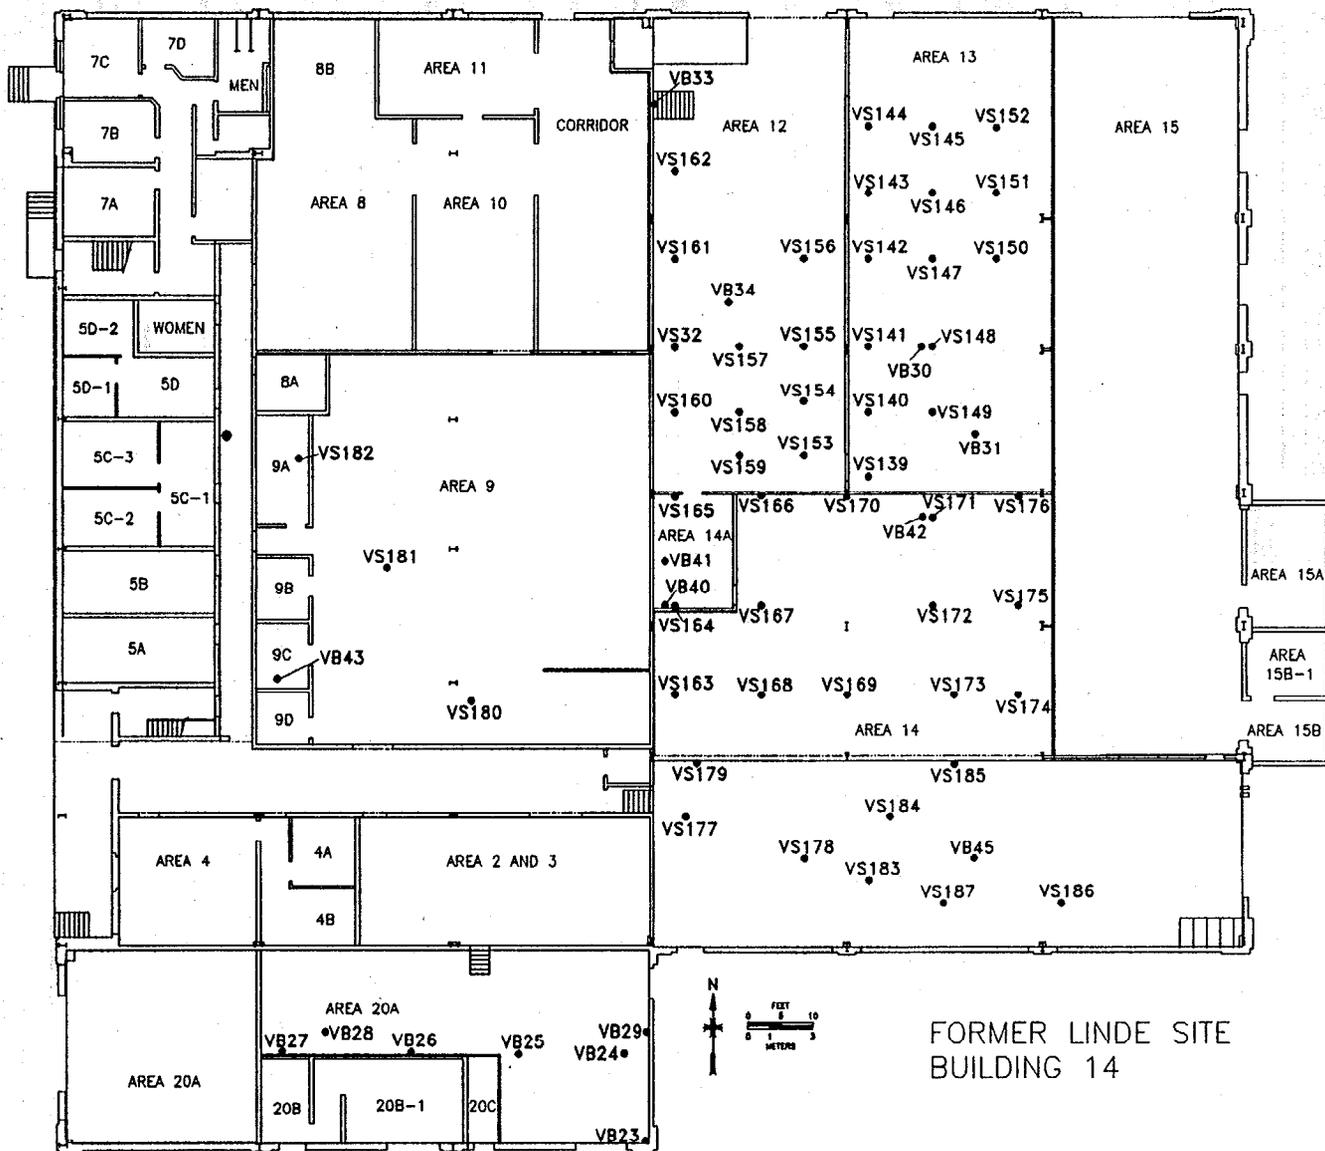
Fig. 4. Diagram showing soil sampling locations at Building 14.

Concentrations of  $^{226}\text{Ra}$  and  $^{232}\text{Th}$  at soil sample locations (Table 4) ranged from 0.50 to 2.0 pCi/g and from 0.26 to 1.3 pCi/g, respectively, in 70 samples from 66 locations. These levels are similar to typical background levels of  $^{226}\text{Ra}$  and  $^{232}\text{Th}$  found in the Tonawanda area (Table 2).

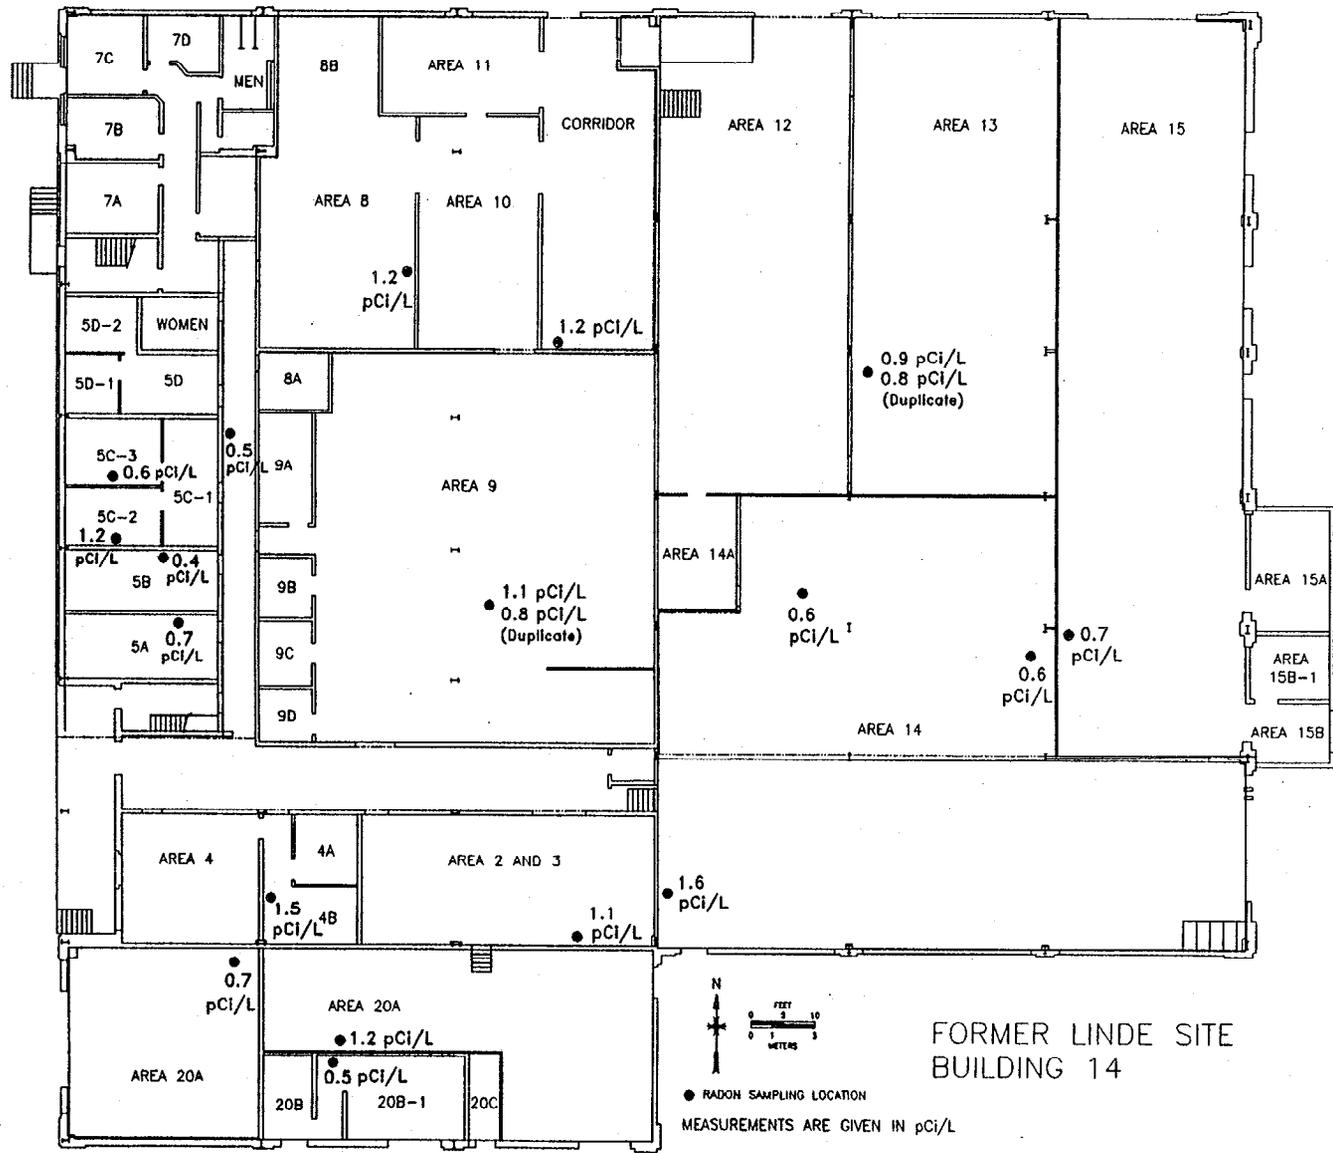
Fig. 5. Diagram showing results of radon measurements at Building 14.

Building 14 at the former Linde site in Tonawanda, New York, was thoroughly investigated inside for radionuclide residues. Surface residual activity levels were generally well below applicable guidelines for protection against radiation. Similarly, removable alpha and beta-gamma activity levels were below guidelines. Gamma exposure rates within the building were at typical background levels, and no elevated indoor radon concentrations were measured.

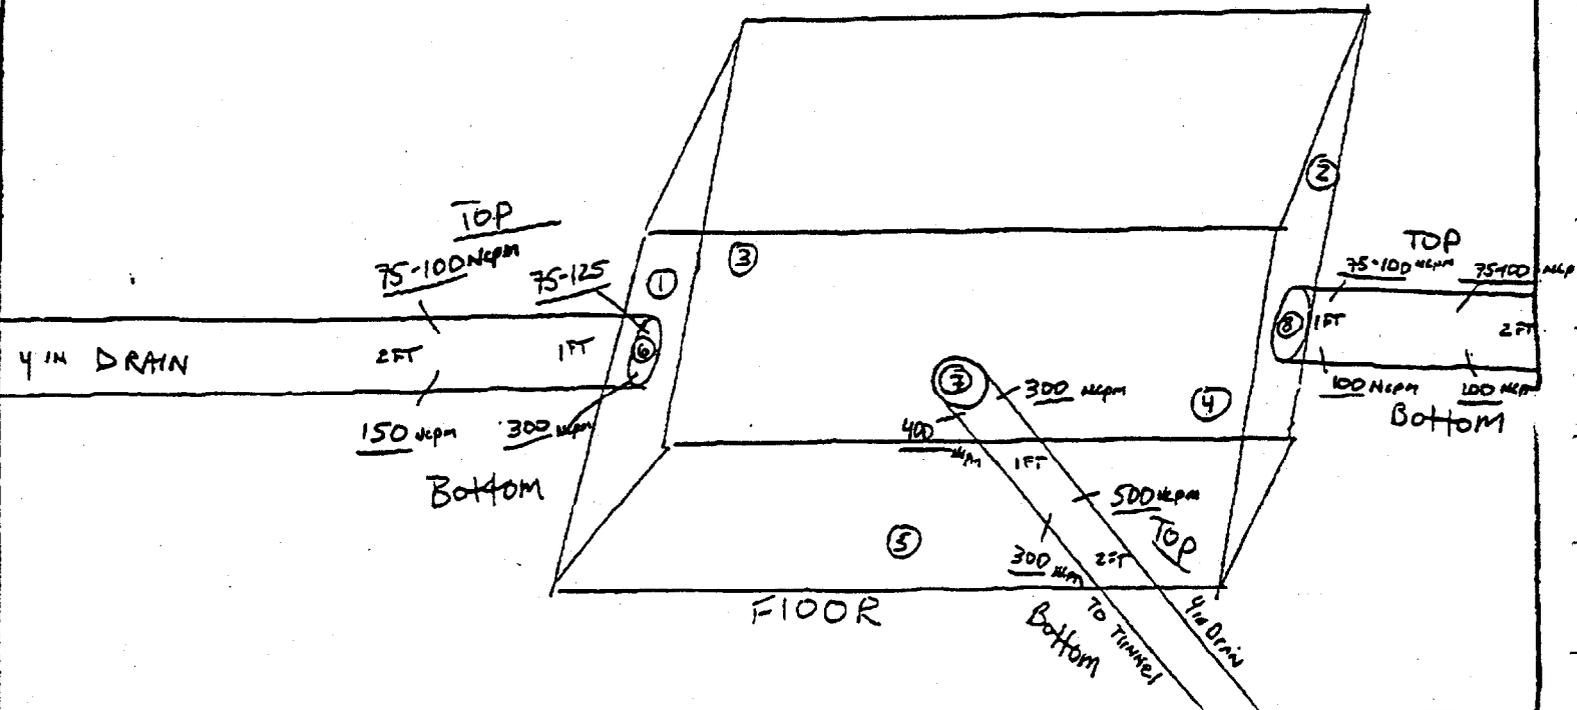
AREA 12 Sump PIT

Loc	Type	Description	Gross	α dpm	Gross	β dpm	Loc	Type	Description	Gross	α dpm	Gross	β dpm
1	S	EAST WALL	2	6	56	-14	E.WALL	D.P.	EAST WALL			50-250	
2		WEST WALL	0	0	69	31	W.WALL	D.P.	WEST WALL			50-180	
3		SOUTH WALL	4	12	77	59	↓	↓	↓			50-180	N/A
4		NORTH WALL	1	3	96	124	S.WALL	D.P.	SOUTH WALL			90-260	
5		FLOOR	2	6	79	65	↓	↓	↓			90-260	
6		EAST PIPE	1	3	65	17	N.WALL	D.P.	NORTH WALL			50-250	
7		NORTH PIPE	1	3	69	31	↓	↓	↓			50-250	
8	↓	WEST PIPE	1	3	67	24	FLOOR	D.P.	FLOOR			75-275	
E.WALL	D.P.	EAST WALL			50-250		↓	↓	↓			75-275
