Report of the Investigating Team for the October 6, 2003, Radiological Event at Building 2026

November 2003

**Prepared by
Joseph P. Flynn
Team Leader**

Prepared by
OAK RIDGE NATIONAL LABORATORY
P.O. Box 2008
Oak Ridge, Tennessee 37831-6285
managed by
UT-Battelle, LLC
for the
U.S. DEPARTMENT OF ENERGY
under contract DE-AC05-00OR22725

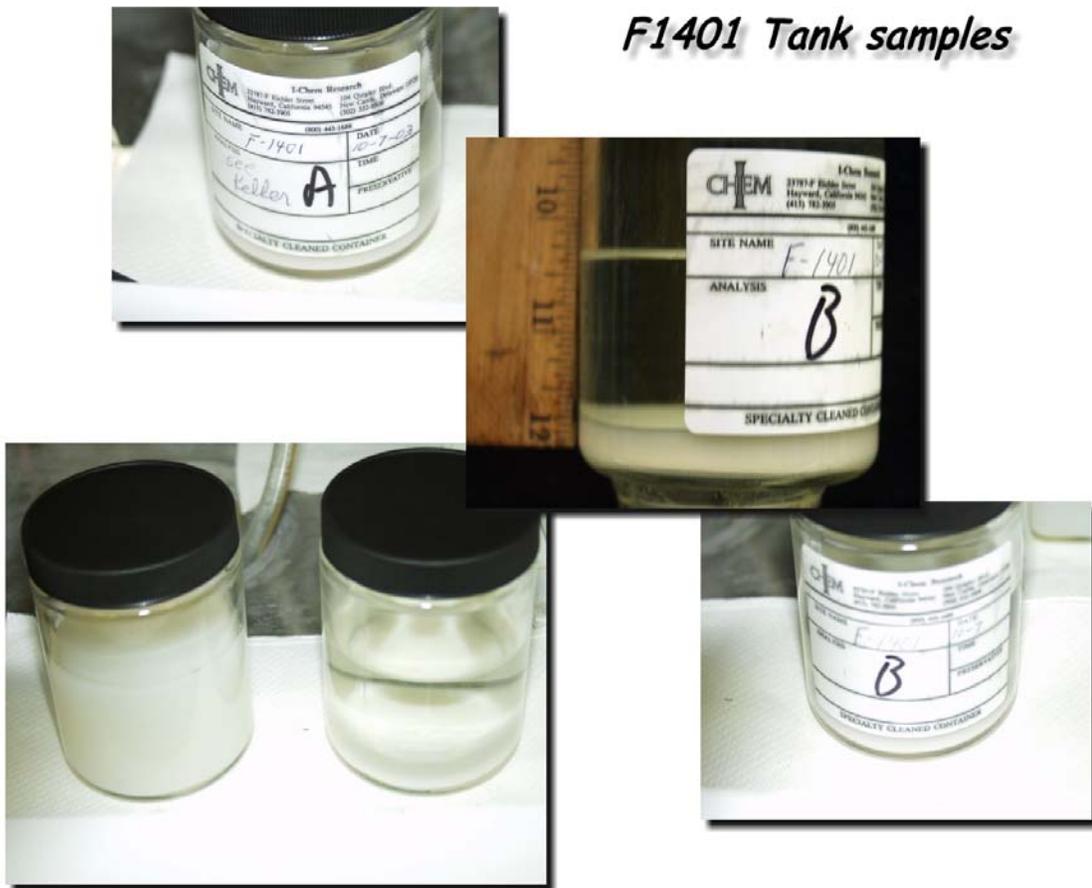
Fig. 1. Tank Sample Photos

Based on the Pu 239/240 analyses performed on the two samples collected from tank 1401, 49.7% of the plutonium is indicated as having reached the tank for one sample (sample number 1401B). The other sample (1401A) resulted in 32% of the plutonium being located in the tank. Reliable sampling of the 1401 tank following the addition of caustic would not be expected. The plutonium and americium should have precipitated and would be expected to exist as a solid phase. The precipitated plutonium would be difficult to re-dissolve in acid. Thus, sampling of this two-phased system in tank 1401 would consist of mixing solids and water, and hoping that some degree of homogeneity could be obtained – a process that would not be expected to yield a high degree of accuracy. In addition, there are the uncertainties regarding the volume of the slurry in tank 1401 and whether representative aliquots from the two acquired analytical samples (likely to be a dilute suspensions themselves) before making acidic dissolutions. The bottom line is these samples should not be highly reliable for quantitative analyses. Given the above, achieving a realistic material balance confirmation from the analytical results using these alkaline samplings, or even having an agreement between the two analytical results obtained should not be expected. Figure 1 below accurately depicts the inhomogeneity of these samples (1401A and 1401B) and the difficulty in obtaining quantitative results.

Tank 1401 still contained two previously disposed batches of material (batches 3 and 4). The analytical results for plutonium 239/240 may be considered the most reliable indicator of the material being disposed of on October 6th, given the isotopic distribution of that sample compared to those for previous disposed plutonium materials. In contrast, the americium (Am-241) analyses must be considered in terms of total americium from three disposals, not just the October 6th disposal. With americium, balance of 56% (1401B) and 40% (1401A) were indicated for this isotope (sum of americium in the disposed batches).
