EVALUATING ENVIRONMENTAL BARRIER COATINGS ON CERAMIC MATRIX COMPOSITES AFTER ENGINE AND LABORATORY EXPOSURES

Karren L. More, Peter F. Tortorelli, and Larry R. Walker
Oak Ridge National Laboratory, Oak Ridge, Tennessee

ABSTRACT

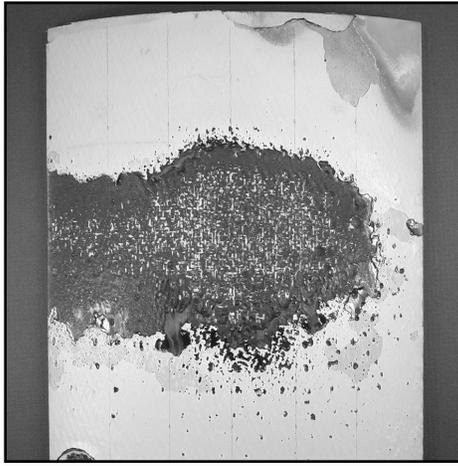
Fig. 3a. Severely damaged area on working surface of inner liner corresponding to a typical fuel injector impingement area.

In areas directly associated with fuel injector impingement (Fig. 3a), corresponding to the hottest areas on the liner surfaces, the loss of EBC due to volatilization was extreme. In fact, most of these localized areas showed evidence of gradual surface recession of the EBC down to the CVD SiC seal coat, which had started to oxidize. In two of the fuel injector impingement areas where the EBC had fully volatilized, oxidation of the CFCC material was evident.

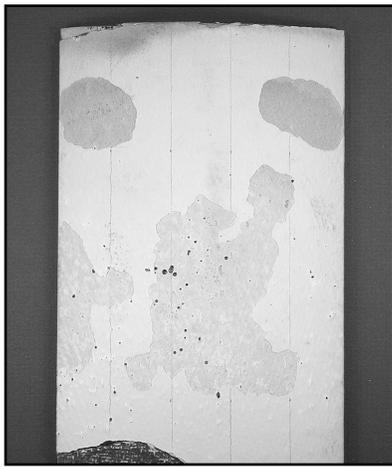
Fig. 3b. Area on working surface of inner liner where EBC appeared to be intact or only slightly damaged.

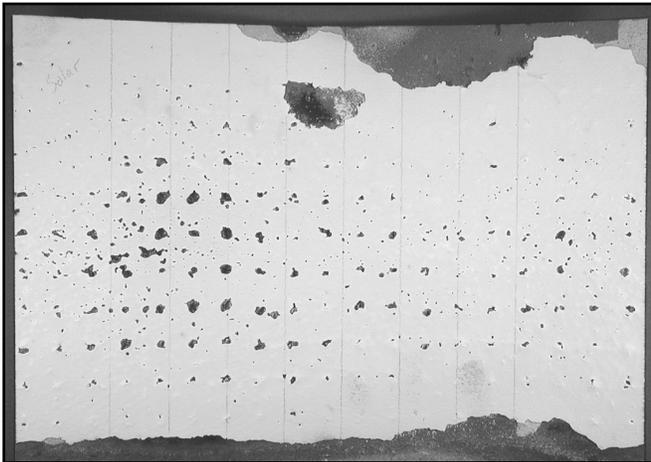
Fig. 3c. "Pinhole" pattern observed on working surface of outer liner.

Surface Asperities and Pinhole Defect Formation. As shown in Fig. 3c, a regular pattern of “pinhole” defects was observed on the working surfaces of both the inner and outer liners, but was especially prevalent across most of the surface of the outer liner. These defects were initially observed during borescope inspections in the early stages of the engine test and increased in number and severity as the engine test progressed. The spacing of the majority of the defects on the outer liner corresponded directly with the tooling used during the CVI processing of the outer liner. The pattern of “tool bumps” are always observed on the surface of as-processed CVI-produced CFCCs and are caused initially by the slight localized pulling or raising of the wound fibrous preform (usually a single fiber tow) during CVI. The tool bumps on the surface of the liner are still evident following the application of the CVD SiC seal coat, as shown in Fig. 15. The surface asperities at this stage usually measure ~0.2-0.25mm in height. After application of the EBC, the surface asperities are still present, as shown on the surface of an as-processed EBC/CVI-CFCC coupon in Fig. 16. A cross-section directly through a typical tool bump shows that in the

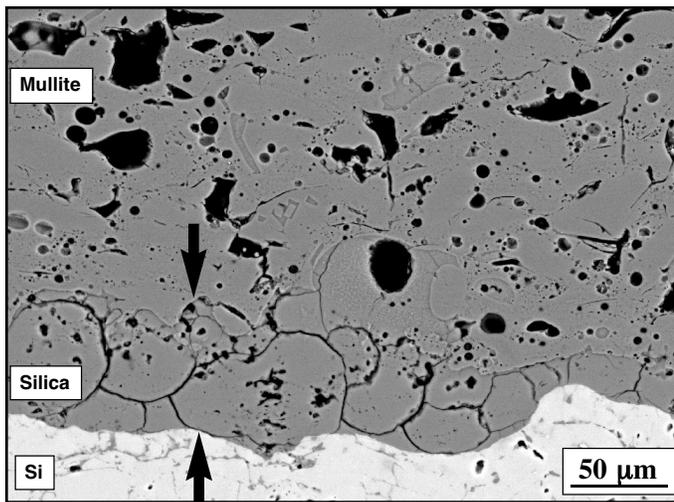
With this in mind, differences in the protective capability of each of the two EBCs became apparent in the early stages of exposure in the Keiser Rig. After 1500h at $1200^\circ C$ and 1.5atm H_2O , imaging the Si/mullite (area circled in Fig. 1) or the Si/(mullite+BSAS) (area circled in Fig. 2) interfaces of the EBC revealed oxidation of the Si bond coat which resulted in the formation of SiO_2 at the interfaces during exposure. Differences between the amount of SiO_2 formed after 1500h for the two EBC formulations are shown in Fig. 4 and Fig. 5 for the Si/mullite/BSAS and Si/(mullite+BSAS)/BSAS mixed-layer EBCs, respectively. Note that the amount of SiO_2 formed in the Si/Mullite/BSAS EBC (Fig. 4) was $\sim 5X$ thicker than that formed in the mixed-layer EBC (Fig. 5) indicating that the protective capability of the mixed-layer EBC was superior. In fact, exposure of the Si/mullite/BSAS EBC/CFCC coupon in the Keiser Rig was suspended after 3000h because excessive oxide formation at the Si/mullite interface led to some EBC spallation at this interface. The primary reason for the greater degree of oxidation for the Si/mullite/BSAS EBC is attributed to excessive micro-cracking and porosity within the mullite intermediate layer after EBC processing. The (mullite+BSAS) intermediate layer in the mixed-layer EBC did not show excessive micro-cracking in the as-processed condition. Exposure of the mixed-layer EBC/CFCC coupon was continued for a total exposure time of 6500h. The Si/(mullite+BSAS) interface in the mixed-layer EBC/CFCC after 5000h at $1200^\circ C$ and 1.5atm H_2O is shown in Fig. 6. A comparison of Fig. 5 and Fig. 6 shows only slow thickening of the SiO_2 at extended times, further demonstrating the superiority of this EBC compared to the Si/mullite/BSAS EBC.

Fig. 4. SEM image of SiO_2 formed at Si/mullite interface ($\sim 50\mu\text{m}$ thick) in standard 3-layer EBC after 1500h at 1200°C and $1.5\text{atm H}_2\text{O}$.

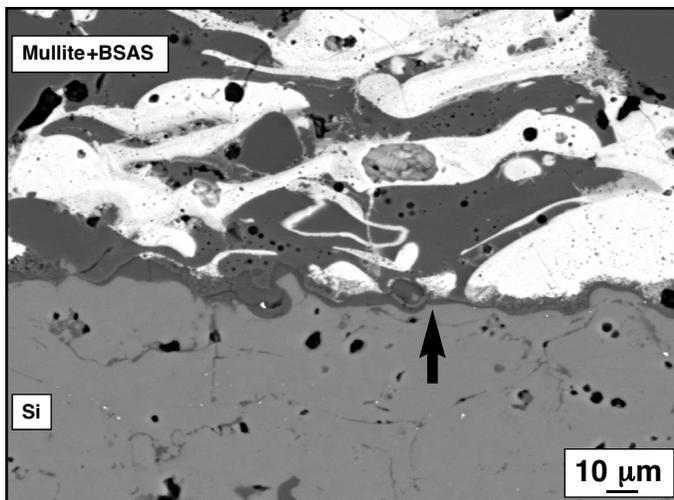
Fig. 5. SEM image of SiO_2 formed at Si/(mullite+BSAS) interface ($<10\mu\text{m}$) in mixed-layer EBC after 1500h at 1200°C and $1.5\text{atm H}_2\text{O}$.

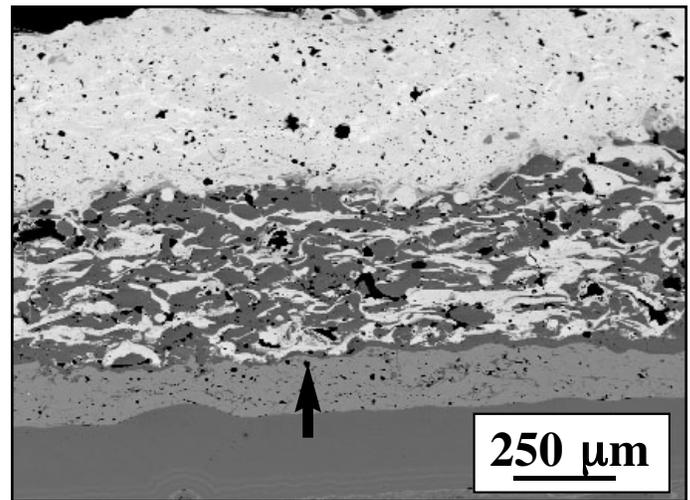
Fig. 6. SEM image of SiO_2 formed at Si/(mullite+BSAS) interface ($\sim 20\mu\text{m}$) in mixed-layer EBC after 5000h at 1200°C and $1.5\text{atm H}_2\text{O}$.

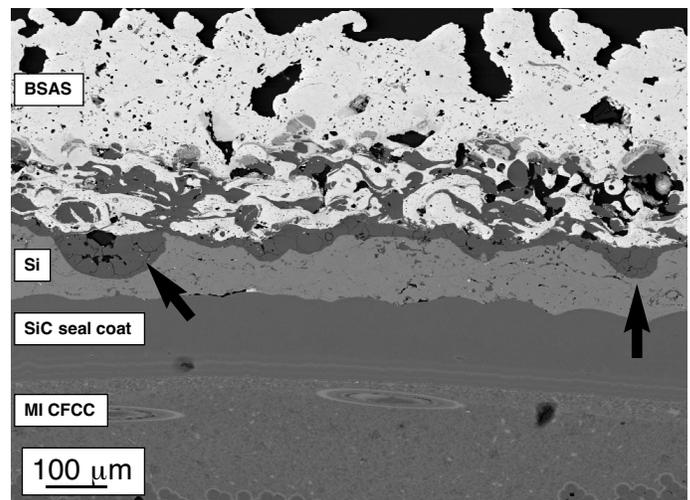
The EBC processing parameters were adjusted in the early stages of this work to minimize the number of processing defects (such as through-thickness cracks) on the final EBC/CFCC liners. However, even under the best processing conditions, some processing defects were still found. When these defects were present, accelerated localized oxidation below the EBC was observed, as shown in Fig. 7. Silica formation (Si oxidation) was excessive in these areas.

Fig. 7. SEM image of accelerated SiO_2 formation associated with processing defects (excess porosity) in mixed-layer EBC after 5000h at 1200°C and $1.5\text{atm H}_2\text{O}$.

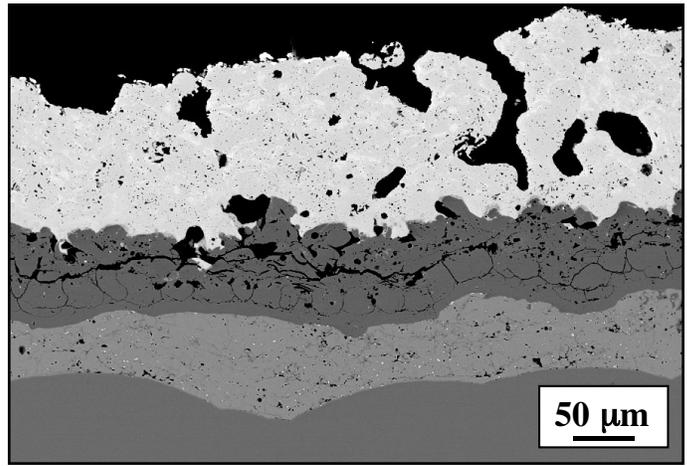
Fig. 8a. SEM image of EBC near aft end of inner liner after engine test (thickness of EBC is close to that of as-processed EBC).

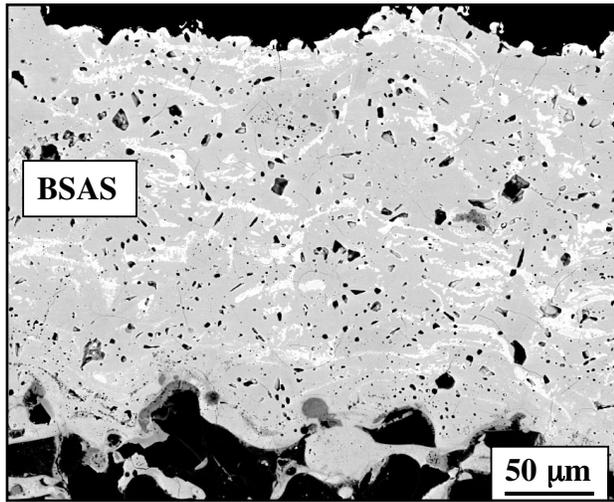
Fig. 9a. SEM image of EBC near aft end of outer liner after engine test (thickness of EBC is close to that of as-processed EBC).

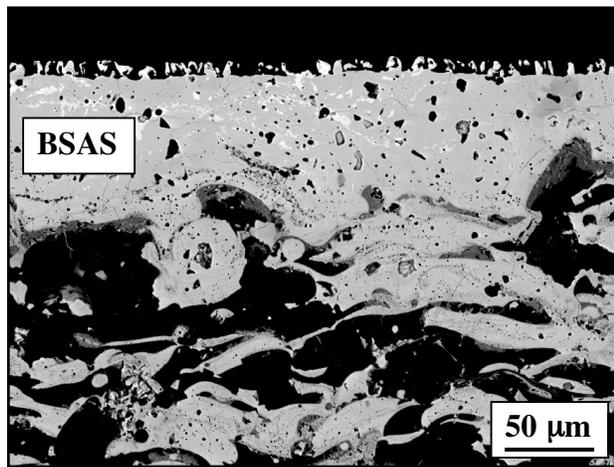
Fig. 9b. SEM image of EBC near center of outer liner after engine testing in an area that appeared to have EBC fully intact but BSAS top coat had recessed to ~60% of its original thickness.

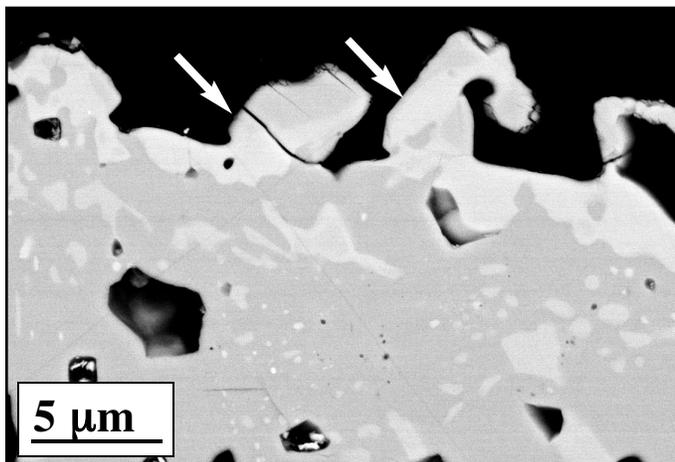
A high magnification SEM image of the surface of the BSAS which had experienced some volatilization is shown in Figure 10. A residual phase was observed on the surface which was clearly more resistant to volatilization (brightly imaging phase on surface.) This phase, a Sr-rich phase identified as $\text{Sr}_2\text{Al}_2\text{SiO}_7$ by X-ray diffraction, remained on the surface of the top coat longer than the BSAS. This phase has its origins in the as-processed BSAS top coat. As shown in Fig. 11, the as-processed BSAS top coat is a two-phase structure composed of the matrix BSAS celsian phase (standard composition 31.5wt% Ba, 4.7% Sr, 15.6% Al, 15.9% Si, and 32.3% O) and another discontinuous, Sr-enriched, "minor" phase with a composition of ~29.7wt% Ba, 13.6% Sr, 18.5% Al, 8.3% Si, and 29.9% O. This phase could not be identified by X-ray diffraction but was crystalline (as determined by electron diffraction.) Since the silica within the BSAS likely contributed to the BSAS volatilization observed during engine testing, less SiO_2 present in the starting and final Sr-rich phases made this a more stable phase. Thus, a key to improving the durability of the top coat for use in this application could be to take advantage of the presence of a Sr-rich phase.

Fig. 10. High magnification image of the surface of a partially volatilized BSAS top coat after engine testing showing $\text{Sr}_2\text{Al}_2\text{SiO}_7$ phase (brightly imaging phase) residing on top coat surface.

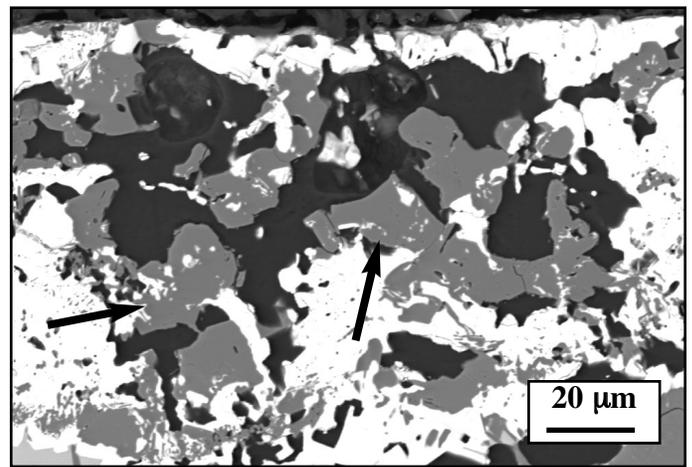
Stability of Mullite in Combustion Environments. In many areas where the BSAS top coat had significantly or completely recessed, the mullite intermediate layer was affected considerably. Once exposed to the combustion environment, the mullite rapidly separated into Al_2O_3 and SiO_2 . The SiO_2 subsequently volatilized leaving behind a porous, completely non-protective layer. This occurred on the inner and outer liner for both the Si/mullite/BSAS and the mixed-layer Si/(mullite+BSAS)/BSAS EBCs. Figure 12 shows an image of the outer liner where the BSAS completely volatilized exposing the mixed intermediate layer (mullite+BSAS) to the combustion environment. The mullite within the mixed layer has started to decompose into SiO_2 and Al_2O_3 (the Al_2O_3 forms around the edges of the mullite, designated by arrows in Fig. 12). The SiO_2 areas have volatilized leaving behind large pores in the layer, rendering the layer non-protective.

Fig. 12. SEM image of mixed mullite+BSAS layer in an area on outer liner where BSAS top coat had fully recessed during engine testing. Arrows denote pure Al_2O_3 .

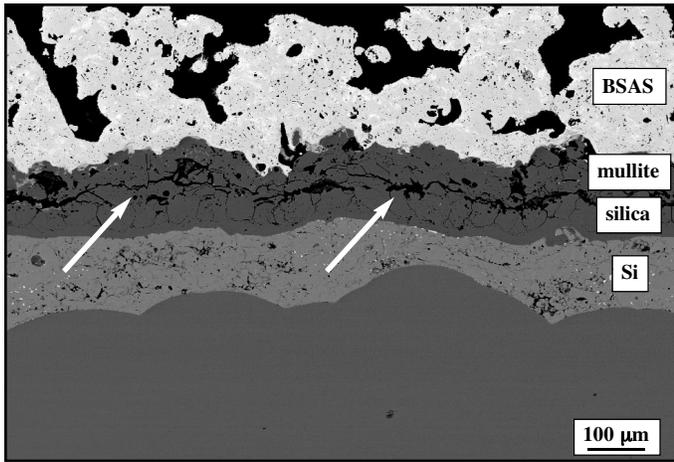
Oxidation Of Si Bond Coat Within EBCs. In areas on both the inner and outer liner surfaces where the EBC was fully intact (usually close to the aft or fore ends of liner), oxidation of the Si bond coat was consistently observed. These results were consistent with observations made on similarly processed EBC/CFCC coupons exposed in ORNL's Keiser Rig. Figure 13 shows a region on the inner liner surface near the aft end where the Si/mullite/BSAS standard EBC was intact. Extensive oxidation of the Si bond coat was observed, as evidenced by SiO_2 formation. Associated with these regions were other areas where EBC spallation was observed. Spallation of the BSAS top coat and mullite layer consistently occurred between the SiO_2 layer and mullite intermediate layer (Note separation between these layers in Fig. 13). Figure 14 shows an SEM image of the Si/(mullite+BSAS)/BSAS mixed-layer EBC from the outer liner close to the aft end of the liner. In this case, the EBC imparted greater protection for the underlying constituents and oxidation of the Si bond coat was minimized and was similar to that predicted by Keiser Rig exposures conducted at 1200°C and 1.5 atm H_2O (see Fig. 6).

Fig. 13. SEM image of EBC on inner liner near aft end showing extensive oxidation of Si bond coat. Spallation consistently occurs between SiO_2 and mullite (arrows).

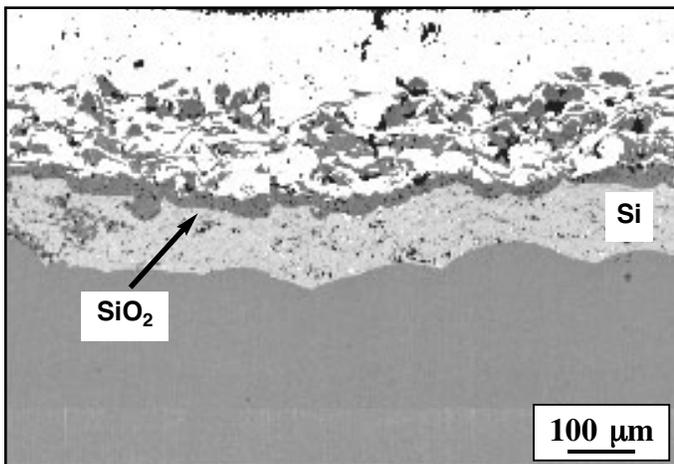
Fig. 14. SEM image of mixed-layer EBC on outer liner near aft end showing minimum oxidation of Si bond coat after ~14,000h engine test consistent with results of Keiser Rig exposures.

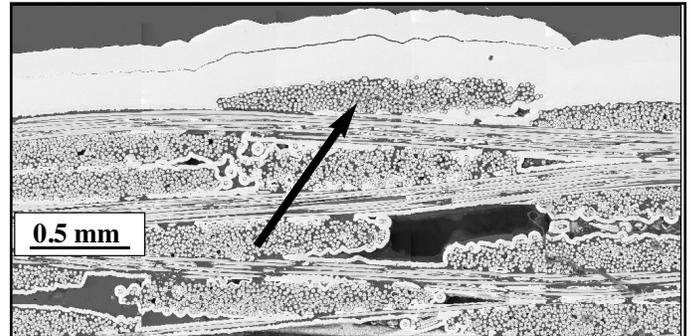
Fig. 15. Cross-section SEM image through a tool-bump after CVD SiC seal coat application. Note raised fiber tow.

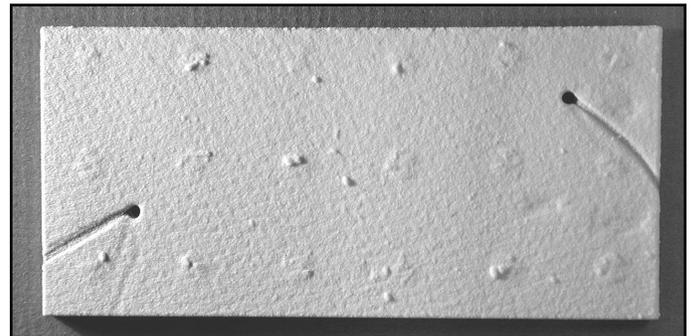
Fig. 16. CVI SiC/SiC coupon after EBC is applied showing obvious surface asperities due to tool bumps.

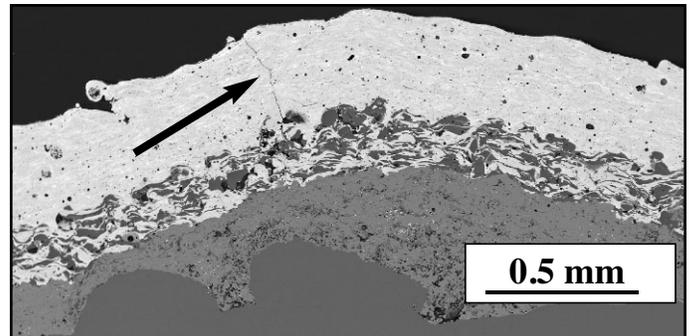
majority of cases, the asperity results in the formation of a through-thickness crack in the EBC, as shown in Fig. 17. Clearly, a through-thickness crack in the EBC will lead to localized accelerated oxidation of the Si bond coat below the surface. In fact, rapid oxidation of the constituents below the surface caused these localized areas to oxidize at rates approaching those of the uncoated CFCCs and severely limited the lifetime of the liner. Figure 18 shows a tool bump area from a relatively cool section (fore end) of the outer liner. In this case, the formation of excessive SiO_2 just below the EBC nearly resulted in the spallation of the EBC. Oxidation did not progress through the CVD SiC seal coat and into the CFCC. However, in much hotter areas near the center of the outer liner, pinholes formed when the rapid oxidation progressed down through the Si bond coat, the CVD SiC, and well into the CFCC, as shown in Fig. 19. In several cases, localized loss of the entire liner thickness resulted from the accelerated oxidation associated with the tool bumps.

Fig. 17. Cross-section SEM image through a tool bump area showing a through-thickness crack associated with a bump.

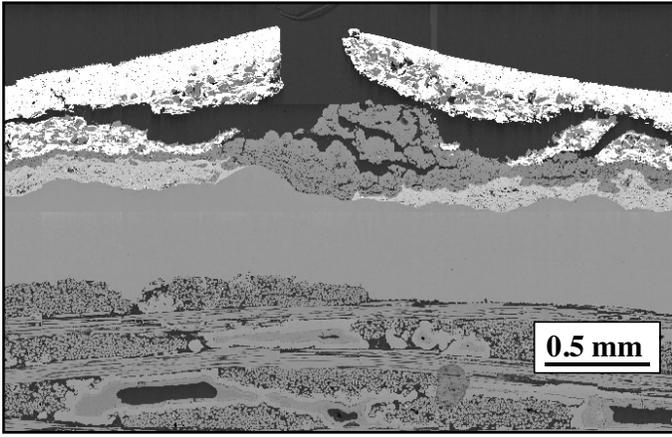
Fig. 18. Cross-section SEM image through a tool bump from fore end (cooler) of outer liner.

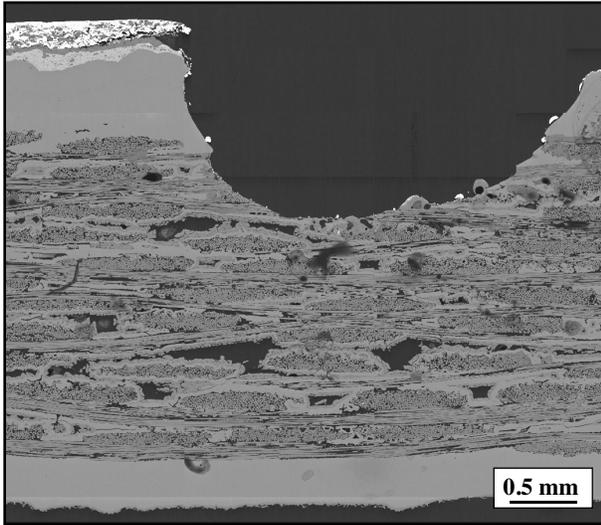
Fig. 19. Cross-section SEM image through a "pinhole" defect formed from a tool bump near center of outer liner.
