**EVALUATION OF CORROSION FAILURE
IN
TRACTOR-TRAILER BRAKE SYSTEM**

July 2002

D. F. Wilson, E. A. Kenik, P. J. Blau

Prepared for the
U.S. Department of Energy
Assistant Secretary for Energy Efficiency and Renewable Energy
Office of FreedomCAR and Vehicle Technologies
High Strength Weight Reduction Materials Program
EE 07 02 00 0

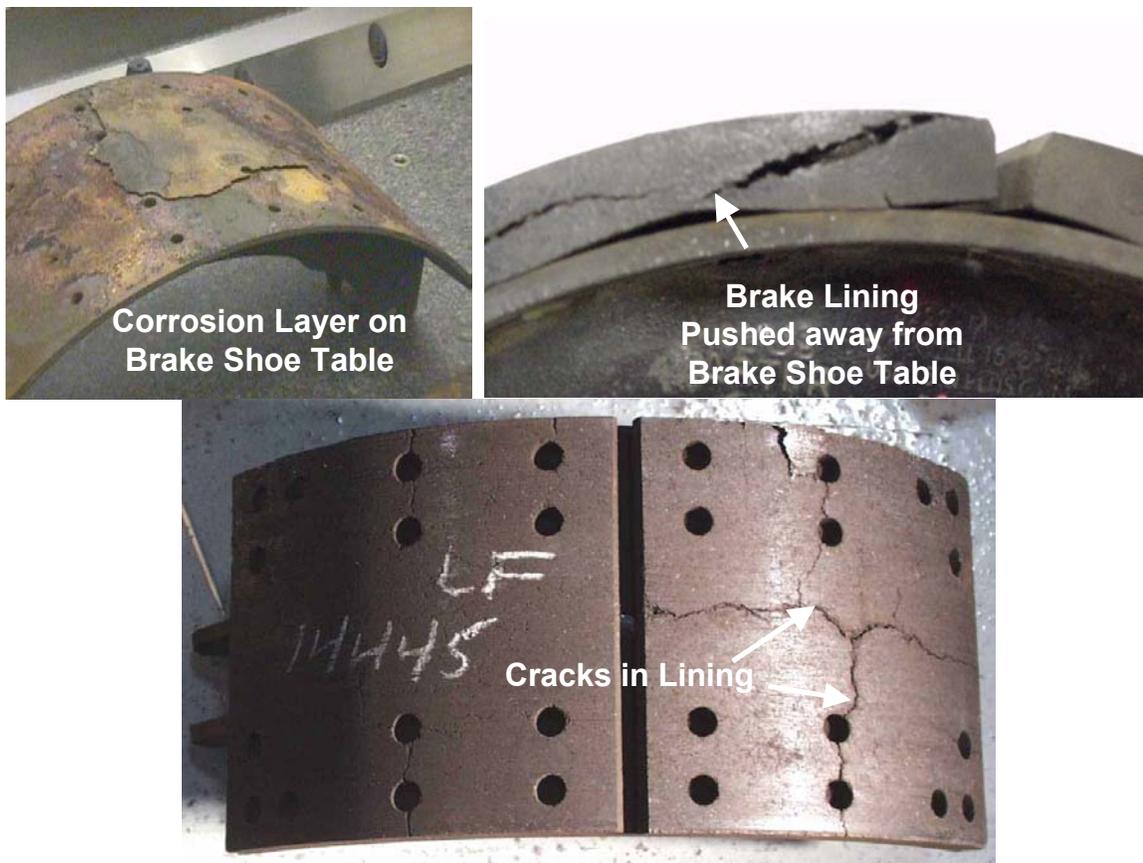
Fig. 2. Brake shoe table and lining showing corrosion product on the table, separation of lining from table and cracking of the lining.

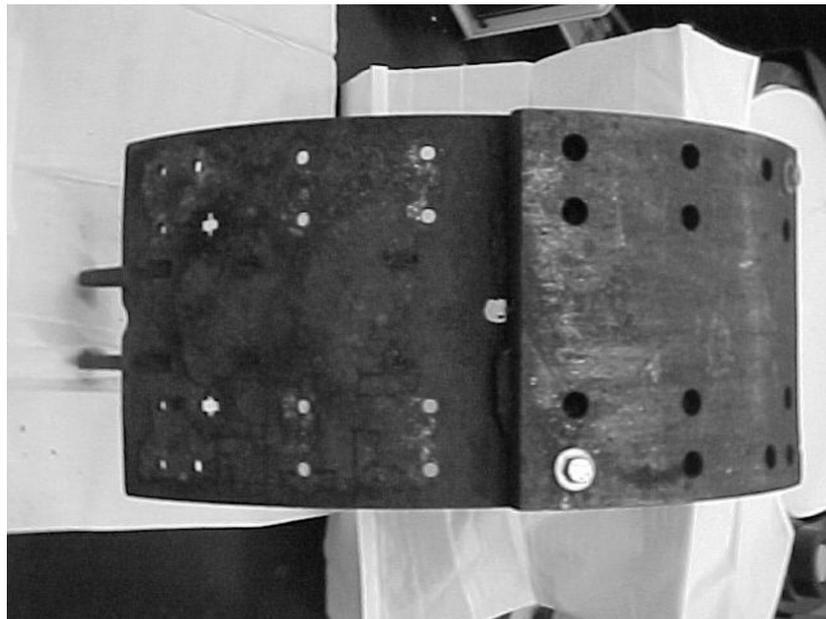
02-2026-02

Fig. 3. Partially disassembled brake system showing shoe table, lining and layout of rivet and ancillary holes.

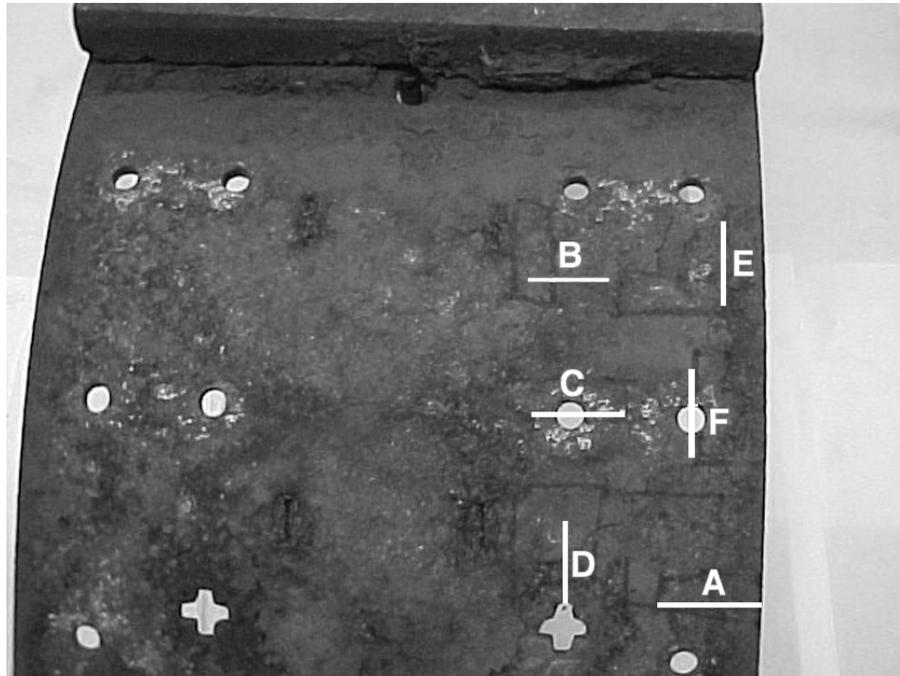
02-2026-04

Fig. 4. Layout of sites on the brake table that were sectioned for evaluation. Transverse sections are from sites A, B, and C, and longitudinal section are from and sites D, E, and C.

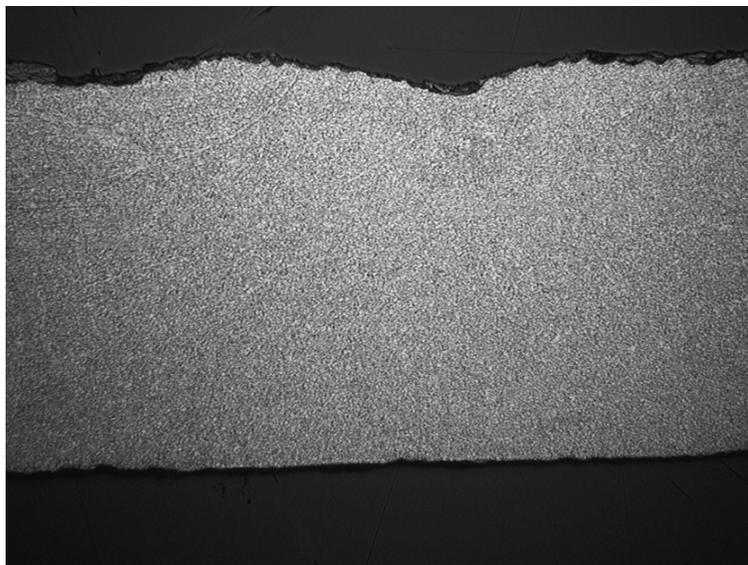
02-2028-01 Brake Shoe Area "B" ^{16X} 300 μ m
Transverse 2% Nital

Optical examination of the cross sections of the shoe table material revealed a typical plain carbon steel structure with corrosion occurring at the brake shoe table/lining interface as shown in Fig. 4. As displayed in Figs. 4 and 5, the corrosion at the table/lining interface is non-uniform as is to be expected for a plain carbon steel exposed to chloride environment. The surface of the brake table that was not in contact with the lining was still relatively smooth (Fig. 6) and the shoulder on the rivet hole is clearly delineated (Fig. 7).

Fig. 5. Typical appearance of cross section showing non-uniform corrosion at the brake table/lining interface (top of picture).

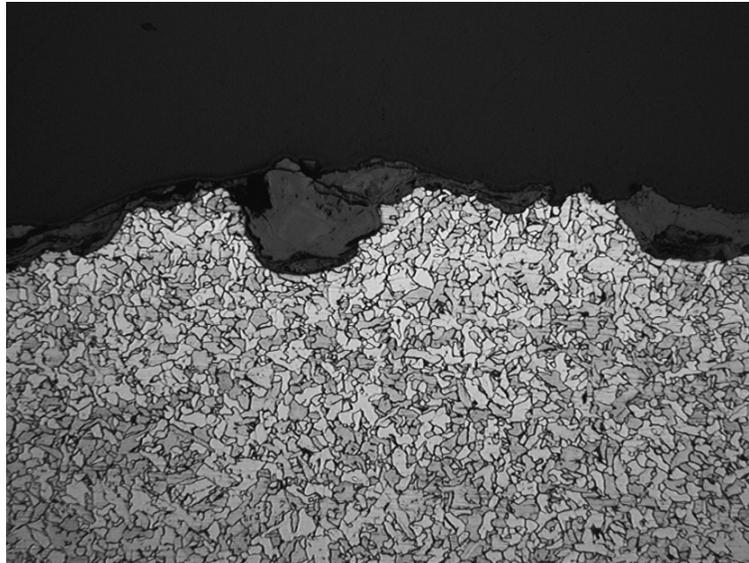
02-2028-03 Brake Shoe Area "B" ^{100X} 50μm
Transverse 2% Nital

Fig. 6. Higher magnification image showing details of the non-uniform corrosion.

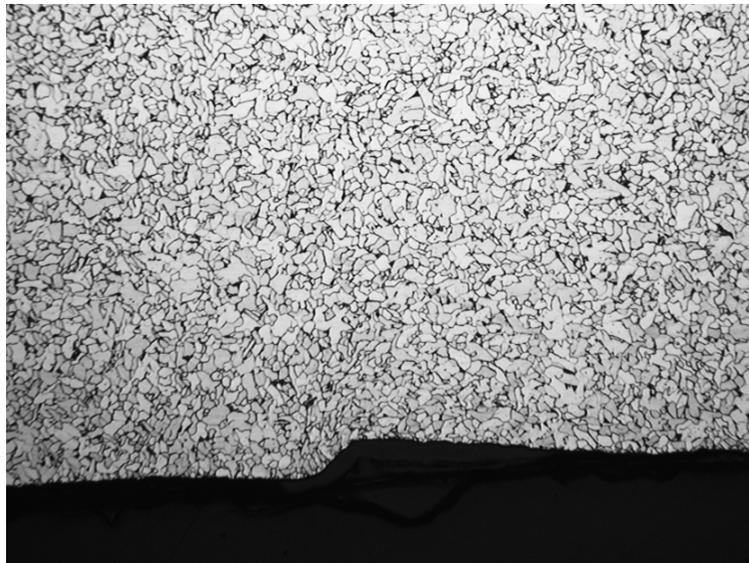
02-2029-07 Brake Shoe Area "C" ^{100X} 50μm
Transverse, Hole area 2% Nital

Fig. 7. Cross-section across a rivet hole showing relatively smooth surface of the surface that was not in contact with the brake lining.

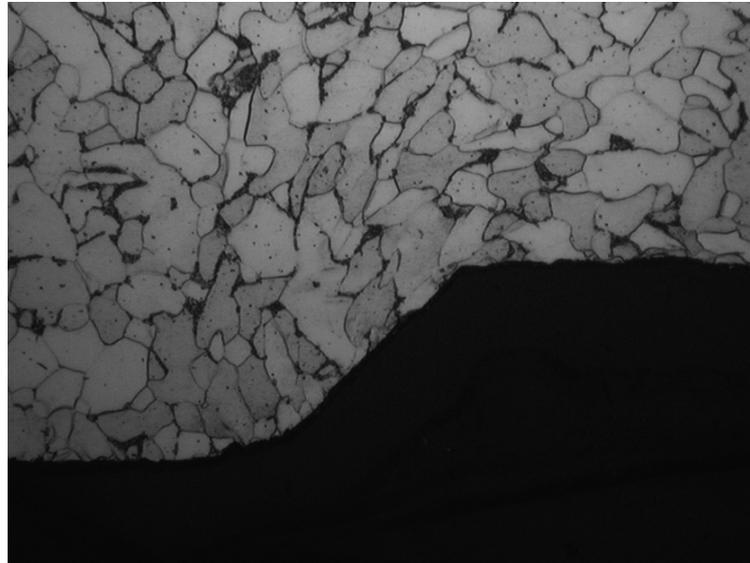
02-2029-08 Brake Shoe Area "C"
Transverse, Hole area 500X 10µm
2% Nital

Fig. 8. Higher magnification image of the surface that was not in contact with the lining shows a delineation of the shoulder of the rivet hole.

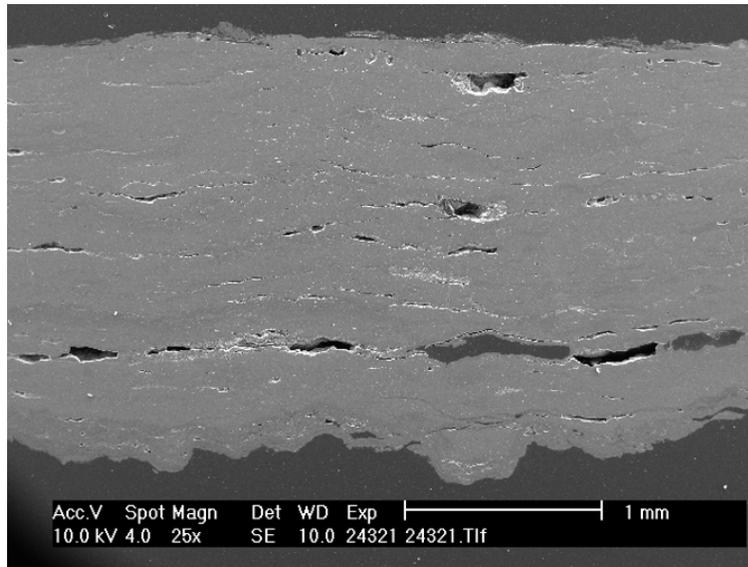
Scanning electron microscopy (SEM) and x-ray microanalysis were used to examine the structure and composition of the oxide scale from the supplied brake table. Both a spalled piece of the scale and the adherent scale on the metal table were studied. A secondary electron (SE) image, Fig. 8, shows that the scale was banded parallel to the original metal interface and contained both porosity and cracks. The corresponding backscattered electron (BSE) image, Fig. 9, revealed local differences in composition. X-ray microanalysis in the SEM showed that the light gray oxide regions were the Fe-rich Fe_3O_4 oxide; whereas the dark gray regions were the Fe-poor Fe_2O_3 oxide. The ratio of the O/Fe peaks is lower for the light gray oxide, x-ray spectrum shown in Fig. 10, relative to that for the dark gray oxide, x-ray spectrum shown in Fig. 11. Trace amounts of Cl were found in the scale. Though there were variations in Cl levels, there was no obvious

Fig. 9. Secondary electron image of the spalled scale showing banding, cracking, and porosity.

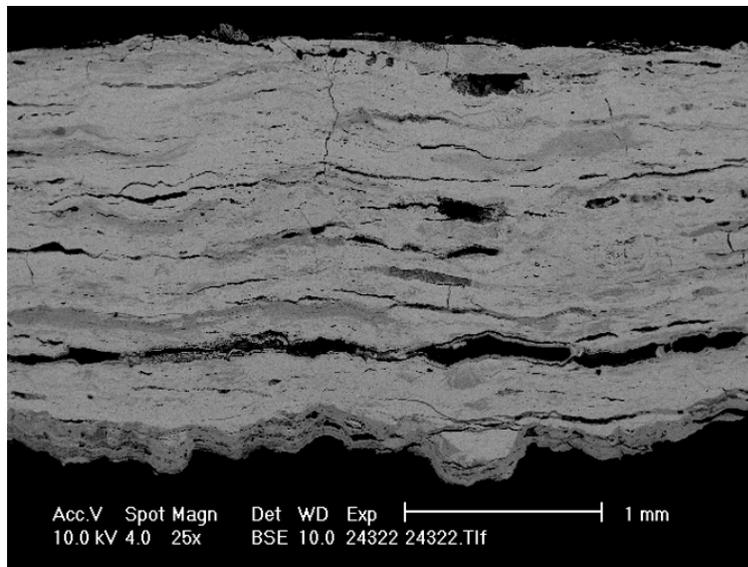
Fig. 10. Backscattered electron image revealed light (Fe_3O_4) and dark (Fe_2O_3) gray regions of different compositions.

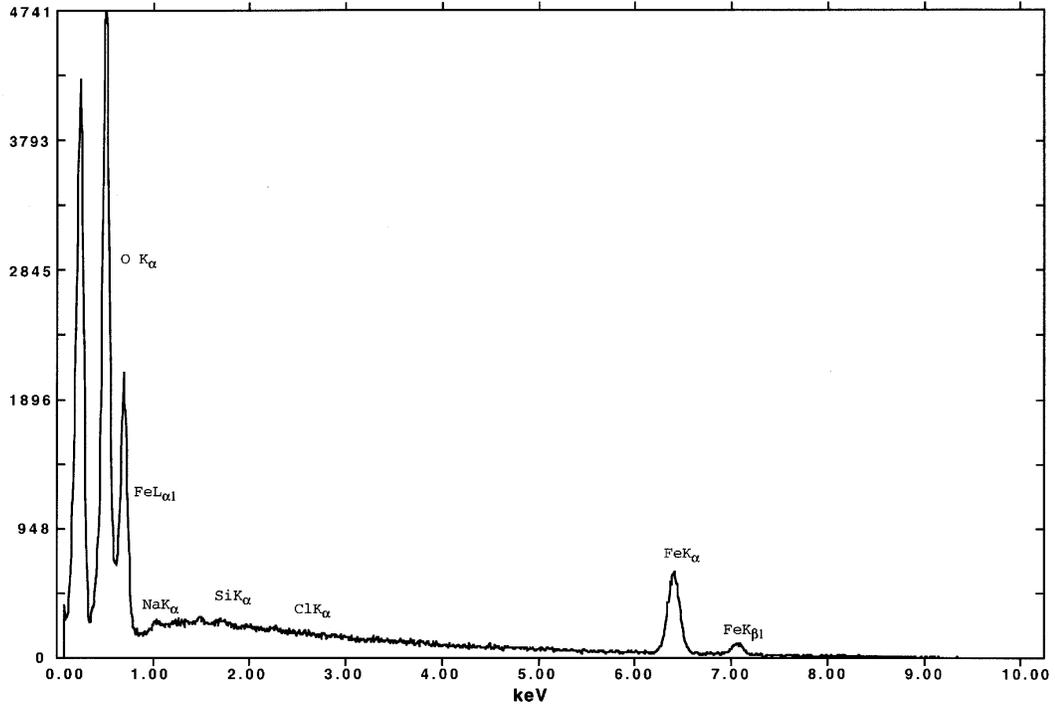
Fig. 11. X-ray spectrum of light gray area showing a lower O/Fe ratio as compared to the spectrum for the dark gray area (following figure).

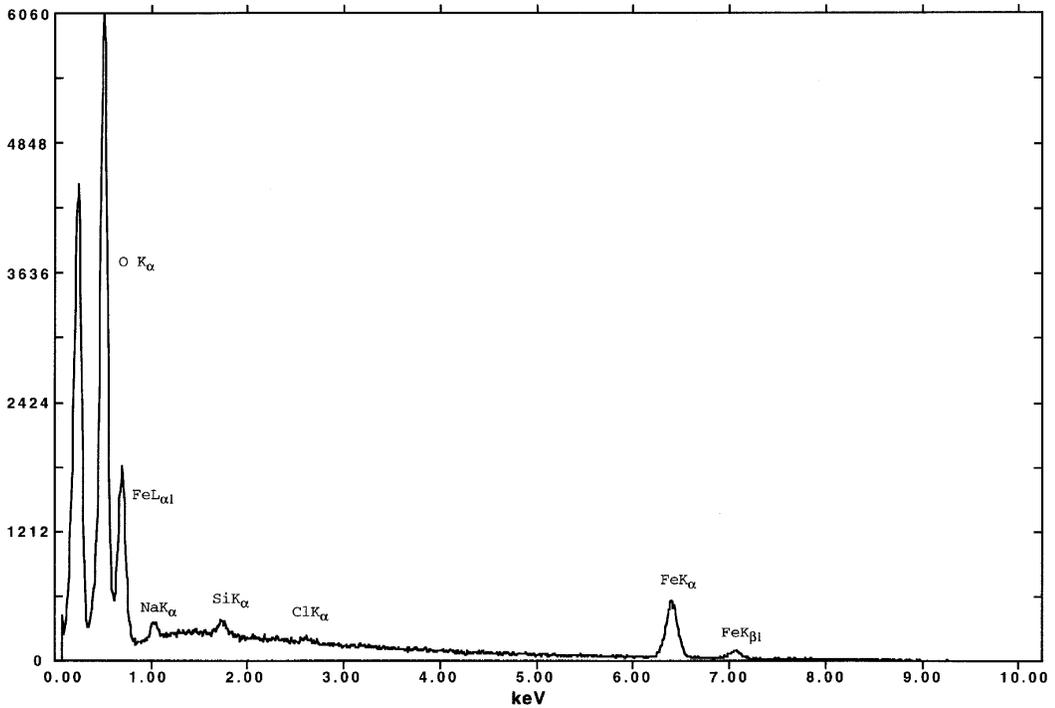
Fig. 12. X-ray spectrum of the dark gray area showing a higher O/Fe ratio as compared to that for the light gray area (previous figure).

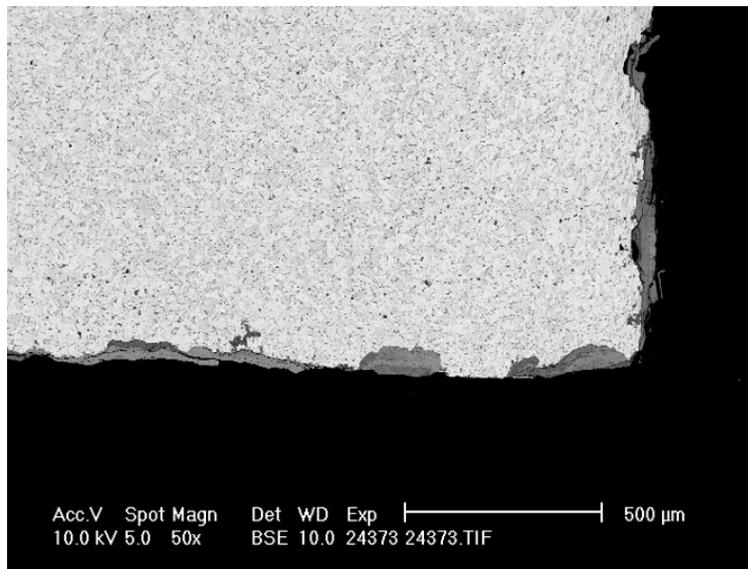
A region of the adherent scale near a hole in the metal table was examined in the SEM. As shown in Fig. 12, there are regions of adherent oxide and regions where the oxide has completely spalled off, leaving bare metal exposed. The adherent scale exhibited similar banding of the oxides, Fig. 13, where the bright phase at the top of the BSE image is the metal table. X-ray microanalysis on both oxides indicated increased levels of the minor elements, Na, Cl, and K. An x-ray spectrum, Fig. 14, shows the minor impurities at a defect in the dark oxide, which showed slightly elevated impurity levels relative to the bulk of the oxide. Note that the vertical scale has been expanded to highlight the impurity peaks. The presence of Mn and S is taken to indicate the presence of a MnS inclusion from the original steel that has been incorporated in the oxide. The inclusion has increased the local concentration of Na, Cl, and K. No Mg or Ca was detected in either the spalled or adherent scales. It is interesting to note that the more likely water-soluble impurities (Na, Cl, and K) are present in the scales; whereas the less soluble impurities (Mg and Ca) are not present. Of course, this observation could simply reflect the actual exposure this particular brake assembly received.

Fig. 13. Backscattered image showing scale attached and spalled areas.

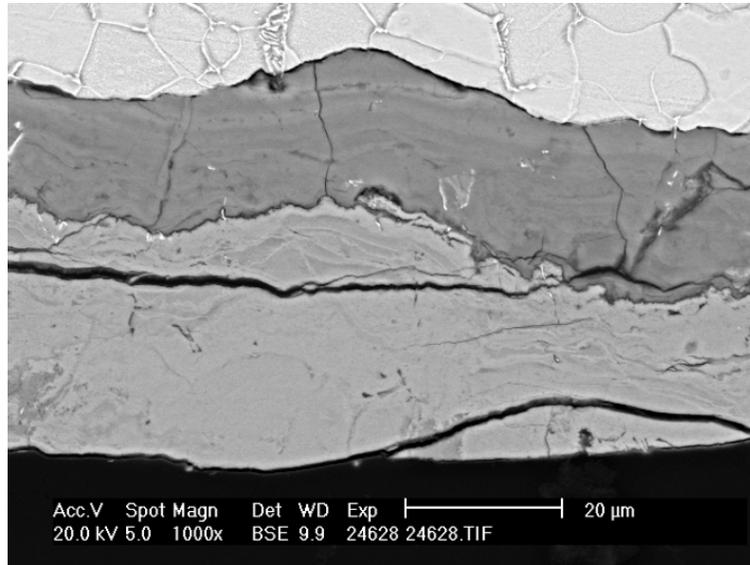
Fig. 14. Backscattered image showing banding in the adherent scale. The light region at the top of the scale is plain carbon steel, the middle dark gray region is Fe_2O_3 , and the bottom light gray region is Fe_2O_4 .

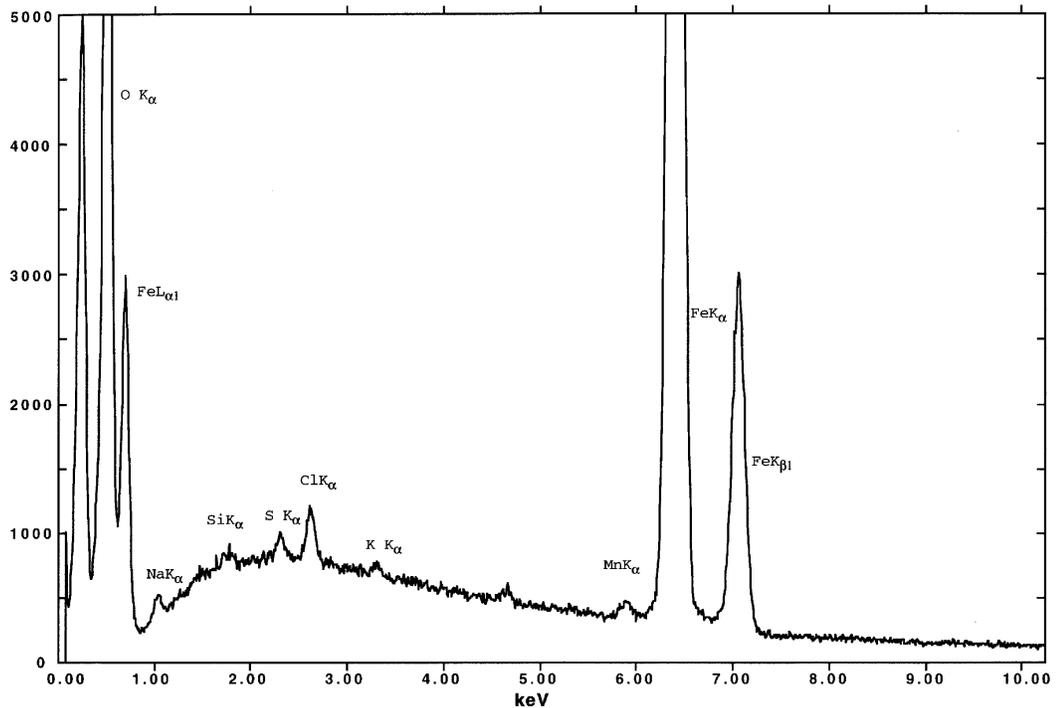
Fig. 15. X-ray spectrum of attached (dark gray) scale showing the presence of sodium, potassium, and chlorine. The manganese and sulfur are assumed to arise from inclusions.
