CORROSION ISSUES IN BLACK LIQUOR GASIFIERS

James R. Keiser, Roberta A. Peascoe and Camden R. Hubbard
Oak Ridge National Laboratory
Oak Ridge, Tennessee 37831

J. Peter Gorog
Weyerhaeuser Company
Federal Way, Washington, 98477

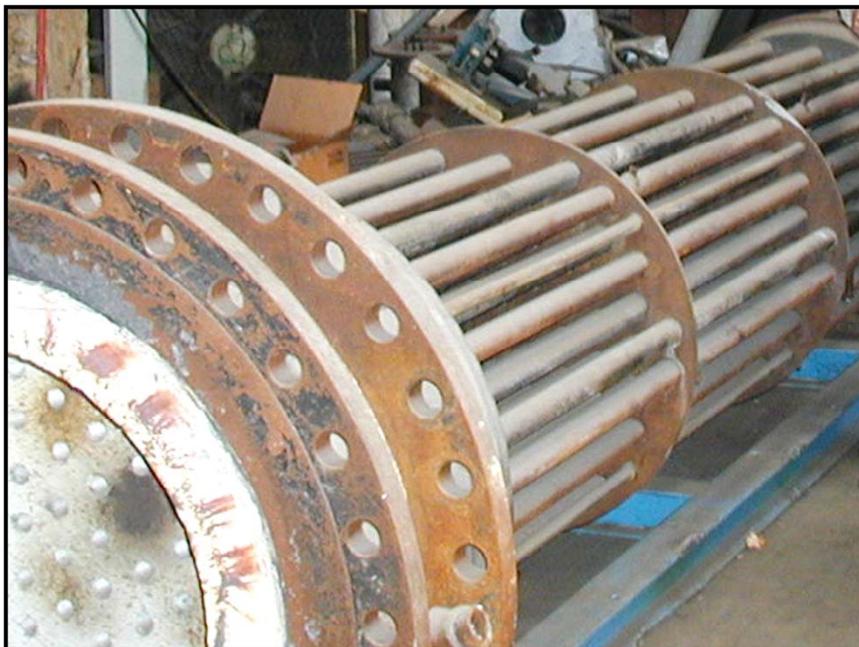
Examination of New Bern LTLT gasifier components. Several alloys were used for the tubes in the pulsed heater tube bundles of the New Bern reformer/gasifier. These alloys appeared to perform well during reformer/gasifier operation, but inspection a few weeks after the bundles were cooled to room temperature revealed cracking in the 253MA (UNS S30815) tubes in one of the bundles. This tube bundle is shown in Fig. 5. As revealed in Fig. 6, metallographic examination of cross sections of the cracked tubes showed that the cracking was intergranular. Further examination showed that the tube material had become sensitized during operation. It was concluded that the cracking was most likely due to polythionic acid stress corrosion cracking (PASCC). Examination of type 310 stainless steel tubes from another tube bundle showed some evidence of sensitization, but not to an extent that the tubes were susceptible to PASCC. As a result of these studies, it was recommended that a stabilized stainless steel (types 321 or 347) or a low carbon grade be used in future applications when sulfidizing gases were expected to be present.

Figure 5. Tube bundle used in PulseHeater steam reformer/gasifier.

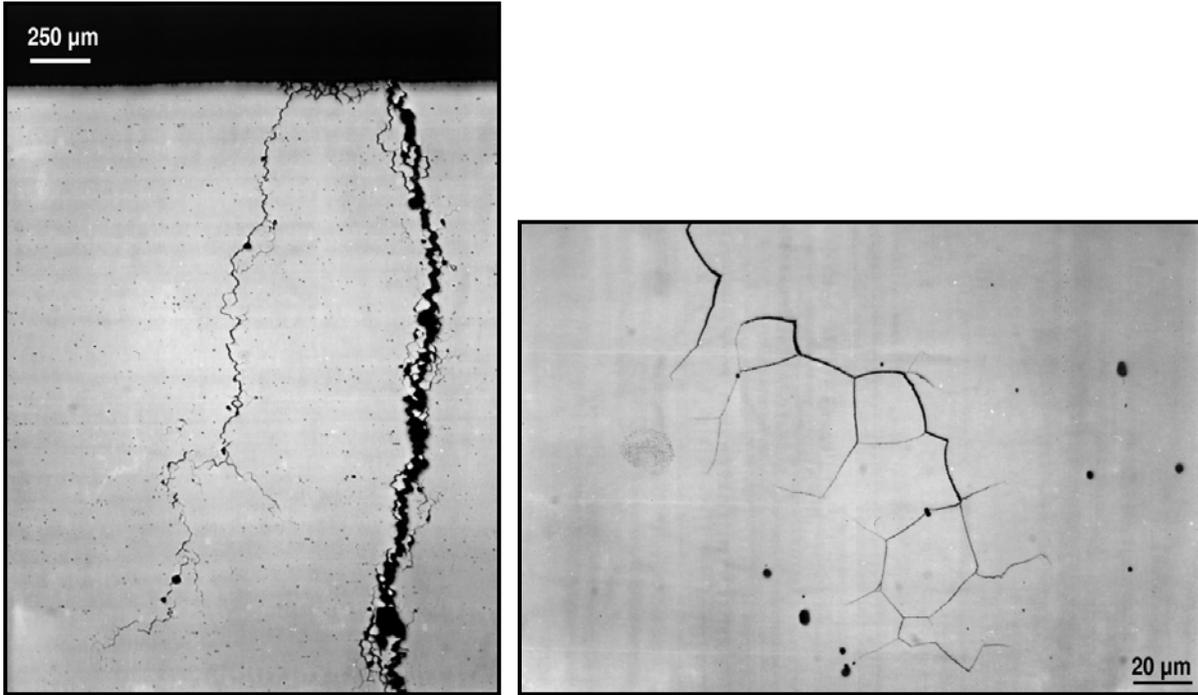
Figure 6. Cross section of cracked tube showing cracking is intergranular.

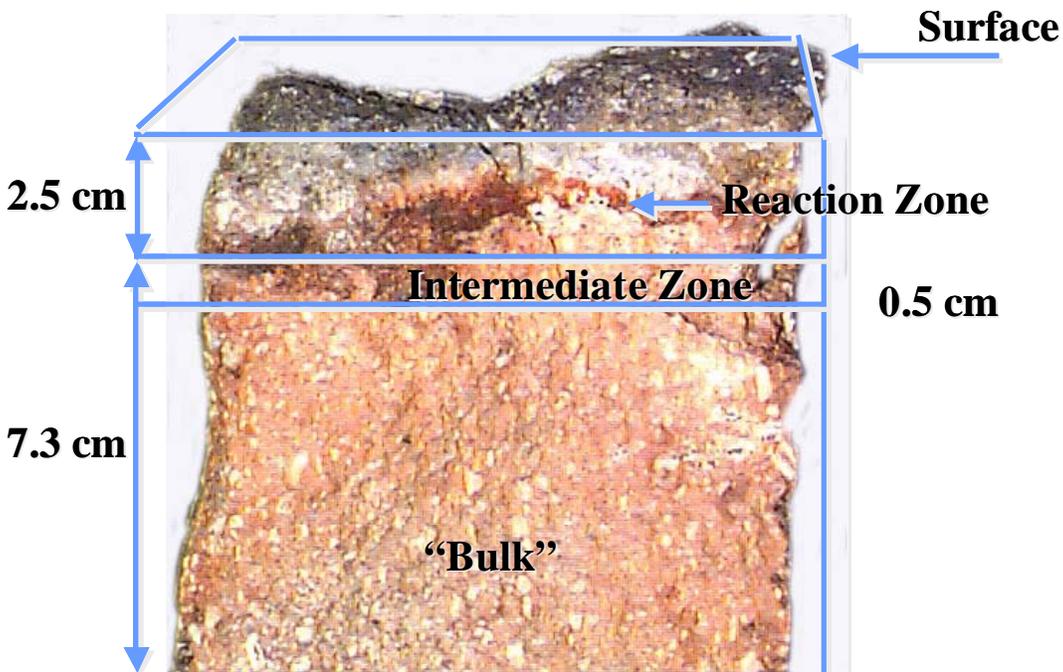
A dense high alumina, silica-bonded refractory brick was the first material used on the hot face as a heat insulating layer and as a barrier to chemical attack of the remaining insulating layers. The brick composition was 58% Al_2O_3 , 37% SiO_2 , 0.9% Fe_2O_3 with minor amounts of P_2O_5 in the bonding phase. Initially, the bricks were almost 23 cm high, and x-ray diffraction (XRD) identified four phases; mullite ($\text{Al}_6\text{Si}_2\text{O}_{13}$), opal ($\text{SiO}_2 \cdot x\text{H}_2\text{O}$), cristobalite (SiO_2) and andalusite (Al_2SiO_5). Figure 7 shows a severely degraded refractory brick that has a reaction layer about 2.5 cm thick. XRD analysis of the reaction layer (see Fig. 8) showed a Carnegieite-like phase ($\text{Na}_2\text{O}-\text{Al}_2\text{O}_3-\text{SiO}_2$) had developed on the surface while the silicate phases had completely vanished. Based on the apparently poor chemical resistance of the bonding phase to sodium salts, as well as the tendency for the silica phases to react at operating temperature, this refractory was deemed inappropriate for use in the HTLP gasifier environment.

Figure 7. Alumina-silica refractory brick from the New Bern high temperature, low pressure gasifier that was examined for evidence of chemical attack

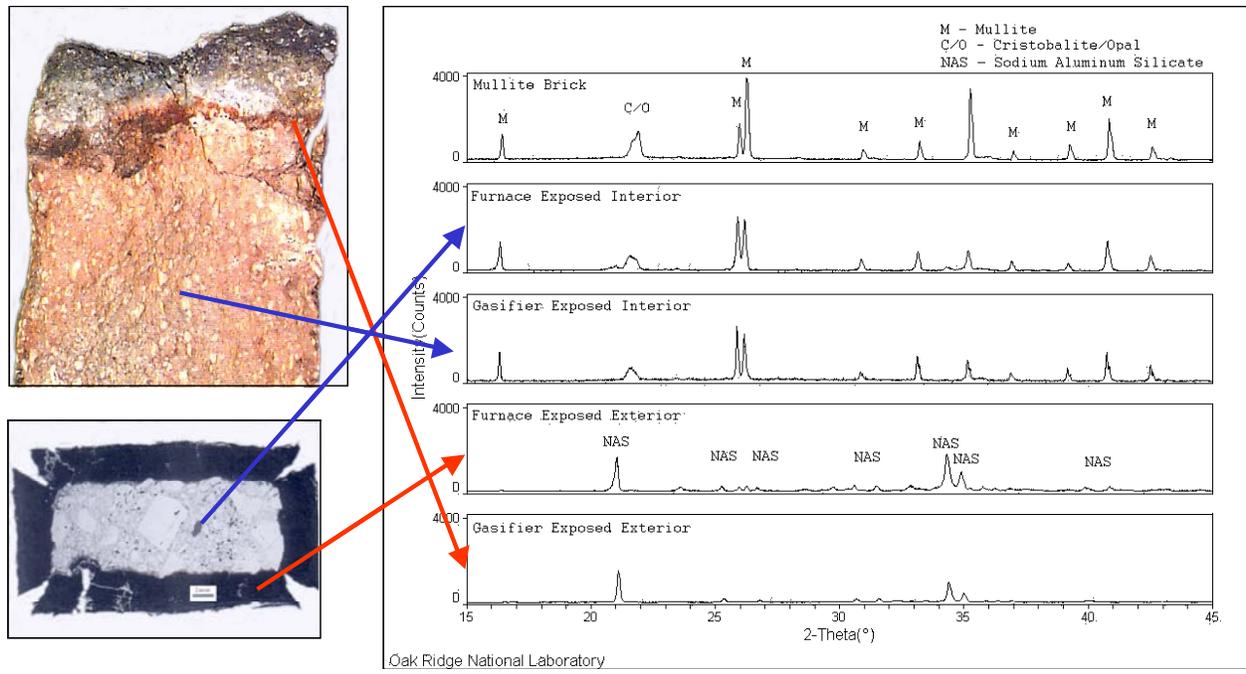
Samples exposed in this system have shown degradation that is similar in appearance and in corrosion product composition to that seen in operating HT gasifiers. For example, Fig. 8 shows a cross section of a sample of the original alumina-silica refractory after exposure for 50 hours in the immersion test system. Both the sample exposed in the test system and the one exposed in the gasifier show the mullite, cristobalite, and opal phases in their interior, and both show sodium aluminum silicate (NAS) on the surface. These results demonstrate that the immersion test system produces the same corrosion reactions as occur in the HTLP gasifier.

Figure 8. Upper photo shows brick removed from New Bern gasifier. The XRD patterns show phases present in the interior and in the degraded surface layer. Lower photo shows sample exposed in the immersion test system. The XRD patterns show the similarities in the phases present on the two samples.

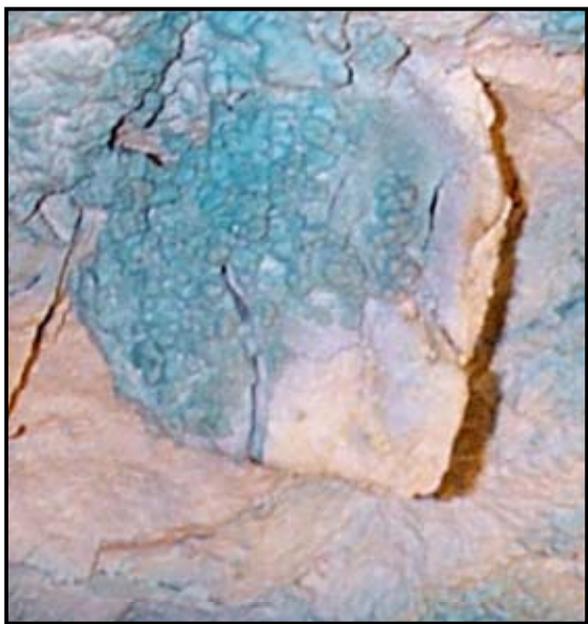
Because of the excessive reaction of the alumina-silica brick observed during the early operation of the gasifier, a test panel of 100% alumina fused cast refractory bricks was installed in the alumina-silica brick lining, and subsequently, the entire lining was replaced with the 100% alumina fused cast refractory bricks. This replacement brick was reported to have a composition of 45% 100% alumina and 53% 100% alumina. Analyses were performed on core-drilled samples removed from the test panel after a few weeks of operation and on brick samples removed from the lining after many months. An example of 100% alumina fused cast refractory that appeared to be coming loose from the lining in the dome of the New Bern gasifier is shown in Fig. 9. Analysis of this material showed that a new phase, NaAlO_2 , had formed on the surface (see Fig. 10), presumably as a result of reaction of the alumina refractory phases with the sodium compounds. The significant volume expansion associated with the formation of the compounds leading to NaAlO_2 would be expected to generate significant stresses in the surface of the refractory bricks.

Figure 9. Refractory lining on the gasifier dome with a piece of loose refractory that was removed for analysis.

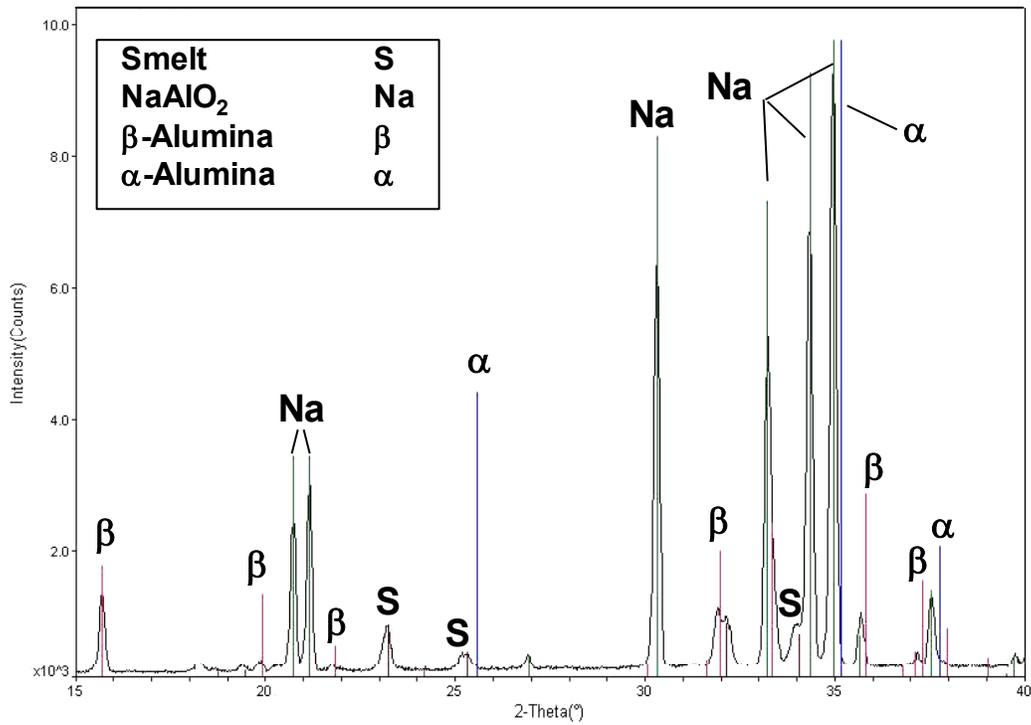
Figure 10. XRD pattern of degraded refractory removed from the gasifier dome showing that NaAlO₂ is one of the phases present.

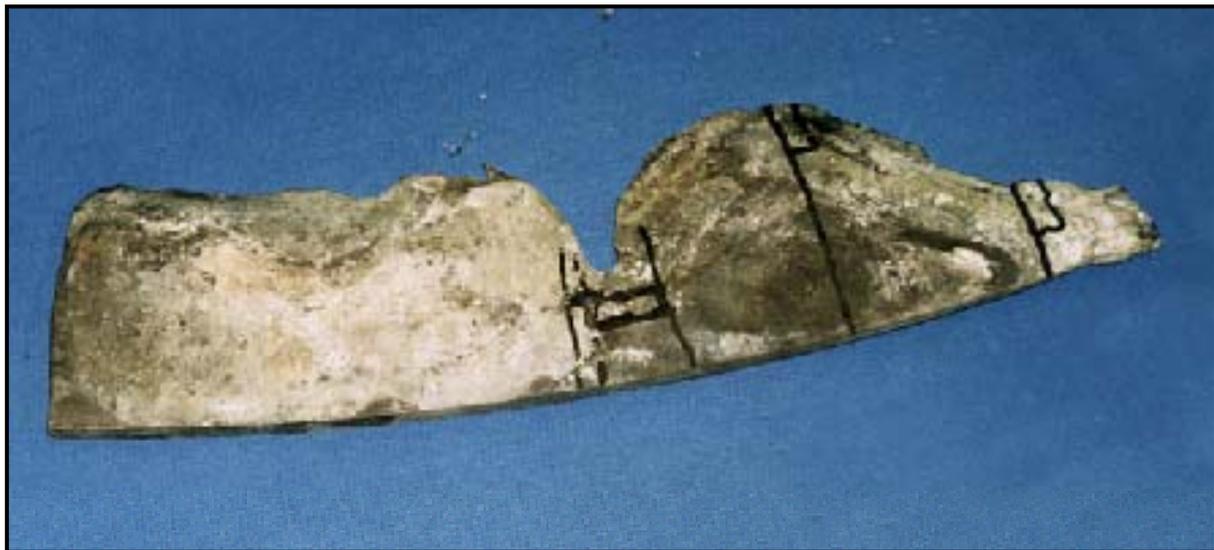
The original design of the gasifier had several circumferential metal rings that were attached to the shell at various levels and were intended to support the refractory bricks. The 16 mm thick rings were fabricated of a Ni-Co-Cr-Si alloy, HR160 (UNS N12160), that, as shown in Fig. 11, was severely corroded during exposure. The edge of the support ring facing the gasifier interior was, in places, corroded completely through its thickness. A cross section of the ring, shown in Fig. 12, indicates that the alloy suffered very rapid general corrosion.

Figure 11. Section of Ni-Co-Cr-Si alloy support ring that was severely corroded during use in the gasifier.

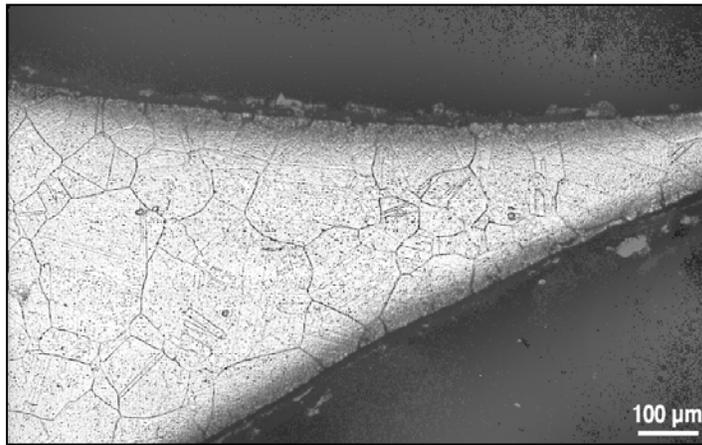
Figure 12. Micrograph of support ring cross section showing thick corrosion product.

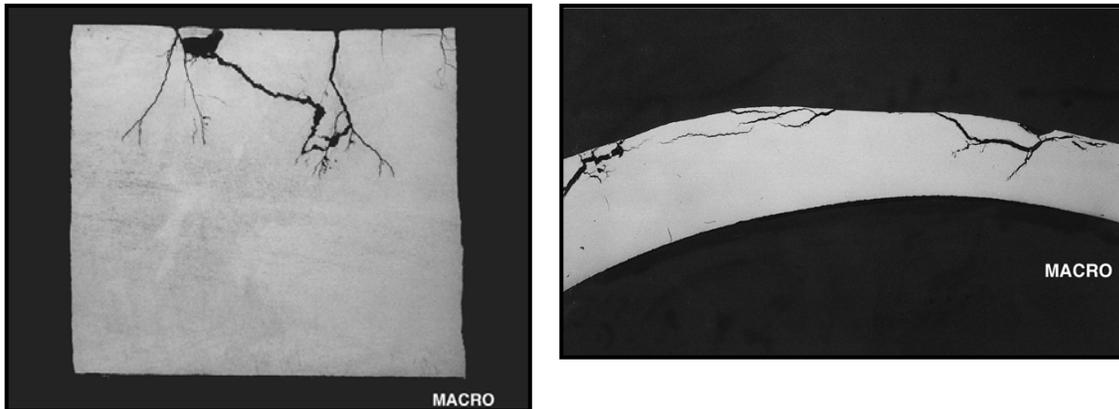
At the bottom of the cylindrical gasifier vessel, there is a transition from the very high temperature gasification environment to the lower temperature environment where the molten smelt is dissolved in water to form green liquor. A water-cooled metal ring provides the transition between the refractory and the uncooled metal components. The original support ring was constructed of heavy-wall stainless steel. Considerable problems were encountered with cracking of the stainless steel; examples are shown in Fig. 13. The problem was resolved by using treated water and thinner sections of carbon steel to promote cooling of the surface of the ring.

Figure 13. Examples of cracking found on portions of the water-cooled stainless steel support ring.

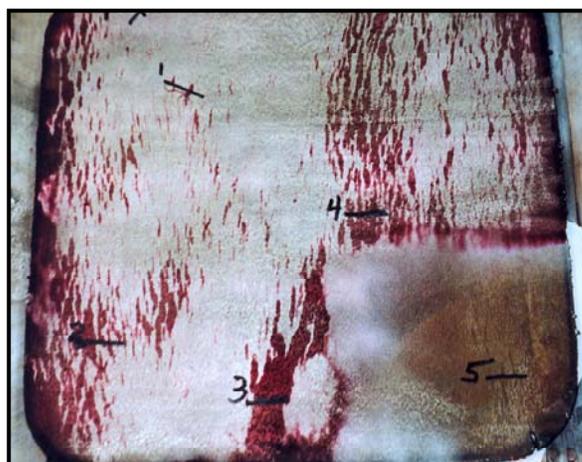
During the first years of operation, the stainless steel gasifier shell did not appear to be encountering any problems. However, observation of the shell was somewhat difficult since its inside surface was behind the refractory lining and the outside surface was covered by a shroud intended to promote convective flow of air over the outer surface of the gasifier shell. Some limited checks of the inside surface were made when the refractory was changed, but no careful records of any observations were kept. In December 1999, shortly before the gasifier was scheduled to restart, a short crack was noticed on the outside of the shell near the bottom of the cylindrical section. A fairly small piece was removed from the shell (shown in Fig. 14), and analysis showed that the cracking had originated on the shell's ID. To determine the extent of the cracking, several other fairly large pieces were removed from the shell, and it was determined that cracking was quite extensive. An indication of the extent of cracking can be found in Fig. 15, which shows the inside surface of the shell section after a dye penetrant check for cracking. Several cross sections were examined metallographically, and chemical analyses were performed on the insulating board that had been in contact with the stainless steel shell. The results showed that the transgranular cracking was likely caused by chloride stress corrosion. Furthermore, as shown in Fig. 16, the crack configuration suggested that the cracking proceeded more

Figure 14. Cracking pattern revealed by dye penetrant examination of the inner surface of approximately 40x40 cm panel removed from the stainless steel gasifier shell. Note that lower right corner was not inspected.

rapidly during selected time periods. As a result of the discovery of this cracking and some subsequent analyses of the integrity of the gasifier shell, it was decided not to restart the gasifier at that time. After much consideration and discussion, the decision has been made to completely rebuild the gasifier; it is expected that operation will be resumed sometime in the year 2003.

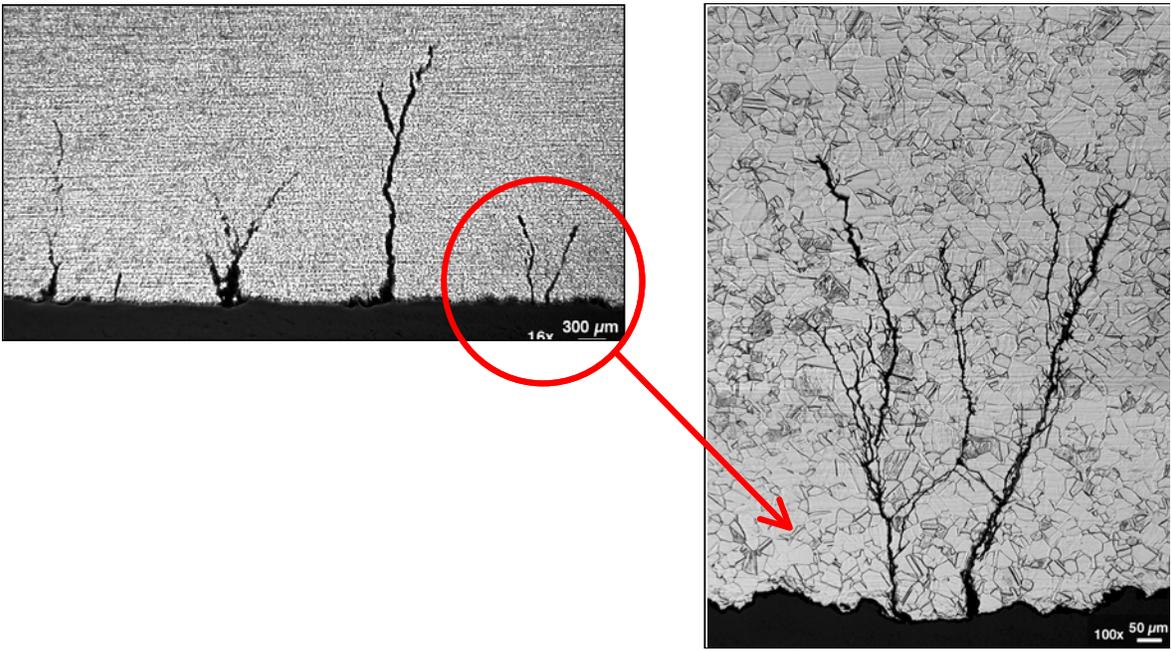
Figure 15. Examples of the narrow, transgranular, branched cracking found on the gasifier shell.

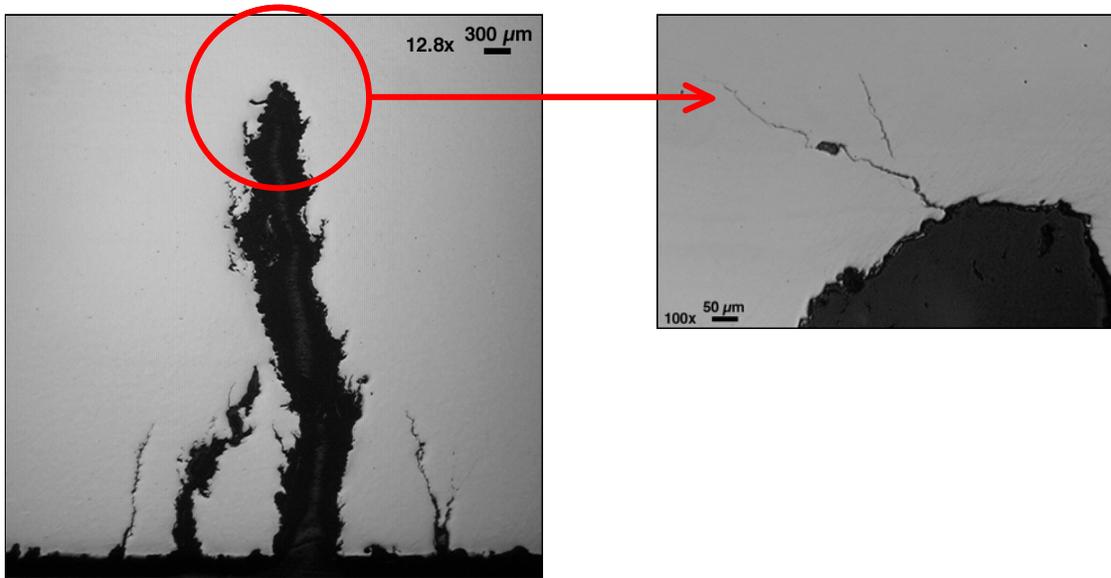
Figure 16. Cracks revealed in the stainless steel gasifier shell. Note that the primary crack on the left appears to have been mechanically deformed causing the sides to separate.

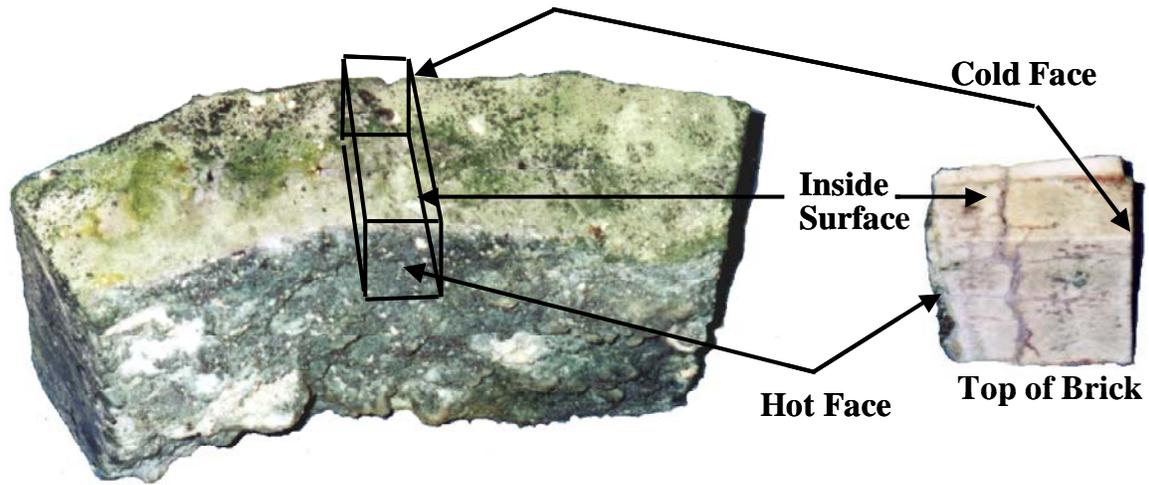
Examination of HTHP Gasifier Components. As already noted, the total operating time on black liquor of the Skoghall HTHP gasifier was about 1000 hours. After the gasifier was taken out of service in 2000, several samples of the fused cast alumina refractory were made available for characterization under the DOE-funded refractory project. One of the bricks received from Sweden is shown in Fig. 17. Sections were cut from each of these refractory bricks, and the changes in composition as a function of distance from the surface were determined. As shown in Fig. 18, the NaAlO_2 phase was found on the surface of these bricks, indicating that even though exposure time was limited, the reaction products found on fused cast alumina bricks from the New Bern gasifier were also present on the Skoghall bricks.

Figure 17. Refractory brick removed from the Skoghall HTHP gasifier and provided for analysis of degradation products.

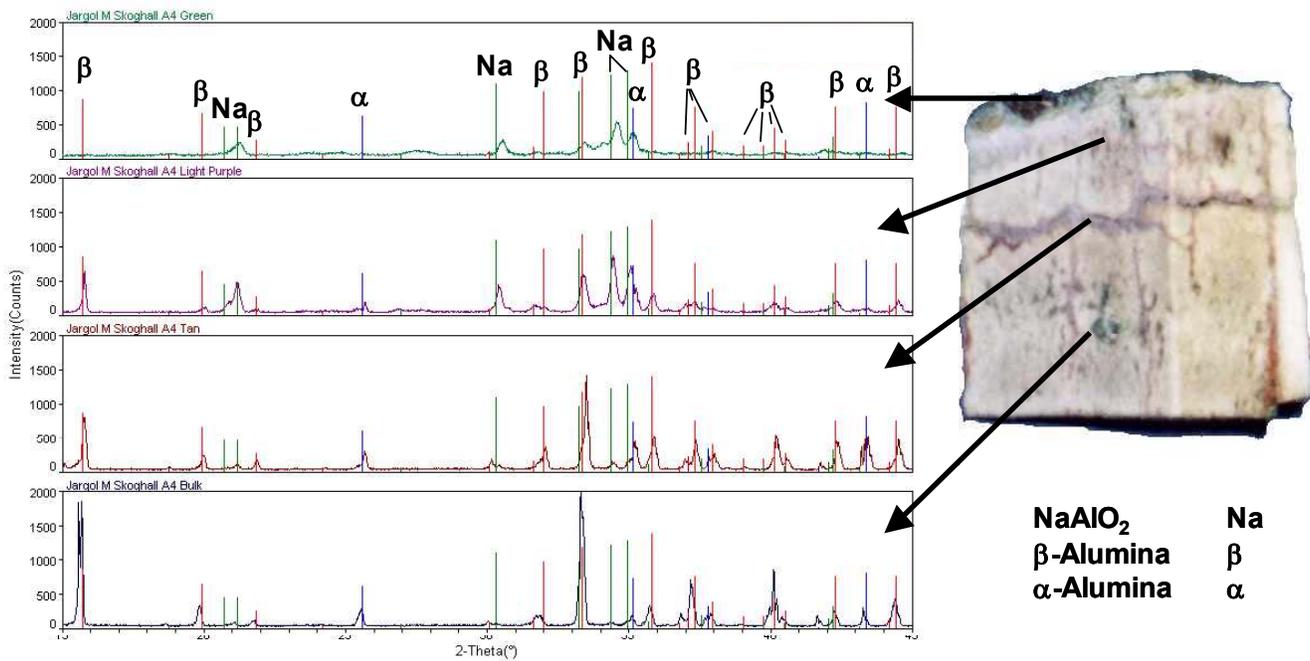
Figure 18. XRD patterns showing that NaAlO_2 was formed on the refractory surface.
