Current Understanding Of Cracking Of Recovery Boiler Primary Air Port Composite Tubes

James R. Keiser*, Douglas L. Singbeil**, Gorti B. Sarma*, Joseph R. Kish**, Kimberly A. Choudhury*, Laurie A. Frederick**, Jerry Yuan†, François Jetté‡, Camden R. Hubbard*, Robert W. Swindeman*, Preet M. Singh††

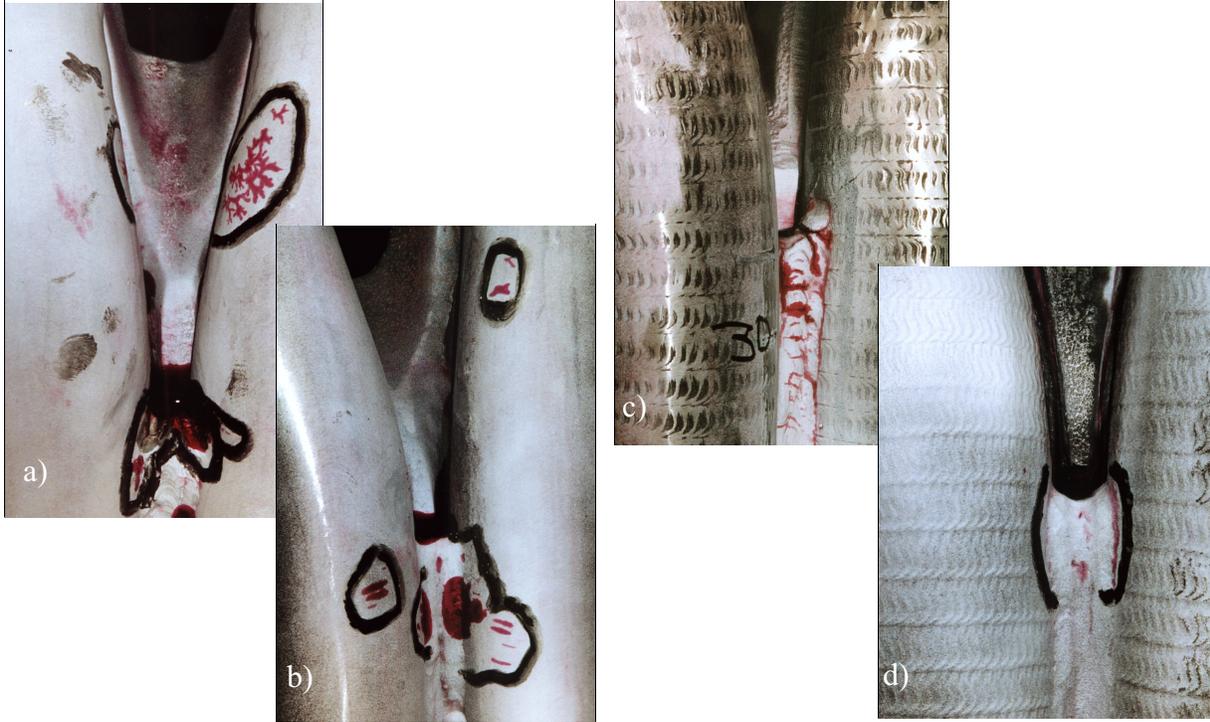
Cracks are seen in several different forms. The most widely recognized are the circumferential, relatively linear cracks and the randomly-oriented, craze or mosaic cracking. In addition, in some air port designs, it is not uncommon to see cracking in the membrane near the terminations and in the membrane to tube welds again in the area of the membrane terminations. Examples of these types of cracking are shown in Fig. 1. The depth of primary air port tube cracks has been investigated during field inspections as well as during laboratory examination of air ports removed from service. Microscopic examination consistently finds that craze cracks do not progress into the carbon steel of the composite tubes, but the circumferential cracks sometimes do continue into the carbon steel. Figure 2 pictures cross sections of circumferential cracks that continue into the carbon steel. Even though not all circumferential cracks continue into the carbon steel, inspection of the tube surface does not provide sufficient information to unequivocally predict the depth of circumferential cracks. Therefore, all of the relatively linear cracks have to be treated as if they advance into the carbon steel. For most mills, this means a grinder is used to remove some of the stainless steel in order to “chase” the crack to the point where it can no longer be detected by means of a dye penetrant examination. Depending on the depth of cracks and the repair philosophy used at each mill, a weld repair may be used to build up the carbon steel and/or to provide a stainless steel cap.

1. Examples of cracking in primary air port composite tubes a) craze cracks, b) circumferential cracks, c) membrane cracks, and d) tube-membrane weld cracks.

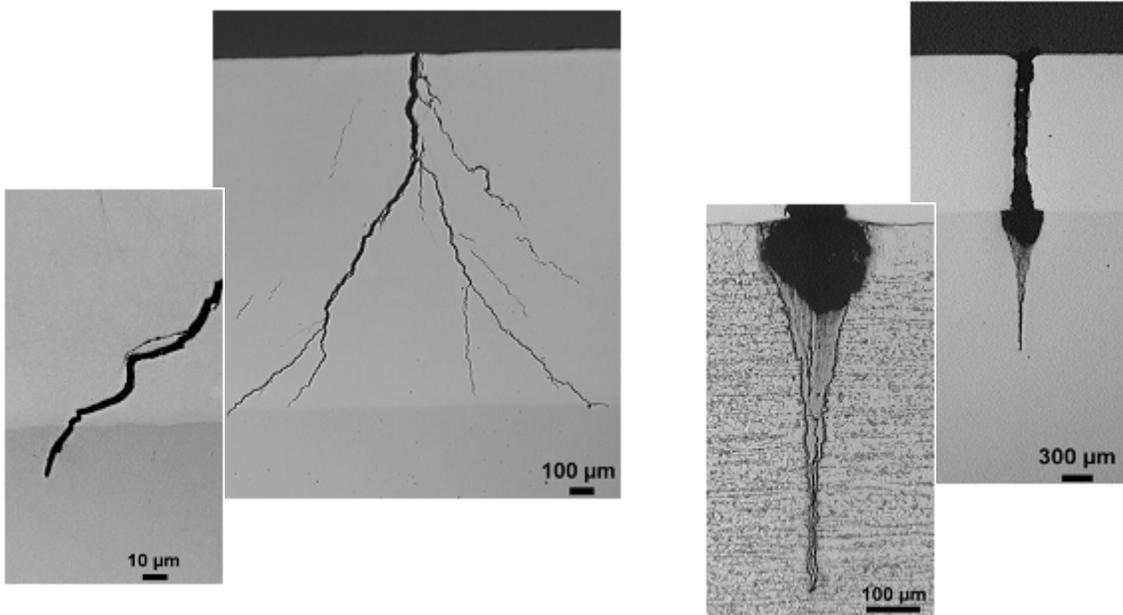
2. Examples of circumferential cracks continuing into the carbon steel.

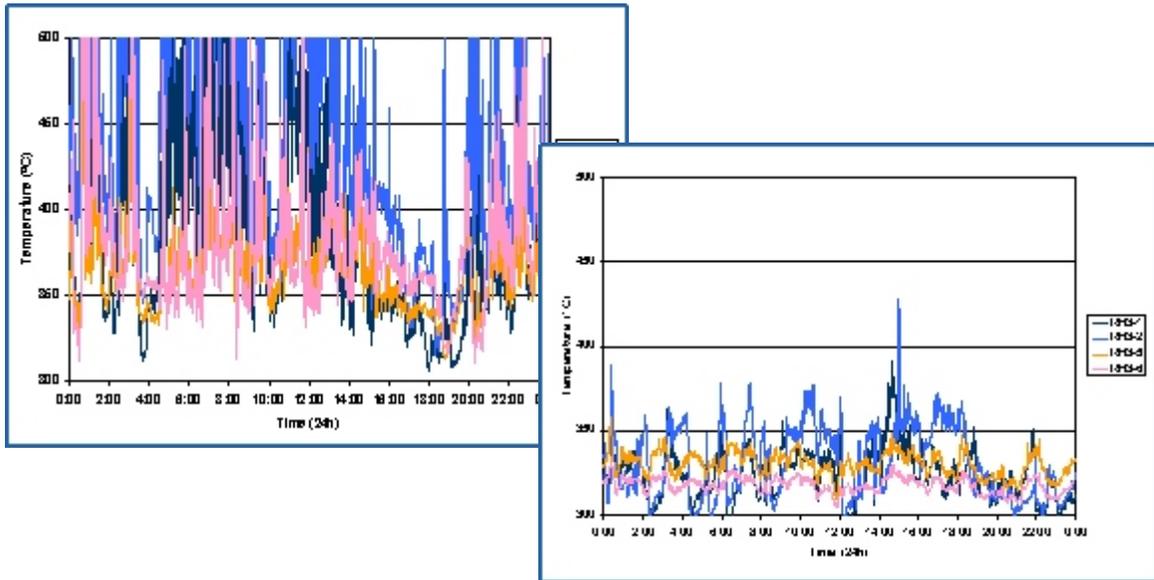
One of the first examples of this association between temperature fluctuations and cracking that was identified in this project is shown in Fig. 3. This figure reveals a clear pattern; the frequency and magnitude of the fluctuations are larger on the air port tubes that had previously experienced cracking. This pattern has been observed in all the instrumented boilers in which cracking of the primary air port tubes has been observed. Consequently, the magnitude of temperature fluctuations has been, and is being used as a means to determine if conditions exist where cracking of the tubes is likely to occur.

3. Temperature fluctuations during one day period for a) primary air port tube with history of cracking and b) primary air port tube with no history of cracking.

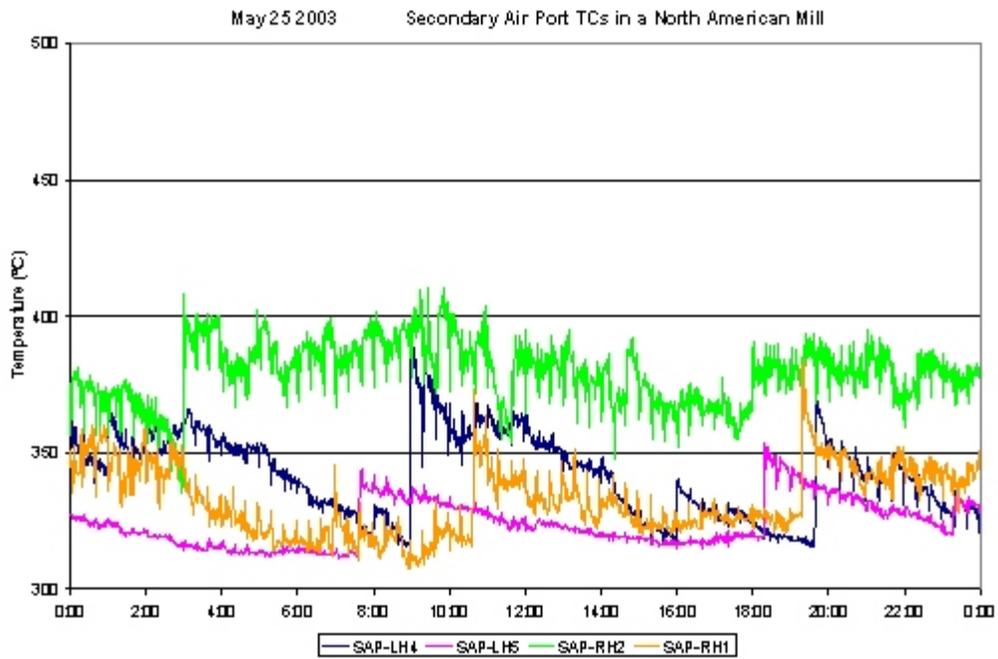
Thermocouples installed at the bends in the upper half of the primary air port openings, and along straight tubes adjacent to the tubes that form the air port opening, confirm that frequent, large temperature fluctuations are much less common, relative to those that occur on the lower half of the openings. Recently, thermocouples were installed on the tubes of four secondary air ports in a boiler that has previously experienced extensive primary air port cracking. With the exception for one day (on one thermocouple), these secondary air ports have not experienced significant temperature fluctuations over more than two months of data collection to the time of writing of this paper. A typical example of the temperature patterns seen for the four thermocouples during one day are shown in Fig. 4.

4. Temperatures measured by thermocouples in secondary air ports of boiler with history of primary air port cracking. The cycle associated with rodder operation is apparent.

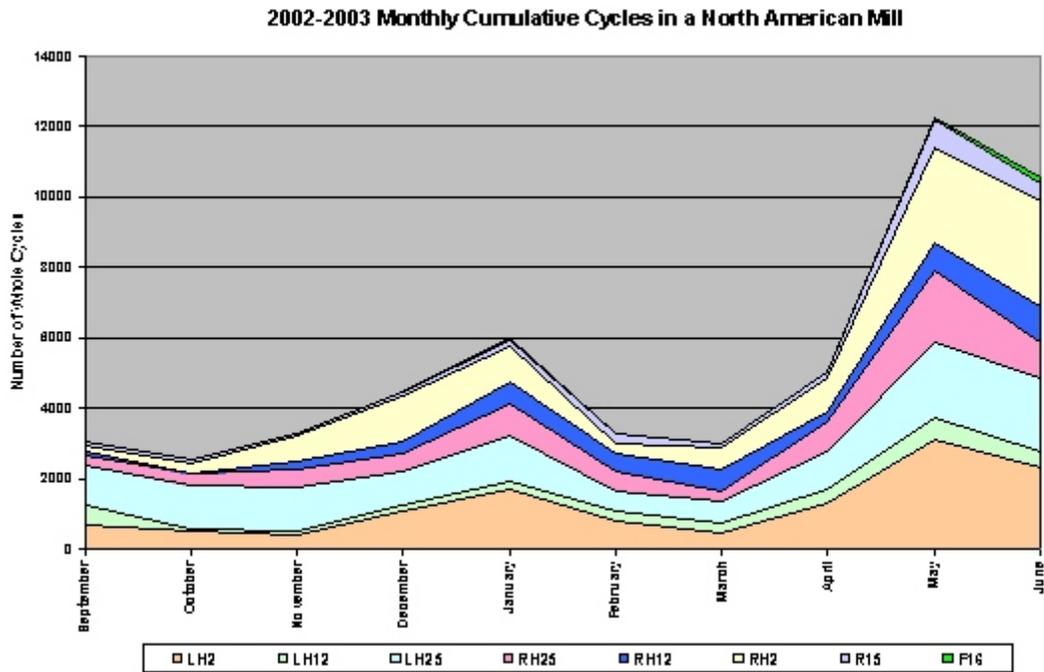
An example of how the cycle count can be used to compare results of the temperature measurements for an extended period of time is shown in Fig. 5. The data shown in the figure indicate the cumulative number of cycles measured each month for the air ports being monitored in recovery boiler "J" listed in Table 1. This representation of the data makes it clear conditions in this boiler changed throughout the year; many more temperature cycles occurred during

the months of May and June than had been observed during prior months. During the month of May when the activity was the greatest, the sum of the cycles for the two thermocouples on air port LH2 was about 3,000.

5. Monthly cumulative cycle count for eight monitored primary air ports (16 thermocouples) in a recently rebuilt recovery boiler. Note that the cycle count was much higher to recent months.

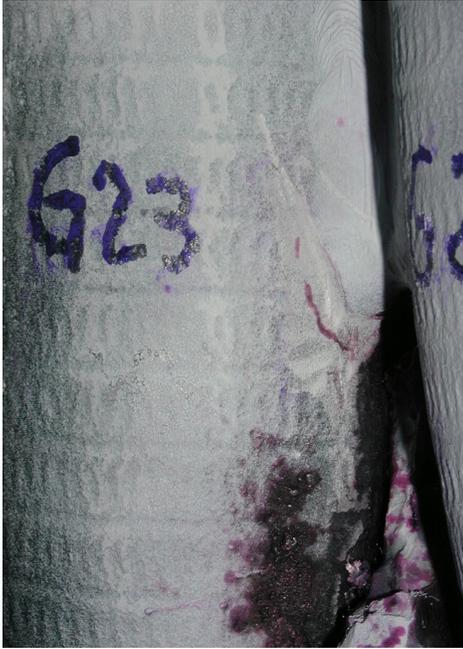
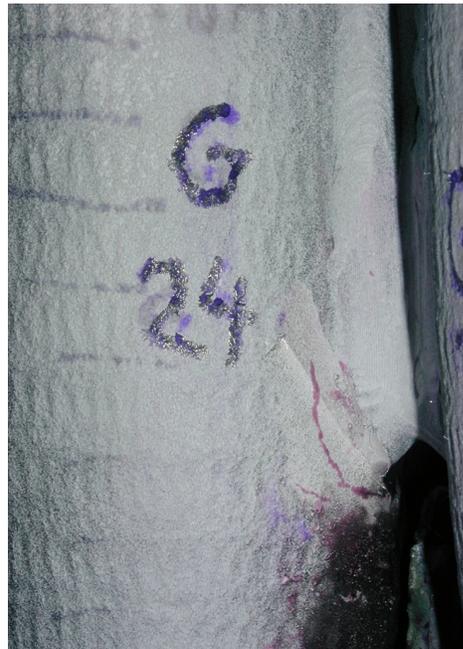
The two alternate materials being given the most serious consideration are Sanicro 38 (modified alloy 825) and Unifuse (weld overlaid alloy 625). Until the most recent inspection, no instances of air port tube cracking had been encountered with either alloy. During a spring 2003 inspection, the cracking shown in Fig. 9 was found in weld overlaid alloy 625 tubes at the top of two primary air ports. These cracks had not advanced past the carbon steel interface, but in about six months the cracks are presumed to have gone from being nonexistent, or at least immeasurably small, to extending through the weld overlay. Some caution has to be used in comparing the performance of the various materials, because there is more experience in North America with the use of weld overlaid 625 tubing for recovery boiler walls than any of the other materials that are alternatives to 304L/carbon steel composite tubing. There are reports of chromized tubing being successfully used in primary air port service, but the

9. Cracking observed at the top of primary air ports in alloy 625 weld overlaid tubes. The tubes had been in service for 2½ years at the time of the inspection when the cracks were found. Note that some of the tube has been ground off in the effort to eliminate the cracks.

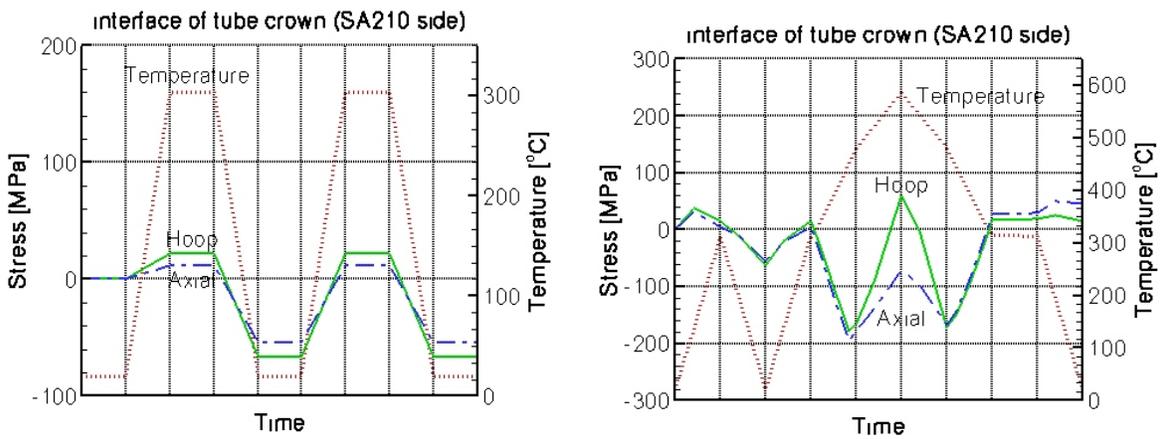
In an effort to understand how the compressive stresses might be changed, finite element modeling studies have been conducted for the situation where there is significant overheating of the air port composite tubes. This would be a situation where steam blanketing developed briefly inside the tube in the vicinity of the bottom of the air port. The results of these calculations are presented in Fig. 12 where the stress in the carbon steel at the interface of the carbon steel and the stainless steel is shown as a function of time and operating temperature for a normal cycle to operating temperature and for a cycle where the tube is briefly heated to about 600°C. For the normal cycle to operating temperature, the stresses in the carbon steel at the SS/CS interface remain compressive after cooling to room temperature. However, if a brief excursion to 600°C is imposed on the tube after it reaches operating temperature, the stresses in this location first become more compressive but then become tensile when the tube is cooled to the operating temperature and then back to room temperature. Obviously, in addition to an association with cracking in the vicinity of the bottom of the air port, the temperature fluctuations, if severe enough, can make the tube vulnerable to penetration of the crack into the carbon steel. Experience from years of monitoring temperatures on primary air port tubes on the nine boilers has shown the air port tubes that suffer from the cracking problem have occasional fluctuations that exceed 600°C; in fact, temperatures over 750°C have been recorded.

12. Calculated residual stresses in the carbon steel at the stainless steel to carbon steel interface. After normal operation, these stresses are compressive whereas the stresses become tensile after a severe temperature excursion.

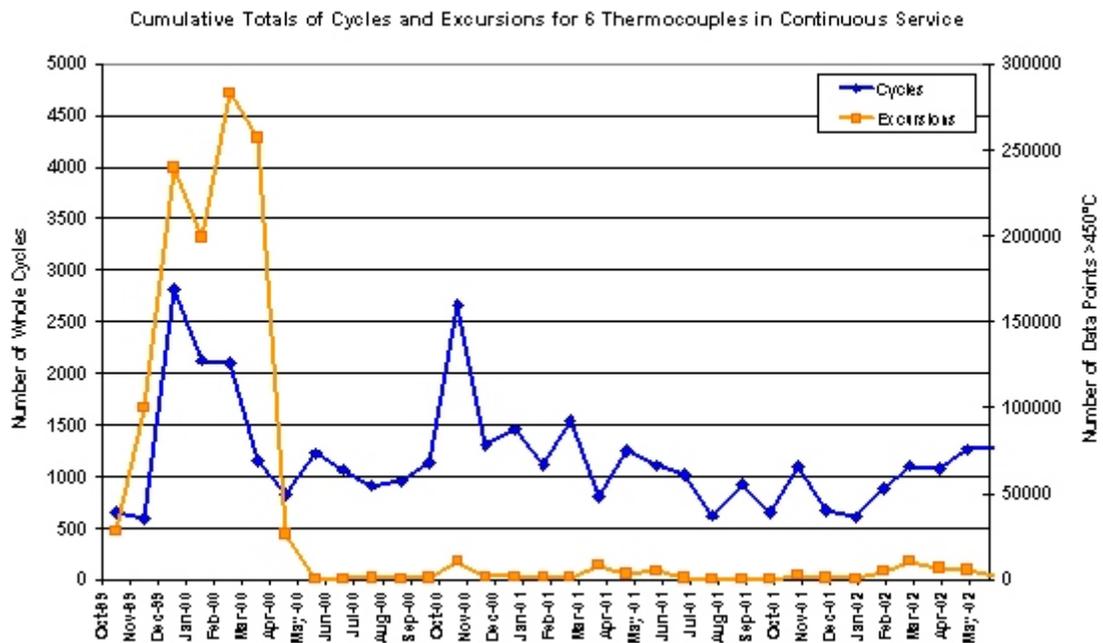
13. Thermal cycles measured on selected thermocouples before and after a change in liquor nozzle type in a boiler that had experienced extensive primary air port tube cracking.
