**Technical Evaluation
of the In Situ Vitrification Melt Expulsion
at the Oak Ridge National Laboratory
on April 21, 1996,
Oak Ridge, Tennessee**

Date Issued—August 1996

Environmental Management Activities at the
OAK RIDGE NATIONAL LABORATORY
Oak Ridge, Tennessee 37831-8169
managed by
LOCKHEED MARTIN ENERGY SYSTEMS, INC.
for the
U.S. DEPARTMENT OF ENERGY
under contract DE-AC05-84OR21400

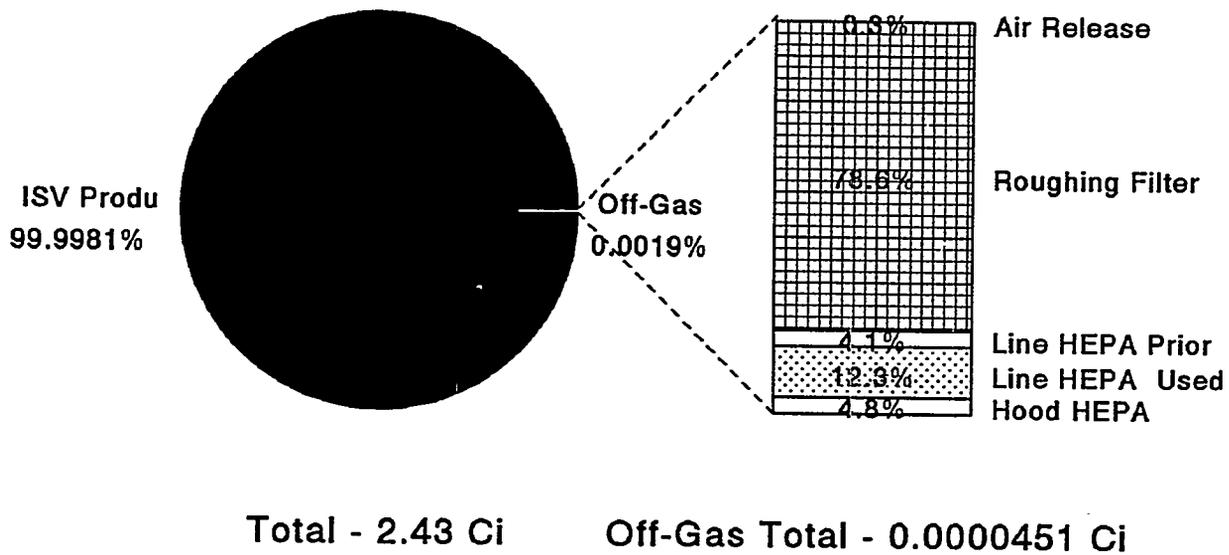
Results of the distribution of ^{137}Cs are depicted in Fig. 3. Most notably, 99.9981% of the ^{137}Cs was retained in the ISV molten body subsequent to the melt expulsion incident. Of the 0.0019% of the ^{137}Cs activity that was released into the process off-gas, most was retained on the hood's roughing filter. Of the fraction that passed the roughing filter, all was retained on the HEPA prefilters as no ^{137}Cs was detected in the off-gas scrub system solutions. Measurable activity, found on the HEPA prefilters switched out of the off-gas flow about two days prior to the melt expulsion incident, indicates that ^{137}Cs was being incorporated into the growing ISV molten mass for several days prior to the melt expulsion incident. The HEPA filters on the hood's off-gas backup blower also contained a significant fraction of the total off-gas inventory. Field surveys of the smear samples from various hood panels and the off-gas pipes revealed no detectable activity; these samples will be assayed in the low-background laboratory environment for quantification of their low-level activity. Their contribution to the total off-gas inventory and distribution would be trivial compared to the various filter samples, which yielded readily detectable activities with field survey instruments and during short (10 min) counting intervals in the low-background laboratory environment.

Fig. 3. Distribution of ¹³⁷Cs in ISV off-gas and equipment following the incident of April 21, 1996.

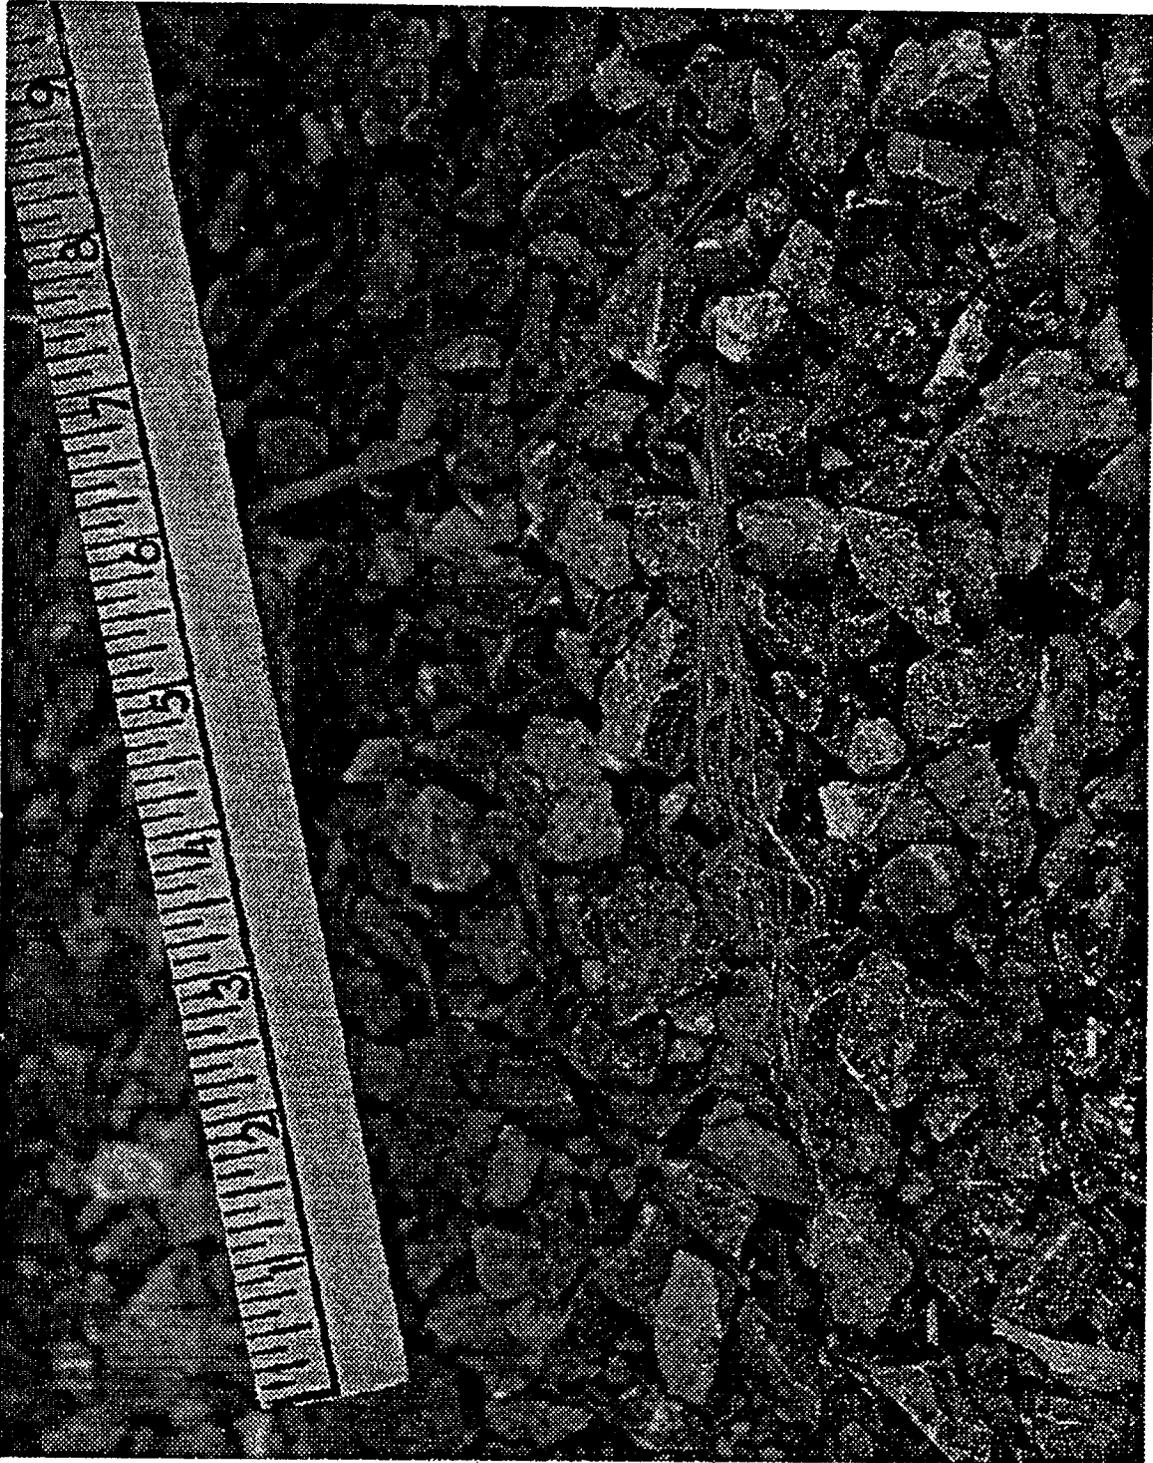
It also found that the samples of hair-like fiber glass, taken at some distance from the hood, were approximately the same specific activity of ^{137}Cs as the bulk glass that flowed from under the hood or was splattered onto the roughing filter. Thus, the thin threads of glass around the site must also have originated from the melt. Observations of the molten glass flow at the southeast corner revealed many fiber strands frozen in the process of formation; apparently, ISV off-gas as it escaped through the narrow gap between the hood foot and the ground surface was of sufficient velocity to entrain glass, which rapidly cooled to solid fibers as it traveled a short distance into the cooler surrounding air.

Fig. 7. Hair-like form of ISV glass expelled approximately 20 ft east of off-gas collection hood during incident of April 21, 1996.

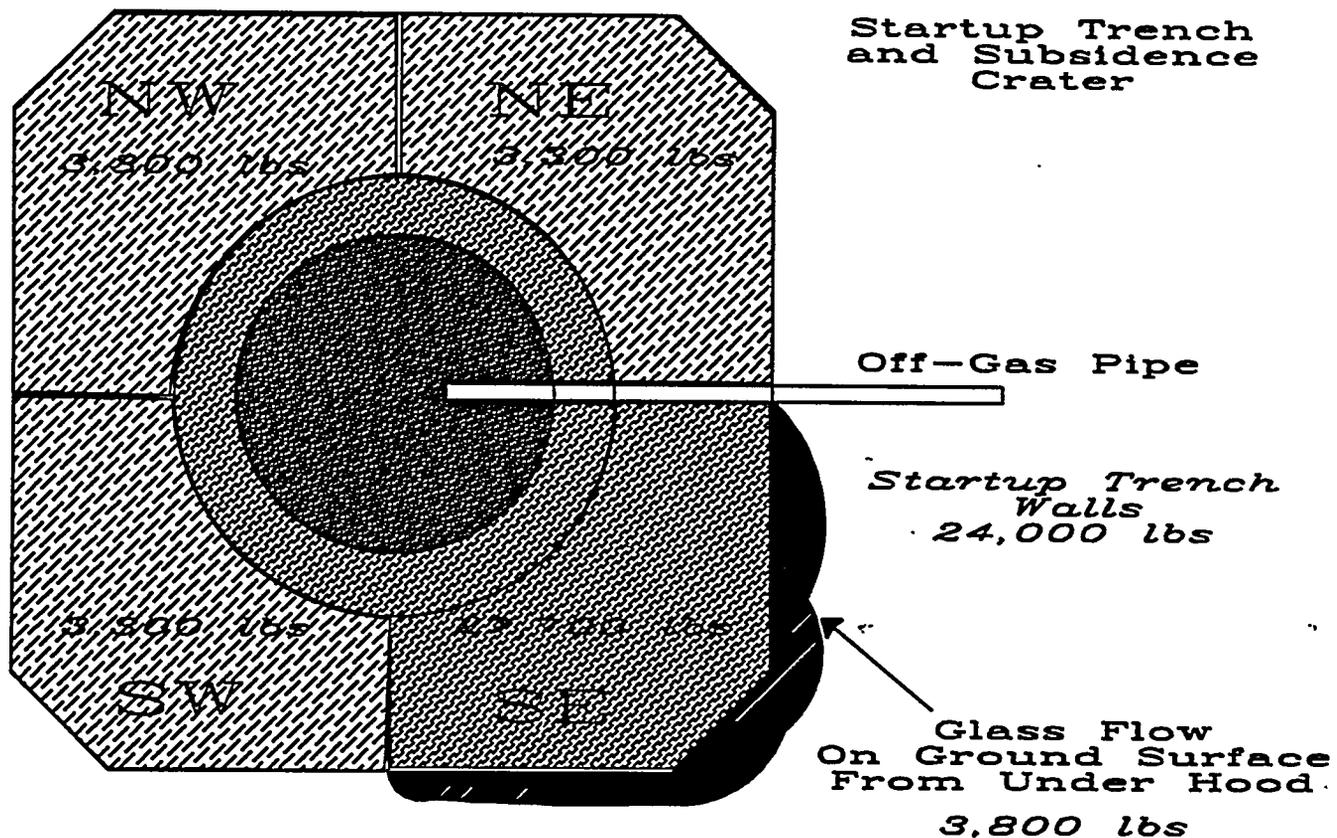
Fig. 8. Estimation of distribution of ISV expelled glass within and around off-gas collection hood after April 21, 1996, incident.

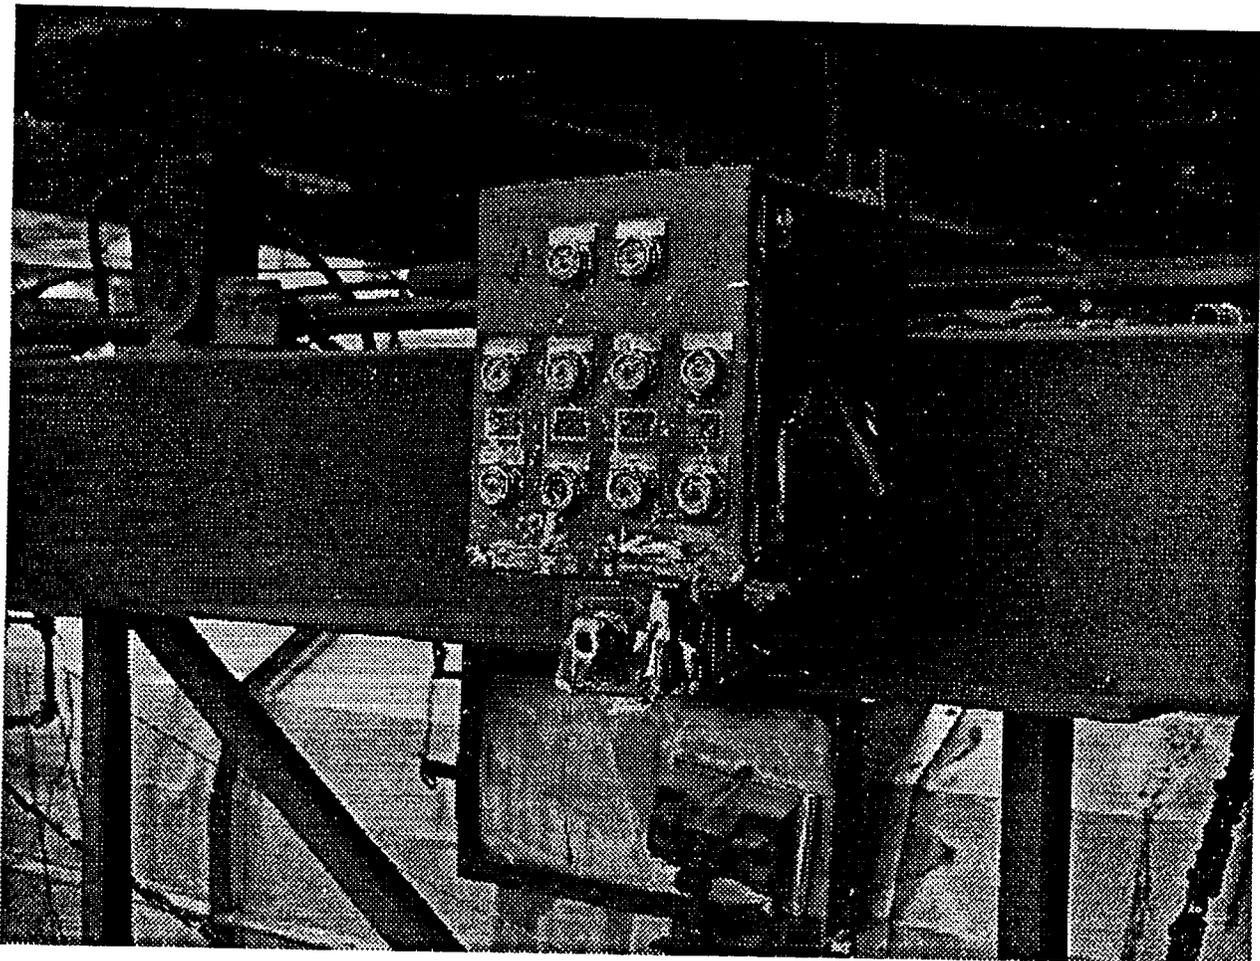
Fig. 9. Damage to the ISV hood's travel system hydraulic lift controller resulting from the fire of April 21, 1996.

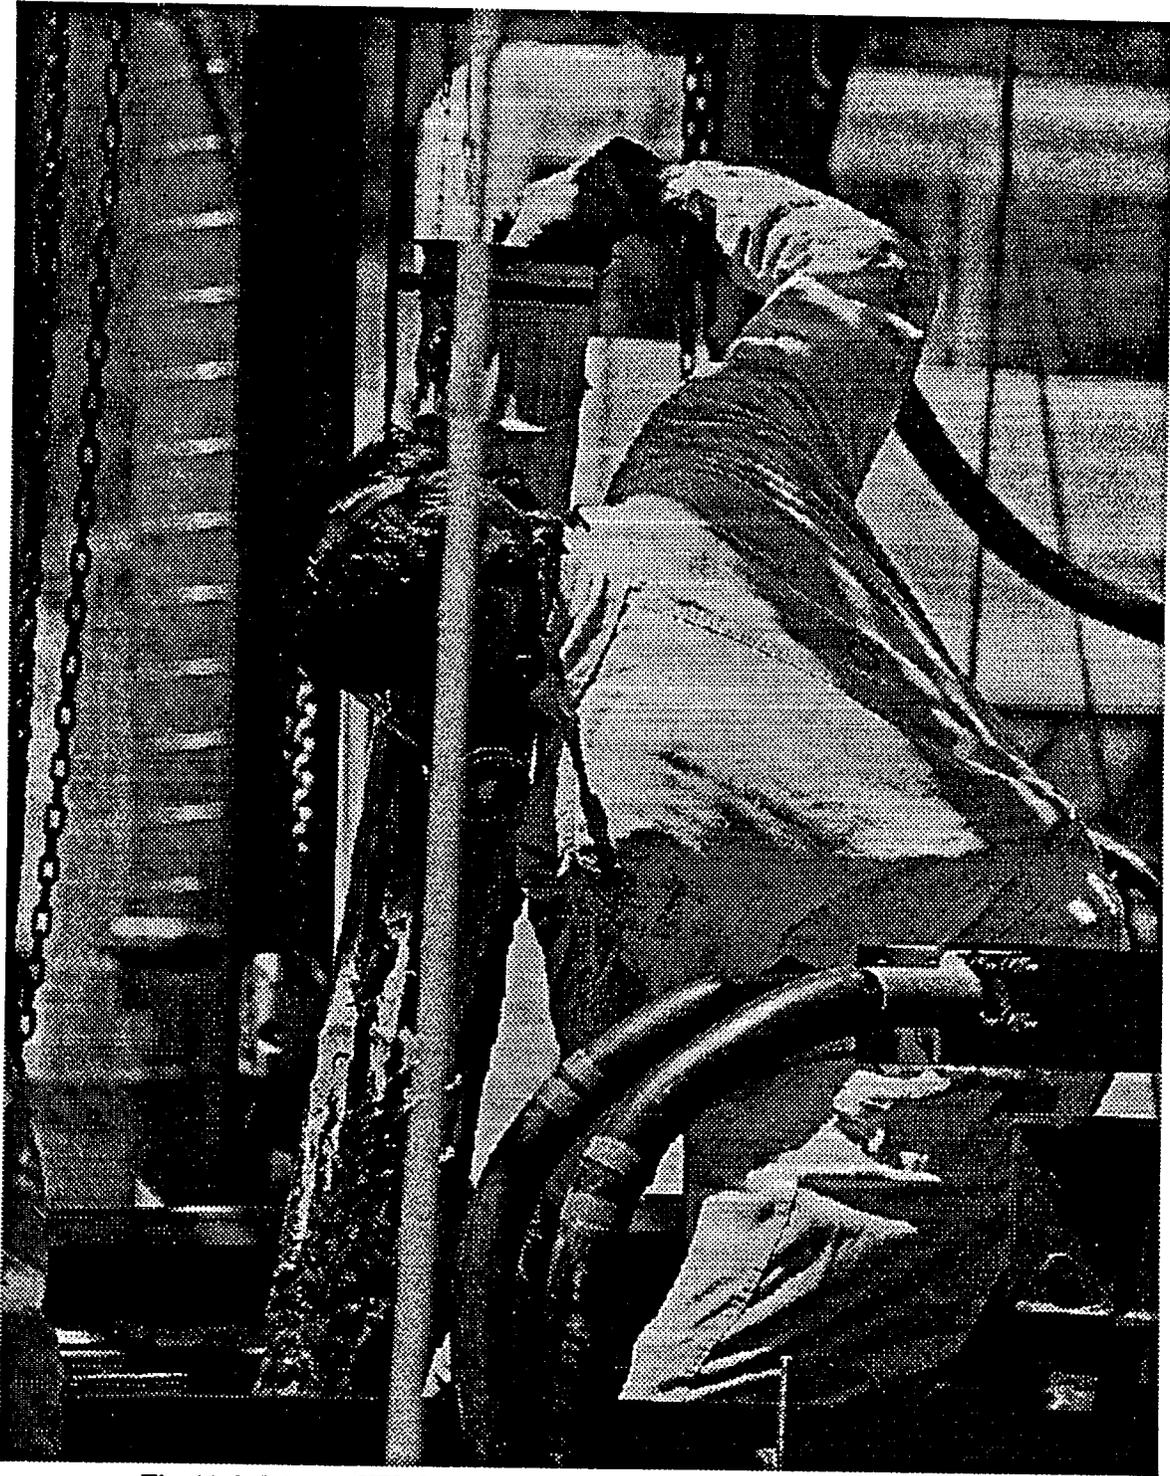
Fig. 11. Splattered ISV glass adhering to one of the 128 roughing filter elements during removal for sampling.

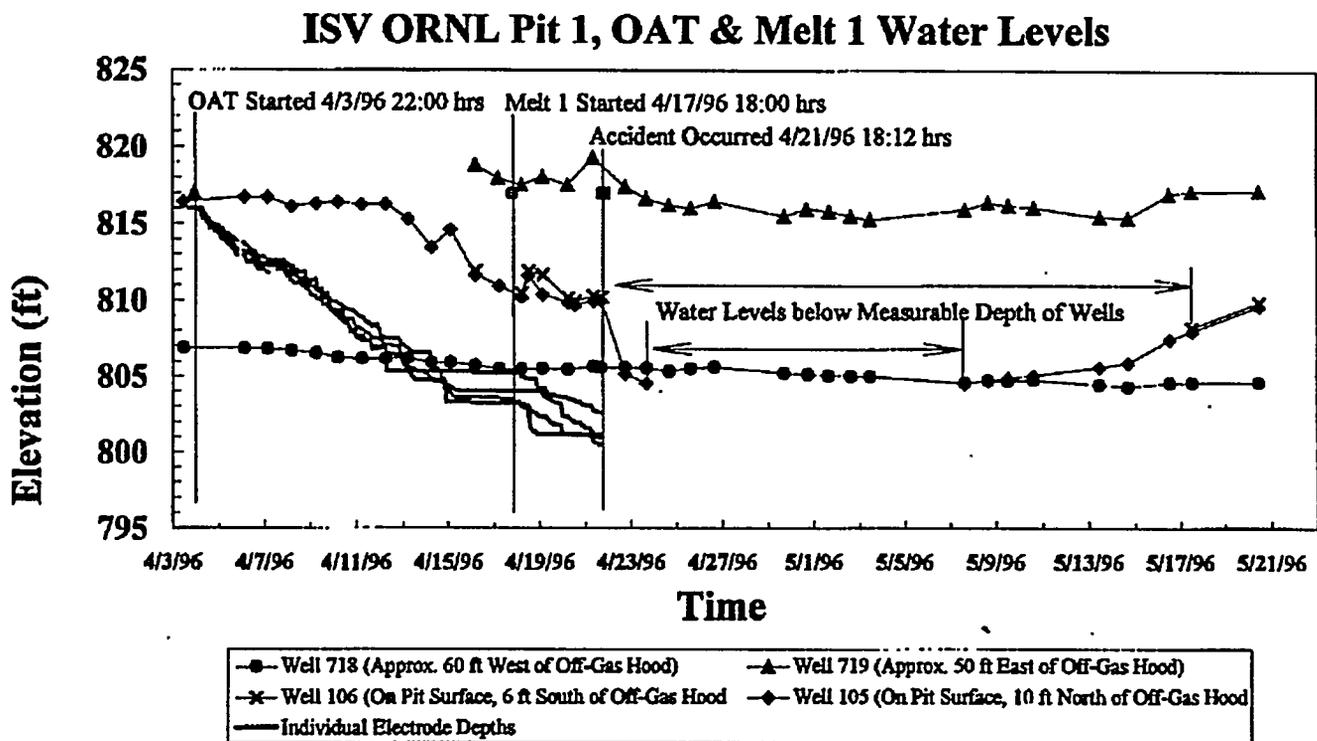
Second, one electrode had been lagging significantly behind (approximately 1 ft less penetration) the other three electrodes. At the time of the melt expulsion incident, this lagging electrode was continuing to make depth progress, like the others, indicating that it was not stuck or frozen into a cold

Fig. 14. Depth of ISV electrode penetration into the ORNL melt as a function of time and its relation to groundwater elevation within and around pit 1.
