**Environmental Health and Safety
Independent Investigation
of the In Situ Vitrification Melt Expulsion
at the Oak Ridge National Laboratory,
Oak Ridge, Tennessee**

Energy Systems Environmental Restoration Program

Date Issued—July 1996

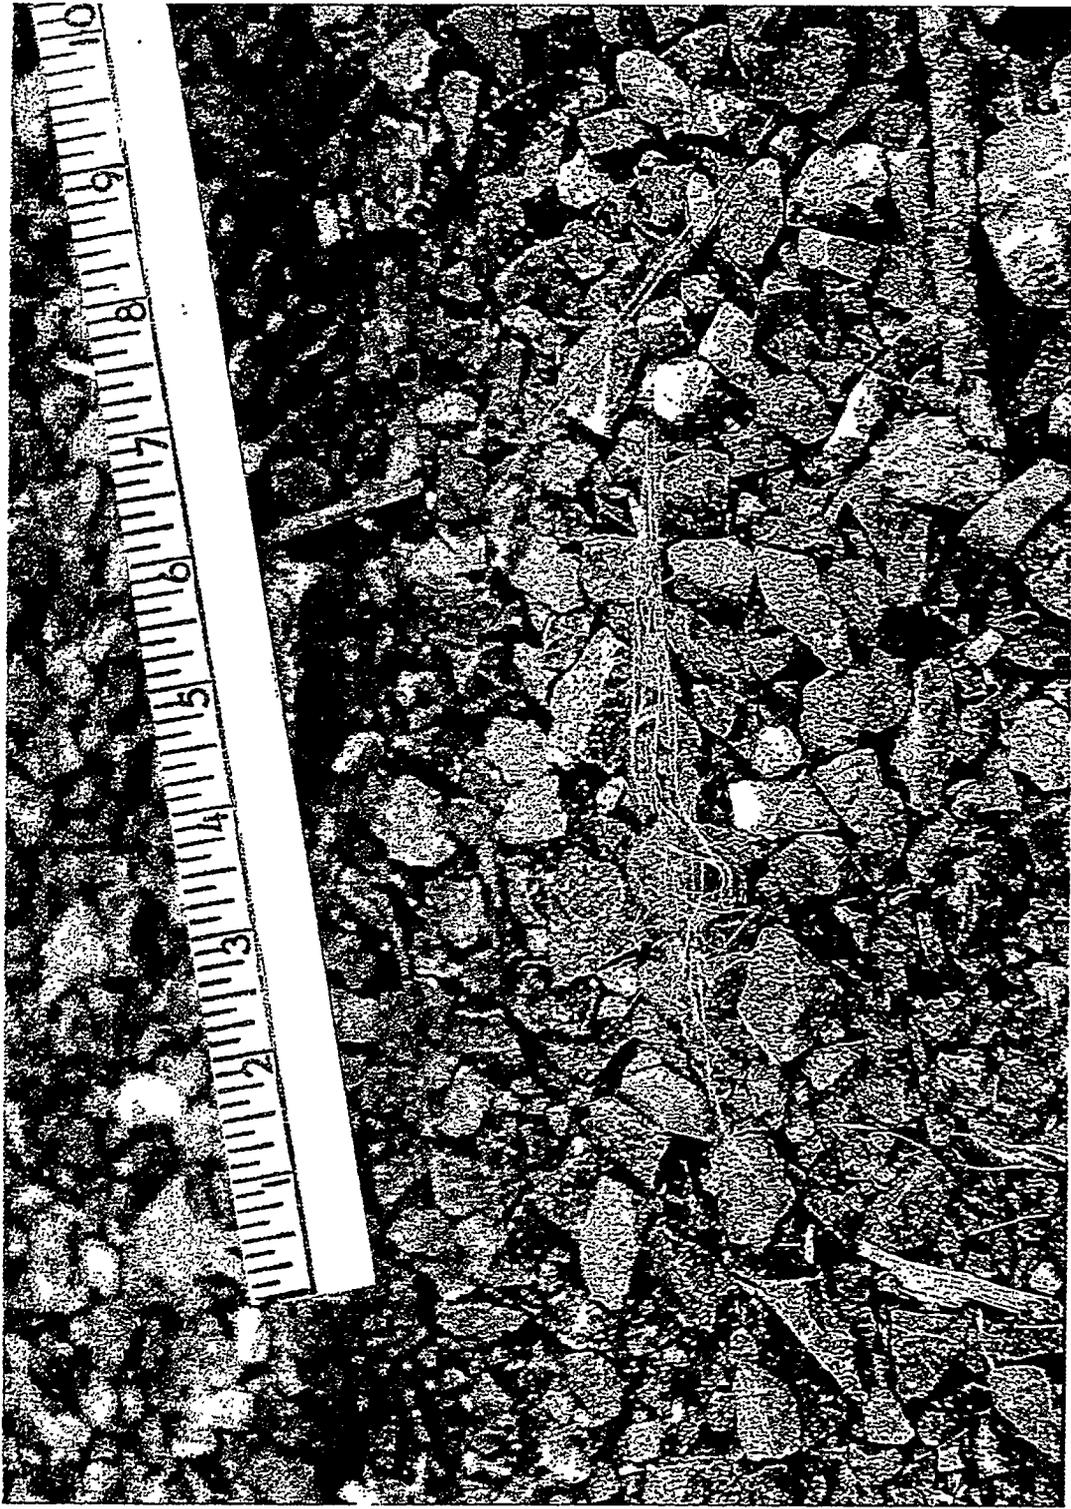
Some pieces of molten glass were ejected and typically read 15,000 to 20,000 dpm/100 cm² with a maximum of 30,000 dpm/cm² or about 3 mrad/h. The main hazard associated with these pieces is the thermal hazard if personnel were in the area during the ejection of the molten glass. These pieces ranged up to about 1 in. \times 3 in.

Fig. 4. Angel hair found at the melt expulsion event at ORNL Pit 1.

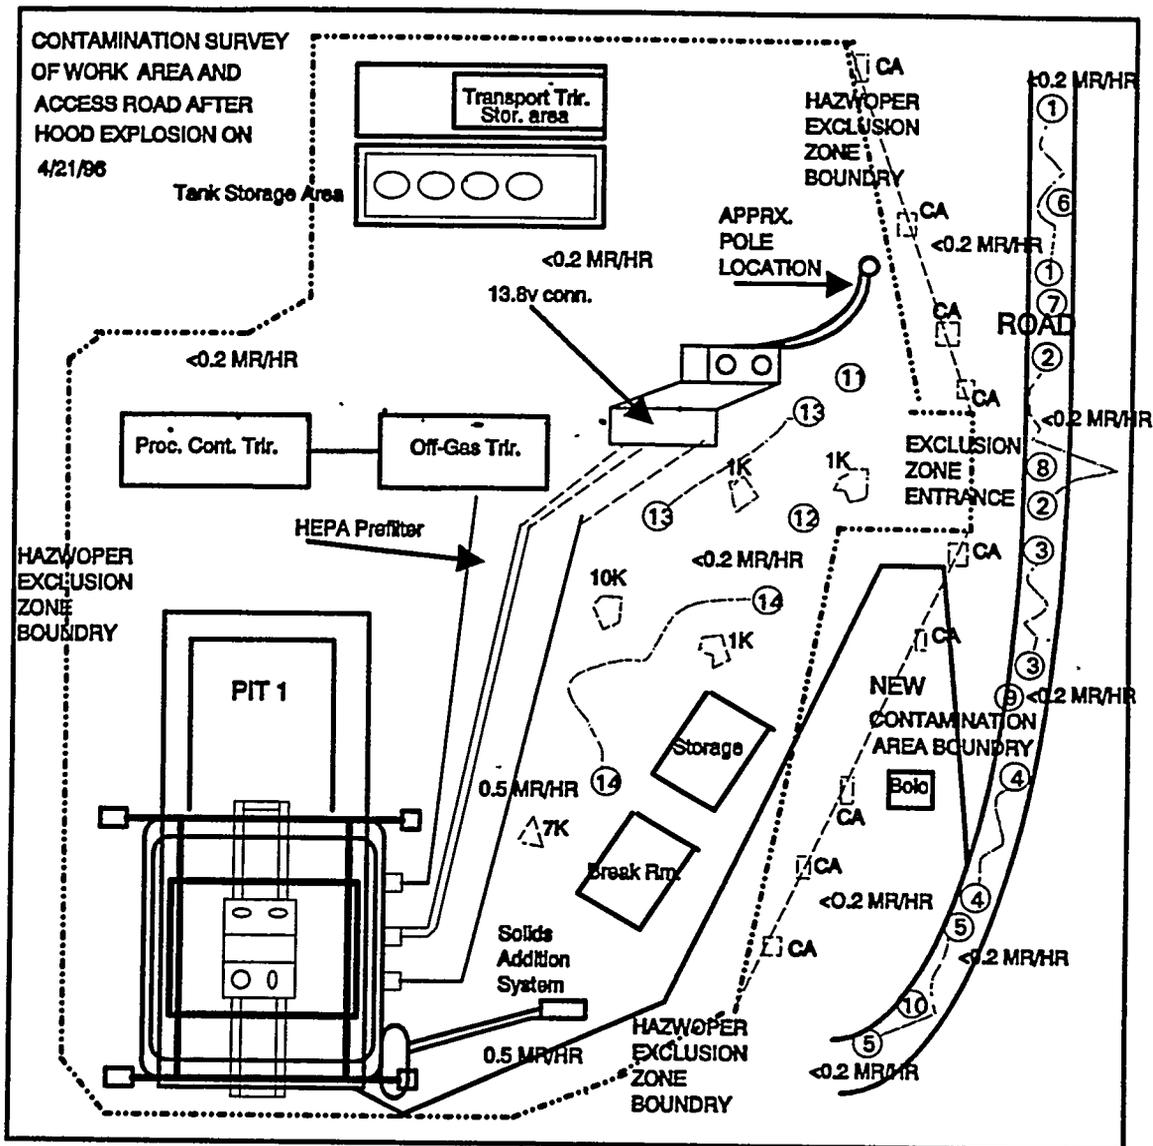
Radiation levels on and around the hood increased as a result of the radioactive material contained in the glass. Prior to the event, all radiation levels on and around the hood were less than 0.2 mR/h. After the event, levels at contact with glass increased to a maximum of 8 mrad/h on the southeast edge of the hood and ranged from 3.5 to 7.0 mrad/h on the south and west sides of the hood.

Fig. 8. Oak Ridge National Laboratory radiological survey data (after the event).
