ORNL/TM-2015/056
CRADA/NFE-14-05024

Aircraft Propeller Hub Repair

Authors
Thomas R. Muth
William H. Peter

Date Published:
February 13, 2015

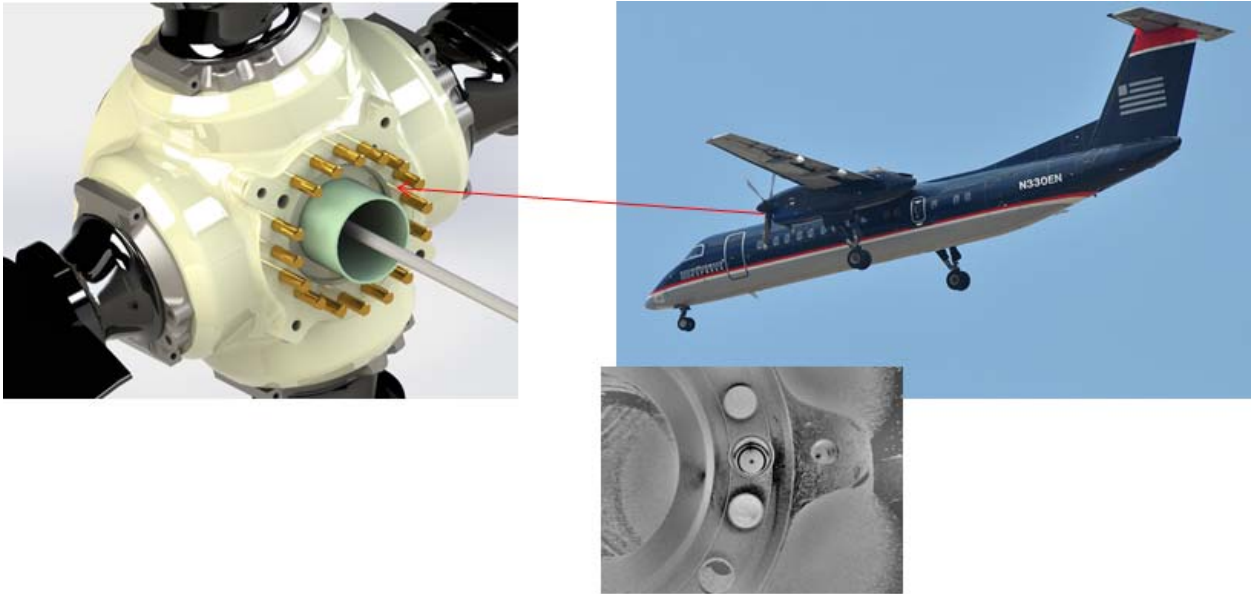
Fig. 1 shows the location of a propeller hub on a turboprop aircraft, with an image showing the typical area of anomalous indications causal for rejection of the hub for flight service. Five propeller hubs were provided to ORNL; one was a refurbished unit that was acceptable for return to service, one was as-removed from an aircraft just prior to performing maintenance refurbishment and the three others were at the minimum material condition (MMC) having just completed maintenance refurbishment, but had deleterious die penetrant indications precluding return to service. A summary of the hub conditions and actions performed by ORNL are in Table 1.

Fig. 1. Depiction of a propeller hub from a turbo-prop aircraft.

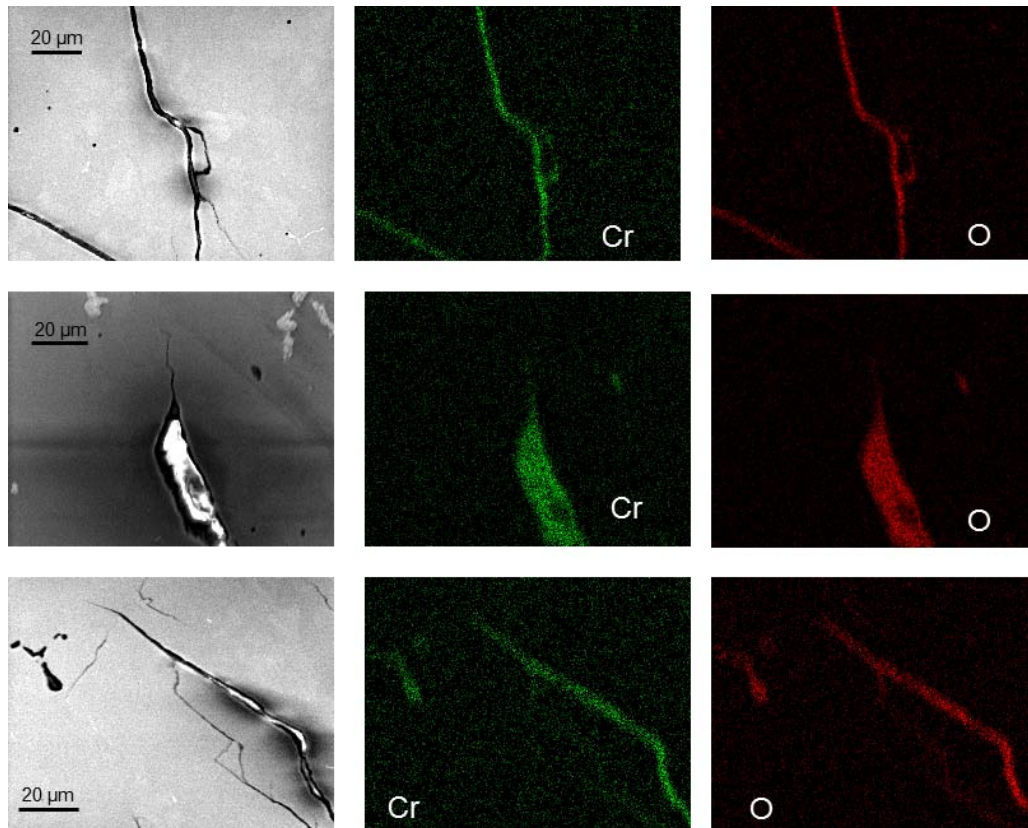
In conjunction with the NTSB information, and the examination of hub A where smearing was observed, fretting was deemed the likely source as a crack initiation event prior to propagation. The observation that the anomalies / cracks were all located adjacent to the dowel pin holes, lead the team to categorize the observations on the five hubs examined as a progression of fretting damage with eventual crack propagation.

away of the contact face prior to examination; however fretting was considered the likely crack initiator, based on the similarities with hub A. It is hypothesized that fretting damage lead to stress concentration and that stress concentration in the zone adjacent to the dowel pin holes, where expected misalignment occurred, resulted in higher structural loads. The crack initiation was followed by propagation during the load cycles in service. The crack propagation in the case of hubs C, D, and E was sufficient to be present after refurbishment machining to MMC.

Two of the hubs with die penetrant indications at MMC were sectioned for examination. Samples were prepared and observed under the optical and the scanning electron microscopes (SEM). The SEM analysis utilized the energy-dispersive x-ray spectroscopy module to identify elements at observed crack openings and discontinuities. The base microstructure was typical of AMS4141 aluminum. In areas where cracks and anomalies were observed, accretions high in chromium and oxygen were identified. Fig. 2 depicts a typical finding. Chromium likely results from the chromate conversion treatment applied to inhibit corrosion of the hub in service.

Fig. 2. Example of typical anomalies identified and associated with fretting in base metal adjacent to one of the dowel pins in one of the examined hubs. There is a noticeable concentration of chromium and oxygen in the crack opening likely associated with the chromate conversion process used to mitigate corrosion.

Because of the common proximity of the die penetrant indications to the dowel pin holes and the damage observed in the same location on the as-removed hub, solutions relating to repair were targeted at the area on the flange face adjacent to the dowel pins. For fretting prevention in new hubs, it was recommended that a recess in the mounting face be machined to simply prevent contact in the fretted area, as depicted in fig. 3.

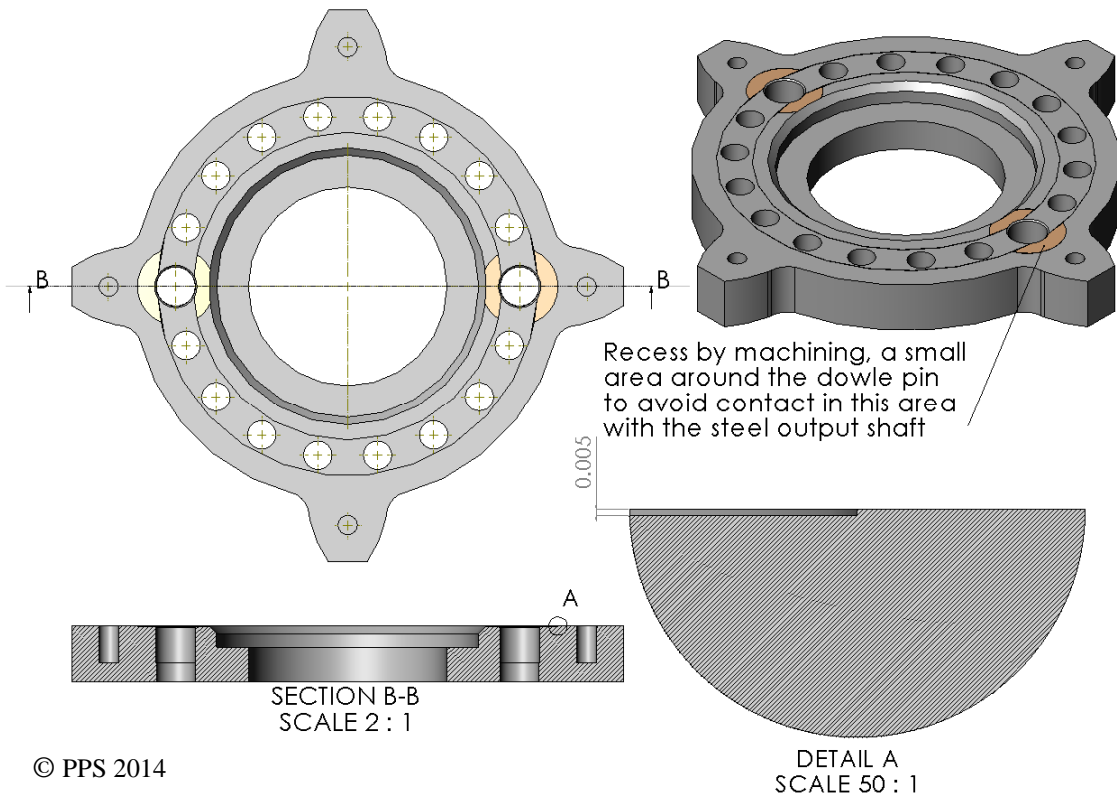
Fig. 3. Recommended solution for hubs to mitigate fretting near the dowel pins; machine a recess approximately 0.005 inches deep to avoid contact in the zone of concern.

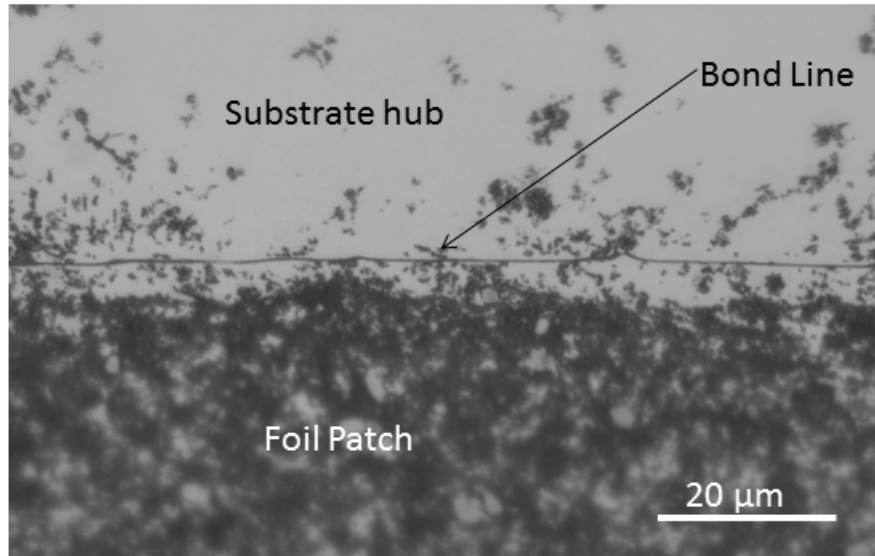
The ultrasonic welding method on the flange face was attempted at Fabrisonics in Columbus, OH, using samples removed from a scrapped hub. Mechanical bonding was observed upon sectioning of the weldment as depicted in fig. 4. The results indicate some promise toward achieving a metallurgical bond with further research.

Fig. 4. Cross section of an aluminum alloy foil being attached via ultrasonic welding to a sample of a hub. The substrate hub is white, and the foil attachment is dark (bottom). The bond line is visible as a linear feature indicating mechanical bonding.

For repair of existing flanges, two approaches were recommended. Both methods require removal of all detectable damage, prior to attempting a repair. If damage removal left the hub above the MMC, then a silver cladding applied via electromagnetic pulse (EMP) technology was recommended. If damage removal left the hub below the MMC then a thin foil aluminum alloy patch, applied via ultrasonic welding was recommended to bring the flange face above the MMC.
