ORNL-2832
UC-25 - Metals, Ceramics, and Materials

CORROSION ASSOCIATED WITH FLUORINATION
IN THE OAK RIDGE NATIONAL LABORATORY
FLUORIDE VOLATILITY PROCESS

A. P. Litman
A. E. Goldman

This report evaluates chemical corrosion on reaction vessels and equipment used during the fluorination of fused-salt fuels and subsequent associated operations in the Oak Ridge National Laboratory (ORNL) Fluoride Volatility Process and is a continuation and expansion of the Metallurgy Division assistance to the Chemical Technology Division in this regard. The fluorination phase consists of converting uranium tetrafluoride to volatile uranium hexafluoride by fluorine sparging of molten fluoride salts and subsequent decontamination and recovery of the uranium hexafluoride.

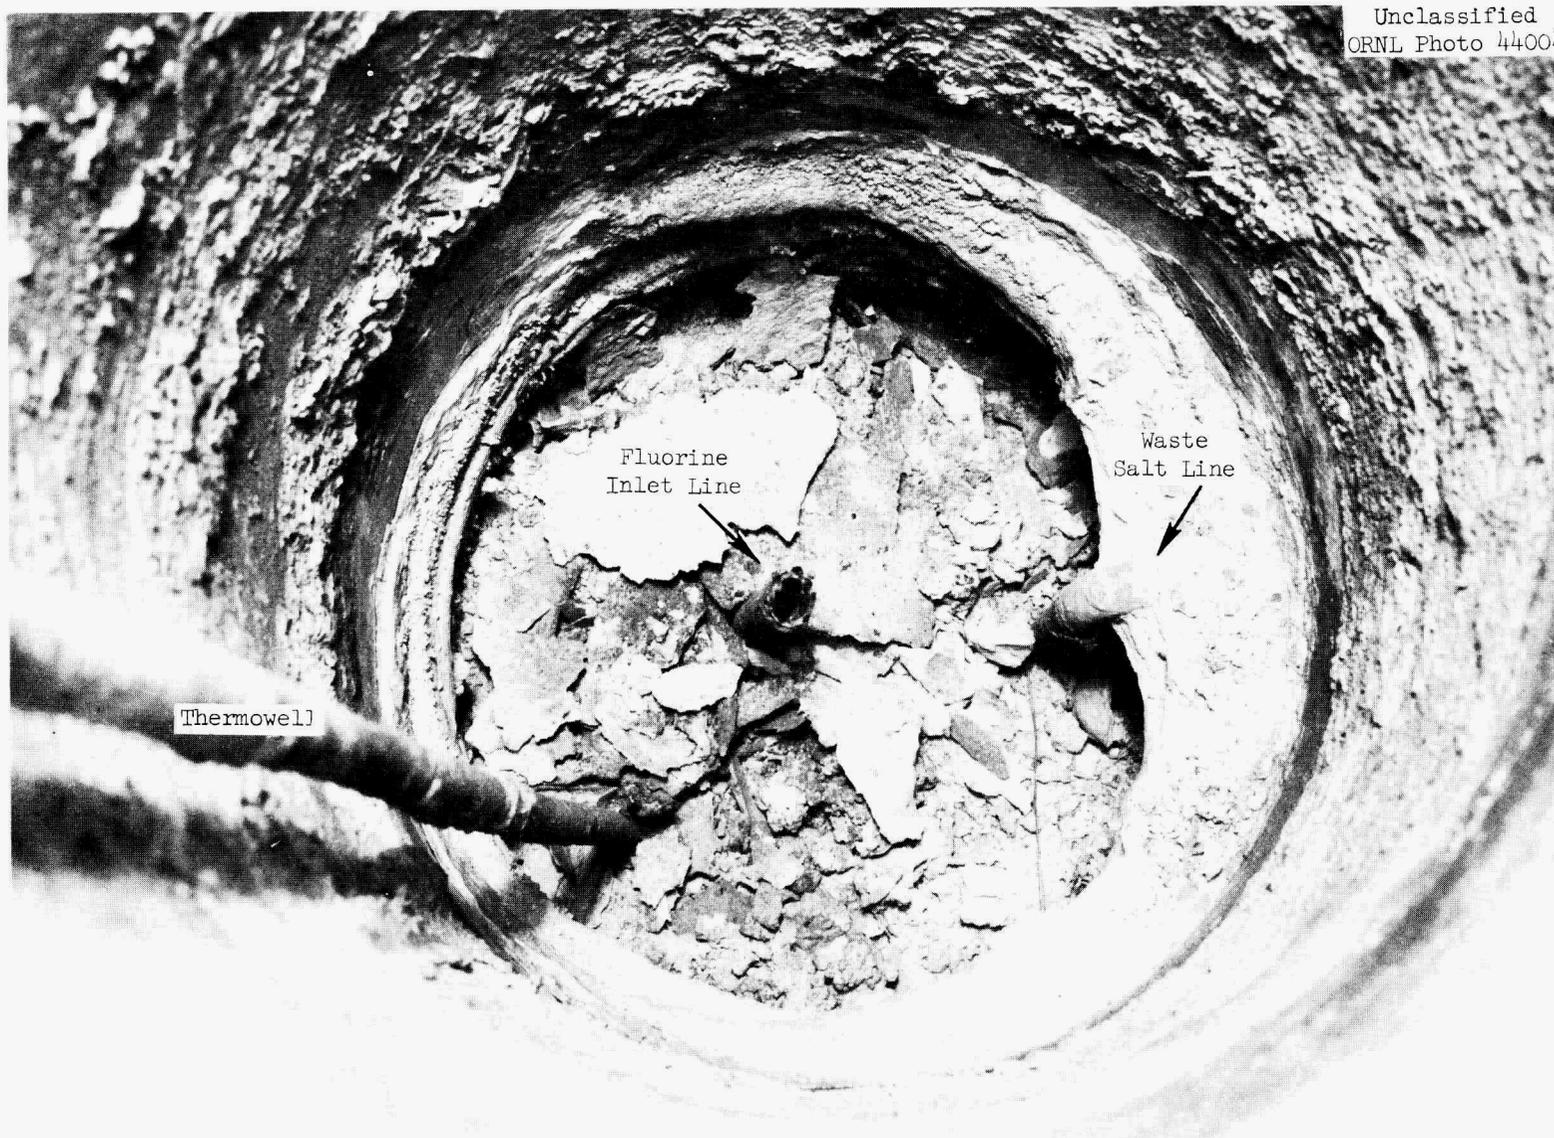
Fig. 14. Interior of Mark II VPP Fluorinator After Run L-4. (Fluorine inlet cut off prior to taking of photograph.)

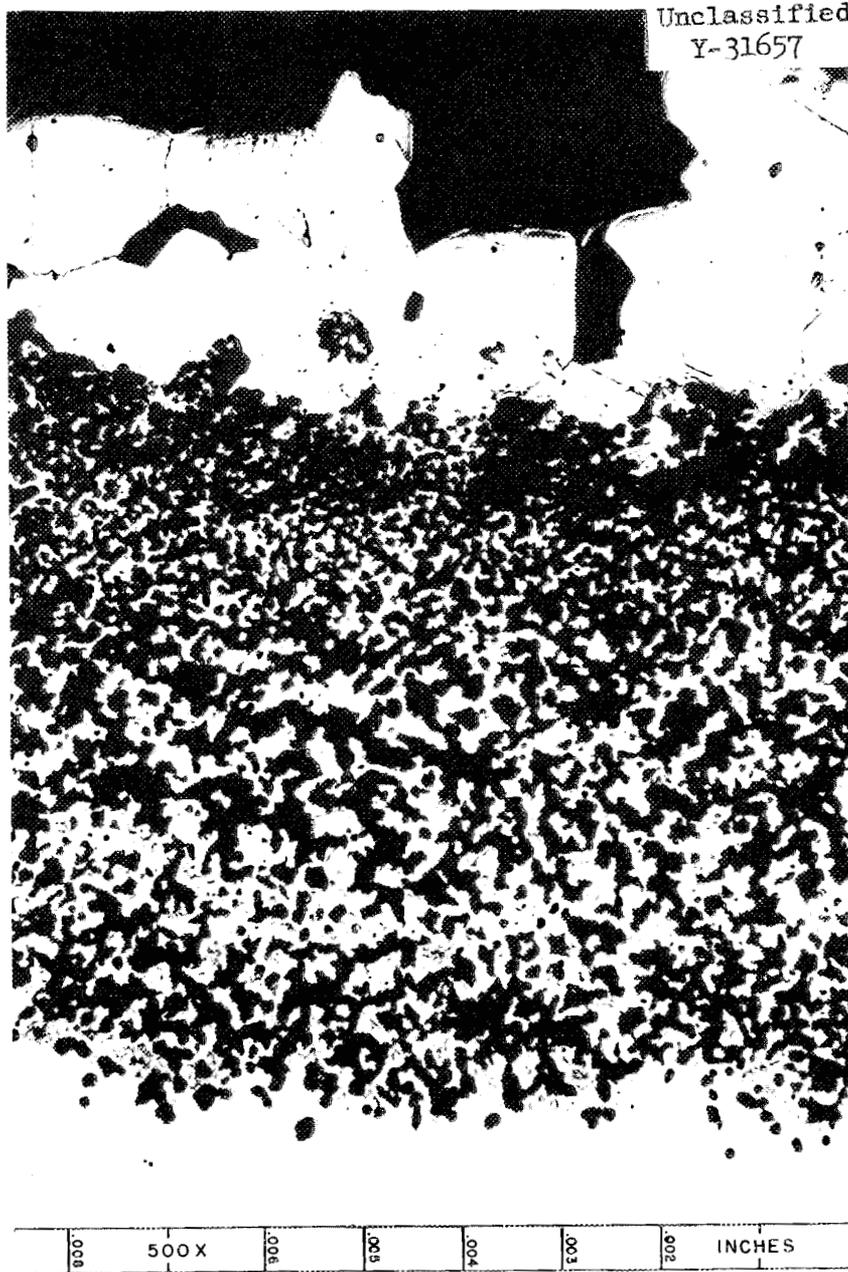
Fig. 51. Surface Layers on Sample from Vapor Region of INOR-8 Miniature Test Fluorinator No. 2. Etchant: Potassium cyanide-ammonium persulfate. 500X.

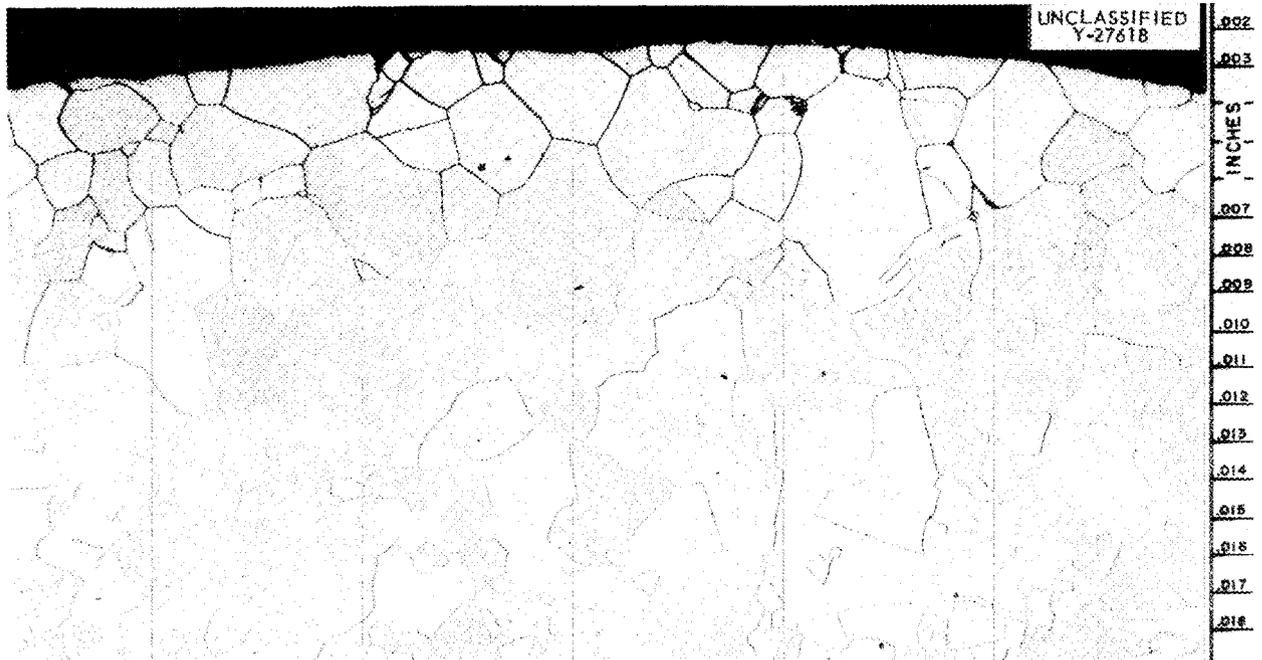
Fig. 59B. Portion of Fig. 59A. Typical Surface and Microstructure. Note intergranular attack. Etchant: $\text{KCN}-(\text{NH}_4)_2\text{S}_2\text{O}_8$. 200X.

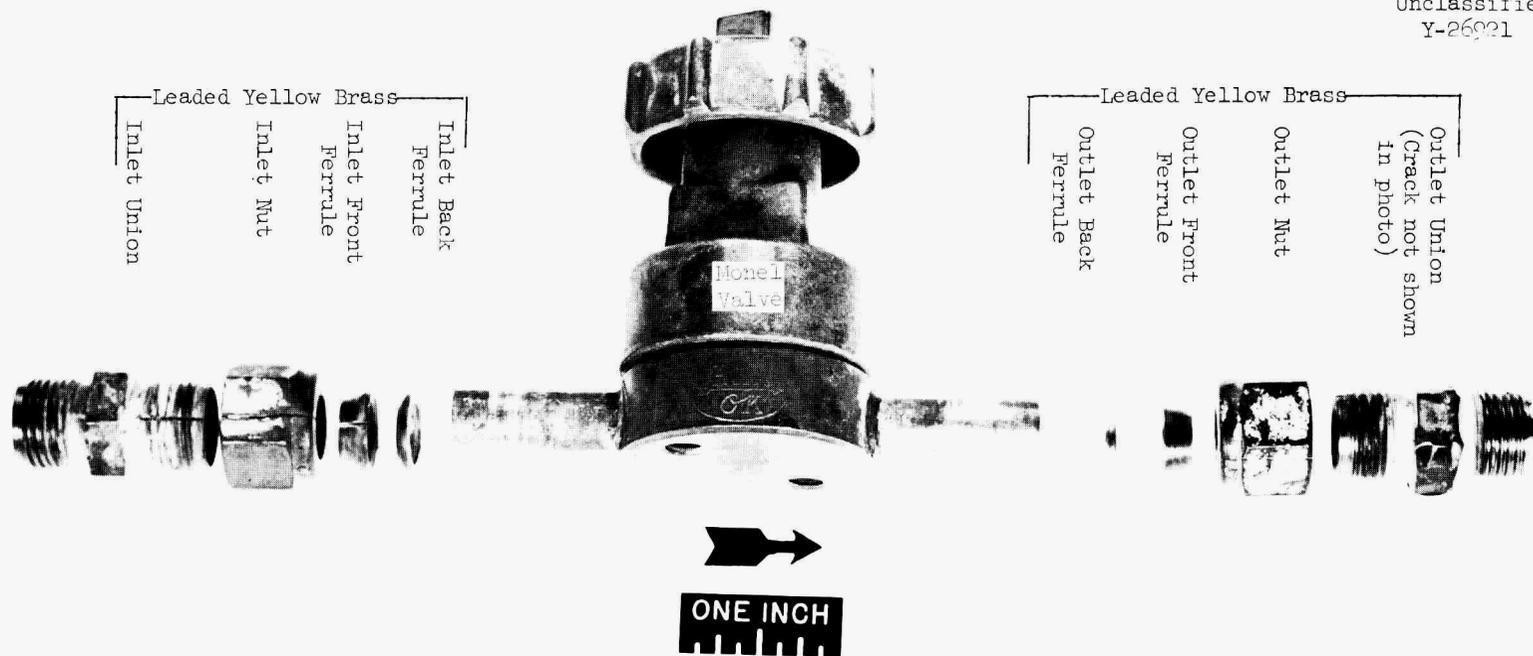
Fig. 88. Photograph of Gas Purge Line (PE-34) Valve and Attached Fittings. (Note fractures in inlet union, inlet nut, and inlet front ferrule.)
