INFLUENCE OF AGING ON THE  
IMPACT PROPERTIES OF HASTELLOY N,  
HAYNES ALLOY NO. 25, AND  
HAYNES ALLOY NO. 188

ORNL-TM-4380

METALS AND CERAMICS DIVISION

DECEMBER 1973

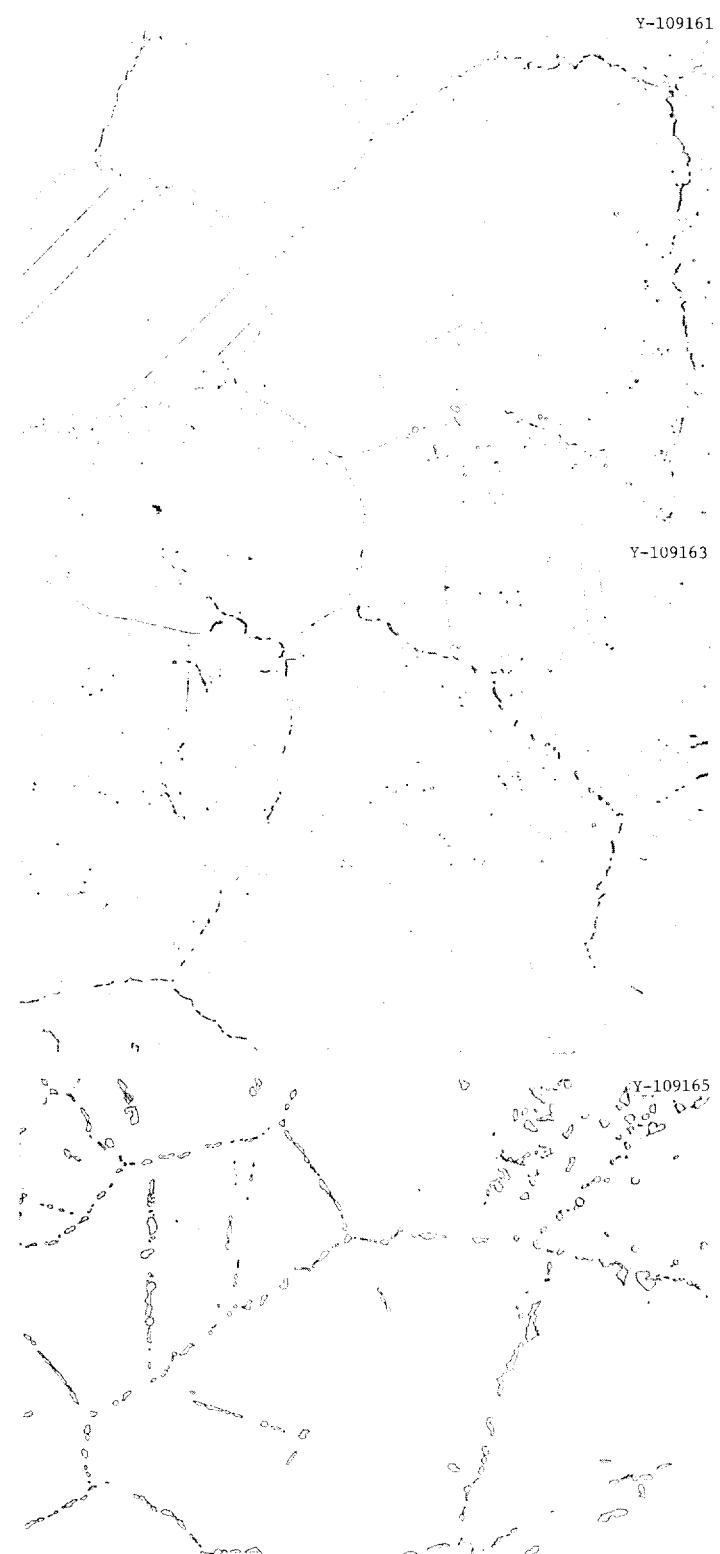
Fig. 14. Photomicrographs of Hastelloy N Annealed 1 hr at 1150°C and Aged at 900°C. 500×. (Reduced 39.5%). (a) 50 hr, (b) 100 hr, and (c) 4000 hr. Impact energies at 25°C were 114, 83, and 36 ft-lb, respectively. Etchant: glyceria regia.

boundaries. Aging at 700°C caused carbide precipitation similar to that noted at 650°C. Aging at 800°C initially caused grain boundary carbide precipitation and some general precipitation (Fig. 12). After prolonged aging at 800°C, the grain boundary carbide agglomerated, and the amount of precipitate within the grain increased (Fig. 13). However, the impact energy continued to decrease with further aging at 800°C (Fig. 1, p. 4) even though the grain boundary carbide appeared to become discontinuous. At 900°C the carbide formed preferentially along the grain boundaries (Fig. 14). It was initially quite fine and became coarser and agglomerated with further aging time. The impact energy decreased with increasing carbide formation and seemed to reach a plateau of about 30 ft-lb after the carbide became quite coarse (Fig. 1, p. 4).

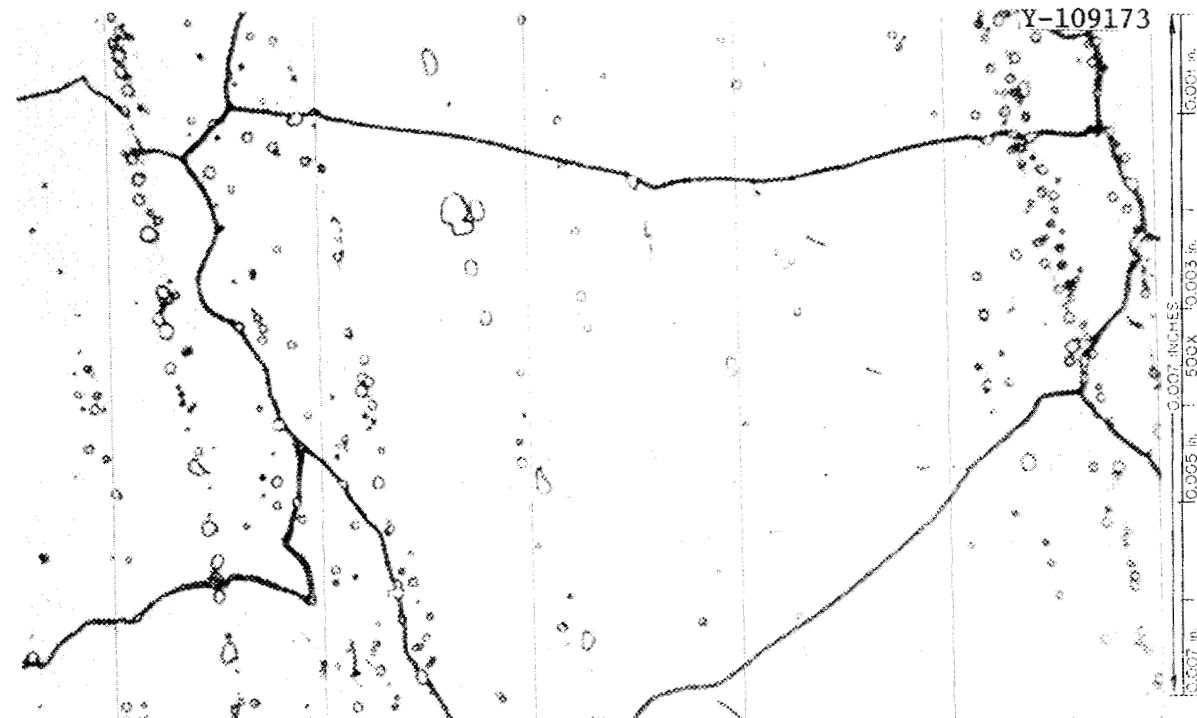
Fig. 16. Typical Photomicrograph of Haynes Alloy No. 25 Annealed 1 hr at 1150°C and Aged 4843 hr at 650°C. Impact energy at 25°C was 2 ft-lb. Etchant: glyceria regia.

The microstructure of solution-annealed Haynes alloy No. 25 is shown in Fig. 15; it contains a primary carbide, likely M<sub>6</sub>C. Even though aging at 650°C caused a steady decrease in the impact energy from 60 to 2 ft-lb (Fig. 4, p. 5), the microstructure changed only slightly. After aging for 4843 hr at 650°C (Fig. 16) the grain boundaries etched very quickly (likely because of the presence of carbide or Laves precipitate), and some precipitate was visible in the grains. Aging at 700°C produced a steady decrease in the impact energy (Fig. 4, p. 5), and large amounts of precipitate (likely Laves phase) were visible in the microstructure (Fig. 17). Aging at 800°C resulted in coarser precipitate than noted at 700°C, and the grain boundaries etched very readily (Fig. 18). Aging at 850°C for 50 hr caused the impact energy to decrease from 50 to 6 ft-lb (Fig. 4, p. 5), but the microstructure showed little change from the solution-annealed condition (compare Figs. 15 and 19). The main difference is the more rapid etching characteristics of the grain boundaries after aging. Aging 4843 hr at 850°C caused the impact energy to decrease only slightly from that noted after aging 50 hr; however, the amount of precipitate increased dramatically (Fig. 20). These observations lead to the speculation that the impact property changes in Haynes alloy No. 25 result primarily from the grain boundary precipitate structure and to a lesser extent on the precipitate within the grains.

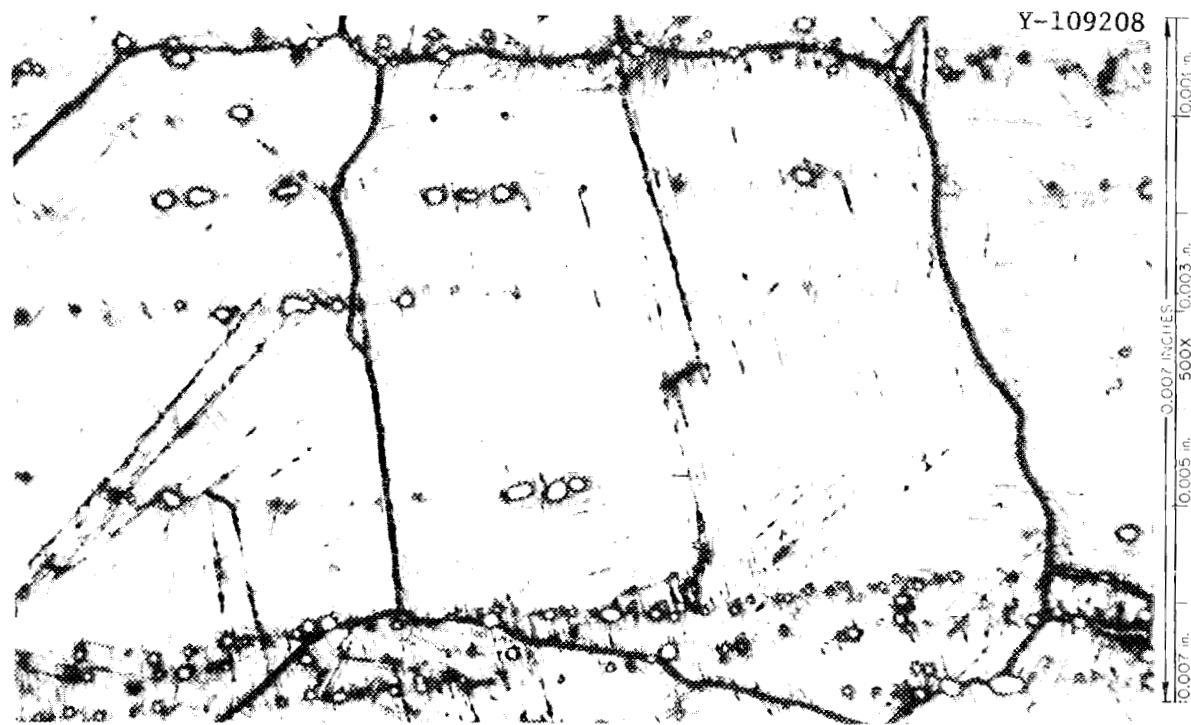
Fig. 17. Typical Photomicrograph of Haynes Alloy No. 25 Annealed 1 hr at 1150°C and Aged 4843 hr at 700°C. Impact energy at 25°C was 5 ft-lb. Etchant: glyceria regia.
