Creep and Creep-Rupture Behavior of ERNiCr-3 Weld Metal

R. L. Klueh
J. F. King

METALS AND CERAMICS DIVISION

Date Published: June 1978

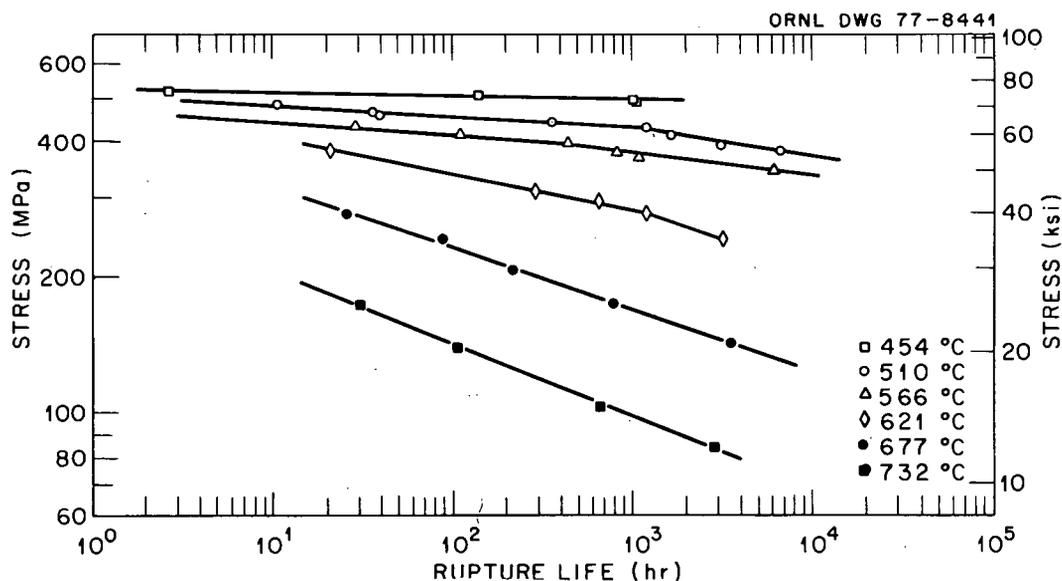
Fig. 1. Creep-Rupture Curves for ERNiCr-3 (Inconel 82) Weld Metal.

creep rate (Fig. 2) indicate a distinct difference in behavior for the two temperature regimes. At the higher stresses and at 454, 510, and 566°C, the curves (Figs. 1 and 2) are quite flat. At 510 and 566°C, there appeared to be changes in slope (it breaks downward) as the stress was lowered. At these temperatures the curves for rupture life (Fig. 1) and minimum creep rate (Fig. 2) both show such breaks. At 454°C, however, only the minimum creep rate curve breaks downward; that is, sufficient rupture-life data were not obtained to determine the break.

Two of the tests failed in less than 80 hr, while the other test ruptured during a temperature excursion at 2450 hr (rupture would be predicted from Fig. 1 to occur in about 5000 hr). One of the tests that failed prematurely contained a burst of about 6% before failure. Both the premature failures had loading strains greater than 22%, whereas the 2450-hr test strained only 14% on loading (Table 2). The latter test contained a strain burst early in the test (during primary creep) of about 4% and three short bursts of less than 0.5%. Tests that contained at least one strain burst may well have had premature failures compared with those found in tests without any bursts. Our results do not permit us to conclude that such rupture lives were not premature failures.

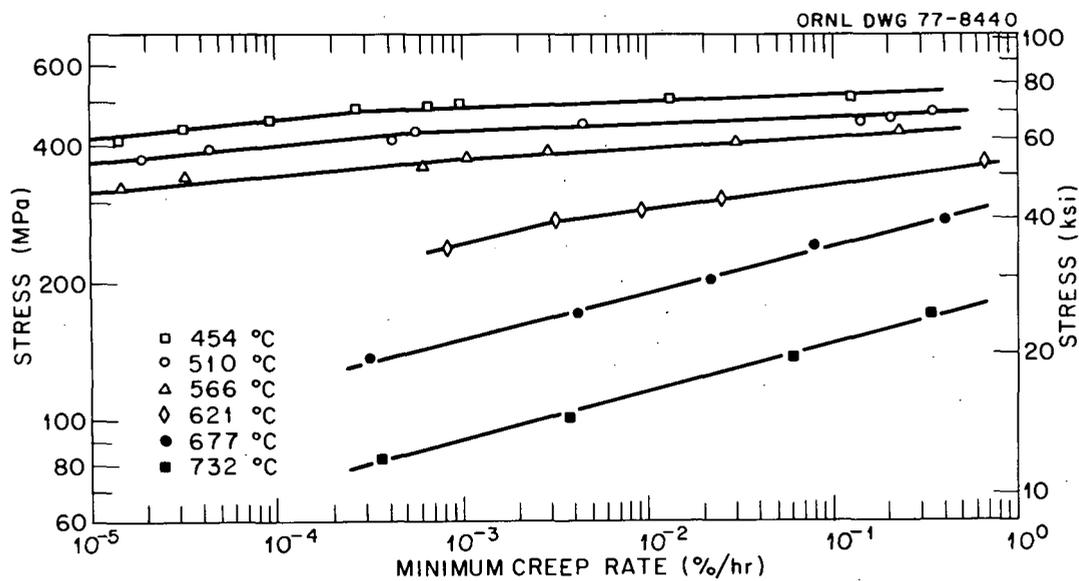
Fig. 2. Relationship Between Stress and Minimum Creep Rate for ERNiCr-3 (Inconel 82) Weld Metal.

where σ is the stress, $\dot{\epsilon}$ the minimum creep rate, and A and n are constants. To characterize the data better, we estimated n for the data in Fig. 2 (Table 4). It should be noted that these are but rough estimates based on the visual fit of the data.

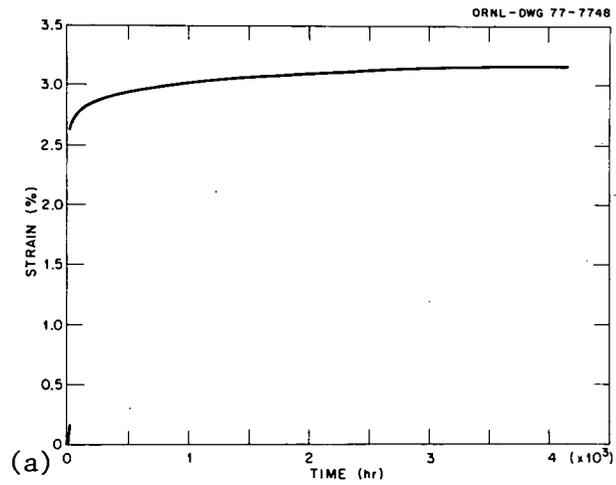
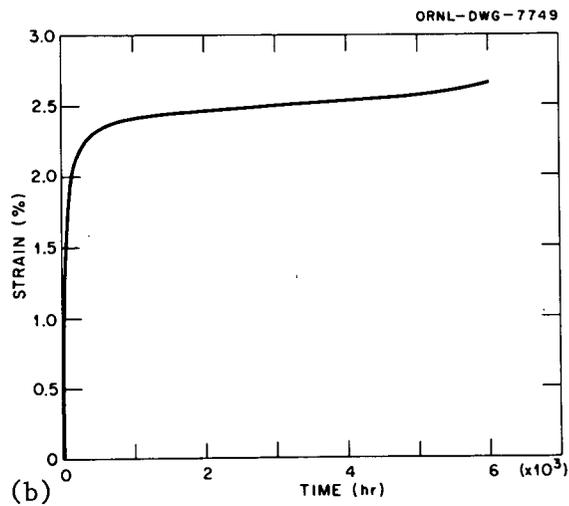
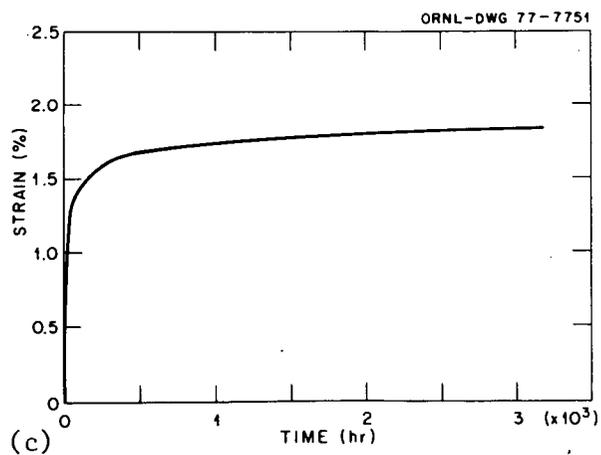
Fig. 3. Example of Creep-Curve Shape at (a) 454°C and 413 MPa; (b) 510°C and 327 MPa; (c) 566°C and 327 MPa. Only the early portion of each curve is shown.

Another indication of the difference in behavior at the high and low temperatures is seen by comparing the creep curves at the various temperatures (Figs. 3 and 4). At the low temperatures (Fig. 3), and especially at low stresses, the curves are characterized by a high initial creep rate followed by a rapid transient during which the creep rate decreases to a "steady state." As discussed in the following section, the low-stress tests — especially at 454°C — may follow a logarithmic creep law, which implies a continuously decreasing creep rate. Once the steady state is reached, it continues almost to failure. That is, these tests showed essentially no tertiary creep. At the highest stresses the transition from the primary to the secondary stage was less abrupt.

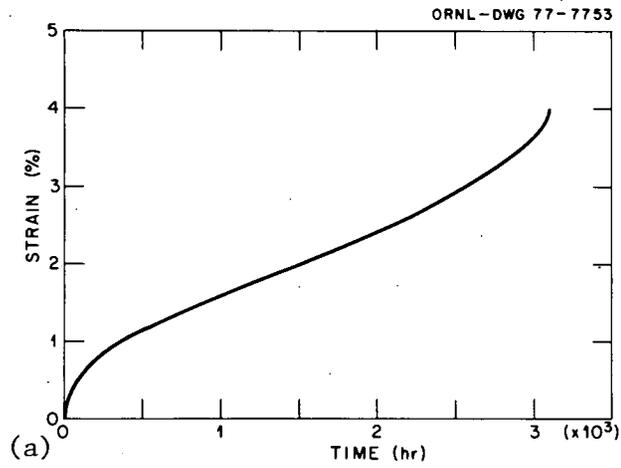
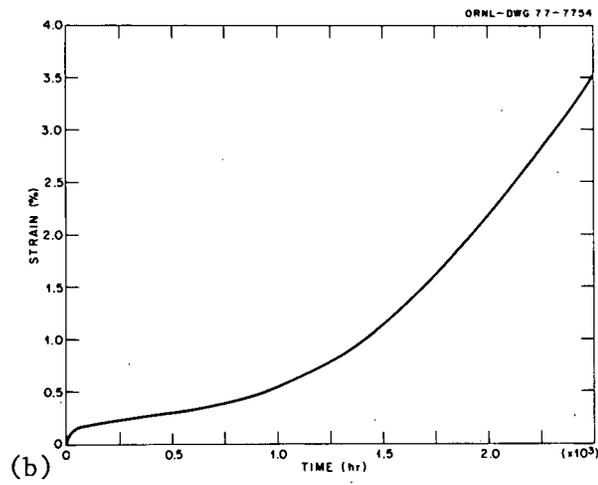
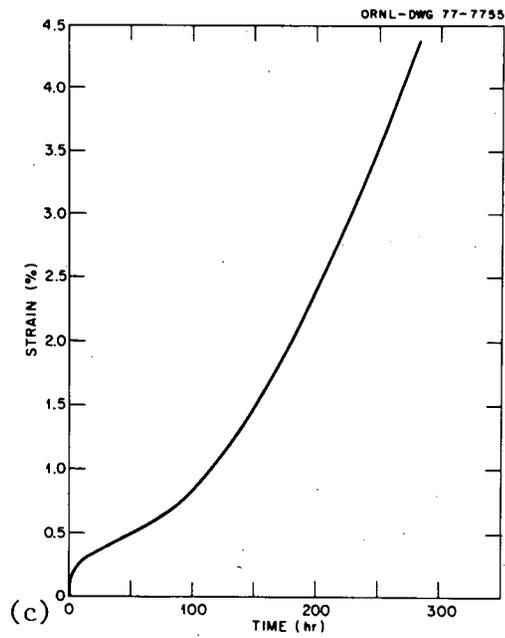
Fig. 4. Example of Creep-Curve Shape at (a) 621°C and 241 MPa; (b) 677°C and 138 MPa; (c) 732°C and 103 MPa. Only the early portion of each curve is shown.

At the two highest temperatures, 677 and 732°C, the creep curves are characterized by very little primary creep [Fig. 4(b) and (c)]. The test quickly reached the steady-state stage, which was also shorter than it was at the lower temperatures. These curves have well-defined tertiary stages. Finally, the curve shapes at 621°C [Fig. 4(a)] appear to fall between those at the low temperatures (Fig. 3) and those at 677 and 732°C [Figs. 4(b) and (c)]. The transition to the steady state occurred over a longer period of time and with more strain than had occurred at 677 and 732°C. Furthermore, the initial creep rate was lower and the transition to the steady-state creep rate was more gradual than in the low-temperature tests.

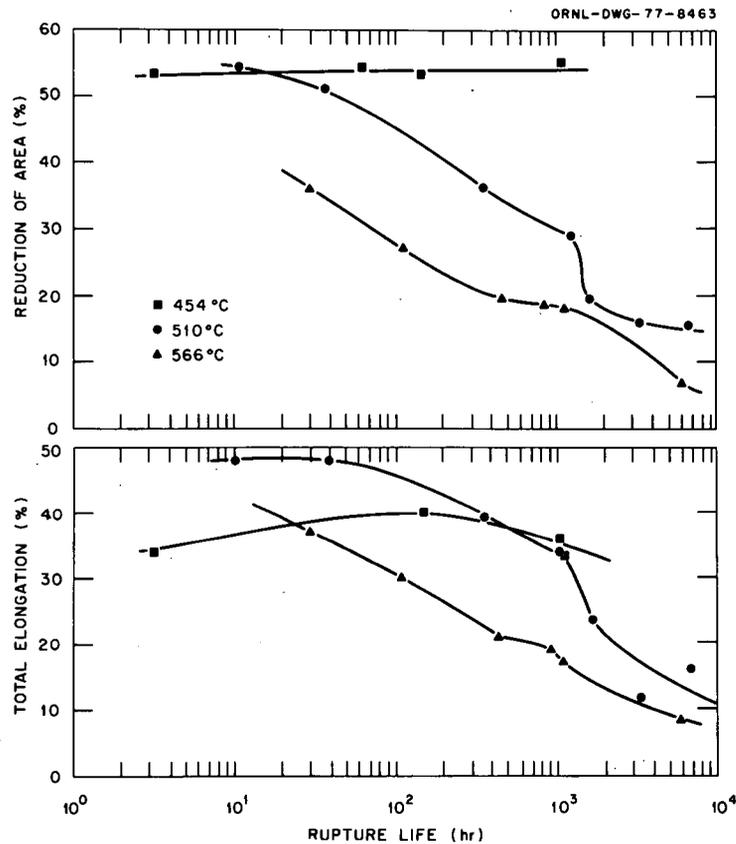
Fig. 5. Total Elongation and Reduction of Area as Functions of Rupture Life for ERNiCr-3 (Inconel 82) Weld Metal at 454, 510, and 566°C. Data points were connected to indicate the trends.

In general the total elongations and reductions of area were consistent at all temperatures (Figs. 5 and 6). Except at 454°C, both decreased with decreasing stress (increasing rupture life). At 454°C ductility changed very little over the range of stresses tested. Interestingly, of the high-temperature tests (Fig. 6), those at 621°C showed the least elongation.

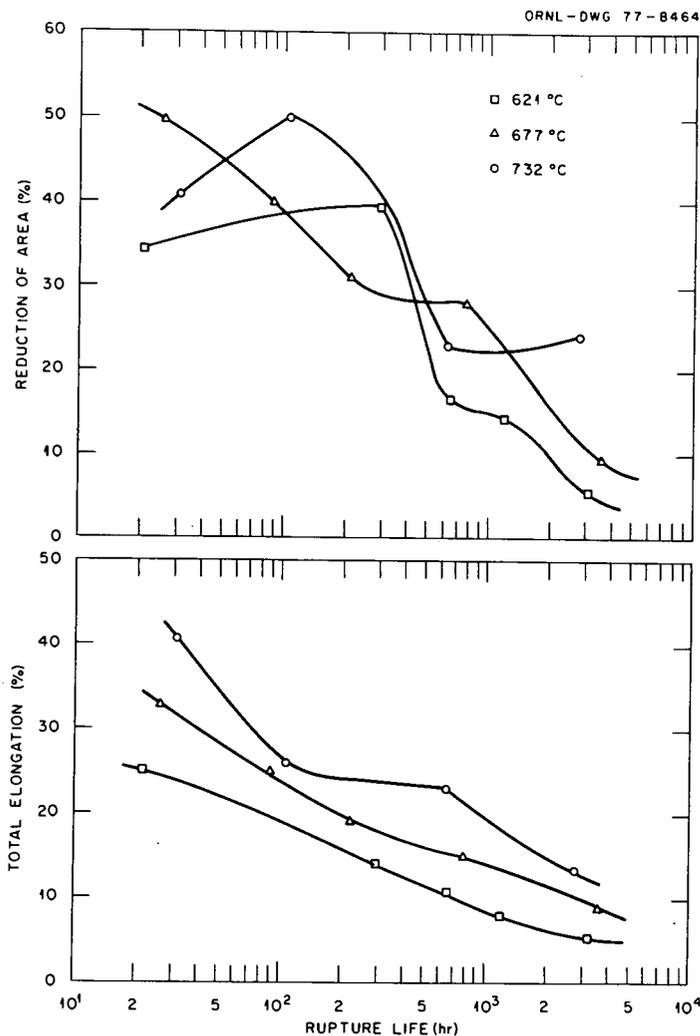
Fig. 6. Total Elongation and Reduction in Area as Functions of Rupture Life for ERNiCr-3 (Inconel 82) Weld Metal at 621, 677, and 732°C. Data points were joined to indicate the trends.

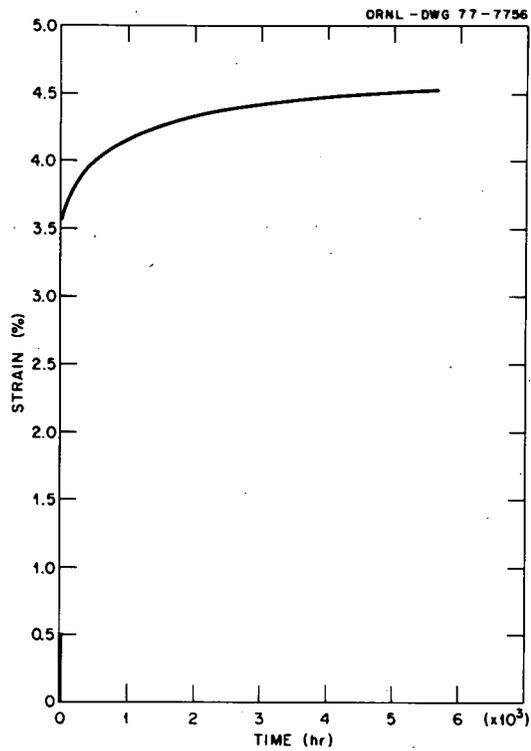
Fig. 7. Example of "Instantaneous Elongation" or a "Strain Burst" During Primary Creep in ERNiCr-3 Weld Metal Tested at 454°C and 434 MPa.

or a "spontaneous deformation." The phenomenon exhibited itself in the form of a jump in the creep curves, examples of which are shown in Figs. 7-9. These "strain bursts" appeared at different times in the creep process: shortly after loading during primary creep (Fig. 7) and during secondary creep (Fig. 8). Single (Fig. 8) and multiple (Fig. 9) bursts were observed. When a burst occurred early in the creep test (Fig. 7), it was difficult to determine whether there was a single or multiple burst.

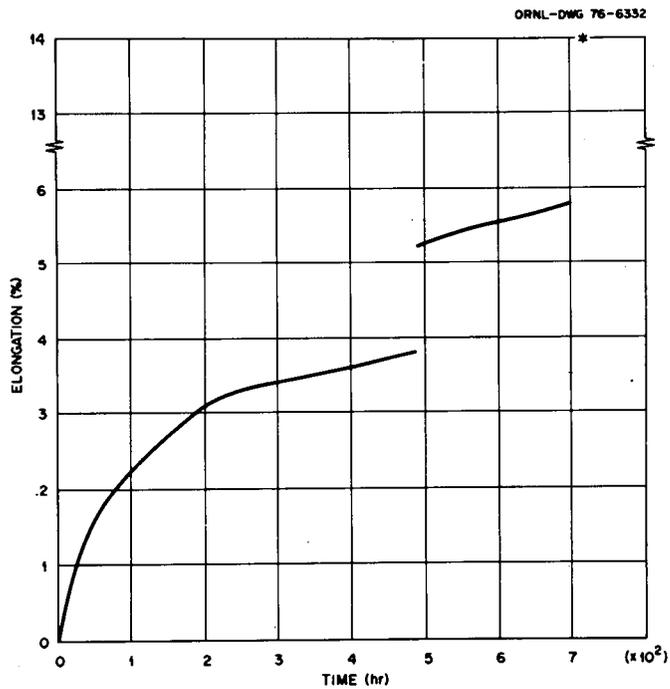
Fig. 8. Example of a "Strain Burst" During Secondary Creep Stage of ERNiCr-3 Weld Metal Tested at 454°C and 496 MPa.

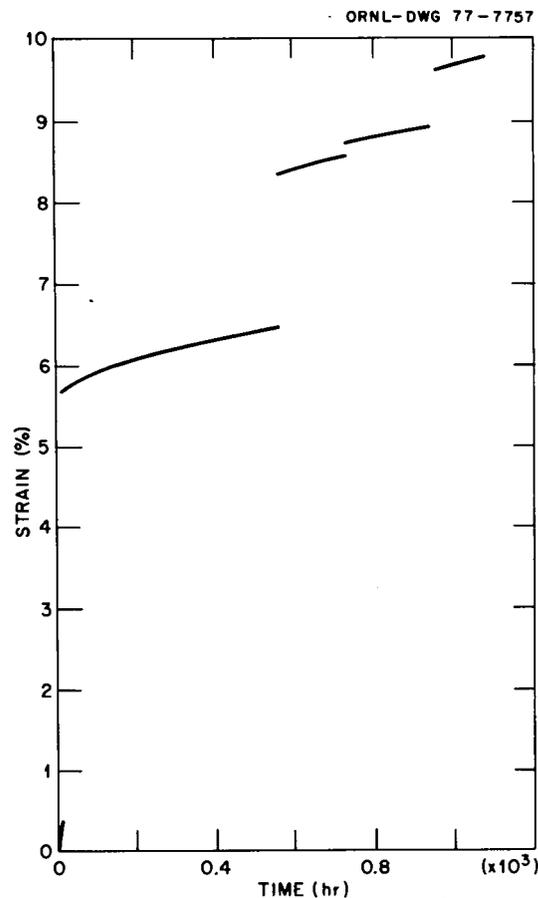
Fig. 9. Example of Multiple "Strain Bursts" in ERNiCr-3 Weld Metal Tested at 454°C and 489 MPa.

the phenomenon at 566°C, and no strain bursts were seen at 621, 677, and 732°C. The estimated strains per burst are given in Table 6. Strain burst magnitudes ranged from strains of about 0.1% to greater than 6%. When the strain burst occurred during the steady-state stage, the creep rate after the burst was usually little different than before it (Fig. 9).

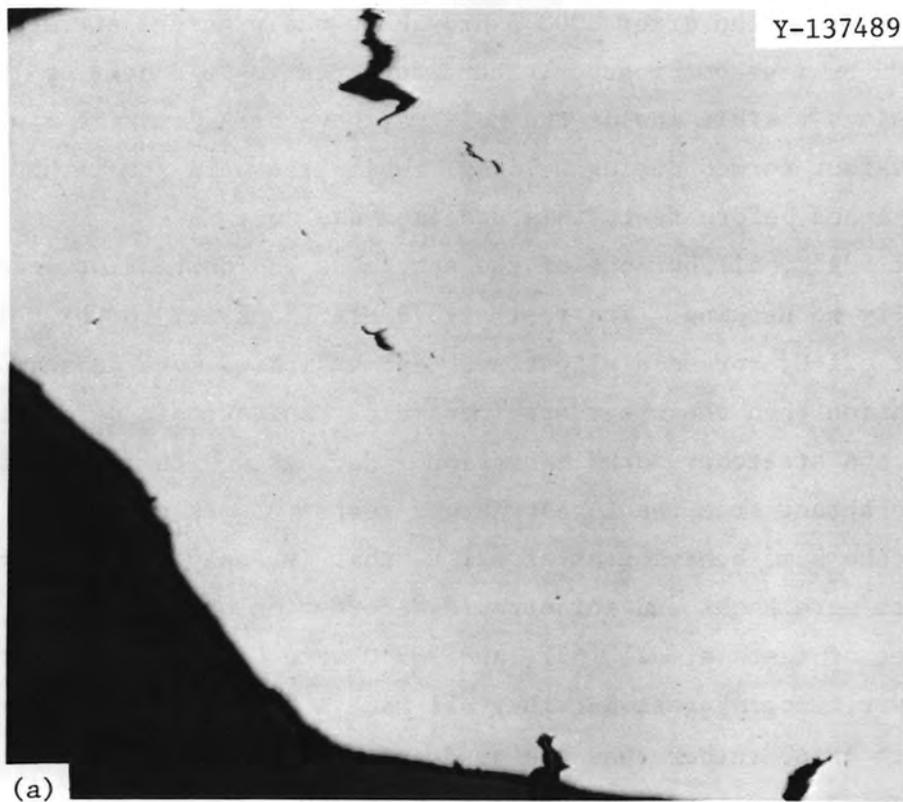
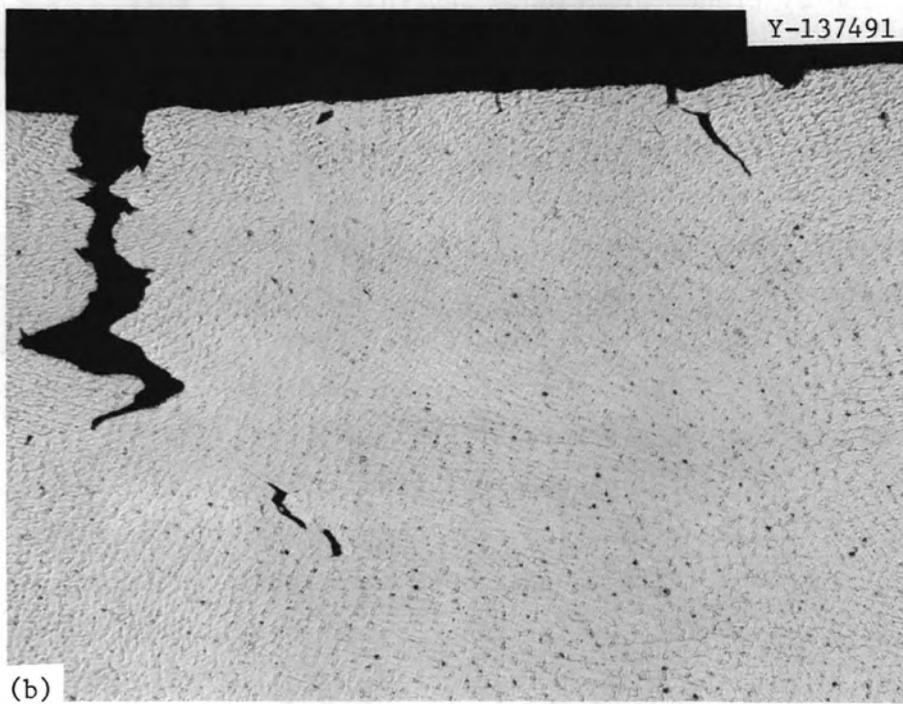
Fig. 10. Scattered Grain Boundary Cracks on Specimen Tested at 396 MPa at 566°C. (a) Unetched 50×. (b) Etched with 5:1 HCl:HNO₃. 100×.

Selected specimens were examined metallographically. At all temperatures, cracks were detected in grain boundaries back from the fracture surface (Figs. 10–13). For all stresses at 454°C and for the highest stresses at 510 and 566°C, only a few grain-boundary cracks were detected, and they were widely scattered on the specimen gage section (Fig. 10). The number of grain-boundary cracks increased with a decrease in the creep stress at 510 and 566°C. For the lower-stress tests at 510 and 566°C, we observed flat fractures with essentially no necking and little deformation near the fracture surface (Figs. 11 and 12). The fractures of both these specimens appeared to be intergranular. Part of the fracture surface on the 345-MPa-test specimen at 566°C appeared oxidized, suggesting that it fractured earlier in the test.

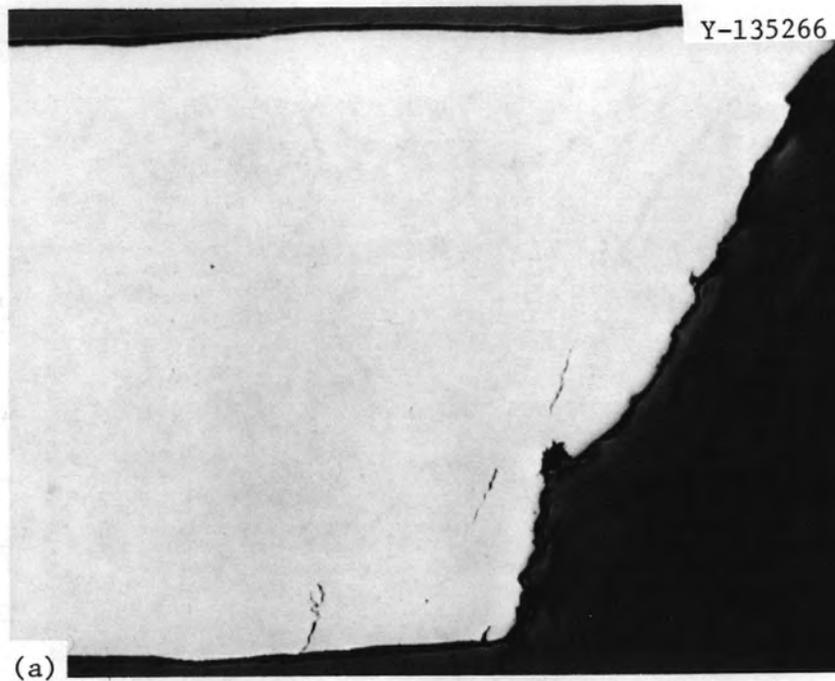
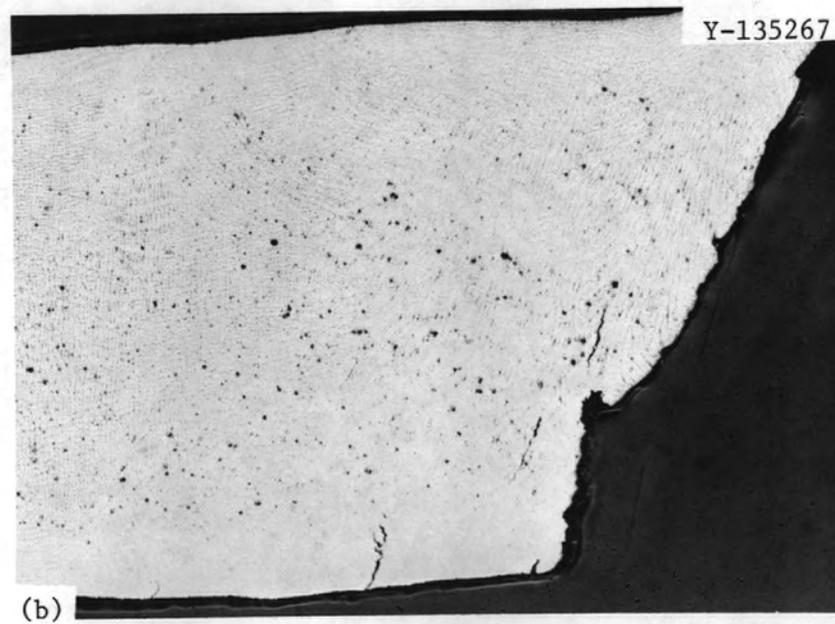
Fig. 11. Grain Boundary Cracks on Specimen Tested at 413 MPa at 510°C. (a) Unetched. (b) Etched with 5:1 HCl:HNO₃. 50×.

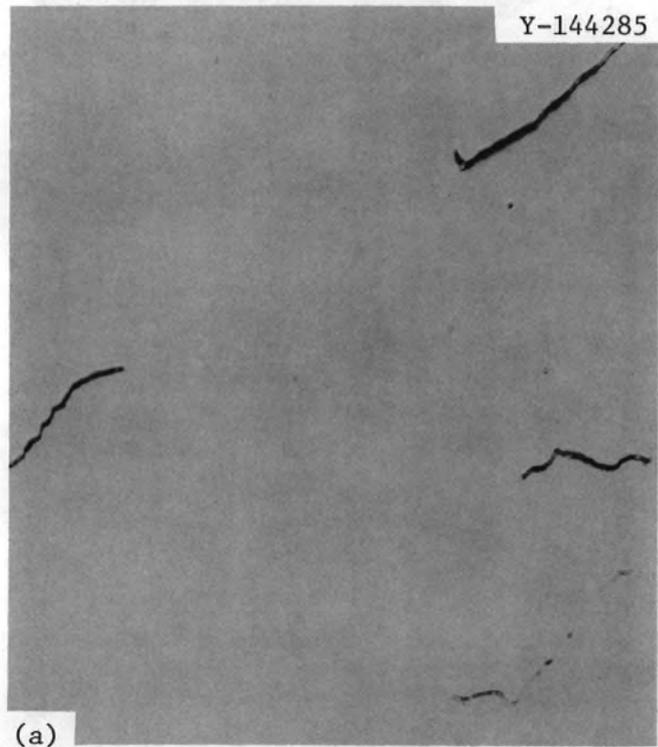
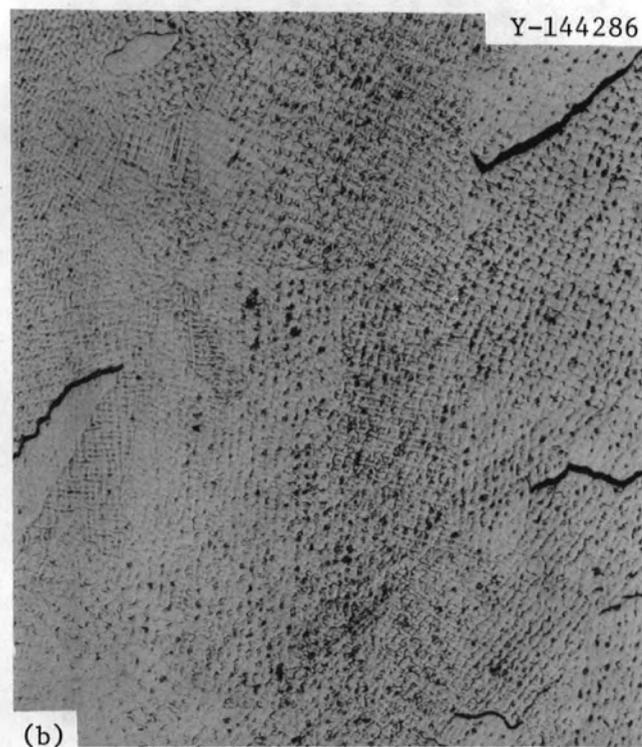
Fig. 12. Grain Boundary Cracks on Specimen Tested at 345 MPa at 566°C. (a) Unetched. (b) Etched with 5:1 HCl:HNO₃.

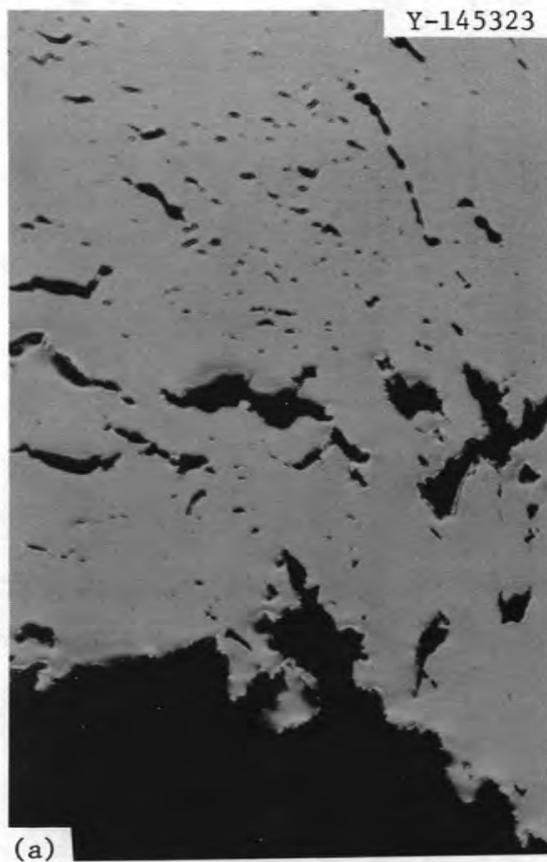
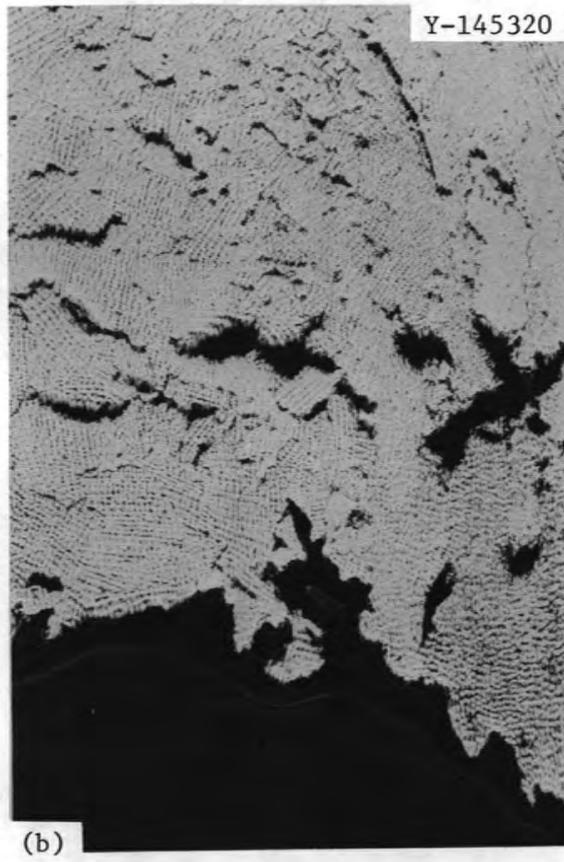
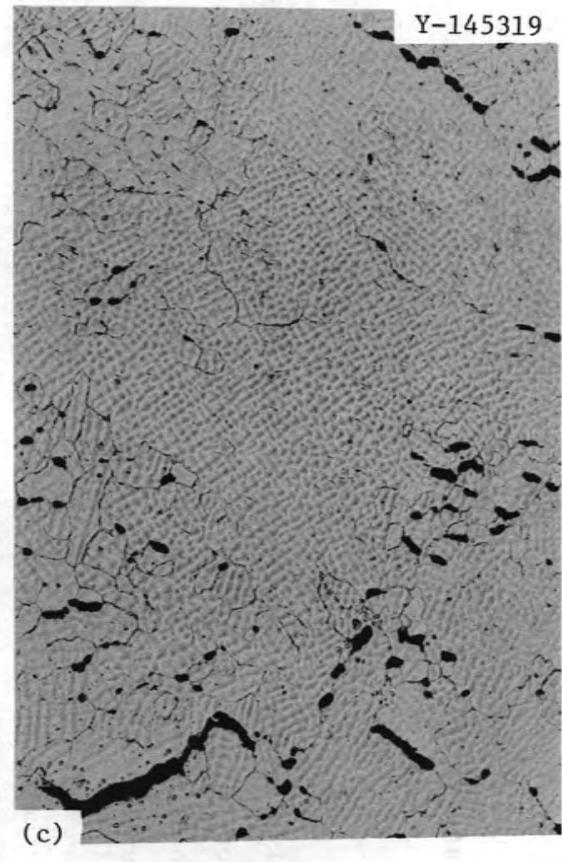
Fig. 13. Example of Grain Boundary Cracks and Cavities in a Specimen Tested at 83 MPa at 732°C. (a) and (b) are near fracture surface, 50×. (c) In gage section back from fracture surface, 100×. (b) and (c) were etched with 5:1 HCl:HNO₃.

lowered and the temperature raised; the failures became more intergranular and grain boundary cracking in the specimen gage length (back from the fracture surface) increased (Fig. 13).

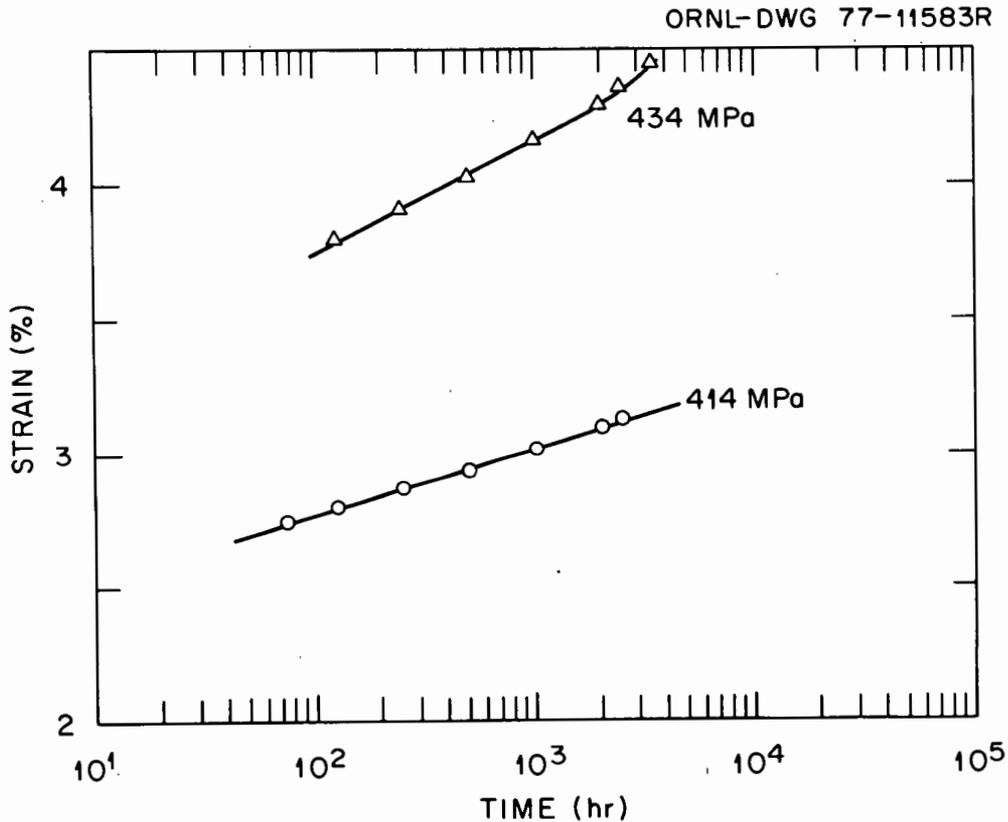
Fig. 14. Semi-Logarithmic Plot of Creep Data for ERNiCr-3 Weld Metal Tested at 413 and 434 MPa at 454°C.

To determine whether Eq. (3) applied, we plotted the strain against $\log t$ for the early portion of the low-stress tests at 454, 510, and 566°C (Figs. 14 and 15). The two low-stress tests (413 and 434 MPa) at 454°C indicated logarithmic creep (Fig. 14). The curve for the 413-MPa test appeared linear to 2500 hr, while the curve for the 434-MPa test was linear to about 2000 hr, then showed an upward curvature. Such upward curvature was obvious at 455 MPa at 454°C (Fig. 15). Plots of the low-stress tests at 510 and 566°C displayed downward curvature (Fig. 15).

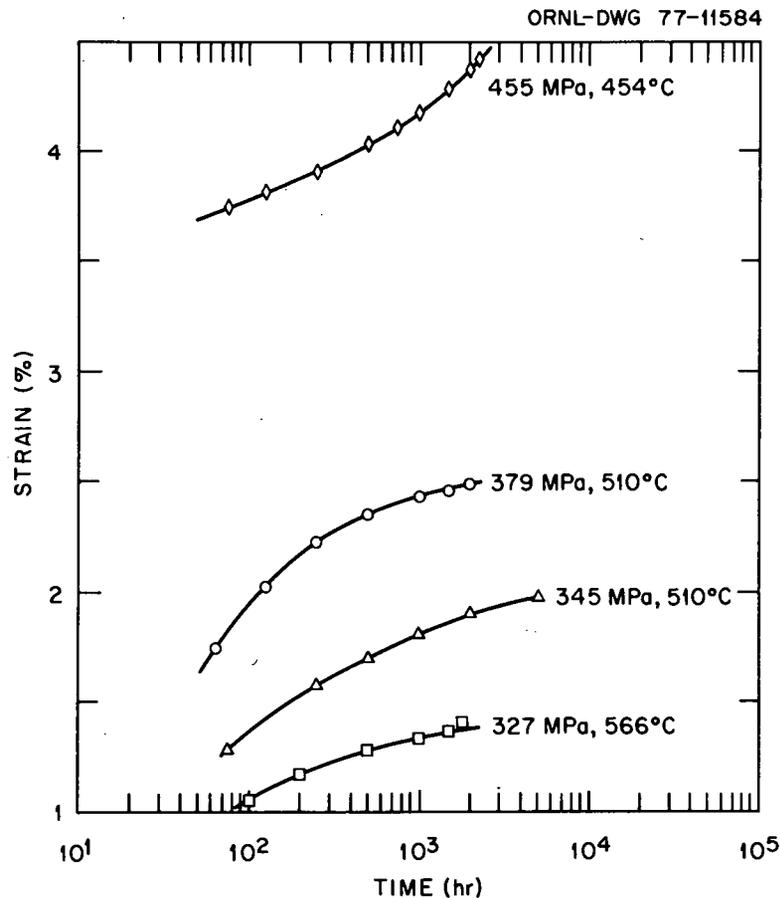
Fig. 15. Semi-Logarithmic Plot of Creep Data for ERNiCr-3 Weld Metal Tested at 455 MPa at 454°C, 345 and 379 MPa at 510°C, and 327 MPa at 566°C.

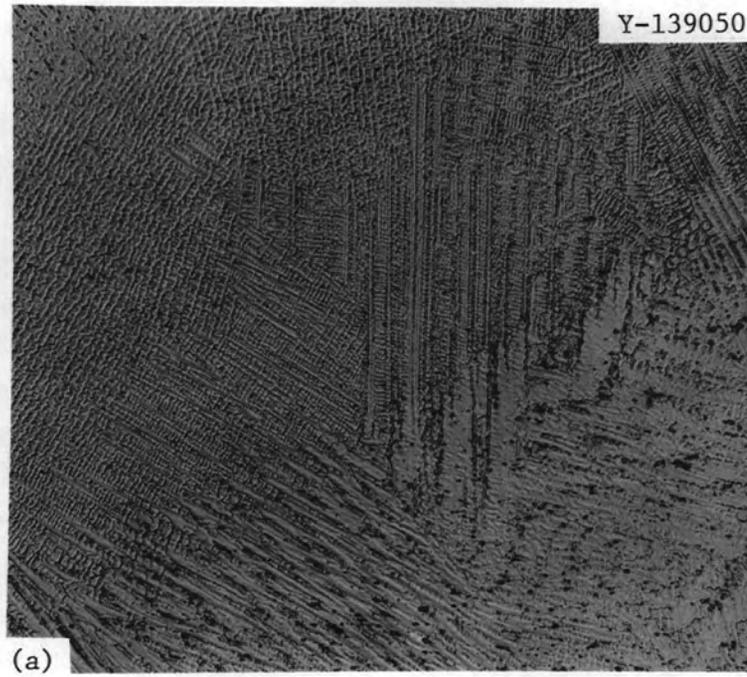
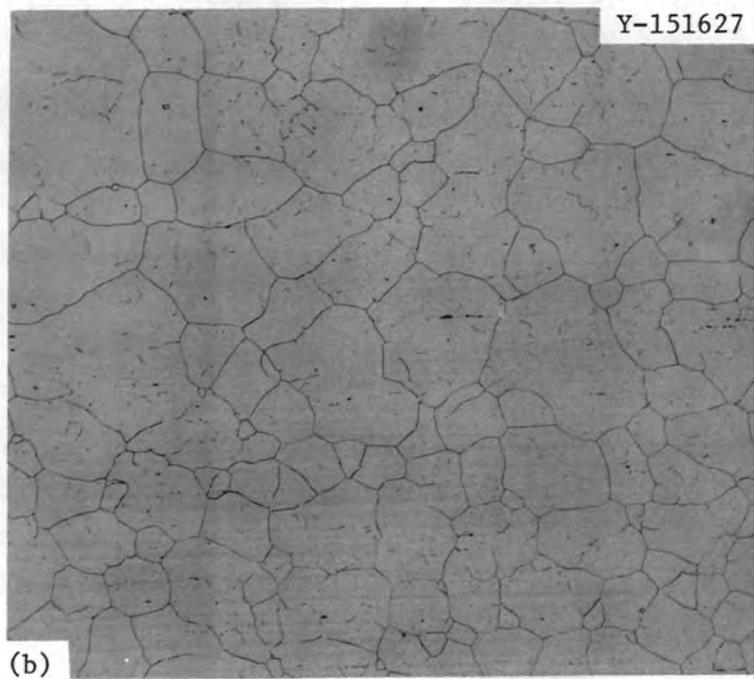
Fig. 16. The Microstructures of (a) Weld Metal (Cast) and (b) Wrought ERNiCr-3. 100 \times .

The microstructures of the cast and wrought ERNiCr-3 show significant differences (Fig. 16). The fine dendritic solidification structure with its accompanying chemical inhomogeneities within a given grain could well give rise to differences in mechanical property behavior. Although the proposed mechanism would still apply — that is, that dislocation pileups are triggered and give rise to dislocation avalanches and a Luders-type deformation — the pileups could result from the fine dendritic structure within the grains. We could also hypothesize that the cast structure in conjunction with short-range order formation gives rise to the much more extensive activity observed in ERNiCr-3 weld metal.

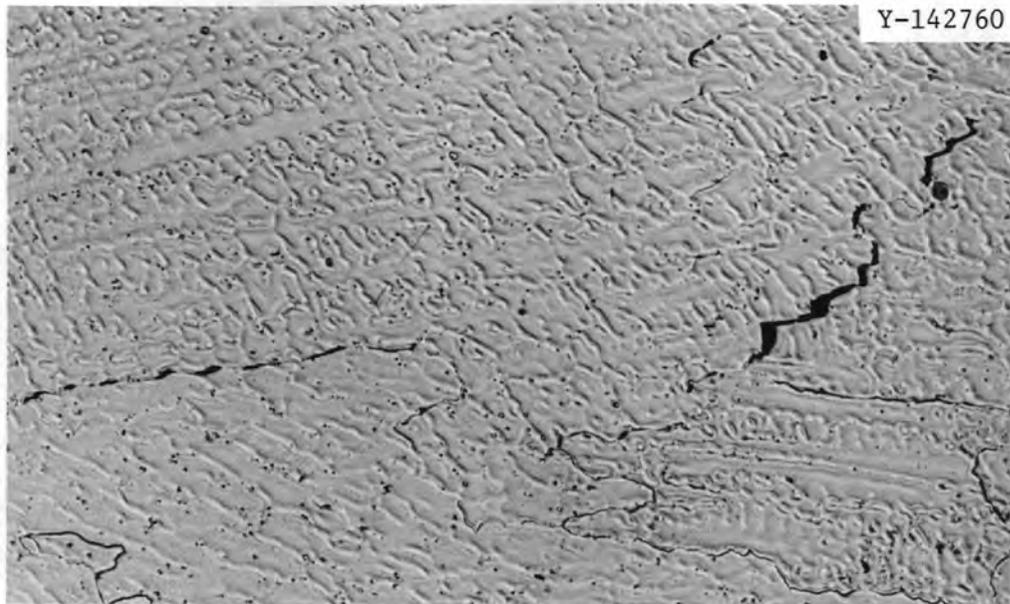
Fig. 17. Example of Scattered Cracks or Voids That Were Observed in As-Welded ERNiCr-3. Etched with 5:1 HCl:HNO₃. 200×.

The as-welded ERNiCr-3 was previously shown to contain very small defects scattered through the microstructure,² defects of a size that radiography could not detect. These defects were always found in grain boundaries and often appeared to be grain boundary cracks (Fig. 17). The tensile failures occurred transgranularly. However, we found no direct evidence to relate the cracks to the grain boundary defects observed on the as-welded material, although we suspected that they were connected.

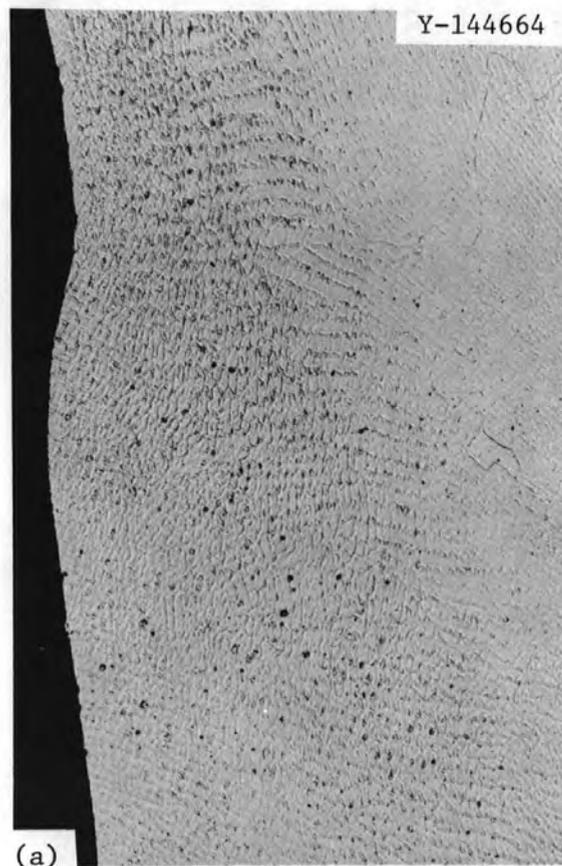
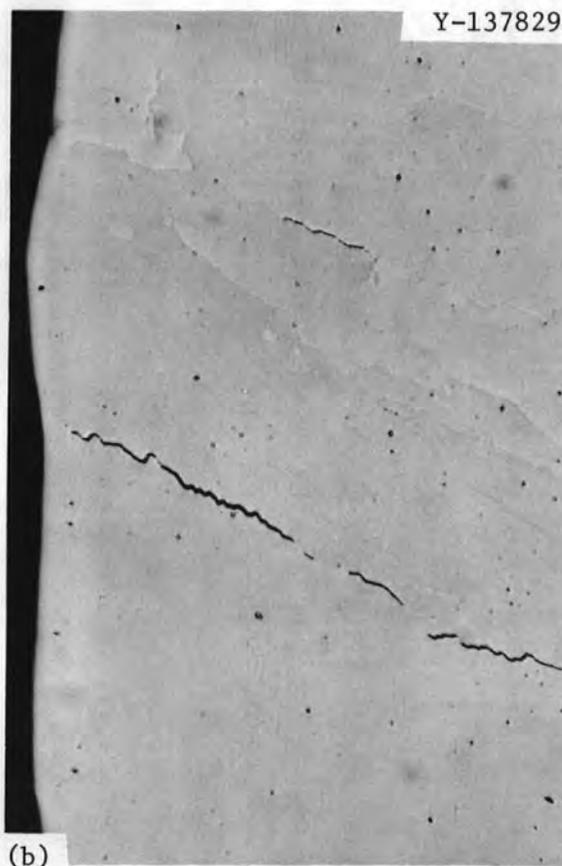
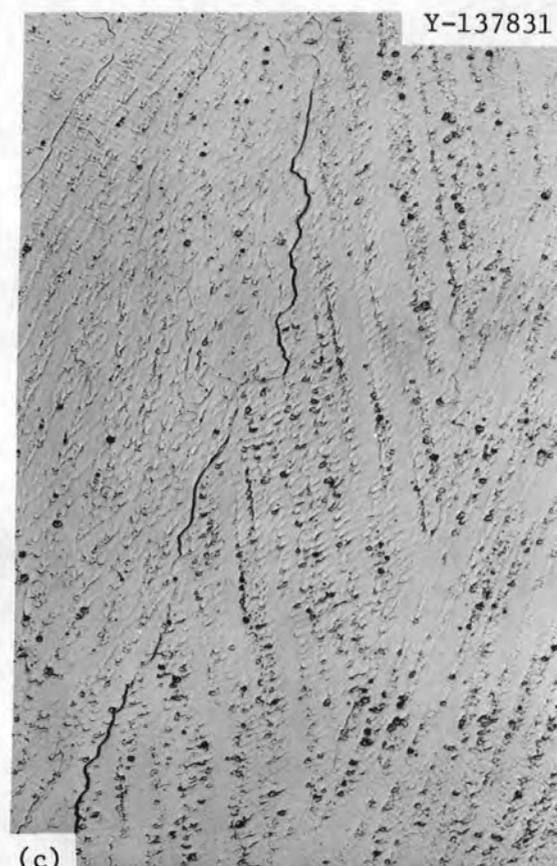
Fig. 18. Photomicrographs That Demonstrate the Cause of "Knobby" Deformation During Creep. (a) Adjacent to position where several grains meet. 100 \times . (b) Adjacent to grain boundary cracks. 50 \times . (c) Enlarged view of crack in (b). 100 \times . (a) and (c) were etched with 5:1 HCl:HNO₃.

The "knobby" deformation was previously related to the microstructure of the weld.² Similarly, in creep specimens metallographically examined (Fig. 18), knobs often appeared on the surface near the position where several grain boundaries met [Fig. 18(a)]. In other cases the knob resulted from grain boundary cracks in material adjacent to the external surface.
