ORNL/TM-7513

Stress Corrosion Studies in Solvent Refined Coal Liquefaction Pilot Plants

Date Published: December 1980

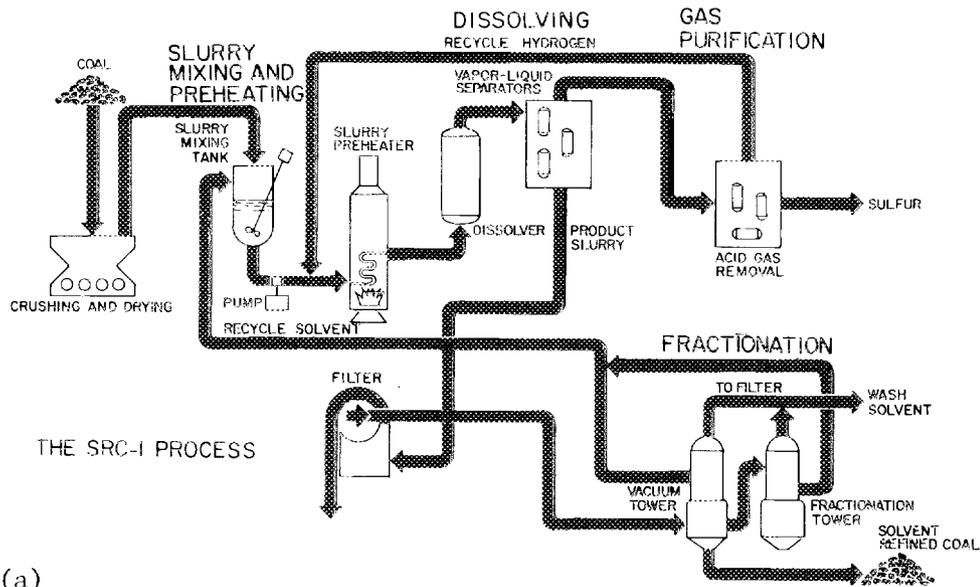
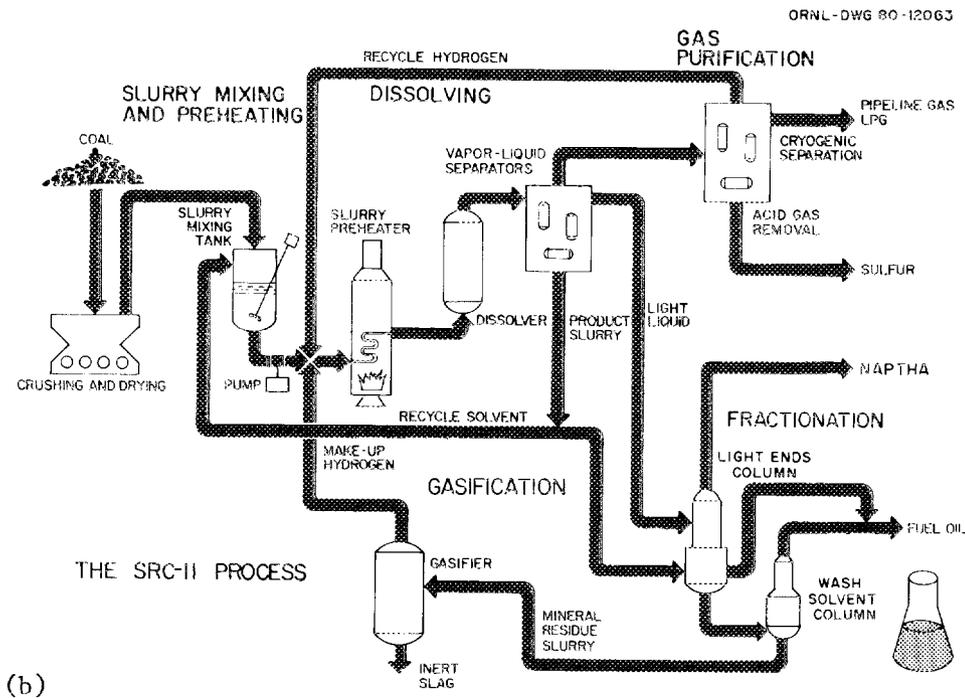
Fig. 1. Schematic Flow Diagrams of the Solvent Refined Coal (SRC) Processes. The significant differences between (a) SRC-I and (b) SRC-II are the filtration step and the melting point of the product. These differences are due to the increased hydrocracking possible in SRC-II, producing a more refined liquid product.

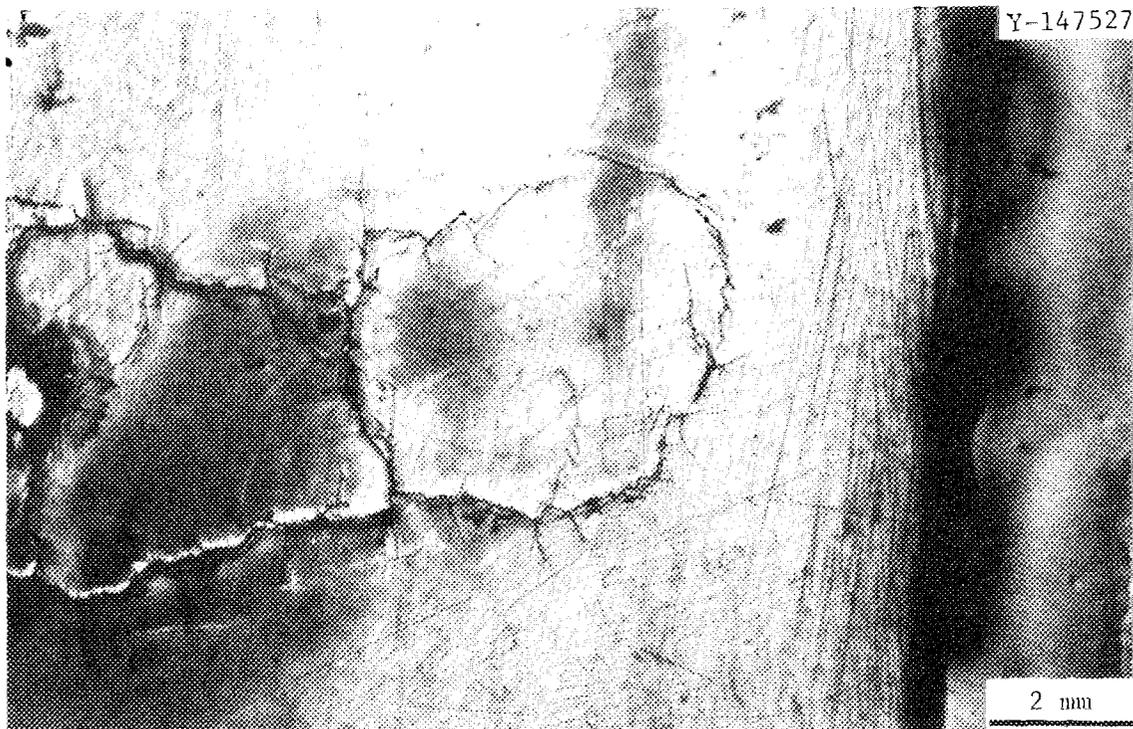
Fig. 2. Cracking Observed on Top Surface of Type 347 Stainless Steel Flange in the Wilsonville SRC Pilot Plant Dissolver. Residual stresses from machining combined with the corrosive environment to produce stress corrosion cracking.

Stress corrosion cracking has been observed at both the Wilsonville and Fort Lewis SRC pilot plants. Nondestructive examination of the Wilsonville dissolver was performed in July 1977, using dye-penetrant and metallographic replication techniques. The dissolver vessel is cast type 310 stainless steel (CK 40) to which a type 347 stainless steel flange is welded. The flange cover plate (or dissolver head) is also type 347 stainless steel. Two type 316 stainless steel nuts welded to the inner surface of the head are used for suspending racks of surveillance coupons inside the vessel. Cracking was found on the machined top surface of the type 347 flange (Fig. 2) and in the weld connecting the nuts to the inside surface of the dissolver head. Reexamination in March 1979 showed no increase in cracking, but pitting was observed for the first time.

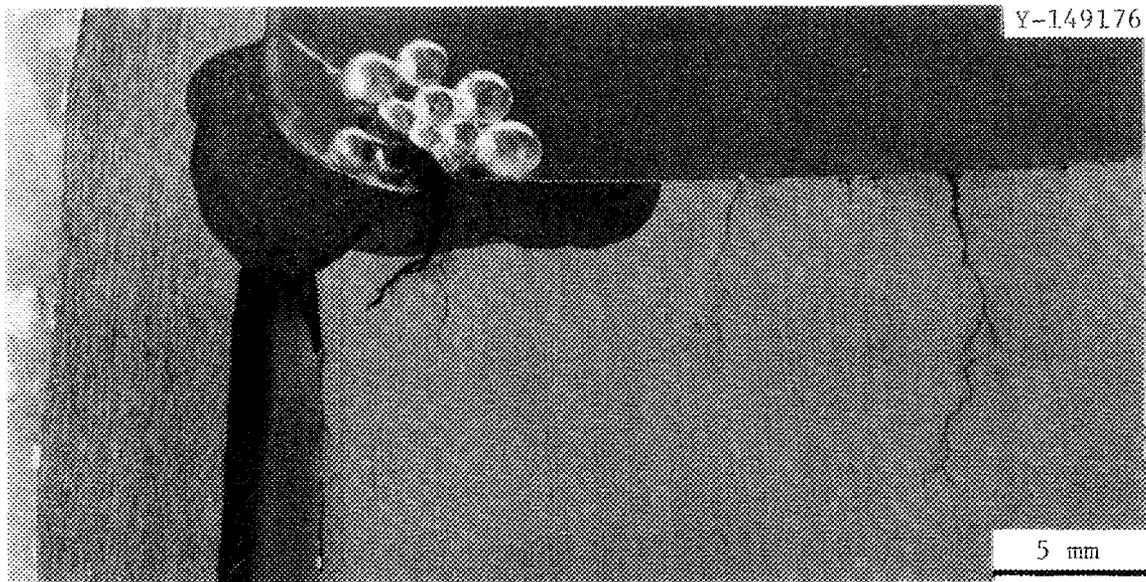
Fig. 3. Cross Section of Type 316 Stainless Steel Blind Flange and Thermowell Showing Cracks Through the Weld and in Areas Away from the Weld. Residual stresses resulted from the weld repair and subsequent grinding.

A type 316 stainless steel blind flange and thermowell assembly, also from the Wilsonville dissolver, was removed from service when

cracks were observed on the flange plate. Metallographic examination revealed that the cracks penetrated a repair weld into the base metal, and more cracks were found in areas that had been ground after repair. The cross section of the flange in Fig. 3 shows the extent of cracking. Etching revealed that the cracking followed substructural boundaries in the weld and was transgranular in the base metal.

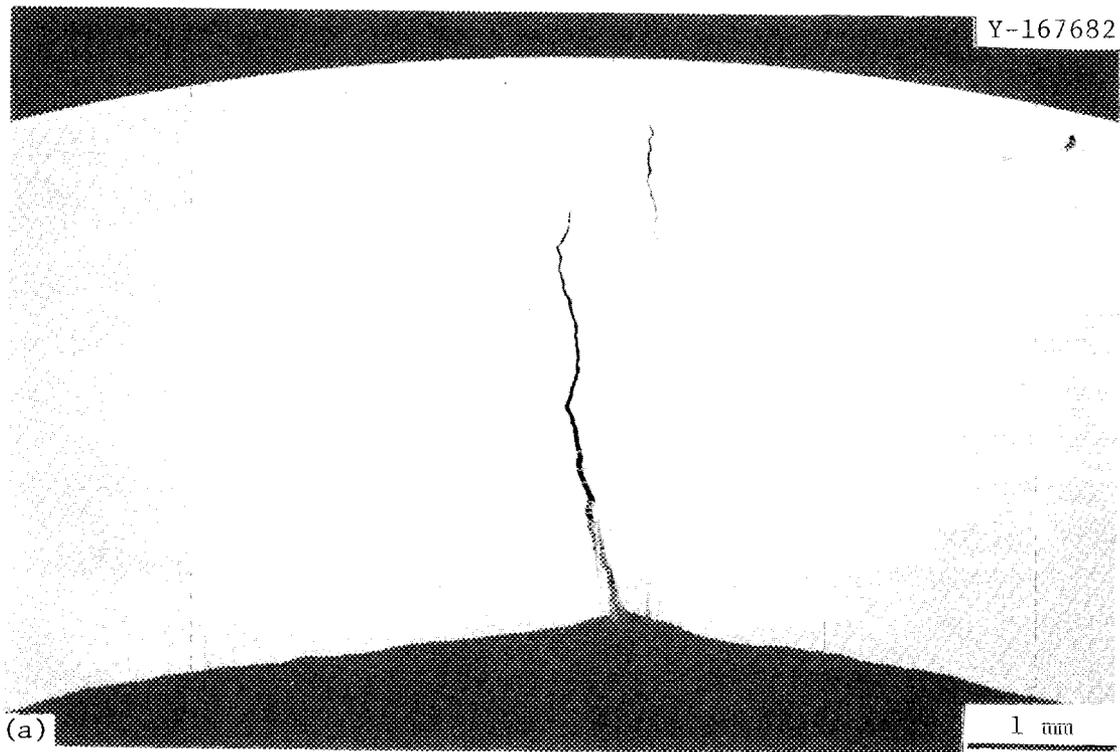
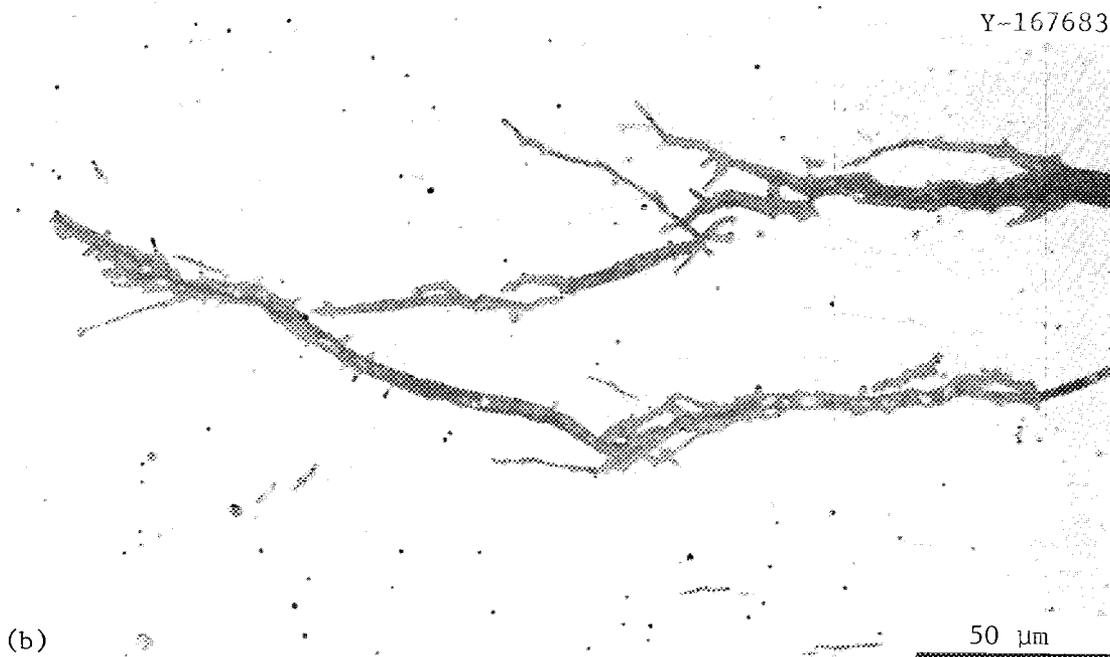
Fig. 4. One-inch Sched-80 Type 316 Stainless Steel Vent Line Off Piping Between Preheater and Dissolver at Wilsonville. (a) Cracks initiated at the inside diameter of the pipe and were observed on every sample cut. (b) Etching revealed the transgranular nature of the cracking.

Severe cracking occurred in a type 316 stainless steel vent line on the piping between the preheater and dissolver at Wilsonville. The 1-in. sched-80 pipe was extensively cracked, with the transgranular cracks initiating from the inner surface (Fig. 4). Microprobe analysis showed some evidence of chlorides in the corrosion scale. Further details of these incidents are reported elsewhere.⁴⁻⁶

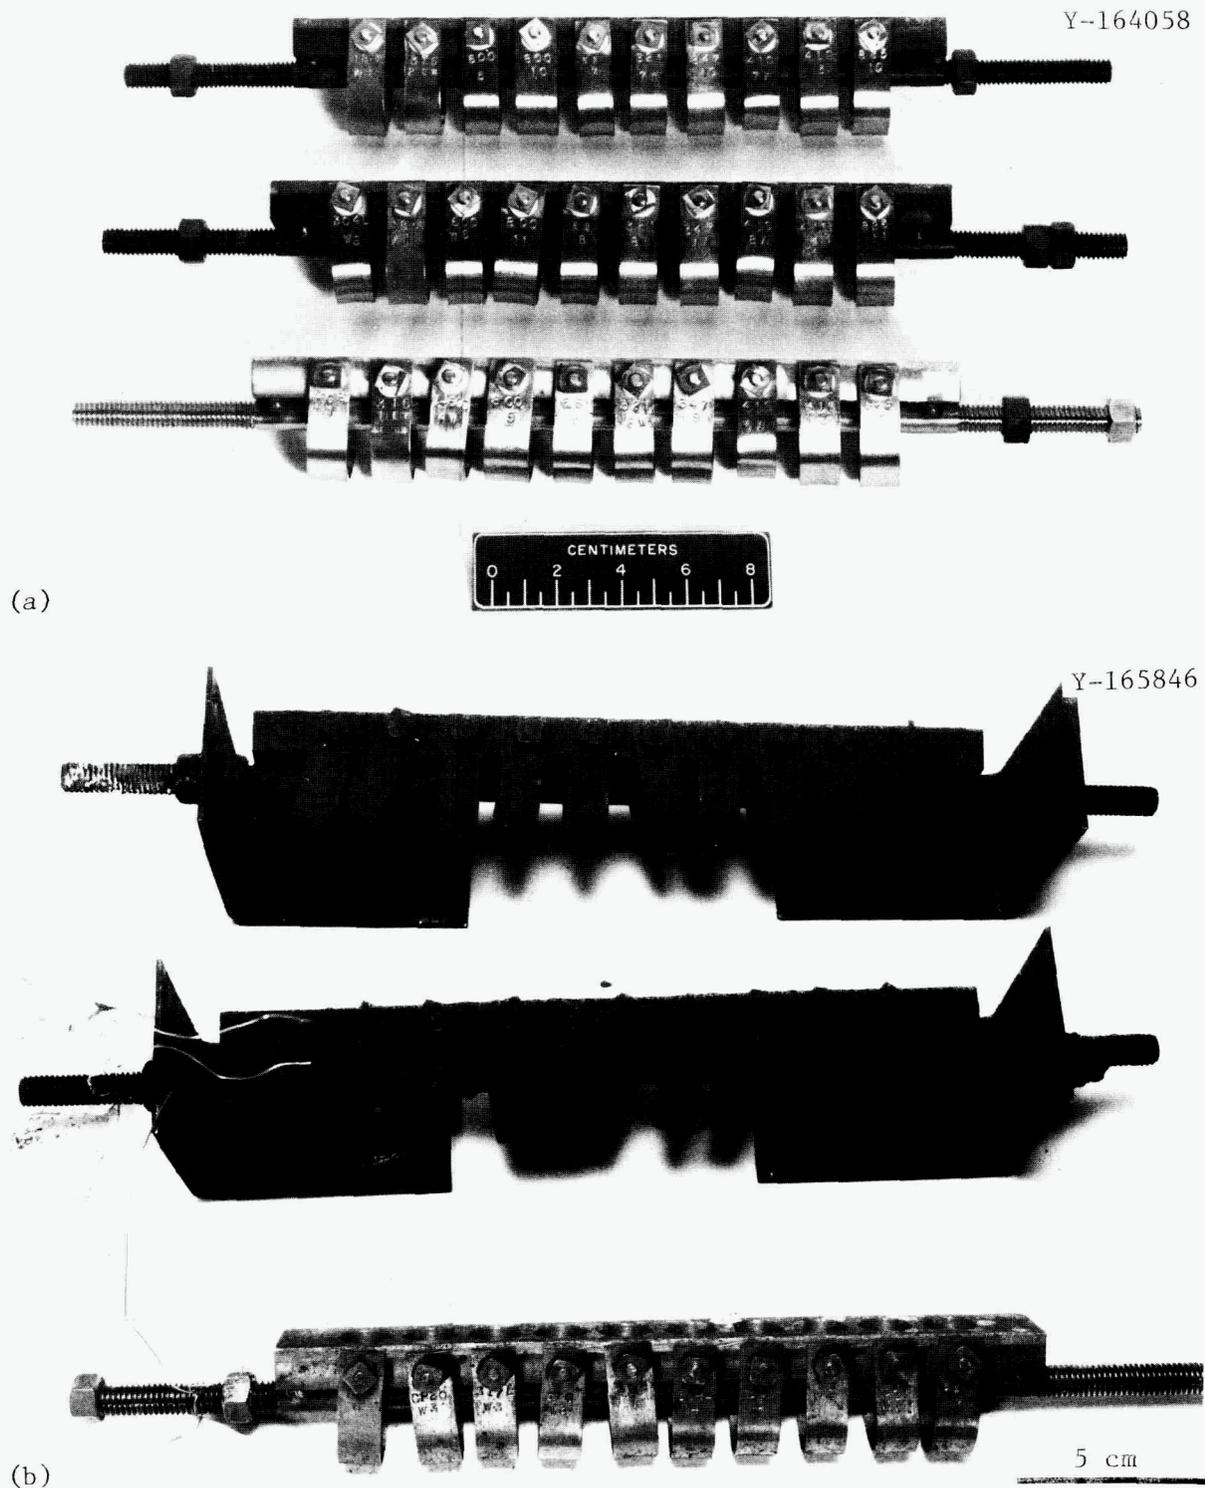
Fig. 5. Racks of Specimens Used for Mounting on Vessel Walls. The racks are mounted on brackets or screwed into nuts so that they are horizontal in the vessel. (a) Racks prior to exposure. (b) Similar specimens after exposure in the Fort Lewis separator vessels.

The specimens were weighed, bent into U-shapes, and attached to racks by nuts screwed onto bolts threaded on both ends. The racks were welded onto rods which are threaded for mounting in plant vessels. The configuration and dimensions varied from vessel to vessel, but some typical arrangements are shown in Figs. 5 and 6. Holes were machined in the rack to reduce the weight. Most of the racks were constructed of type 304L stainless steel; however, titanium and Hastelloy C-276 were used for

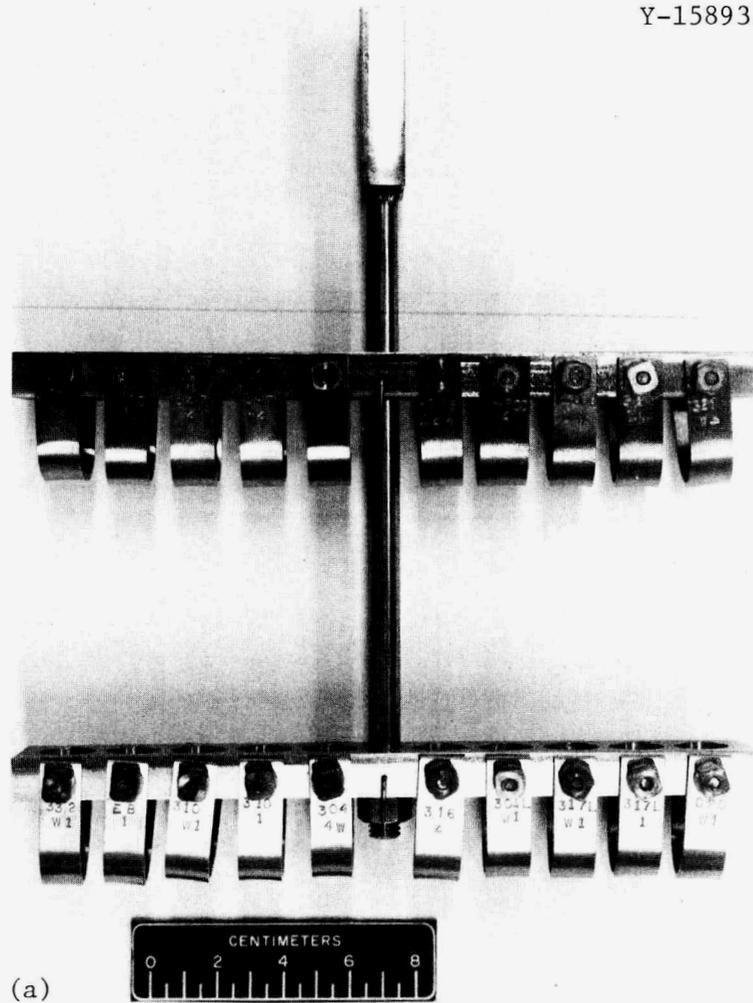
Fig. 6. Rack Configuration Used for Suspending Specimens from Vessel Head. (a) Rack before insertion into the dissolver at the Fort Lewis SRC pilot plant. (b) Rack after exposure for 2800 h at operating temperature. Note the specimen missing from the left side of the top rack.

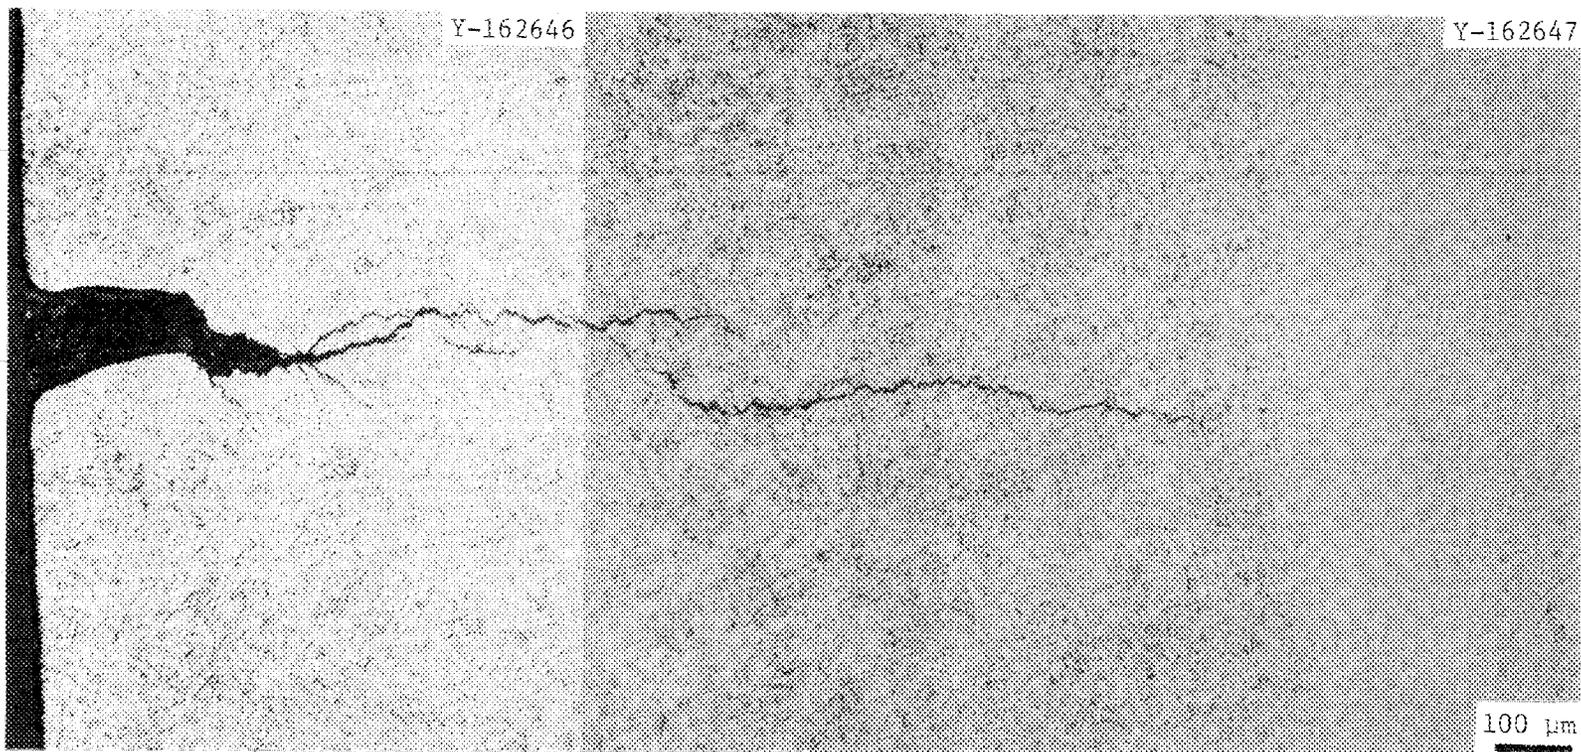
Fig. 7. Crack in Type 410 Stainless Steel U-Bend Specimen Exposed for 736 Operating Hours in the High Pressure Separator at Fort Lewis. The crack initiated at the surface and penetrated through the base metal and heat-affected zone before stopping at the weld.

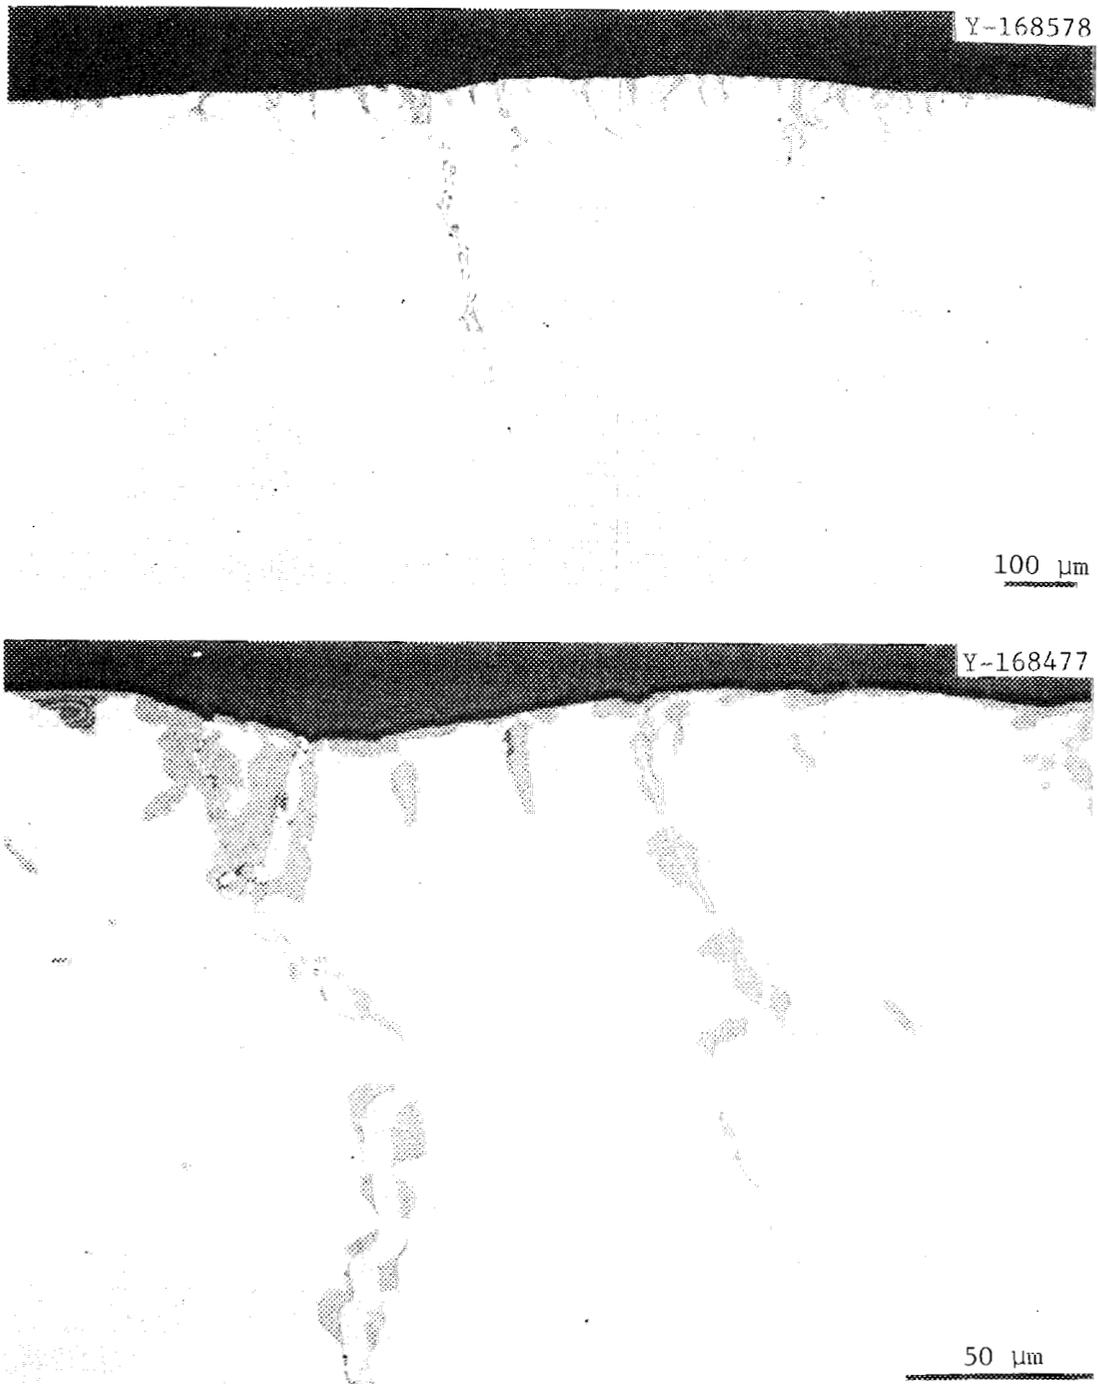
Fig. 8. Hastelloy C-276 U-bend Specimen After Exposure in the Fort Lewis SRC Pilot Plant High Pressure Separator (2800 h).

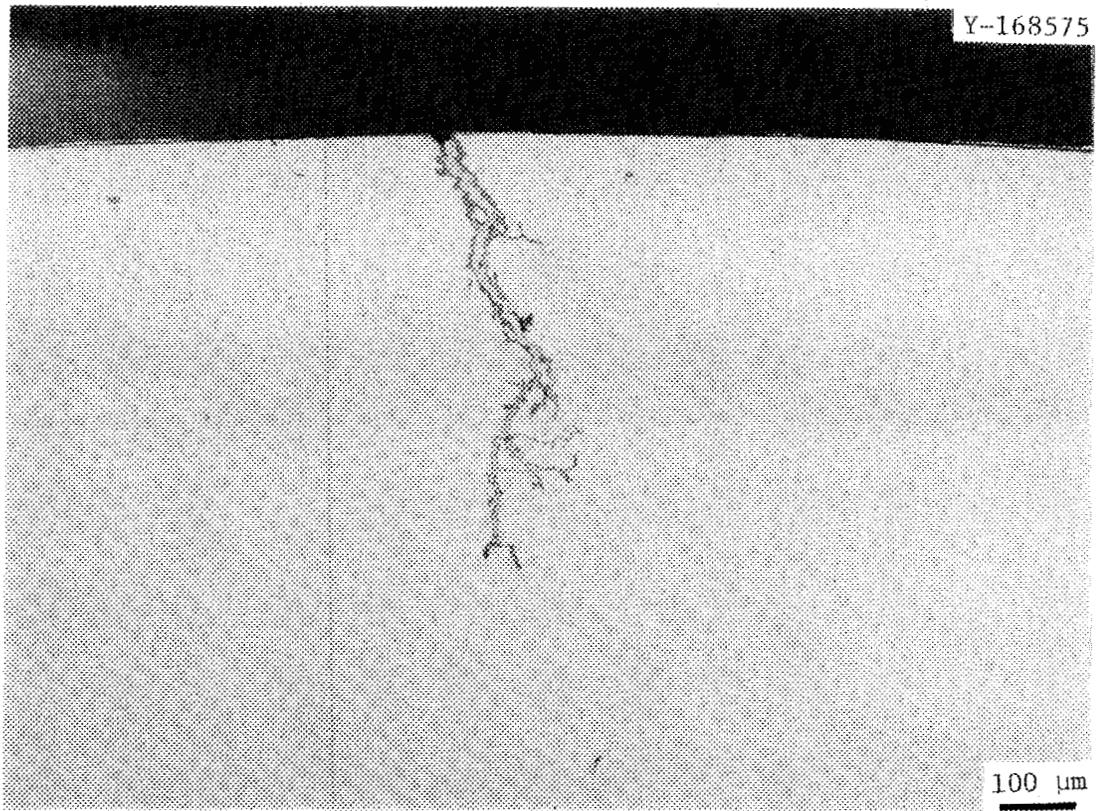
Fig. 9. Inconel 625 U-Bend Specimen Cracked After Exposure in the High Pressure Separator at Fort Lewis (2800 h at Temperature).

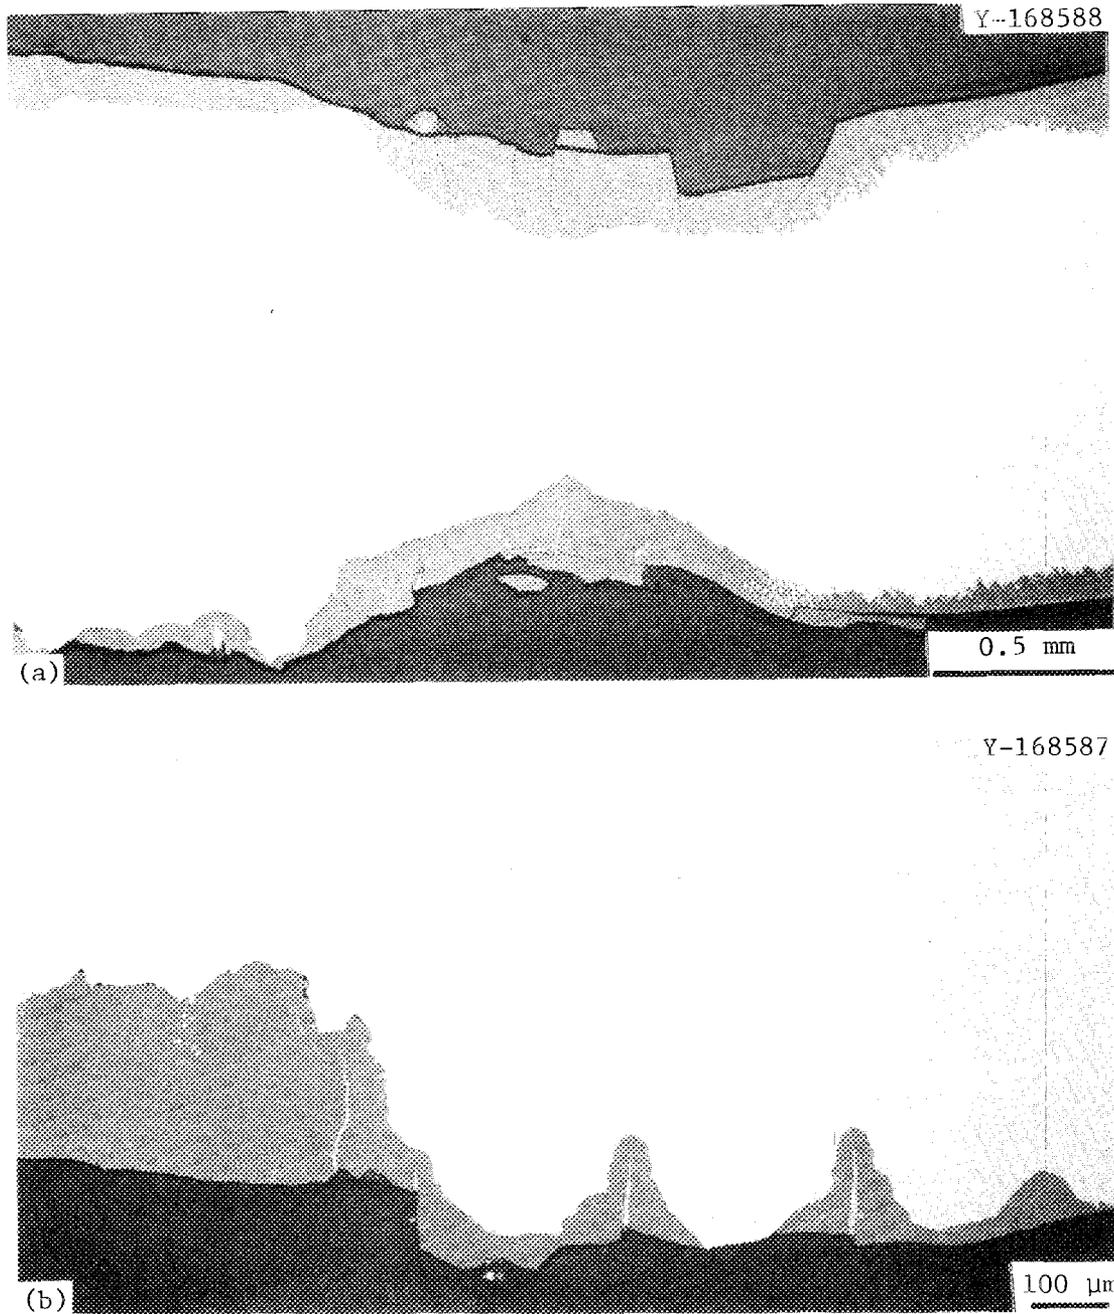
Fig. 10. Alloy 800H Specimen Was Extensively Attacked, Particularly Near Weld. This U-bend had been exposed in the Fort Lewis dissolver for 2600 h at operating temperature. (a) Cracking and sulfidation led to thinning of weld. (b) Sulfidation attack occurred from the cracks to more fully penetrate the alloy.

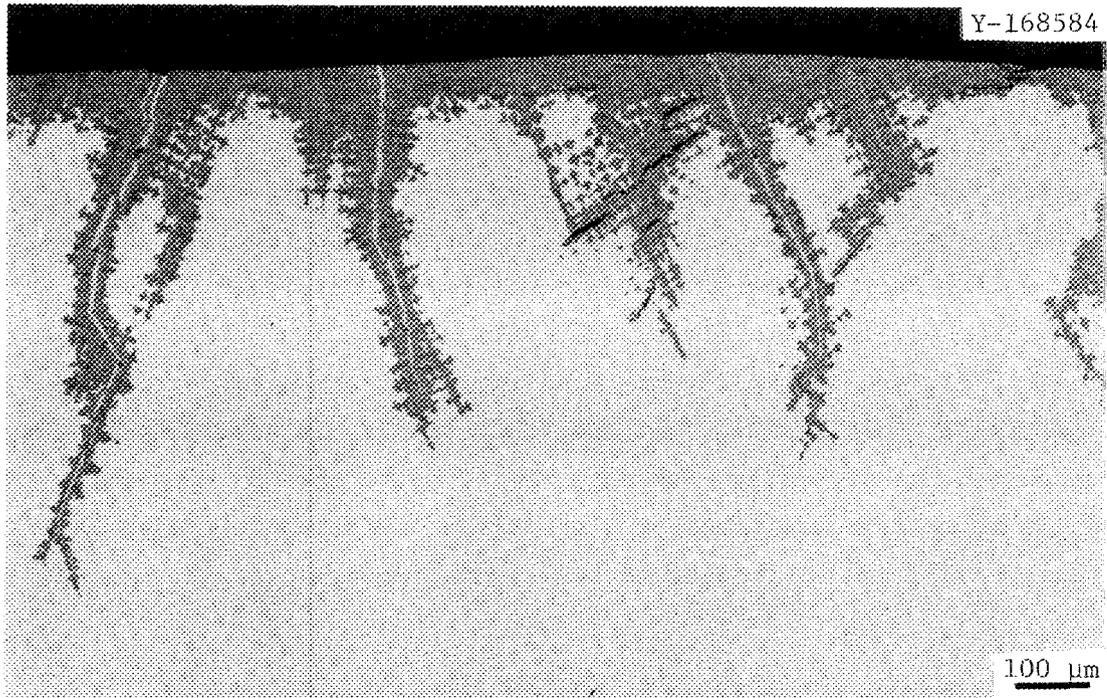
Fig. 11. Sulfidation Attack and Cracking of Inconel 625. This U-bend specimen was exposed in the Fort Lewis dissolver for 2600 h at operating temperature. Note the dendritic nature of the penetrations, indicating that the attack is in the weld.

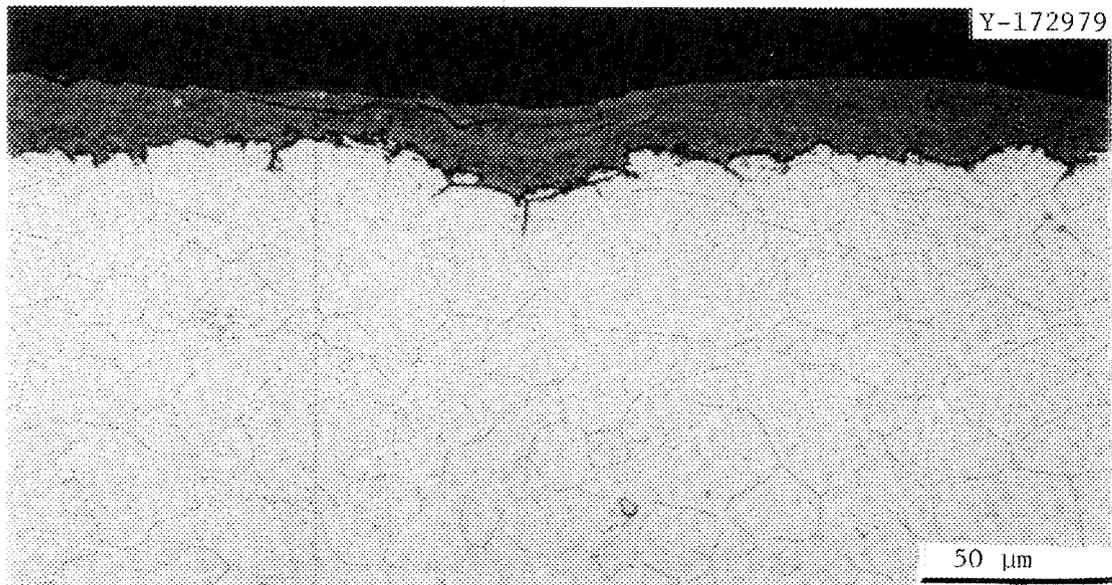
Fig. 12. Intergranular Penetrations Were Observed in Austenitic Stainless Steels After 2707 h of Exposure in the Fort Lewis High Pressure Separator. Section is from a type 347 stainless steel U-bend.

The third round of testing in the Fort Lewis separator vessels yielded similar results to the previous exposures. The amount of attack (both general corrosion and cracking) was greater in the high pressure separator than in the other two vessels; however, except for the high-nickel alloys, the corrosion rate was still within acceptable ranges. The 26 Cr-1 Mo displayed the best resistance to corrosion and cracking. Most of the type 410 specimens exhibited transgranular cracking and/or heavy pitting. The high-nickel alloys were again sulfidized, but the attack was not as severe as was noted previously for the specimens from the dissolver vessel. Three austenitic stainless steel specimens in the high pressure separator showed small intergranular penetrations after 2707 h: types 304L, 321, and 347 (Fig. 12).

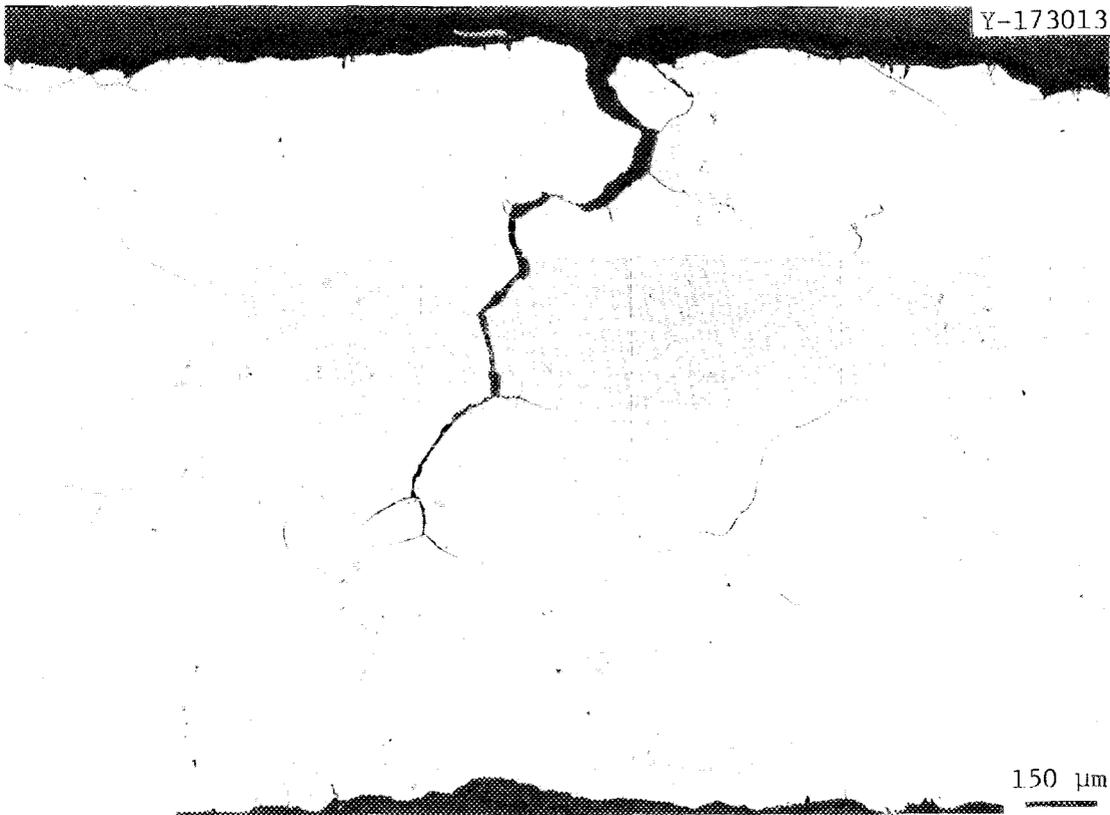
Fig. 13. Intergranular Cracking Occurred on Alloy 800H U-Bend Specimen Exposed for 5341 h in the Middle of the Fractionation Column at Wilsonville.

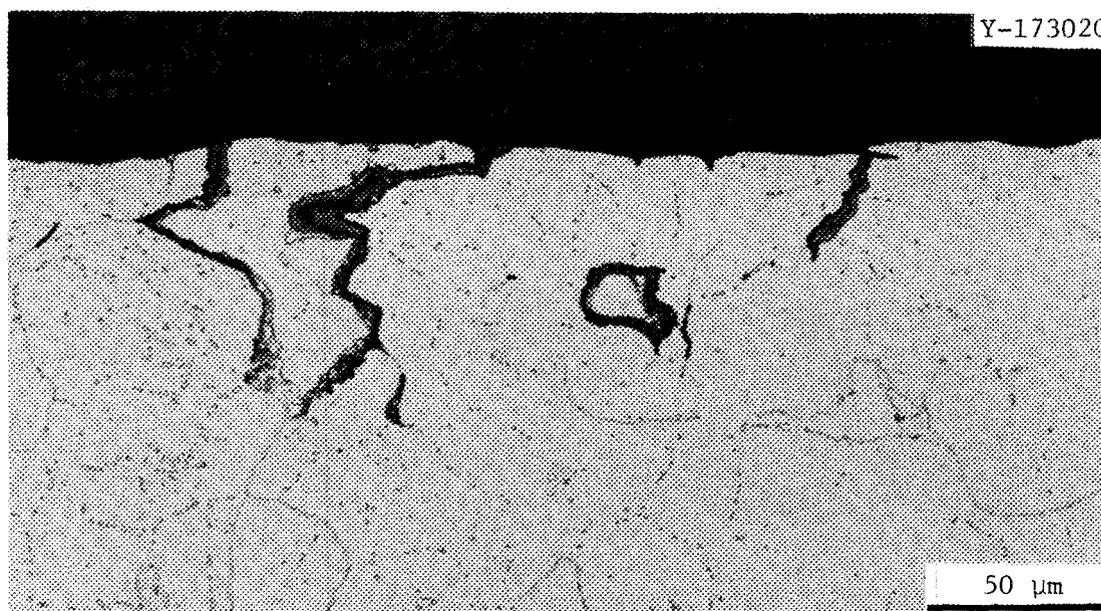
Fig. 14. Inconel 600 U-Bend Specimen Was Intergranularly Attacked After 5341 h Exposure in Wilsonville Fractionation Column Near the Middle Manway.

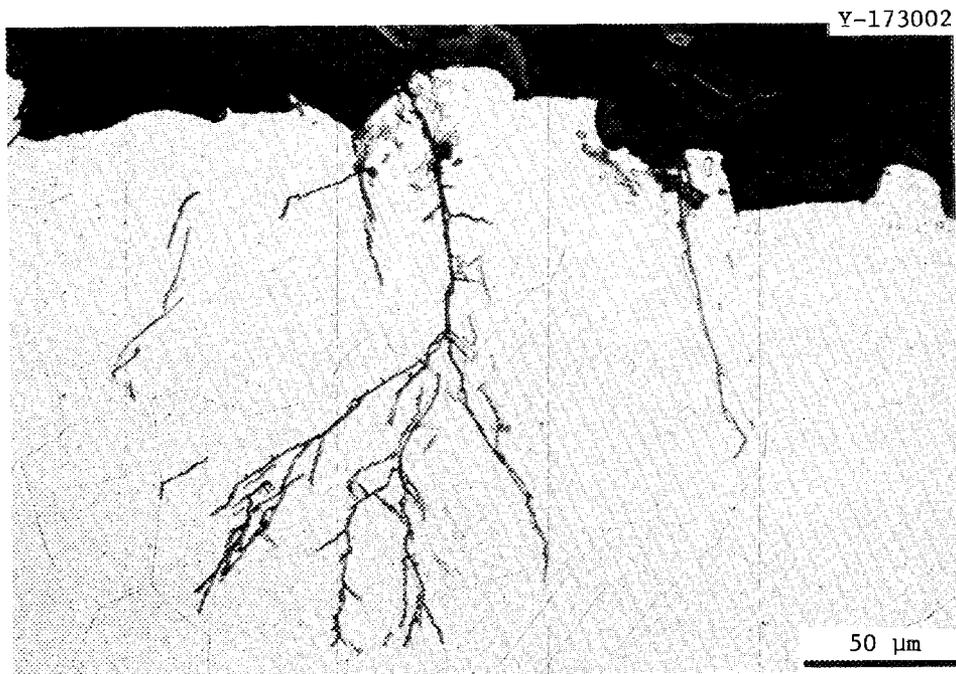
Fig. 15. Transgranular Cracking on Type 304L Stainless Steel U-Bend Exposed for 5341 h in the Middle of the Wilsonville Fractionation Column.

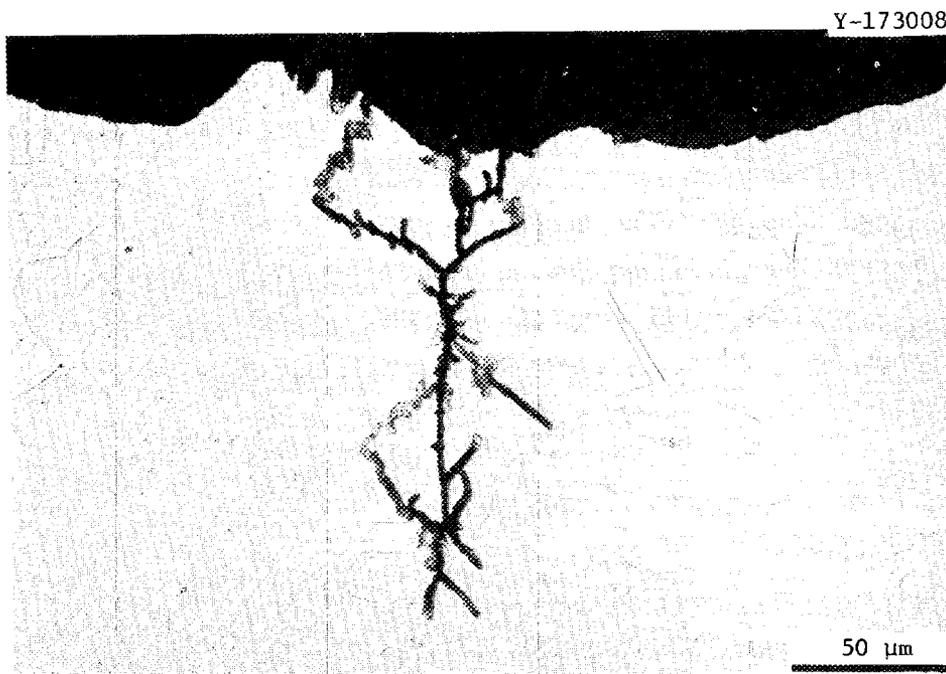
Fig. 16. Type 310S Stainless Steel U-Bend Specimen Displayed Transgranular Cracks After 5341 h Exposure in the Middle of the Fractionation Column at the Wilsonville SRC Pilot Plant.

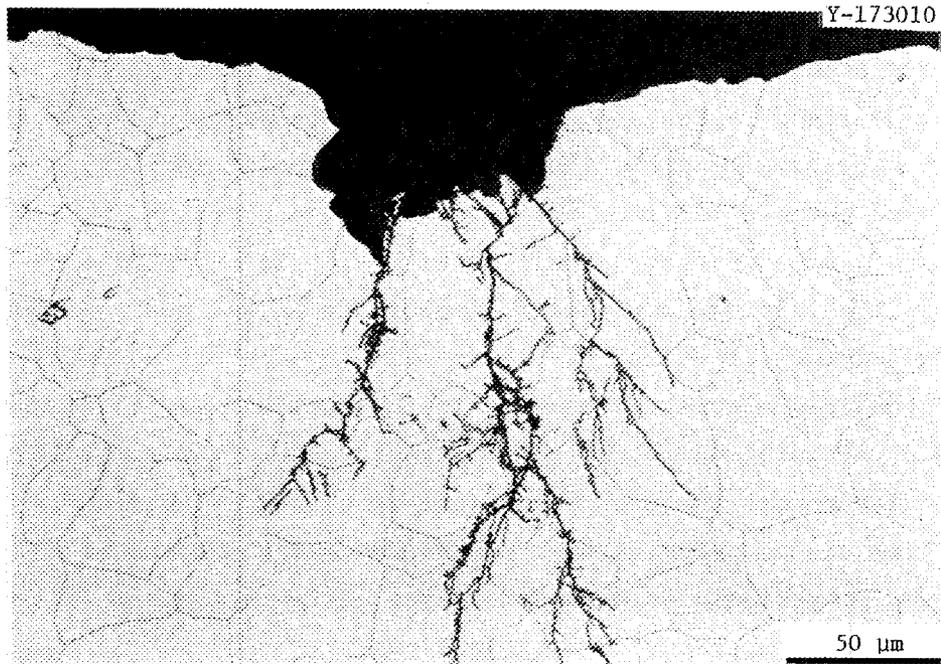
Fig. 17. Transgranular Cracking of Type 321 Stainless Steel U-Bend Specimen Exposed for 5341 h in the Middle of the Wilsonville Fractionation Column.

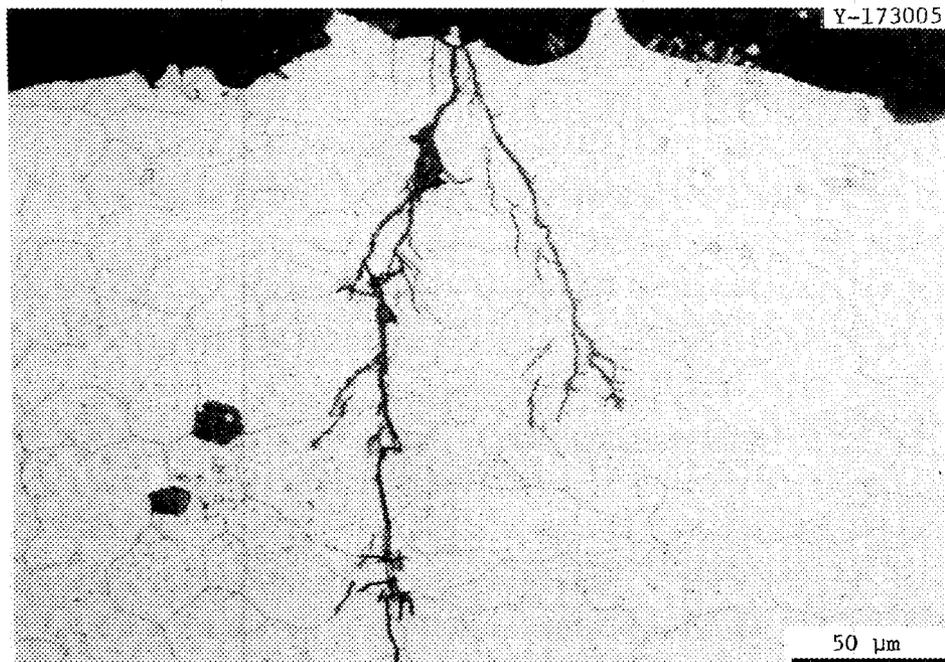
Fig. 18. Type 347 Stainless Steel U-Bend Specimen Exposed in the Middle of the Wilsonville Fractionation Column for 5341 h Showed Transgranular Stress Corrosion Cracking.
