ORNL/TM-9108

## **Weldability and Mechanical Property Characterization of Weld Clad Alloy 800H Tubesheet Forging**

Date Published: September 1984

Prepared for  
Office of Converter Reactor Deployment  
Division of High-Temperature Reactor Development

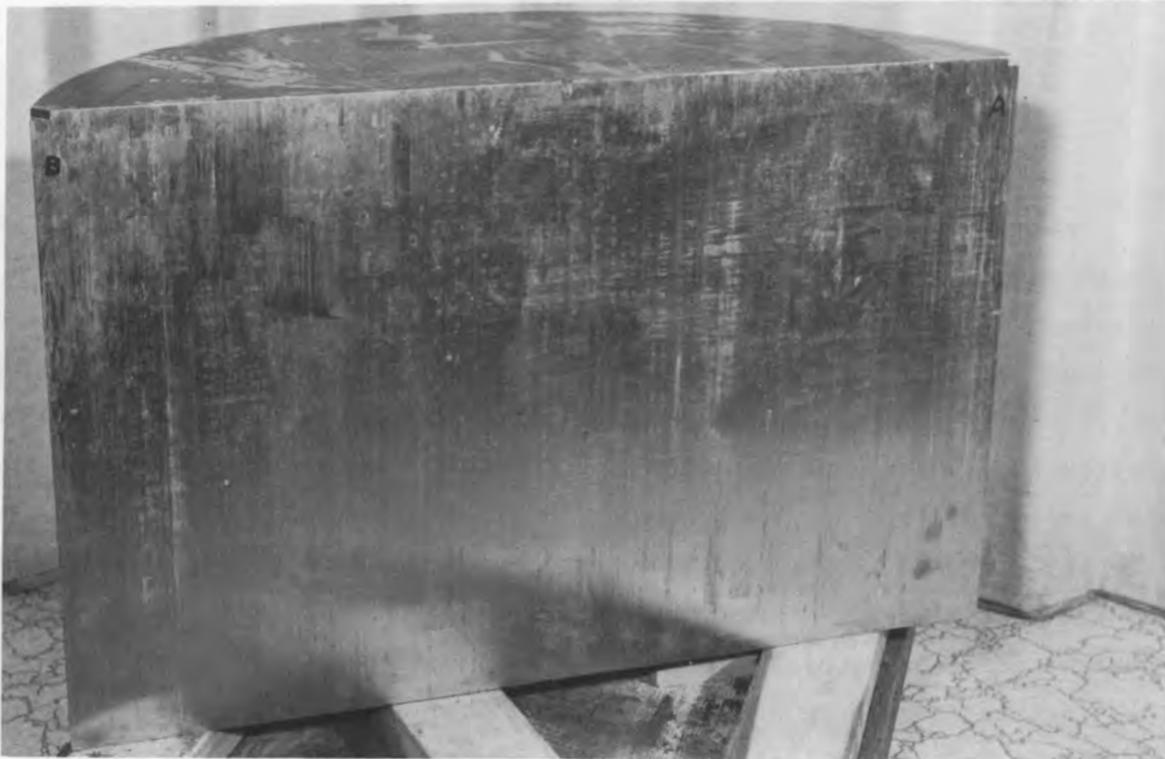
Y-183570

Fig. 1. Section of alloy 800H forging received at ORNL for weld cladding study. This section is about 460 mm thick by 740 mm wide.

A vertical section of an alloy 800H forging was obtained from GA Technologies for weld cladding study at ORNL. This section, Fig. 1, was from a 2500-kg forging, about 760 mm in diameter by 500 mm thick, produced at Cameron Iron Works, Houston, Texas. This forging, heat 54788, was produced on an experimental basis to evaluate large forgings of this alloy. After forging, the piece was solution annealed at 1120°C for 10 h and water quenched. The major evaluation of the forging properties has been conducted at GA Technologies.<sup>1</sup> That evaluation found that the macrostructure of the forging varied greatly, as shown in Fig. 2. The large grains exceeded ASTM 00 in size. The large grain microstructure and the variation of structure throughout the forging prompted the concerns with weldability because weld cladding will be required.

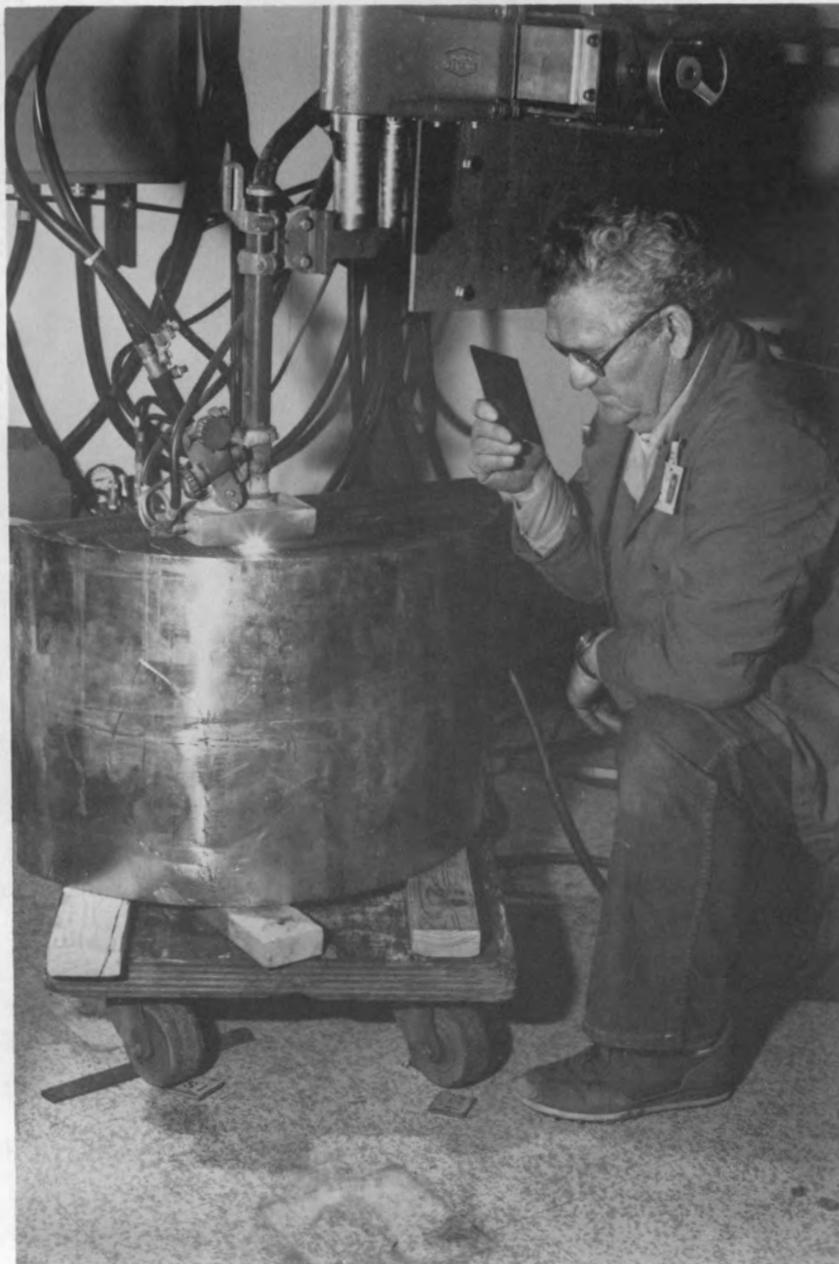
CYN-4911

Fig. 4. The hot-wire gas tungsten arc welding process being used to clad the alloy 800H forging section.

Weld cladding was accomplished by the hot-wire gas tungsten arc process shown in Fig. 4. The clad deposit was AWS specification ERNiCr-3. This filler metal has a nominal composition of 67% Ni-20% Cr-3% Mn-3% Fe-2.5% Nb. A surface view of the completed first layer is shown in Fig. 5. Seven layers were deposited to complete the clad to a depth of 19 mm. Welding parameters for this cladding are listed in Table 1. After welding, the top of the forging with the weld clad was removed by sawing. An additional area on the bottom, identified in Fig. 2 as having large grains and as-cast structure, was weld clad later by the same technique and welding procedure. The top layer and this localized bottom section were used for the subsequent studies.

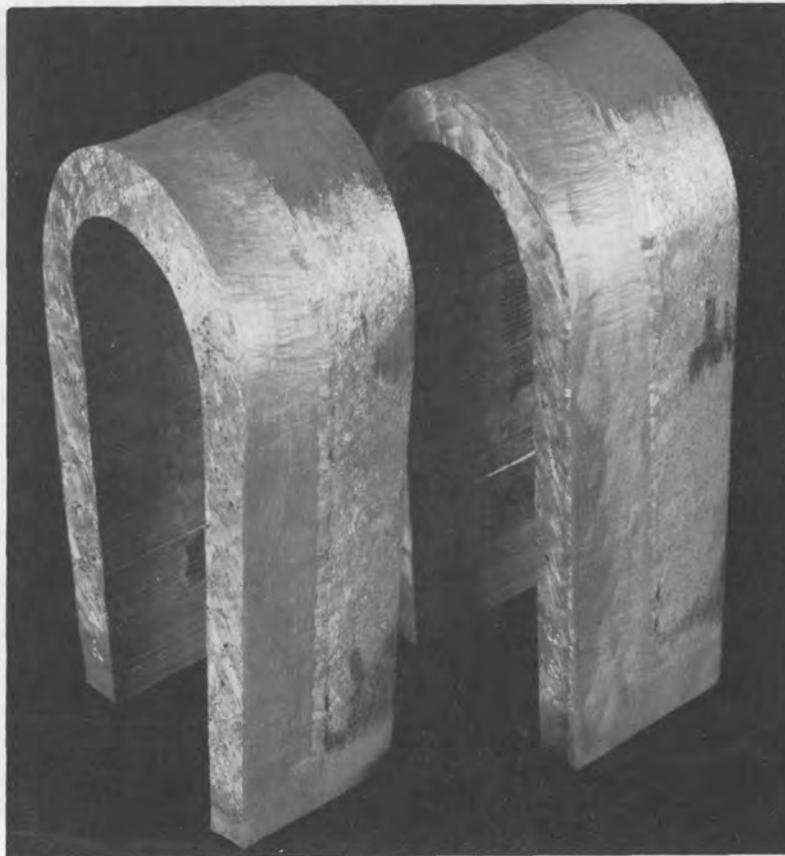
Y-184599

Fig. 6. Side-bend test specimens containing weld metal cladding and forging base material revealed no gross defects and good ductility at the fusion line.

The clad forging was examined to determine if weldability problems existed and to determine the tensile and creep properties of the weld clad. From visual examination and observations made during the weld cladding, no weldability problems were apparent. Side-bend test specimens were prepared and tested as shown in Fig. 6. These specimens contained one-half forging base material and one-half weld cladding. After bending, the specimens contained no gross defects, and the fusion line had good ductility.

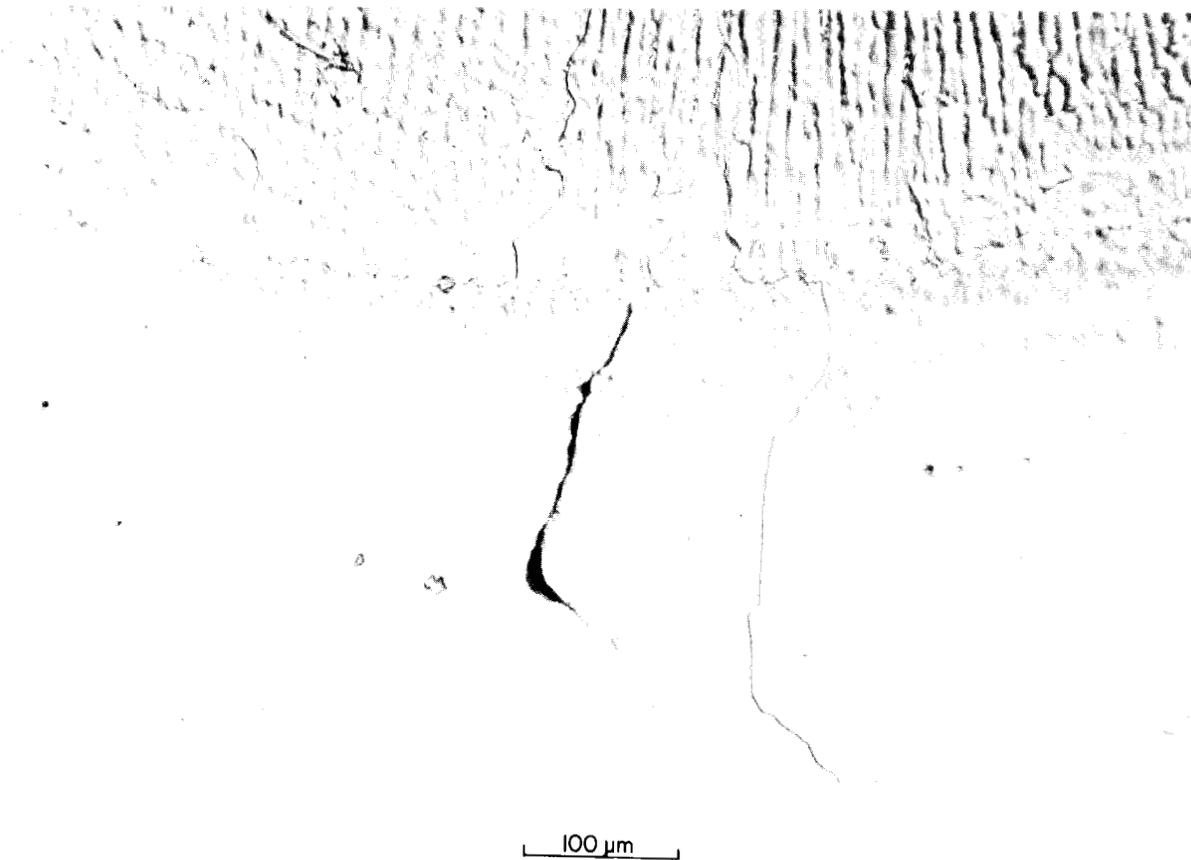
Y-185806

Fig. 10. Heat-affected zone hot crack found in the large-grained region near center of forging bottom.

Microprobe examination of this as-cast zone revealed a high concentration of titanium. Heat-affected zone (HAZ) hot cracking in alloy 800 weldments has been associated with localized titanium enrichment.<sup>2</sup> A few fissures were found at or near the fusion line in the HAZ of the weld-clad bottom section, but these were not conclusively determined to be caused by the as-cast structure. Figures 10 and 11 show two of the areas containing hot cracks. These cracks could cause problems in a clad tubesheet.

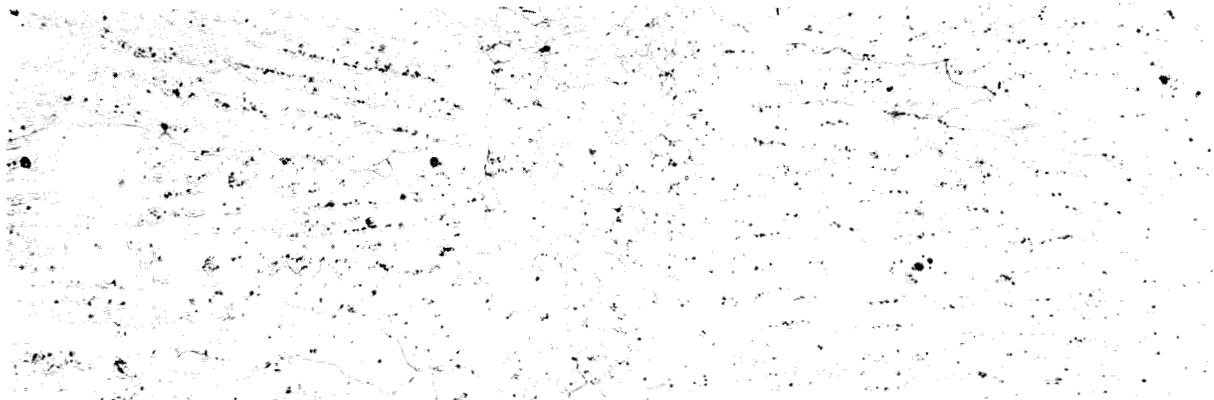
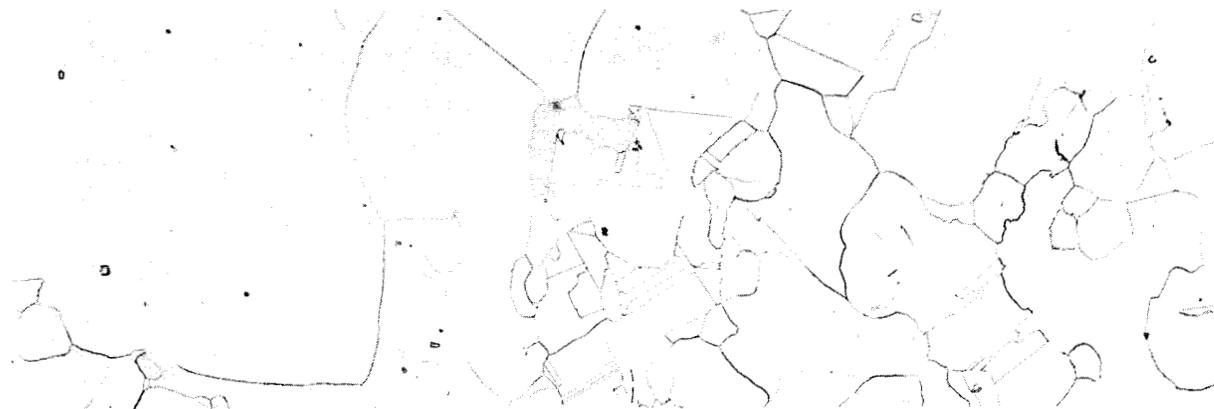
Fig. 17. Fractured specimen from test 23332 (649°C, 241 MPa) etched. (a) Fracture in alloy 800H. (b) Typical microstructure of deposited ERNiCr-3. (c) Typical microstructure of alloy 800H.

The sample from test 23332 (649°C, 241 MPa) was an interface sample, and the failure location in this sample was typical of that for other samples with an interface in the gage section between base metal and weld overlay. This sample was examined metallographically, and typical photomicrographs are shown in Figs. 16 and 17. The fracture occurred in the HAZ of the alloy 800H. The grain size of the alloy 800H was very

irregular, with regions having coarse and fine grain sizes. The weld deposit had a cellular dendritic structure with some thin layers of fine-grained material between adjacent passes.
