ORNL/TM-10606

An Investigation of Ceramic Coatings for Protection of SiC from High-Temperature Corrosion

AN INVESTIGATION OF CERAMIC COATINGS FOR PROTECTION
OF SiC FROM HIGH-TEMPERATURE CORROSION

Date Published - February 1988

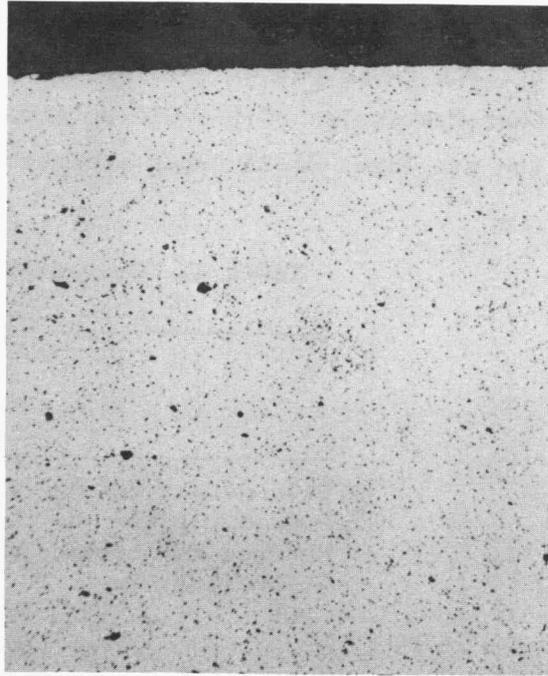
Fig. 1. Polished cross sections of SiC substrate materials.

Polished cross sections of the substrate materials (Fig. 1) show that SA was much smoother than CS101. The latter material was tried as a substrate to take advantage of possible mechanical bonding to the rougher surface associated with the surface-connected porosity.
