ORNL/TM-11691

## Corrosion Behavior of Continuous-Filament-Wound Ceramic Composite Tubes

Metals and Ceramics Division

Date Published: May 1991

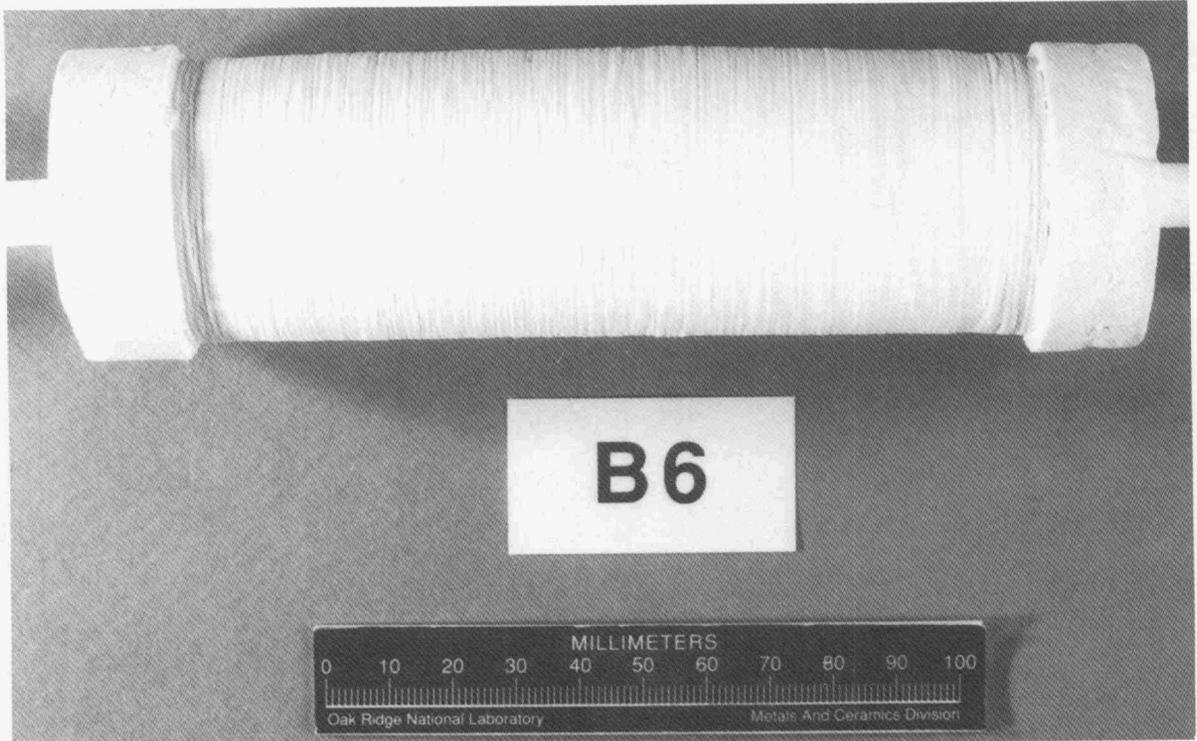
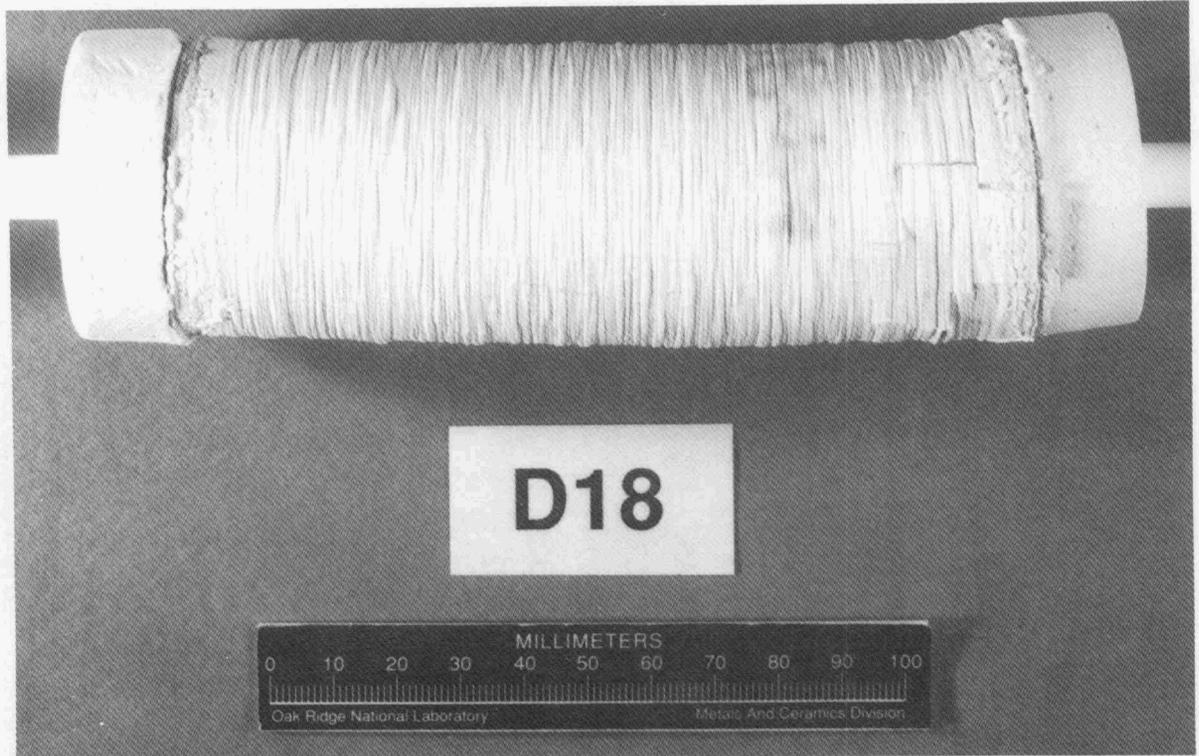
Fig. 5. Hoop-wound specimens after exposure to the corrosive atmosphere for 500 h. B6,  $\text{Al}_2\text{O}_3$  matrix; D18,  $\text{ZrO}_2$  matrix.

A set of five specimens was tested in air at about 1150°C for 500 h. As shown in Table 2, these specimens were heated sequentially for 100, 200, and 200 h, a total of 500 h including three thermal cycles between 20°C and the maximum temperature. A set of six specimens was tested in the corrosive atmosphere, four for 500 h with four thermal cycles and two for 300 h with three thermal cycles. Specimens exposed to air alone exhibited no visual evidence of degradation, such as bending, cracking, or spalling; however, each type of degradation occurred in specimens exposed to the corrosive atmosphere, as shown in Figs. 5–7. Figure 5 shows slight bending with no cracks in B6, and slight bending, cracking, and spalling in D18. Figure 6 shows cracking and spalling of outer layers of F15, and cracking and severe bending of H3. Figure 7 shows numerous cracks and spalling of I2, and bending and severe cracking of K3. The cracks in all specimens were perpendicular to the filaments.

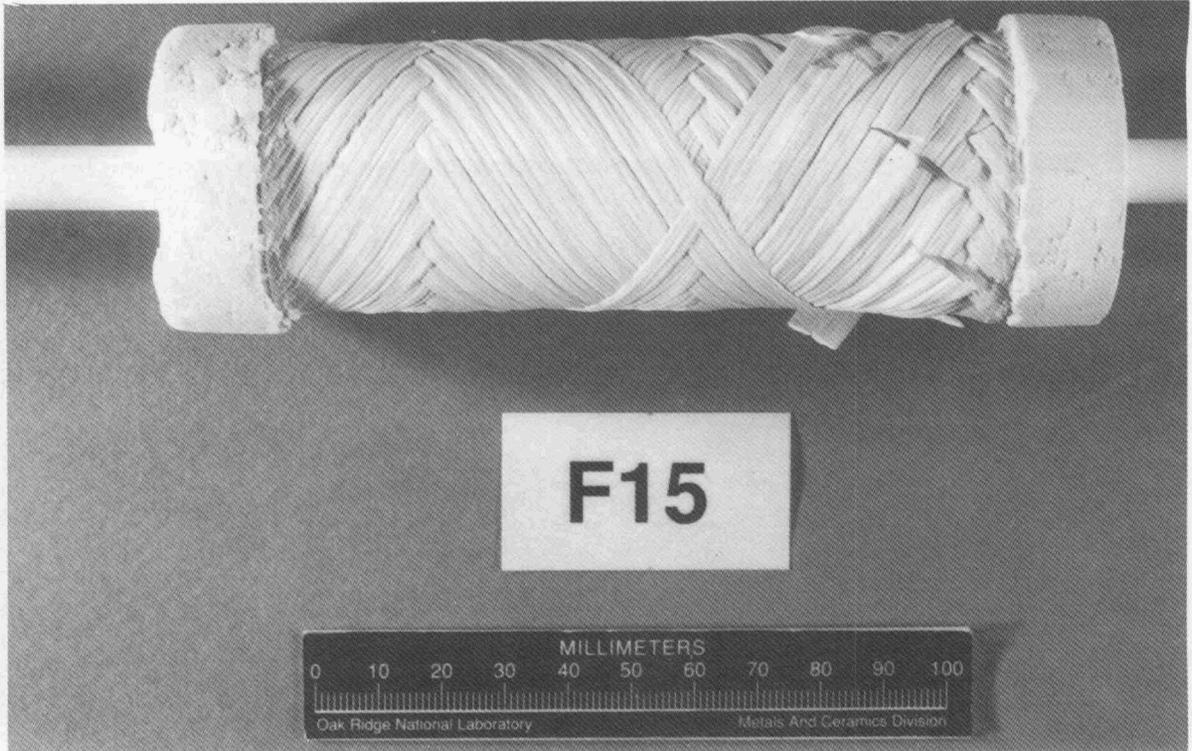
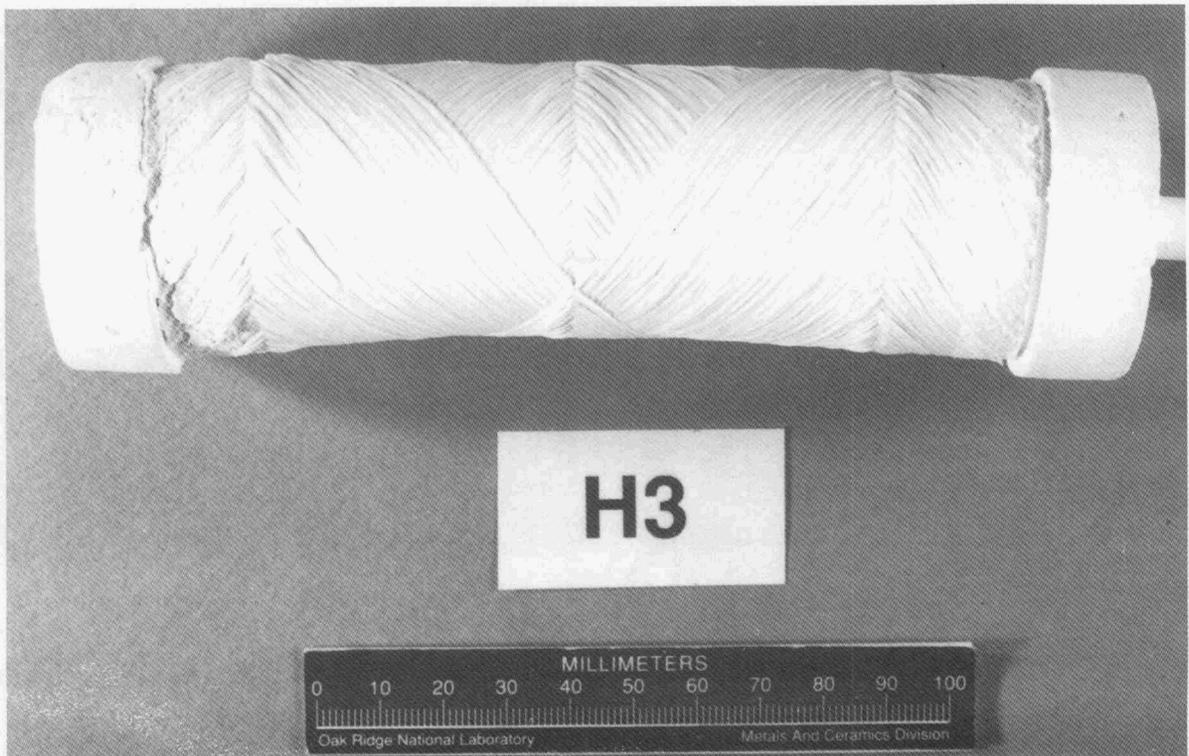
Fig. 6. Helical-wound specimens with  $ZrO_2$  matrices after exposure to the corrosive atmosphere for 500 h.

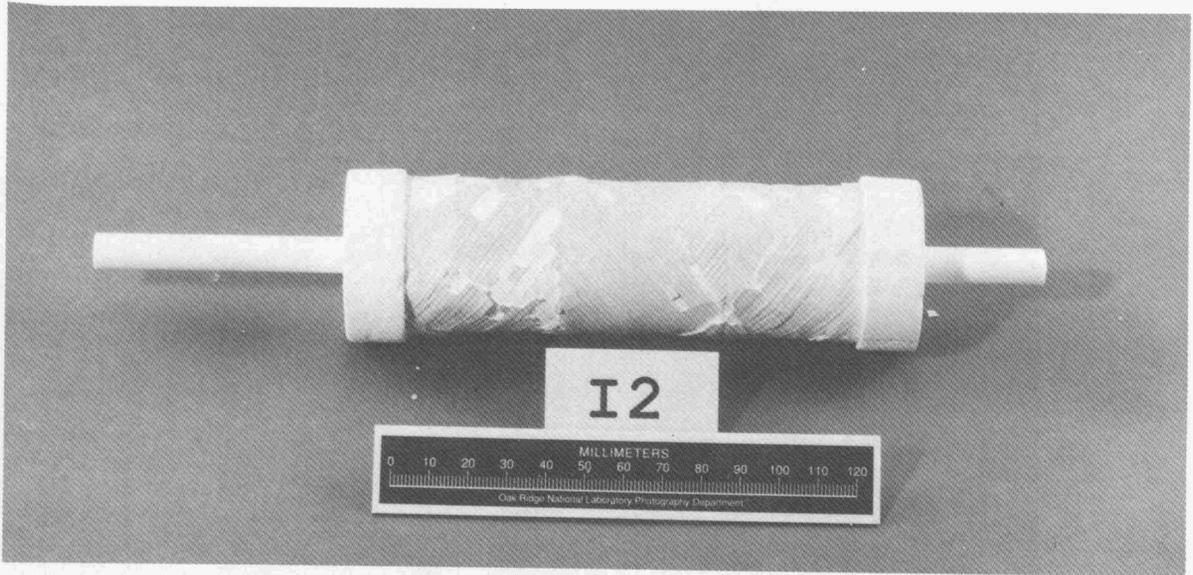
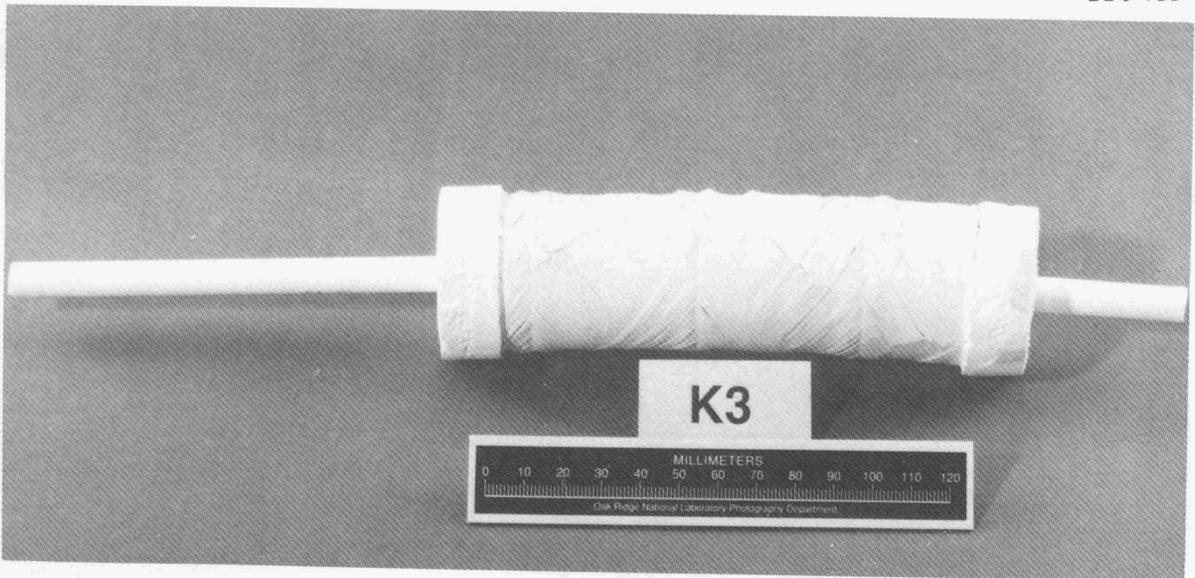
Fig. 7. Helical-wound specimens with  $ZrO_2$  matrices after exposure to the corrosive atmosphere for 300 h. I2,  $SnO_2$  coating; K3,  $ZrO_2$  coating.

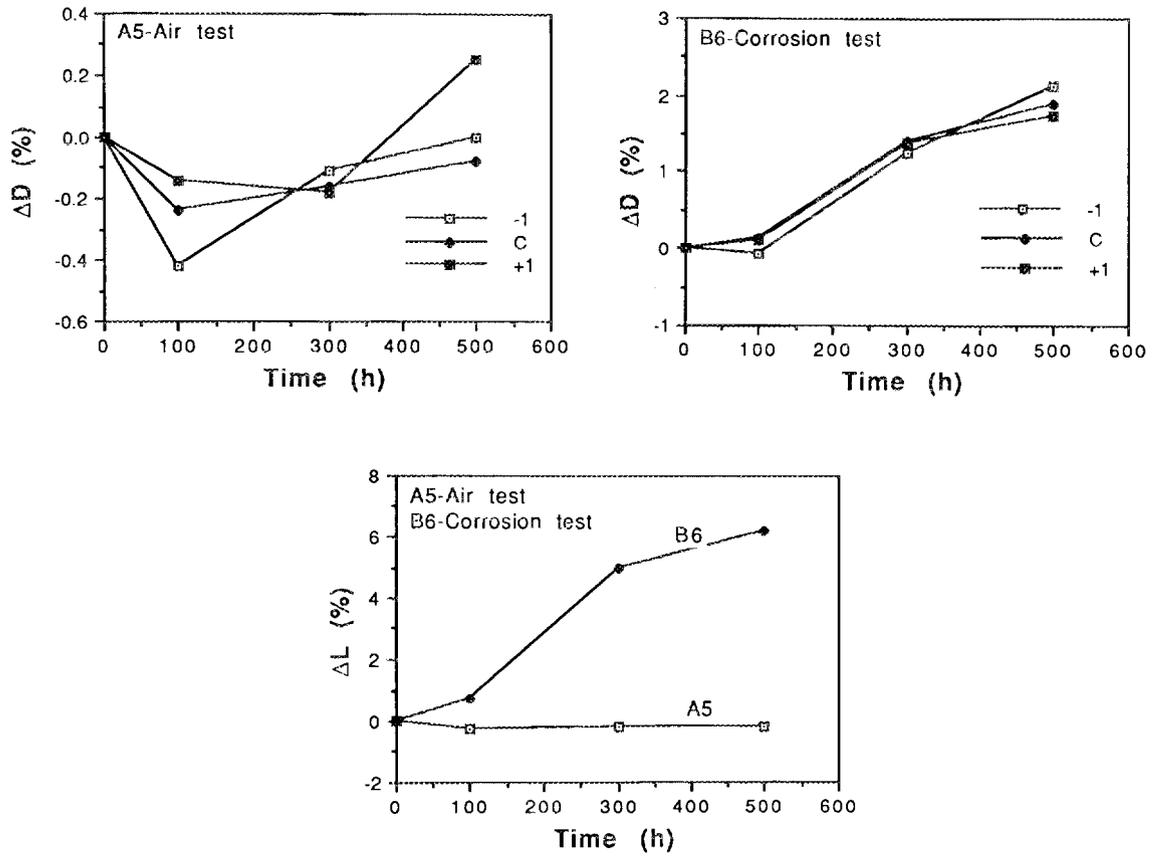
Fig. 8. Dimensional changes in hoop-wound specimens A5 and B6 with  $Al_2O_3$  matrices.

The dimensional changes of specimens heat-treated in the corrosive atmosphere were substantially larger than those of similar specimens heat-treated in air. As with specimens thermally treated in air, eight approximately equally spaced circumferential measurements at each of three longitudinal positions were used to determine the average cumulative diameter changes ( $\Delta D$ ), and four approximately equally spaced measurements were used to determine the average cumulative length changes ( $\Delta L$ ). In Figs. 8–12 the longitudinal positions for diameter measurements are designated C for midpoint and +1 and -1 for positions ~25 mm on either side of the midpoint. Figures 8–12 show that the  $\Delta D$  values for specimens exposed to air ranged from about -0.5 to +0.3%, while Figs. 8–13 show that the  $\Delta D$  values for specimens exposed to the corrosive atmosphere ranged up to +6%. The  $\Delta L$  values showed similar ranges for the two atmospheres. Helical-wound specimen E9, which was tested in air, was not paired with a similar specimen tested in the corrosive atmosphere; therefore, its dimensional changes are compared with hoop-wound specimen A5 in Fig. 10. This comparison does not clearly favor one type of winding method over the other. Specimen I2, which was not paired with a similar specimen tested in air, had substantial dimensional changes after 300 h (Fig. 13). Unfortunately, comparisons based on dimensional changes among specimens exposed to the corrosive atmosphere for 500 h in Figs. 8, 9, 11, and 12 do not reveal a clear choice between  $\text{Al}_2\text{O}_3$  and  $\text{ZrO}_2$  matrices nor between hoop and helical winding.

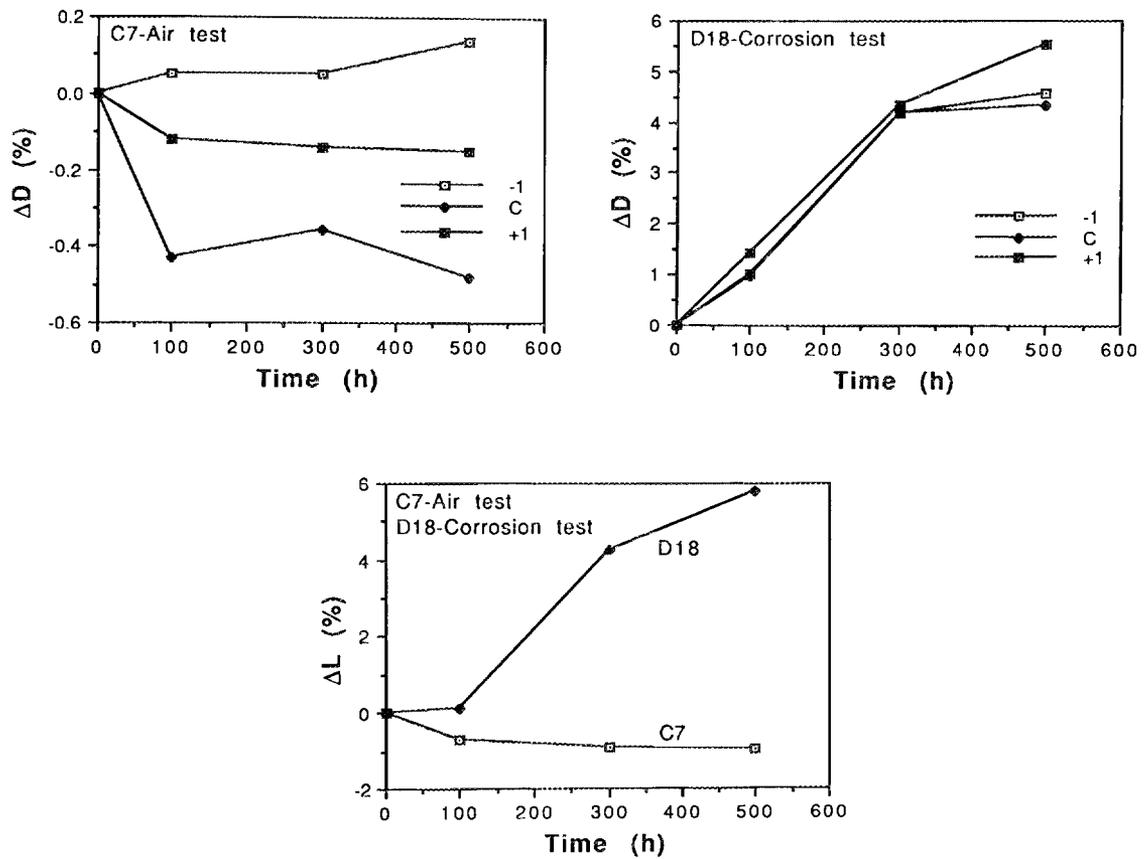
Fig. 9. Dimensional changes in hoop-wound specimens C7 and D18 with ZrO<sub>2</sub> matrices.

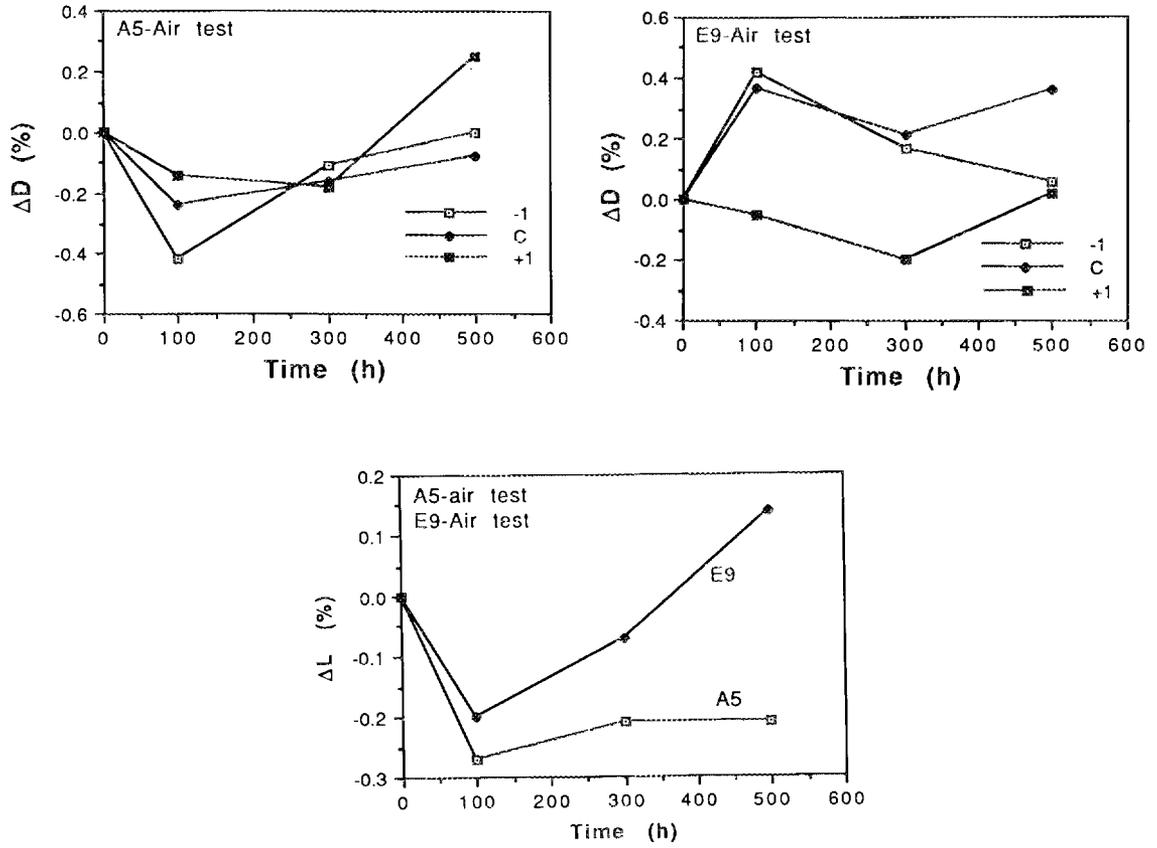
Fig. 10. Dimensional changes in hoop-wound (A5) and helical-wound (E9) specimens with  $Al_2O_3$  matrices tested in air.

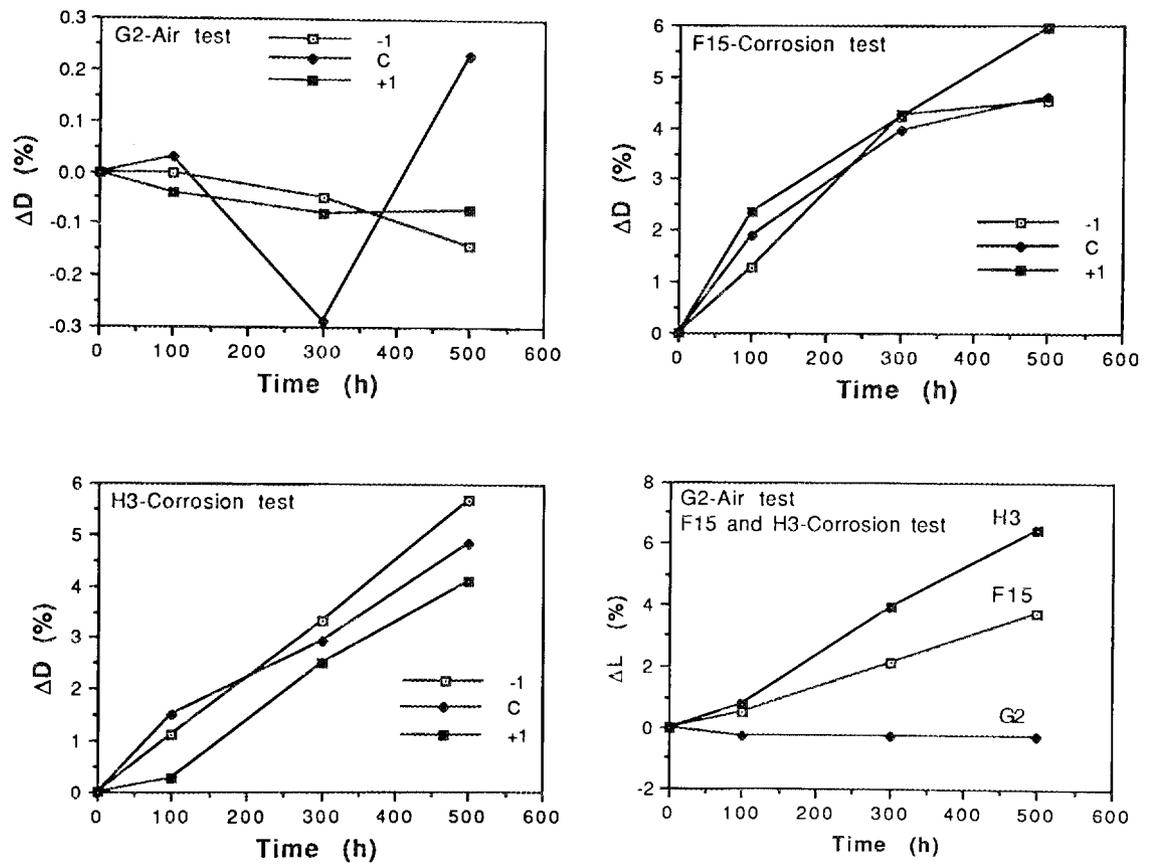
Fig. 11. Dimensional changes in helical-wound specimens G2, F15, and H3 with  $ZrO_2$  matrices.

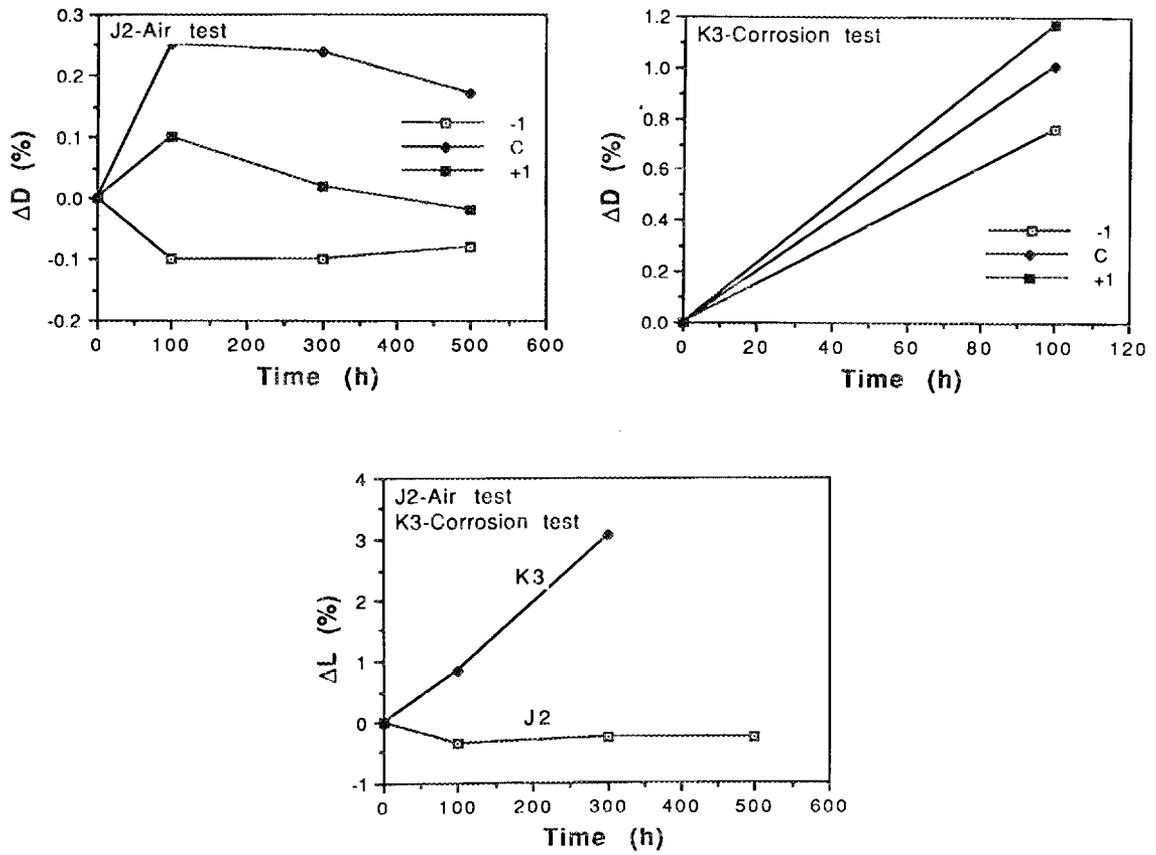
Fig. 12. Dimensional changes in helical-wound specimens J2 and K3 with ZrO<sub>2</sub> matrices.

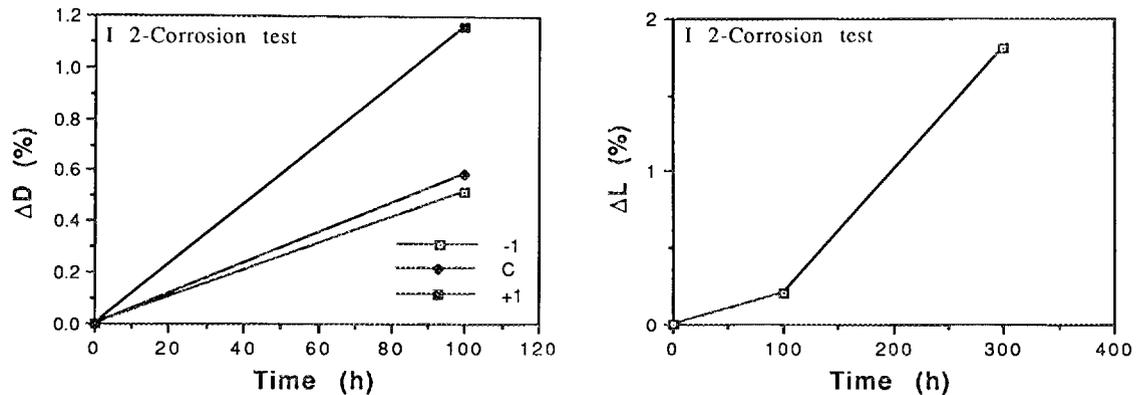
Fig. 13. Dimensional changes in helical-wound specimen I2 with a ZrO<sub>2</sub> matrix.

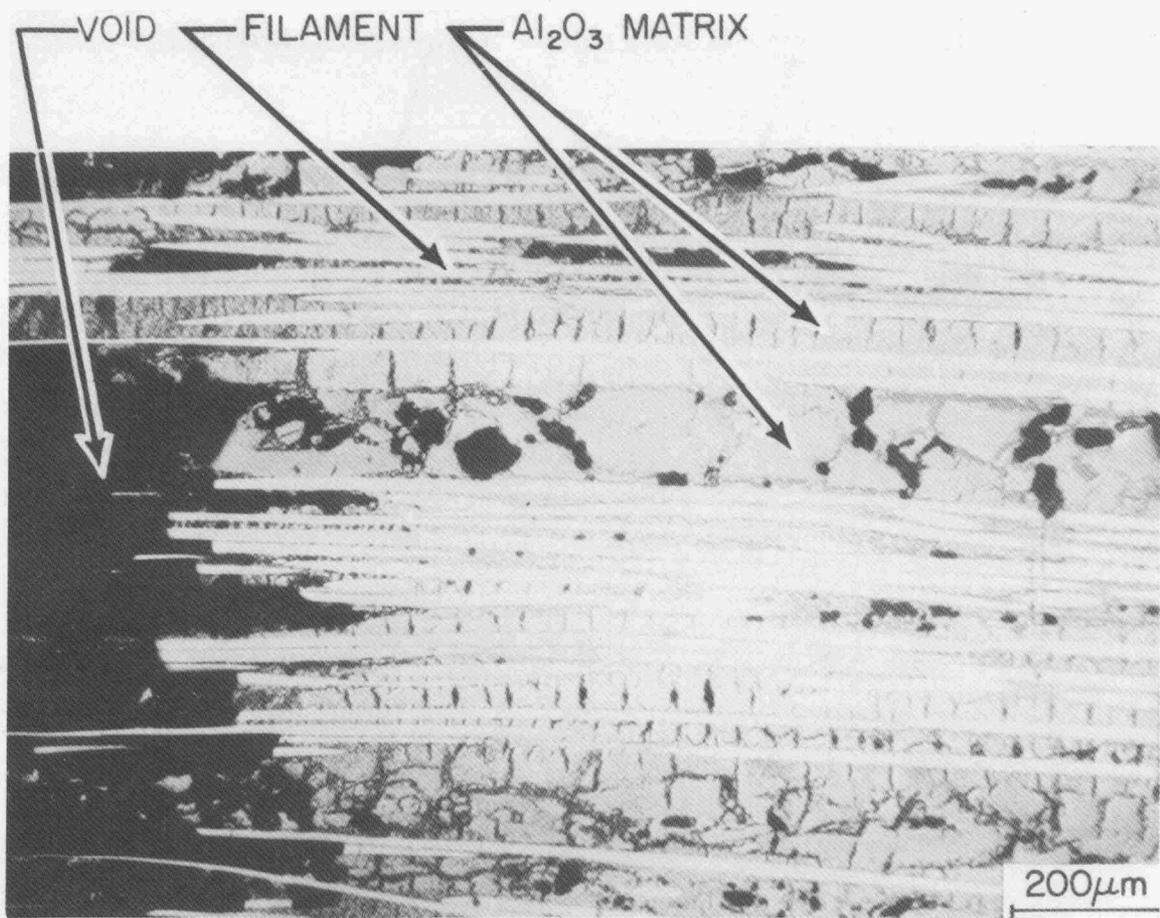
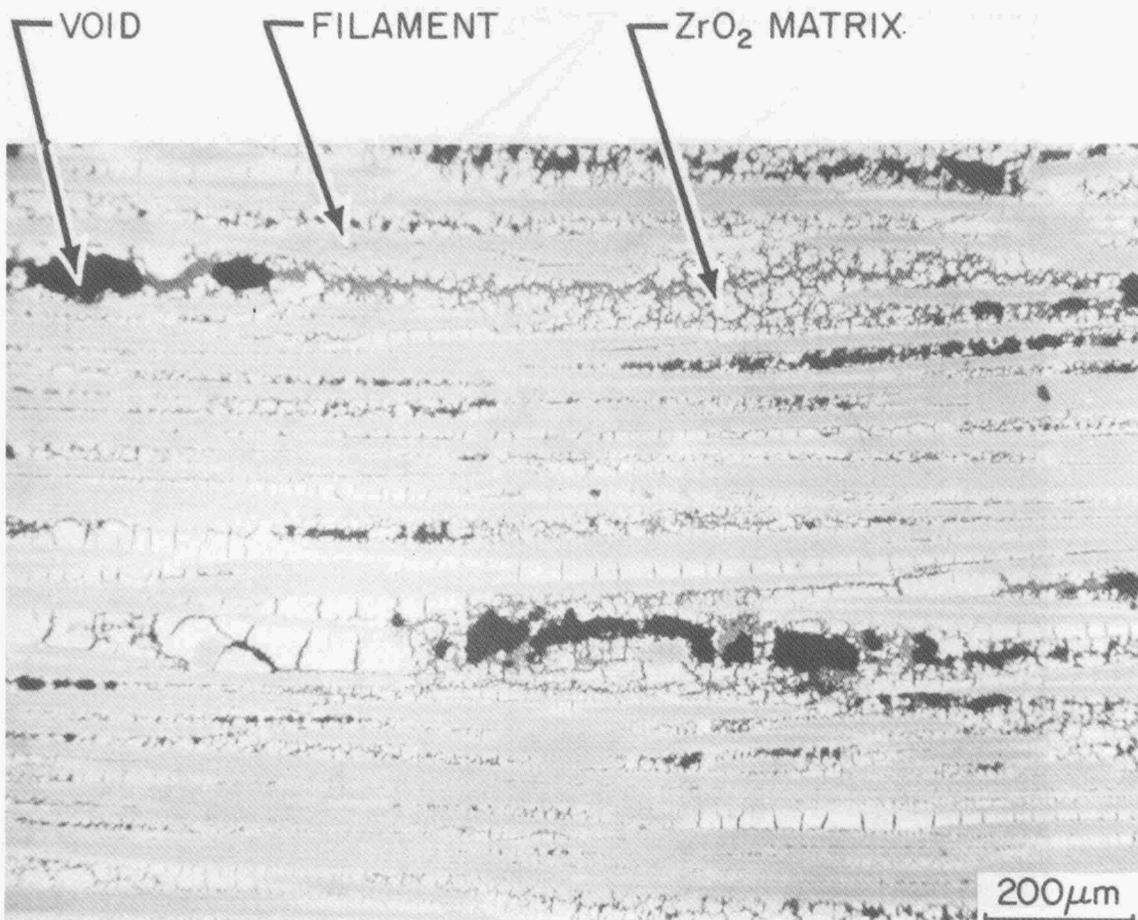
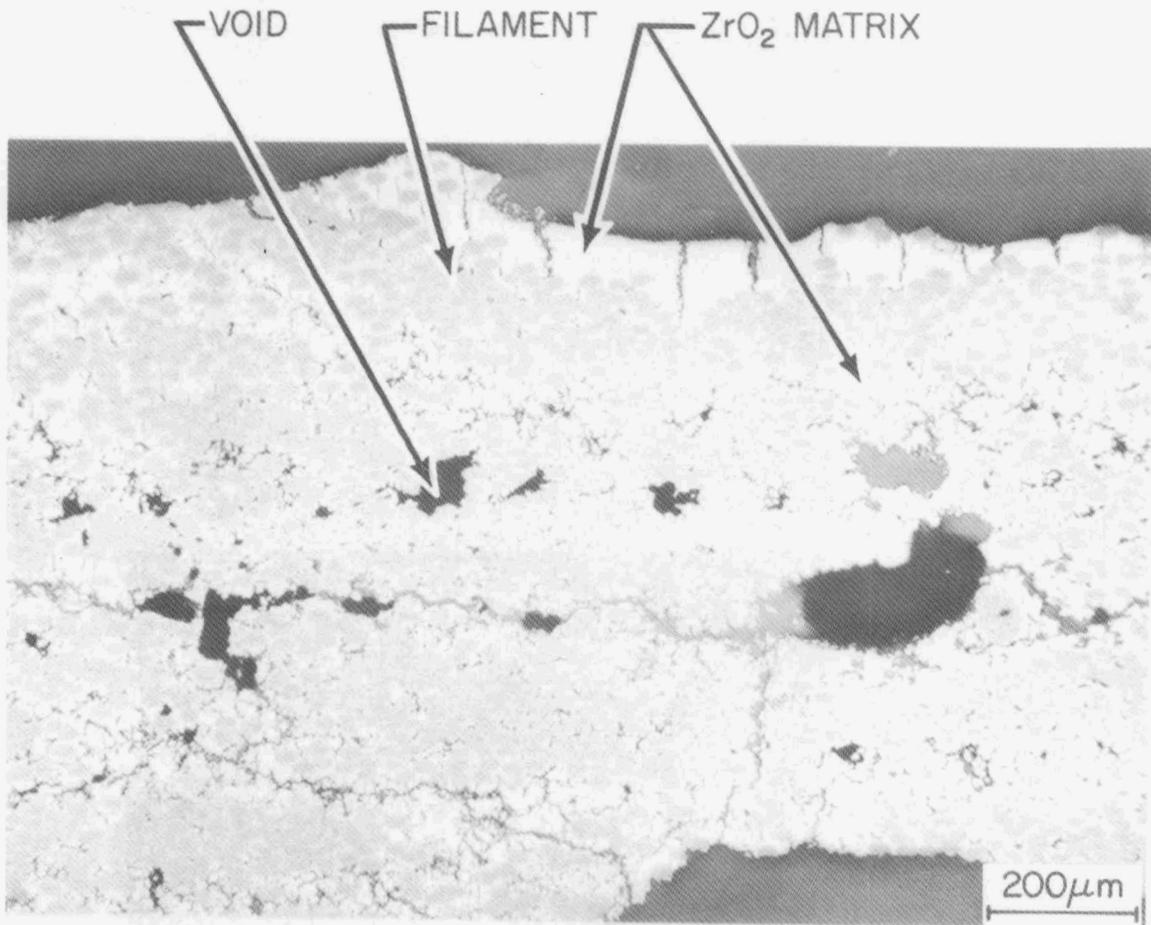
Fig. 14. Specimen A5 after testing in air.

Fig. 15. Specimen C7 after testing in air.

Fig. 16. Specimen G2 after testing in air.

Optical micrographs of specimens tested in air (Figs. 14–16) showed pores, cracks, and large voids in the matrix, which were probably present in the as-fabricated condition. Voids were usually filled with epoxy, the material used to prepare the specimen for examination. The cracks in the matrices were always perpendicular to the uncracked filaments, indicating that the filaments substantially strengthened the composites. Optical micrographs of samples from the most severely damaged regions of specimens tested in the corrosive atmosphere also revealed structural degradation (Figs. 17–22). Some had exfoliated layers that appear as wide cracks in the optical micrographs. Figure 17(a) shows a cross section perpendicular to the filaments of a hoop-wound specimen (B6) with an Al<sub>2</sub>O<sub>3</sub> matrix. The dark-gray regions are voids filled with epoxy. Cracks such as that in the lower part of the picture probably formed by linking voids under thermal stresses. Figure 17(b) shows voids in the matrix in regions of low filament population. A cracked and porous layer of material about 50  $\mu\text{m}$  thick at the surface contained no filaments.

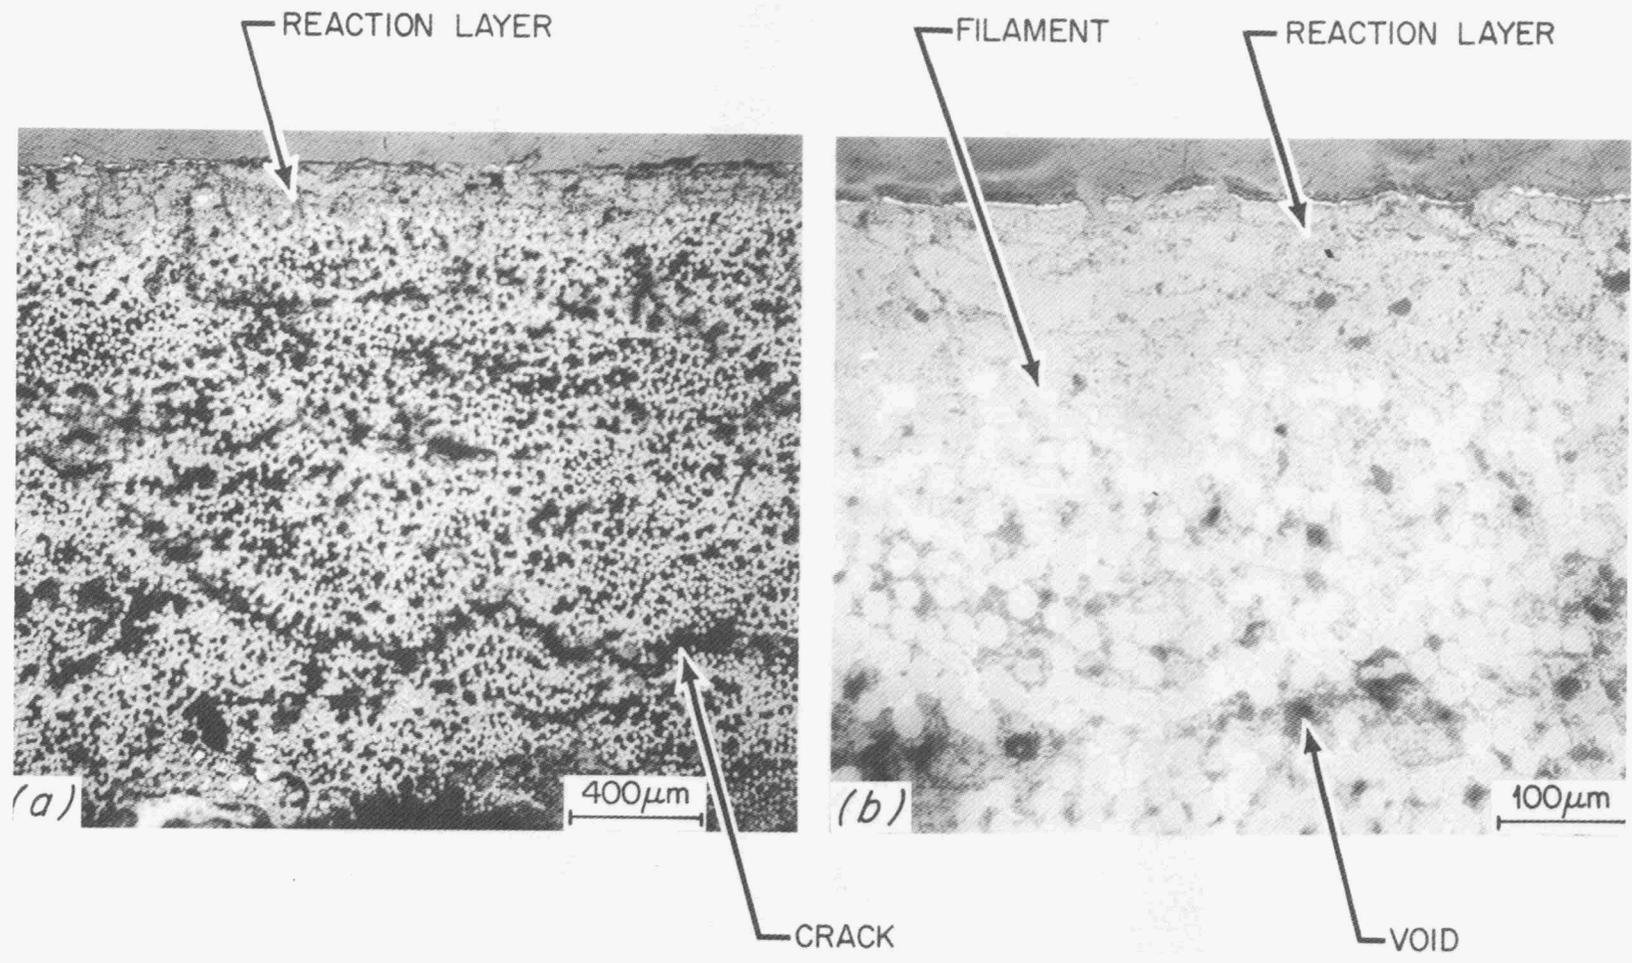
Fig. 17. Specimen B6 after corrosion testing.

Figure 18(a) shows cracks and voids in the structure of a hoop-wound specimen (D18) with a  $\text{ZrO}_2$  matrix, and Fig. 18(b) shows numerous cracks in the matrix. Regions of low filament population are also evident. Large cracks and voids are shown in a helical-wound specimen (F15) with a  $\text{ZrO}_2$  matrix [Figs. 19(a) and (b)]. In addition, an apparent reaction zone is present at the filament/matrix interface. Other helical-wound specimens with  $\text{ZrO}_2$  matrices in Figs. 20–22 (H3, I2, and K3, respectively) exhibit cracks and voids in the matrix. The dense  $\text{SnO}_2$  coating on specimen I2 and the porous  $\text{ZrO}_2$  coating on specimen K3 are evident in Figs. 21(a) and 22(a). An apparent reaction zone like that mentioned above is present in specimen K3 in Fig. 22(b).

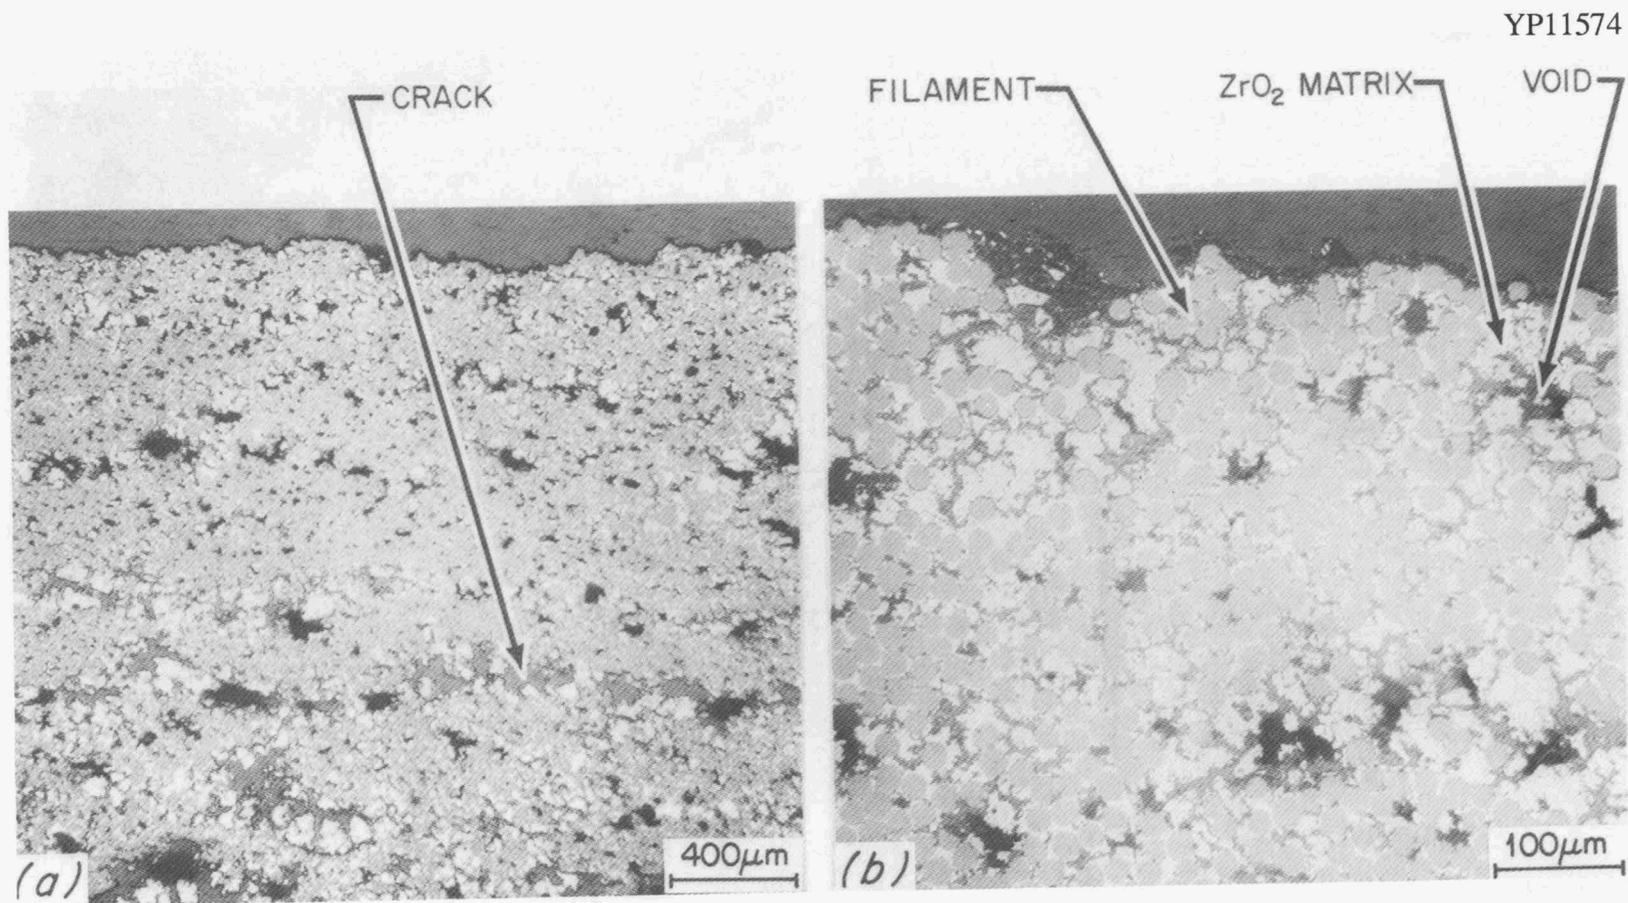
Fig. 18. Specimen D18 after corrosion testing.

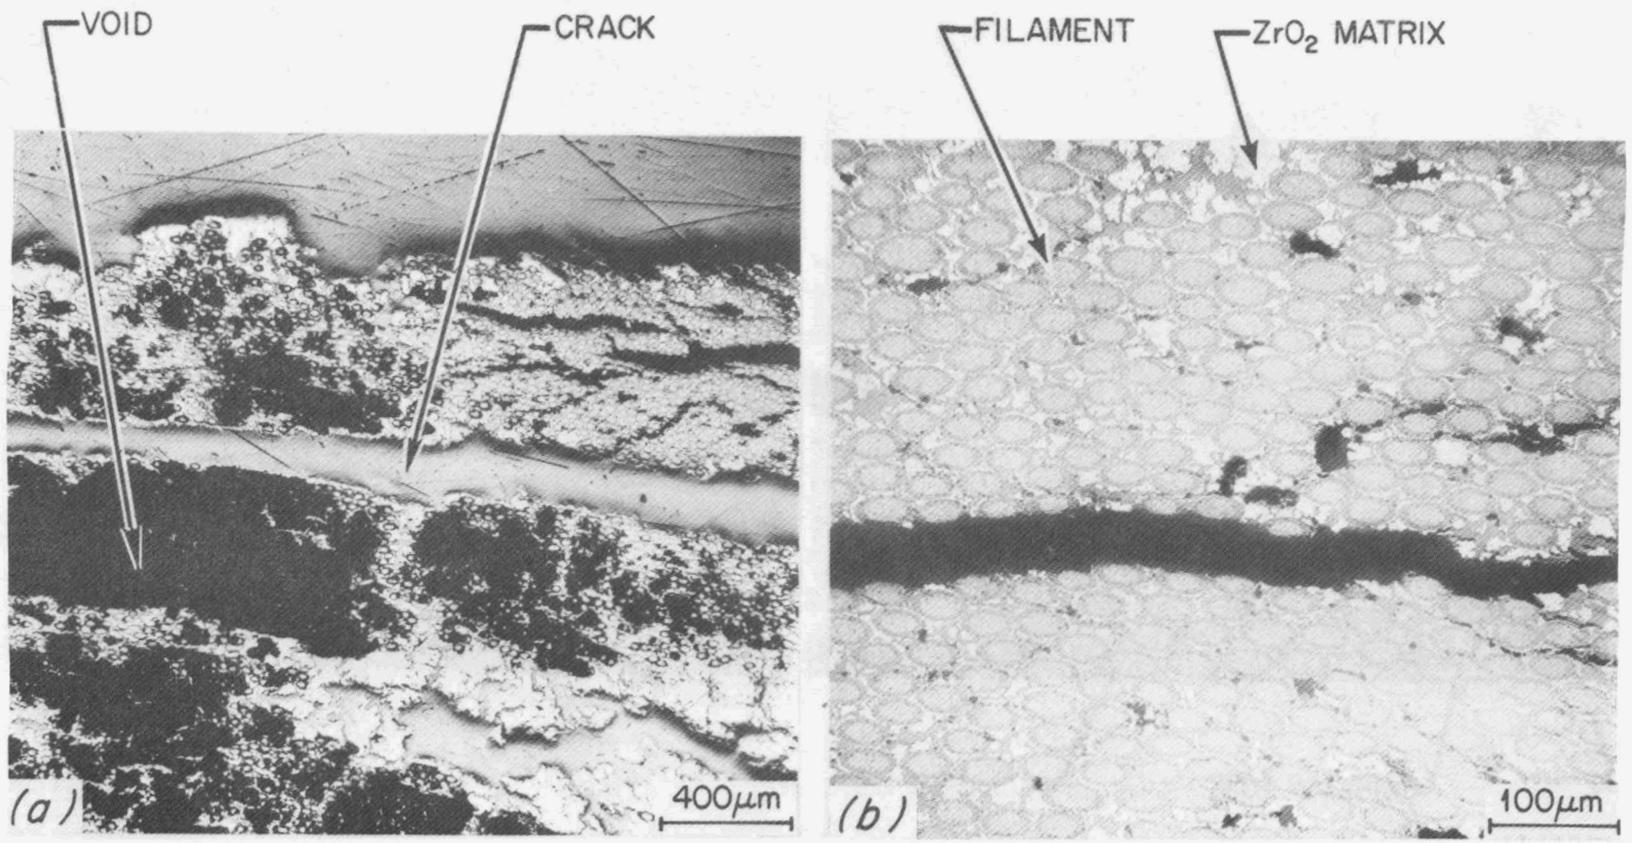
Fig. 19. Specimen F15 after corrosion testing.

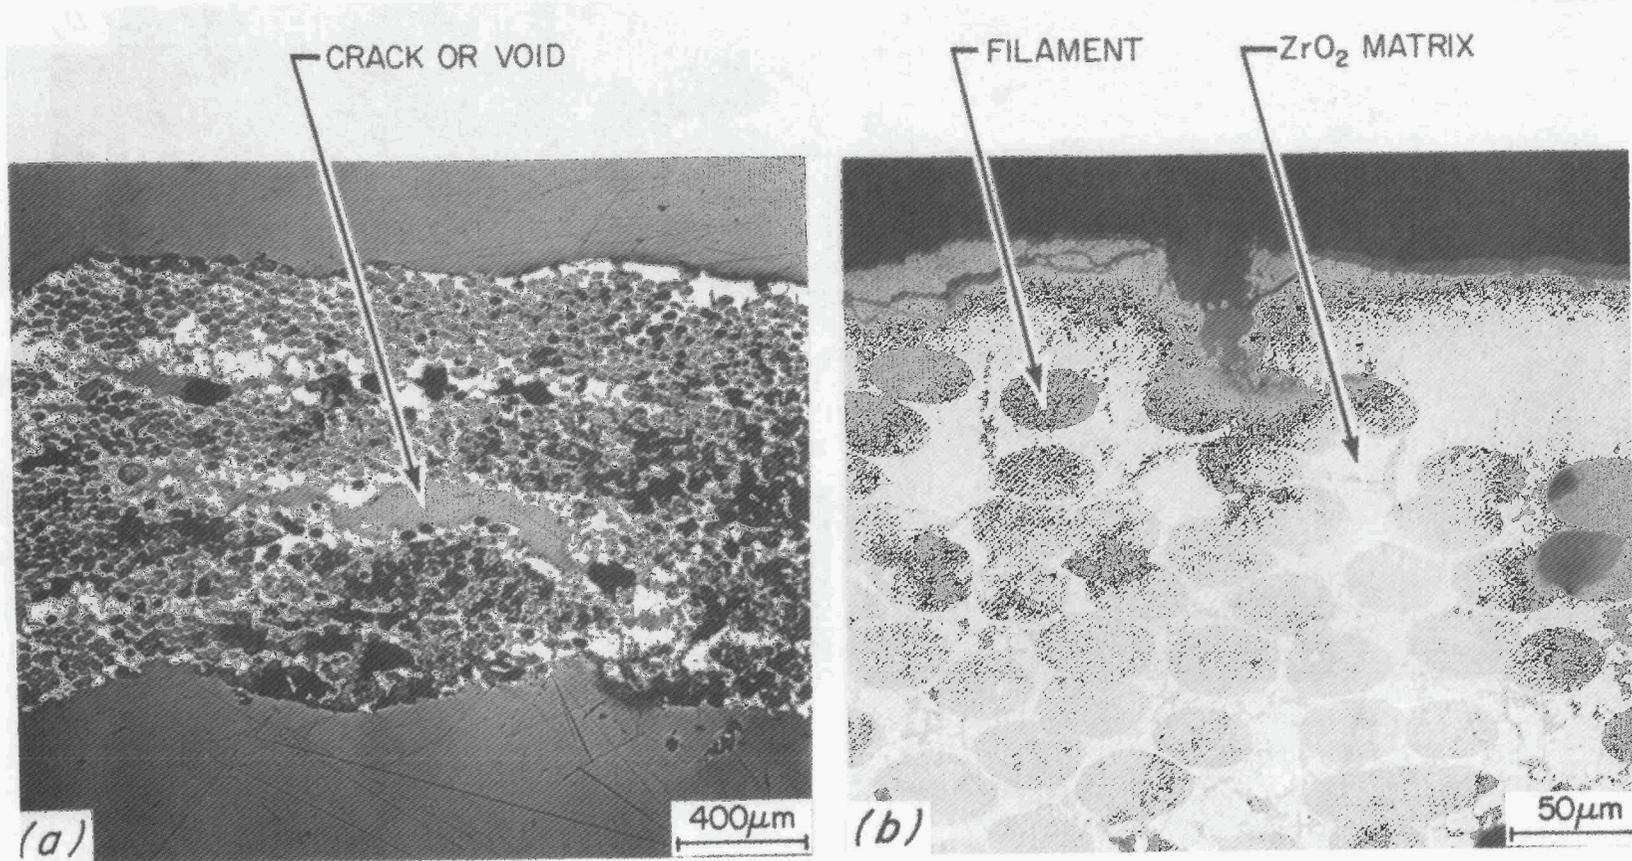
Fig. 20. Specimen H3 after corrosion testing.

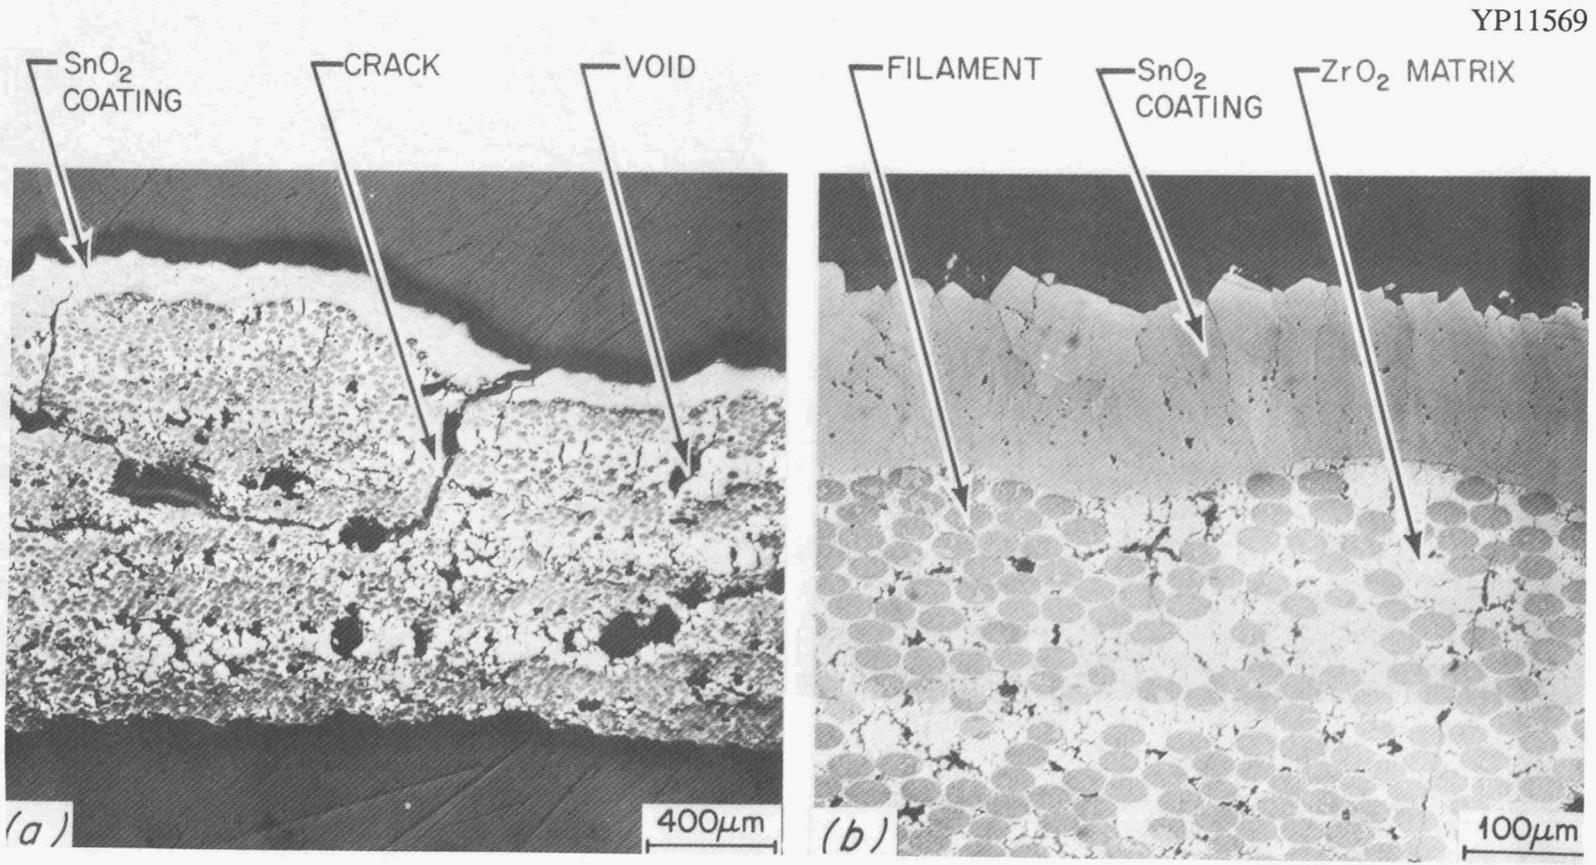
Fig. 21. Specimen 12 after corrosion testing.
