ORNL/TM-11691

## Corrosion Behavior of Continuous-Filament-Wound Ceramic Composite Tubes

Metals and Ceramics Division

Date Published: May 1991

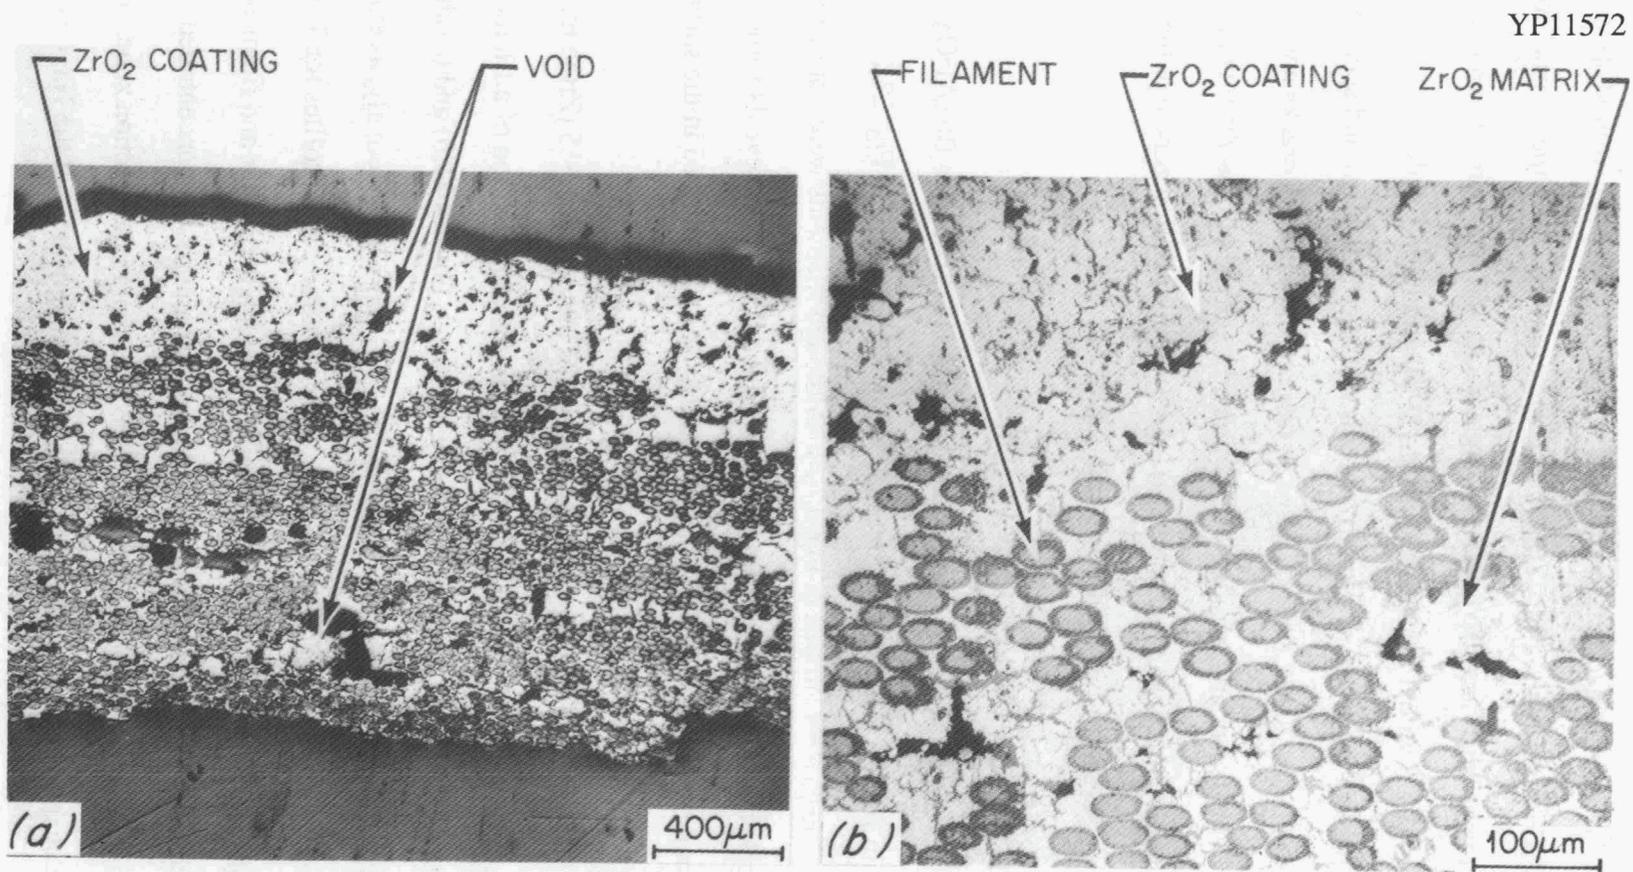
Fig. 22. Specimen K3 after corrosion testing.

Figure 18(a) shows cracks and voids in the structure of a hoop-wound specimen (D18) with a  $\text{ZrO}_2$  matrix, and Fig. 18(b) shows numerous cracks in the matrix. Regions of low filament population are also evident. Large cracks and voids are shown in a helical-wound specimen (F15) with a  $\text{ZrO}_2$  matrix [Figs. 19(a) and (b)]. In addition, an apparent reaction zone is present at the filament/matrix interface. Other helical-wound specimens with  $\text{ZrO}_2$  matrices in Figs. 20–22 (H3, I2, and K3, respectively) exhibit cracks and voids in the matrix. The dense  $\text{SnO}_2$  coating on specimen I2 and the porous  $\text{ZrO}_2$  coating on specimen K3 are evident in Figs. 21(a) and 22(a). An apparent reaction zone like that mentioned above is present in specimen K3 in Fig. 22(b).

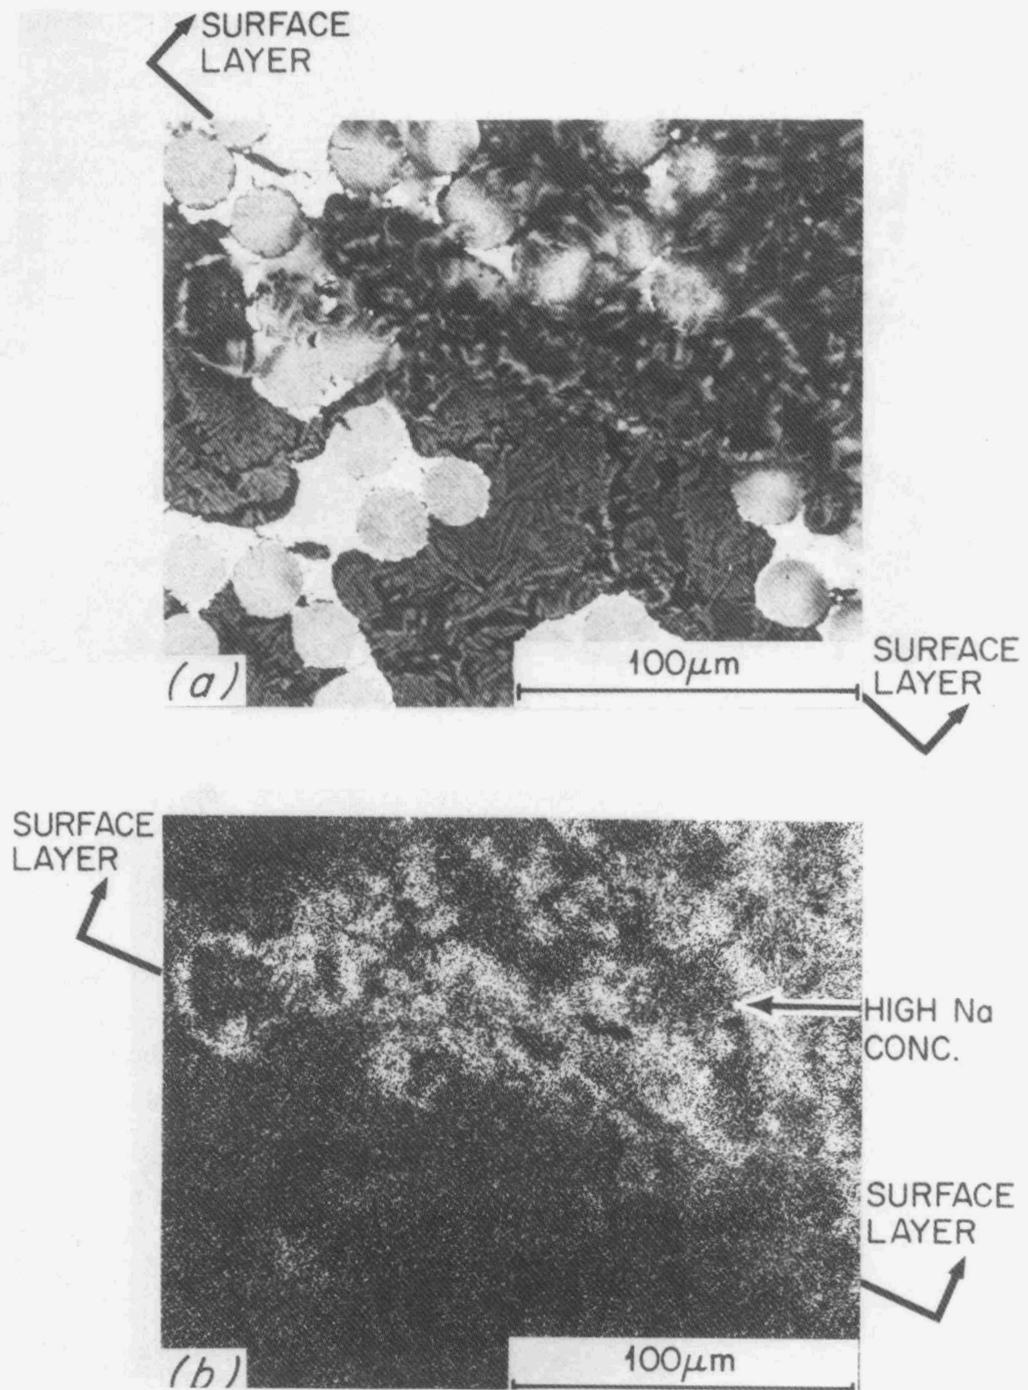
Fig. 23. Electron microprobe analysis of specimen B6 after corrosion testing.

The results of electron microprobe analysis of specimen B6 ( $\text{Al}_2\text{O}_3$  matrix) are shown in Fig. 23. The backscattered electron (BSE) image in Fig. 23(a) shows the region near the surface mentioned in Fig. 17(b). Although filaments were not visible in the optical micrograph of the surface layer in Fig. 17(b), the BSE image reveals some filaments. The elemental dot map in Fig. 23(b) shows that Na was concentrated in the surface layer along with a high concentration of Al (not shown in Fig. 23).

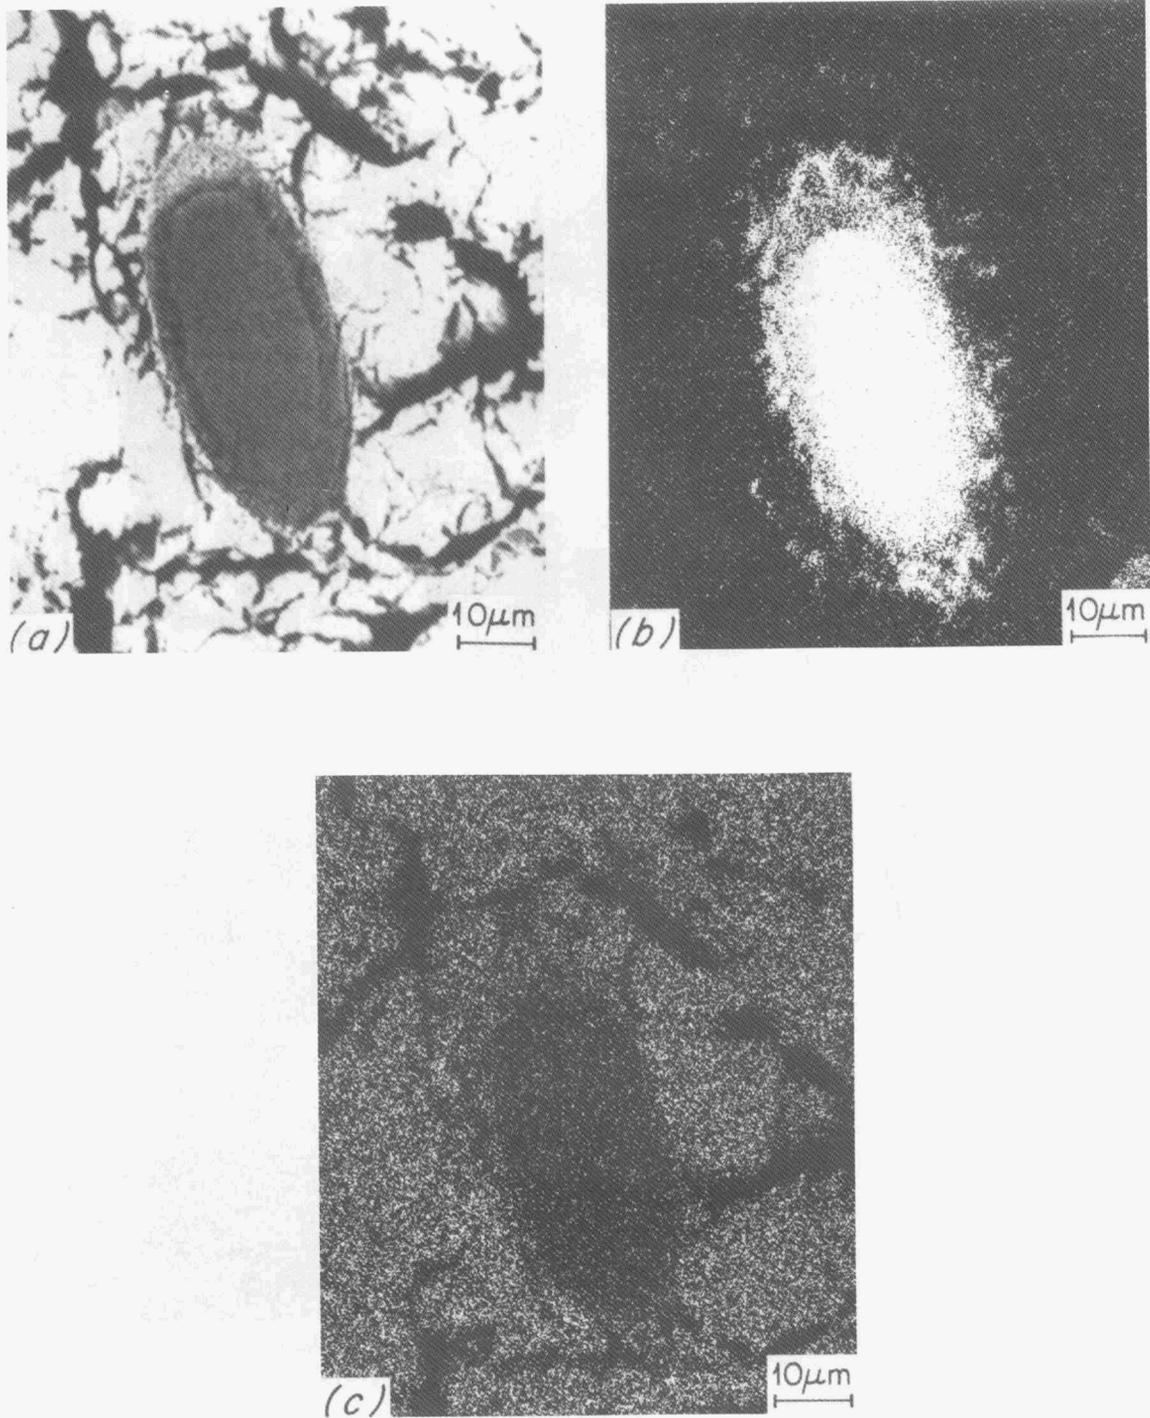
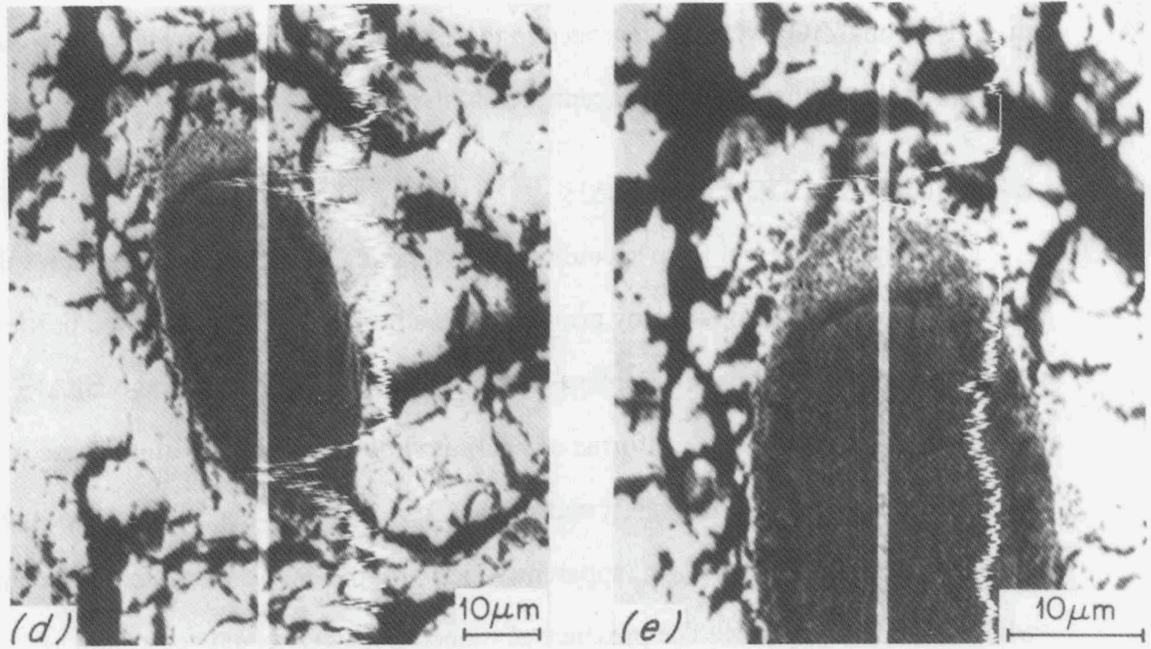
Fig. 24. Electron microprobe analysis of specimen F15 after corrosion testing.

Fig. 24. (Continued)

The electron microprobe analysis results of specimen F15 ( $\text{ZrO}_2$  matrix) are shown in Fig. 24. The BSE image [Fig. 24(a)] shows the cross section of a filament, the cracked  $\text{ZrO}_2$  matrix, and the reaction zone at the interface. Figures 24(b) and (c) show that  $\text{Al}_2\text{O}_3$  and  $\text{ZrO}_2$  were concentrated in the filaments and matrix, respectively, as expected. Figures 24(d) and (e) show the results of concentration line profiles for Ti and Na. The straight light line shows the path of analysis through the matrix and filament, and the saw-toothed lines show the concentration changes. Titanium was concentrated in the reaction zone and Na was concentrated in the matrix adjacent to the reaction zone. The presence of Ti is unexplained (none was detected in other specimens); but the Na, no doubt, was

derived from the corrosion atmosphere. Sodium carbonate apparently migrated through the  $\text{ZrO}_2$  matrix to react with the  $\text{Al}_2\text{O}_3$ -20 wt %  $\text{ZrO}_2$  filaments, indicating that Na forms compounds more readily with  $\text{Al}_2\text{O}_3$  than with  $\text{ZrO}_2$  at the temperatures used in these tests.

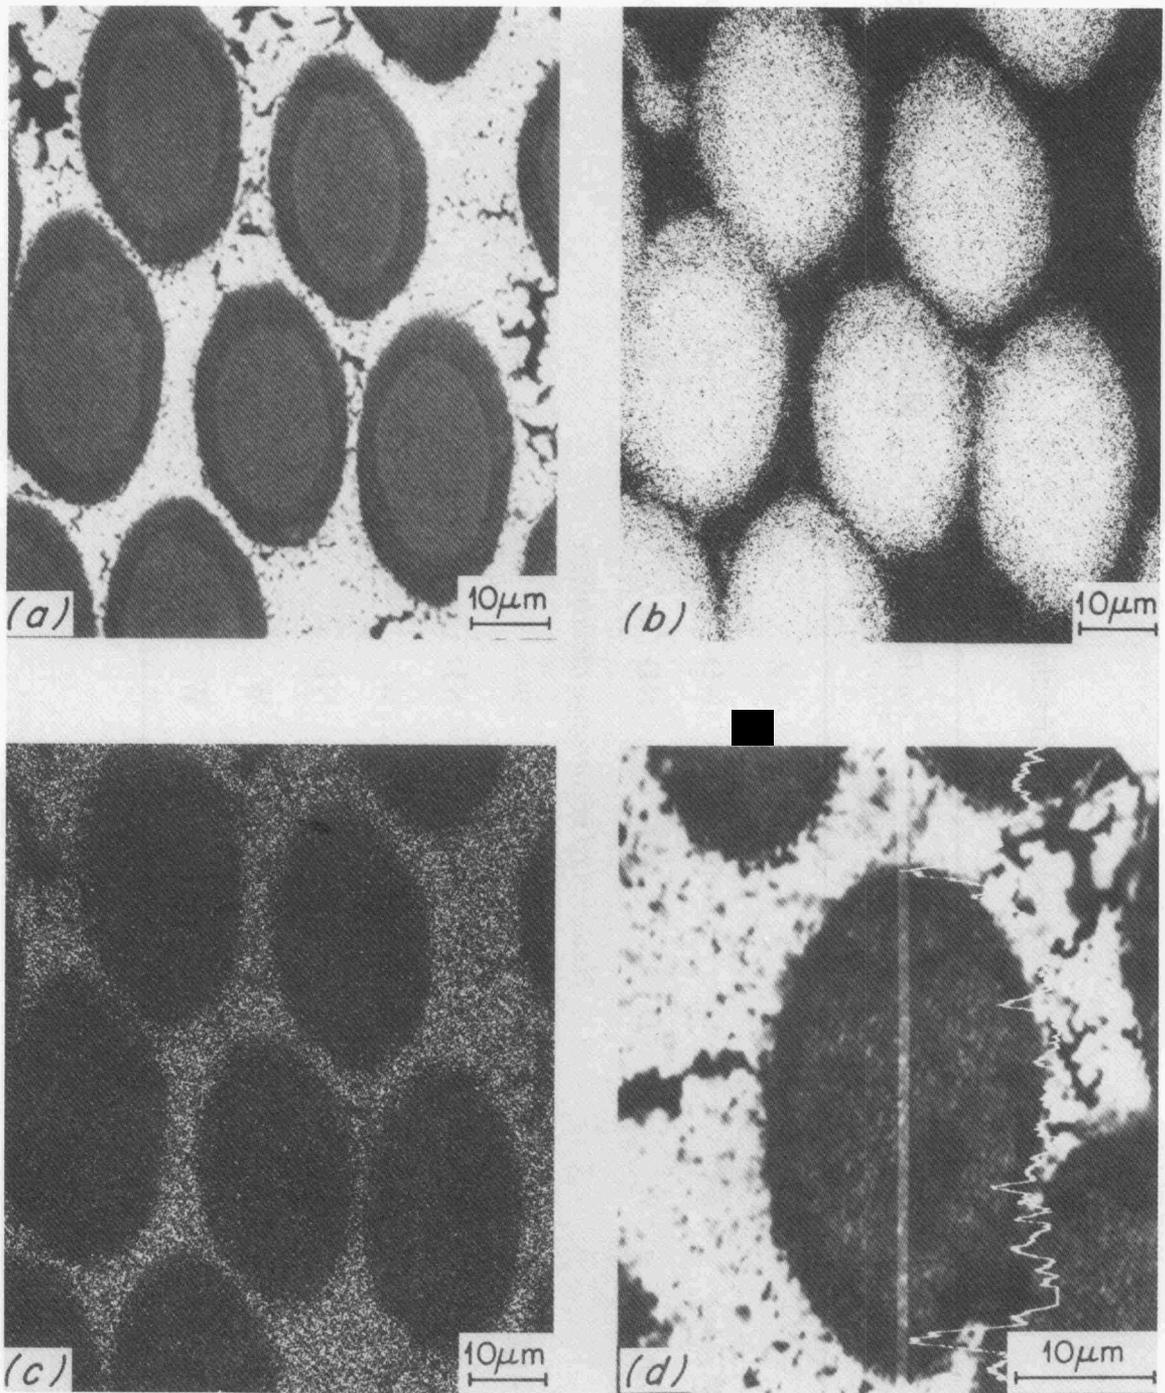
Fig. 25. Electron microprobe analysis of specimen K3 after corrosion testing.

Figure 25 shows similar results for specimen K3. The BSE image in Fig. 25(a) clearly shows a reaction layer at the matrix/filament interface. Figures 25(b) and (c) show that  $\text{Al}_2\text{O}_3$  and  $\text{ZrO}_2$  were concentrated in the filaments and matrix, respectively, and Fig. 25(d) shows that Na was concentrated at the interface.
