**Site Characterization Report  
for Building 3515 at Oak Ridge  
National Laboratory,  
Oak Ridge, Tennessee**

Date Issued—August 1994

Prepared by  
Bechtel National, Inc.  
Oak Ridge, Tennessee  
under subcontract 12B-99053C

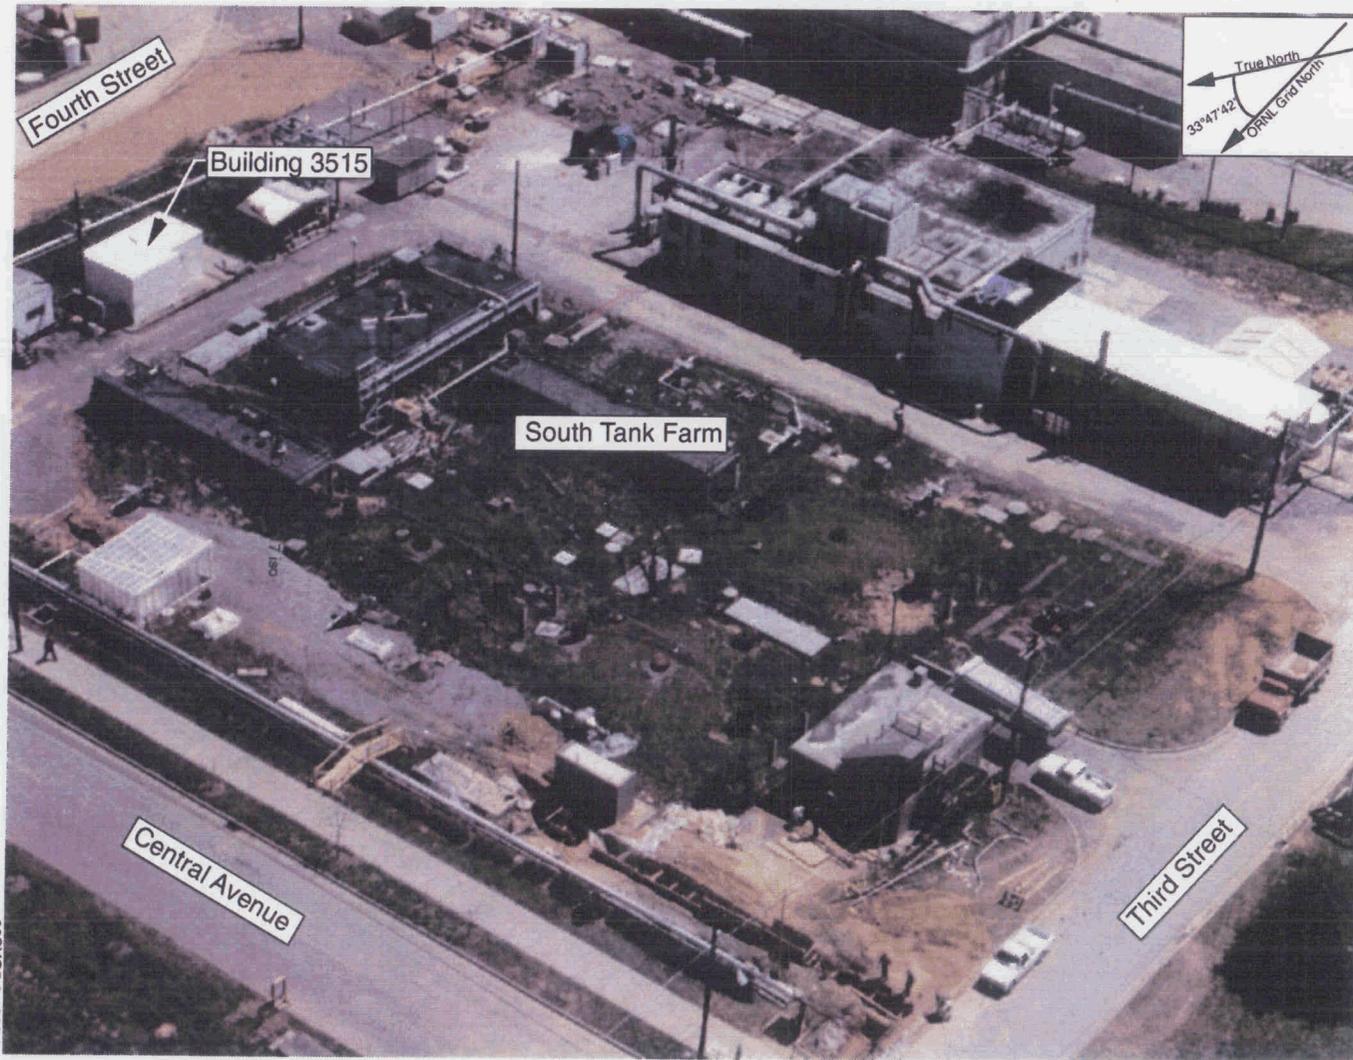
Fig. 2.1a. Site plan.

Building 3515 is in Bethel Valley in the ORNL main plant area, as shown in Fig. 2.1a. It is on the east side of the South Tank Farm, near the intersection of Central Avenue and Fourth Street. ORNL grid coordinates are approximately N21,940 and E31,030. Figure 2.1b is a 1986 aerial photograph of the South Tank Farm area and Building 3515.

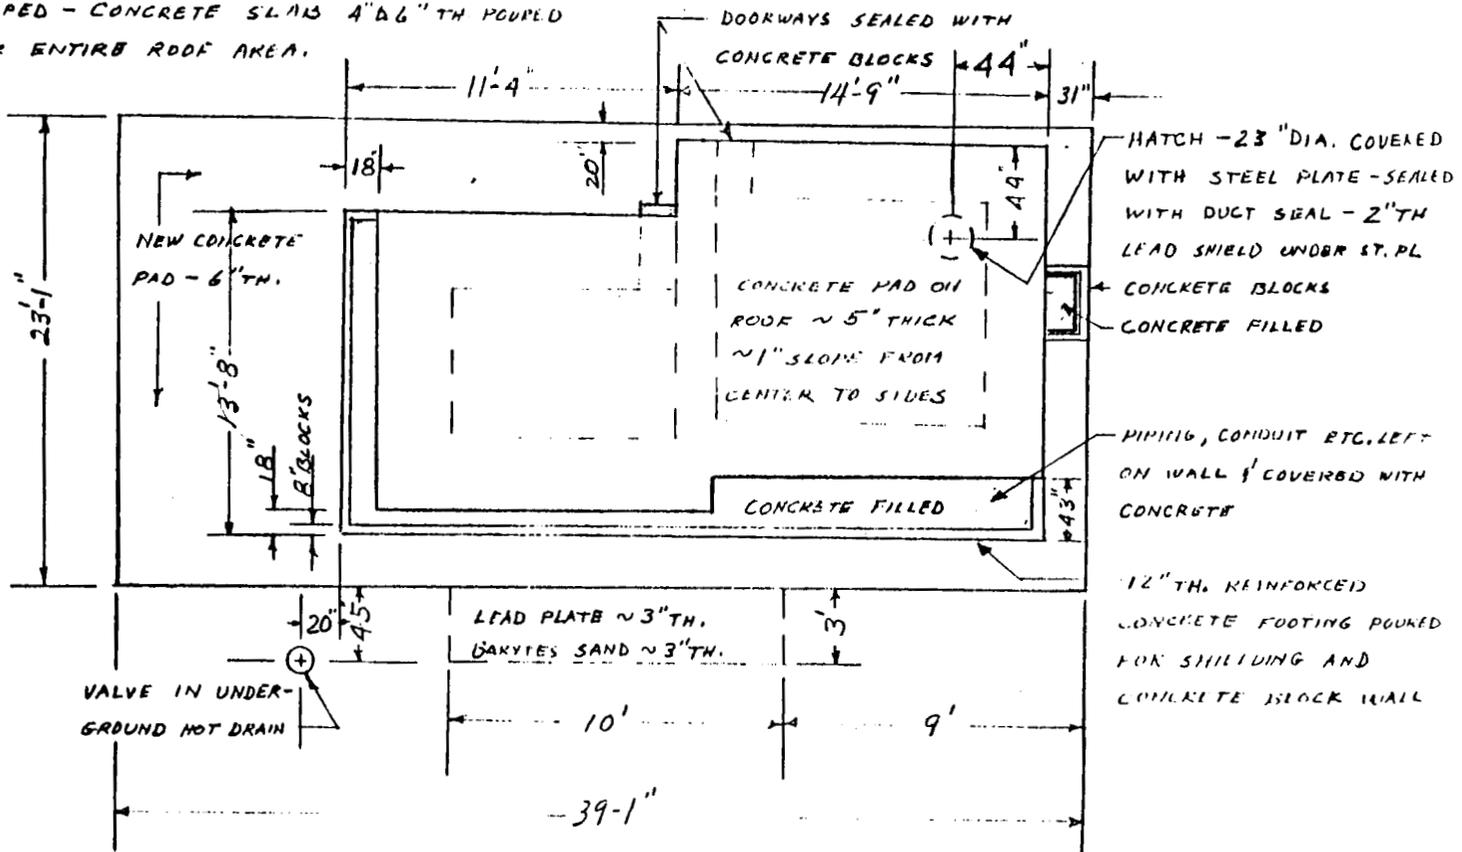
A-RD-2108  
 BLDG. 3515 ALTERATIONS  
 3/25/64 E.S. Pierce

ALL PIPING, FUNNELS ETC FROM CELL ROOF TO  
 INSIDE OF CELLS CUT OFF ~3" ABOVE ROOF  
 & CAPPED - CONCRETE SLABS 4" & 6" TH POURED  
 OVER ENTIRE ROOF AREA.

Figure 2.4 indicates that a 10 ft by 3 ft by 3-in.-thick lead plate covers contaminated soil directly adjacent to the concrete foundation. The presence of the lead plate was not verified during the site investigation because a plastic cover and gravel pad, installed to remediate soil contaminated by leaks from the drain line, now cover that entire area.

Prior to alterations circa 1964 (see Fig. 2.4), the original south wall of Building 3515 measured 3 ft 3 in. or 3 ft 9 in. thick, depending on the cross-section location. According to ORNL drawing D-338, an inner portion of this wall was stacked block (no mortar) approximately 1 ft 8 in. thick.

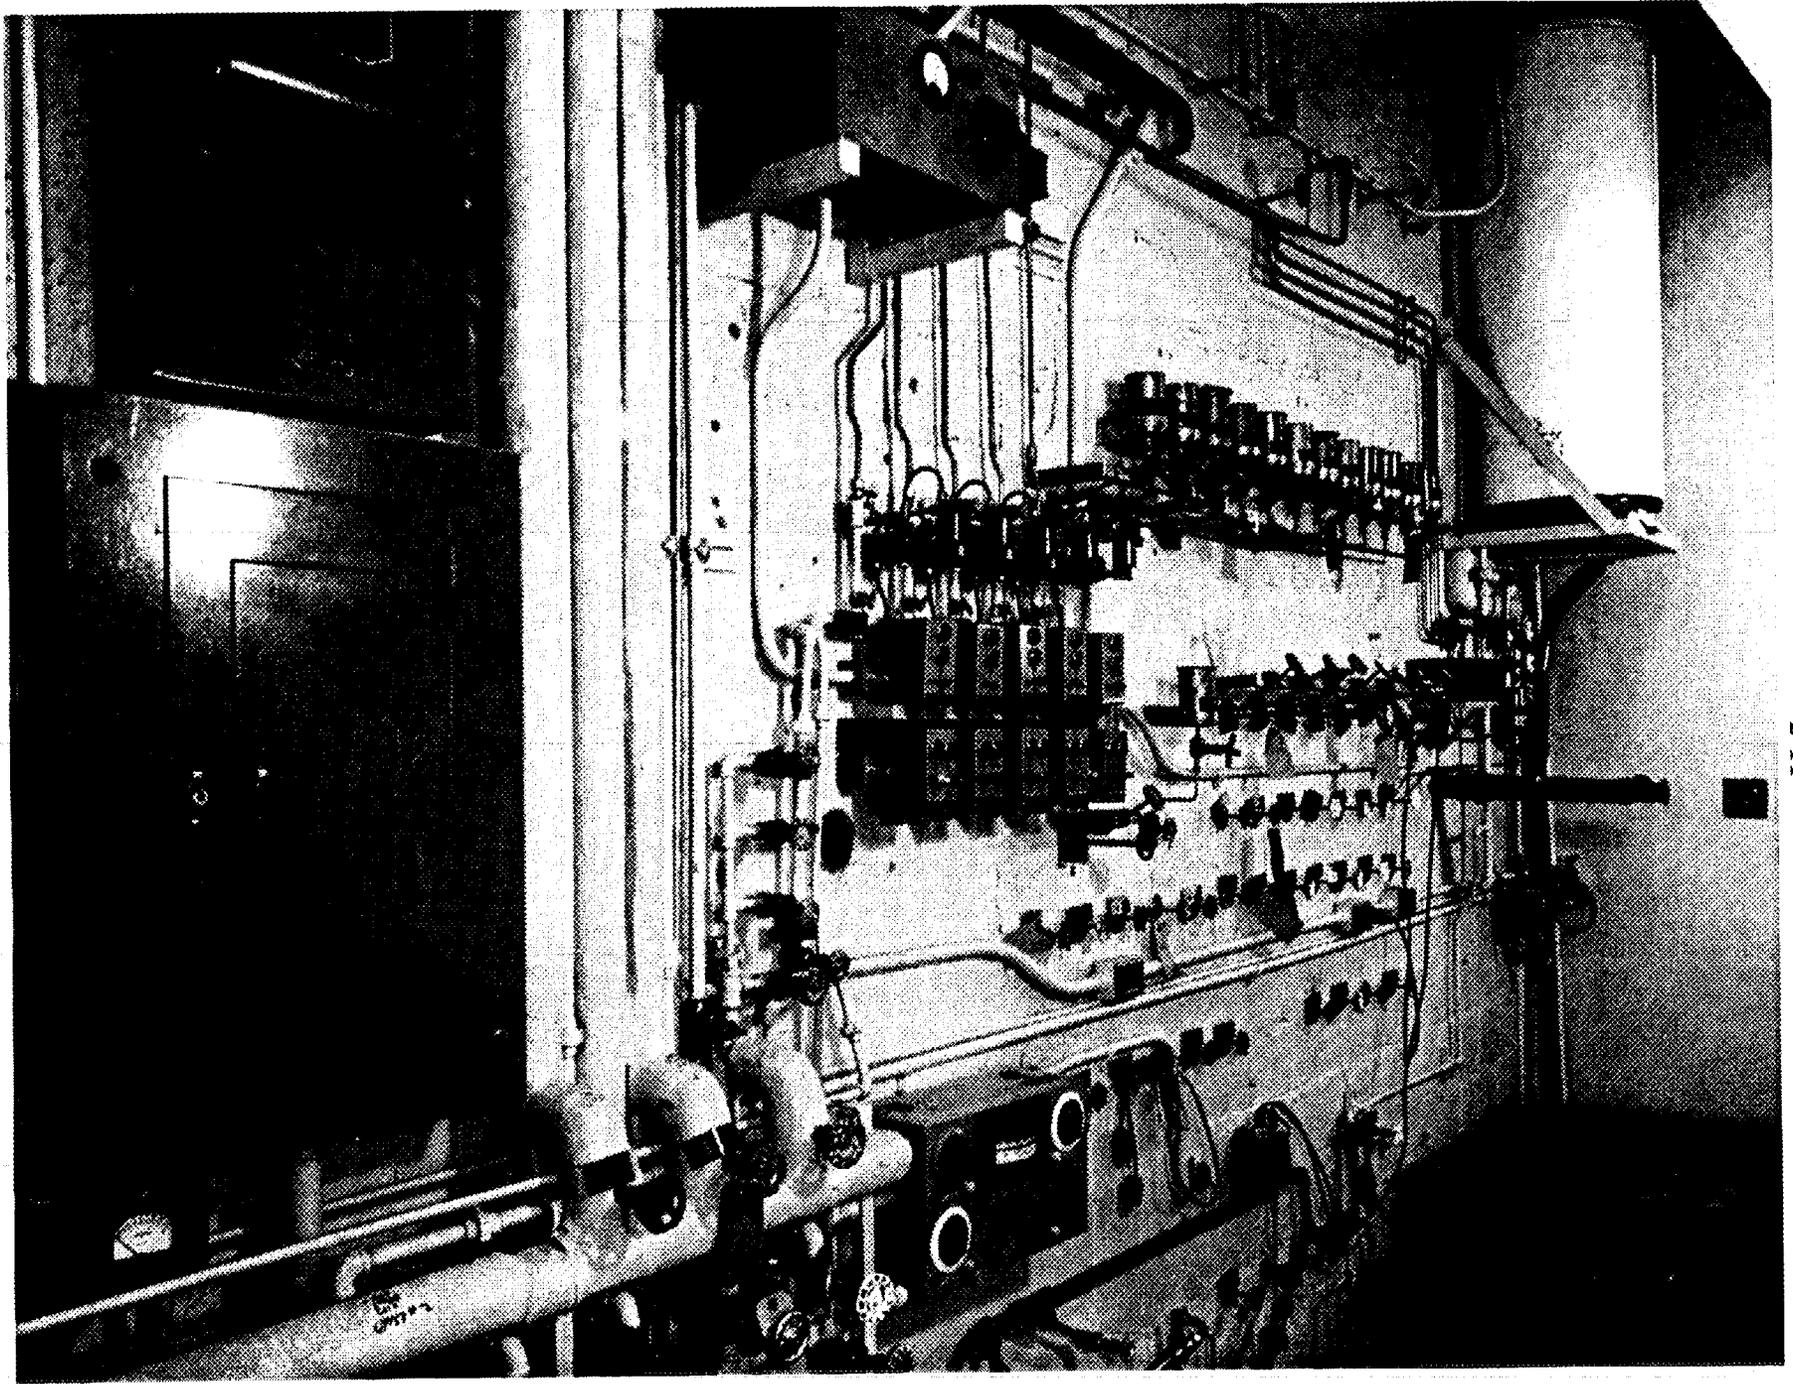
Fig. 2.6. West wall of gallery or control room on east side of north cell. (ORNL photo 10491; October 31, 1952)

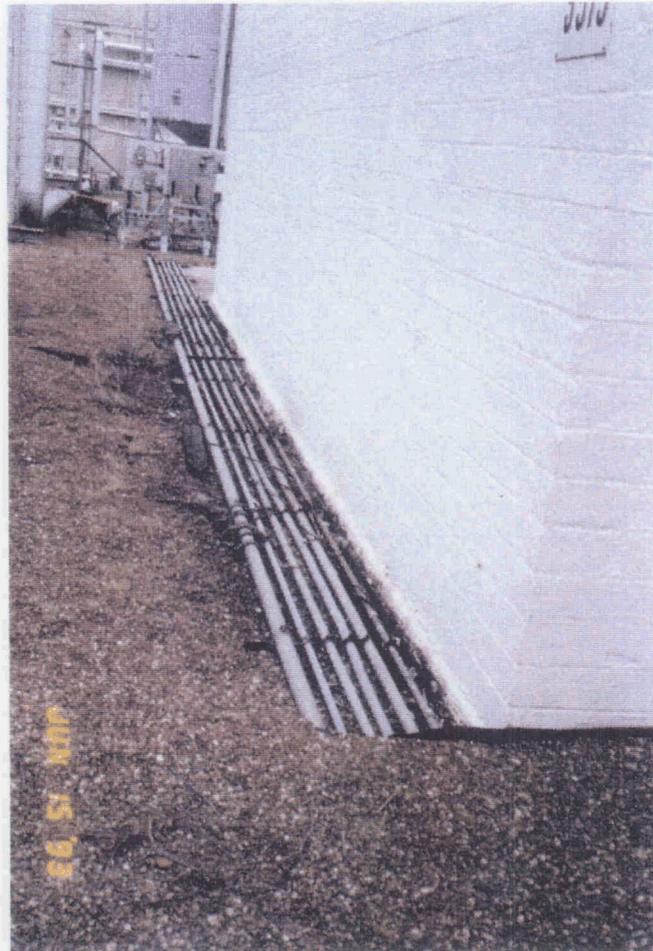
Fig. 2.7. Electrical conduit lying at the base of the east wall.

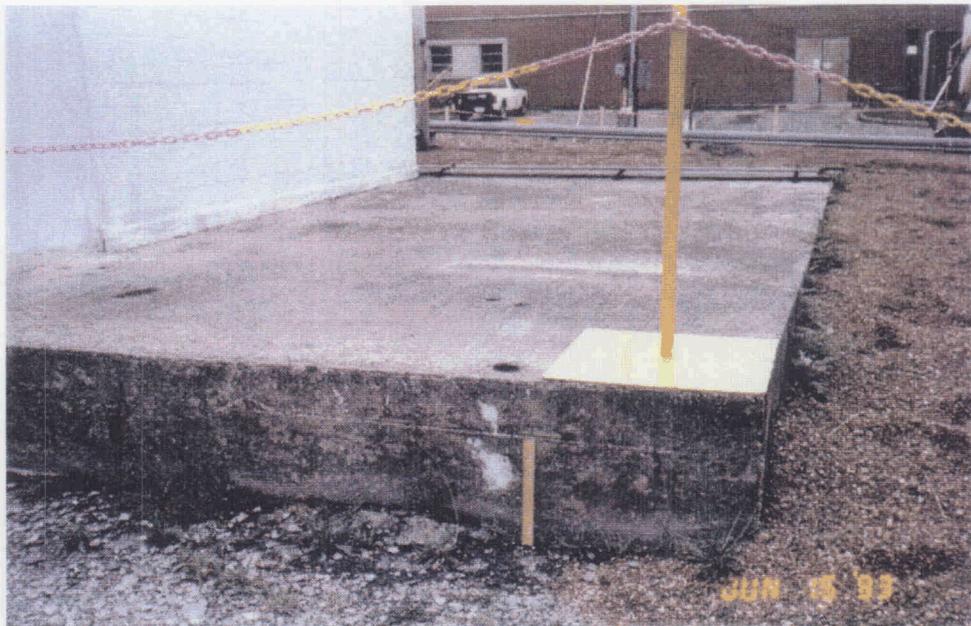
The concrete pad (foundation) extends 10 ft 8 in. from the south wall (Fig. 2.8). It was from this area of the pad that concrete cores were drilled from two locations for radiological and chemical analyses (see Sect. 3). Drilling at the location closest to the building progressed only 9½ in. before the drill encountered a steel plate, the extent and purpose of which are unknown. The other core penetrated the entire depth of the pad; this core (Fig.

Fig. 2.8. Concrete pad by the south wall.

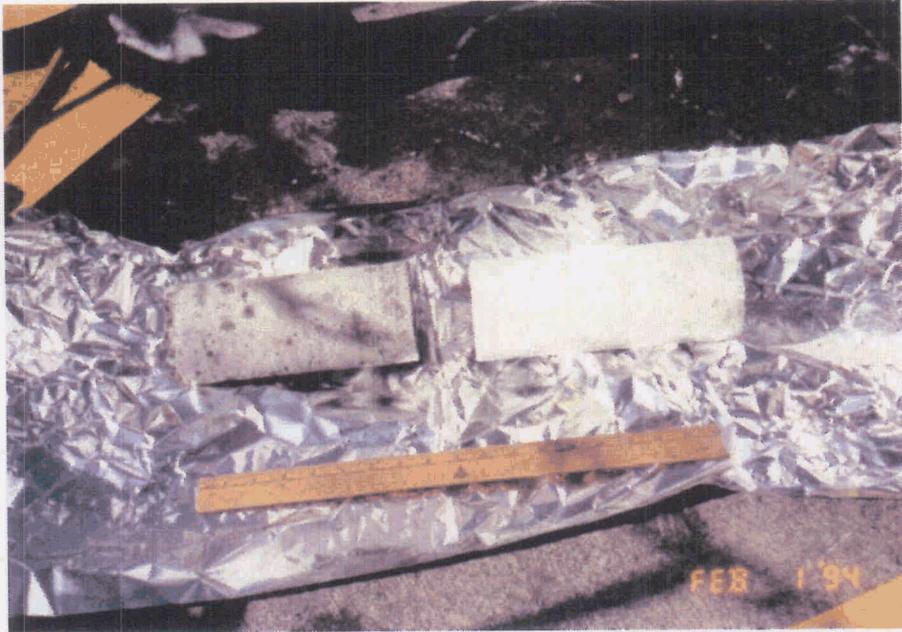
2.9) indicates that the pad is 1.5 ft deep and consists of two separate pours; the first (bottom layer) is 0.7 ft thick and the second (top layer) is 0.8 ft thick. A 4.5-ft-deep soil composite sample was taken below the concrete pad; refusal (i.e., bedrock) had not been reached at this depth.

Fig. 2.9. Concrete core (location 73.SB002) from the concrete pad south of Building 3515.

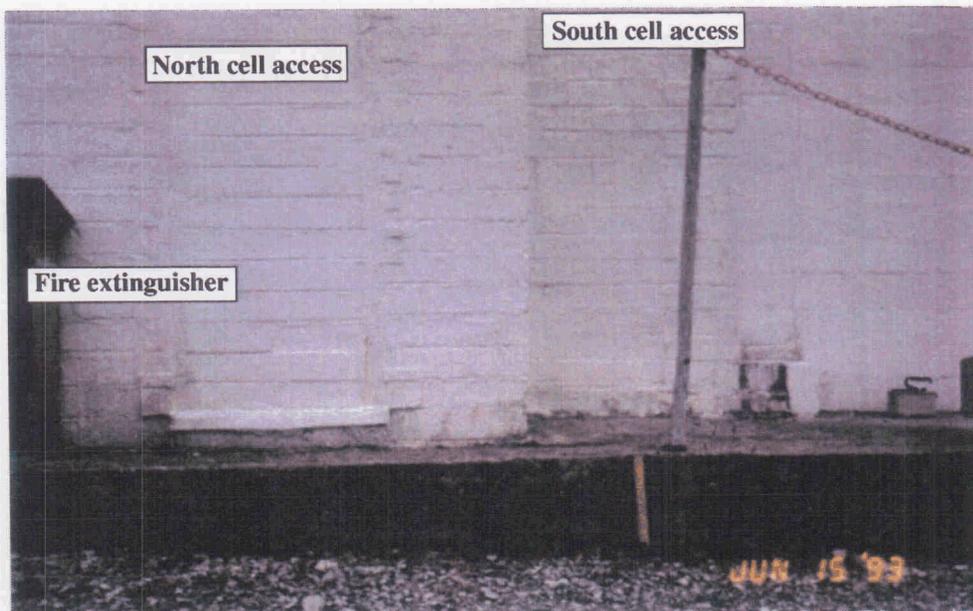
Fig. 2.10. Blocked-up entrance ways to cells on the west wall.

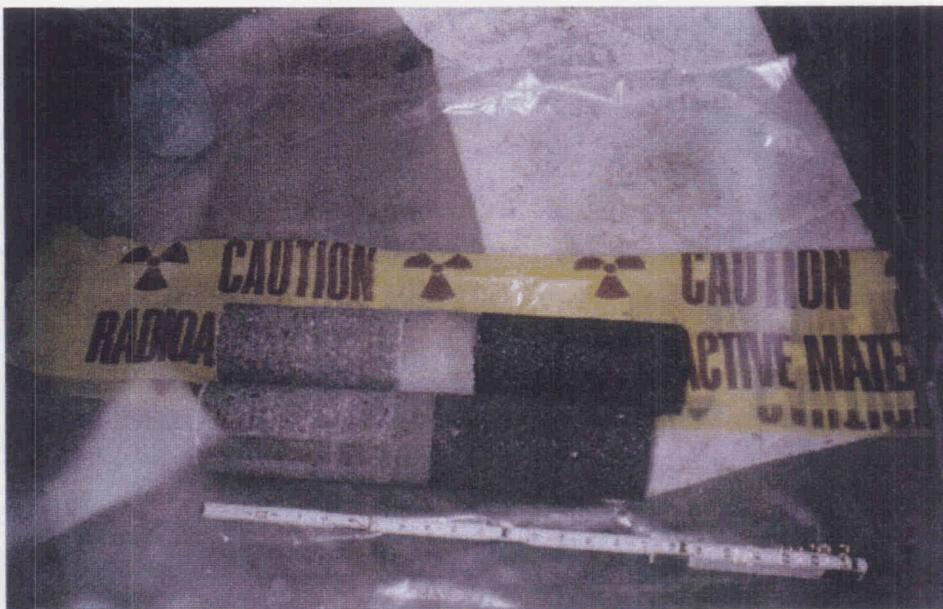
Two 4-in.-diameter core holes were drilled in the north cell entrance way (see Sect. 6, Fig. 6.1); access to the north cell for the camera and instruments was through one of these holes. The north cell door cores (Fig. 2.11) were approximately 1.5 ft long and contained two concrete block sections "sandwiching" poured concrete fill. There is also a layer of stacked blocks in the entrance way; the core drill did not penetrate all the way through the stacked blocks, but pushed some of them into the north cell.

Fig. 2.11. Two concrete cores from the north cell door.

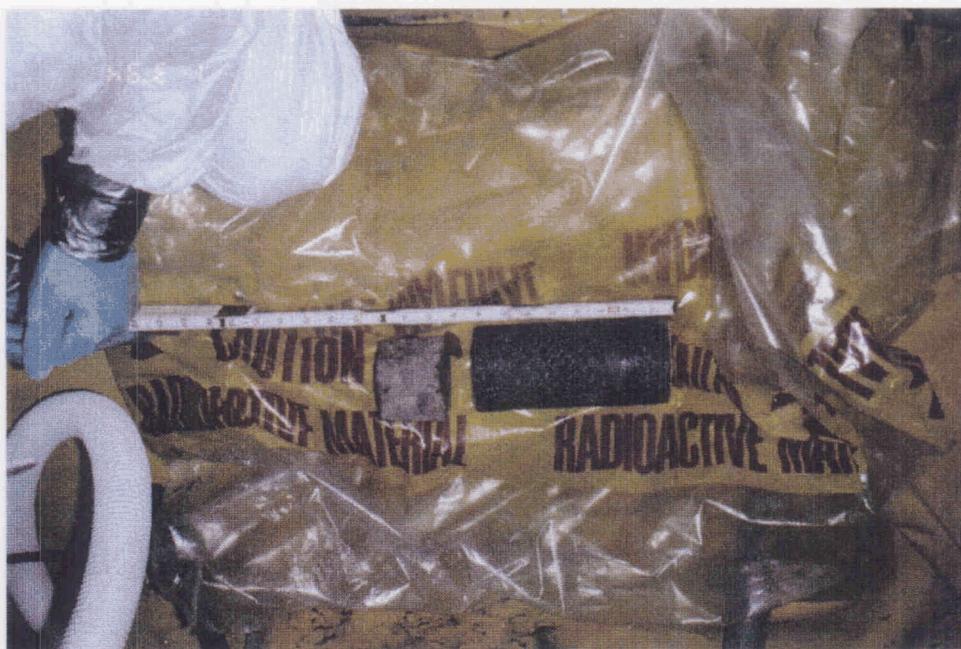
Fig. 2.12a. Single concrete core from the south cell door.

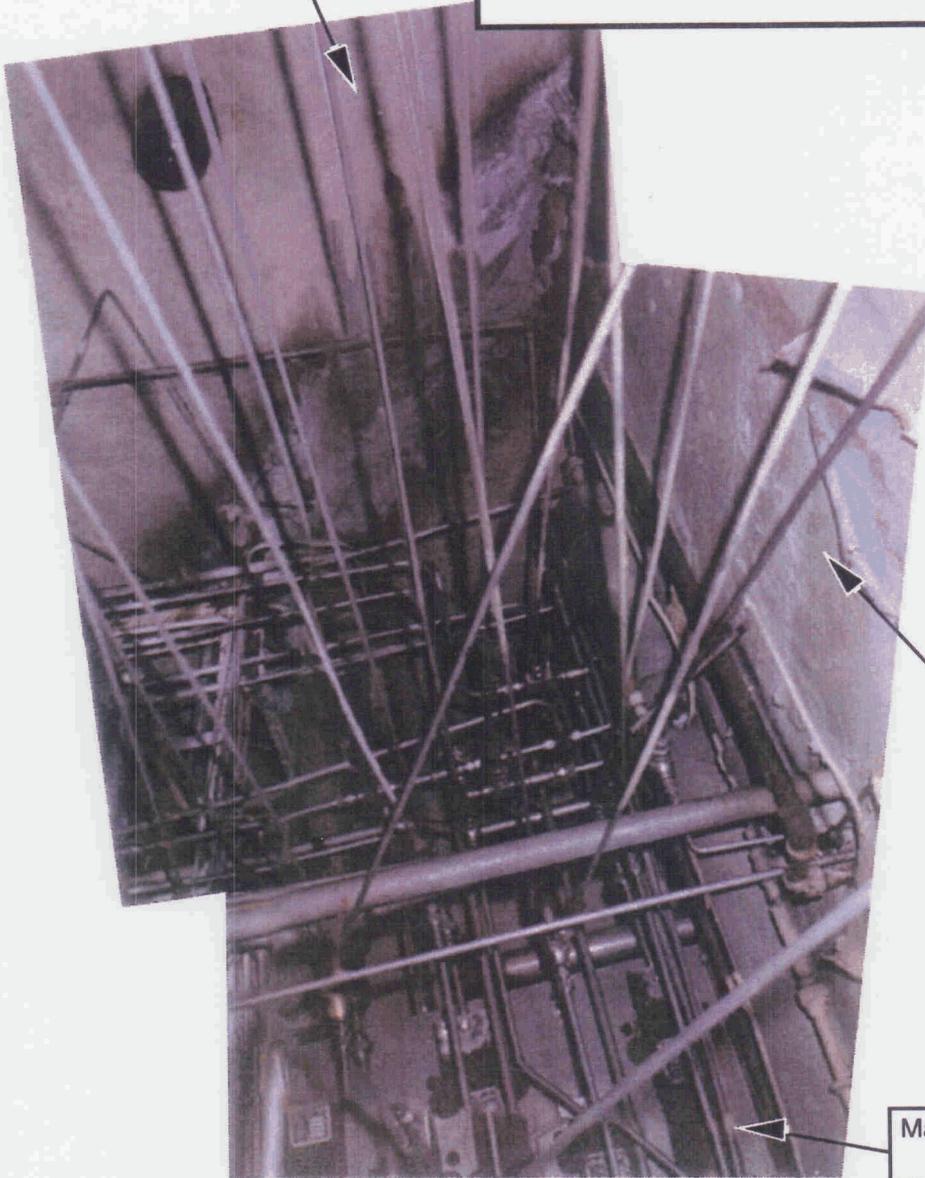
Fig. 2.14. North cell interior: composite photograph showing overhead view of cell from cell doorway.

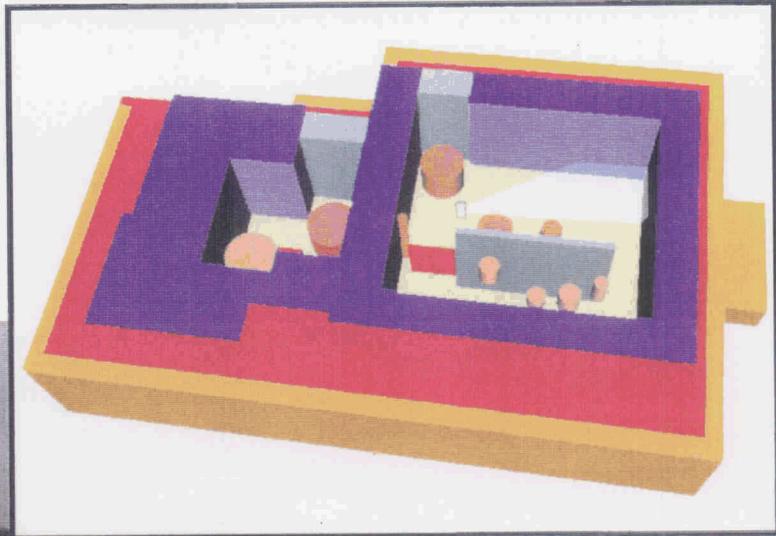
Fig. 2.15. North cell interior: northwest corner.

Figure 2.15, which shows the northwest corner of the cell, provides additional detail on the lamp/light fixtures on the west wall. The paint skin on the west wall has formed bubbles but is not flaking off; the floor in the northwest corner shows significant deterioration, discoloring, and patches of detritus. Near the top of the west wall (not shown in Fig. 2.15) is what appears to be a radiator or heat exchanger with cooling fins.

West wall

Precipitator No. 1

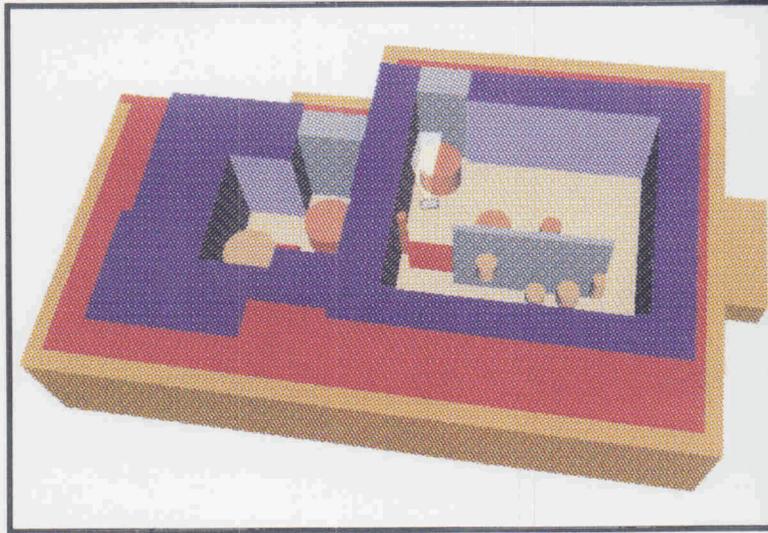
Fig. 2.16. North cell interior: southwest corner of cell behind vessel S-5.

Figure 2.16 is a 1993 photograph of the southwest corner of the cell immediately behind the S-5 vessel showing valve extension handles passing to the south of the doorway and some of the stacked concrete blocks filling up the doorway.

Vessel S-5

Valves include two- and three-way solenoid valves, Alloyco and Powell ¼-in. semineedle valves, Powell ¼-in. check valves, a few Durco plug valves, and a few 1-in. gate valves. The process design specified that all valves, where possible, be on the west side of the equipment rack. Many valve extension handles were taken through the east wall of the cell into the control room (see Fig. 2.17), but extension handles also were taken through the west wall to meter flow for the product sample and removal station and through the walls around the doorway (Figs. 2.14 and 2.16) for the manometer board and the vacuum reducer on the south wall.

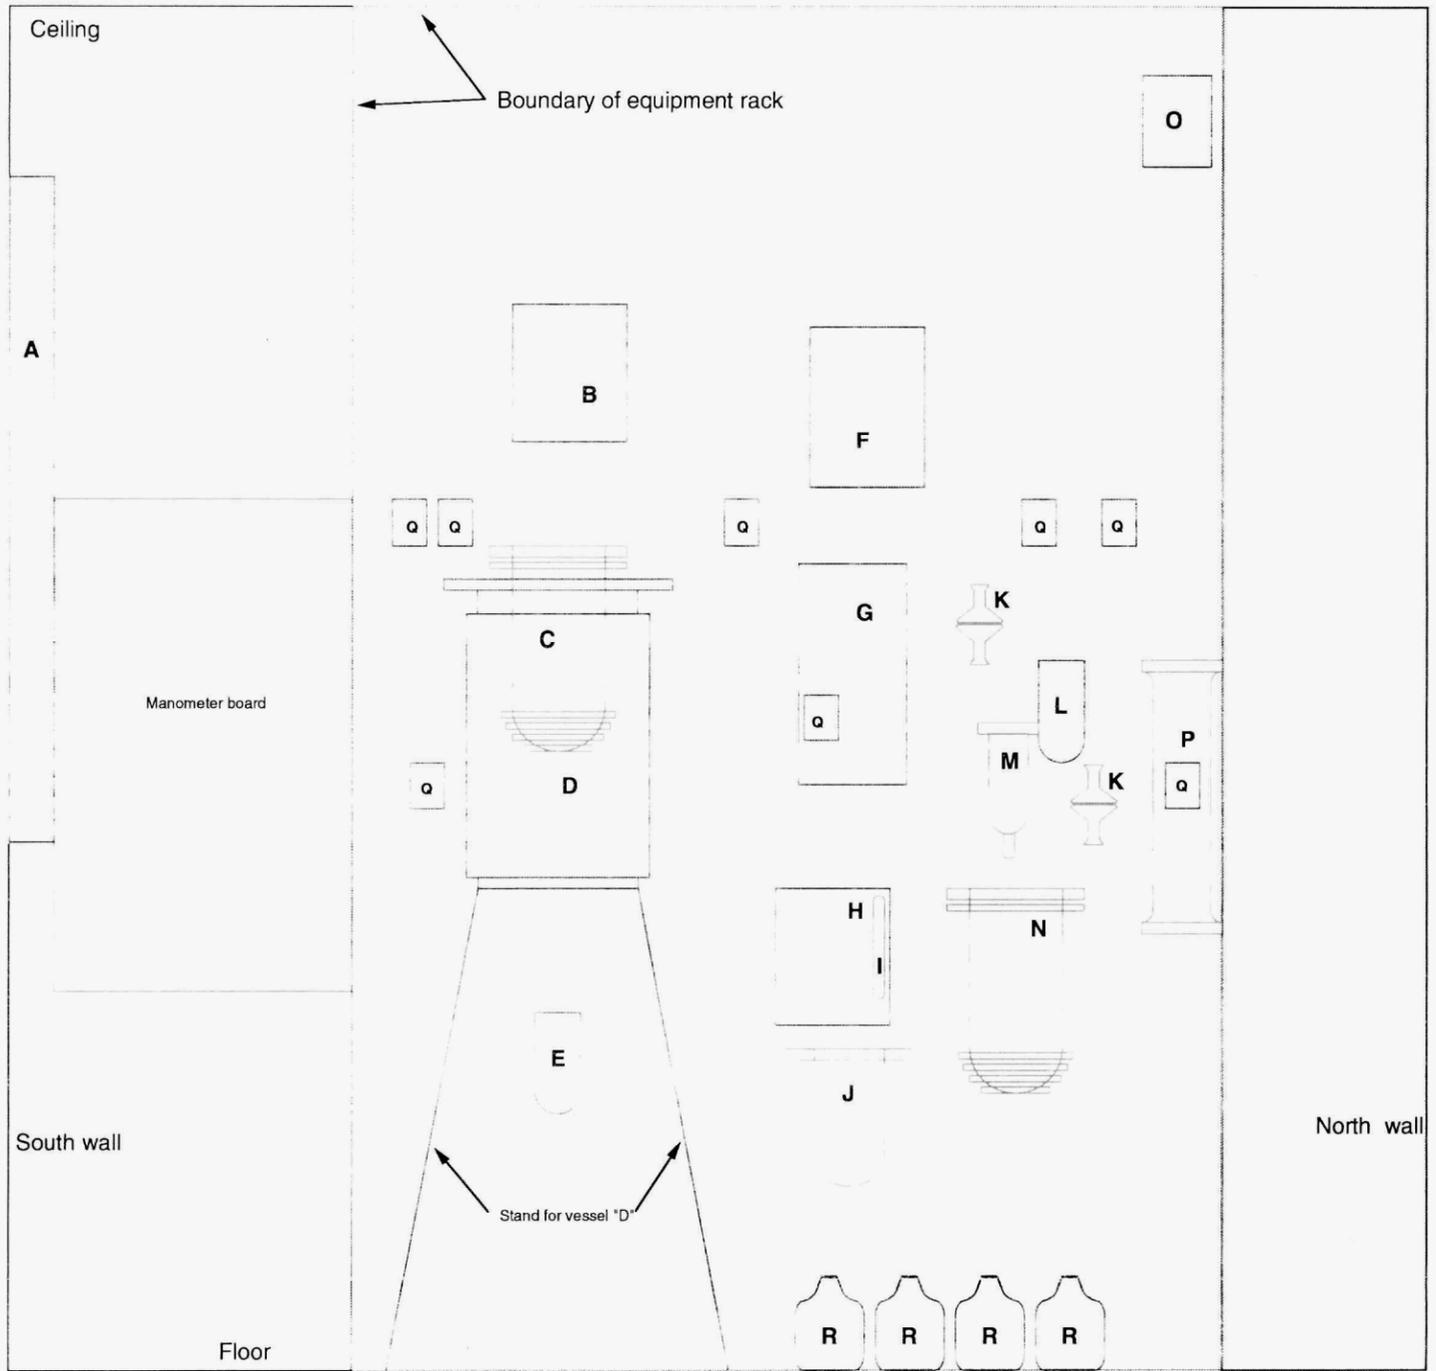
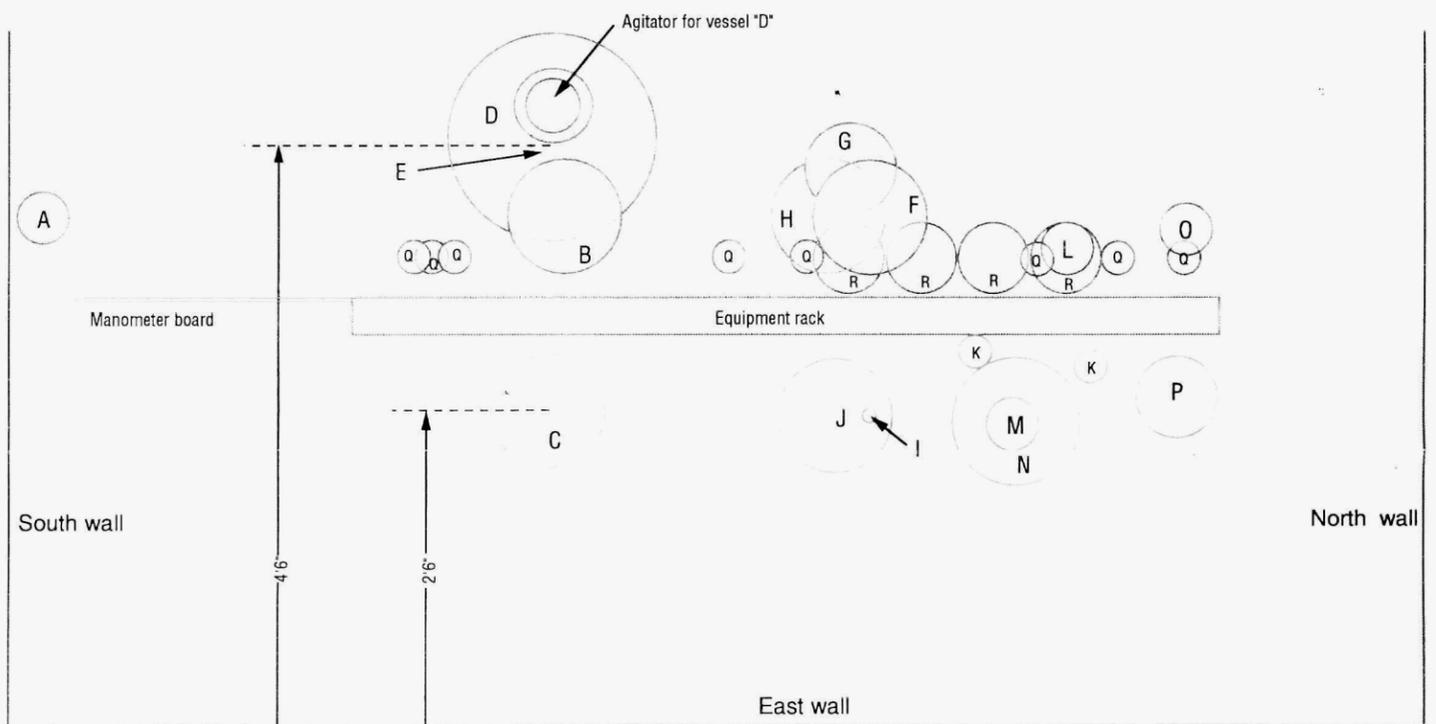
Fig. 2.18. Location of vessels on the north cell equipment rack.

Vessel in Fig. 2.18	Potential Vessel Type	Description			ORNL Fabrication Drawing	Vessel ID in ORNL drawing D-RD-732 <sup>a</sup>
		Material	Length (in.)	Diameter (in.)		
A	Vacuum scrubber	Stainless steel	60-3/4	4-3/4	C-RD-633	None
B	Filtrate vessel No. 1 (15 L)	Stainless steel	12-3/4	10	C-RD-614	T-1
C	Crystallizer No. 2	Glass	18	8	C-RD-627 <sup>b</sup>	C-2
D	Precipitator No. 1 <sup>c</sup>	Stainless steel	27	15	A-RD-617 C-RD-618	P-1
E	Filter <sup>d</sup>	Glass	13	10-1/2	D-RD-655	F-1
F	Sampler transfer (15 L)	Stainless steel	12-3/4	10	C-RD-616	T-3
G	Unknown <sup>e</sup>	Stainless steel	16	8	NA	T-4
H	Filtrate vessel No. 2 (15 L)	Stainless steel	12-3/4	10	C-RD-615	T-2
I	Glass condenser	Glass	11-1/2	1-1/2	C-RD-643	None
J	Ru Scrubber	Glass	13	6	D-RD-628 <sup>b</sup>	SC-1
K	Product filter	Glass pipe	7-1/2	4	A-RD-703	F-2, F-4
L	Product transfer	Stainless steel	10-1/4	4-1/2	C-RD-629	PT-1
M	Selas filter assembly	Glass pipe	12-1/4	3	A-RD-702	F-3

N	Precipitator No. 2 (10 L)	Glass	17	8	D-RD-624 <sup>b</sup>	P-2
O	Vent overflow	Stainless steel	8	5	C-RD-636 <sup>b</sup>	None
P	Sample dilution (5 L)	Pyrex pipe	24	4	B-RD-630	PT-2
Q	Solution addition funnels (500 mL)	Stainless steel	5	3	C-RD-636	None
R	Storage bottles <sup>f</sup>	Glass (bottles)	16	9	NA	S-1 <sup>f</sup>

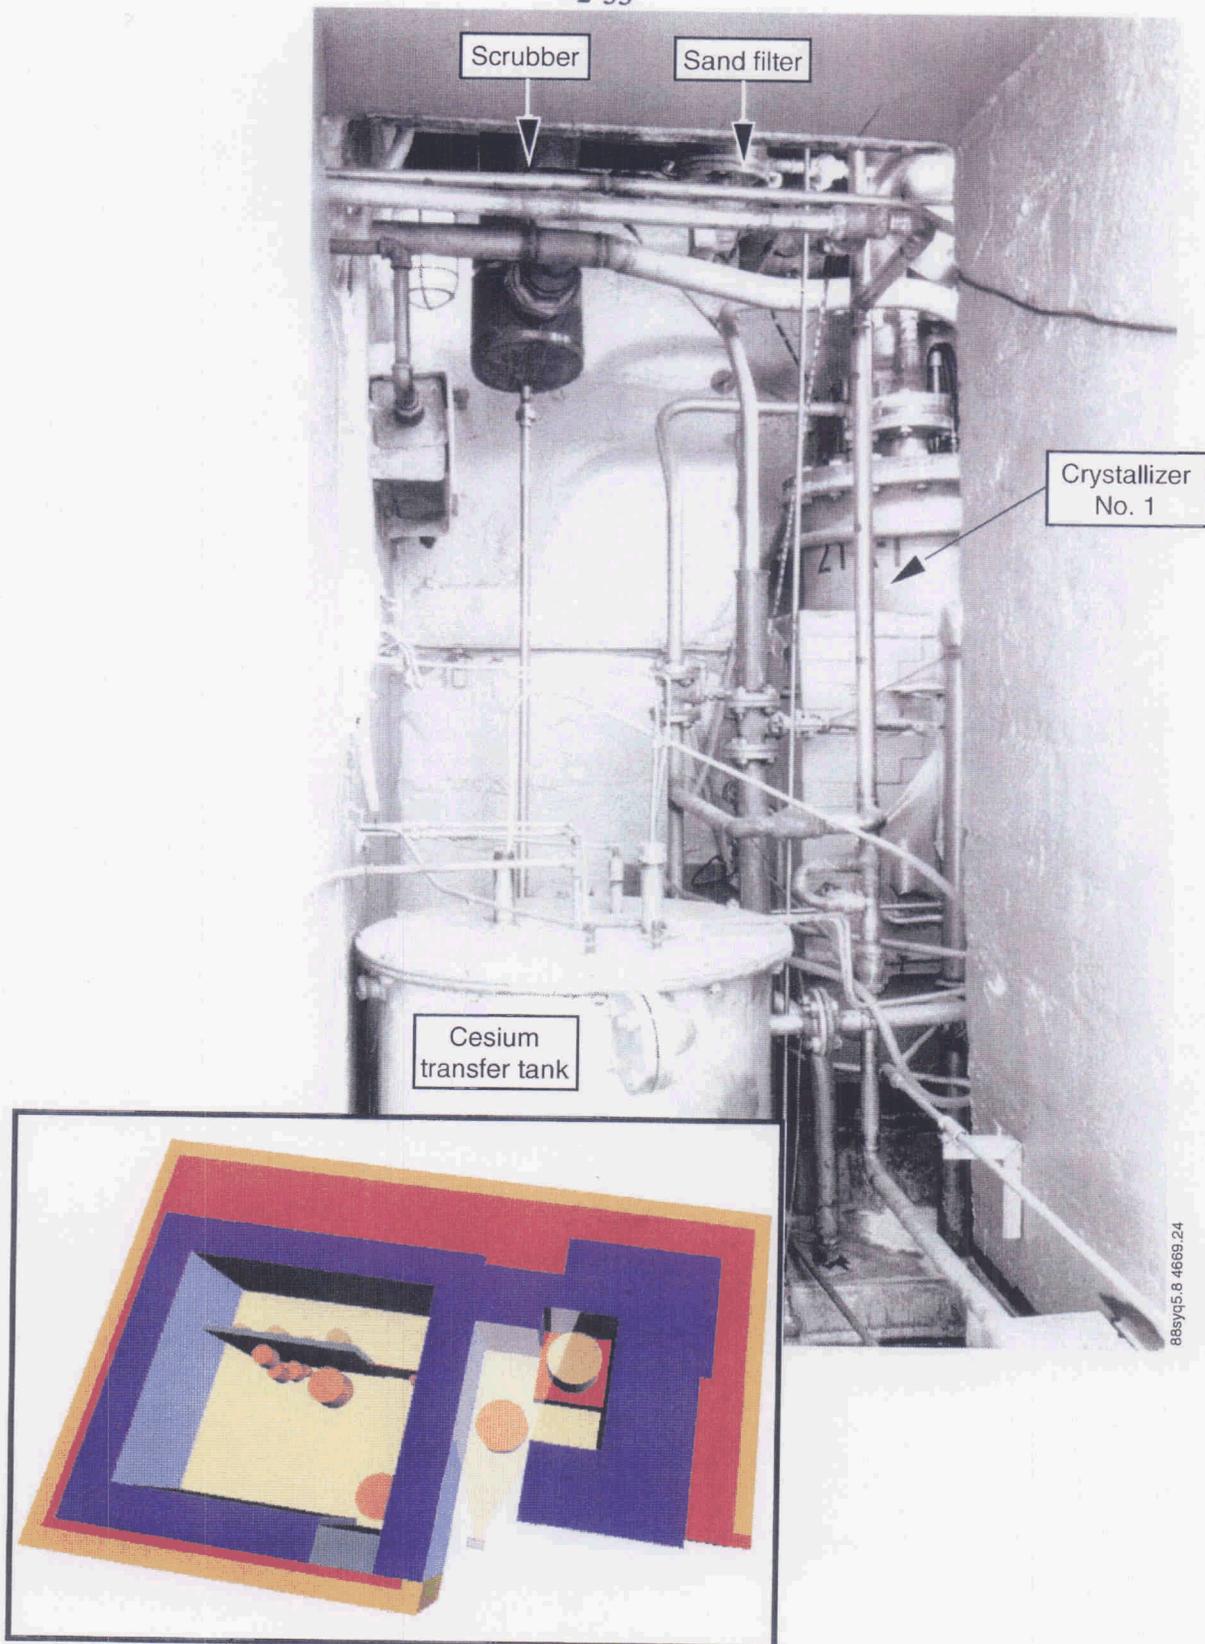
Figures 2.20 and 2.21 are photographs of the south cell interior taken in October 1952 from the entrance way. A comparison with photographs taken during the 1993-94 site investigation (shown later in this subsection) indicates that the cell piping and equipment remain essentially unchanged.

Fig. 2.20. South cell. (ORNL photo 10503; October 31, 1952)

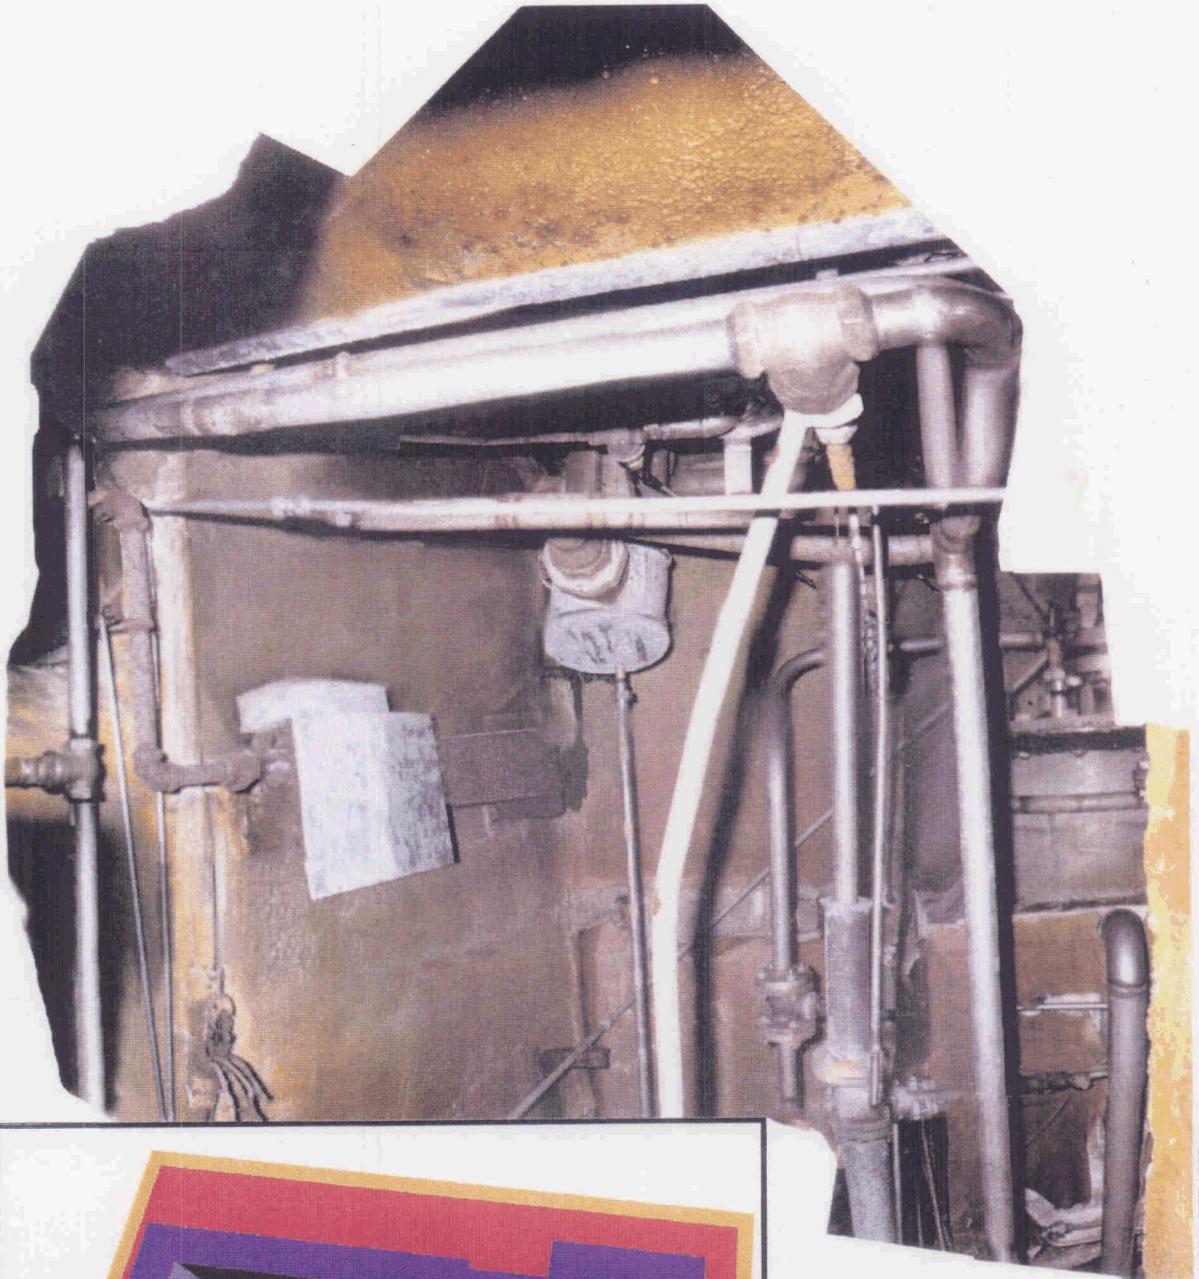
Fig. 2.22. South cell: composite photograph from entrance way showing north and east portions of cell.

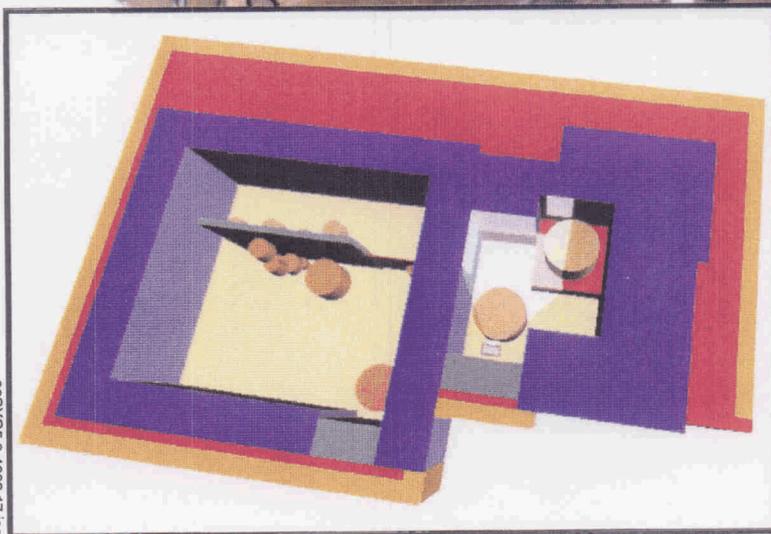
88SY05.8.4669.17

Figure 2.22 is a 1994 composite photograph from the entrance way that primarily shows the north and east sides of the south cell. Seen in this figure are the crystallizer vessel, the scrubber, and assorted piping, including penetrations through the north wall for pipes at the top and end of the entrance way. The wall coloring in the photographs varies from yellow to brown to red, depending on camera lighting (flash) and photograph development. The exception is the wall coloring in the alcove, which is gray, indicating that the alcove walls may not have been painted and/or not exposed to the same chemicals as the other walls. Some of the paint covering the walls has deteriorated and is blistering or peeling.

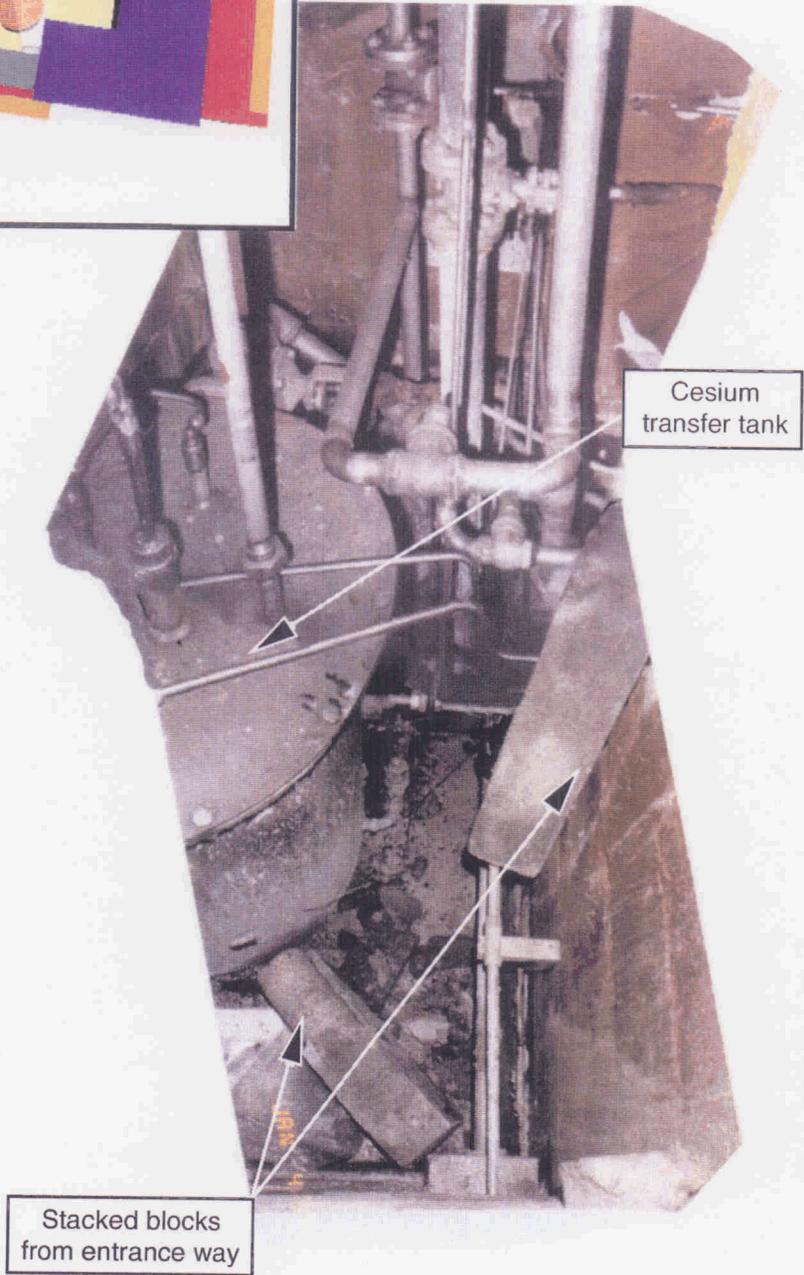
Figures 2.23 and 2.24 are composite photographs of the cesium transfer tank, ancillary piping, valves, extension handles, and the area around the tank. Detritus is seen on the top of the tank as well as on the floor; only a small fraction of the piping shows rust. Shown in Fig. 2.23 are two concrete blocks that were pushed into the cell during the attempt to gain access through the stacked blocks in the entrance way. (One of the blocks was drilled halfway through before it fell out of the stack.)

Fig. 2.23. South cell: composite photograph of cesium transfer tank and entrance way floor.

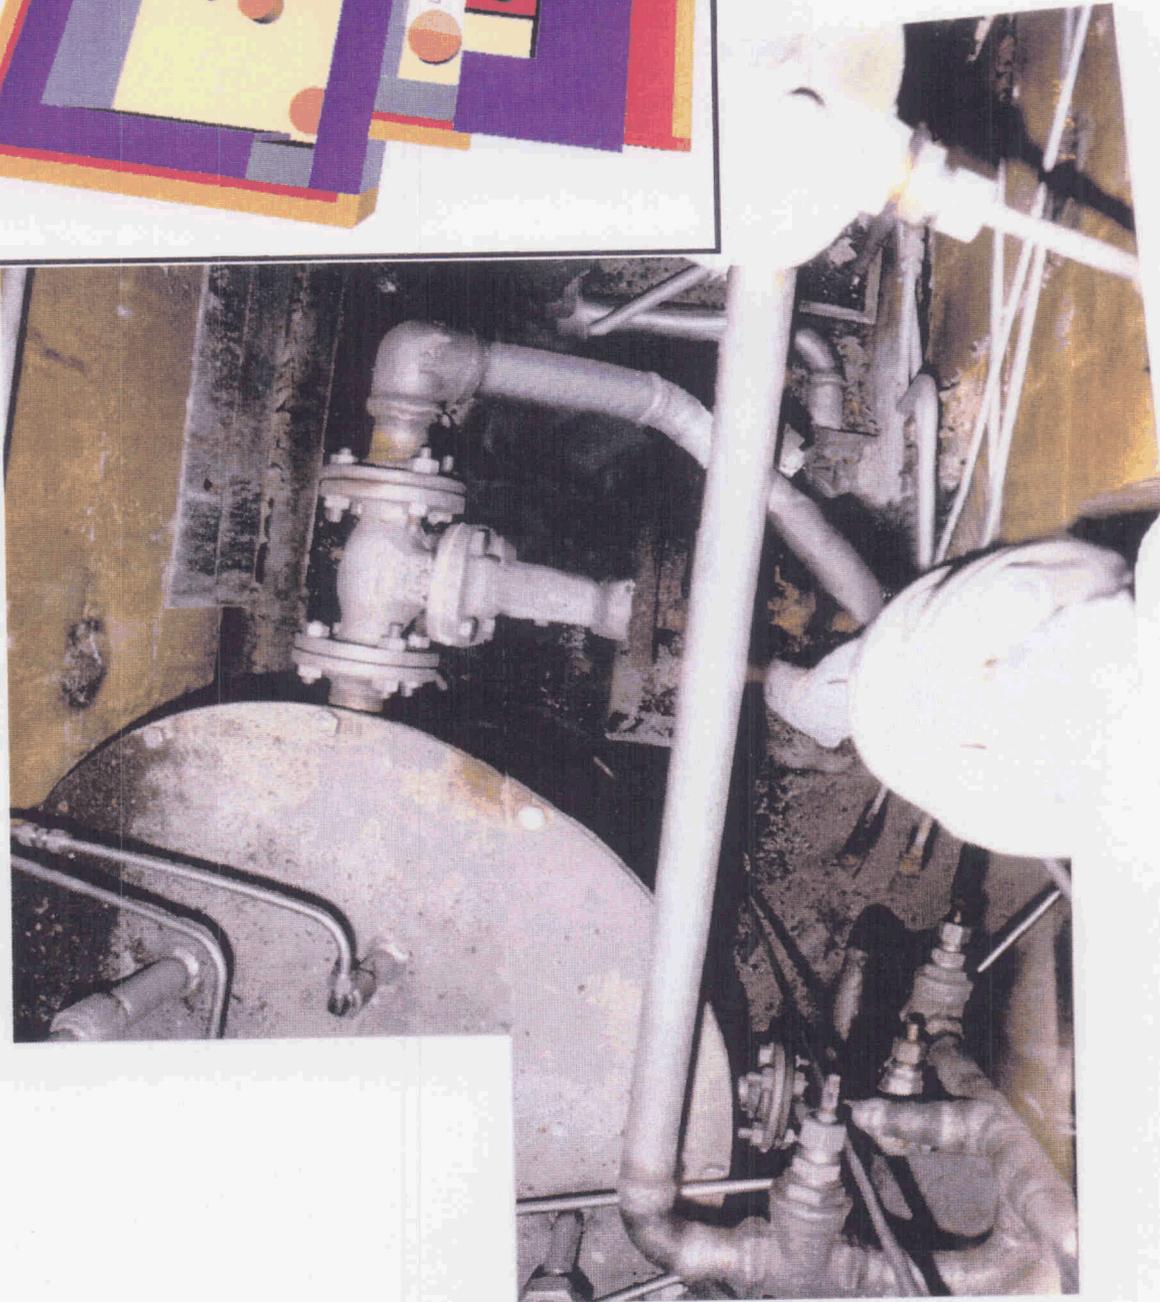
Fig. 2.24. South cell: composite photograph of floor area behind (to the east of) cesium transfer tank.
