**Site Characterization Report  
for Building 3515 at Oak Ridge  
National Laboratory,  
Oak Ridge, Tennessee**

Date Issued—August 1994

Prepared by  
Bechtel National, Inc.  
Oak Ridge, Tennessee  
under subcontract 12B-99053C

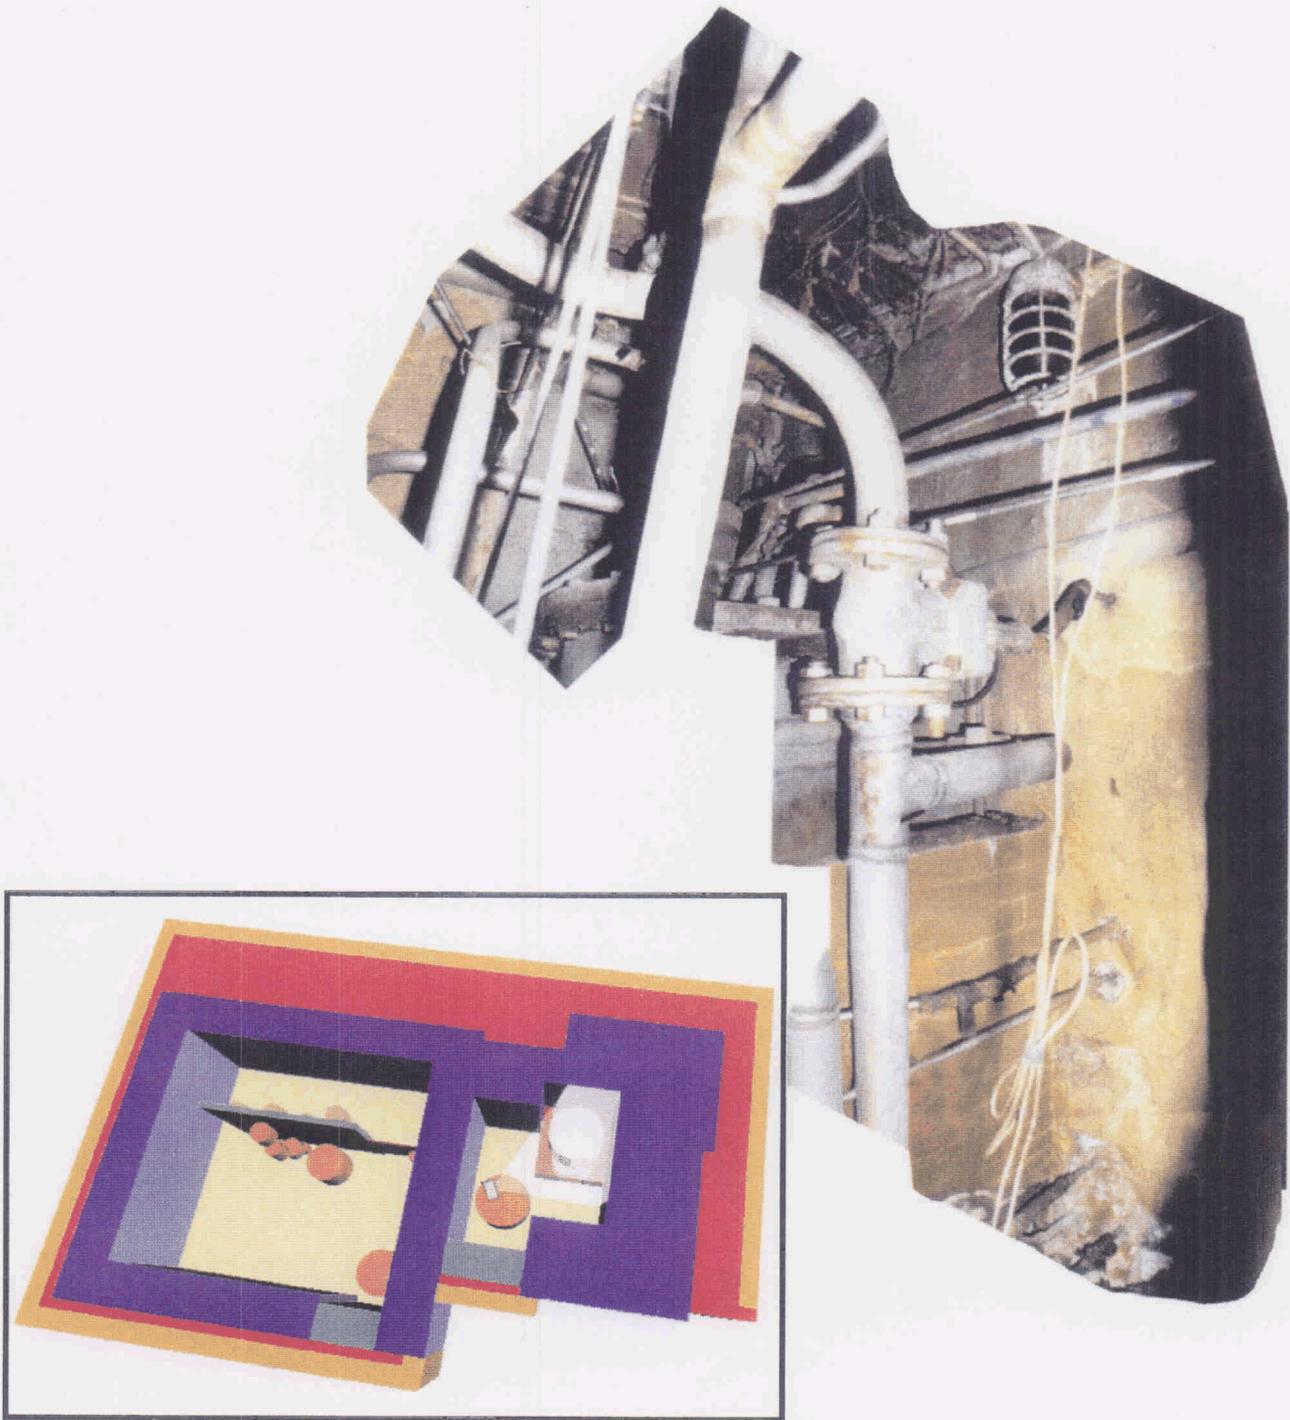
Figure 2.25 is a composite photograph showing the crystallizer vessel, the shield wall, and the cell's south wall. Figure 2.26 shows the bottom portion of the south wall between the crystallizer shield wall and the west wall. Some flaking of the concrete wall and paint are evident where the valve extension handles and pipes penetrate the wall. The steel I-beams and steel plate forming the ceiling have rusted in the area above the crystallizer vessel.

Fig. 2.25. South cell: composite photograph of southeast corner and south.

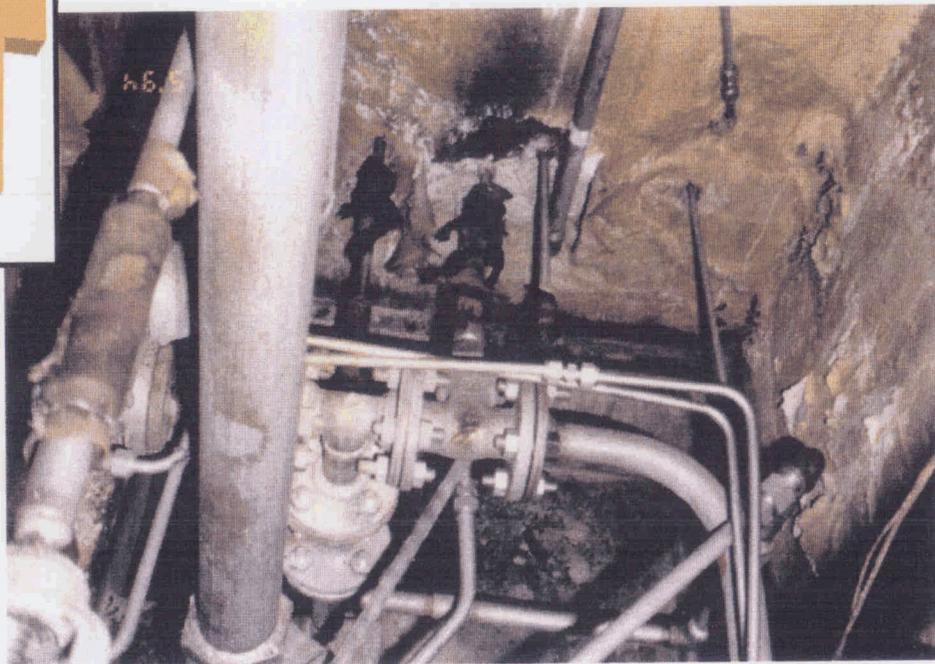
Fig. 2.26. South cell: bottom portion of southwest corner.

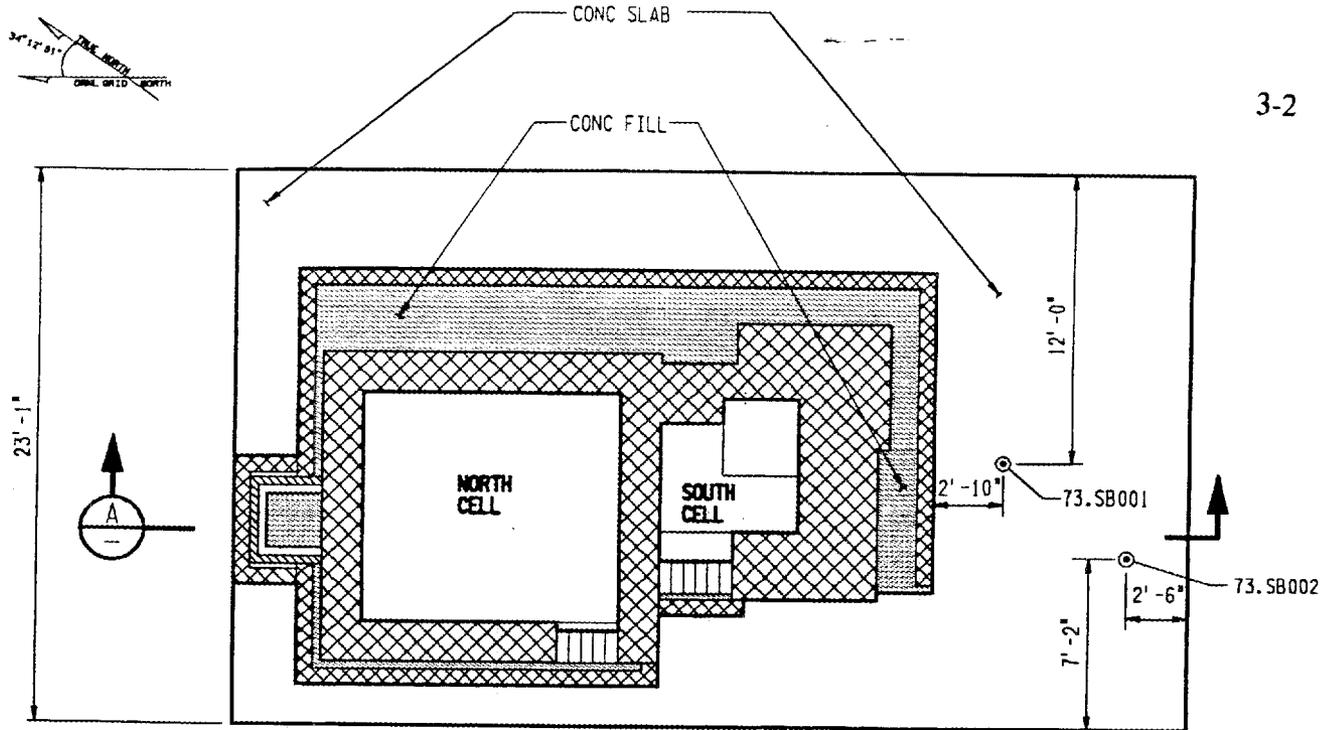
**BUILDING 3515, PLAN**

Figure 3.1 shows the boring locations for the concrete cores and the soil sample. Table 3.1 provides location number, sample number, sample type and description, and types of analyses performed for each sample. Laboratory analyses included a full suite of hazardous chemicals and radionuclides; results are presented in Sects. 4 and 5.

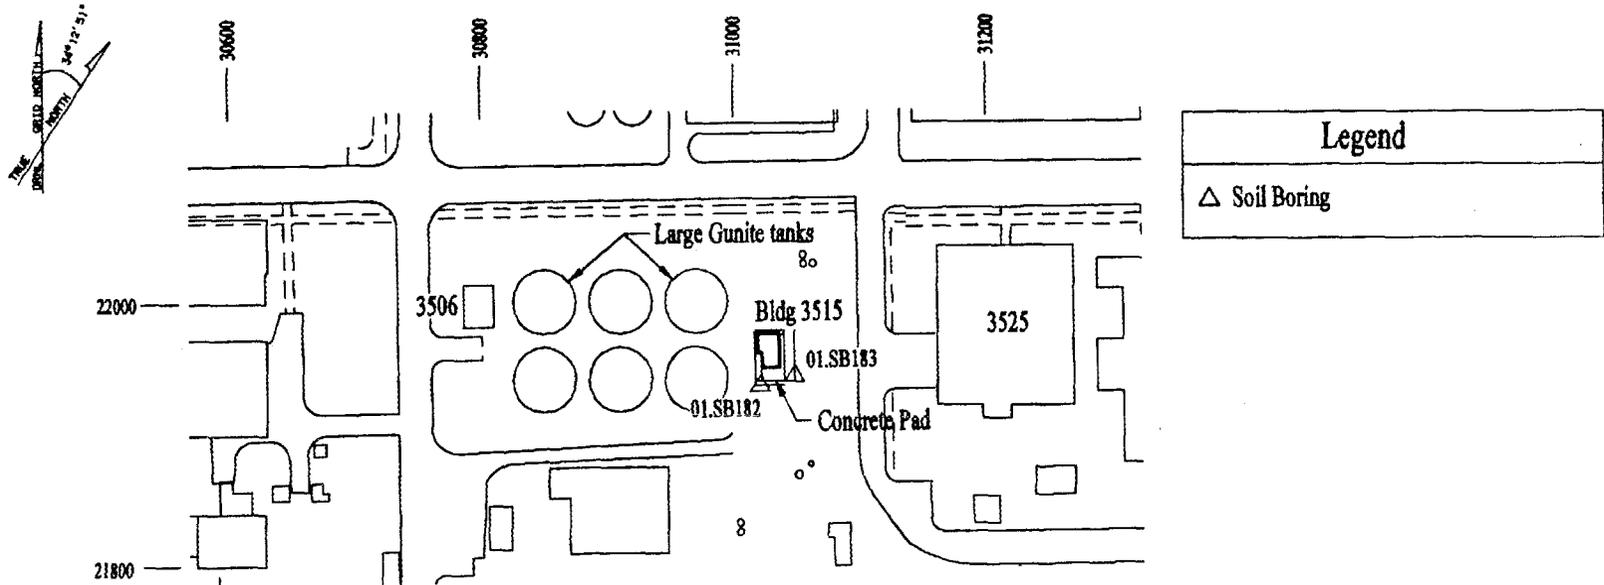
Fig. 4.1. WAG 1 soil boring locations near Building 3515.

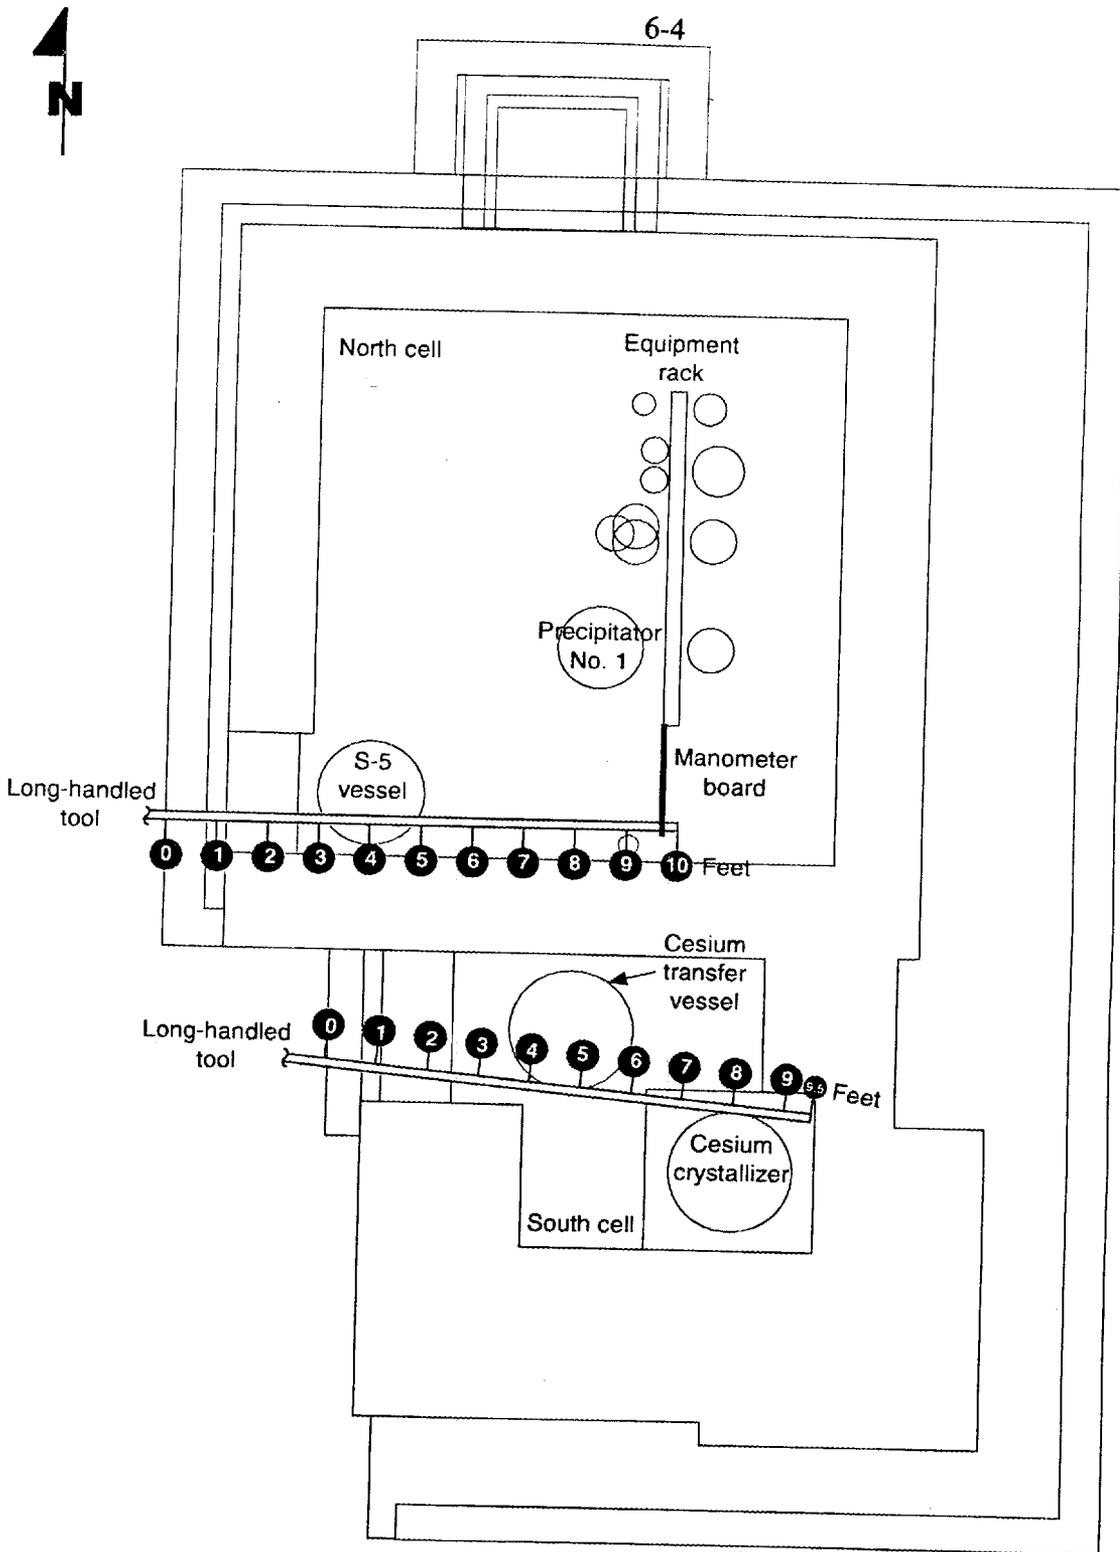
**Fig. 6.1. Penetration distance of long-handled tools into cells from access holes.**  
 (Note: locations and sizes of vessels are approximate; drawing not to scale.)

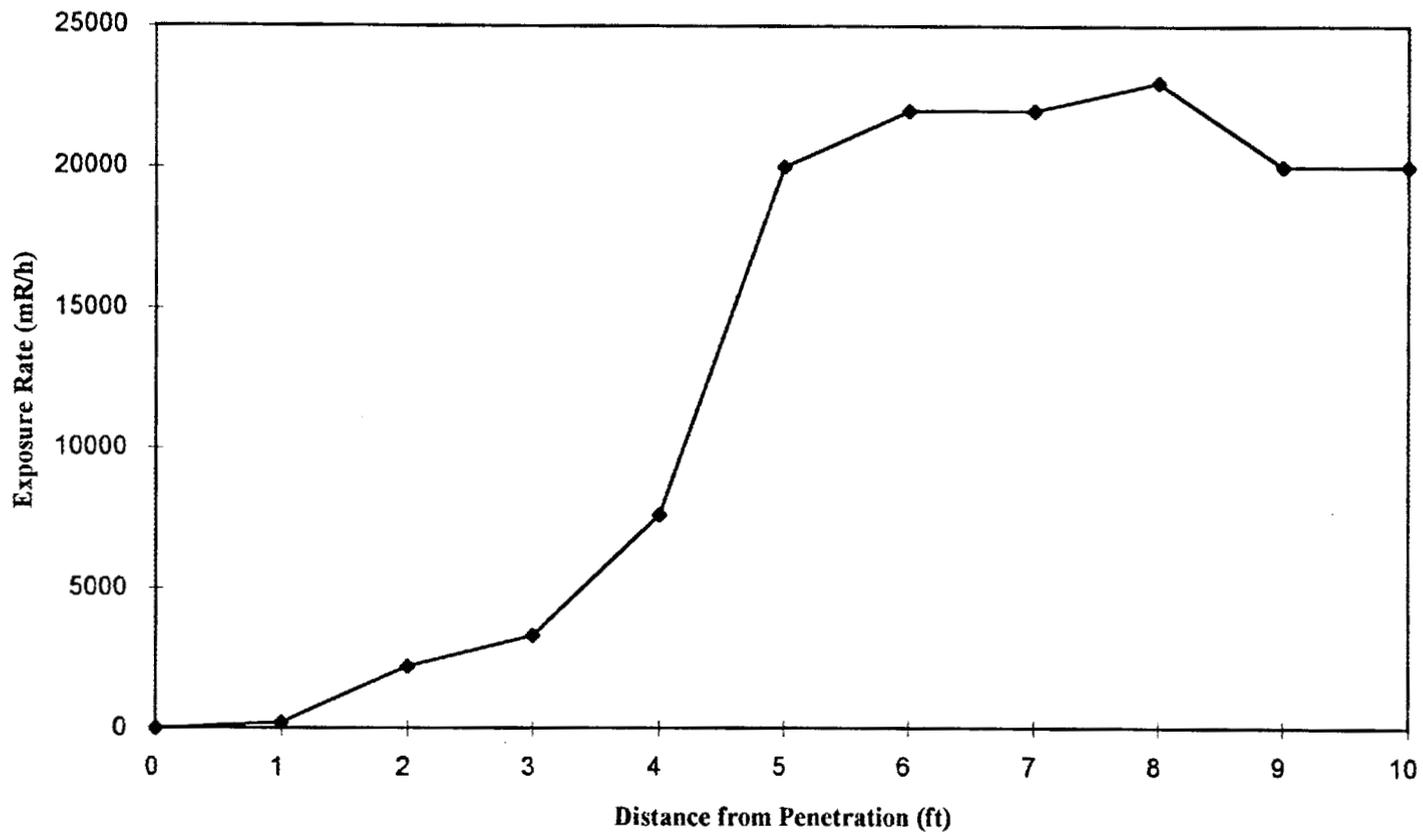
Fig. 6.3. North cell teletector measurement results.

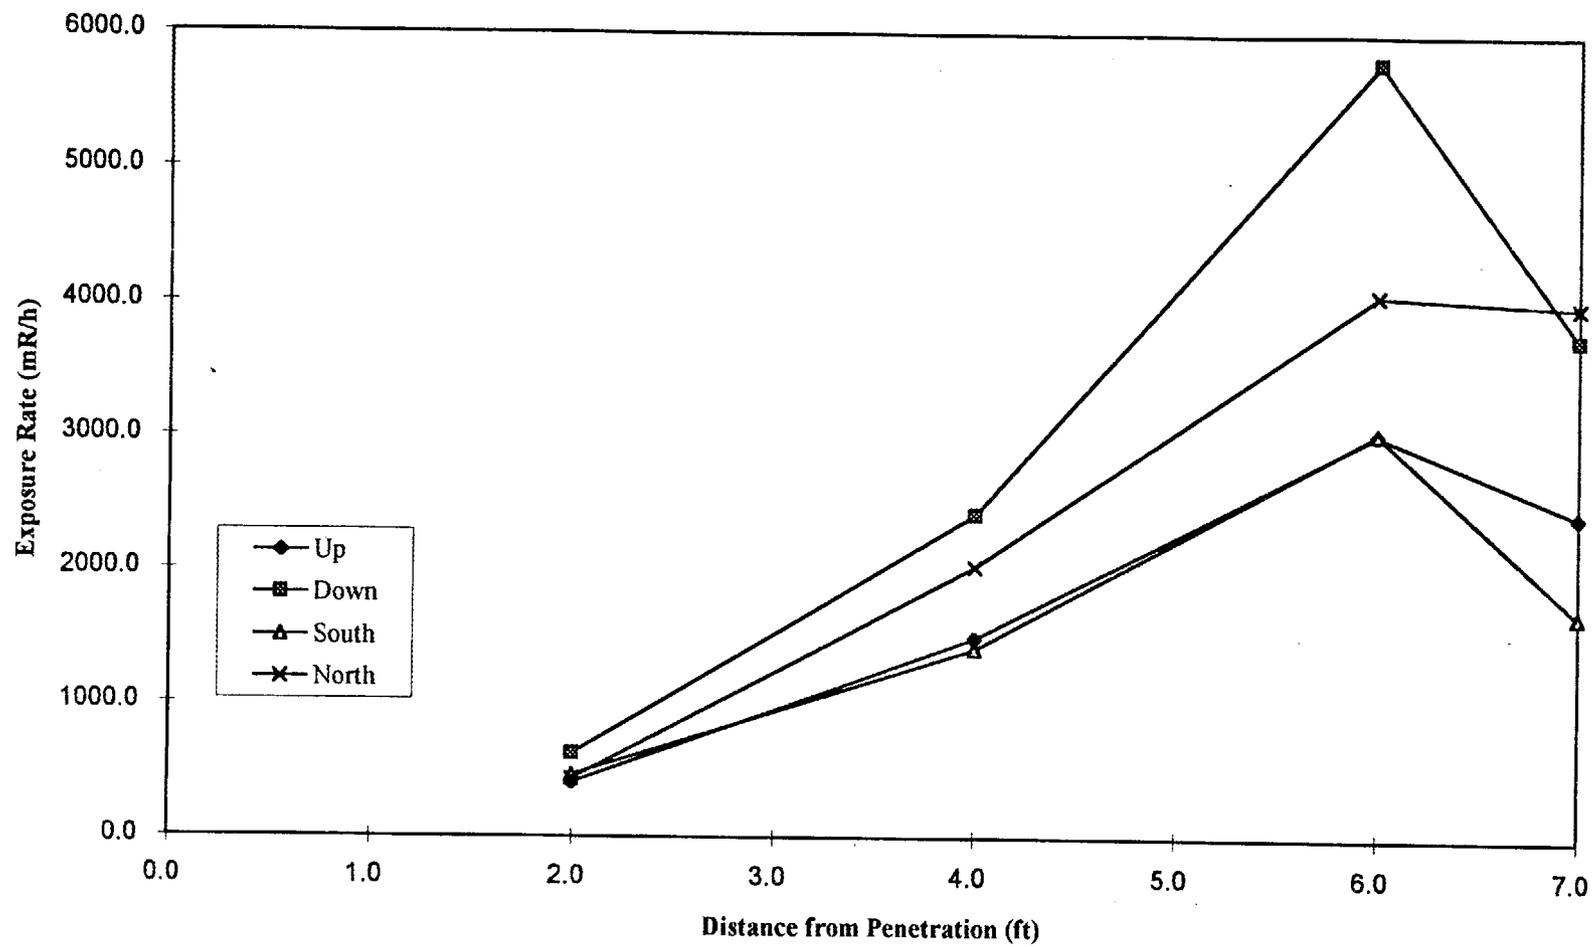
A directional HP-290 probe took horizontal measurements at 2, 4, 6, and 7 ft from the penetration. At each location, measurements were taken in the up, down, south, and north directions to determine which direction contributed the most to the exposure field in the cell. Three 30-s integrated counts were performed in each direction, and the average of the three counts was used with the calibration data to calculate exposure rate. The probe was shielded by ¼ in. of lead (used for gamma shielding to reduce the intensity by a factor of 2 for the cesium-137/barium-137m 662-keV gamma line) and encased in a ¼-in.-thick rectangular Plexiglas box to minimize the effects of beta fields. Figure 6.4 plots results as a function of distance, and Table E.2 presents detailed results. The radiation exposure rates increased with distance from the access hole (approximately 400 mR/h at 2 ft to approximately 5000 mR/h at 6 ft). Trends in radiation exposure rate were similar to those from teletector results. Figure 6.5 compares the teletector and HP-290 probe profiles. The down direction (toward the floor) is the major contributor to the exposure field, followed by the north direction (toward the equipment on the equipment rack). The other two directions are relatively minor contributors.

Fig. 6.4. North cell HP-290 directional probe results.

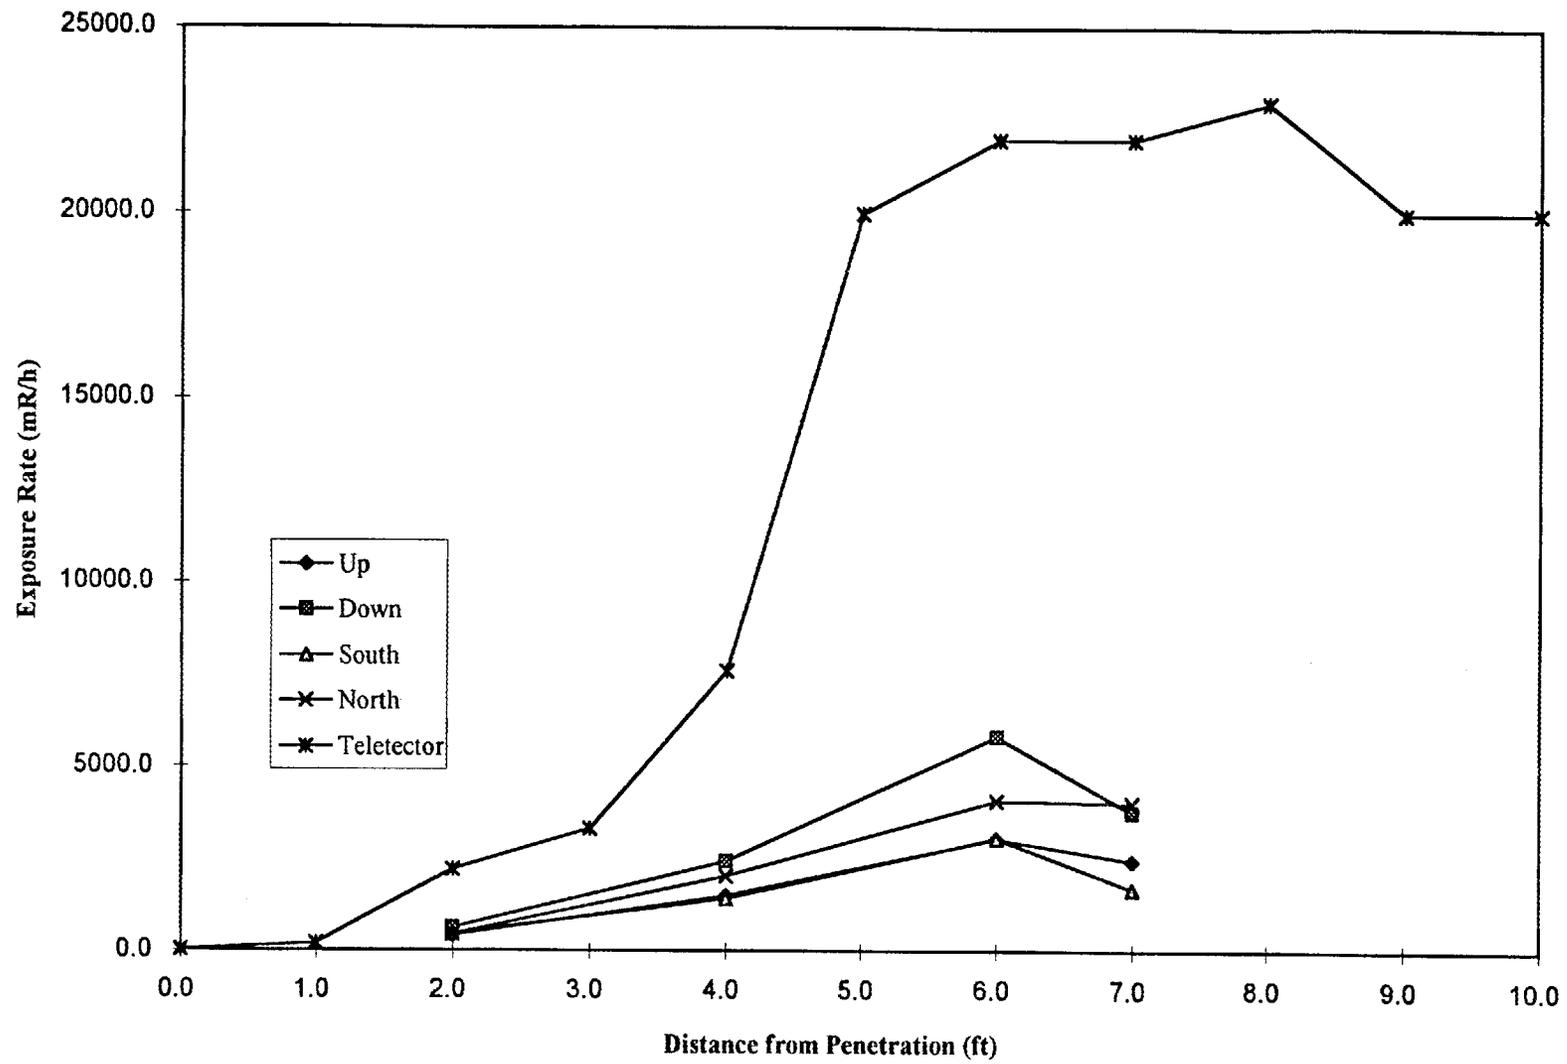
Fig. 6.5. North cell exposure profile from HP-290 and teletector probes.

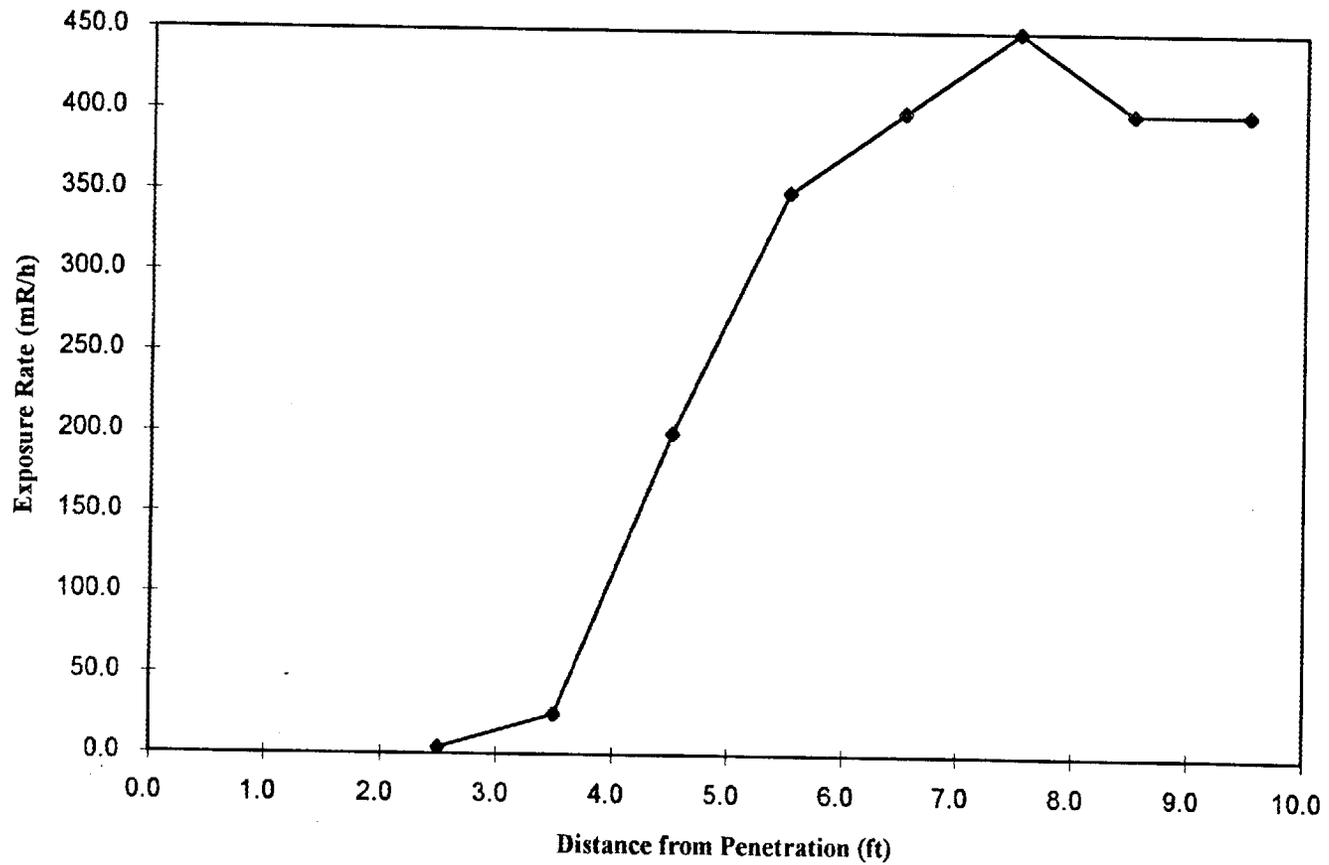
A teletector took a series of eight horizontal omnidirectional measurements at approximately 1-ft intervals between 2.5 and 9.5 ft from the access hole. Exposure rates ranged from approximately 4 mR/h at 2.5 ft to 450 mR/h at 7.5 ft, but decreased to 400

mR/h at 8.5 and 9.5 ft. Results of these measurements are plotted in Fig. 6.14, and detailed results are tabulated in Table E.5.

Fig. 6.14. South cell teletector measurement results.

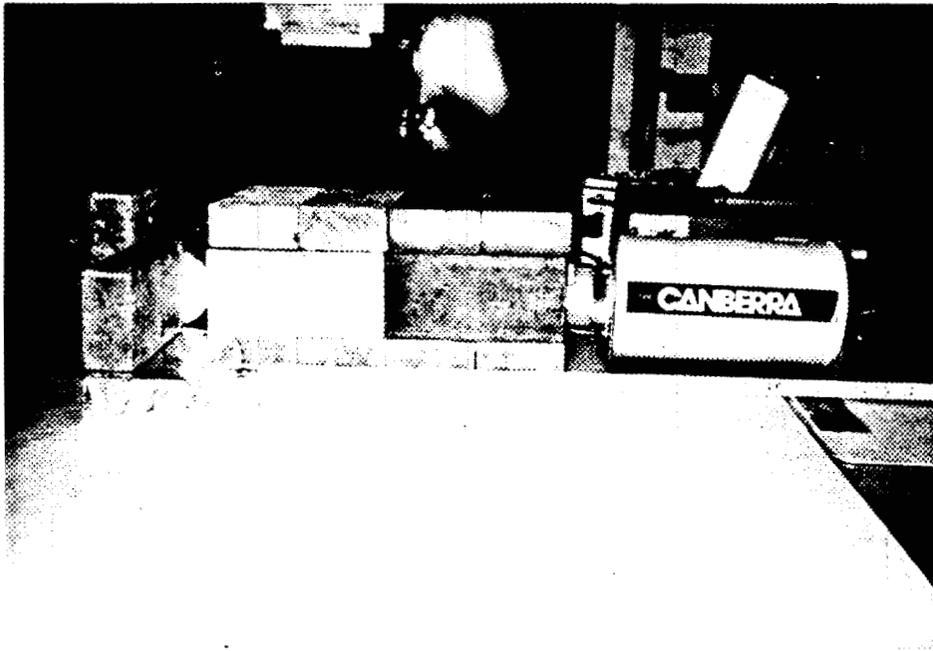
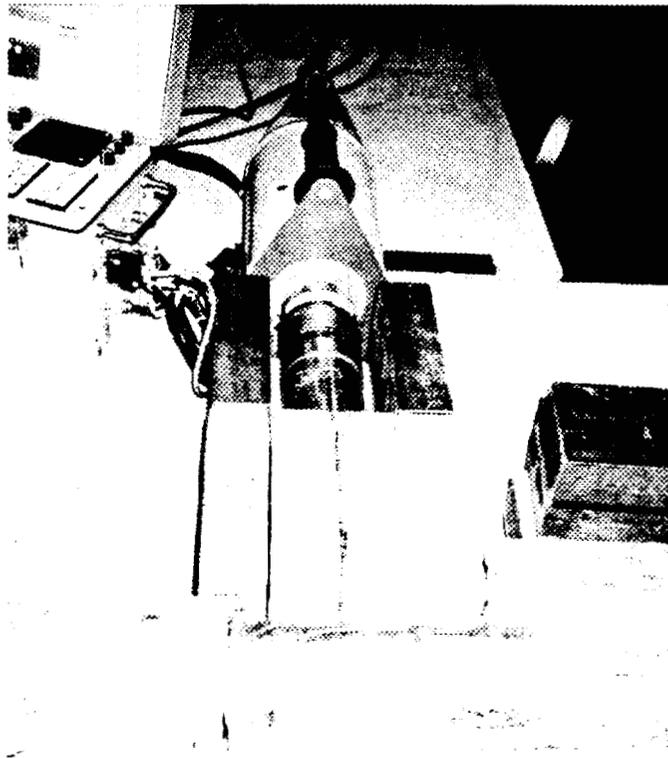
Fig. 6.26. Gamma spectroscopy (HPGe) slit scanning geometry/configuration.

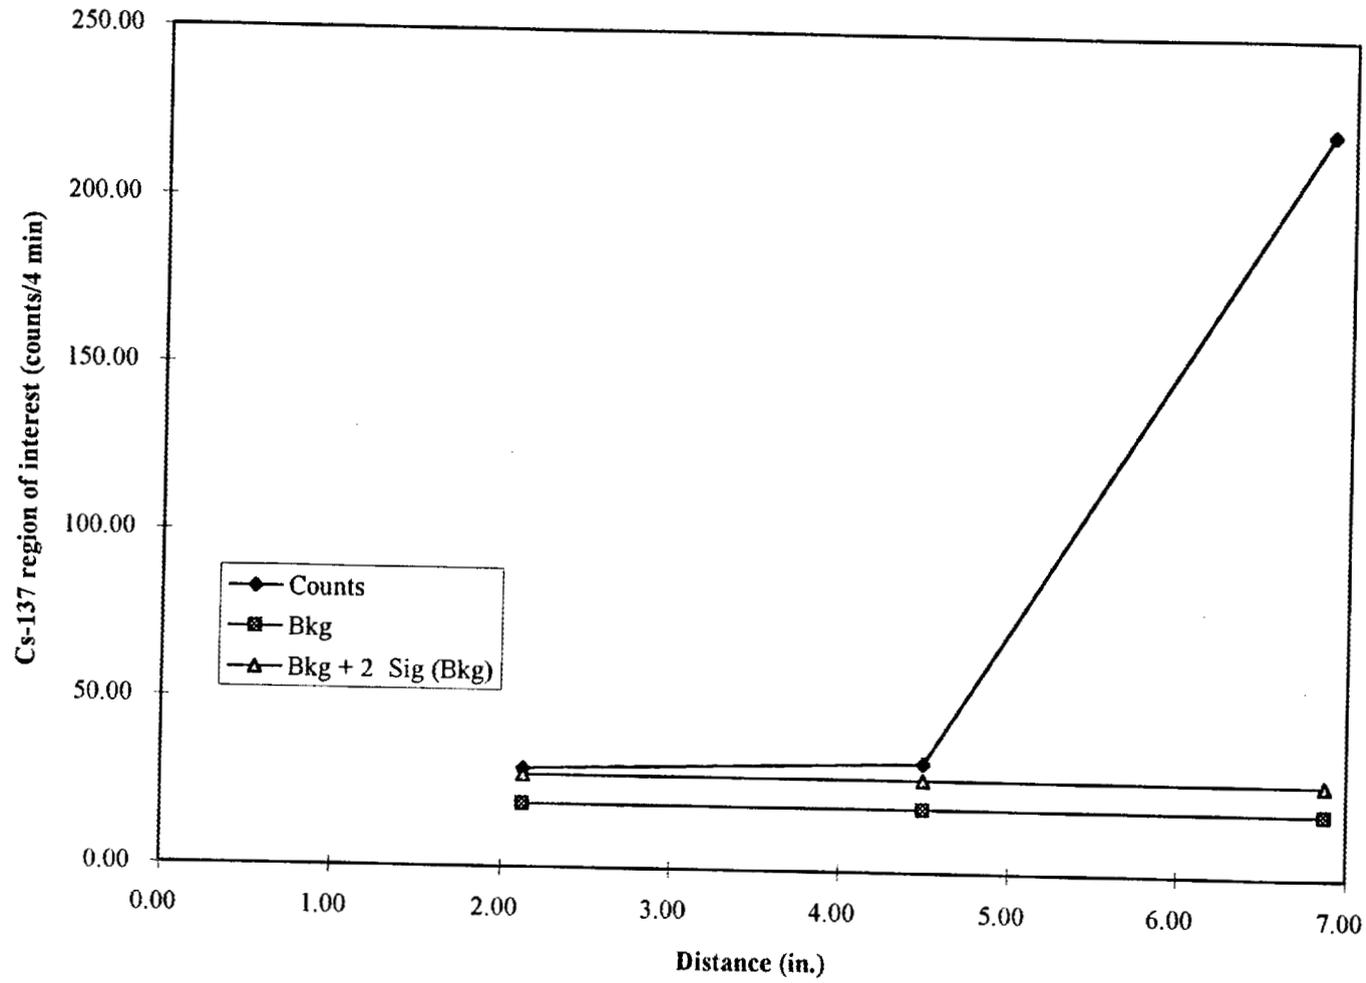
Two concrete core samples were obtained from the concrete pad outside Building 3515. The first (73.SB001; see Fig. 3.1) was drilled approximately 3 ft south of the southern wall of the building to a depth of approximately 9.5 in. before a flat metal surface was encountered and coring was stopped. Readings are near the counting area background on

the top (surface) and in the middle; however, on the bottom portion (last inch), readings appear to be higher than background by approximately 1 order of magnitude. This core is fairly uniform from one end to the other and is moderately clean and free of loose surface contamination except for the bottom portion, which was in contact with the metal surface.

Fig. 6.27. Slit scanning results for concrete core 73.SB001.

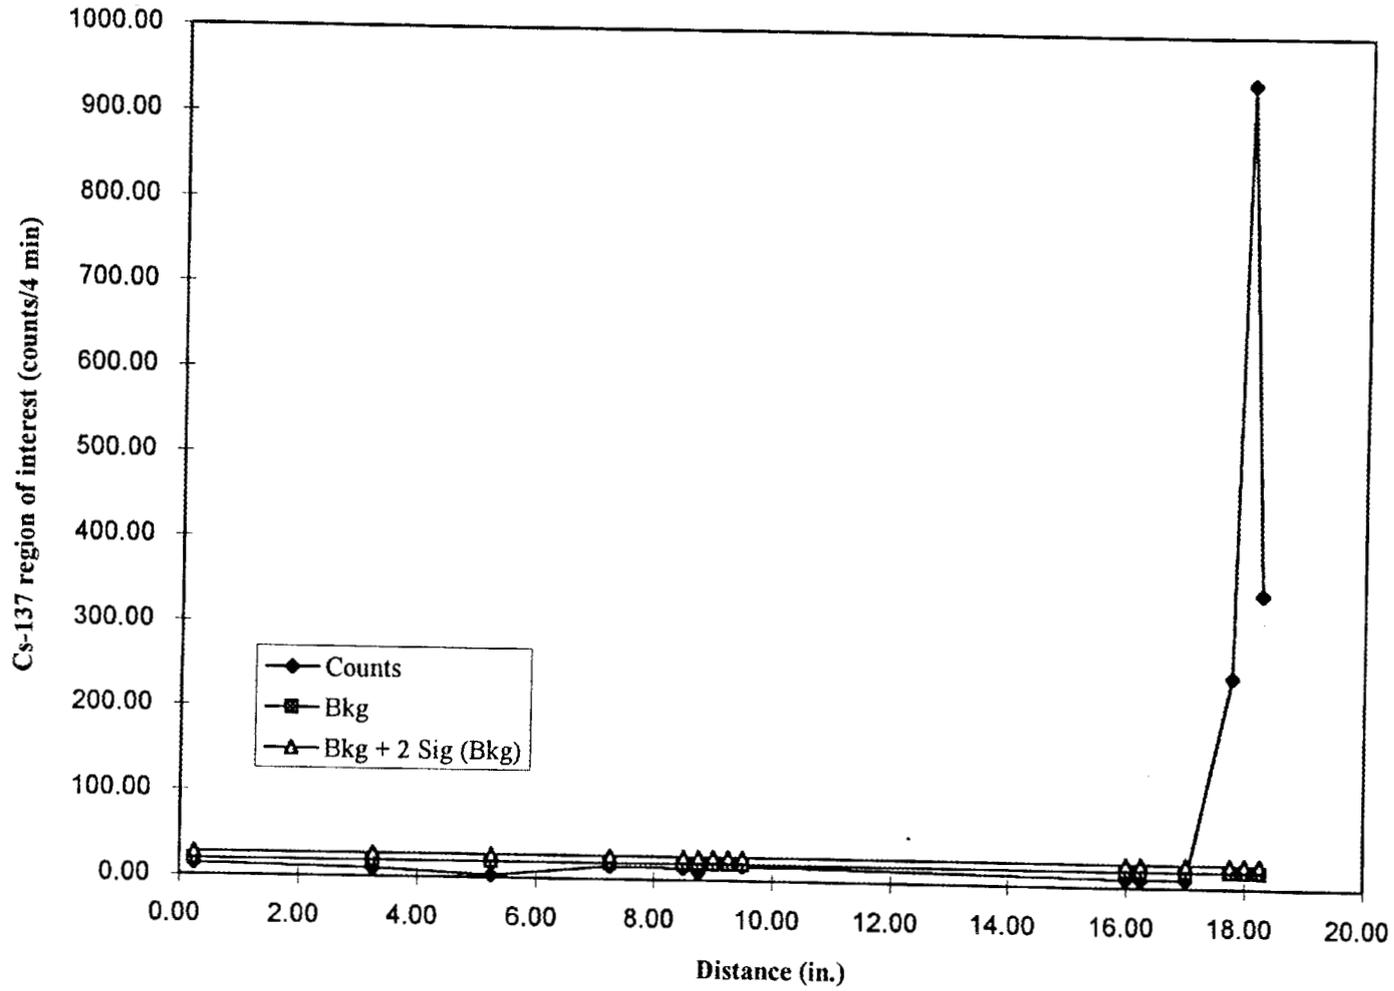
Fig. 6.28. Slit scanning results for concrete core 73.SB002.
