ORNL/TM-12943

**High-Temperature Mechanical
Performance of a Hot Isostatically
Pressed Silicon Nitride**

Metals and Ceramics Division

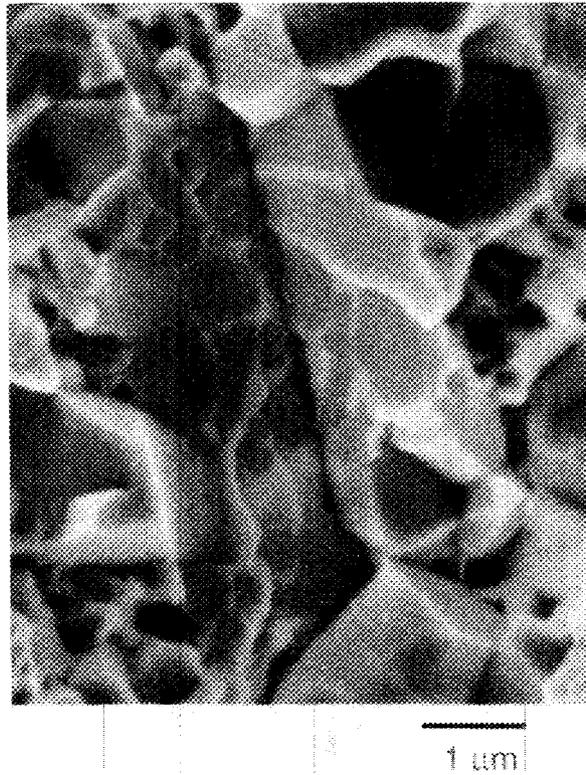
ORNL-PHOTO 10587-95

Fig. 2. Scanning electron micrograph of as-received PY6 microstructure.

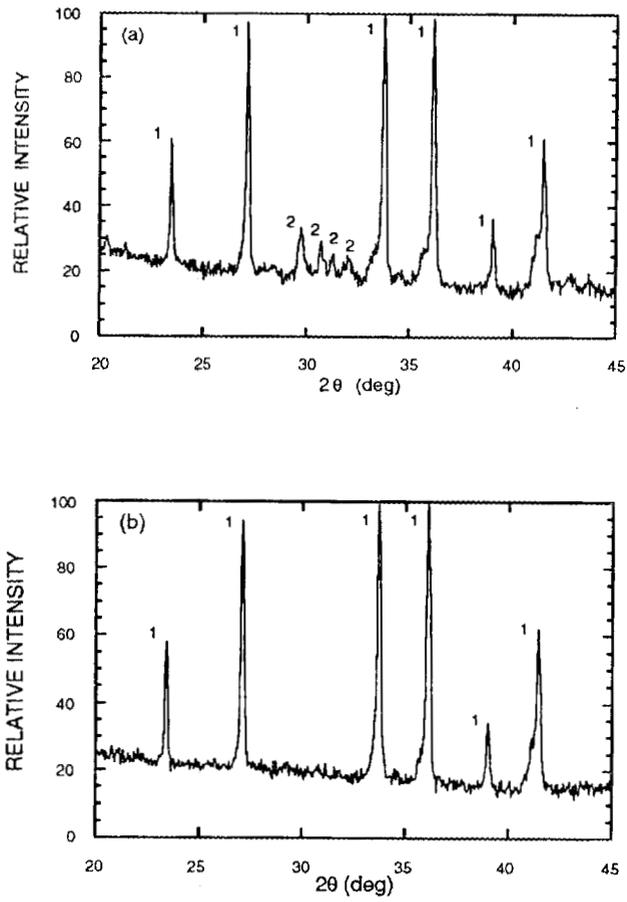
ORNL-DWG95-5926

Fig. 3. Most PY6 specimens had (a) a crystalline second phase, while (b) a few did not (1 = β - Si_3N_4 and 2 = α - $\text{Y}_2\text{Si}_2\text{O}_7$).

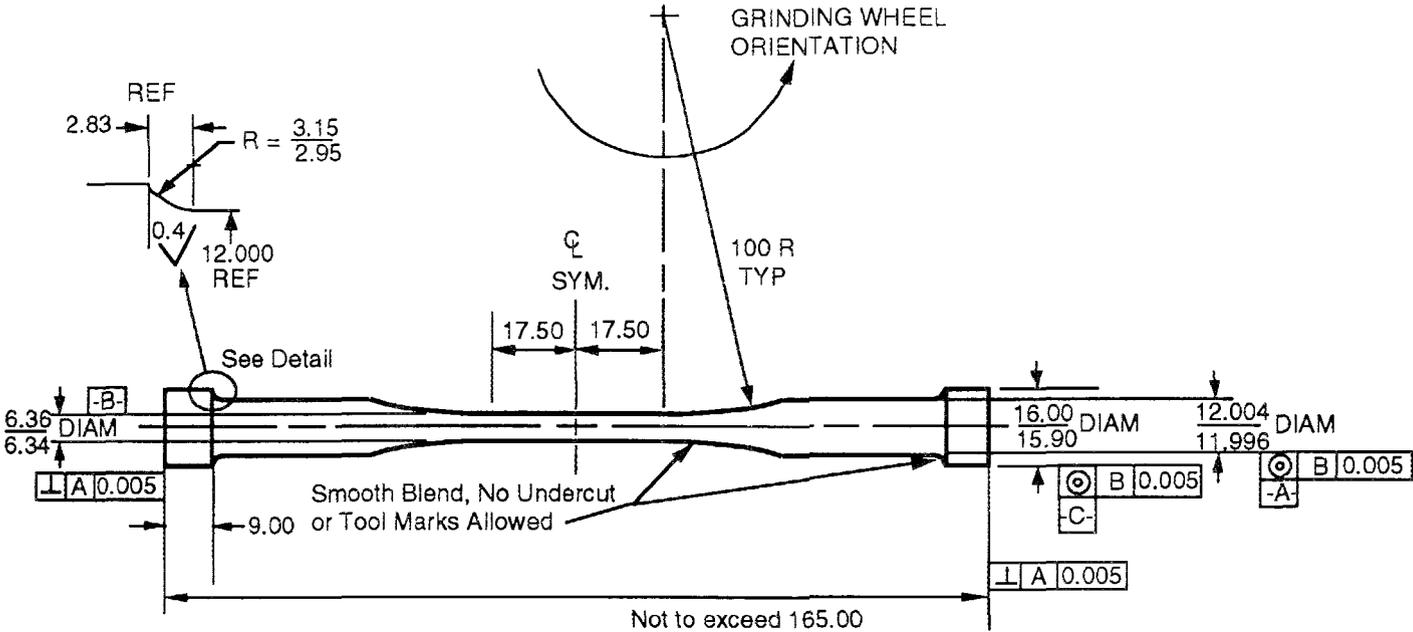
Fig. 4. PY6 Button-head specimens were machined to the dimensions shown. The gage section diameter and length were 6.35 and 35 mm, respectively.

All button-head tensile specimens were commercially machined to the specifications shown in Fig. 4. The gage section diameter was 6.35 mm, and the gage length was 35 mm. Final machining of the gage section was conducted in a longitudinal orientation to avoid transverse machining damage.

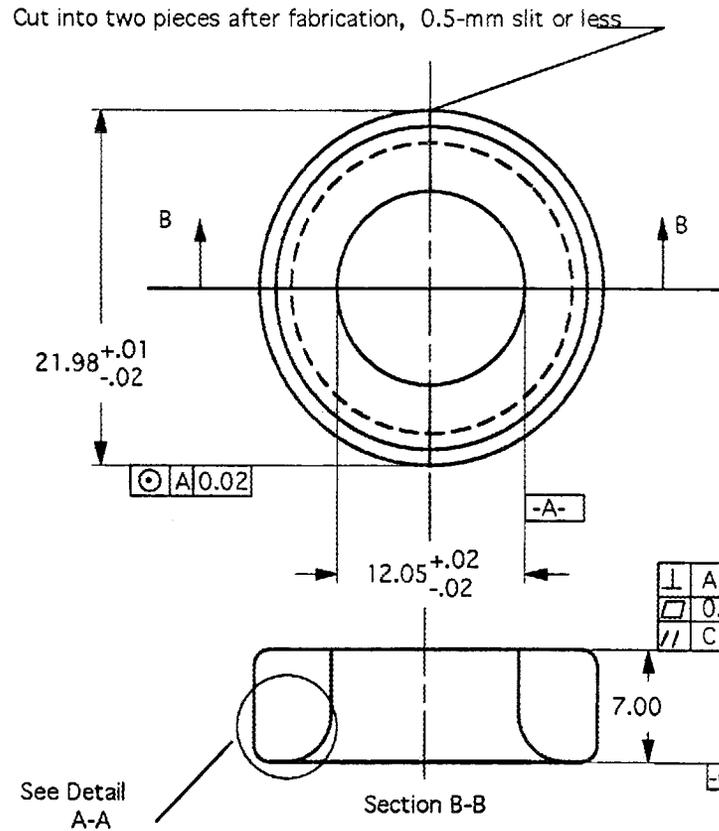
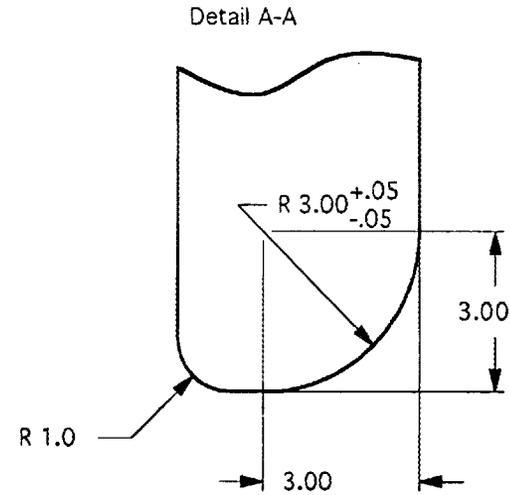
Fig. 5. Oxygen-free, copper collets were used for all the tensile tests.

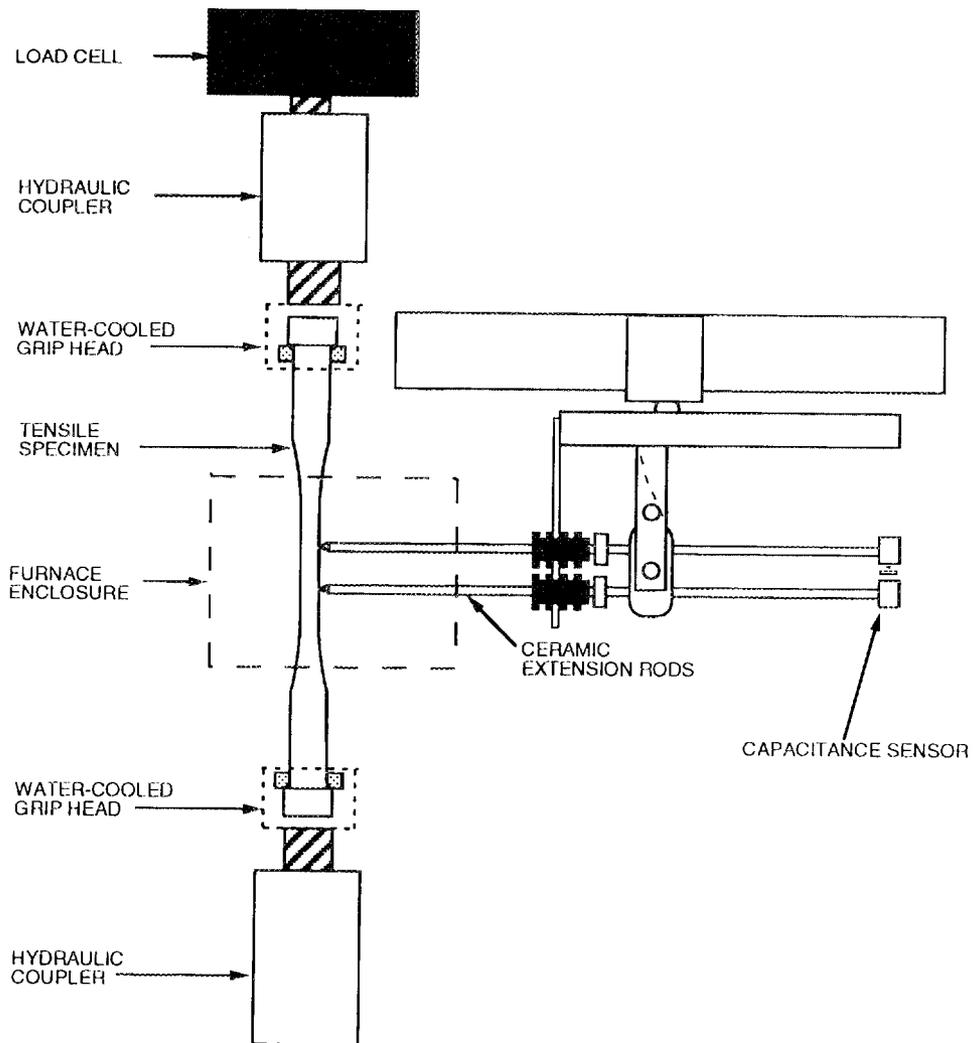
Fig. 6. Schematic diagram of a button-head specimen and the load train system used for all tensile testing.

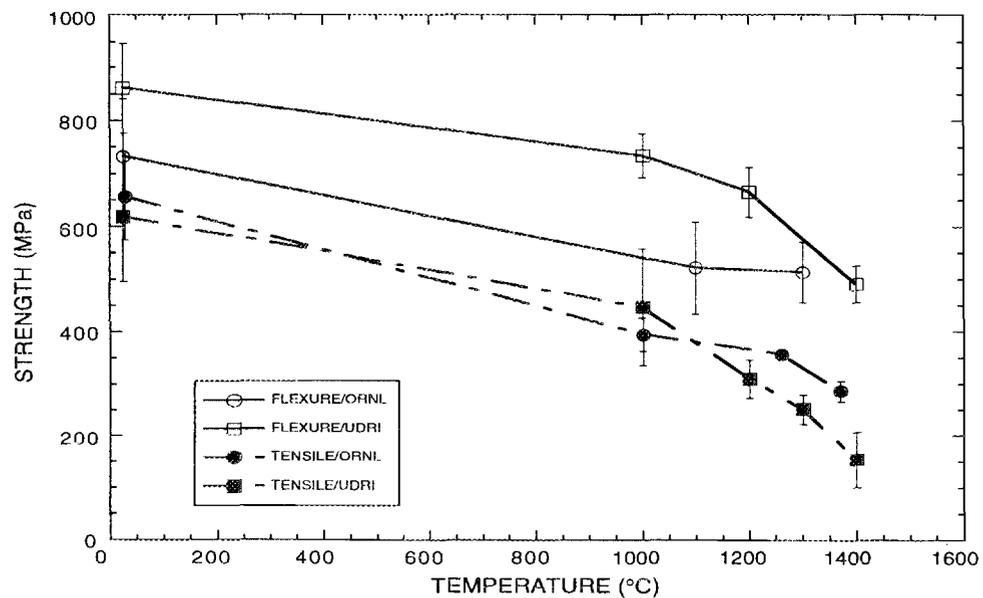
ORNL-DWG95-5930

Fig. 7. Tensile and flexure strength of PY6 silicon nitride as a function of temperature.

The strength exhibited a gradual decrease as the temperature was increased to 1000°C. Both S_t and S_{MOR} decreased sharply as the temperature exceeded 1100°C, with the exception of the Oak Ridge National Laboratory (ORNL) flexure data. However, the ORNL flexure strength values increased slightly as the temperature increased from 1100 to 1300°C. This behavior may have been a consequence of enhanced creep-assisted crack blunting in the ORNL flexure specimens due to the high α -Si₃N₄ content in the starting material. The presence of α -Si₃N₄ in the ORNL flexure specimens suggests that the α -to- β transformation was not completed during the HIPing process.

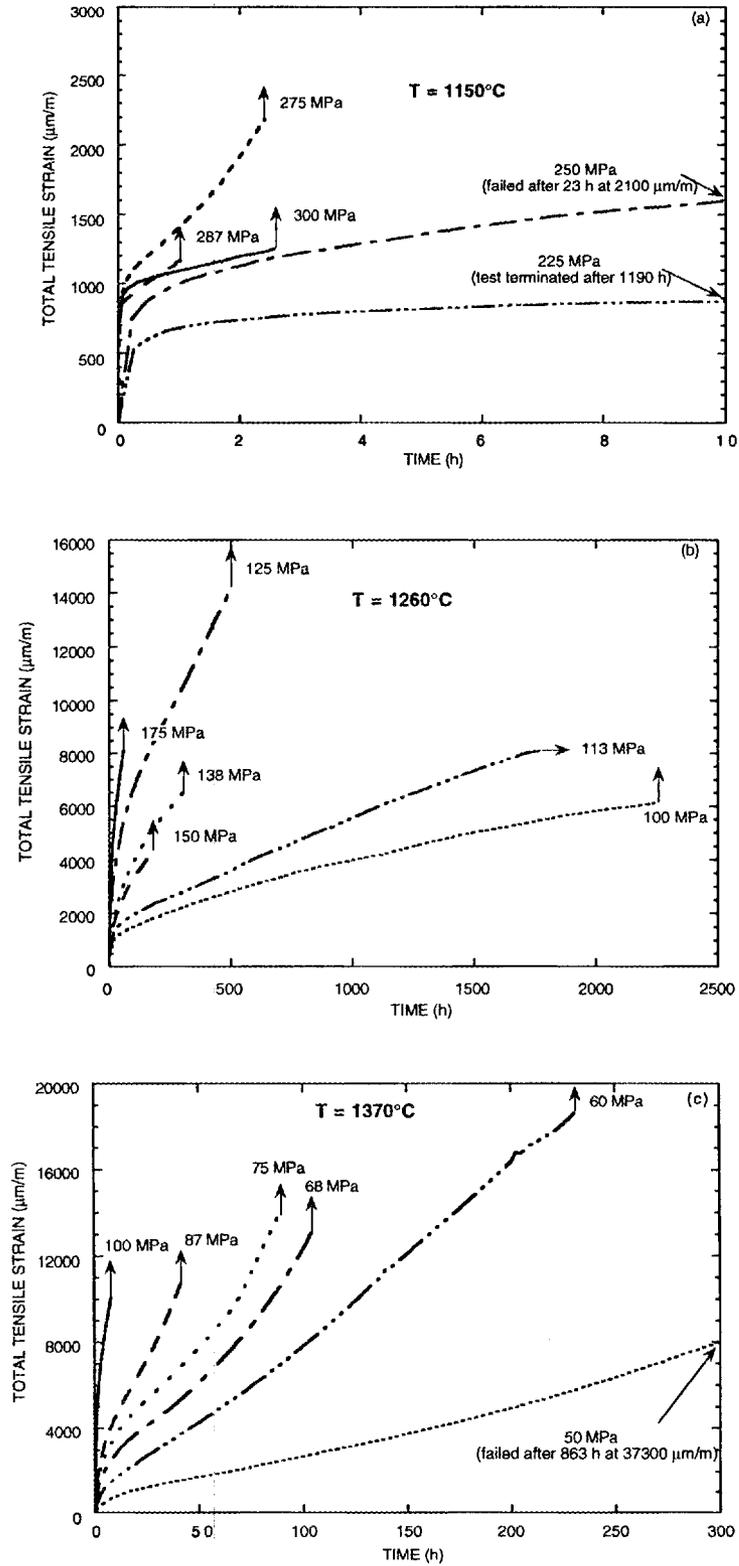
ORNL-DWG95-5931

Fig. 8. Creep histories of PY6 silicon nitride at (a) 1150, (b) 1260, and (c) 1370°C.

The 1370°C data exhibited a trend of increasing strain rate with increasing stress. However, the creep curves for the 1260°C tests were somewhat inconsistent. In particular, the data generated at 125 and 150 MPa did not follow the trend of increasing creep strain rate with increasing stress. This behavior, which was also apparent in the strain rate versus stress curves, was found to be a result of specimen-to-specimen variations in the crystallinity of the intergranular phase; see ref. 3 for explanation of this observation. For a given stress level, samples containing an amorphous intergranular phase would be expected to creep at faster rates than samples containing a highly crystallized grain boundary phase.

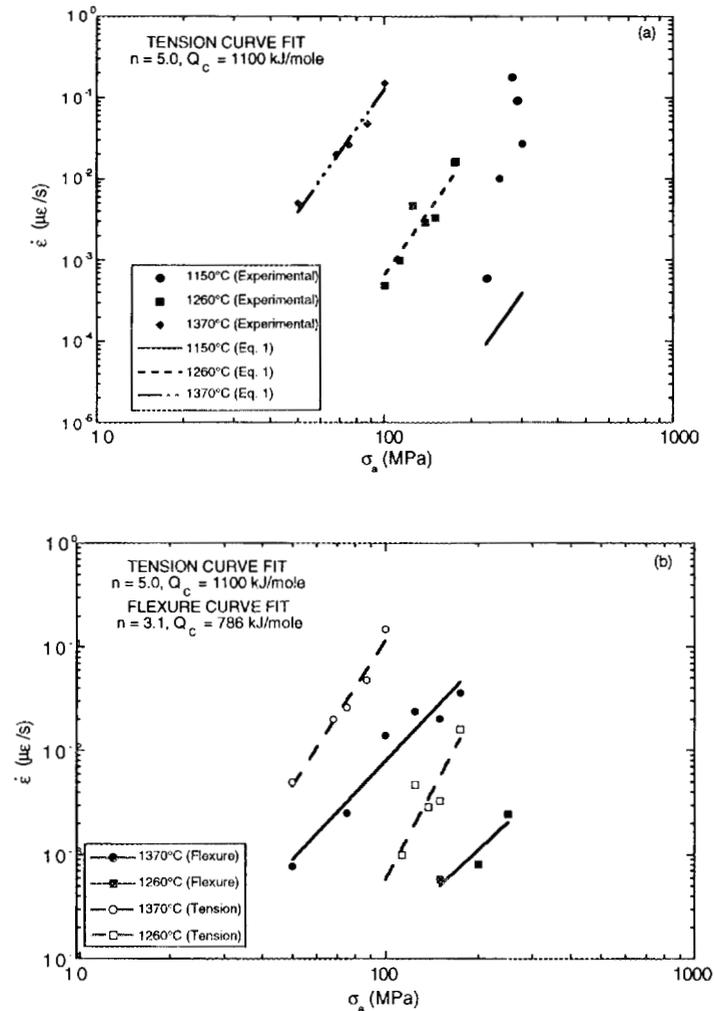
ORNL-DWG95-5932

Fig. 9. Stress and temperature dependencies of the minimum creep rate for (a) tension and (b) flexure.

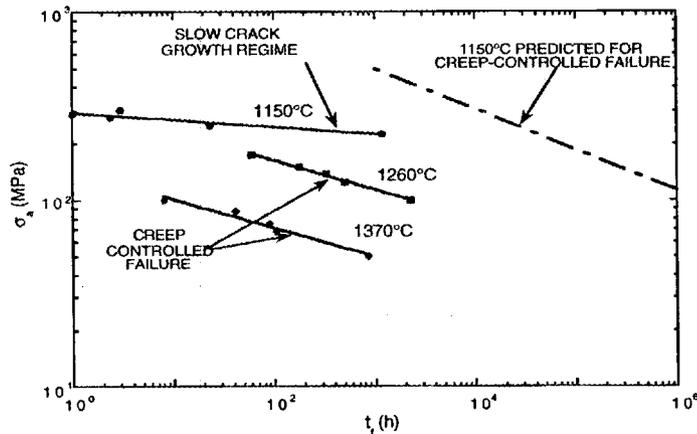
ORNL-DWG95-5933

Fig. 10. Static fatigue behavior of PY6 at 1150, 1260, and 1370°C.

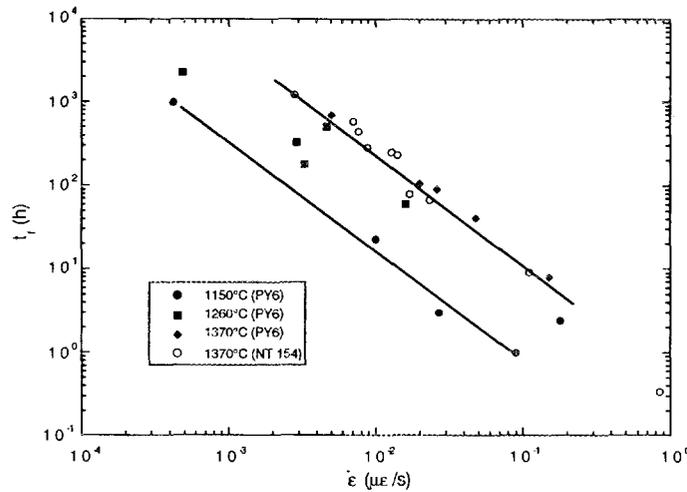
ORNL-DWG95-5934

Fig. 11. Fatigue life as a function of creep strain rate.

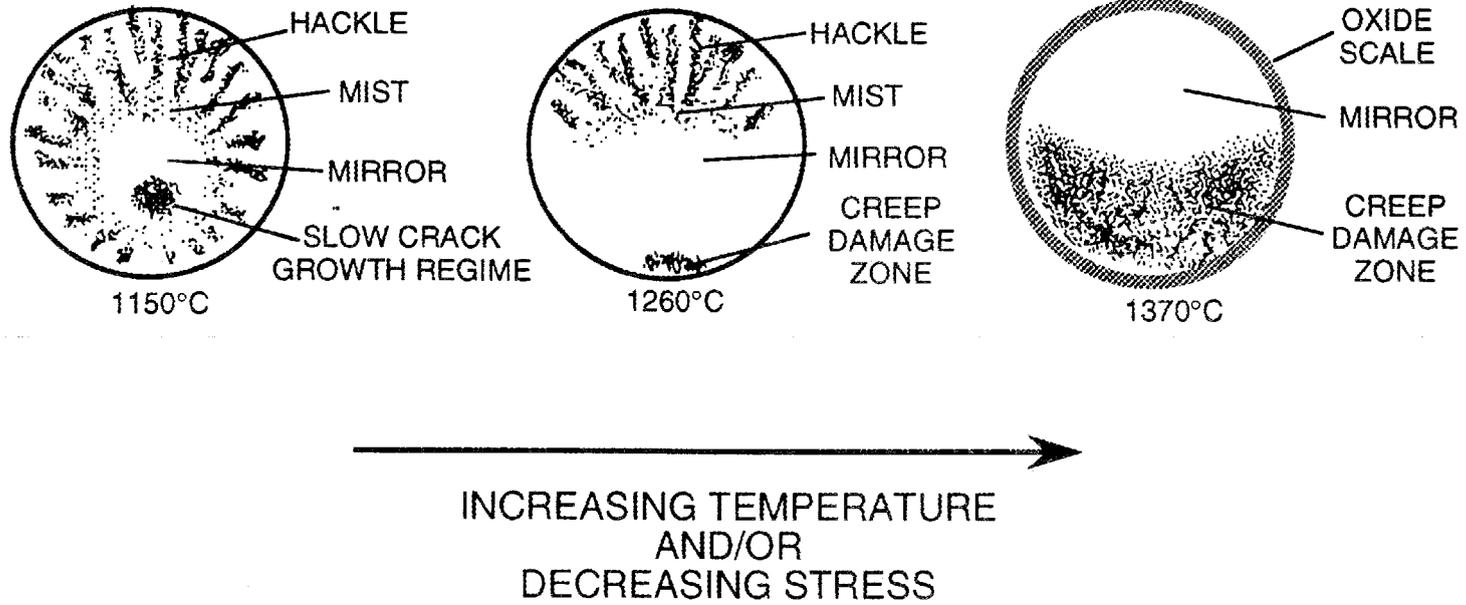
Fig. 12. Schematic diagram showing the transition from fast fracture markings for tests conducted at low temperatures and/or high stresses to creep damage-like markings produced at higher temperatures and/or lower stresses.

Optical microscopy of the tensile fracture surfaces revealed a transition in the fracture markings as the test temperature increased from 1150 to 1370°C. This transition is schematically shown in Fig. 12. At 1150°C, the fracture surfaces contained well-defined mirror, mist, and hackle regions. At 1260°C, the fracture surface was characterized by a relatively small creep damage zone (a region of high surface roughness) originating at the gage section surface. At 1370°C, the creep damage zone covered as much as 50% of the fracture surface with the mirror region comprising the rest. The fact that hackle markings were absent indicates that the mirror size exceeded the specimen cross section. The creep damage zone was similar to that observed on surfaces generated at 1260°C in that both cavitation and microcracking were predominate features. In addition, the size of the creep damage zone

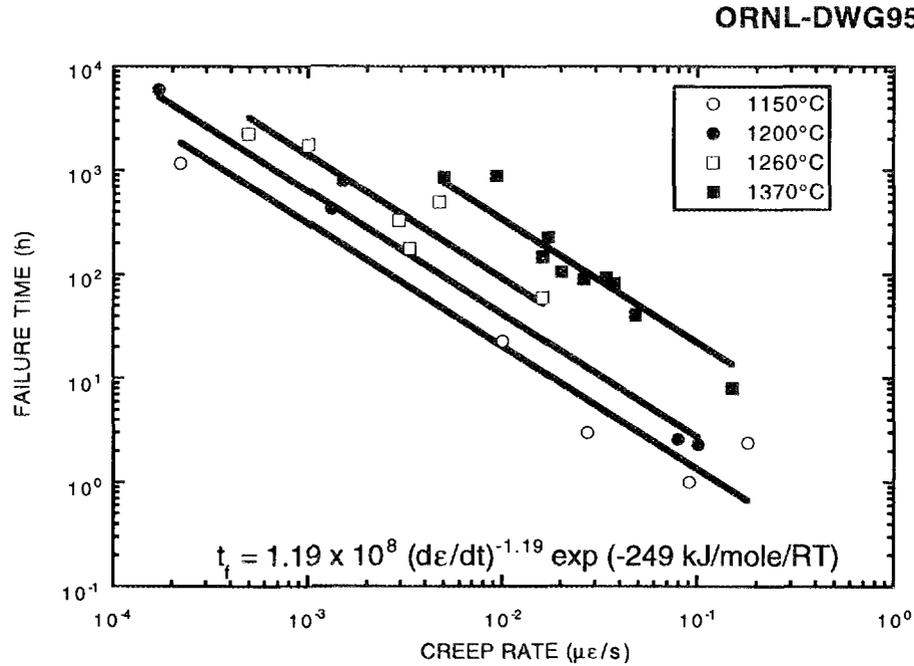
Fig. 16. Stratification of the time to failure-minimum creep rate data at 1150, 1200, 1260, and 1370°C was described by the modified Monkman-Grant relation; see Eq. (6).

linear regression analysis and were 1.19 and -249 kJ/mole, respectively. They were obtained using the time-to-failure and minimum strain rate data for static creep tests at 1150, 1200, 1260, and 1370°C, which are shown in Fig. 16. For $m = 1.19$, the value of ΔQ constitutes only -45 of the -249 KJ/mole total. It follows that most of the temperature dependence represented by the modified Monkman-Grant curves is due to the $Q_c(1 - m)$ term in Eq. (6).

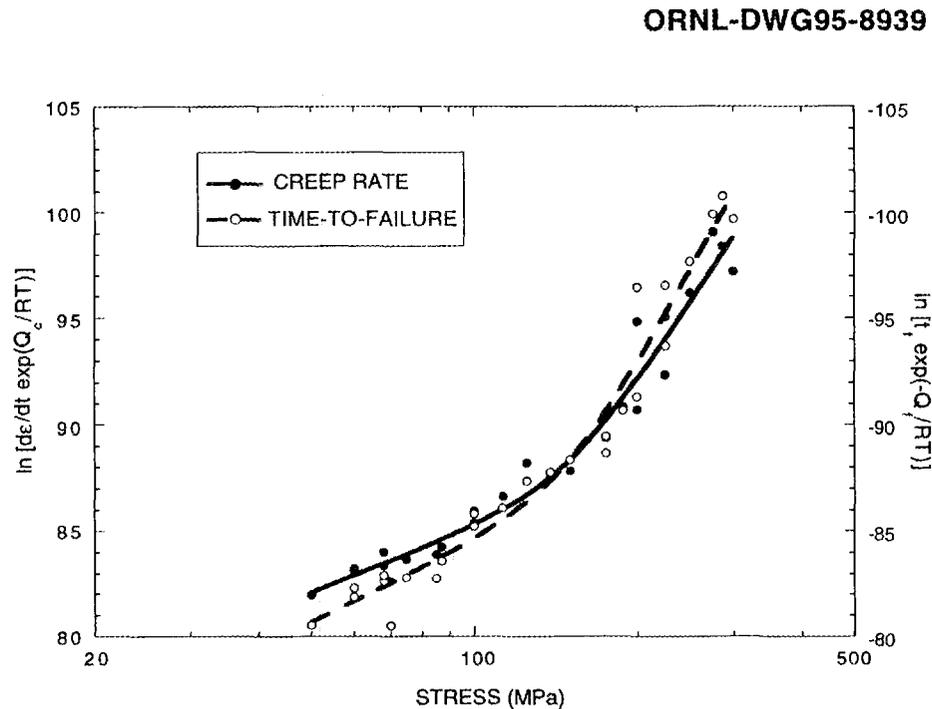
Fig. 17. Sherby-Dorn temperature-compensated minimum creep rate and time to failure as a function of stress.

The obtained relation illustrated in Fig. 17 was extended to predict the time to failure and minimum creep rate for static creep tests at 1200°C, which are shown in Figs. 18(a) and (b), respectively. For the prediction of time to failure and minimum creep rate at 1200°C, the Sherby-Dorn analysis had good predictive capabilities, as evidenced by the confirmatory experimental data also shown in Figs. 18(a) and (b).

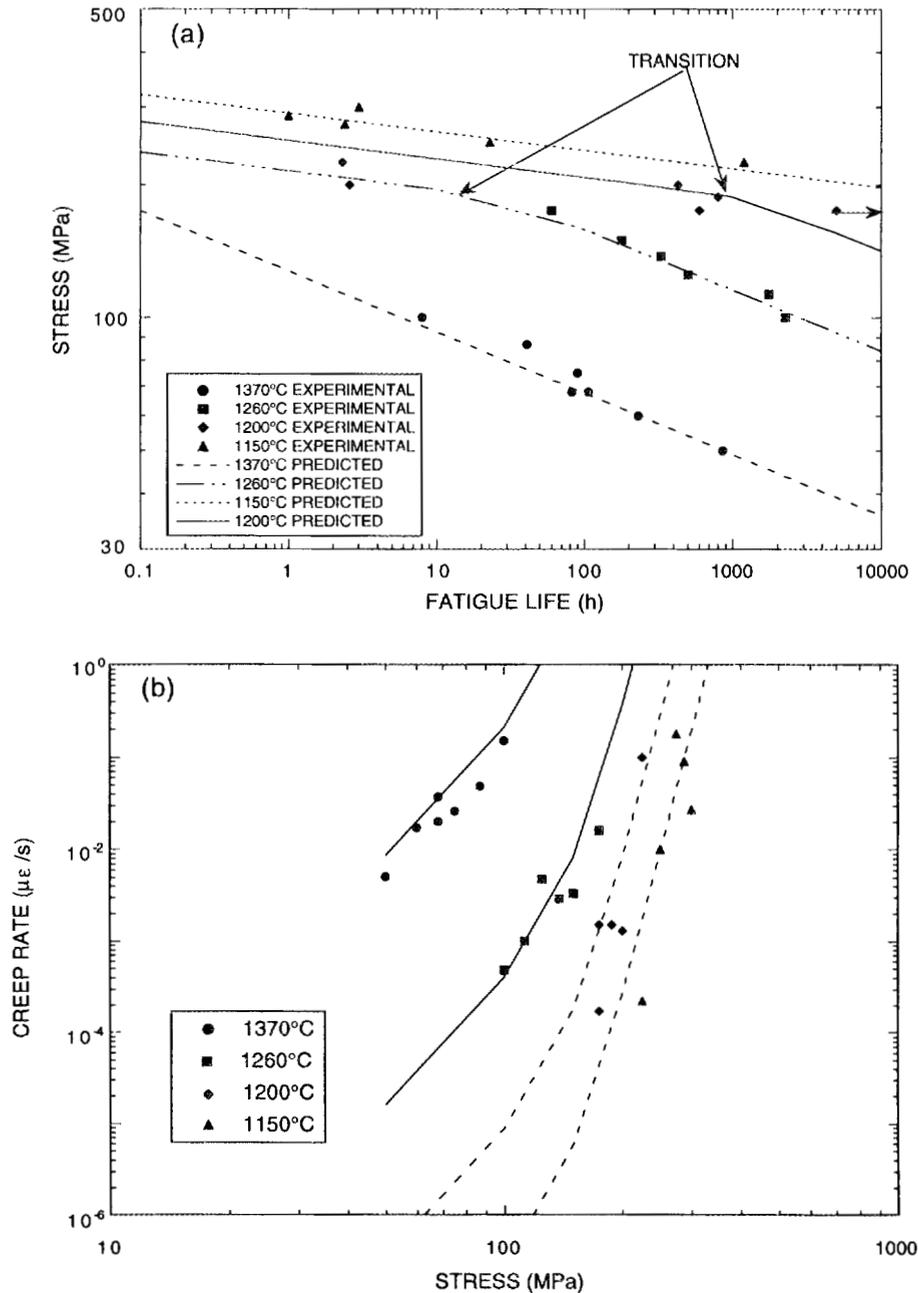
ORNL-DWG95-8940

Fig. 18. Time to failure (a) and minimum creep rate (b) were predicted at 1200°C from information obtained from static creep tests at 1150, 1260, and 1370°C using the Sherby-Dorn temperature-compensated time-to-failure and minimum creep rate approaches. Data from confirmatory static creep tests conducted at 1200°C are shown with that predicted for 1200°C.

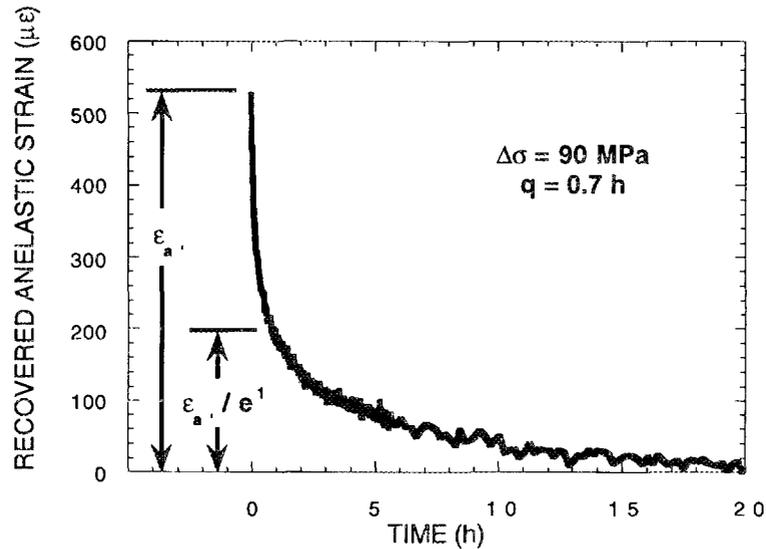
ORNL-DWG95-8941

Fig. 19. Strain relaxation behavior of PY6 at 1370°C. The relaxation time constant, q , was determined to be 0.7 h.

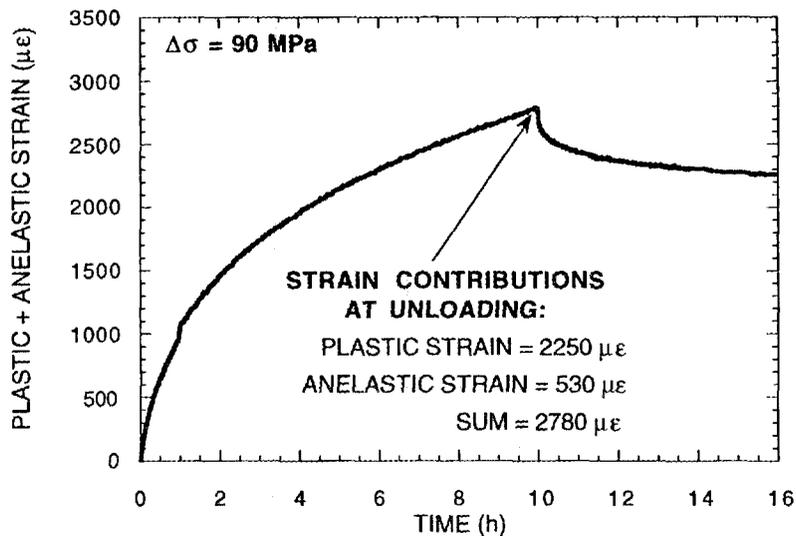
Fig. 20. The contribution of the anelastic strain to the total creep strain is small. Shown here is a PY6 specimen strain relaxed at 1370°C with the initial stress = 100 MPa. Strain relaxation testing showed that most of the creep strain is plastic, non-recoverable strain.

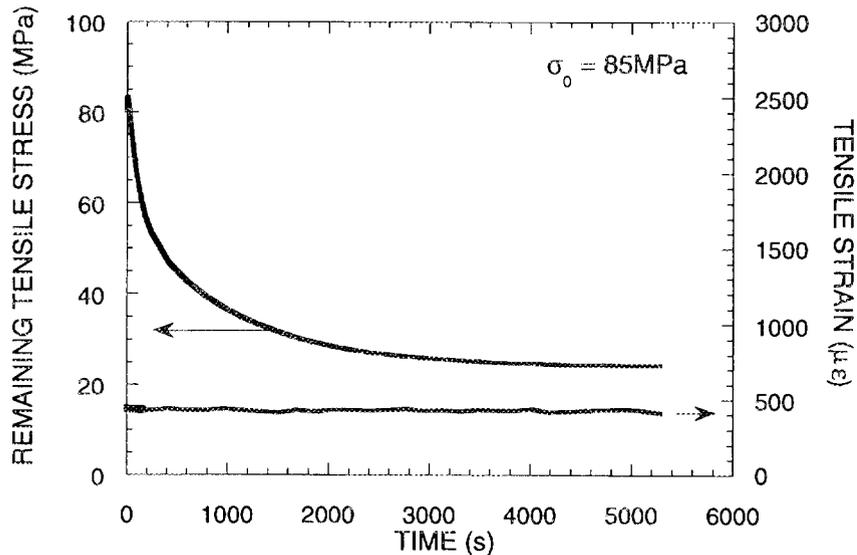
ORNL-DWG95-8943

Fig. 21. An example of a stress relaxation history for PY6 at 1370°C and the constant strain that was held during the test.

The creep rate as a function of stress for the stress relaxation tests illustrated in Fig. 21 is illustrated in Fig. 22. Data generated from the stress relaxation test are compared to data generated from static creep tests. The power law curve-fitted stress (or creep) exponents are equivalent for both types of tests. However, the creep rates for the stress relaxation tests are much larger than the static creep tests for equivalent stresses. The stress relaxation test was conducted at 420 $\mu\epsilon$; with reference to Fig. 8, this was most likely in the primary regime for PY6 at this temperature. The fact that the stress relaxation test yielded a creep exponent equivalent to that generated from static creep tests (where minimum creep rates occurred in the primary creep region at relatively high stresses and the secondary creep region at relatively low stresses) may have been a coincidence; however, the creep

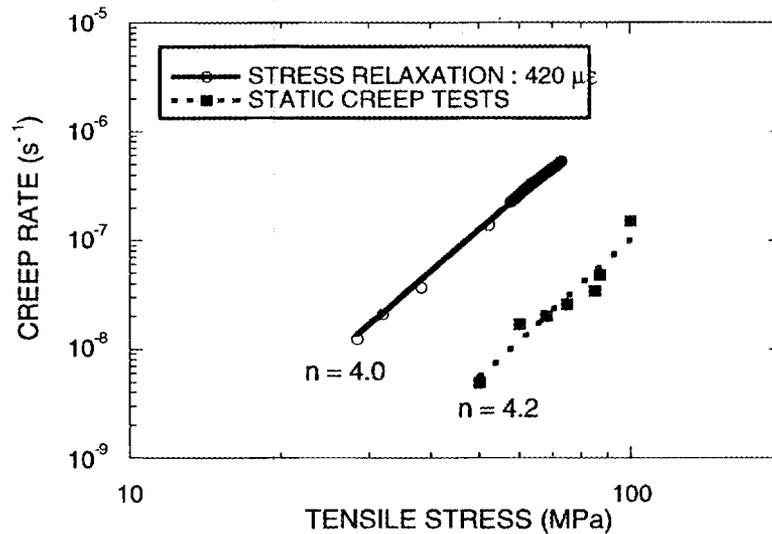
Fig. 22. Comparison of creep rate as a function of stress from one stress relaxation test versus several static creep tests for PY6 at 1370°C. Power-law curve-fitted values of the stress (or creep) exponents are shown.

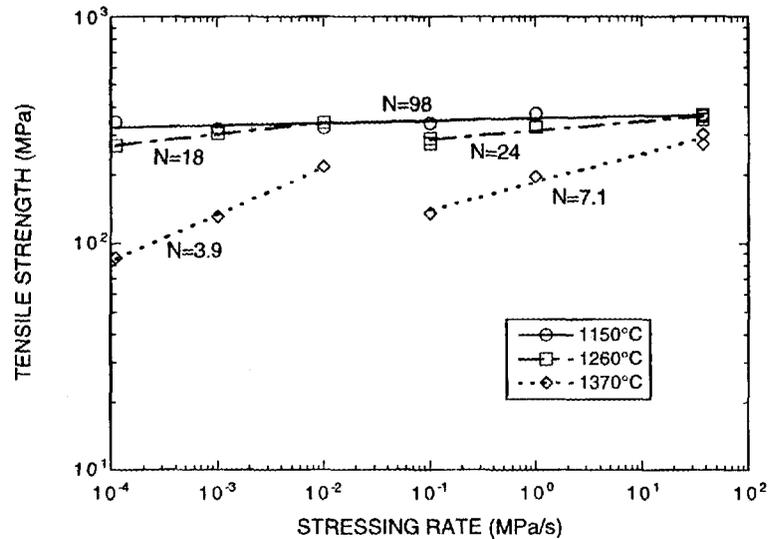
Fig. 23. Tensile strength as a function of stressing rate for PY6 at 1150, 1260, and 1370°C.

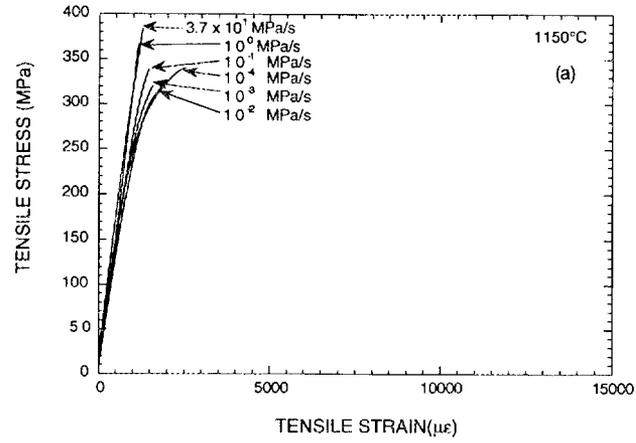
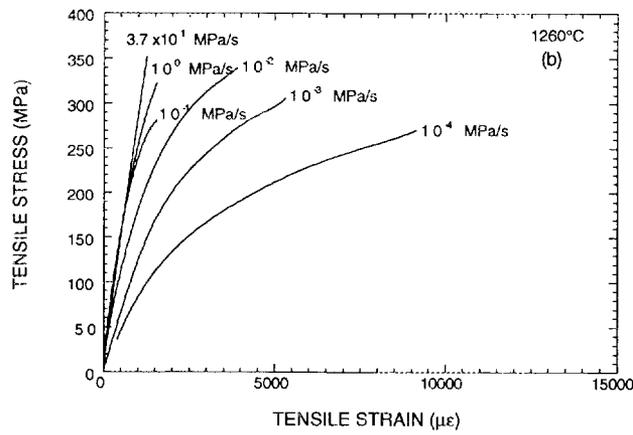
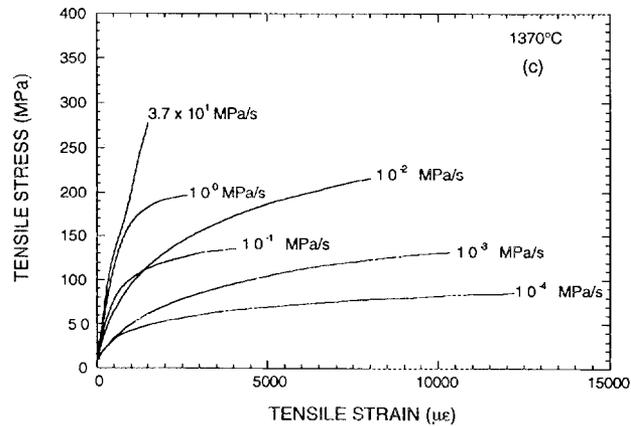
ORNL-DWG95-8946

Fig. 24. Stress-strain curves generated from dynamic fatigue tests at (a) 1150, (b) 1260, and (c) 1370°C.

To illustrate the stressing rate dependence on the elastic limit, the first 800 $\mu\epsilon$ (or 0.08% strain) of Fig. 24(c) are shown in Fig. 42. Four of the five stressing rates shown match rates used in the present cyclic fatigue study; 37 MPa/s was included as a comparison to show a faster stressing rate response. Although it is somewhat of a subjective determination, the effective elastic limit is somewhere between \cong 80 to 100 MPa for 1 MPa/s and as low as \cong 30 MPa for 0.001 MPa/s. Note that these stressing rates were used in the cyclic fatigue tests for specimens PY6-2 and PY6-5, respectively. The MPM model predicts a plastic contribution to the total strain for *all* stresses during each cycle; whereas in the experimental case, there may only be a plastic strain contribution for stresses *above* the elastic limit for that corresponding stressing rate. For cyclic tests PY6-1, PY6-2, and PY6-3, the frequencies or stressing rates were *fast enough* that there was not an appreciable amount of time above the elastic limit for each stressing rate to accumulate the total strain predicted by the MPM

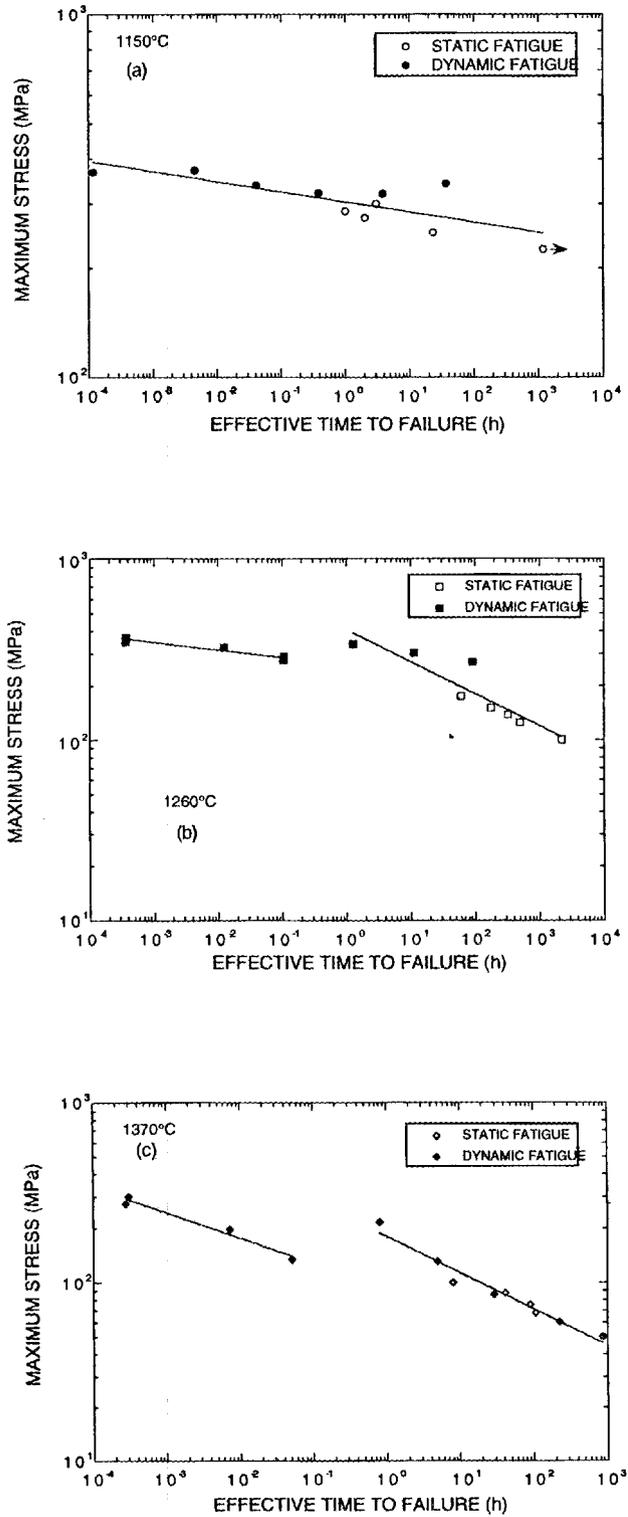
ORNL-DWG95-8947

Fig. 25. Maximum stress as a function of time to failure for PY6 at (a) 1150, (b) 1260, and (c) 1370°C.

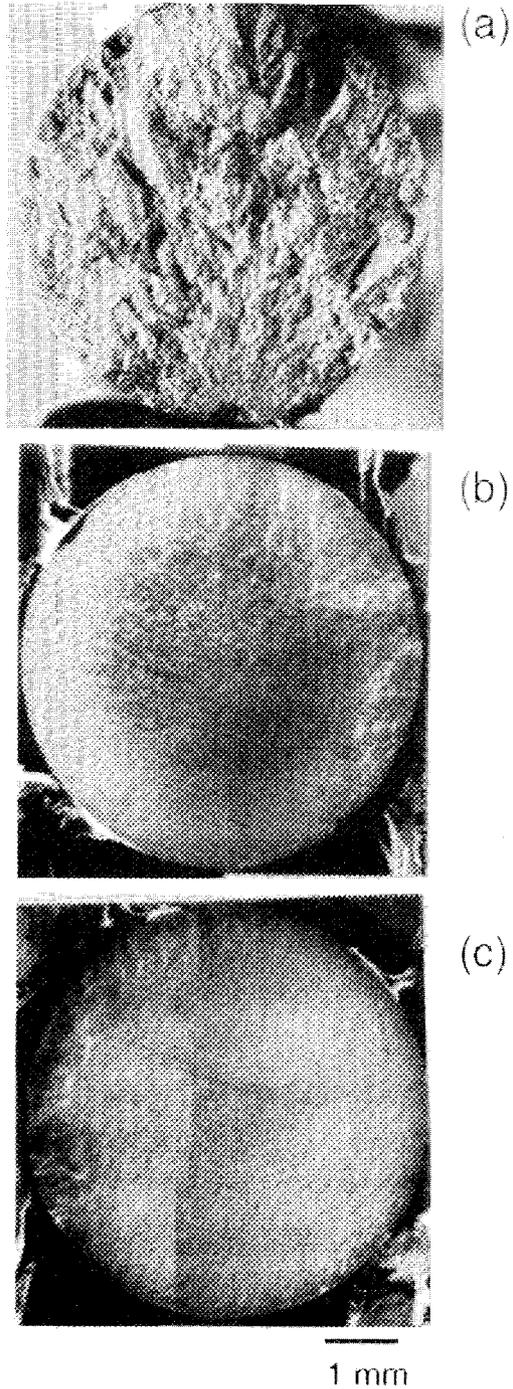
ORNL-PHOTO 10591-95

Fig. 26. Typical fracture surfaces generated in dynamic fatigue: (a) 37 MPa/s at 1370°C, (b) 10^{-3} MPa/s at 1370°C, and (c) 10^{-4} MPa/s at 1370°C.

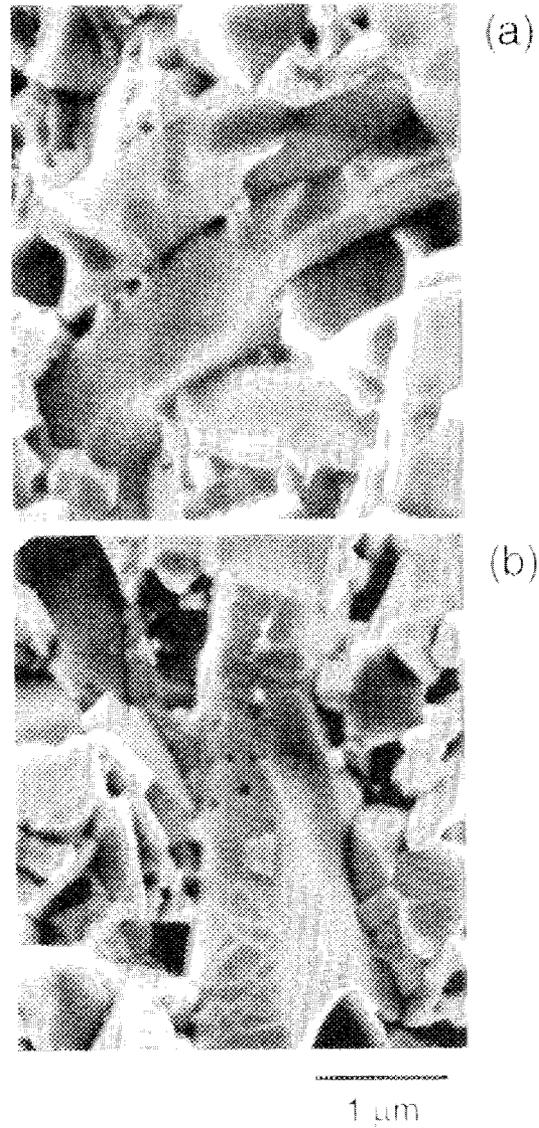
ORNL-PHOTO 10592-95

Fig. 27. Scanning electron micrographs of secondary fracture surfaces from specimens tested in dynamic fatigue: (a) 37 MPa/s at 1370°C, no cavitation, and (b) 10^{-3} MPa/s at 1370°C, cavities present along with a skeletal pattern of grain boundaries on grain facets.

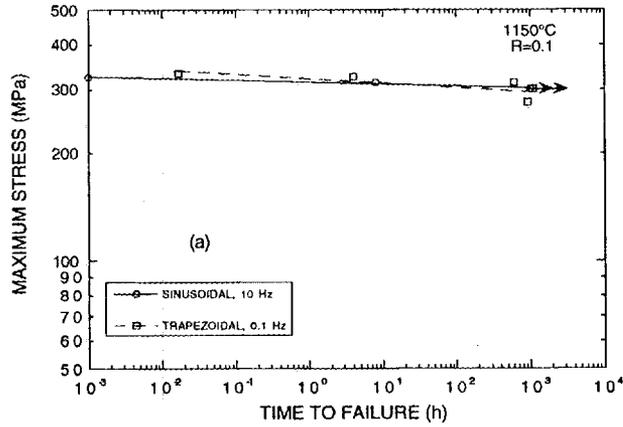
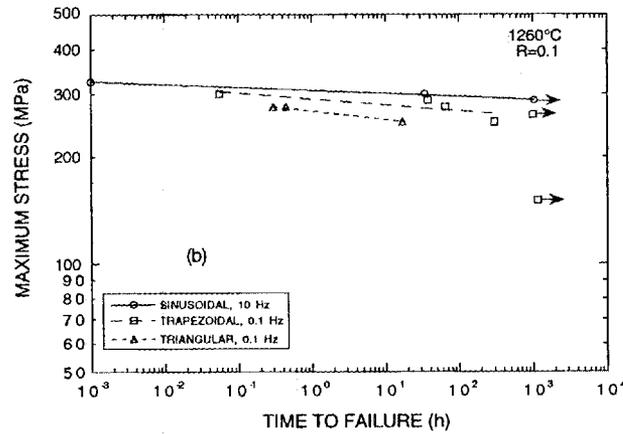
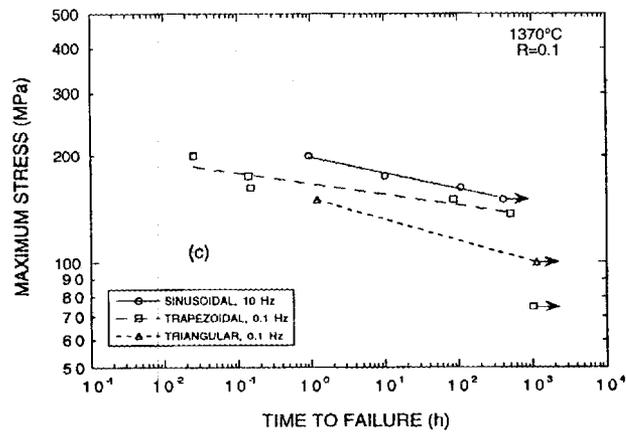
Fig. 28. Cyclic fatigue life of PY6 for various frequencies and waveforms at (a) 1150, (b) 1260, and (c) 1370°C.

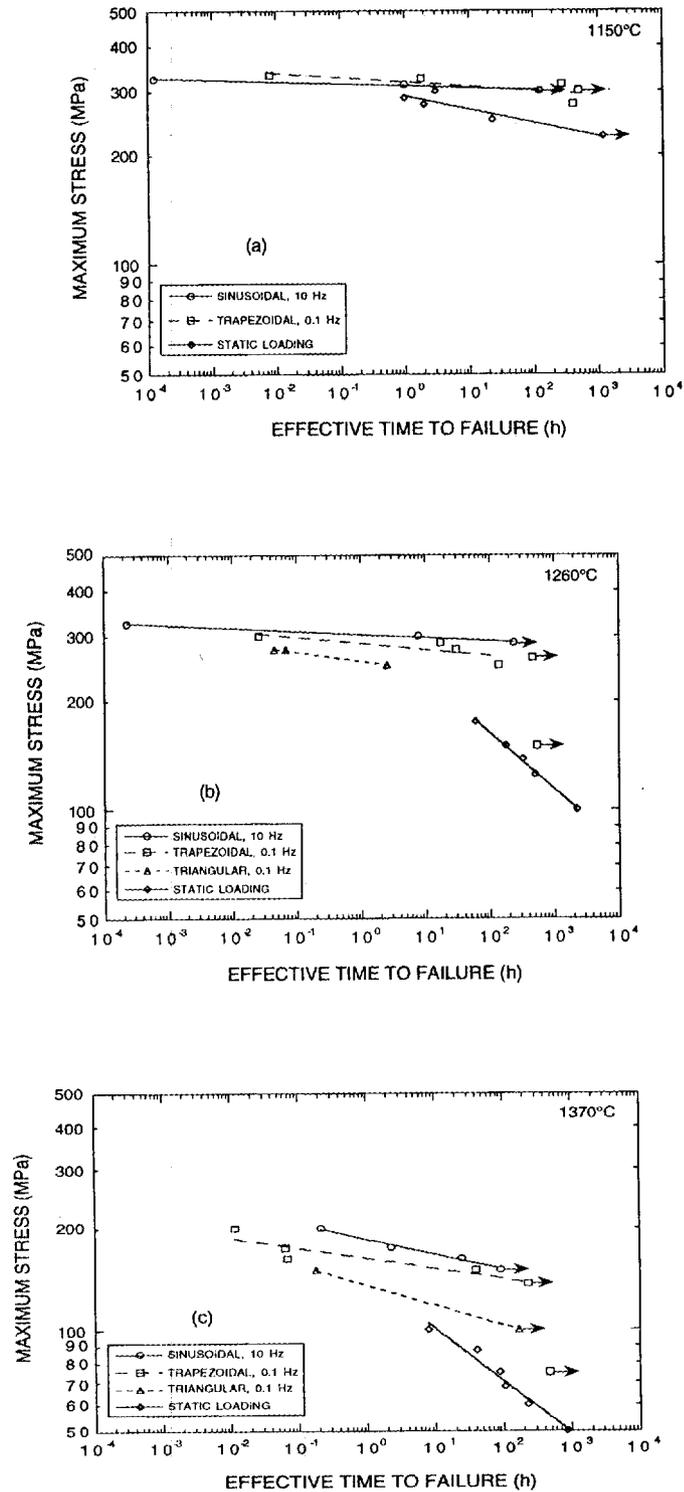
ORNL-DWG95-8949

Fig. 29. Comparison of static and cyclic fatigue by an effective time-to-failure approach for data generated at (a) 1150, (b) 1260, and (c) 1370°C.

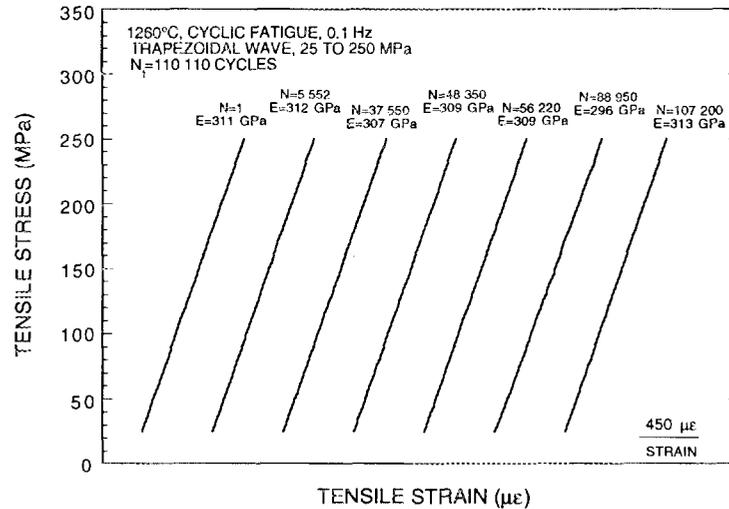
Fig. 30. Cyclic stress-strain behavior of PY6 at 0.1-Hz trapezoidal loading at 1260°C with stress of 25 to 250 MPa.

Only discrete cyclic stress-strain behavior was recorded for tests under 0.1-Hz trapezoidal loading at 1150, 1260, and 1370°C. The typical cyclic stress-strain behavior for these cases is shown in Fig. 30. For all applied stress levels at 1150 to 1370°C, the cyclic stress-strain behavior remained linear to the final few cycles prior to the failure of specimens. Moreover, the elastic modulus did not significantly change during cyclic fatigue testing. Previous studies have indicated that damage accumulation by formation and growth of creep cavities and microcracks could cause a progressive decrease in Young's modulus and lead to an apparent nonlinear stress-strain relation; see ref. 31 for review. Therefore, the absence of measurable hysteresis in the cyclic stress-strain response implied that little, if any, creep cavitation or microcracking would occur during cyclic fatigue testing at 0.1-Hz trapezoidal loading. This was supported by the monotonic tensile stress-strain behavior in dynamic fatigue tests. At 1260 and 1370°C, nonlinear stress-strain behavior prevailed at stressing rates $\leq 10^{-2}$ MPa/s where creep rupture was the dominant failure mechanism. When the stressing rates became greater than 10^{-2} MPa/s at 1260 and 1370°C, the stress-strain

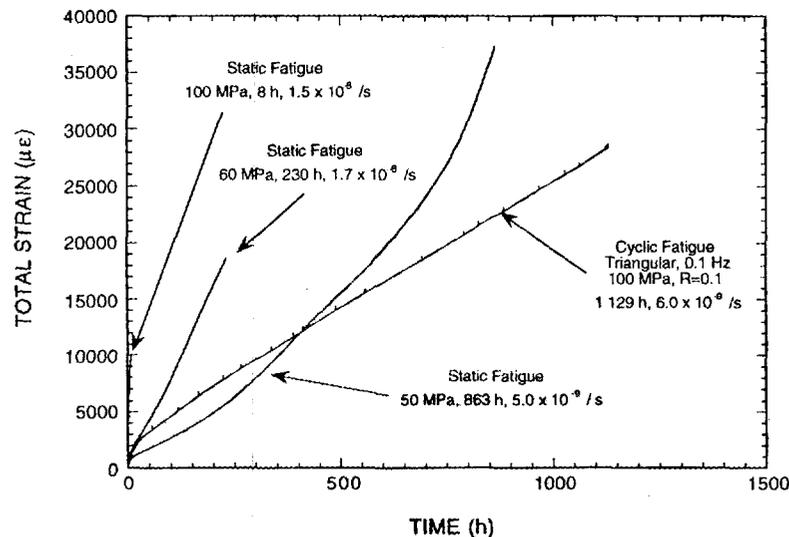
ORNL-DWG95-8951

Fig. 31. Comparison of strain-time relations for static and cyclic fatigue of PY6 at 1370°C.

Although stress-strain hysteresis was not observed during cyclic fatigue testing, an extensive amount of strain ratchetting was found; see Fig. 31. Note that strain ratchetting here refers to the time-dependent progression of the cyclic stress-strain curves along the strain axis. Creep deformation under a tensile mean stress was the first speculation as the mechanism responsible for this strain ratchetting. As shown in Fig. 31, at the early stage of the strain-time history, the cyclic fatigue curve (mean stress = 55 MPa) fell between the two static fatigue curves (applied stresses = 50 and 60 MPa, respectively). This seems to agree with the postulation. However, as no tertiary regime occurred under cyclic loading, the cyclic fatigue curve eventually fell below the static fatigue curve with an applied stress of 50 MPa, suggesting the mechanisms controlling the process of damage accumulation for static and cyclic fatigue were different. More discussion on this phenomenon will follow in Sect. 3.6.2. More evidence supporting this conclusion is presented in Fig. 32 where minimum strain rate was plotted against applied stress in log-log base for both static and cyclic fatigue (0.1-Hz triangular loading) tests. The minimum strain rate for cyclic fatigue was defined as the minimum degree of increase in the strain corresponding to the minimum stress level throughout the test. The mean stress was used as the abscissa for the cyclic fatigue tests in Fig. 32. Fitting the data given in Fig. 32 to a simple power-law relation between minimum strain rate and applied stress ($\dot{\epsilon}_{\min} = A\sigma^n$, A is a constant) yields the following n values: $n = 19, 5.6,$ and 4.4 for static fatigue at $1150, 1260,$ and 1370°C , respectively, while $n = 22$ and 10 for cyclic fatigue tests at 1260 and 1370°C , respectively. The significant difference in the corresponding stress exponent values between static fatigue ($n = 5.6$ and 4.4) and cyclic fatigue ($n = 22$ and 10) at 1260 and 1370°C indicated the damage mechanisms were different for these two loading histories. Therefore, creep was not believed to be the primary damage mechanism leading to the final failures in cyclic fatigue specimens. The similarity of high n values between static fatigue at 1150°C ($n = 19$) and cyclic fatigue at 1260 and 1370°C ($n = 22$ and 10 , respectively) suggests a damage accumulation process analogous to SCG was the dominant failure mechanism for cyclic fatigue. Note that the strain-time curves for static fatigue at 1150°C also had a dominant steady-state regime; see Sect. 3.3. In this sense, the observed strain ratchetting for cyclic fatigue at 1260 and 1370°C might have actually reflected compliance changes that resulted from the subcritical extension of a localized damage zone in a manner similar to SCG.

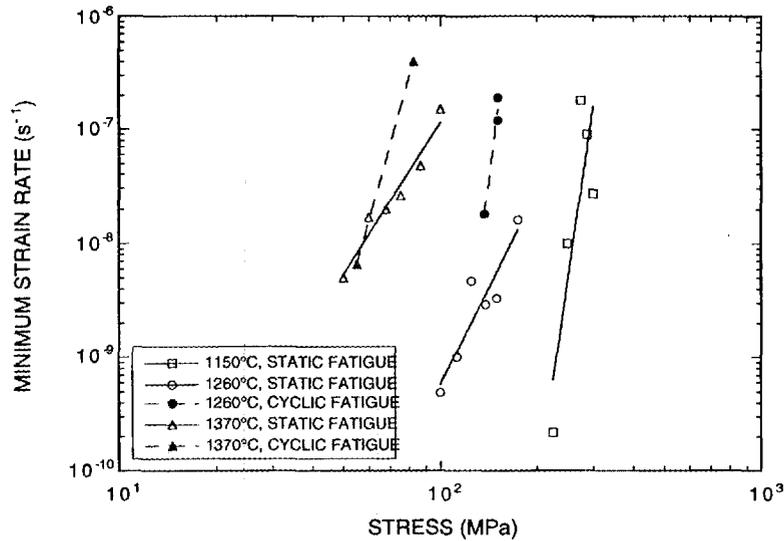
Fig. 32. Comparison of minimum strain rate for static and cyclic fatigue of PY6 at 1150 to 1370°C as a function of static or mean stress.
