ORNL/TM-12943

**High-Temperature Mechanical
Performance of a Hot Isostatically
Pressed Silicon Nitride**

Metals and Ceramics Division

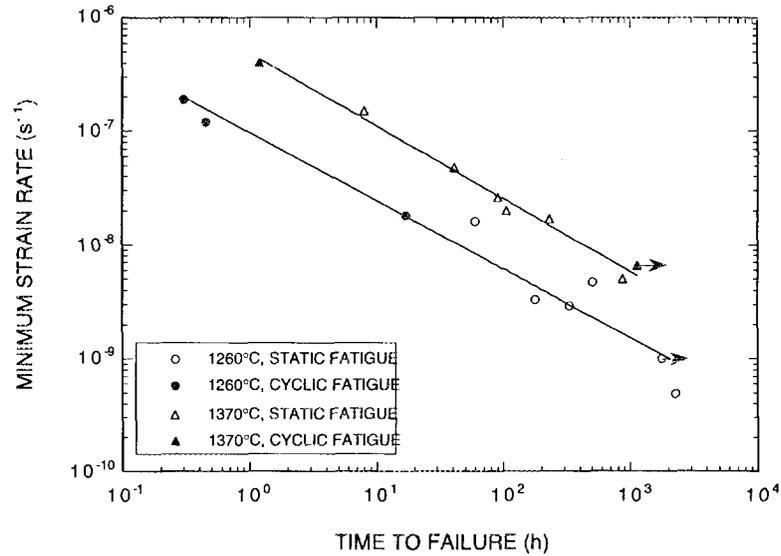
Fig. 33. Comparison of Monkman-Grant-type relations for static and cyclic fatigue of PY6.

A Monkman-Grant plot¹⁰ [$t_f = C(\dot{\epsilon}_{\min})^{-m}$; C is a constant] of the minimum strain rate versus time to failure indicated distinct curves for each test temperature of 1260 and 1370°C regardless of loading history, as shown in Fig. 33. The values of m, estimated from the data in Fig. 33, are approximately 1.5 and relatively independent of temperature. The agreement of cyclic and static fatigue data fitted in the Monkman-Grant relationship implied that stress may not be an appropriate controlling parameter for the correlation of static and cyclic fatigue life at

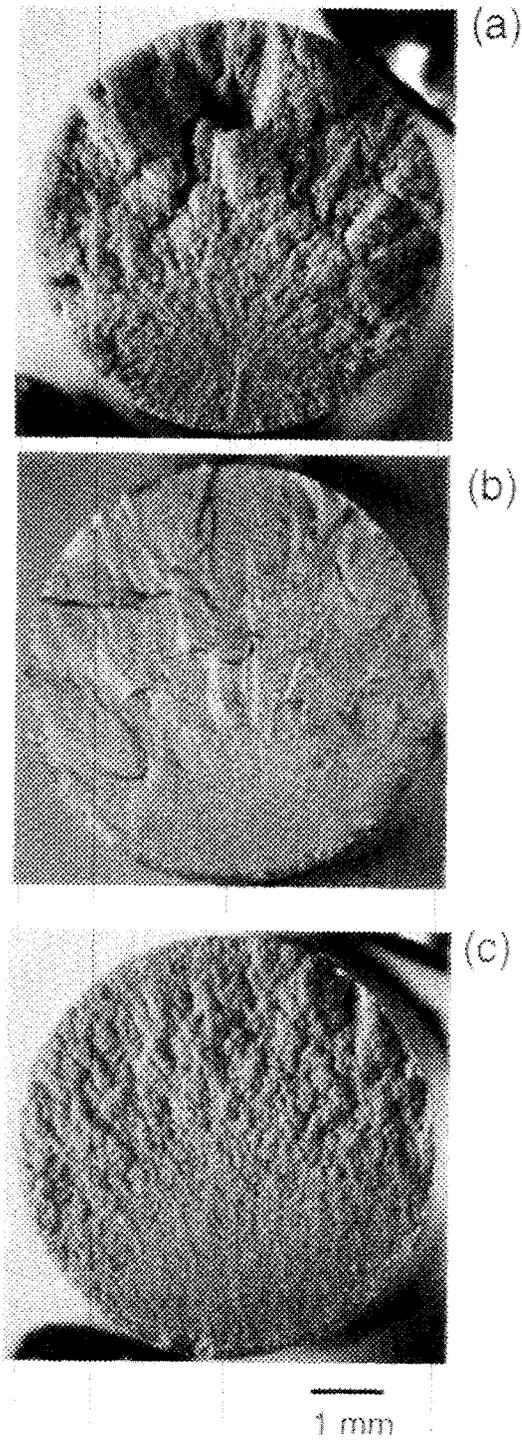
ORNL-PHOTO 10593-95

Fig. 34. Typical fracture surfaces of cyclic fatigue (0.1-Hz, trapezoidal waveform) specimens tested at (a) 1150°C, $\sigma_{\max} = 275$ MPa, $t_{cf} = 916$ h; (b) 1260°C, $\sigma_{\max} = 250$ MPa, $t_{cf} = 306$ h; and (c) 1370°C, $\sigma_{\max} = 150$ MPa, $t_{cf} = 86$ h.

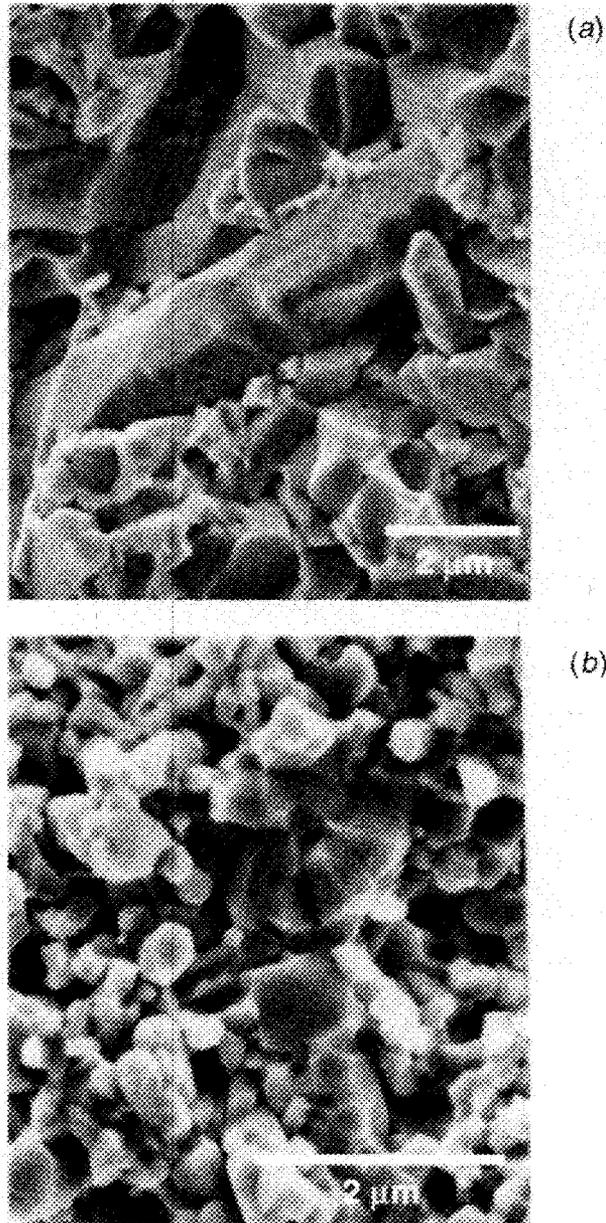
ORNL-PHOTO 10594-95

Fig. 35. Comparison of microstructures of specimens tested at 1370°C in (a) static fatigue, $\sigma_S = 75$ MPa, $t_{sf} = 90$ h, cavities present; and (b) cyclic fatigue, $\sigma_{mean} = 75$ MPa, $t_{cf} = 516$ h, no cavities present.

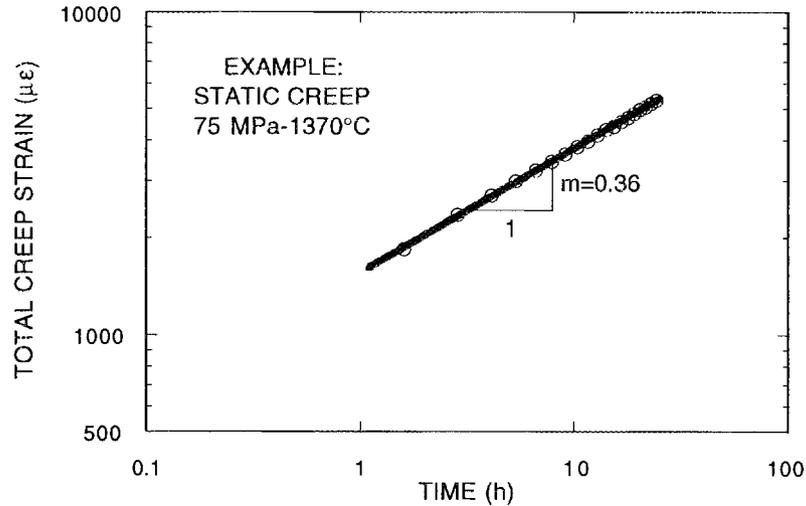
ORNL-DWG95-8954

Fig. 36. The plastic component of creep was dependent on time to an exponent less than one. No single constant can be multiplied by the factor t^1 and still satisfactorily describe the experimental data throughout the duration of the test.

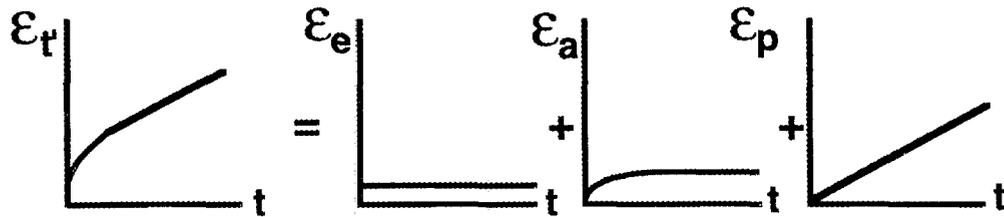
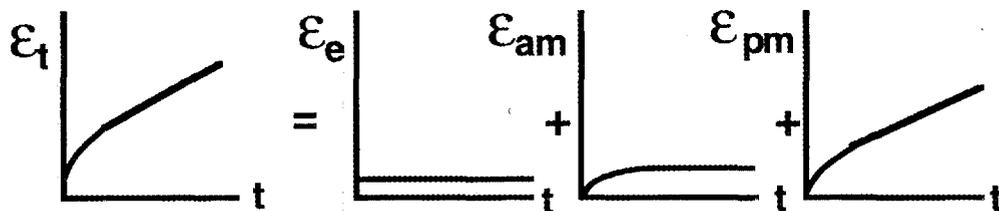
Fig. 37. The plastic term in the Pao and Marin model is linearly dependent with time [$m = 1$ in Eq. (29)] while it is dependent with time raised to some exponent [$m < 1$ in Eq. (29)] in the modified Pao and Marin model.

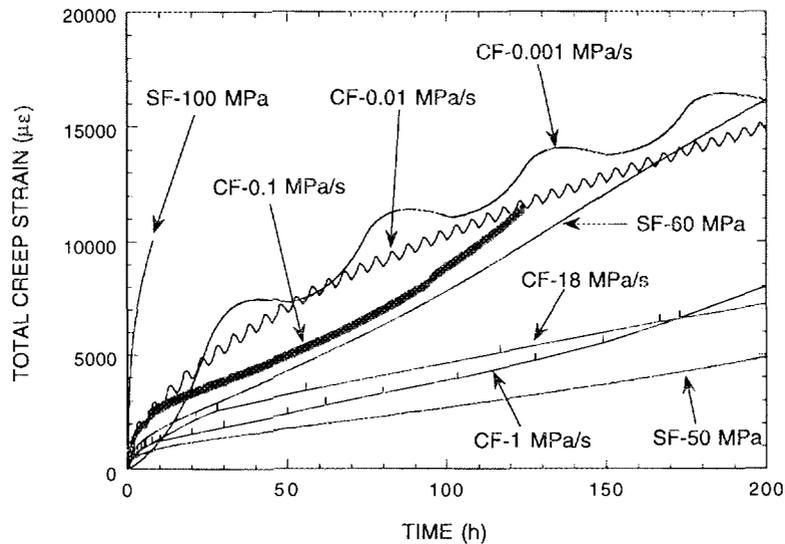
ORNL-DWG95-8955

Fig. 38. Strain-time histories of cyclic fatigue (CF) tests are compared with static fatigue (SF) strain histories.

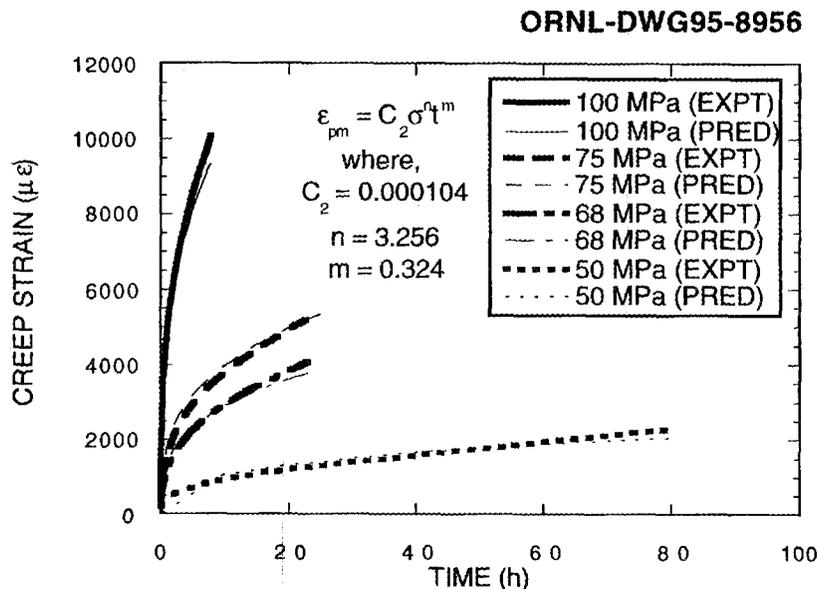
Fig. 39. The variables C_2 , n , and m were determined from multilinear regression of total creep strain versus time from static creep histories.

for four static creep stresses of 50, 68, 75, and 100 MPa. It was determined that $C_2 = 0.000104$, $n = 3.256$, and $m = 0.324$. It was noteworthy that the stress dependence on the total creep strain was found to be 3.256, while the stress dependence on the minimum creep rate was previously determined to be 4.7 for PY6 at 1370°C, as described in Sect. 3.3. The time exponent of 0.324 is quite close to the one-third predicted by the classical Andrade analysis.³⁴ The experimental data and the fitted curves are shown in Fig. 39. Even though the total strain is plotted as the ordinate in Fig. 39, the use of it (versus *just* the plastic strain) does not affect the slope determination of the plastic creep time exponent (i.e., m) on the log-log plot because the elastic and anelastic contributions are small and effectively constant over the life of the test. These three values of C_2 , n , and m were used in Eq. (29) for analyses.

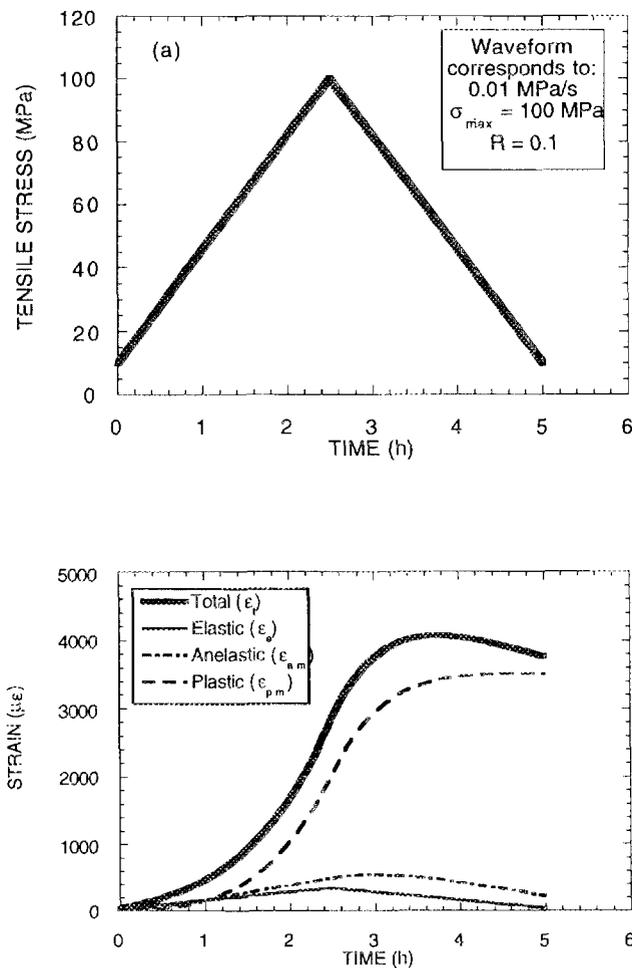
ORNL-DWG95-8957

Fig. 40. For an arbitrary triangular waveform (a), examples of elastic, anelastic, plastic, and total strain are predicted (b) for one cycle using Eq. (29).

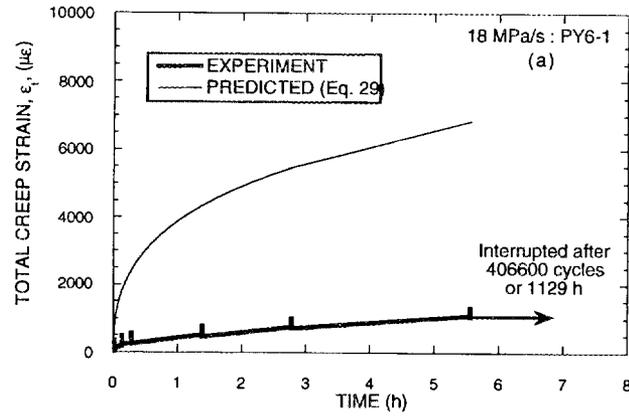
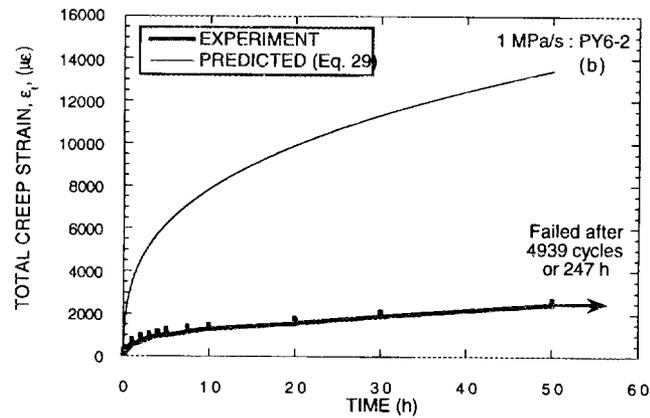
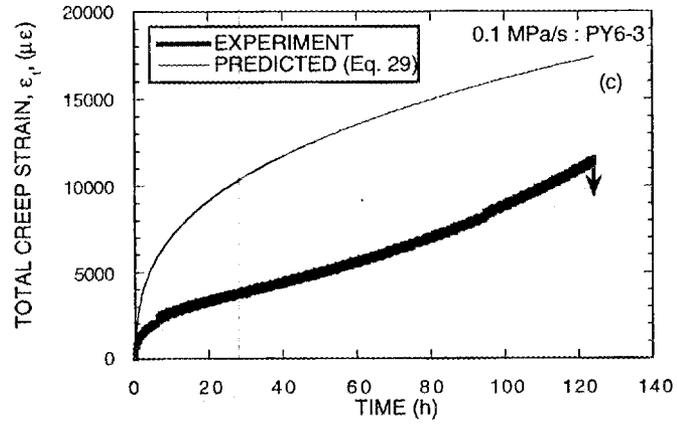
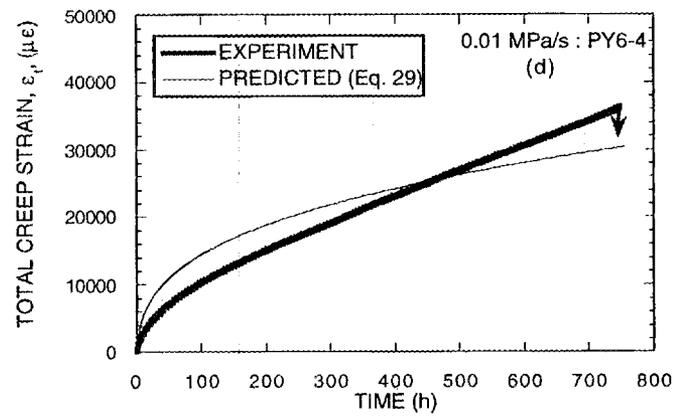
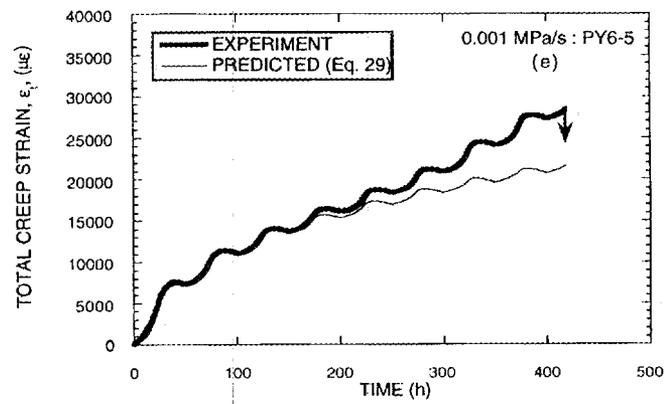
Fig. 41. Experimental cyclic creep strain as a function of time is compared with data predicted using the MPM model for specimens (a) PY6-1, 0.1 Hz, 18 MPa/s; (b) PY6-2, 0.0056 Hz, 1 MPa/s; (c) PY6-3, 0.00056 Hz, 0.1 MPa/s; (d) PY6-4, 0.000056 Hz, 0.01 MPa/s; and (e) PY6-5, 0.0000056 Hz, 0.001 MPa/s.

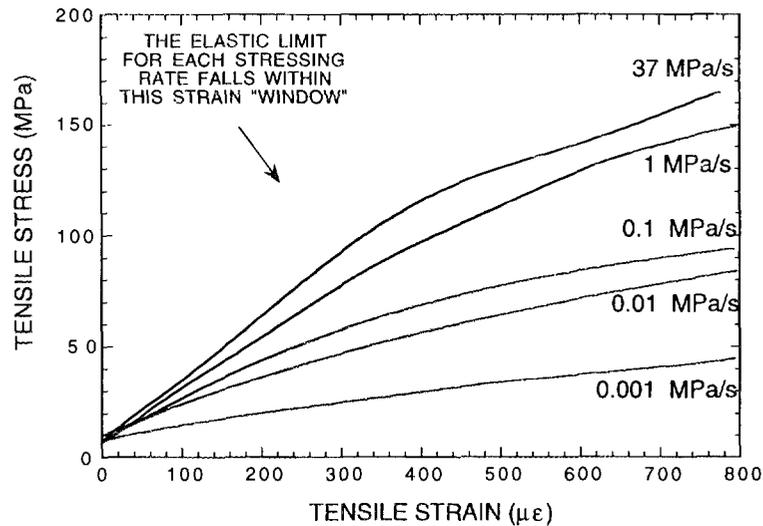
Fig. 42. The elastic limit of PY6 silicon nitride is a function of the stressing rate. As the stressing rate is decreased, the elastic stress limit decreases and plastic creep occurs at lower stresses. Curves shown are taken from Fig. 24(c).

To illustrate the stressing rate dependence on the elastic limit, the first 800 $\mu\epsilon$ (or 0.08% strain) of Fig. 24(c) are shown in Fig. 42. Four of the five stressing rates shown match rates used in the present cyclic fatigue study; 37 MPa/s was included as a comparison to show a faster stressing rate response. Although it is somewhat of a subjective determination, the effective elastic limit is somewhere between \cong 80 to 100 MPa for 1 MPa/s and as low as \cong 30 MPa for 0.001 MPa/s. Note that these stressing rates were used in the cyclic fatigue tests for specimens PY6-2 and PY6-5, respectively. The MPM model predicts a plastic contribution to the total strain for *all* stresses during each cycle; whereas in the experimental case, there may only be a plastic strain contribution for stresses *above* the elastic limit for that corresponding stressing rate. For cyclic tests PY6-1, PY6-2, and PY6-3, the frequencies or stressing rates were *fast enough* that there was not an appreciable amount of time above the elastic limit for each stressing rate to accumulate the total strain predicted by the MPM

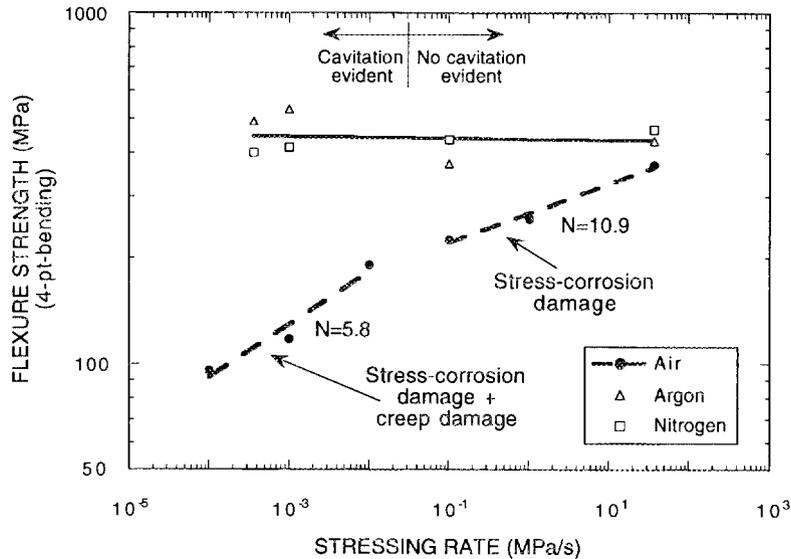
Fig. 43. The adjusted flexure strength of PY6 silicon nitride at 1370°C was found to be independent and dependent of the stressing rate in inert environments and ambient air, respectively.

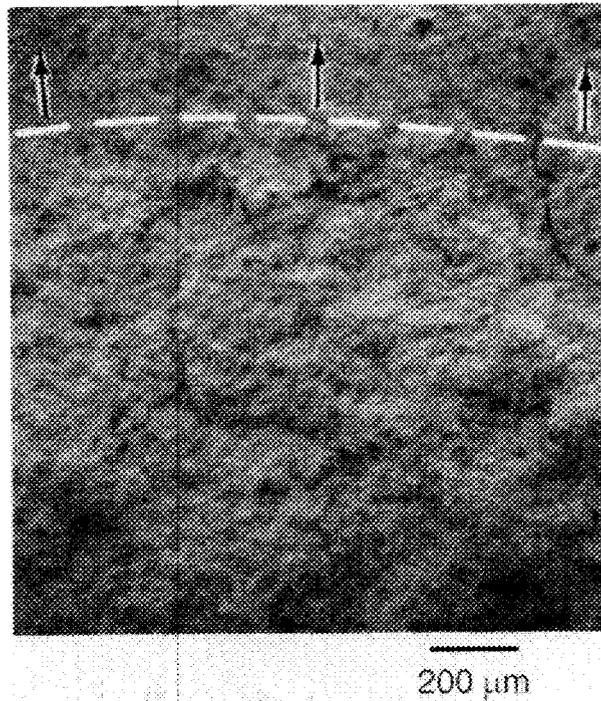
ORNL-PHOTO 10595-95

Fig. 44. The transition from the stress-corrosion cracking (SCC) damage zone (lower half) to fast fracture (upper half) is shown on the specimen tested in ambient air at 10^{-4} MPa/s. Note the rough versus smooth topography of the SCC damage and fast fracture zones, respectively. The surface shown was etched, and the arrows describe the crack propagation direction.

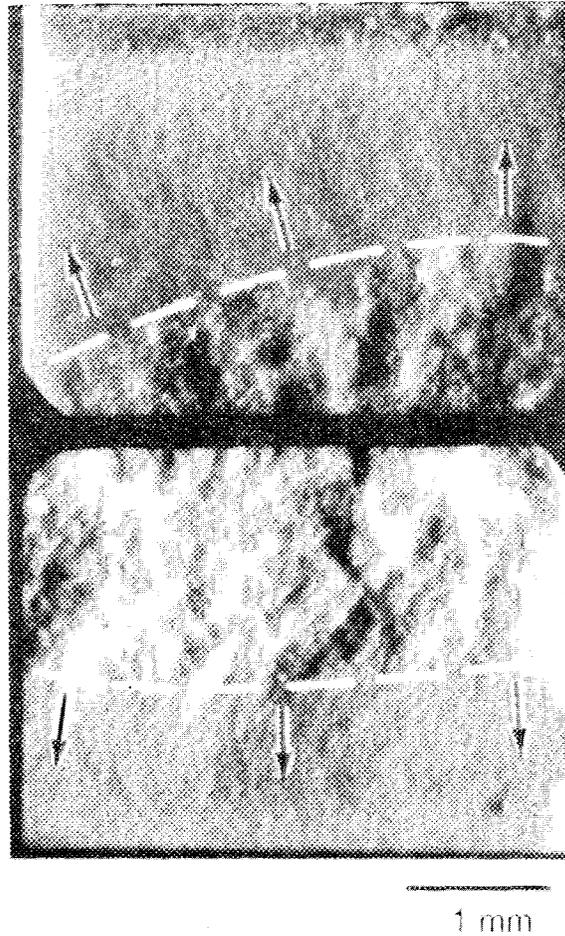
ORNL-PHOTO 10596-95

Fig. 45. A stress-corrosion cracking (SCC) damage zone was observed on the fracture surfaces of all specimens tested in ambient air at 1370°C. The top and bottom specimens shown were tested at 10^{-2} and 10^{-4} MPa/s, with adjusted flexure strengths of 191 and 96 MPa, respectively. Tensile sides are beveled, and arrows show crack propagation direction.

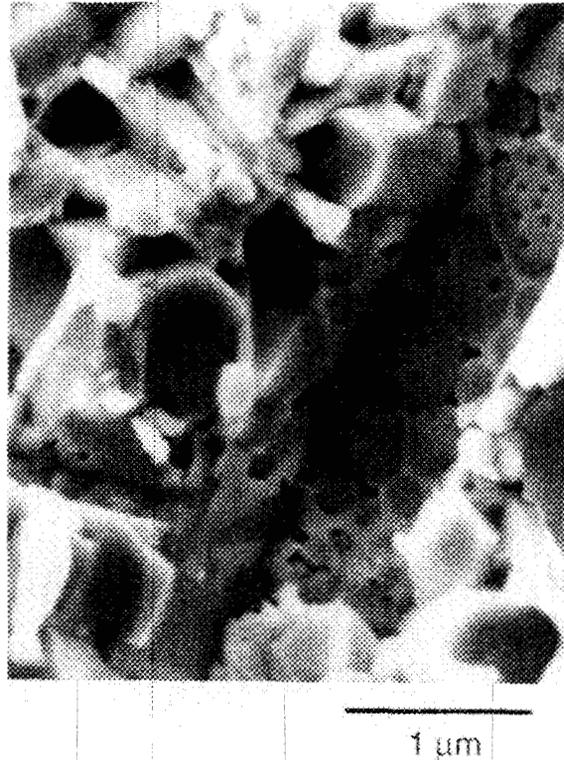
Fig. 48. Lenticular cavitation was observed in specimens when $\dot{\sigma} < 0.1$ MPa/s. The microstructure of a nitrogen-tested specimen stressed at 10^{-3} MPa/s is shown. Specimens tested in air and argon at this stressing rate showed similar cavitation. Specimens were refractured at room temperature after testing but prior to microscopy in order to reveal the microstructure.
