Wind-Driven Rain: From Theory to Reality

Hugo Hens, PhD
Fellow Member ASHRAE

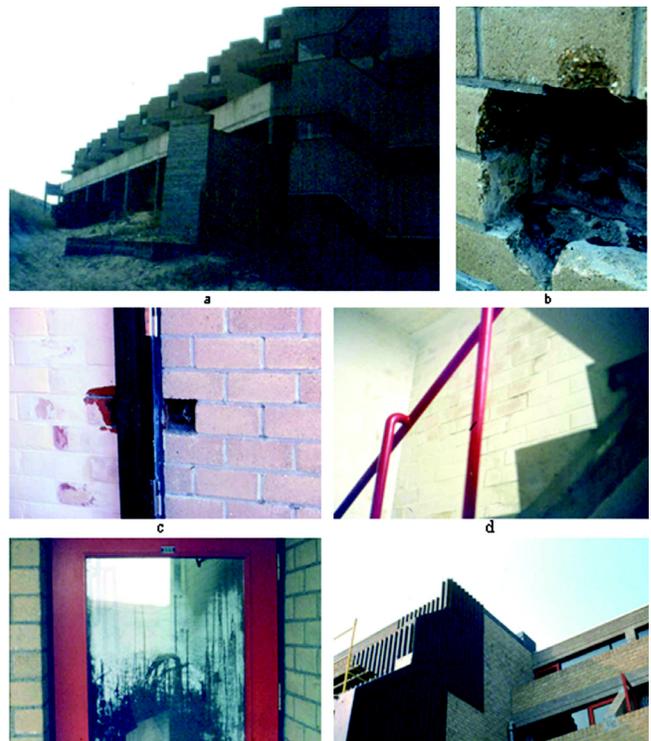
Figure 6 Hotel at the Belgian coast: (a) the building, (b) tray short-circuited by mortar debris, (c) lack of a watertight layer where the veneer touches the inside walls, (d) wet inside leaf, (e) surface condensation on double glazing, (f) final retrofit

by the one above (Figure 6a). As a consequence, each balcony acted as a rain gauge. The façade consisted of a cavity wall with a 9 cm thick concrete block veneer, a 3–4 cm wide unfilled cavity, and a 14 cm thick nonplastered concrete block inside leaf. The veneer blocks showed no capillary activity, whereas their 9 cm height made a full mortar fill of the head joints during block-laying difficult, which resulted in mortar drops in the cavity and debris accumulation on the tray (Figure 6b). Over time, microcracks also formed between the pointed head joints and the concrete blocks. Coping stones covering the hollow walls along the balconies had no watertight layer below that stopped rain from penetrating and leaking into the hollow.

veneer, cross the cavity, moisten the inside leaf, and humidify large parts of the inside surface (Figure 6d). At the same time, water dripped out of the floor at the central light in each room

and wetted the bed below. Drying, in turn, elevated the relative humidity inside, causing surface condensation on the double-glazed windows during colder weather (Figure 6e).

The problem was addressed by cladding the existing façade with a new rain-tight layer composed of factory-made fiber-cement elements (Figure 6f). The costs were impressive, though lower than they would have been if the veneer wall had to be removed, all trays cleaned, rain barriers added where needed, the veneer brick-laid again, and the inside leaf plastered.

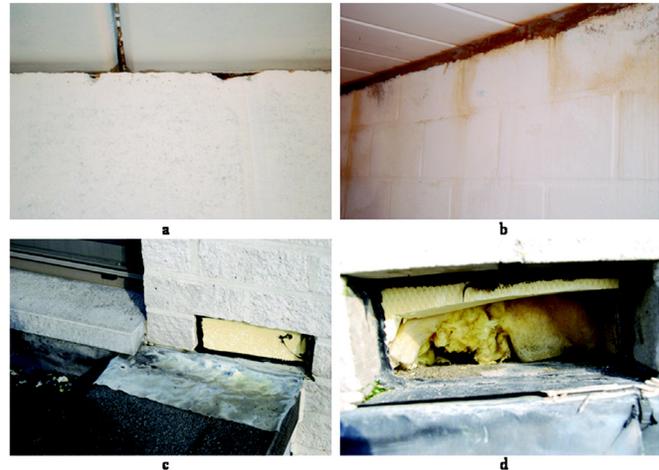
Figure 8 *New detached house: (a) watertight layer between basement wall and concrete floor elements, (b) run-off in the basement along the exterior below grade walls, (c) poor flashing down the filled cavity wall above the low-sloped roof covering part of the living room, and (d) wrongly mounted tray down the filled cavity of that wall.*

Leakage in the living room and the damp spots in the sleeping rooms were caused by bad flashing and bad tray detailing down the filled cavity at the low-sloped roof above the living room (Figures 8c and 8d). That leakage may not have occurred if a capillary brick veneer was used. In fact, the hardly capillary sand-lime stone aggravated rain water penetration through the head joints. Subsequent cavity run-off collected at the failing tray, where it found its way to the inside.
