Overview of Creep Strength and Oxidation of Heat-Resistant Alloy Sheets and Foils for Compact Heat-Exchangers

*Philip J. Maziasz, J.P. Shingledecker,
B.A. Pint, N.D. Evans, K.L. More, and E. Lara-Curzio*

Oak Ridge National Laboratory

Fuel Cells: Materials, Processing & Manufacturing Technologies Symposium
ASM Materials Solutions 2004, 18-20 October, Columbus, OH

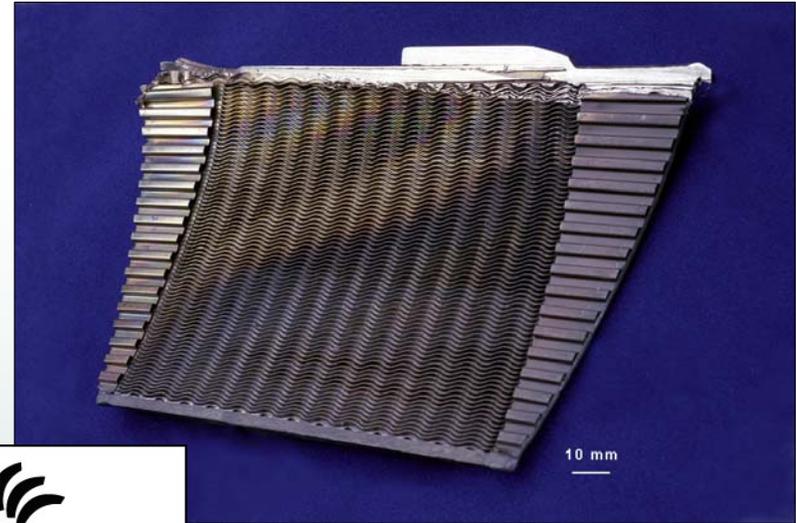
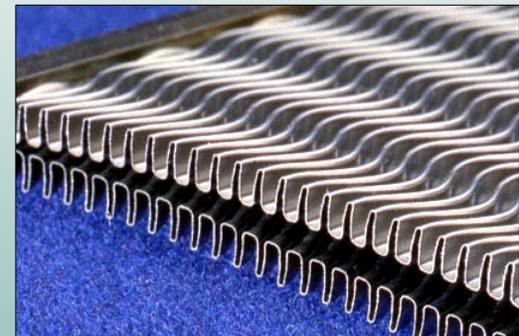
Primary Surface
Recuperator (PSR)

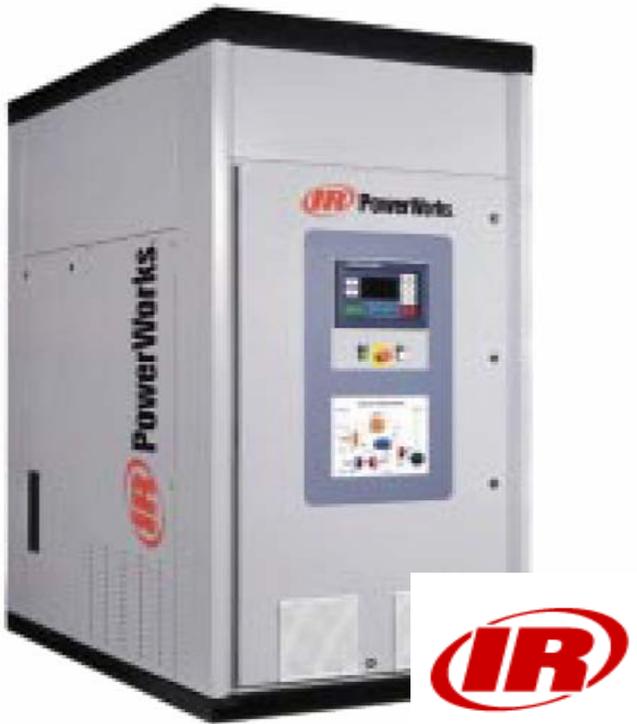
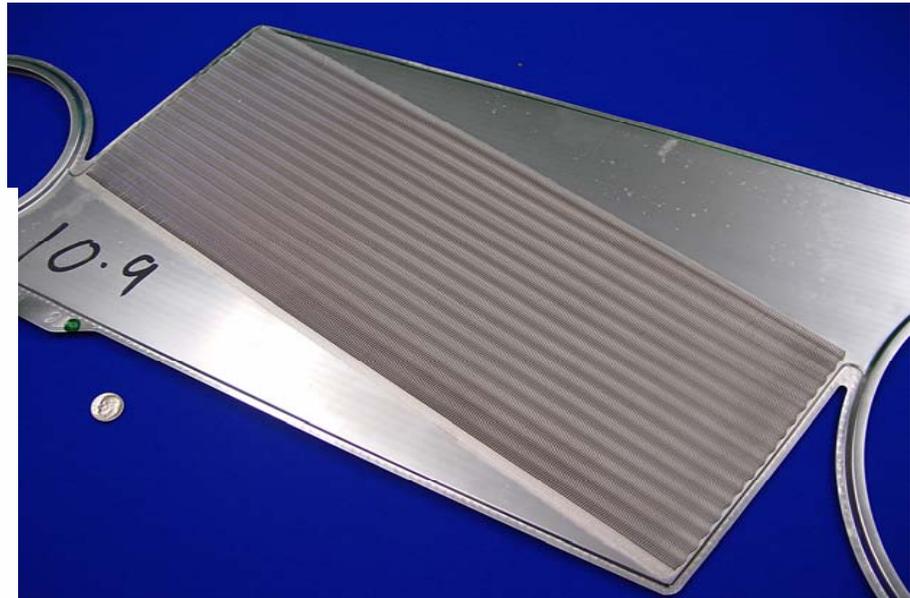
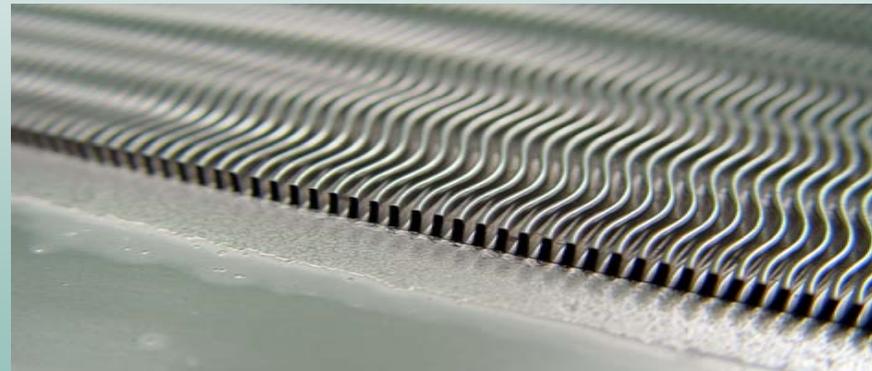
Brazed Plate and Fin
Recuperator (PFR)

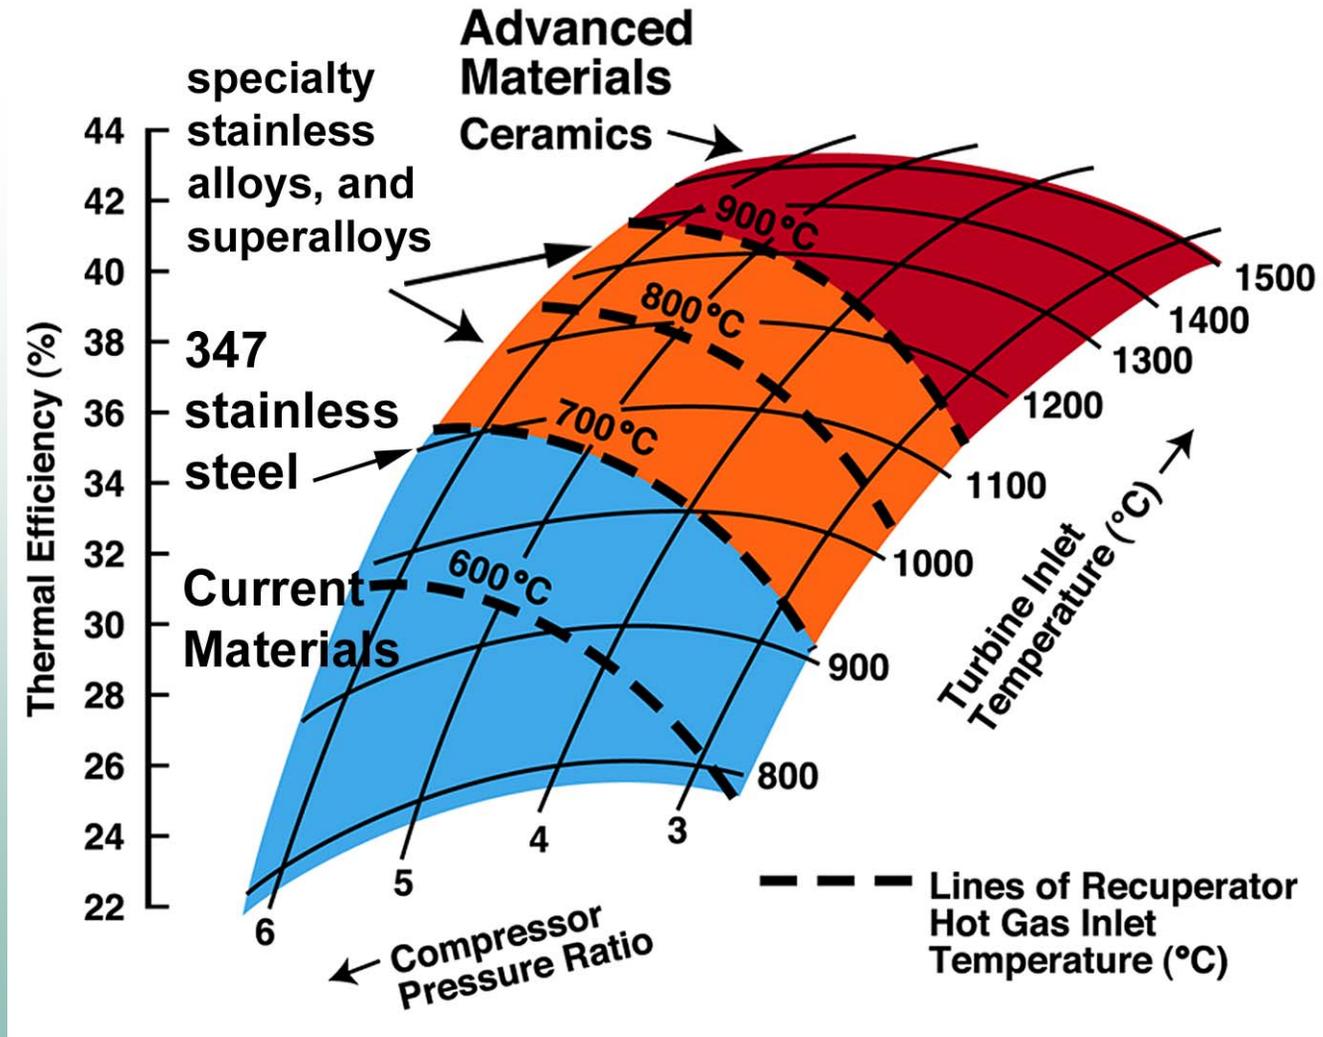
Materials Selection is Determined by the Recuperator Hot-Gas Inlet Temperature and by the Alloy Capabilities

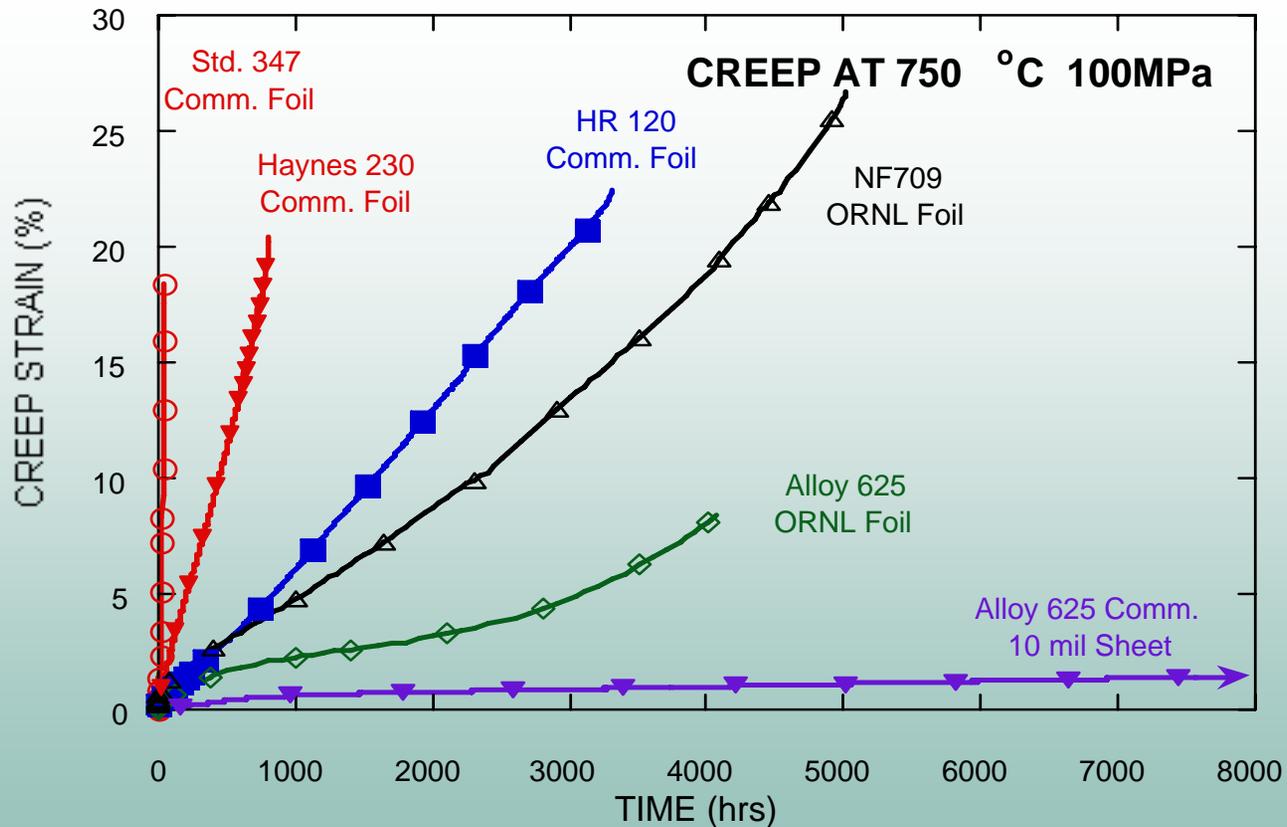
Several commercial heat-resistant alloys have better creep-rupture resistance than 347 steel

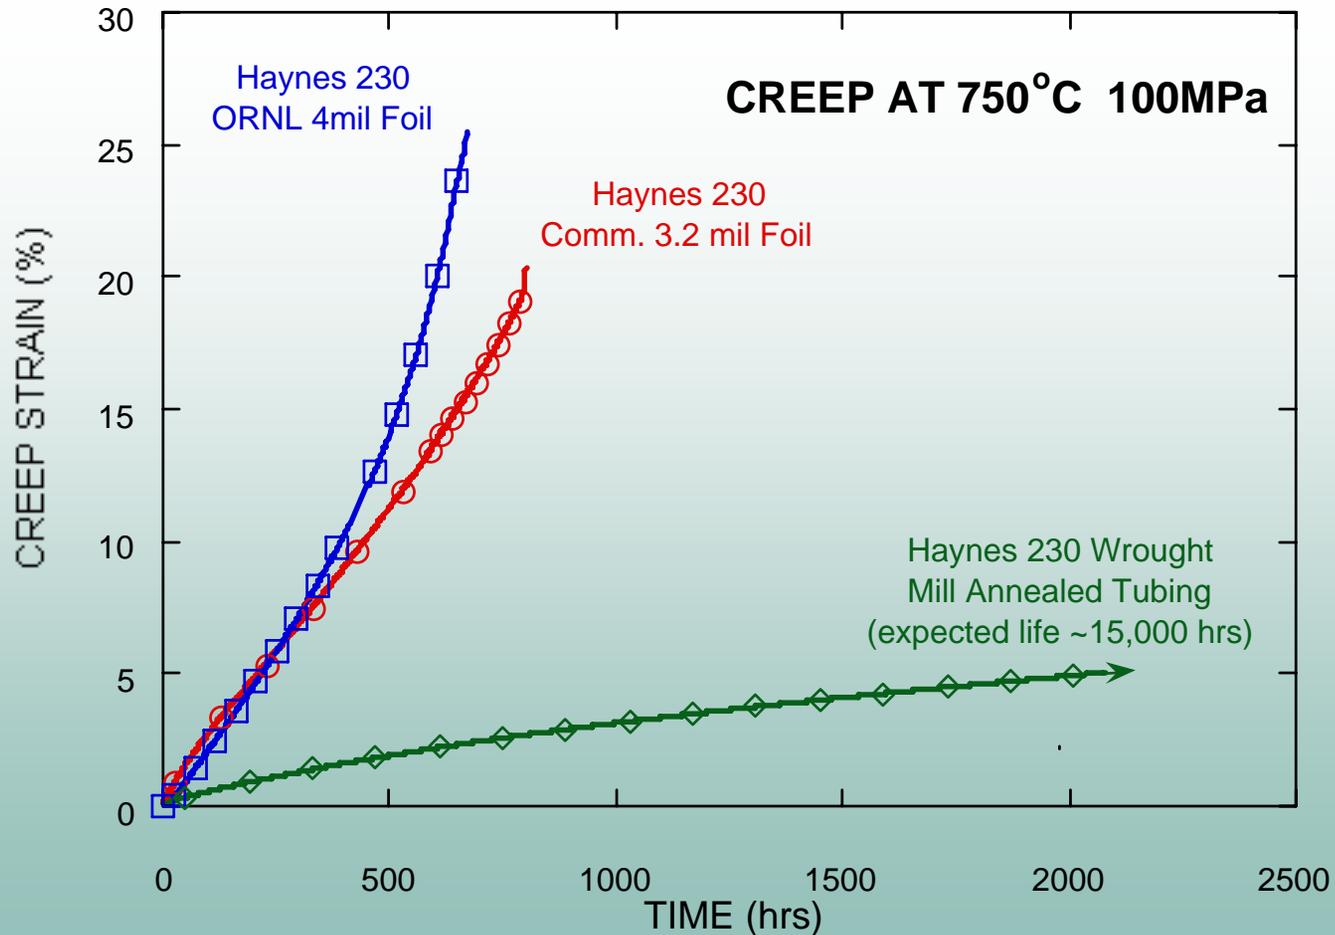
Alloy Selection for Recuperators is Complicated by Grain Size/Processing Effects That Make Foils and Sheets Much Weaker than Plate or Tubing

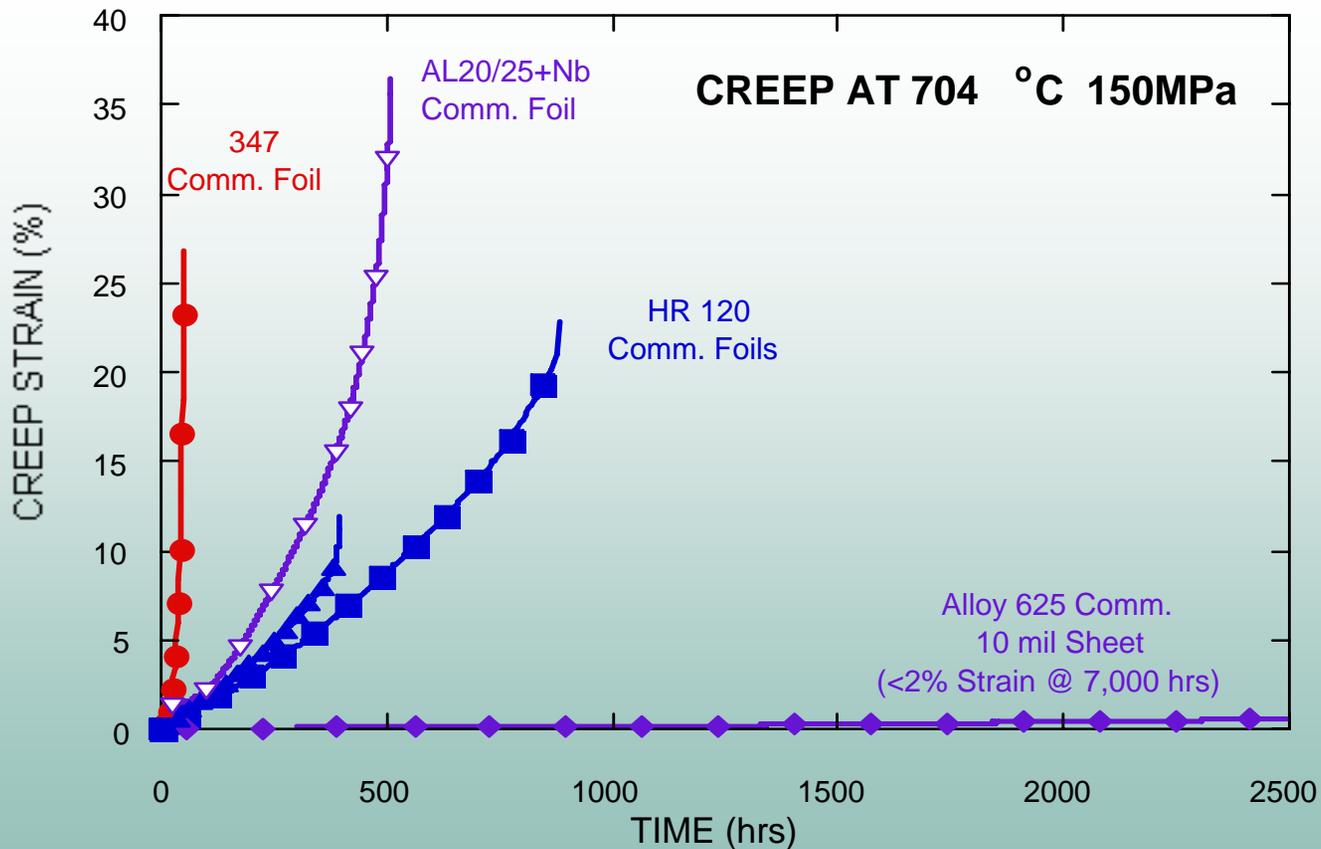
Several commercial heat-resistant alloys have better creep-rupture resistance than 347 steel

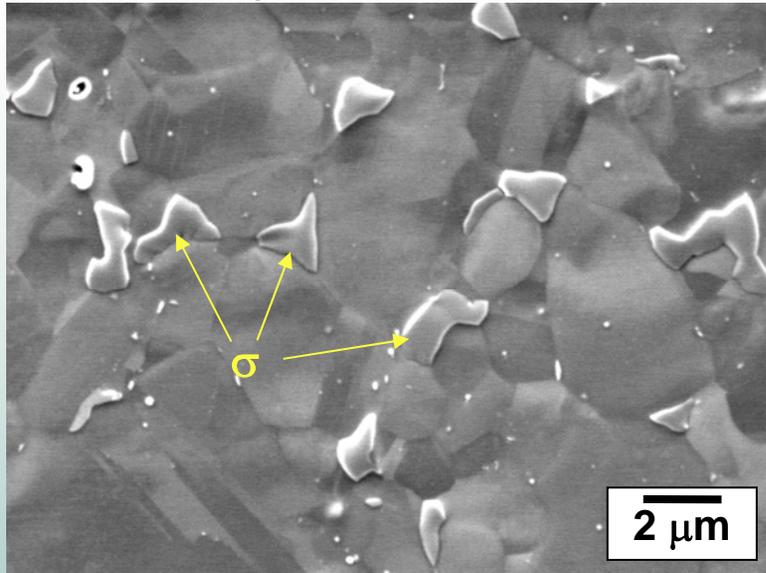
SE SEM image

T347 crept 704°C , 152 MPa $t_r=51.4\ \text{h}$

Alloy 625 Has Finer Precipitation of M_6C Instead of the FeCr σ -phase for Better Creep Resistance

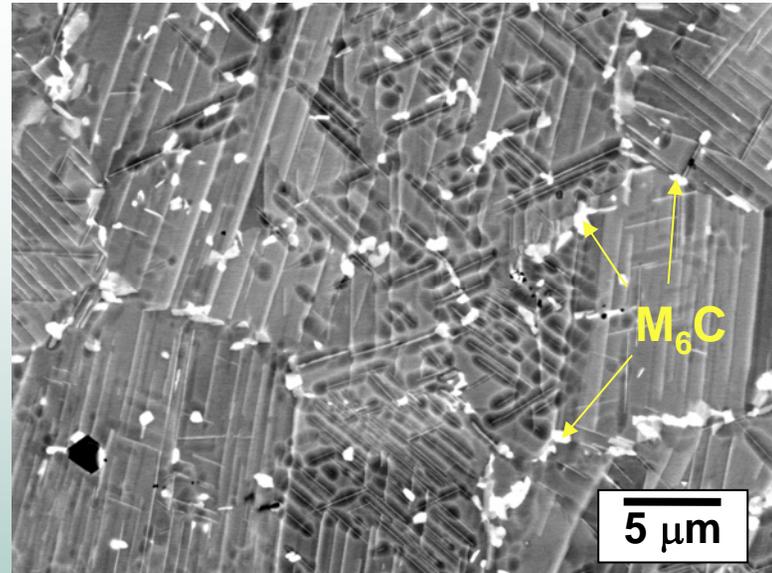
BSE SEM image

Alloy 625 crept 750°C , 100 MPa $t_r=4510\ \text{h}$

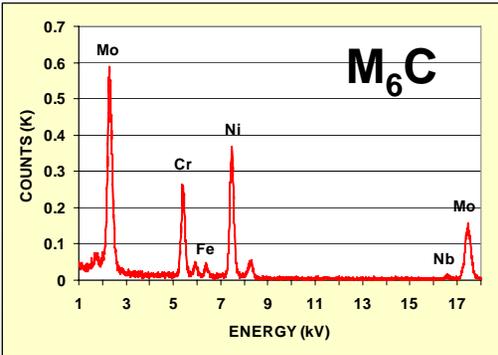
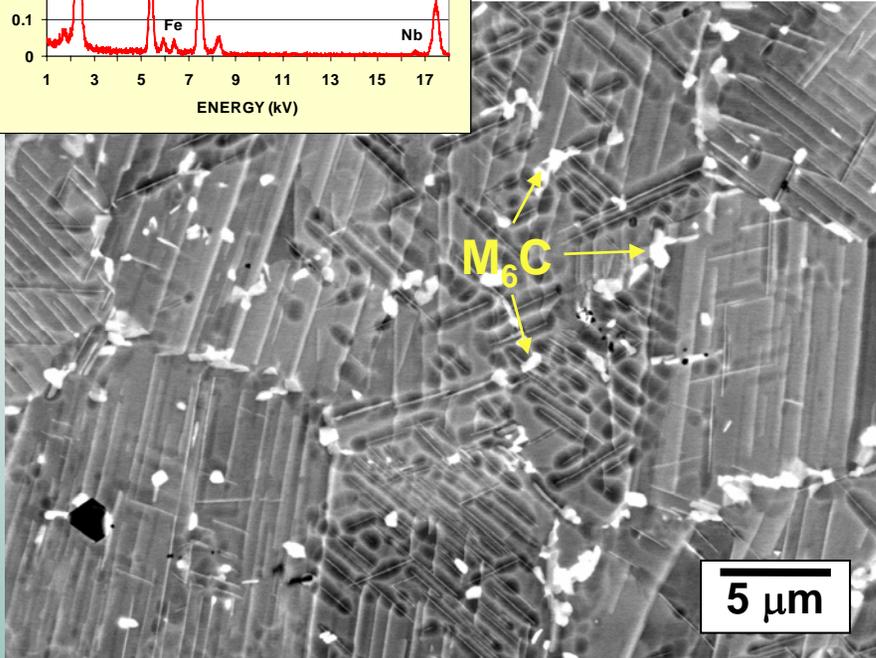
Grain Boundary Phases and Distributions Develop Differently in Alloy 625 and HR120 During Creep

Alloy 625 crept 750°C,
100 MPa, $t_r=4510$ h

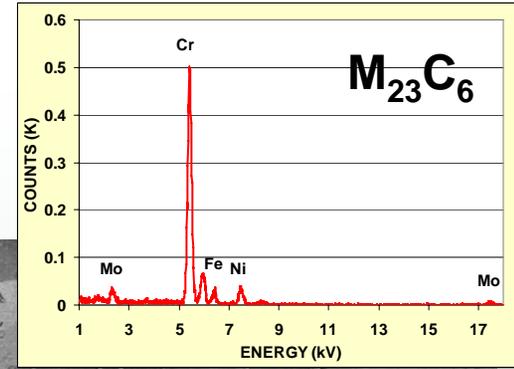
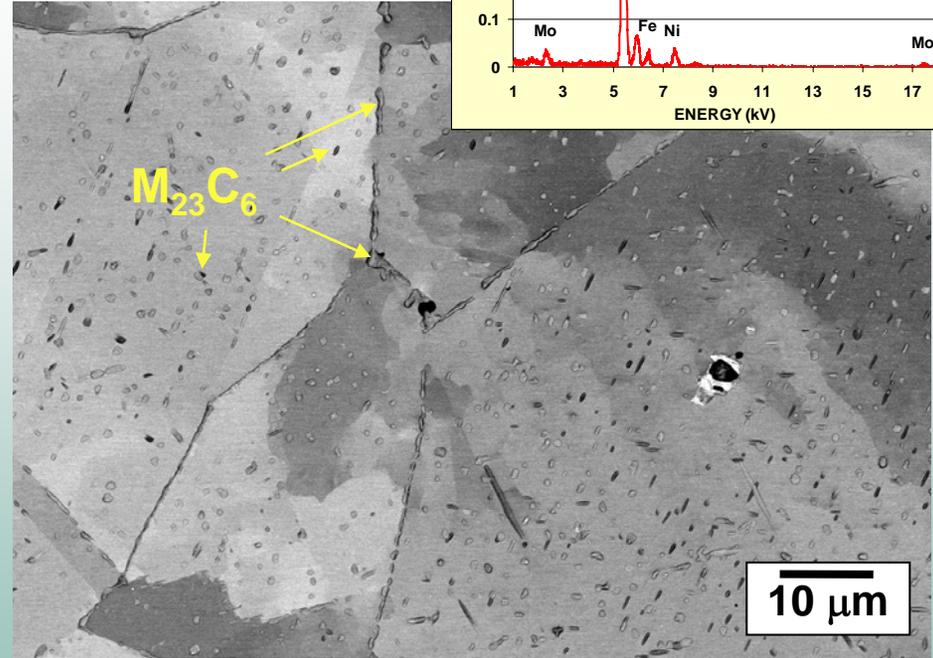
Alloy HR120 crept 750°C,
100 MPa, $t_r=3319$ h

BSE SEM images

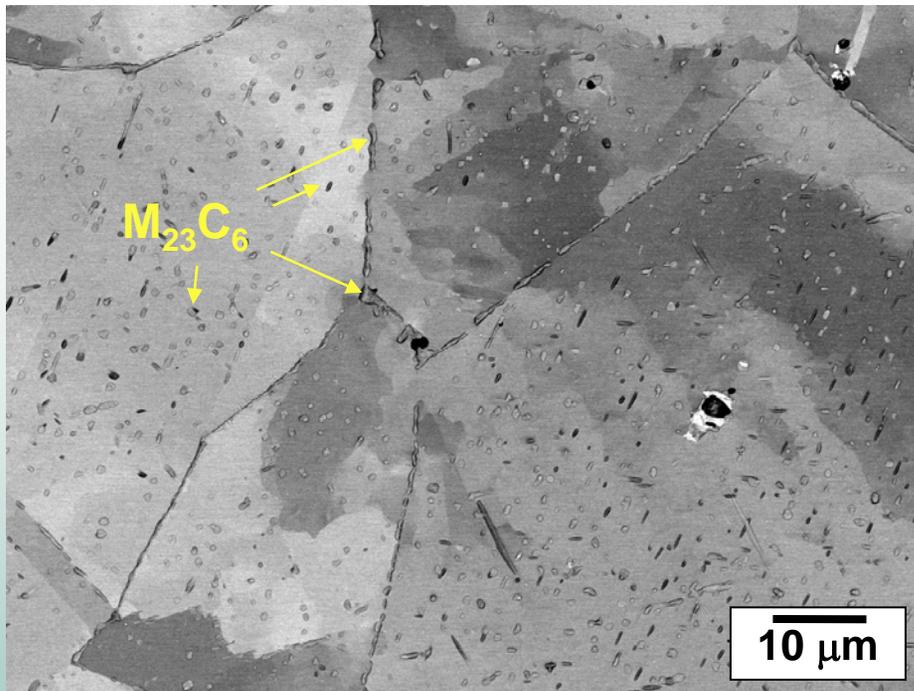
Alloy HR120 crept 750°C,
100 MPa, $t_r=3319$ h

Subtle Difference in Grain Boundary and Matrix Carbides and Distributions Affect the Creep Differences Between NF709 and HR120

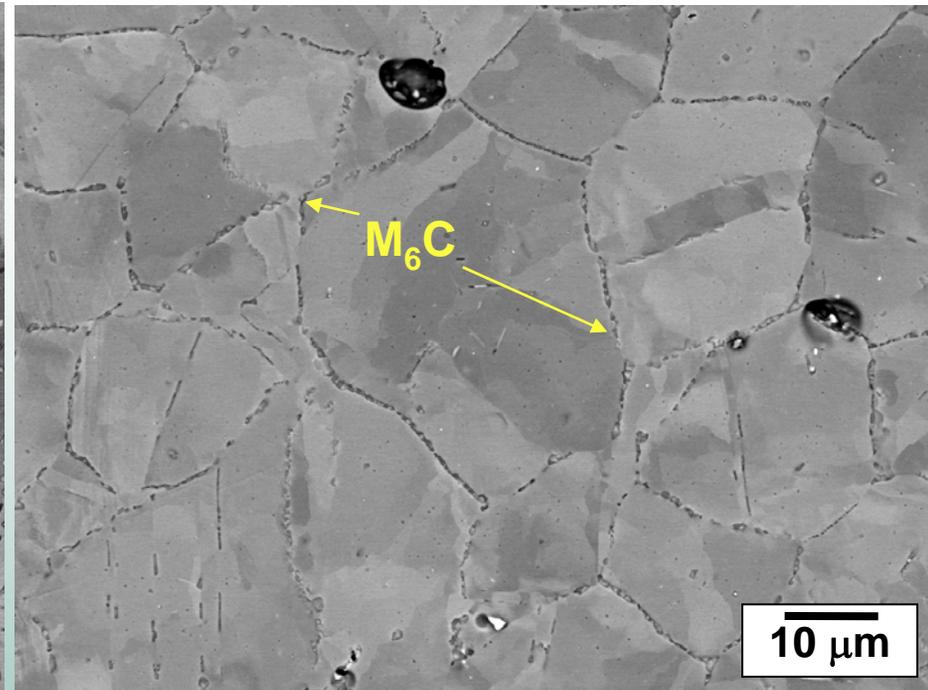
Alloy NF709 crept 750°C,
100 MPa, $t_r=5015$ h

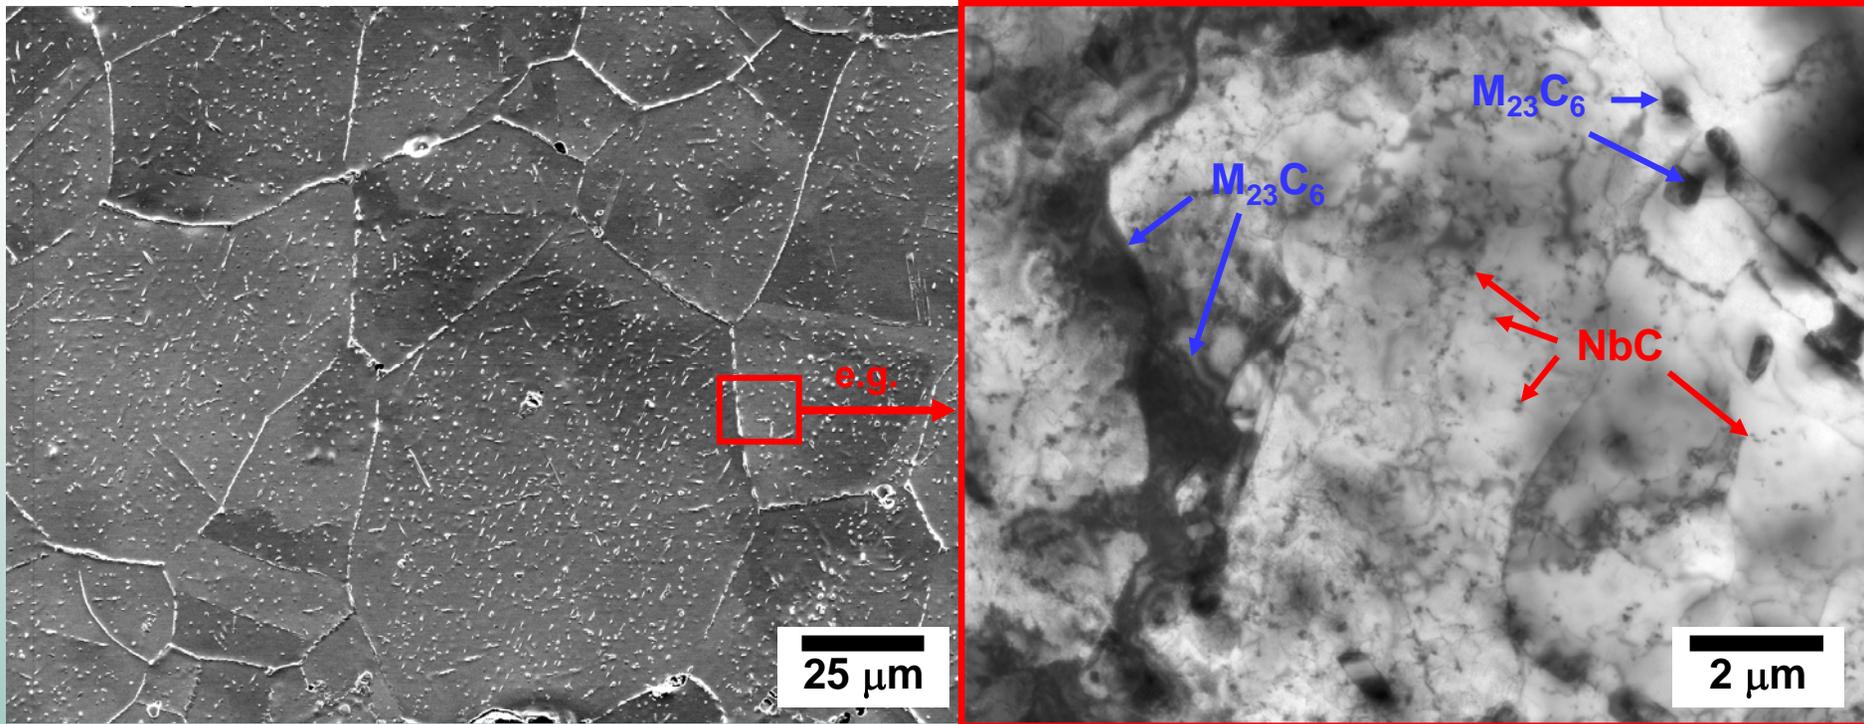
HR120 Foil Develops $M_{23}C_6$ Within Grains and Along Grain Boundaries and Finely Dispersed NbC Within the Grains During Creep at 750°C

SE SEM Image

TEM Image

Creep Tested 750°C 100mPa; $t_r = 3320$ h

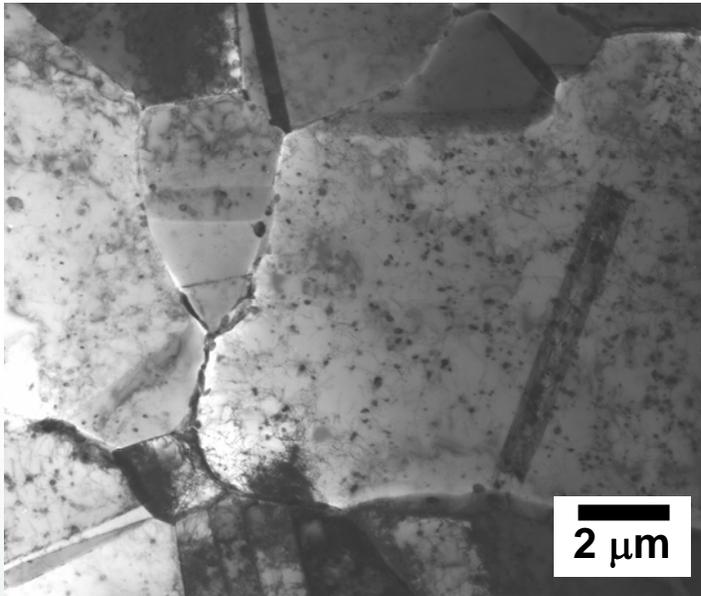
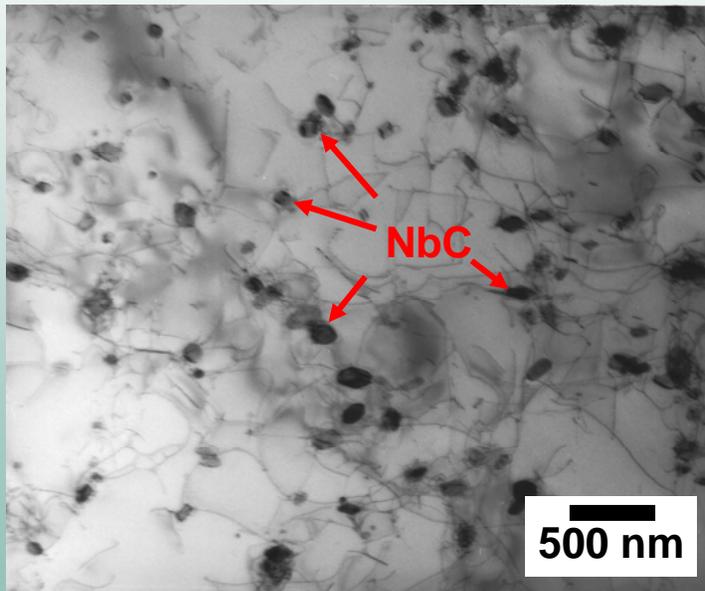
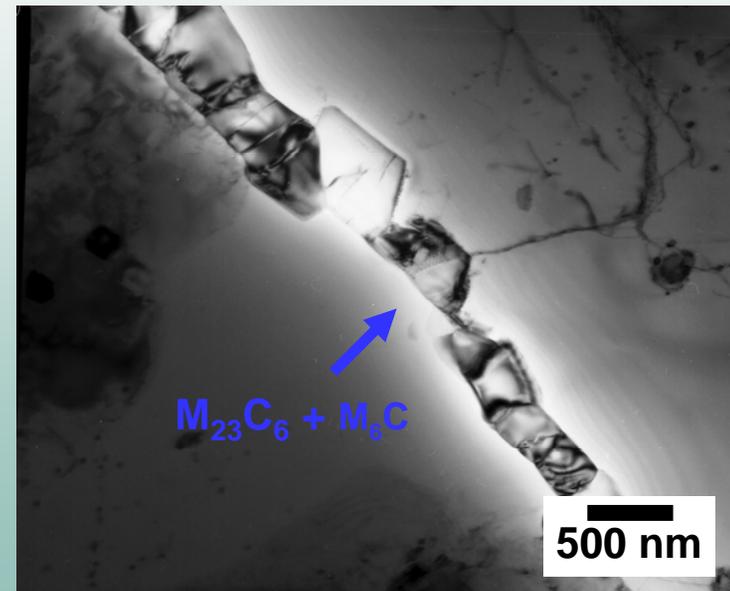
**NF709 Foil Contains
Finely Dispersed NbC
Within the Grains and
 $M_{23}C_6$ and M_6C Along
Grain Boundaries After
Creep at 750°C/100 MPa
for 5015h**

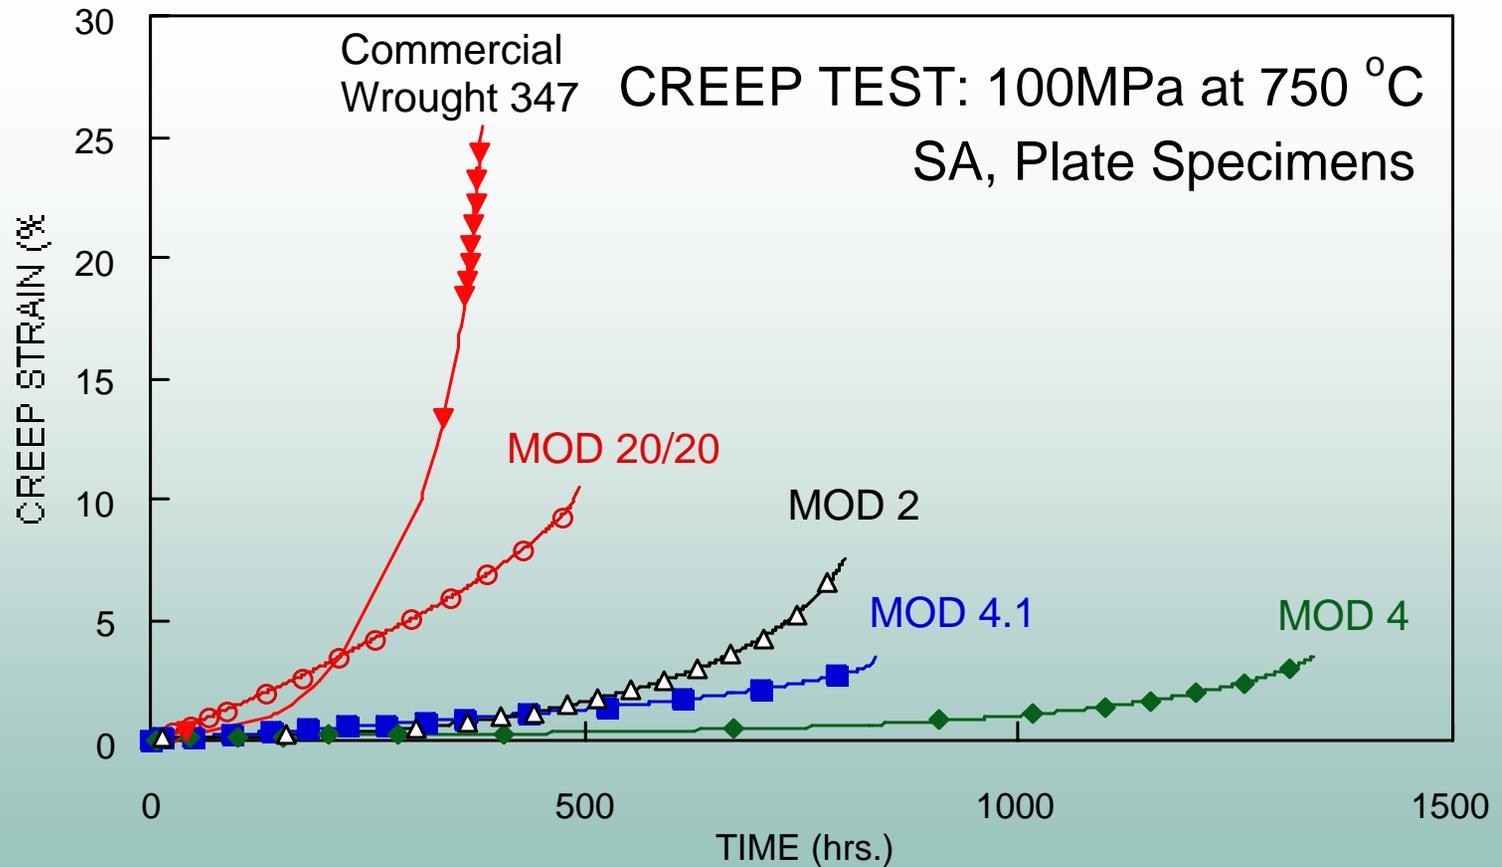
ORNL has developed new, modified 347 stainless steels with much better creep resistance at 750°C

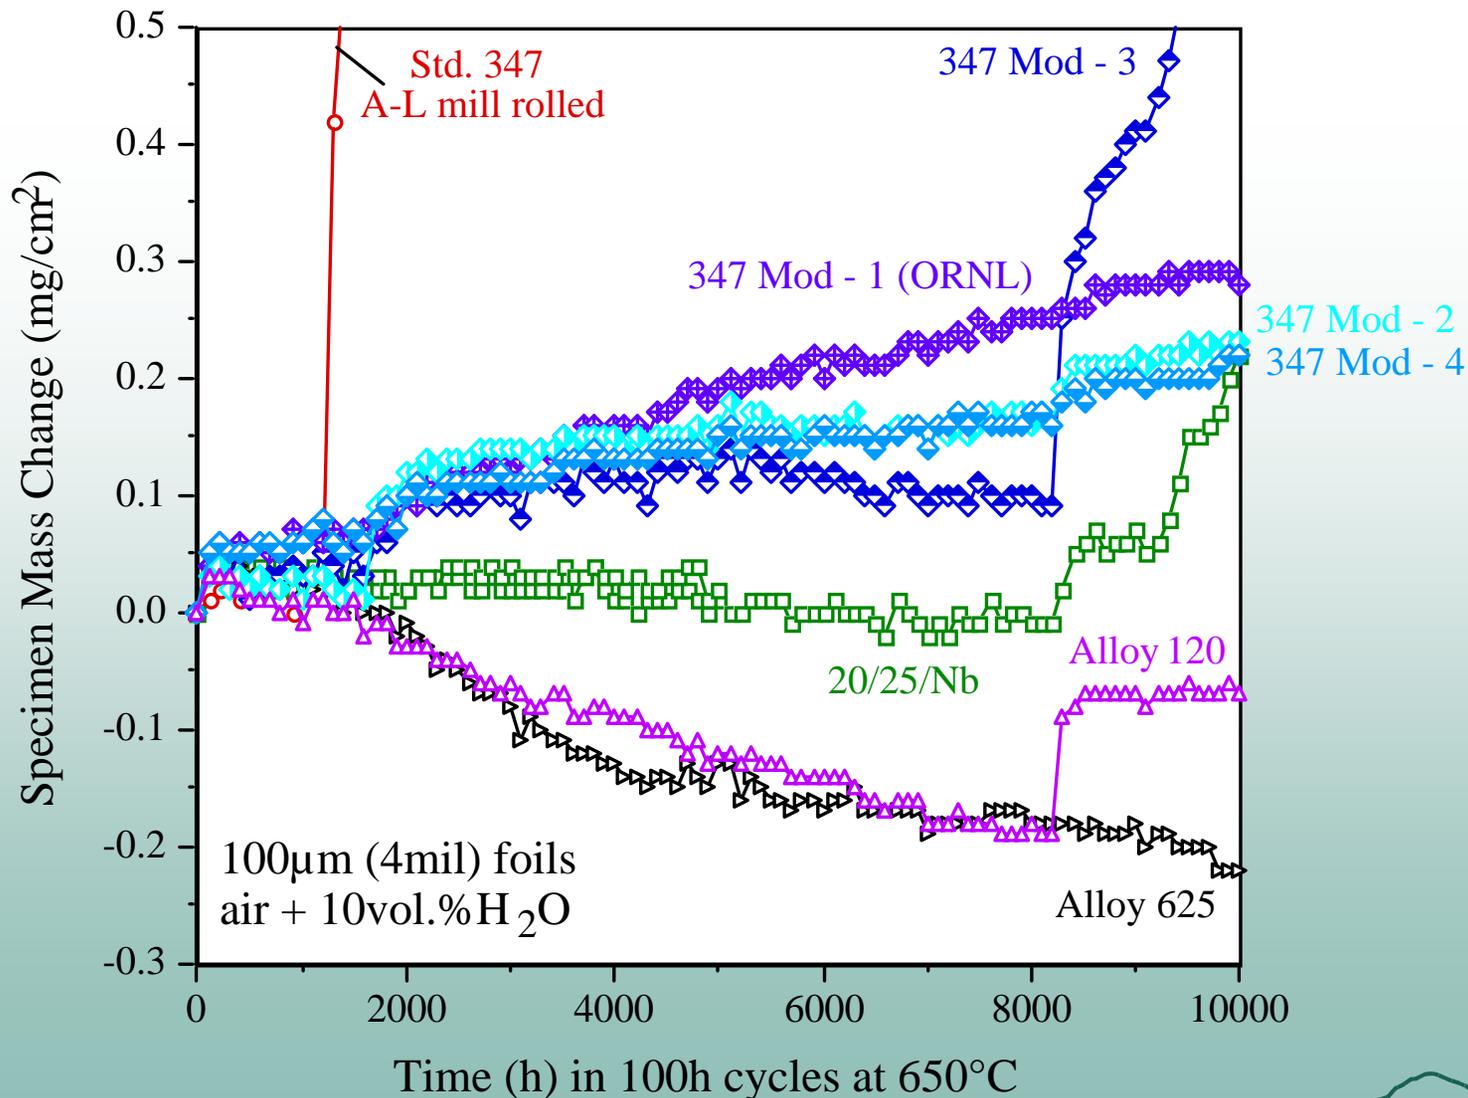
Several more heat resistant alloy also show much better resistant to moisture enhanced oxidation than 347 steel

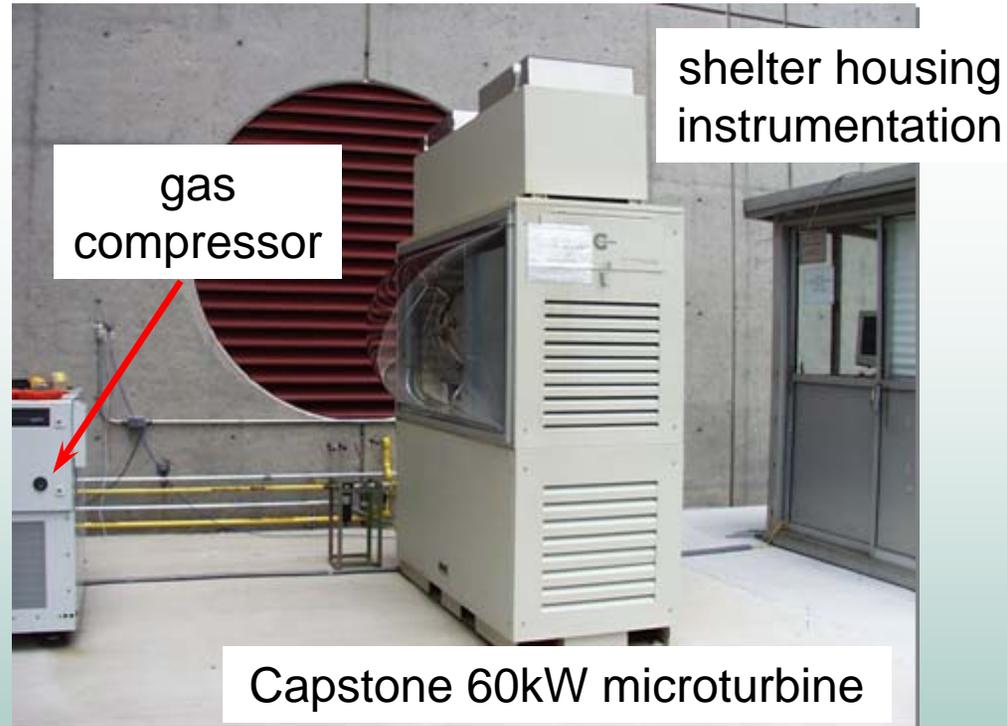
As part of the Advanced Materials for Recuperators Program, ORNL established a microturbine test facility to **screen** and **evaluate** candidate materials for advanced microturbine recuperators

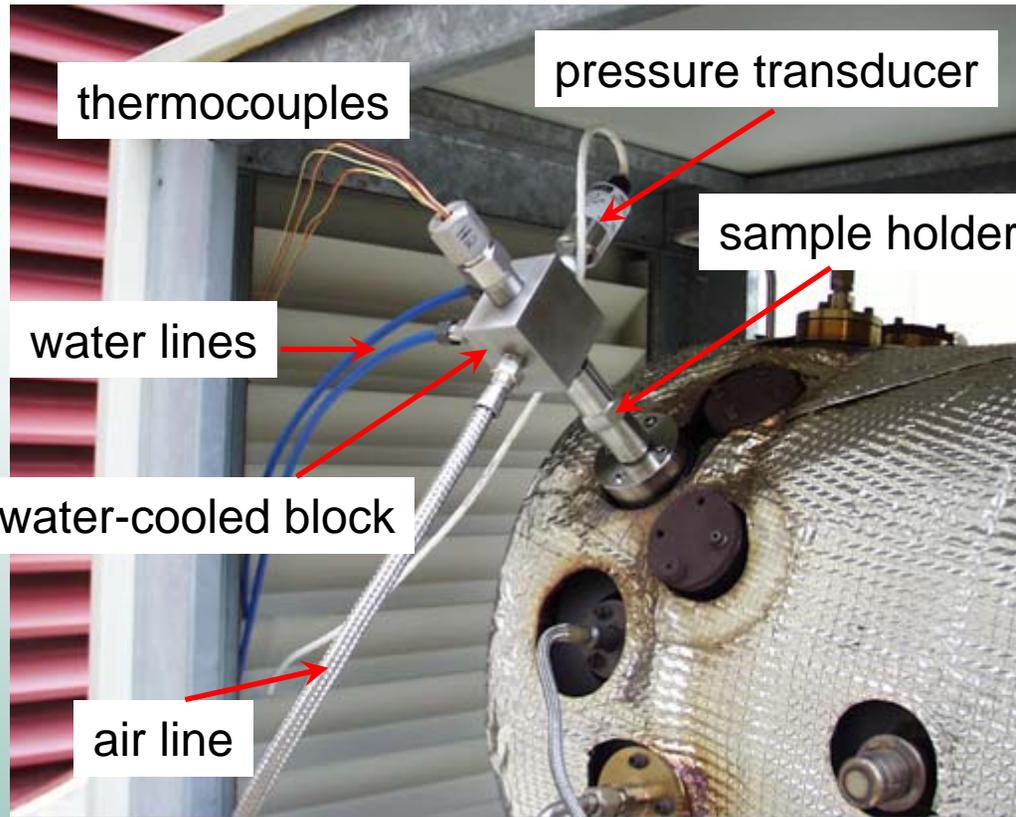
- Modified Capstone C60 microturbine
- Higher TET (850°C)
- Placement of test specimens at the entrance of recuperator.

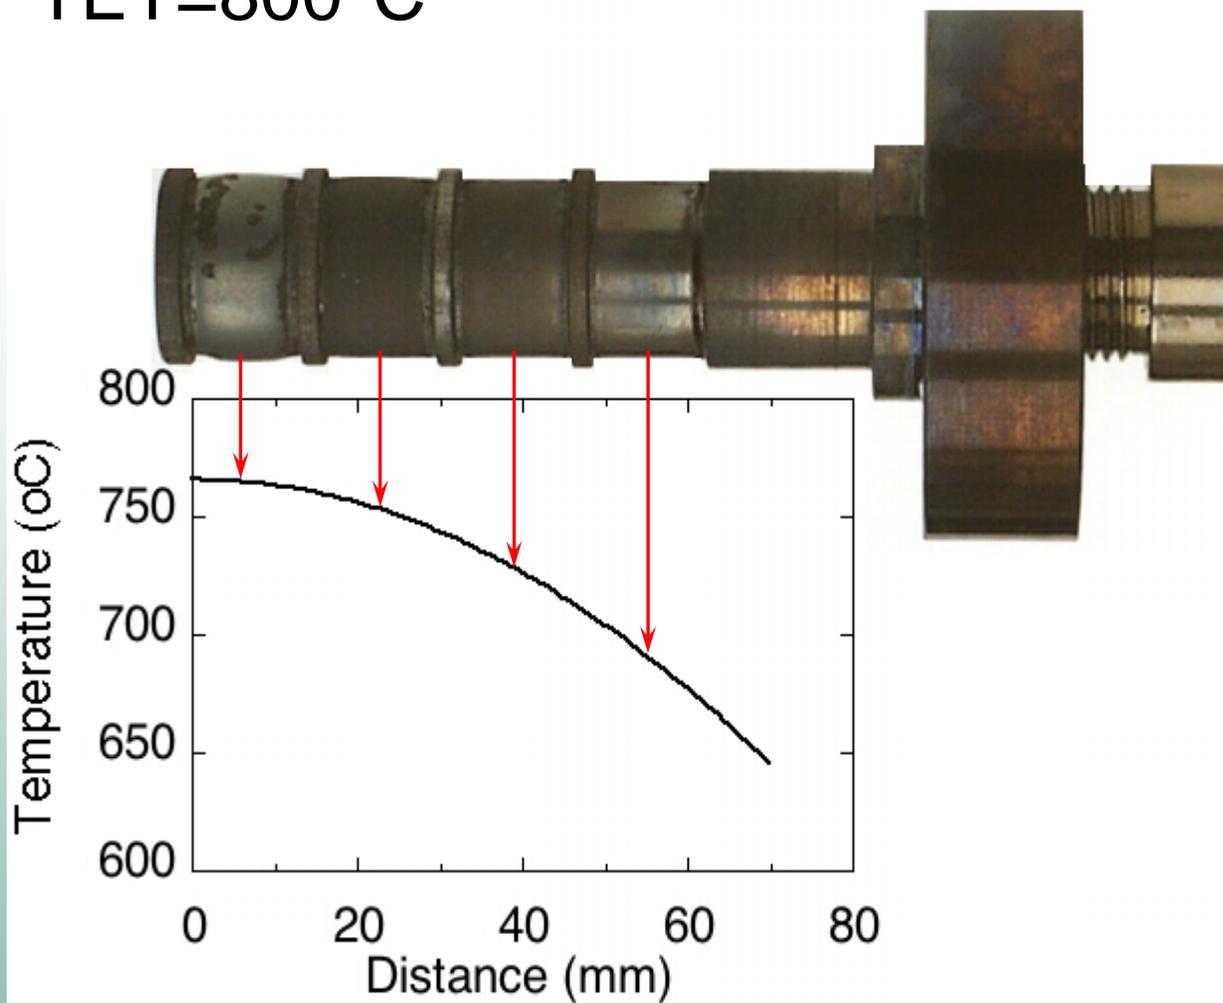
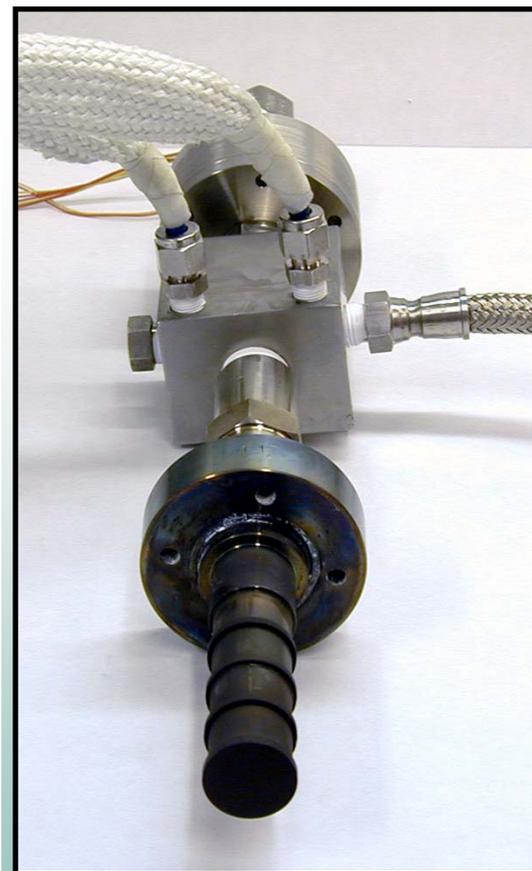
Temperature distribution along sample holder

TET=800°C

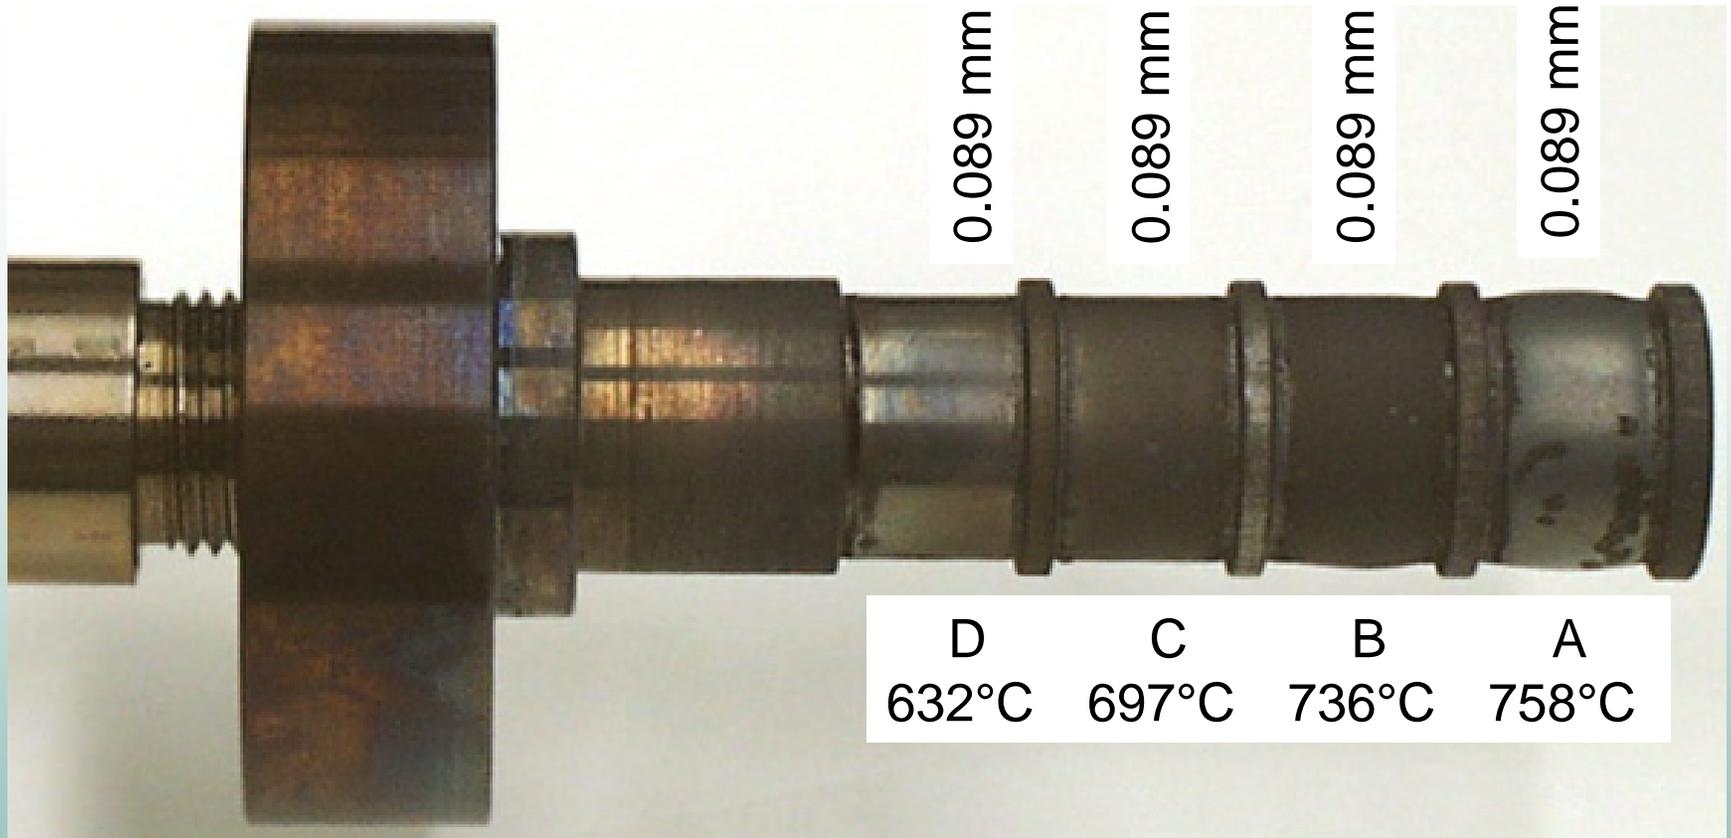
347-stainless steel after 500-hr exposure (TET=800°C)

60 psi internal pressure -> 50 MPa hoop stress

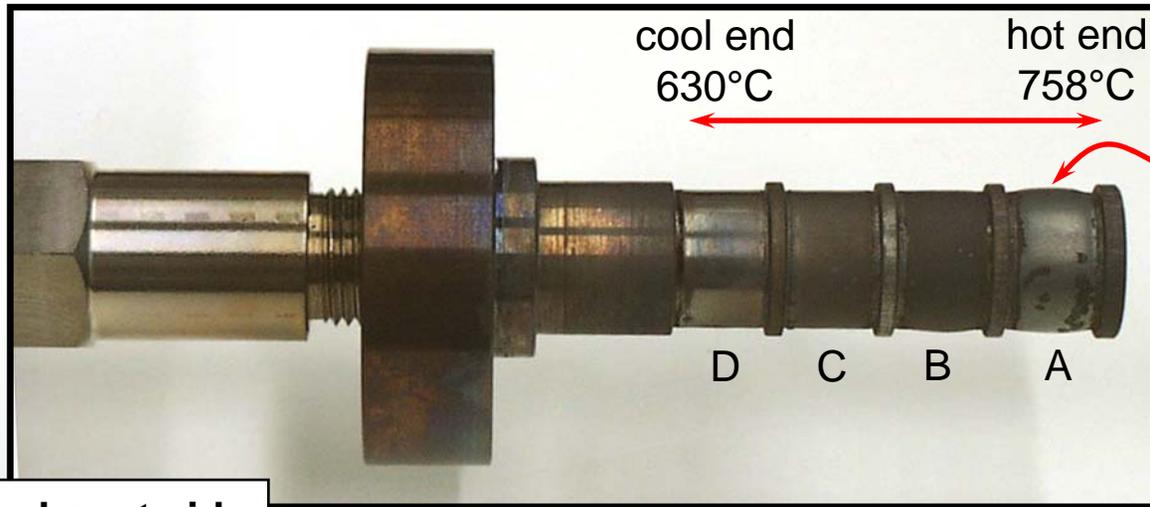
347-stainless steel after 500-hr exposure

ballooning due to creep deformation

cross-sectional analysis

Position D
500 h @ ~632°C
very little corrosion

Position C
500 h @ ~697°C
thin scale

Position B
500 h @ ~736°C
~3 μm scale

Position A
500 h @ ~758°C
~20 μm scale

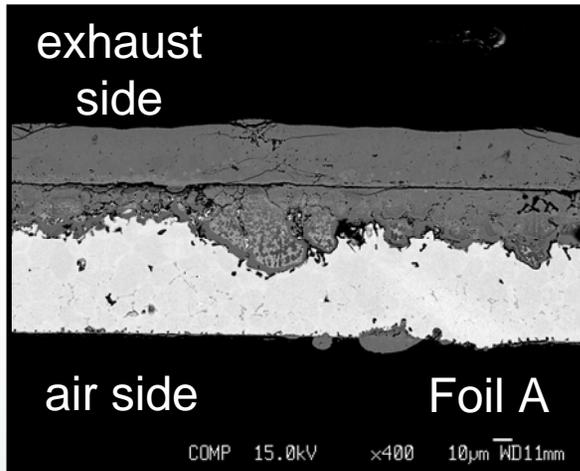
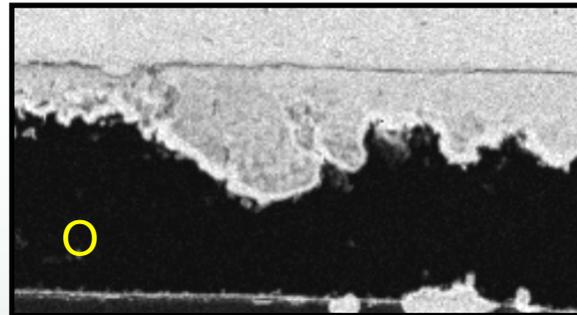
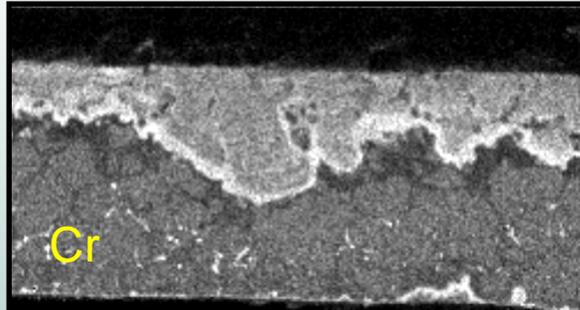
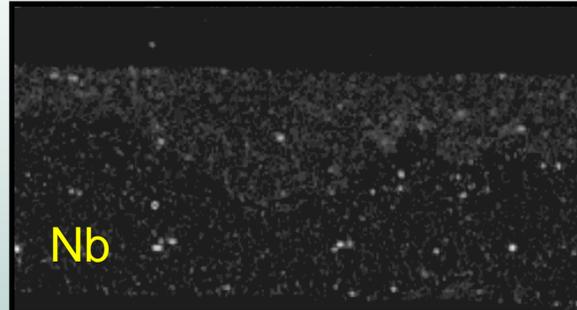
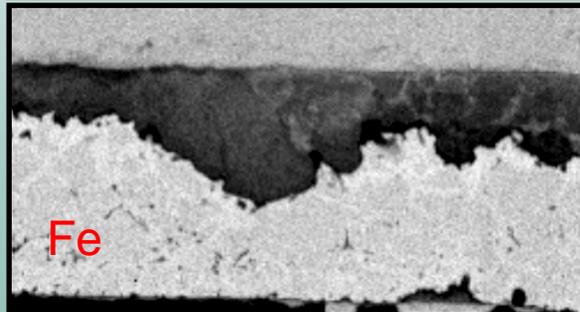
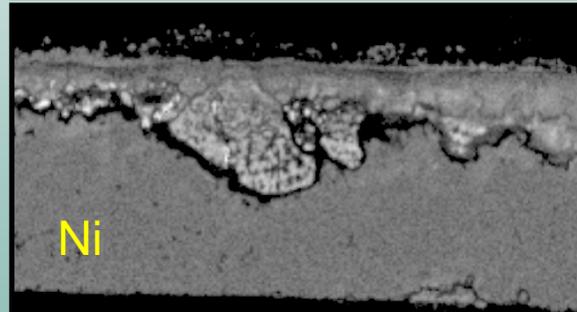
347-stainless steel after 500-hr exposure

Foil exposed at
758°C

- Multilayered oxide scale:
 - Ni-Cr-O
 - Fe-O
- Depletion of Cr at GBs
- Carbide formation
