Overview of Creep Strength and Oxidation of Heat-Resistant Alloy Sheets and Foils for Compact Heat-Exchangers

*Philip J. Maziasz, J.P. Shingledecker,
B.A. Pint, N.D. Evans, K.L. More, and E. Lara-Curzio*

Oak Ridge National Laboratory

Fuel Cells: Materials, Processing & Manufacturing Technologies Symposium
ASM Materials Solutions 2004, 18-20 October, Columbus, OH

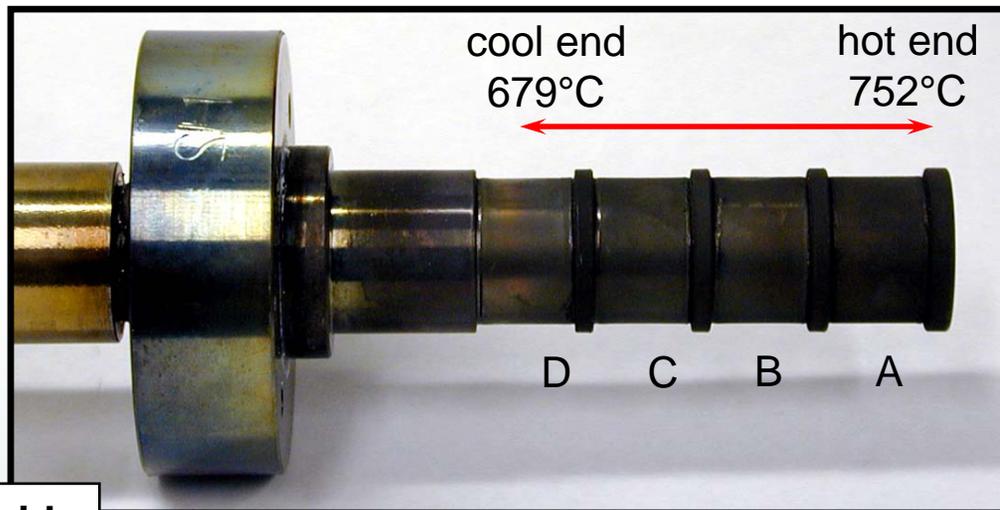
HR230® after 500-hr exposure (TET=800°C)

cross-sectional analysis

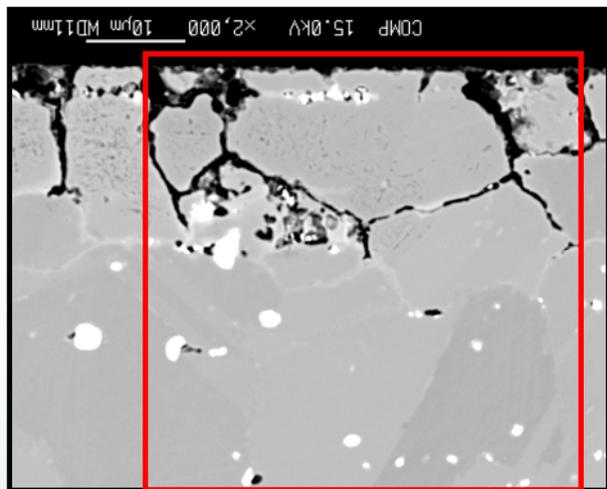
HR230® after 500-hr exposure (TET=800°C)

Foil exposed at 752°C

- Limited corrosion products found on surface
- Significant cracking along grain boundaries
- Grain boundaries near surface are poor in Cr but rich in W and C.

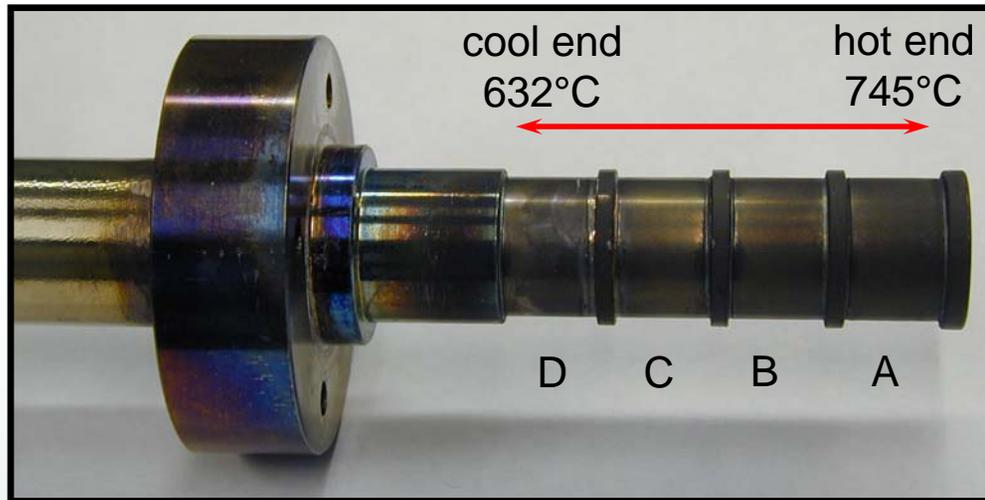
HR120® after 500-hr exposure (TET=800°C)

cross-sectional analysis

Position D
500 h @ ~632°C

Position C
500 h @ ~700°C

Position B
500 h @ ~730°C

Position A
500 h @ ~745°C

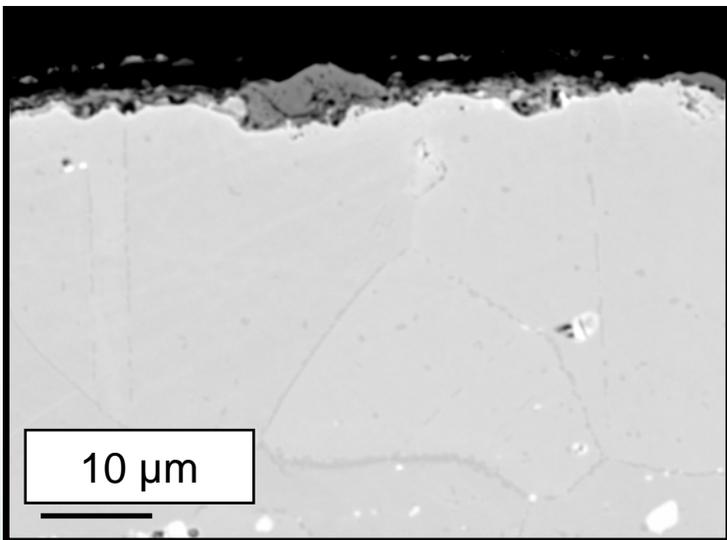
HR120® after 500-hr exposure (TET=800°C)

Foil exposed at 745°C

- Limited corrosion (oxides of Cr, Si and Fe)
- Grain boundaries near surface are poor in Cr but rich in Ni
