# **NDE Technology for Ceramic Composites**

**W. A. Ellingson, C. M. Deemer, J. G. Sun, and  
E.R. Koehl**

**Argonne National Laboratory, Argonne, IL 60439**

**Presented to the ASME Turbo Expo 2006**

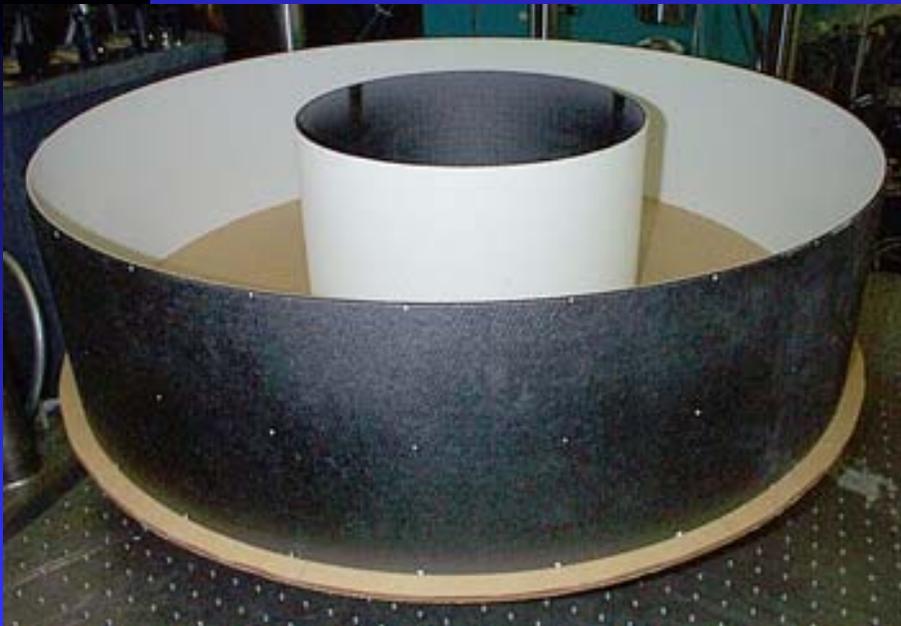
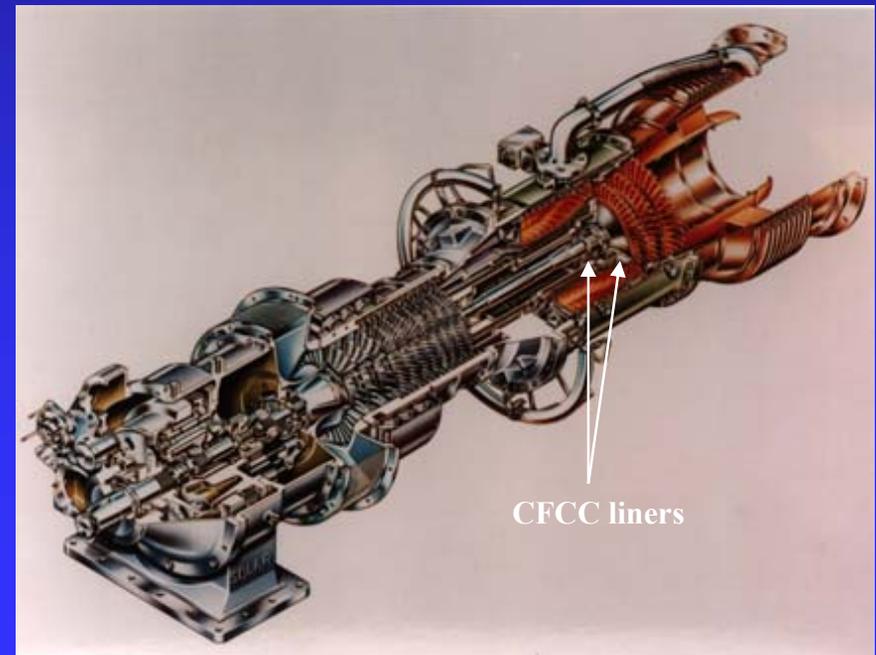
## Solar Turbines Combustor Liner

**EBC coated continuous fiber ceramic composite components in field tests of stationary gas turbine engines**

Outer Liner - 30" diameter

Inner Liner - 13" Diameter

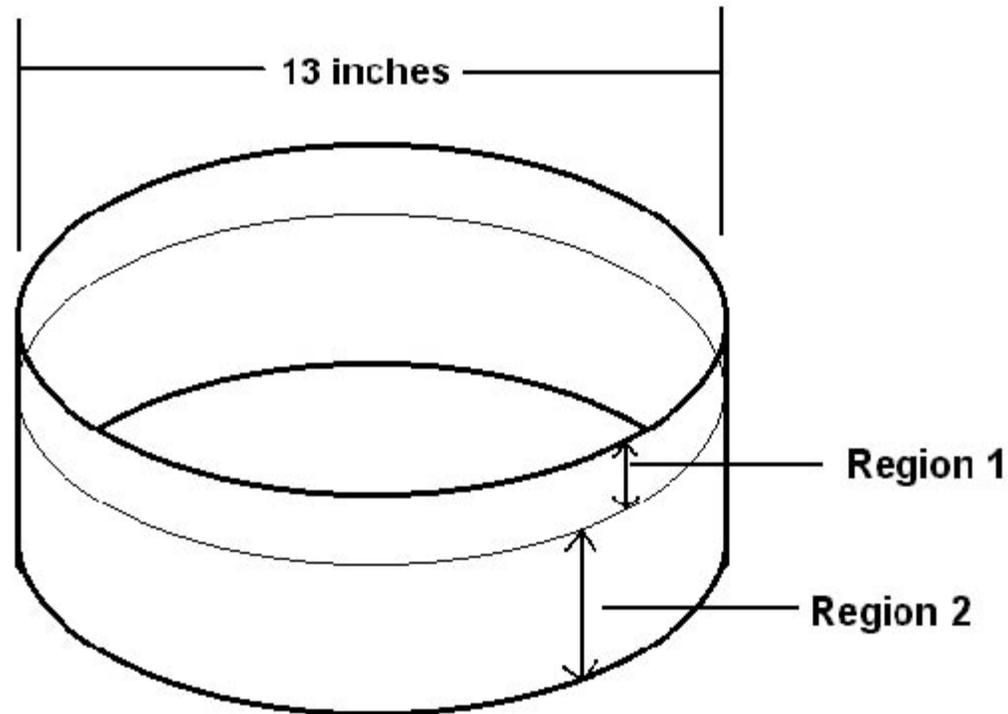
## EXAMPLE OF USE OF NDE TECHNOLOGIES TO ASSESS MATERIALS PROCESSING ISSUES(Porosity)

Before running in engine

NDE data suggest difference in material density. Unknown at time. Region 2 > Region 1

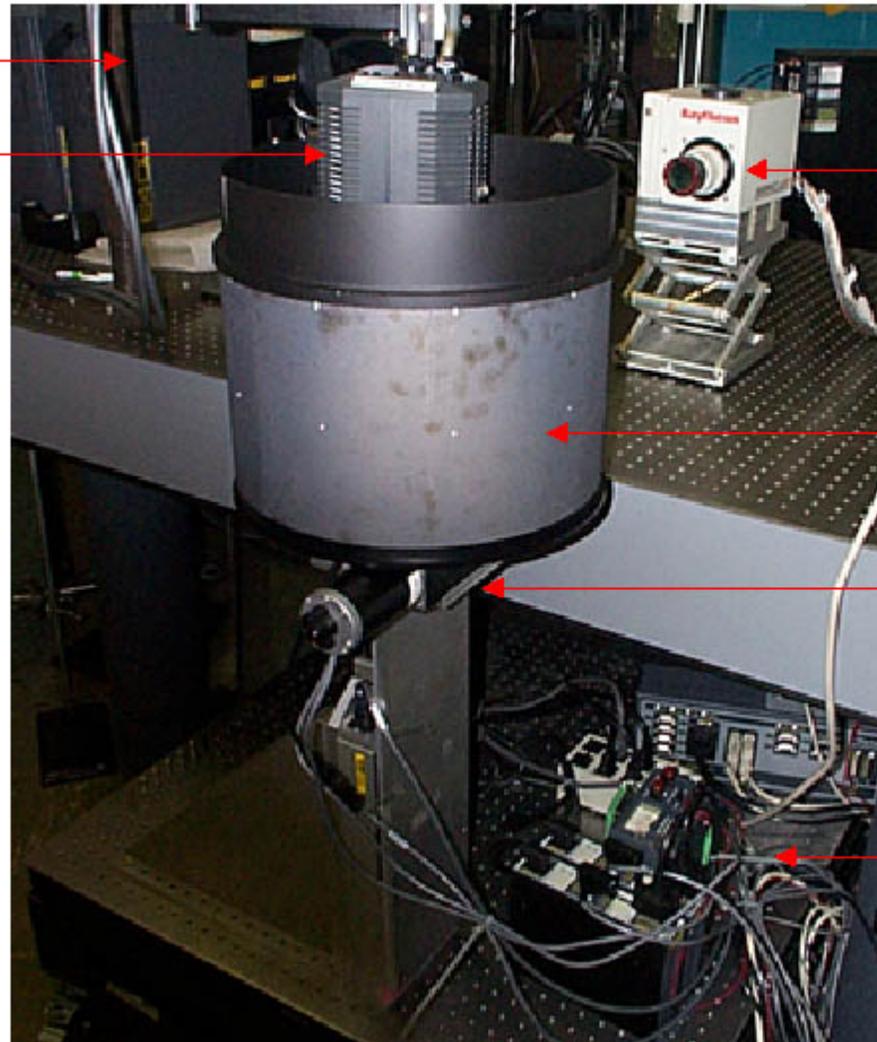
## Automated Thermal Imaging Apparatus for Testing a 13" Liner

Power supply

Flash lamp

Infrared camera

A 13-inch Liner

Rotation-translation stage unit

Motion control electronics

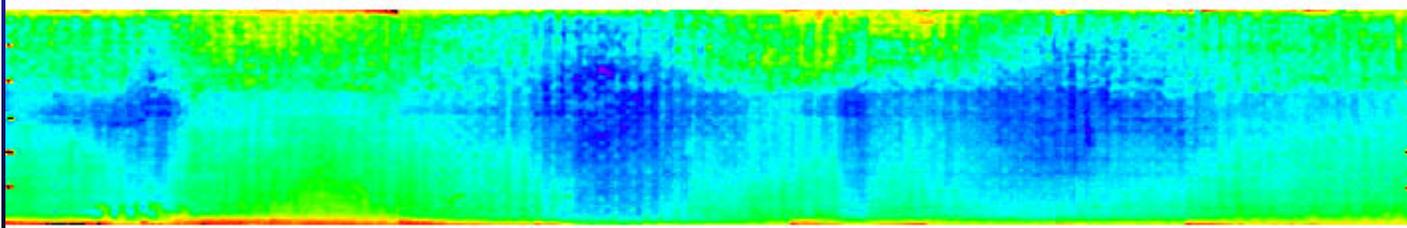
Thermal Diffusivity Image

# DETECTION OF POROSITY BY NDE METHODS:: Thermal imaging, water and air-coupled ultrasonics

- Correlation to NDE data to SEM data

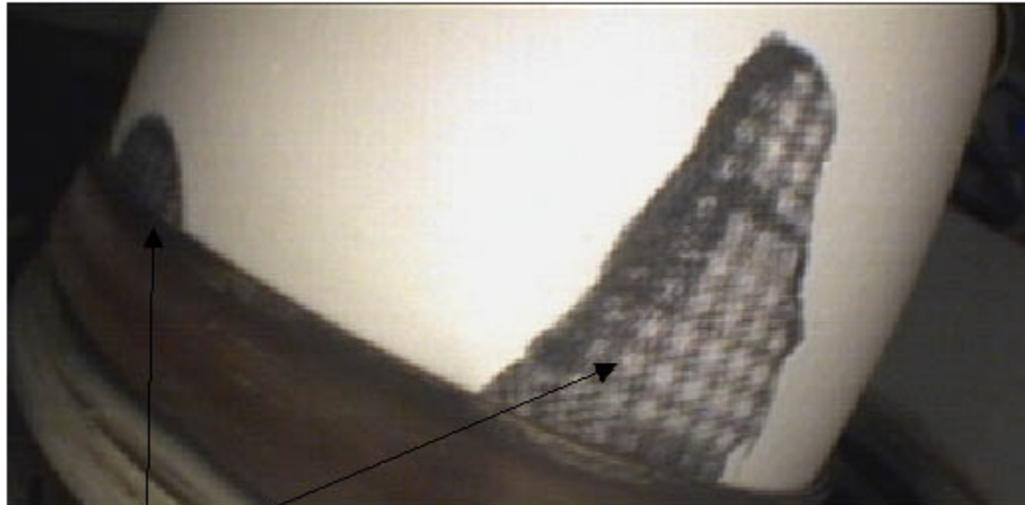
Boroscope Photo (after 1730 hours engine test)

# Correlation of NDE Predicted Damage with Boroscope Observation for EBC Coated Inner Liner in Solar Turbine's Bakersfield Engine

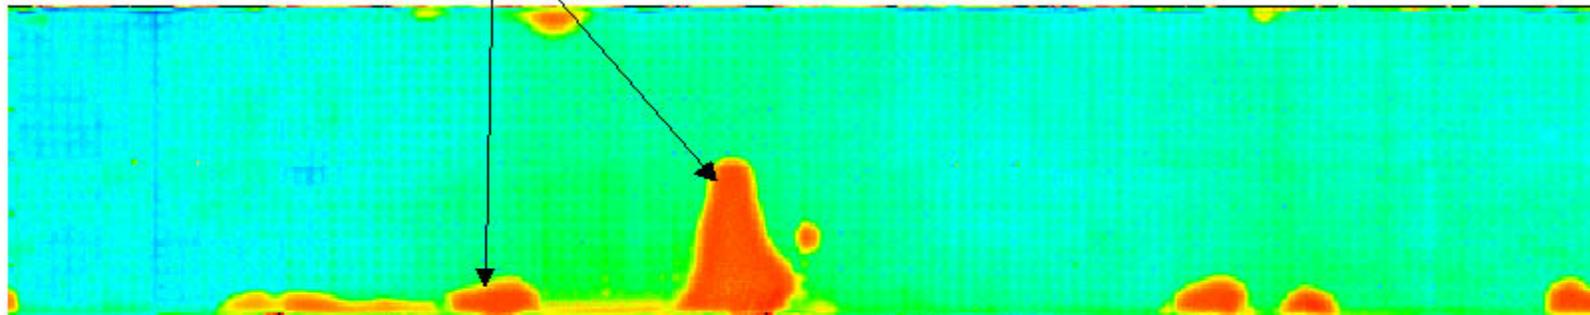
Thermal Diffusivity Image Data (prior to test)

Low diffusivity

High diffusivity

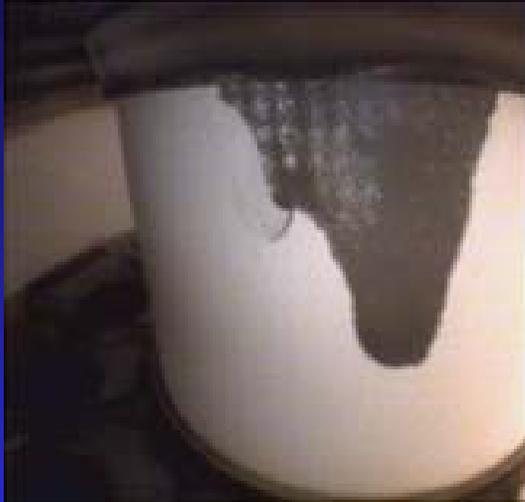
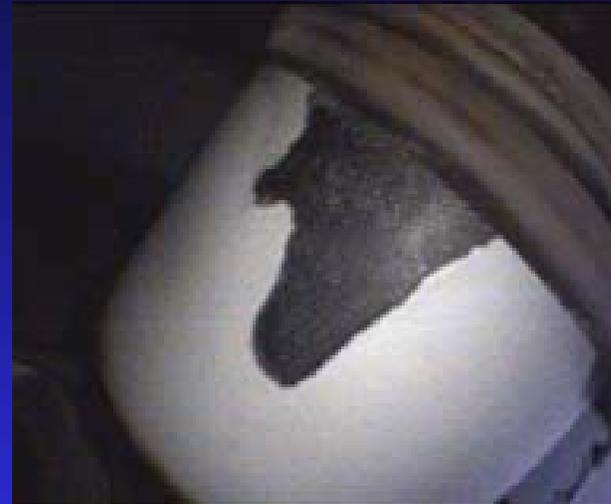
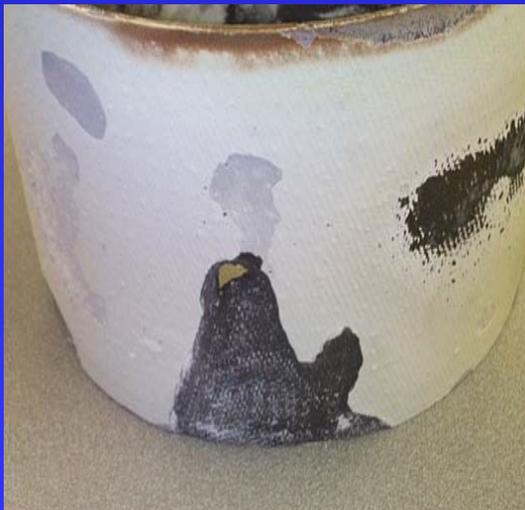
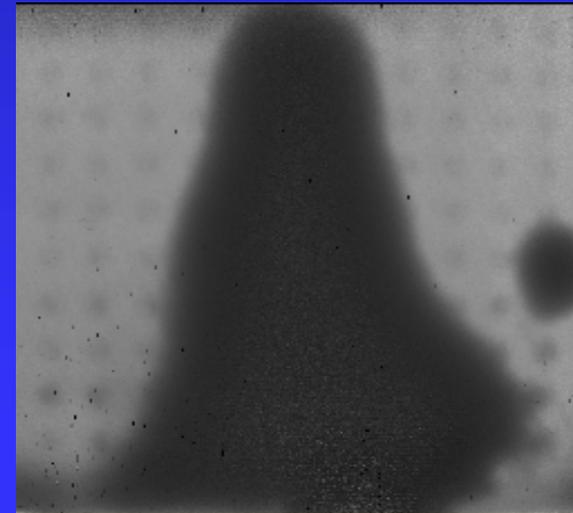
# SPALLATION OF 13" diameter EBC COATING

4533  
hours

7317  
hours

14,000  
hours

Thermal  
Diffusivity  
Map

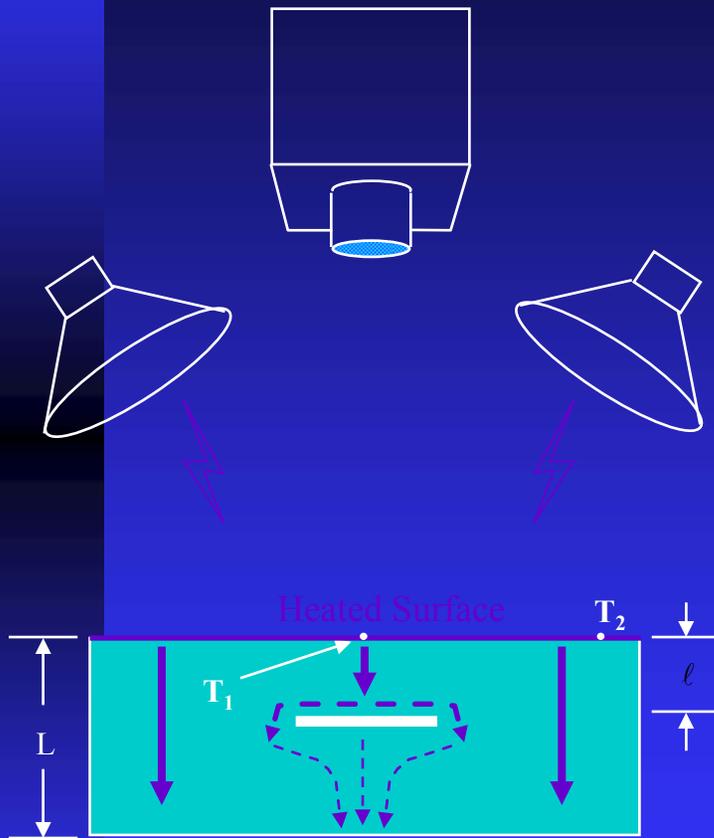
Thermal imaging system Setup

# Analytical method for calculation of defect depth

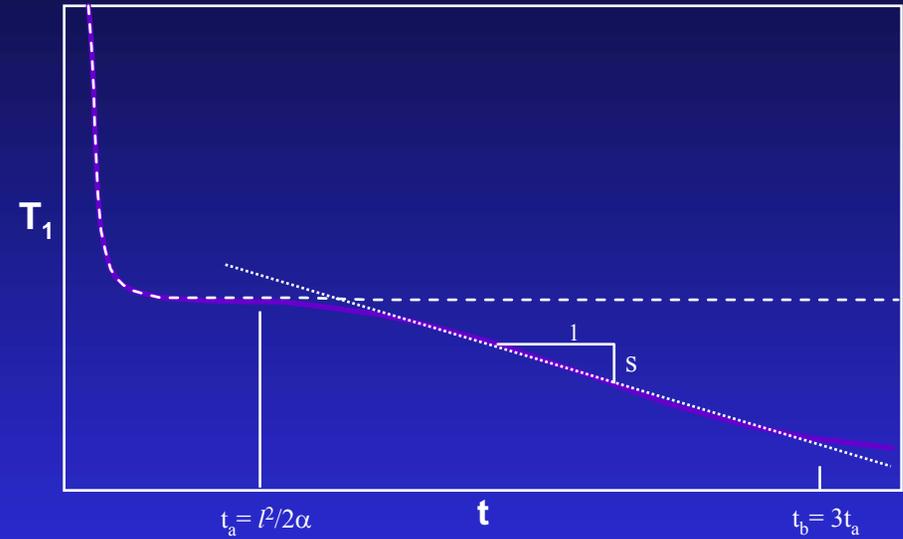
Typical Surface Temperature Variation

Theoretical model:

$$T(t) = \left[ 1 + 2 \sum_{n=1}^{\infty} \exp\left(-\frac{n^2 \pi^2}{l^2} \alpha t\right) \right] - st$$

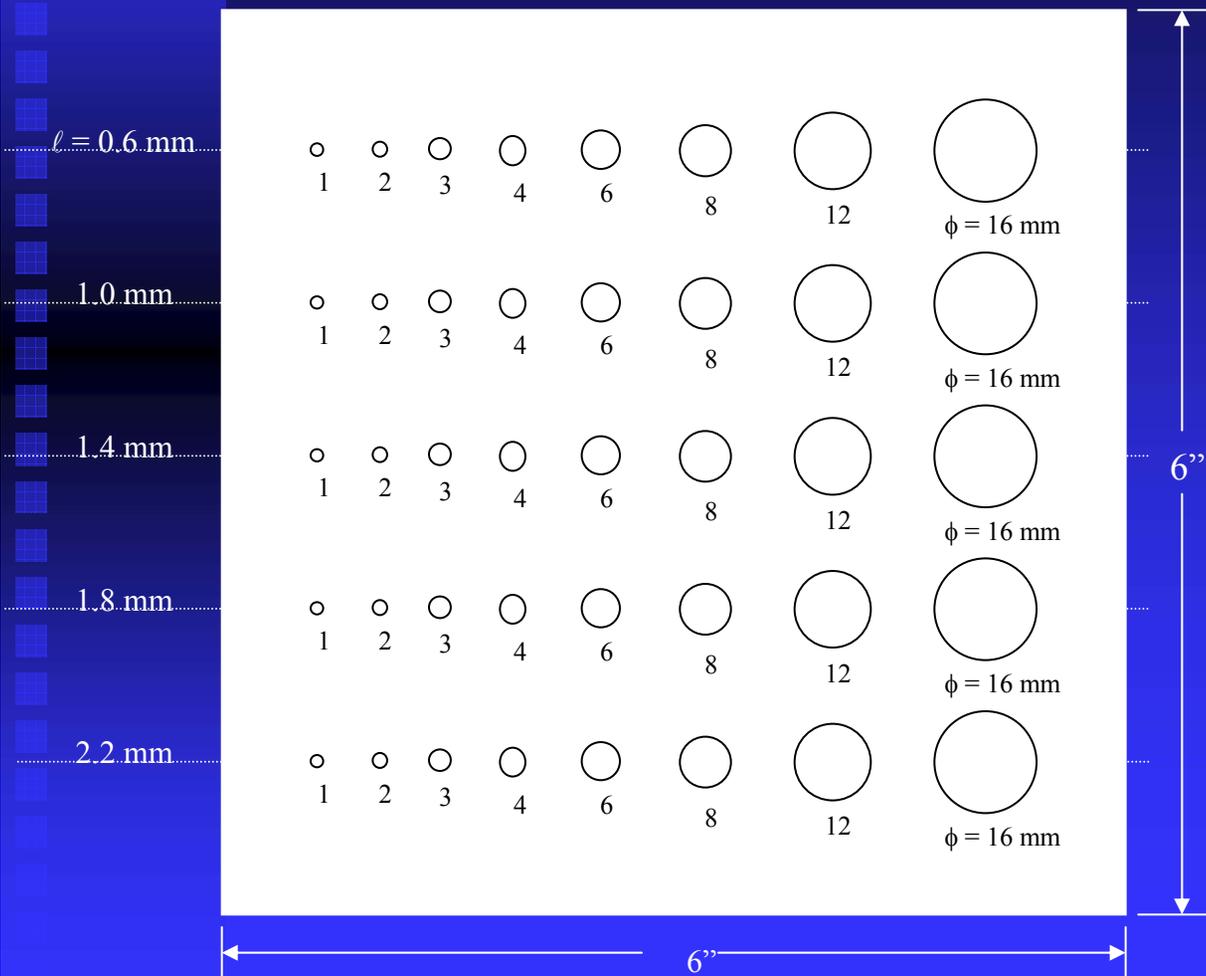
Machining diagram of CMC plate

# Measurement of flat-bottom holes in ceramic-matrix-composite (CMC) plates

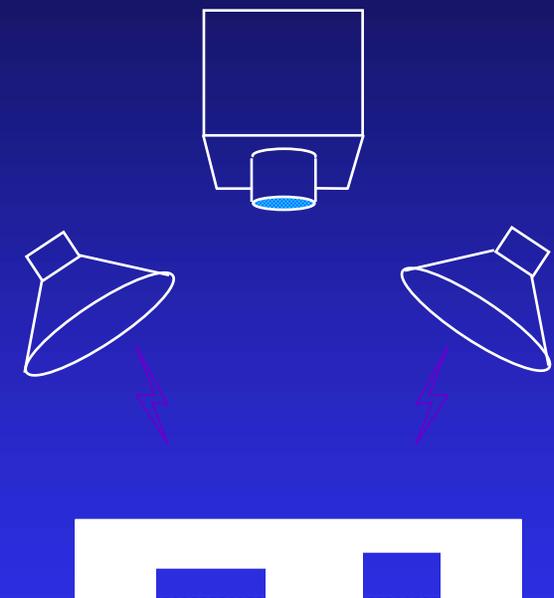
Test setup

Measure:

- diameter  $d$
- depth  $l$

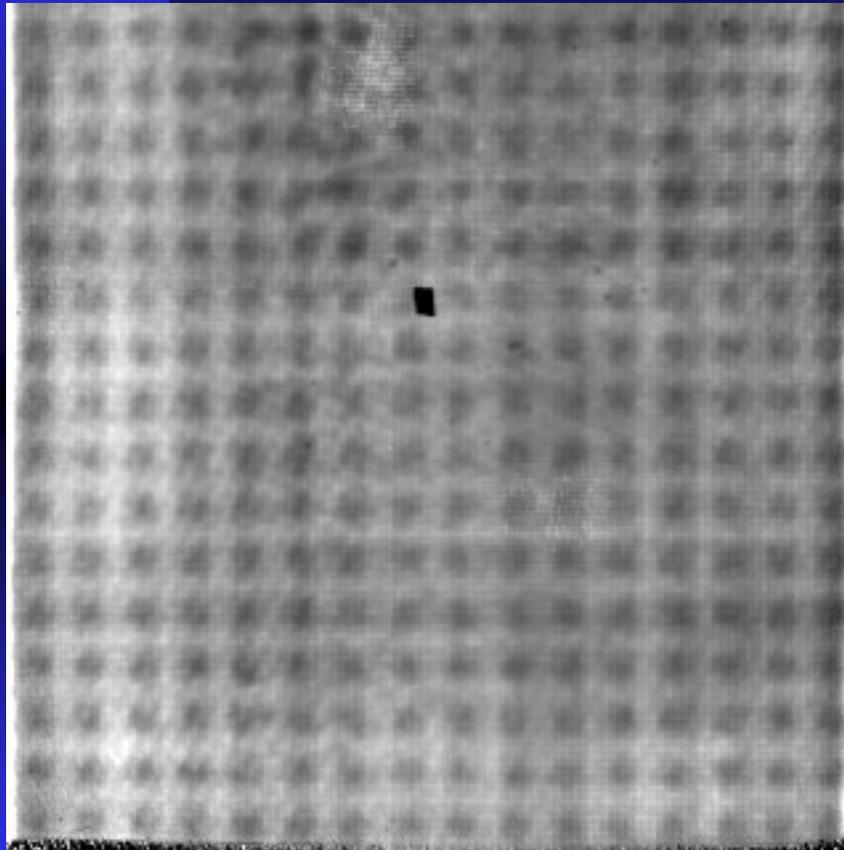
Thermal Diffusivity Image  
- before machining of holes

5 mm<sup>2</sup>/s

9 mm<sup>2</sup>/s

Mean diffusivity =  $7.4 \pm 0.4$  mm<sup>2</sup>/s

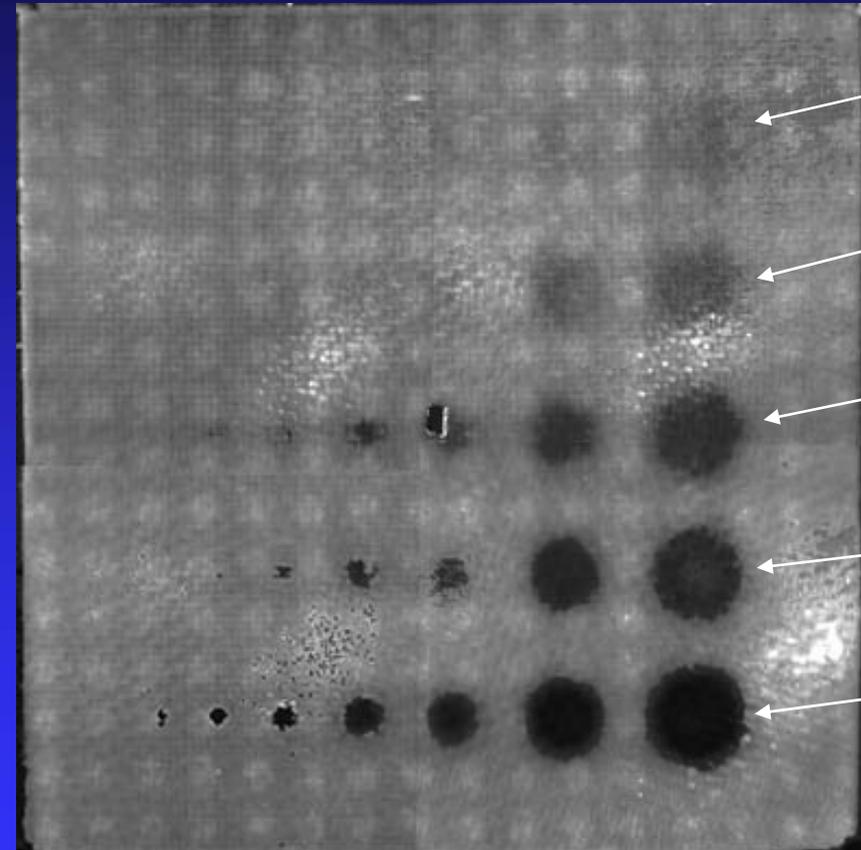
Predicted Depth Map  
- after machining of holes

Predicted  
(measured)  
depth (mm)

2.15  
(2.2)

1.86  
(1.8)

1.22  
(1.4)

1.08  
(1.0)

0.51  
(0.6)

Mean thickness = 2.6 mm

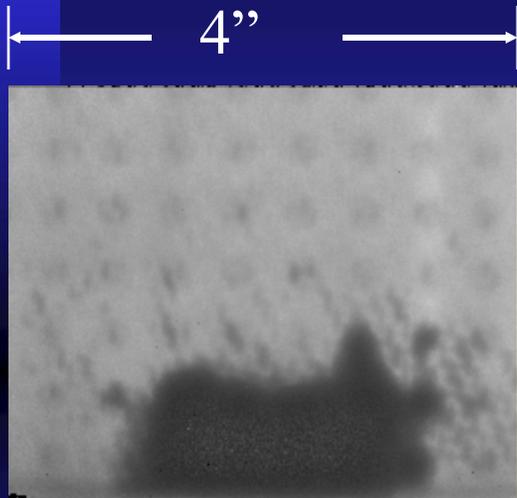
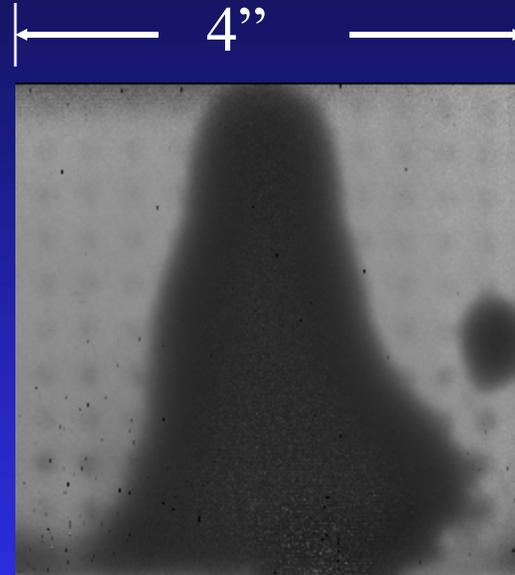
# Effect of Coating Processing on Delam size

Lower Diffusivity

Higher Diffusivity

**Delam size Before Coating**

**Delam size After Coating**  
--Note the delam has grown  
In size

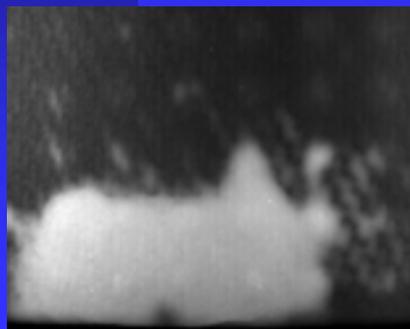
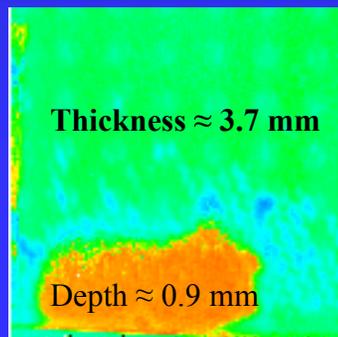
**A Front-Flash  
Thermal Image**

**Predicted 2-D  
Depth Image**

Distance of Delam Below surface  
Depth determined from Xray CT = 0.5~1 mm  
Depth determined from thermal imaging = 0.9 mm

t = 0.1 Sec

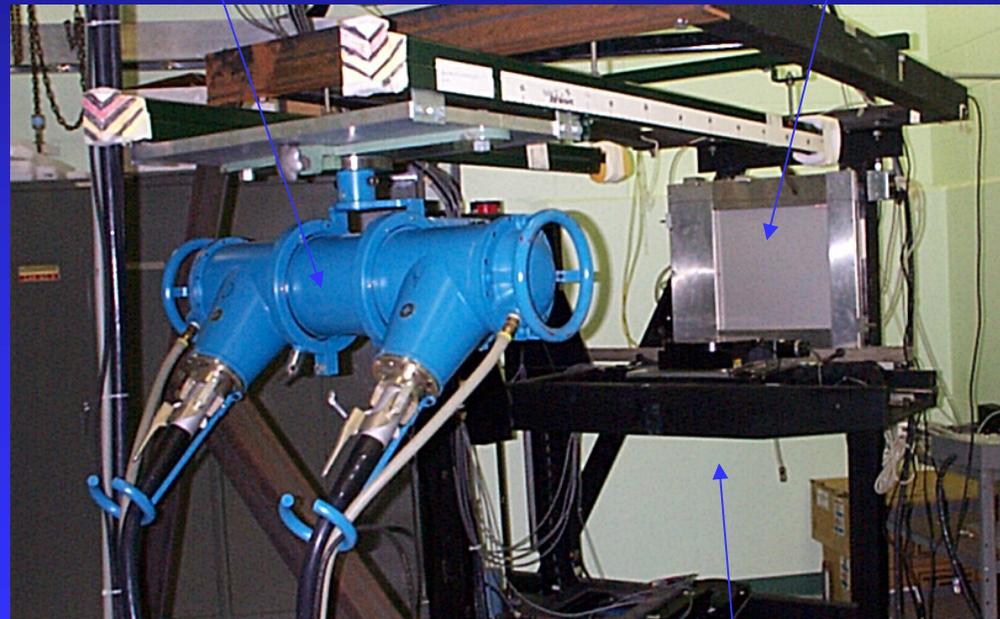
# 3D X-RAY COMPUTED TOMOGRAPHY FACILITY USED FOR ACQUIRING VERIFICATION DATA

TFI 320 kVp X-ray Source

- Max 10 mA
- Spot sizes:
  - 4.0 mm x 4.0 mm
  - 0.8 mm x 0.8 mm

Flat-Panel 40-cm x  
40-cm  $\alpha$ -Si Detector

X,Y,Z, $\theta$   
Motion Stages

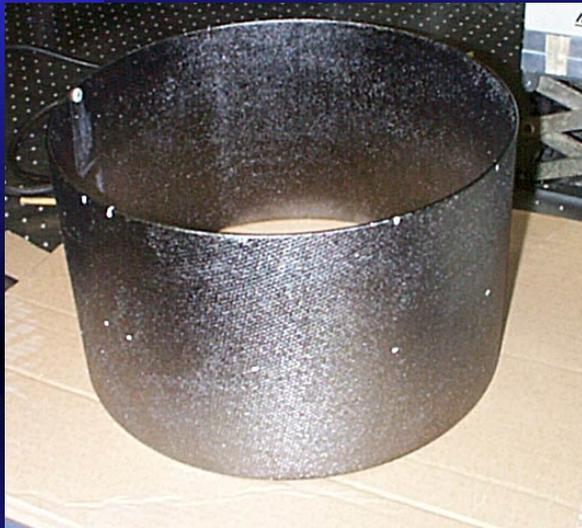
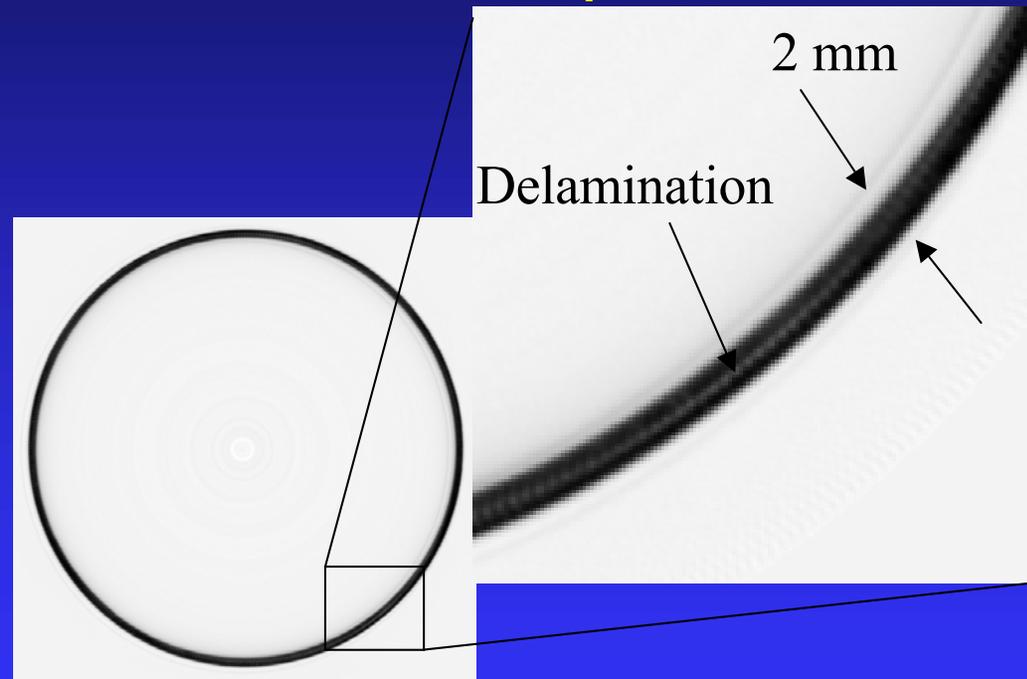
# EXAMPLE OF X-RAY COMPUTED TOMOGRAPHY FOR DELAM DETECTION

Can handle up to 36 in-diameter

MI SiC/SiC  
Non-Coated

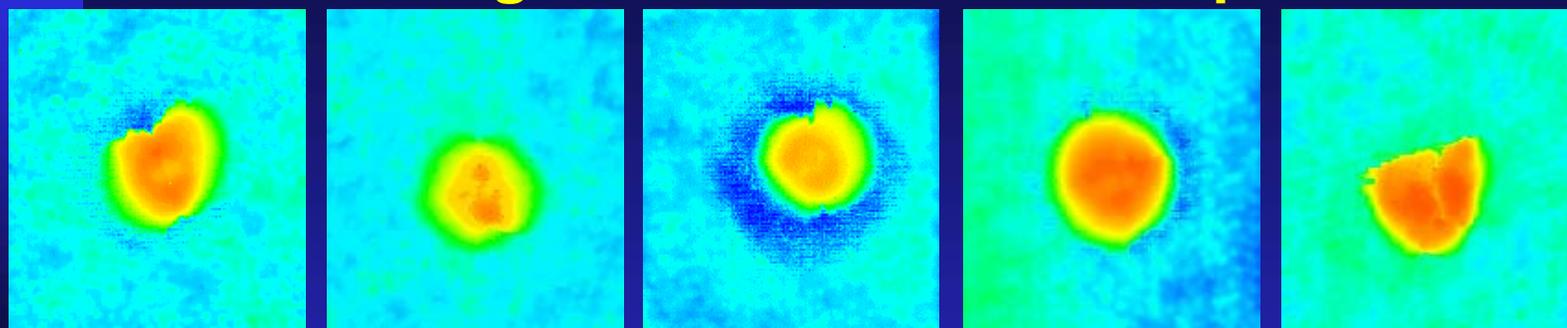
# Noncontact Thermal Diffusivity Imaging and Air-Coupled Ultrasound for Assessing Impact Damage Level :: SiC/SiC Composites

D3 (1 ft-lb)

E3 (1 ft-lb)

I2 (1.5 ft-lb)

A2 (2.2 ft-lb)

H2-2 (2.2 ft-lb)

Low Thermal Diffusivity High

Specimen	Impact Energy
1	1.36 Joules (1 ft-lb)
2	1.36 Joules (1 ft-lb)
3	2.04 Joules (1.5 ft-lb)
4	3 Joules (2.2 ft-lb)
5	3 Joules (2.2 ft-lb)

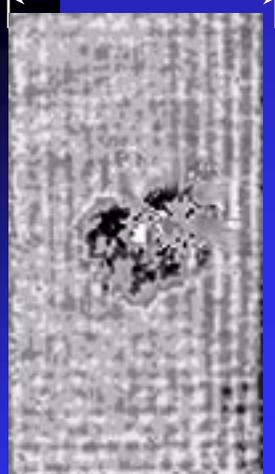
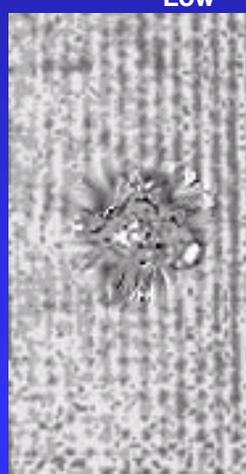
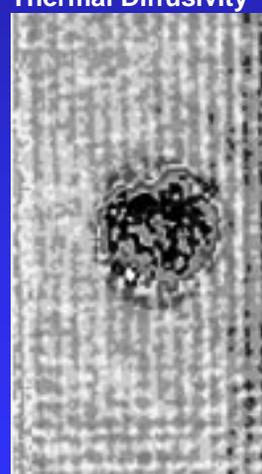
Low Transmission  
(low density, high porosity) 0

50  
Through-Thickness Transmission

High Transmission  
(high density, low porosity)

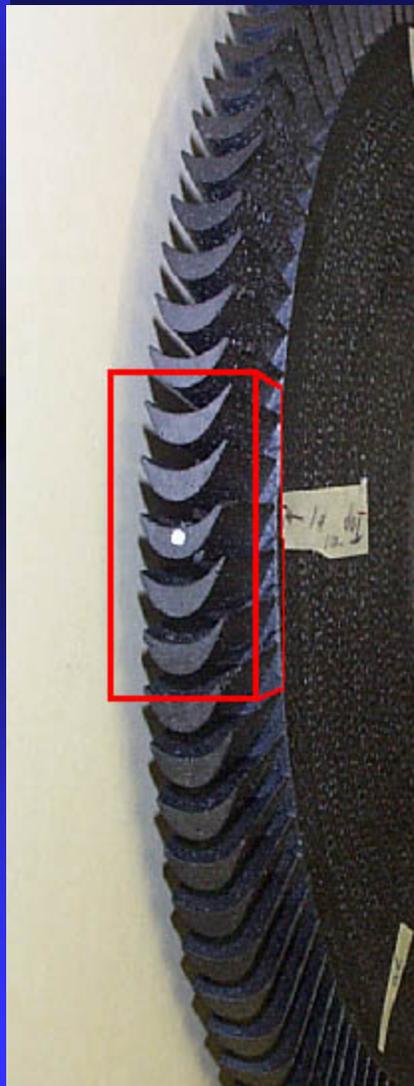
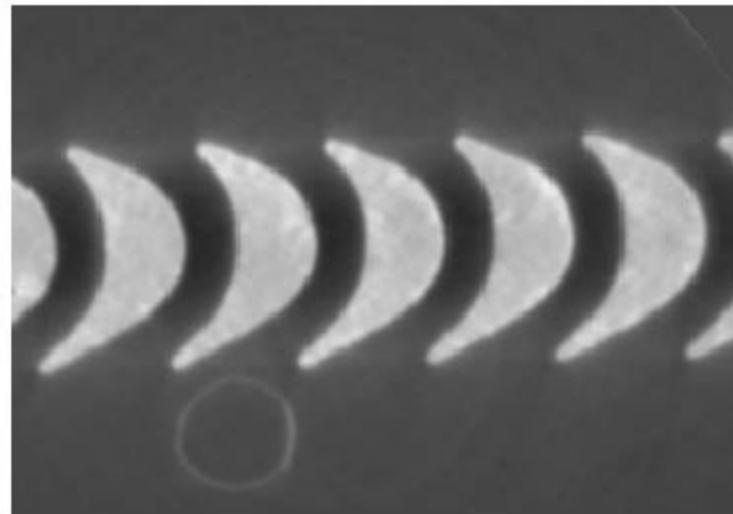
Typical X-Ray CT image through 5 blades

# NDE TECHNOLOGY FOR ASSESSING CONDITION OF ROTATING COMPONENTS: C/SiC --Impact Acoustic resonance /Xray Tomography

5 blade sections were imaged in 3D X-Ray CT. Each data set 48 .25mm thick X-Ray CT sections per blade. 95  $\mu$ m pixels.

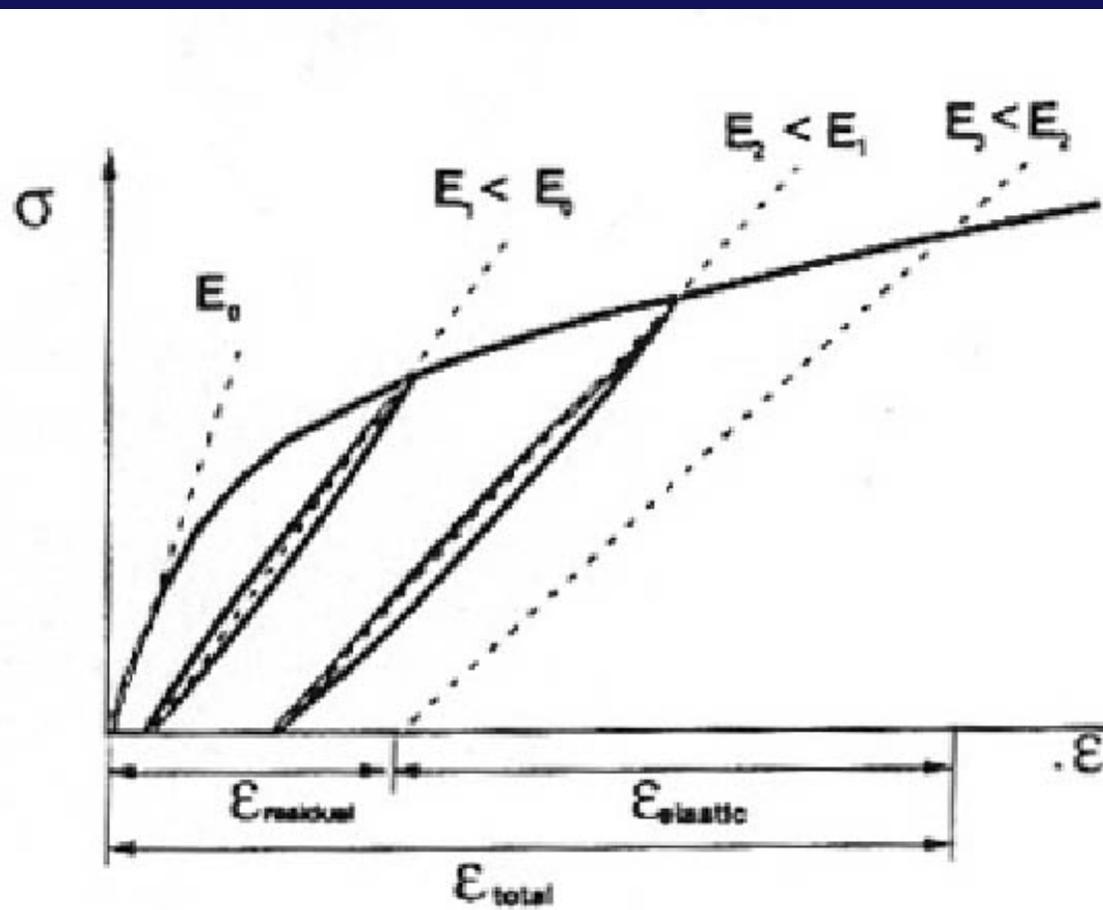
# Effect of load-cycling on elastic modulus For C/SiC

Typical Tensile/Relation Test

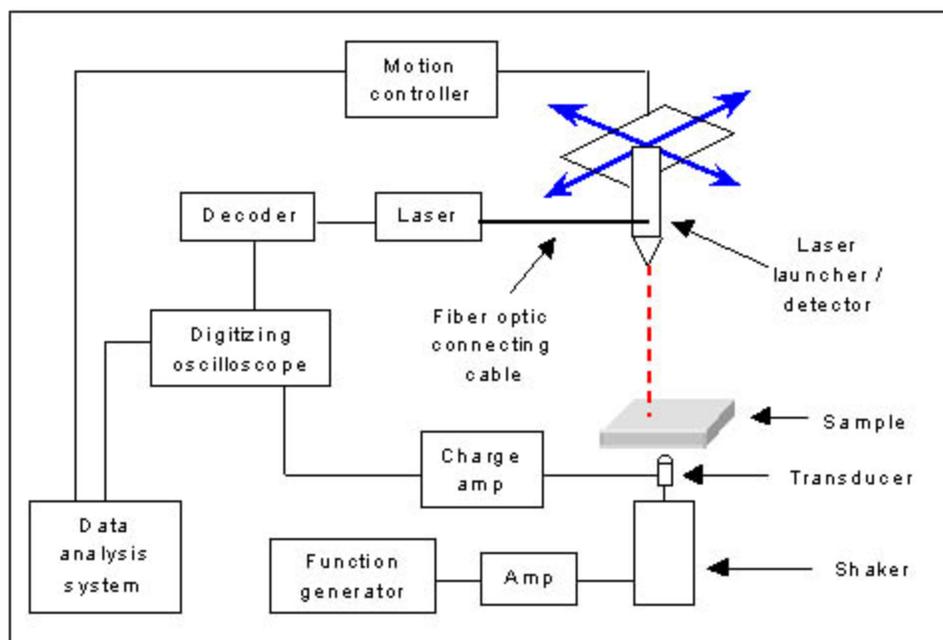
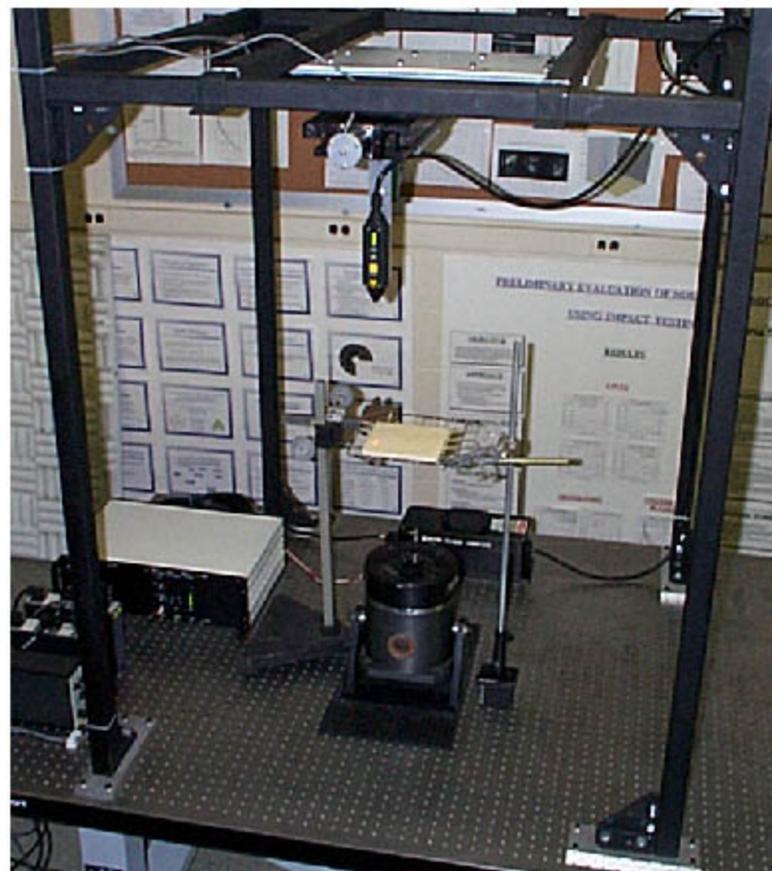
# IMPACT ACOUSTIC RESONANCE SYSTEM WITH LASER VIBROMETER: SOFTWARE PACKAGE USED FOR DETERMINATION OF MODE SHAPE

Use of scanning laser vibrometer for confirmation of mode shapes

AS OPPOSED TO FIXED LOCATION ACCELEROMETER, SCANNING LASER ALLOWS FREE MOVEMENT OF DETECTOR

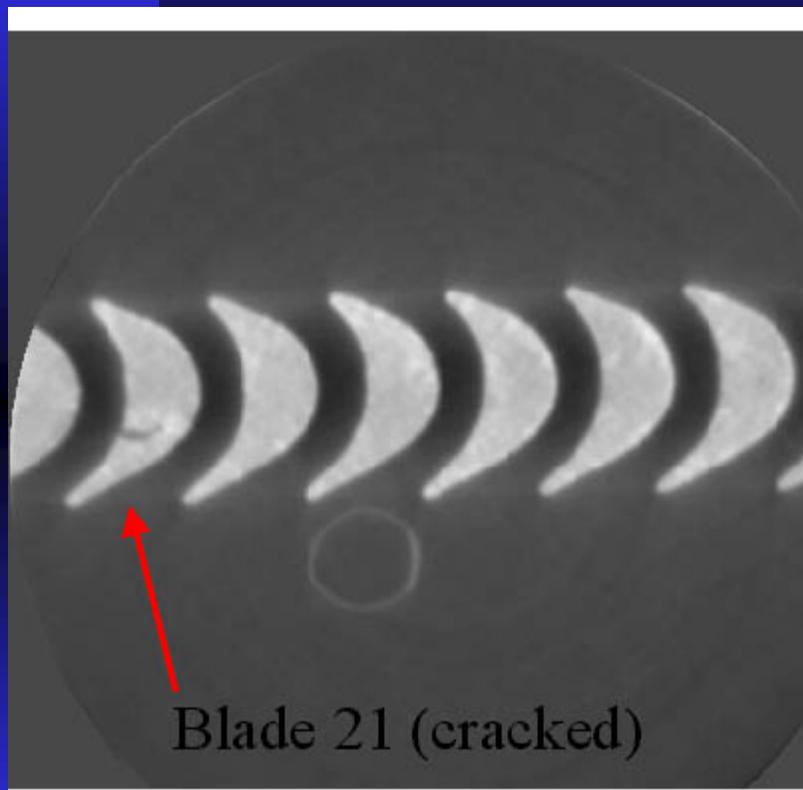
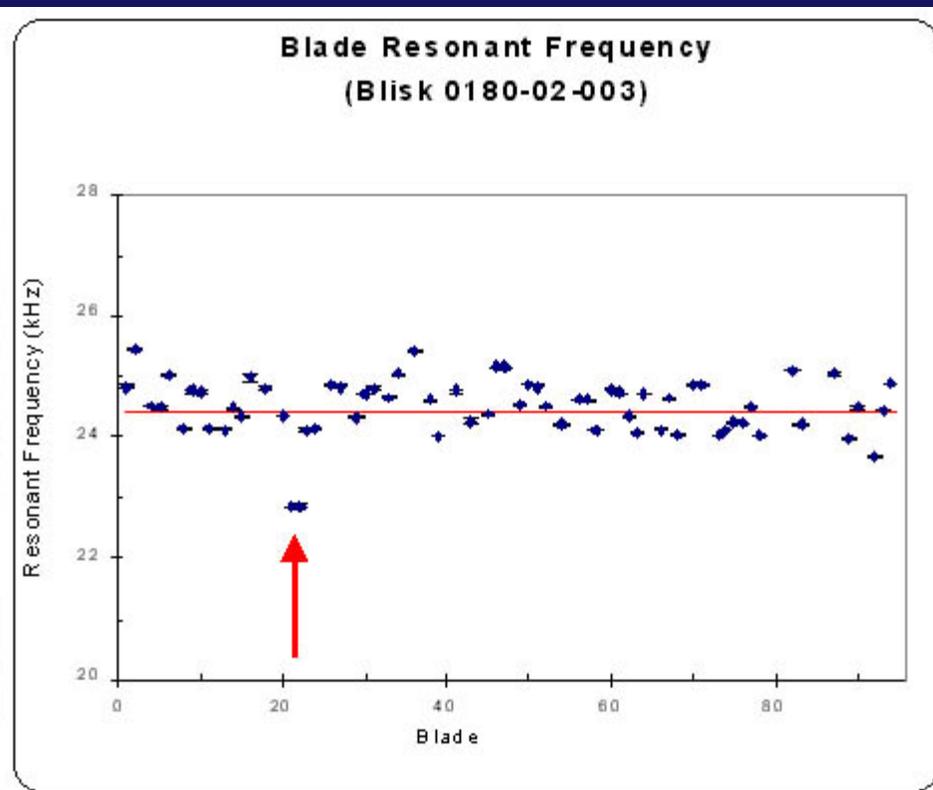
## Correlation of Resonant Frequency of Cracked Blade and x-Ray CT image data

Xray Tomographic image data

Note the cracked blade. Same one with lower resonant frequency

Resonant frequency

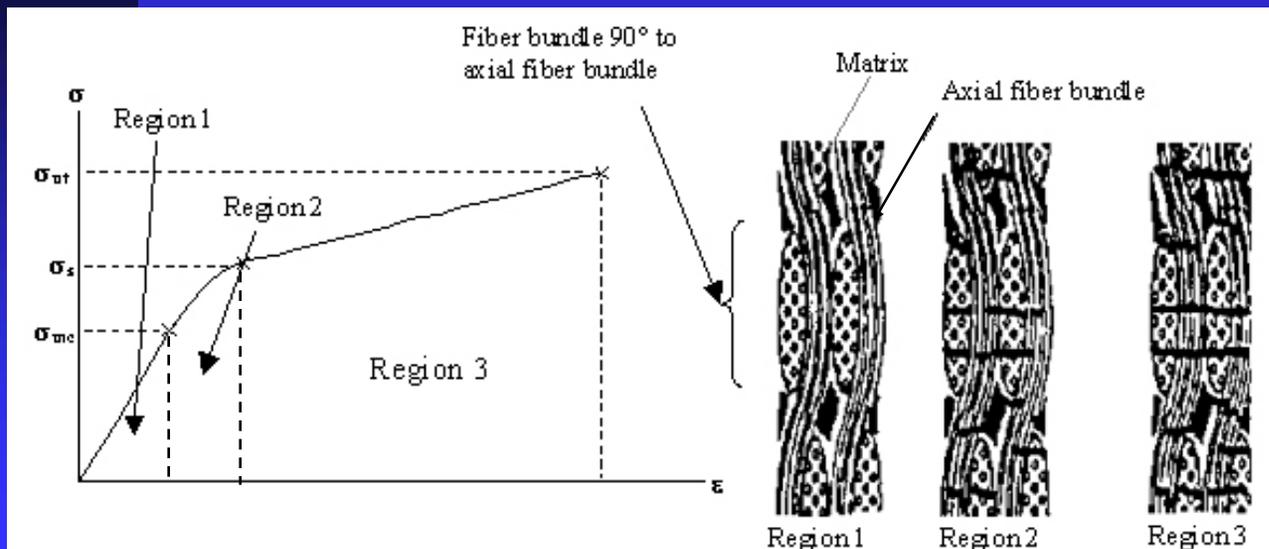
# PREDICTING REMAINING USEFUL LIFE

- When a component should be removed is not well defined.
  - ◆ especially for on-engine conditions where dynamic loading occurs
- Material degradation from environmental attack is dependent on the amount of matrix cracking.
- Number of cracks in the matrix can be associated with stress level from monotonic testing.
  - ◆ Failure of the material assumed to occur in non-linear region of stress-strain relationship (Region 2).
- Accumulation of cracking is estimated from the decay of the elastic modulus using shear lag model.
- Decay of elastic modulus can be monitored using nondestructive ultrasonic guided plate waves.

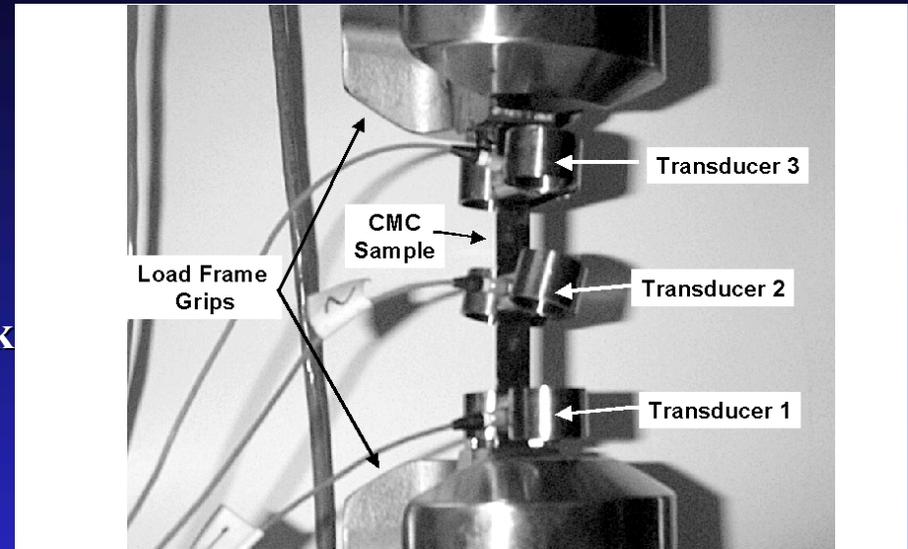
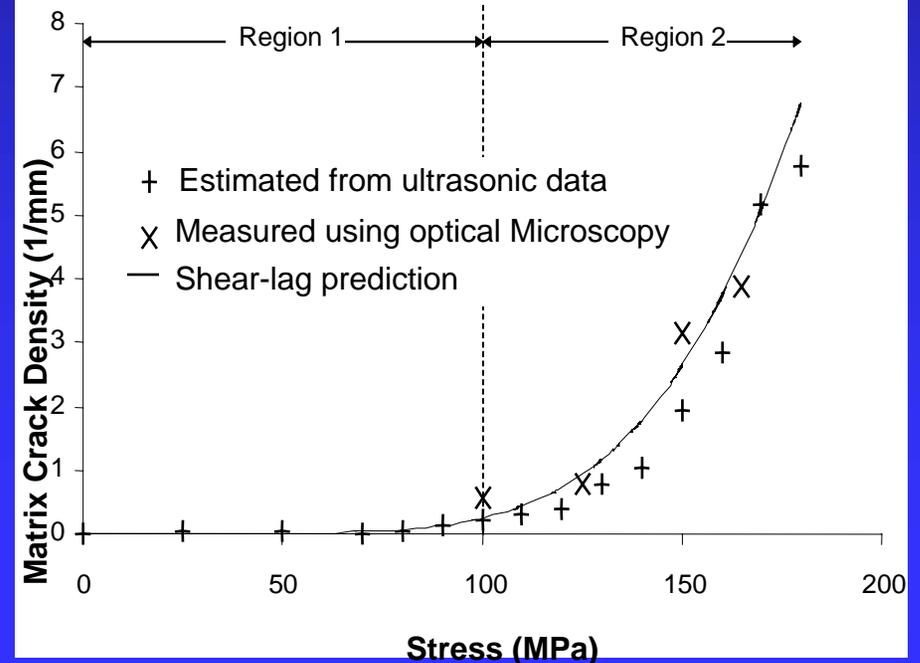
# Approach for RUL Estimation

- Velocities of ultrasonic guided plate wave:
  - ◆ Measured using contact ultrasonic transducers,
  - ◆ Directly related to elastic modulus.
- Evaluate “current” transverse matrix crack density using shear-lag model
  - ◆ Monotonic tensile loading and
  - ◆ Tension-tension cyclic fatigue.

- Assume future loading conditions
- Using shear-lag model:
  - ◆ Compute number of tension-tension cyclic fatigue cycles required to reach current damage state,  $N^*$
  - ◆ Compute number of tension-tension cyclic fatigue cycles required to reach failure damage state,  $N_T$
  - ◆ Take difference to find RUL,  $N_R$

MI SiC/SiC

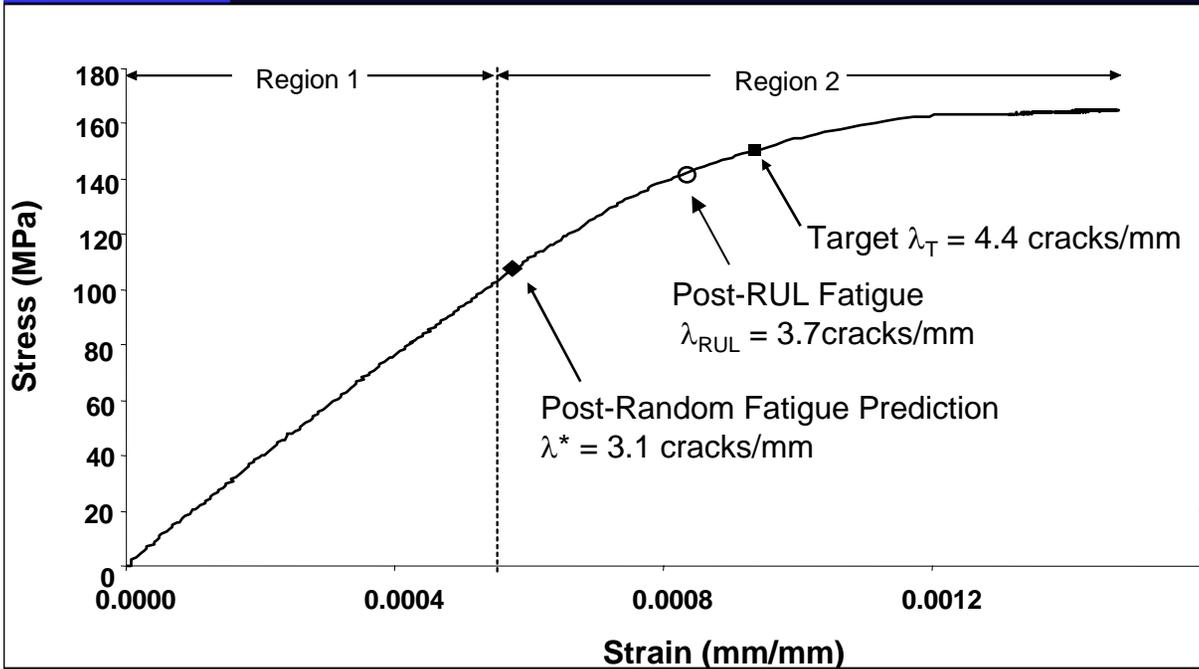
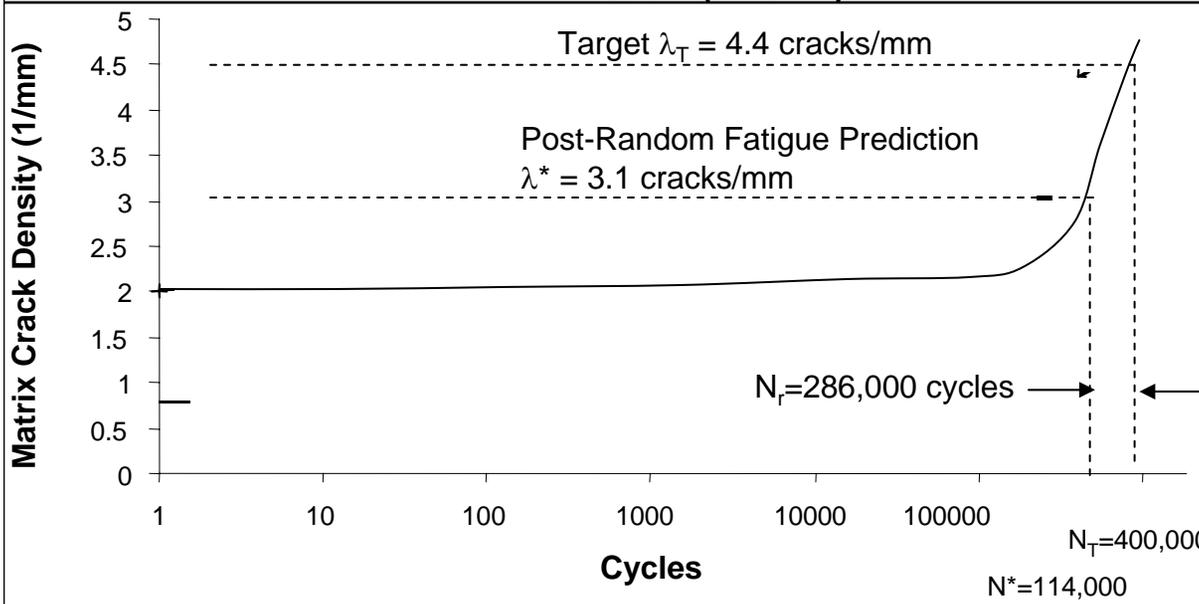
# Current and Failure Matrix Crack Density

- Determine failure matrix crack density
- Unknown matrix cracking extent induced by random tension-tension cyclic fatigue
- Estimate matrix crack density using ultrasonic data
- Compute number of cycles required to induce current matrix crack density,  $N^*$ :
- Compute number of cycles required to induce failure matrix crack density,  $N_T$ .
- Estimate RUL,  $N_r = N_T - N^*$ :
- Samples cycled at assumed future loading condition for  $N_r$  cycles
- Post-RUL fatigue damage was compared to target matrix crack density – 17% below target
