Effect of Material Parameters on Mechanical Performance of Environmental Barrier Coatings

*H. T. Lin, A. A. Wereszczak, M. K. Ferber, and
T. P. Kirkland*

Ceramic Science and Technology Group
Metals and Ceramics Division
Oak Ridge National Laboratory
Oak Ridge, TN 37831-6068

Study was Motivated by Fracture of EBC-SN282 Nozzle During Thermal Shock Proof Test at Solar Turbines

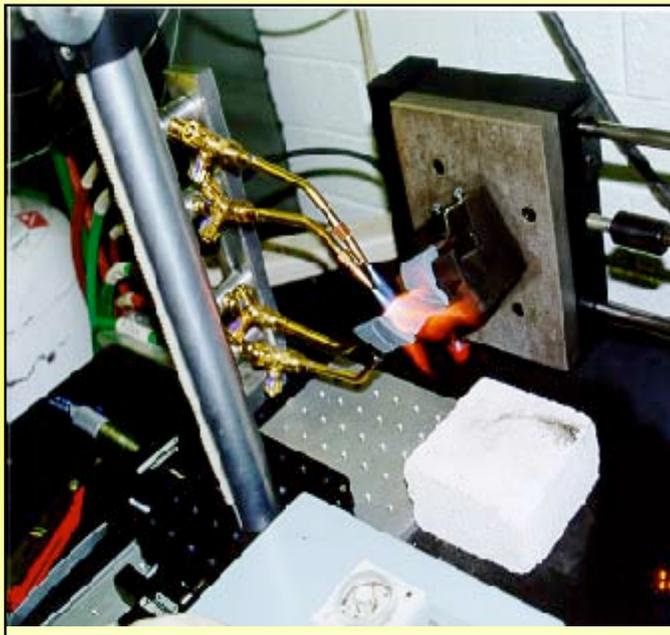
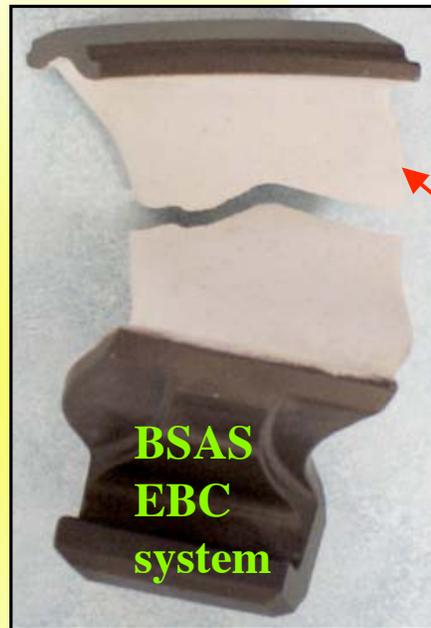
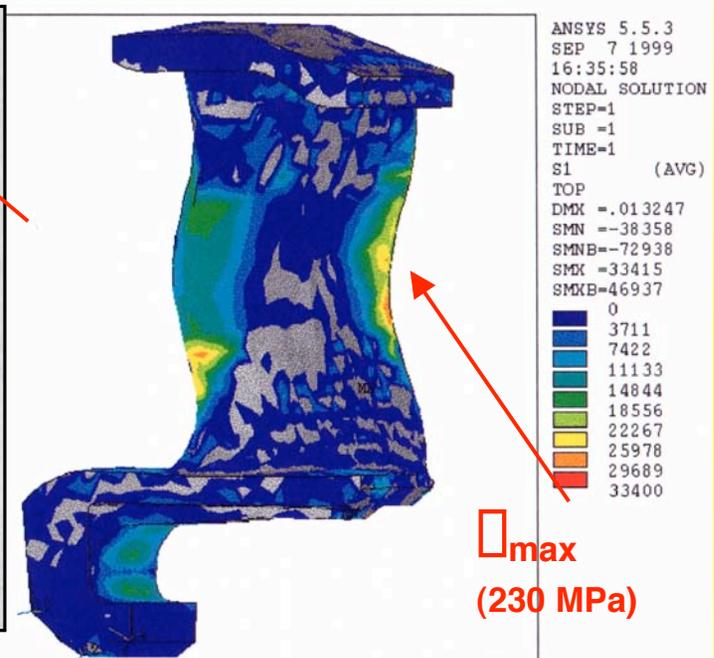
Solar SN282_11
2072°F, 28.6 s

Suction side

The first stage nozzle is designed for Centaur 50S Gas Turbine

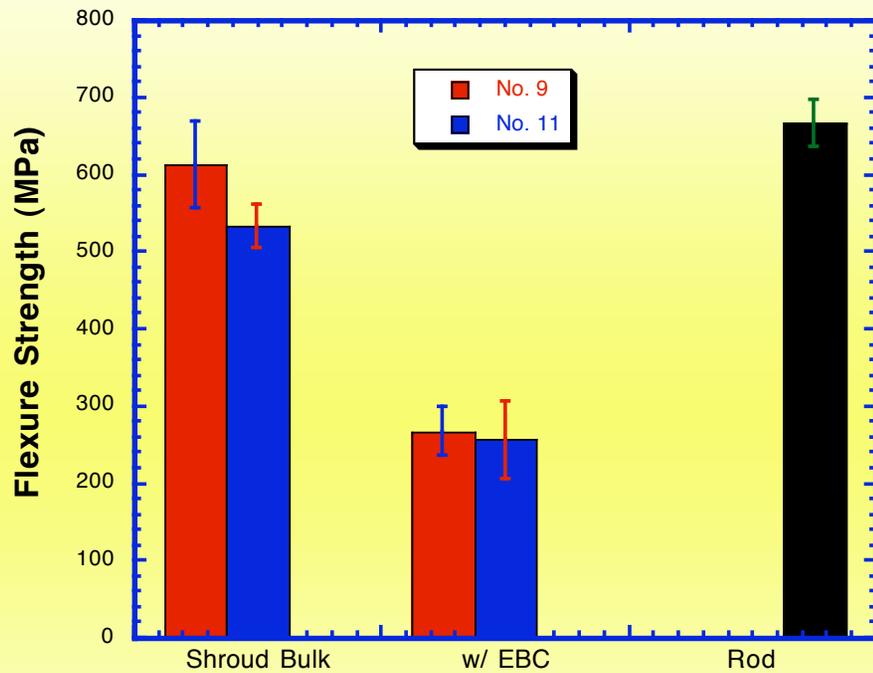
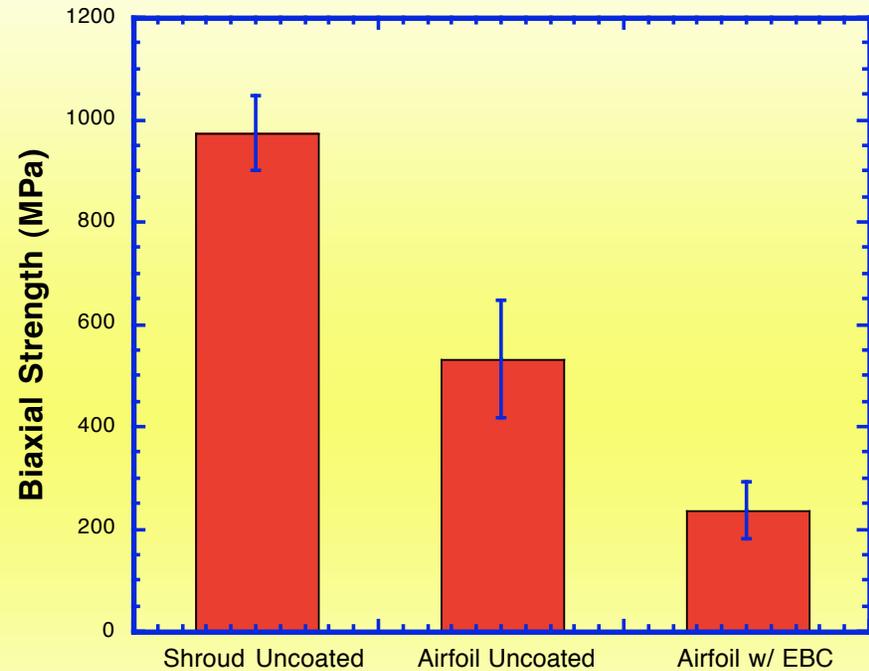
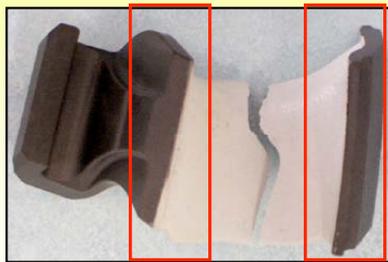
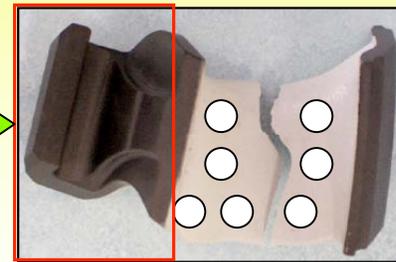
Inner
Shroud

Significant Strength Degradation Observed in EBC SN282 Samples Extracted from Nozzles

The strength of bend bars from inner shroud region is comparable to those obtained from production rods

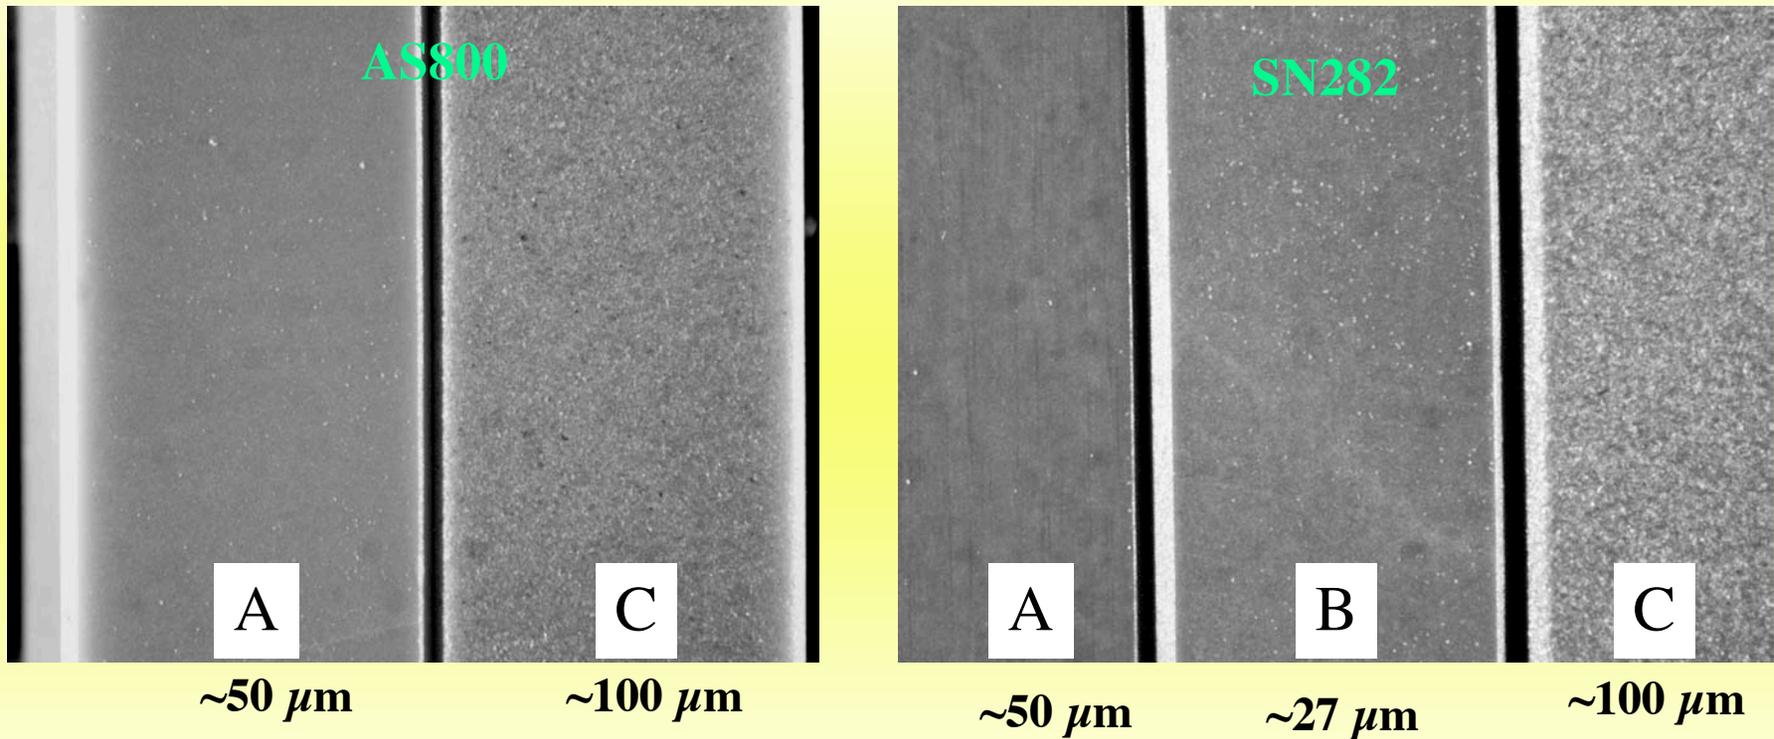
Grit Blast Conditions Employed for Surface Preparation Result in Different Surface Morphology of Substrate

Grit blast step was carried out prior to the EBC coating process to ensure a better mechanical adhesion

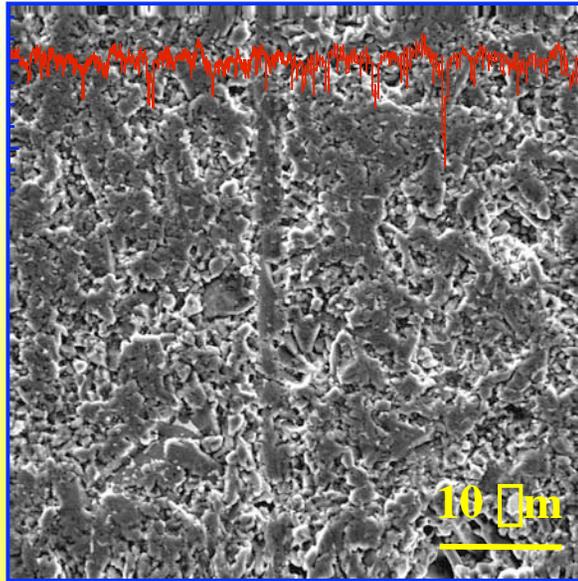
As-machined

Grit Blast Conditions Employed Could Introduce Substantial Surface (and Subsurface) Damages

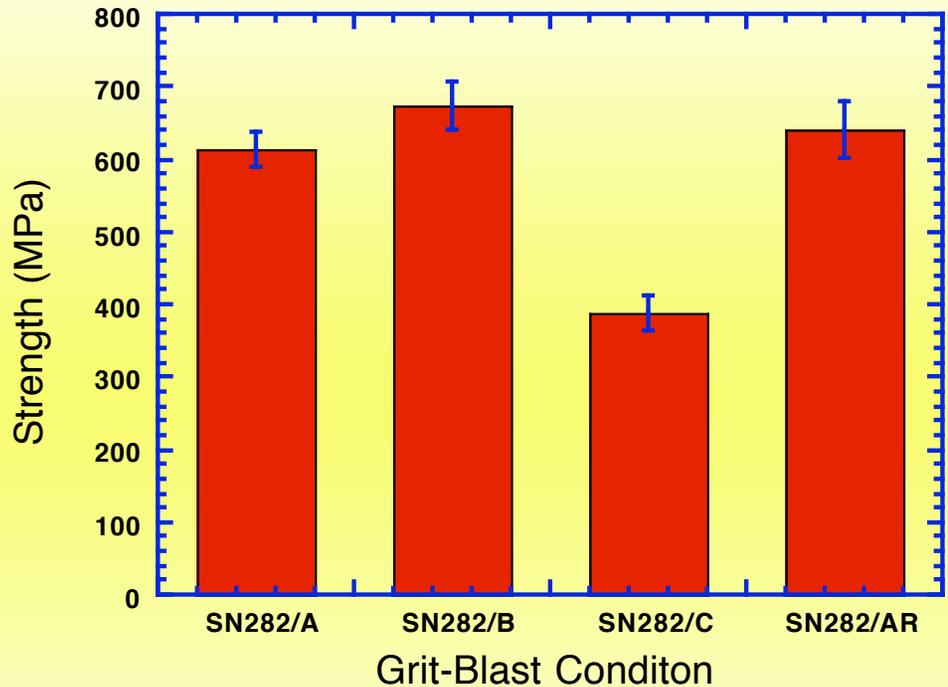
Grit Blast Conditions Employed for Surface Preparation Could Influence the Mechanical Property of Airfoils

K_{IC} (SN282):
6 MPa \sqrt{m} \square 40% decrease

**The extent of strength degradation is related to the material toughness
(damage tolerance) and also hardness**

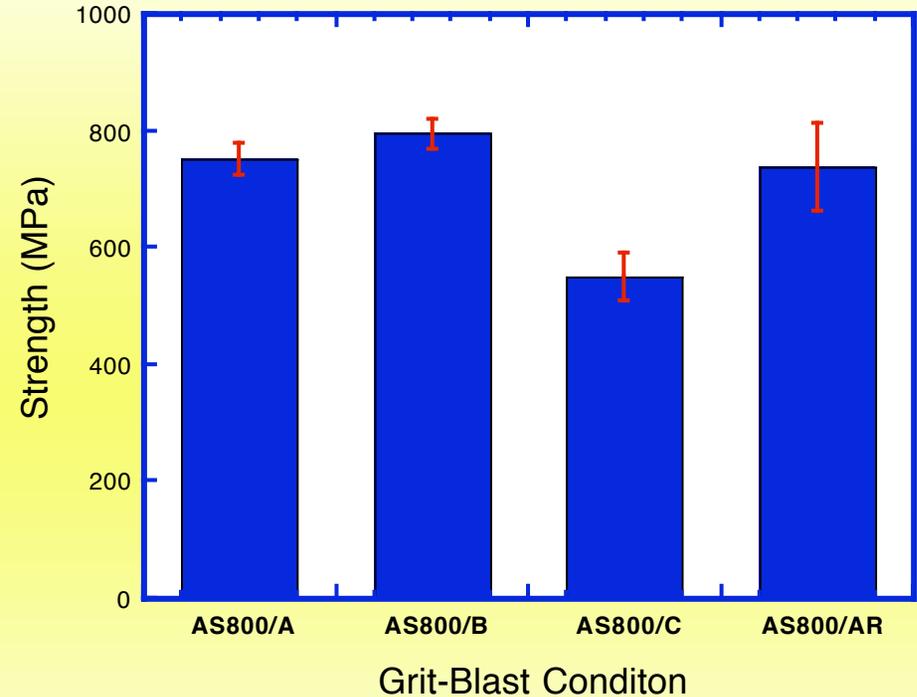
K_{IC} (AS800):
8.5 MPa \sqrt{m} \square 26% decrease

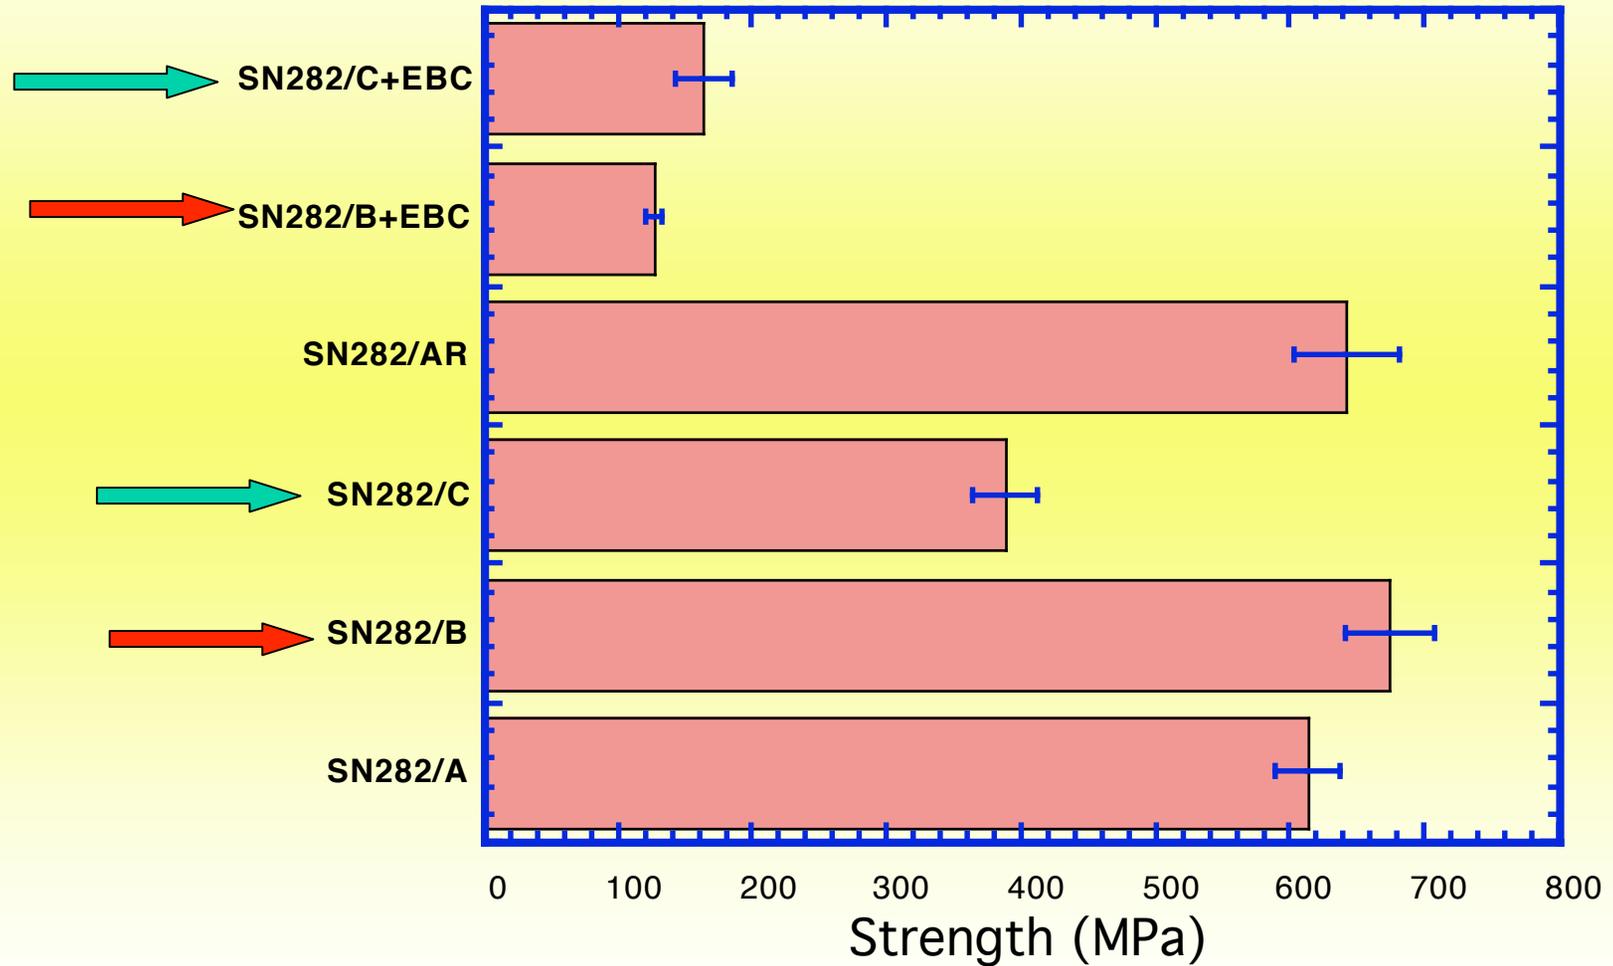
Mechanical Strength of SN282 Samples is Significantly Decreased After Deposition of BSAS EBC System

Strength degradation of EBC Si_3N_4 is independent upon grit blast condition

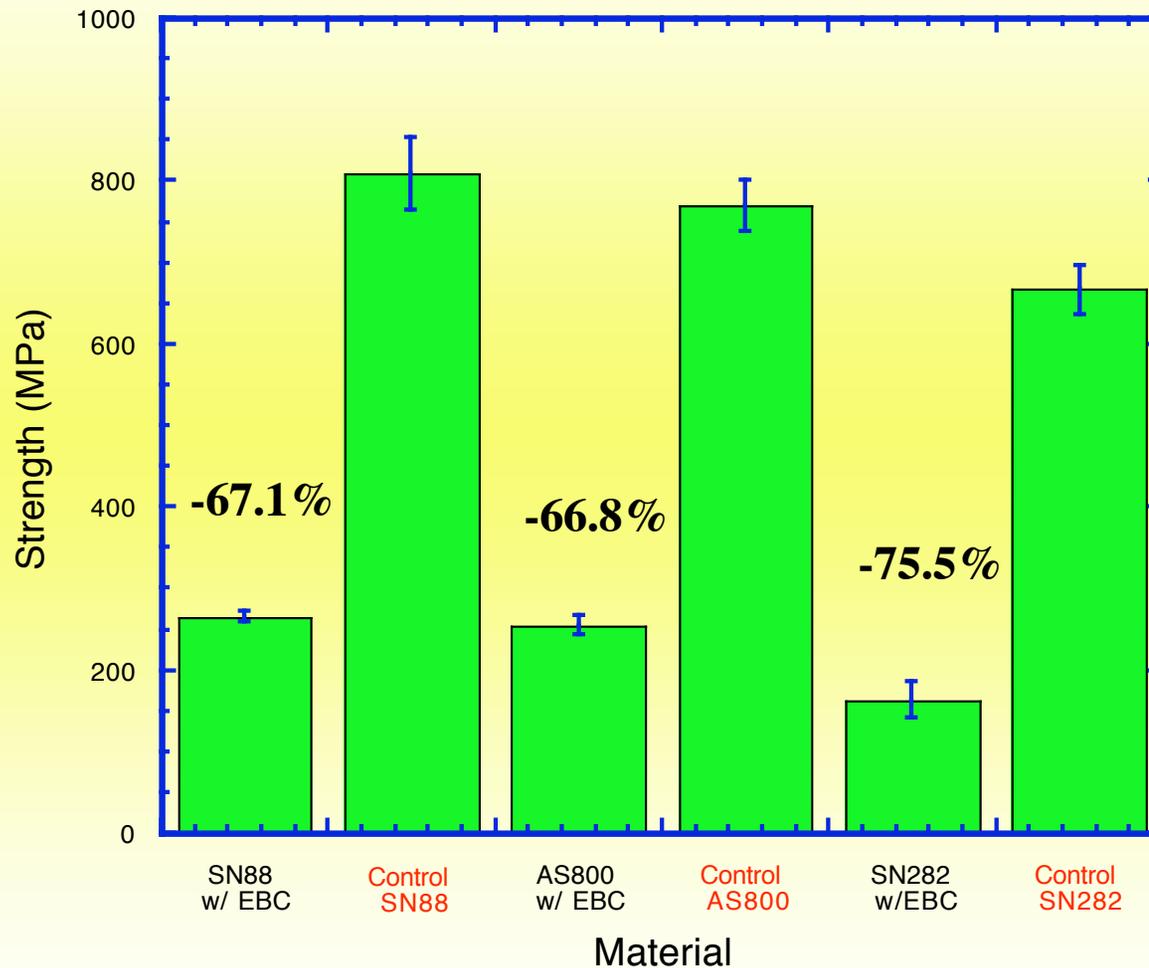
Substantial Strength Degradation Occurred in all EBC-Coated Commercially Available Advanced Silicon Nitrides

Extent of strength degradation is independent of mechanical properties (strength & toughness) of substrates

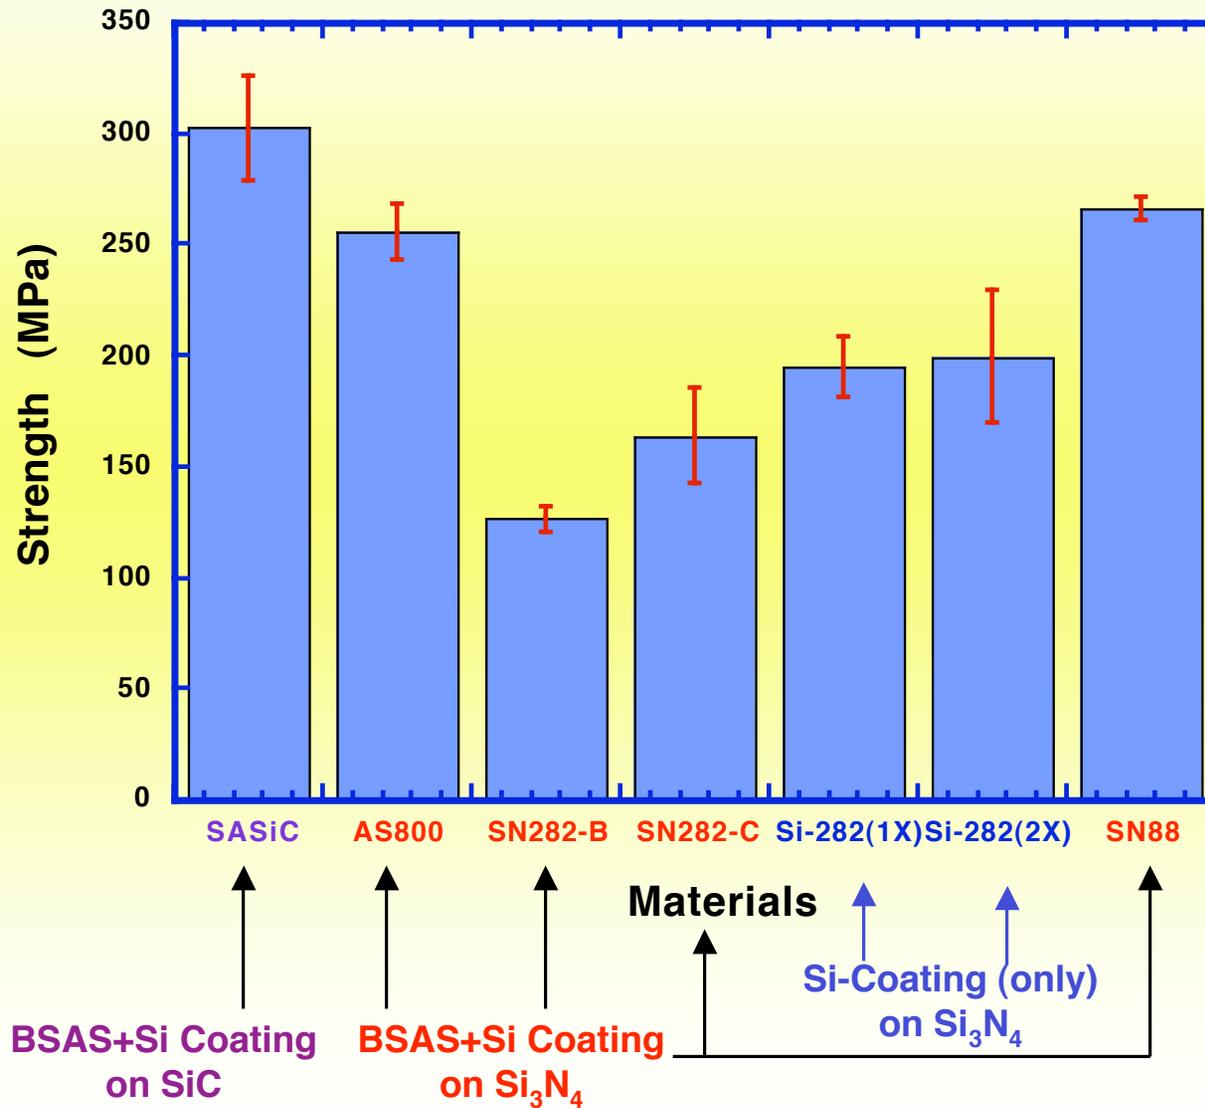
Flexural Strength Comparison of BSAS EBC Coated Silicon Nitride Ceramic Samples

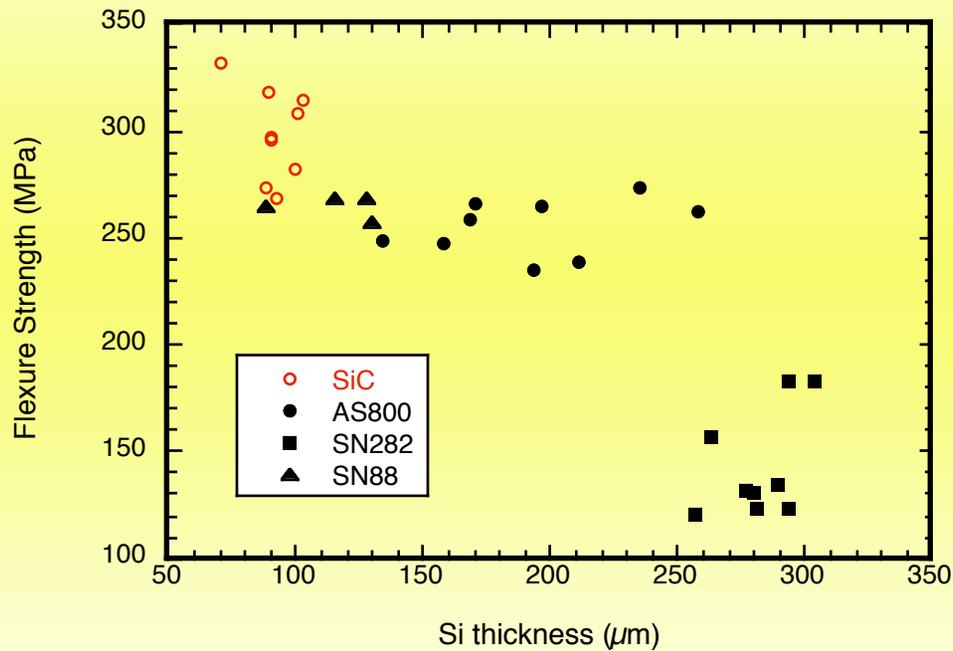
Strength as a Function of Si Thickness

Dependence of BSAS EBC/Si₃N₄ Strength on Si Bond Coat Thickness Appears to be Very Subtle

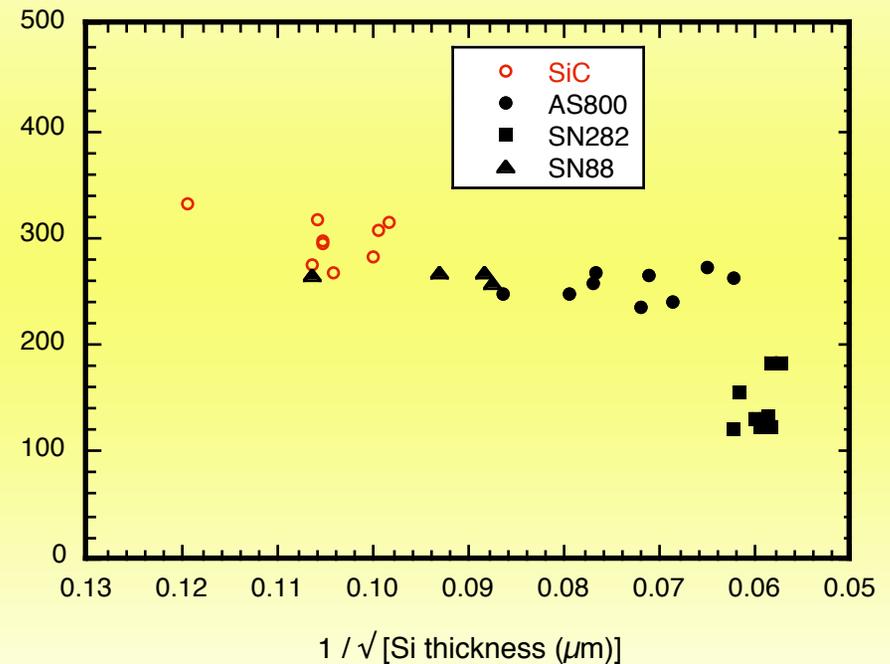
Strength as a Function of 1 / √ (Si Thickness)

$$K_{IC} = \sigma_a Y \sqrt{a}$$

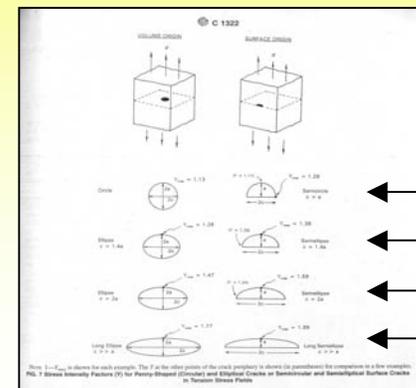
When the roughness parameters shown above are used to “back-calculate” the crack geometry correction factor, Y, there is good correlation with Ra and Rq and surface-located, elliptical, strength-limiting flaws shown below

$$S = \frac{K_{Ic}}{Y\sqrt{c}}$$

$$Y = \frac{K_{Ic}}{S\sqrt{c}}$$

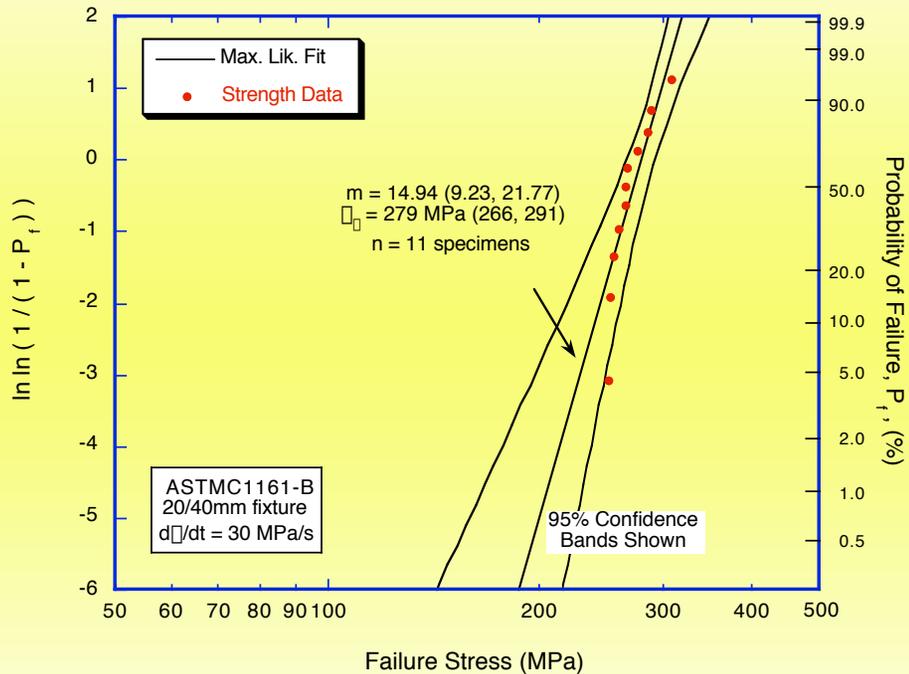
Si-SN282-As-Coated
Uncensored Flexure Strength Distribution
20°C - 30 MPa/s

$$\sigma_{\text{avg}} = 253 \pm 9.8 \text{ MPa}$$

However, Si-SN282 Strength Results Seems to Exclude the Hypothesis of “Si” Surface Roughness Effect

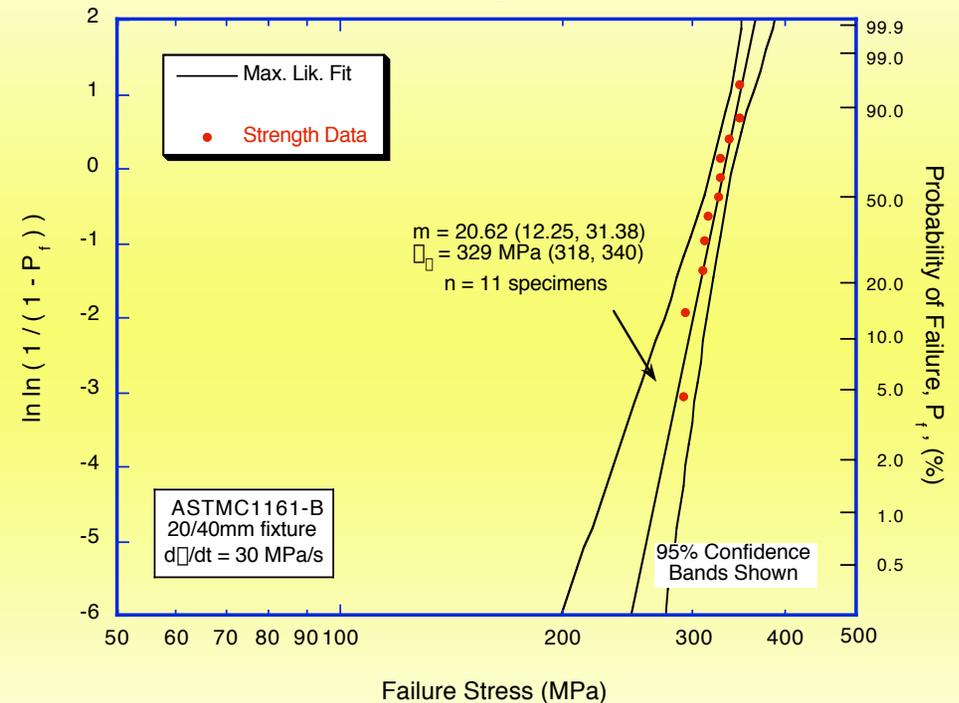
Si-SN282-600 Grit
Uncensored Flexure Strength Distribution
20°C - 30 MPa/s, Logitudinally Machined

$$\sigma_{\text{avg}} = 270 \pm 17.7 \text{ MPa}$$

Fine surface finish (600 grit) of Si bond coat slightly improve strength and Weibull modulus

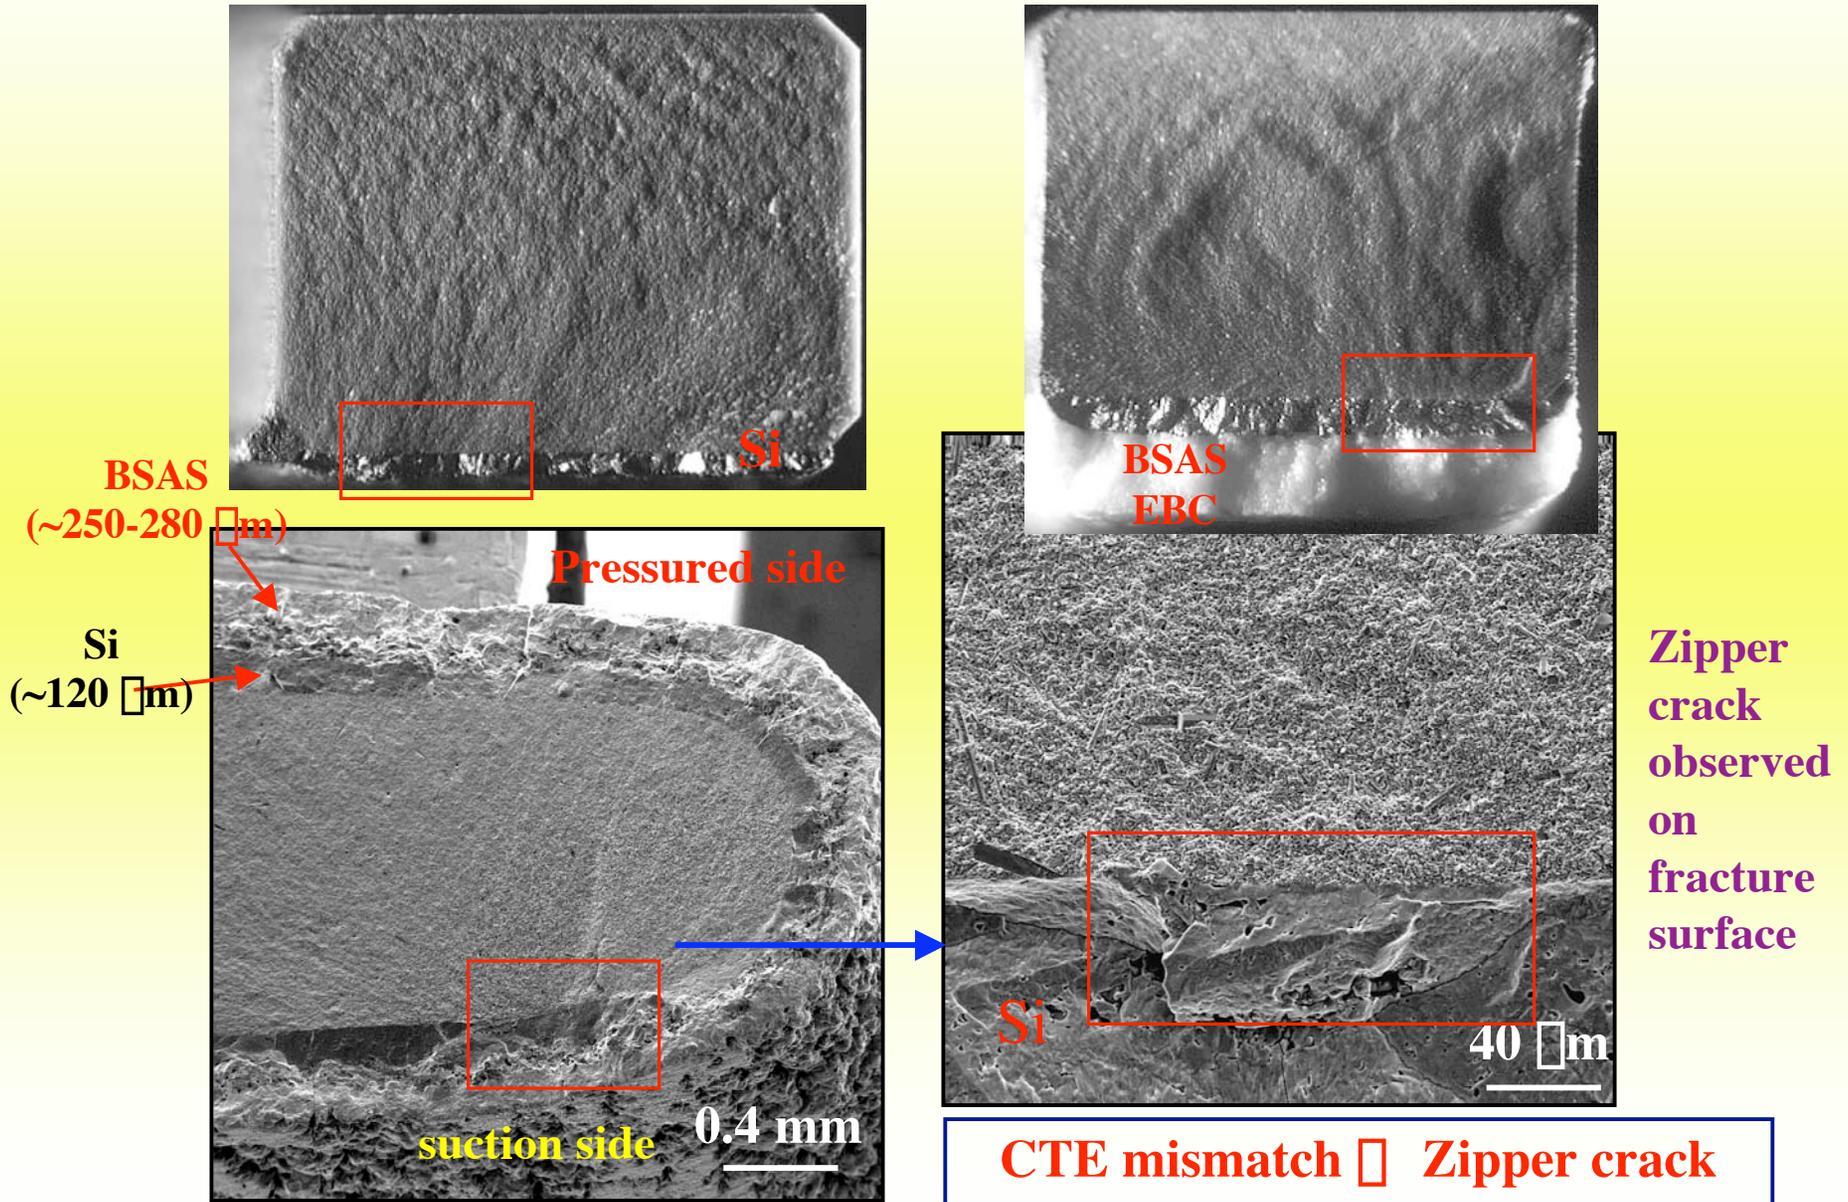
Zipper Crack Observed in all Si- and BSAS EBC-Coated Silicon Nitride Samples

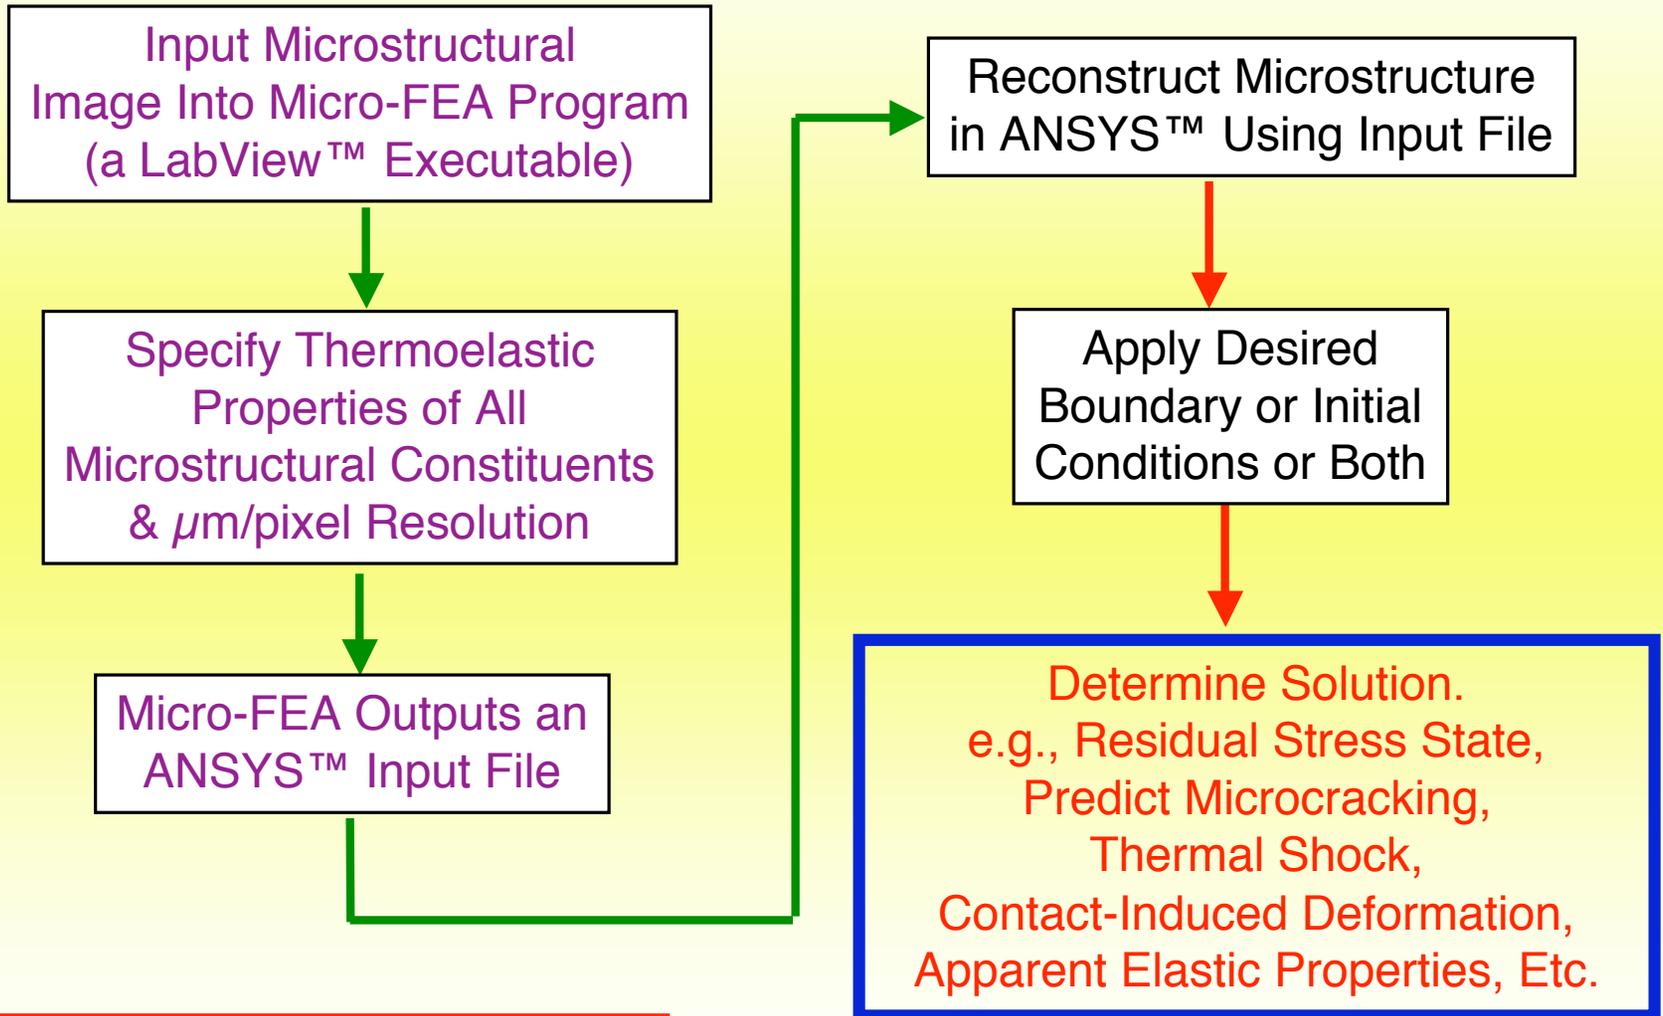
Micro-FEA (Finite Element Analysis) Method

By Wereszczak & Ferber

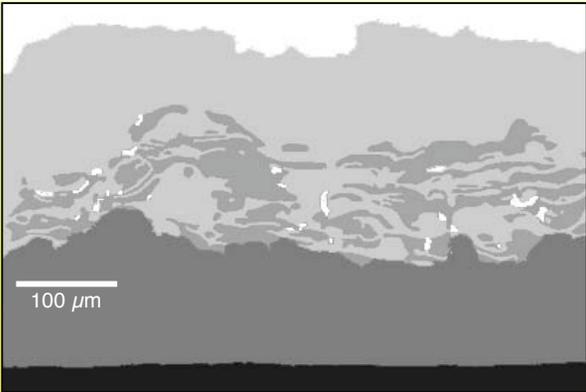
Microstructural Region

Micro-FEA of SN282 Bend Bar Coated with BSAS EBC

281 x 400 pixels
1.45 μm/pixel
407.45 x 580.00 μm

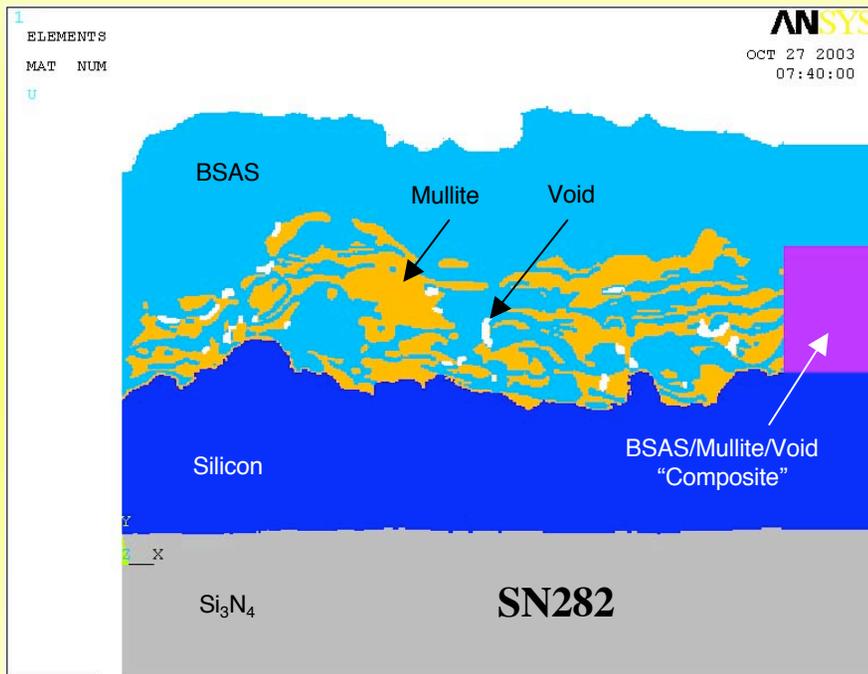
μ -FEA Reconstructed Model

Thermoelastic Properties of BSAS EBC System and SN282 Silicon Nitride Substrate

E (GPa)	ν	CTE (ppm/C)
Si ₃ N ₄	315	0.29	2.9
Silicon	80	0.20	4.9
BSAS	80	0.24	5.0
Mullite	130	0.23	3.5
BSAS/Mullite	60	0.23	4.2
TREF = 1250C			
TUNIF = 25C

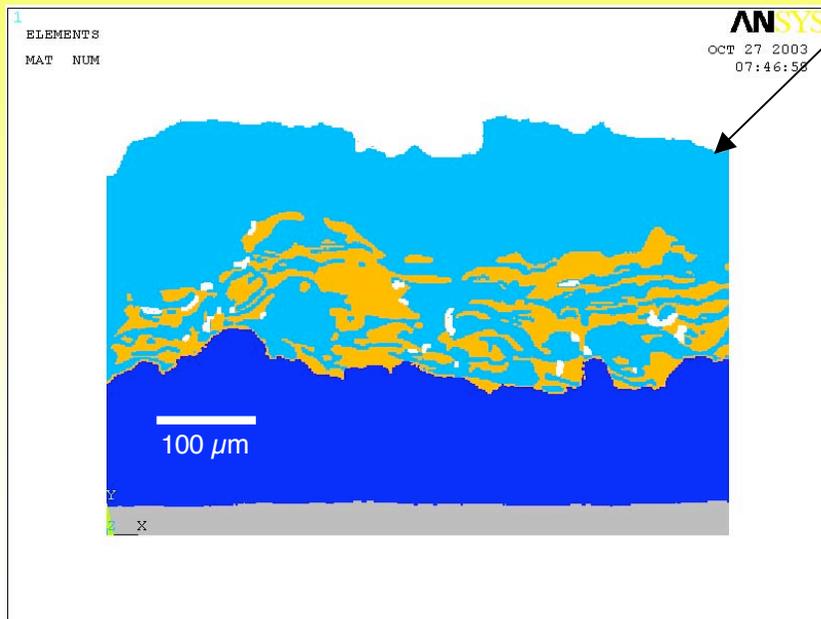
Detail

Inclusion of a Semi-Infinite Field in the FEA Acts To Apply Appropriate BCs on the Micro-Modeled Region

SEM micrograph taken from a polished cross section of bend bar extracted from EBC-SN282 nozzle

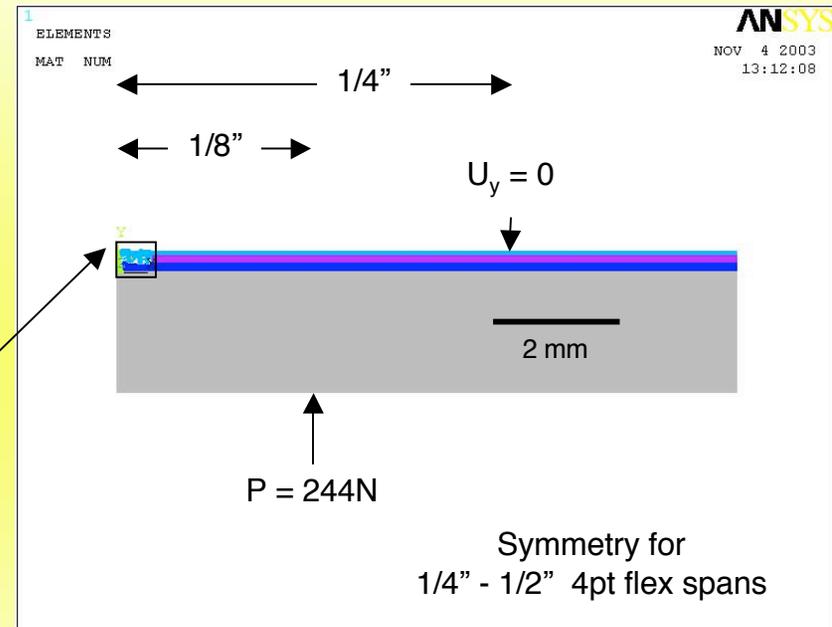
Whole Modeled Geometry

Case study was also carried out on ASTM standard MOR bar (20/40 mm loading spans)

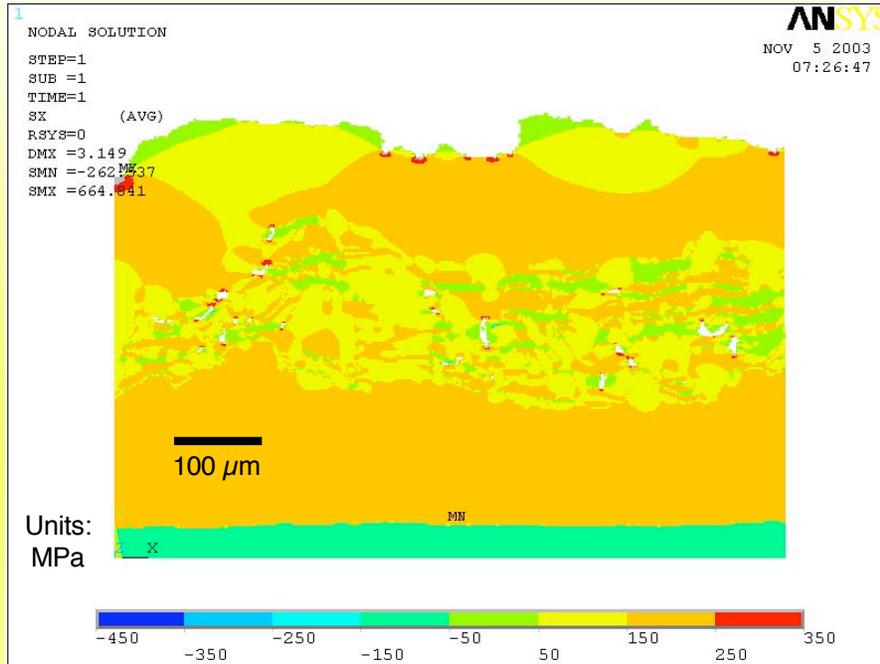
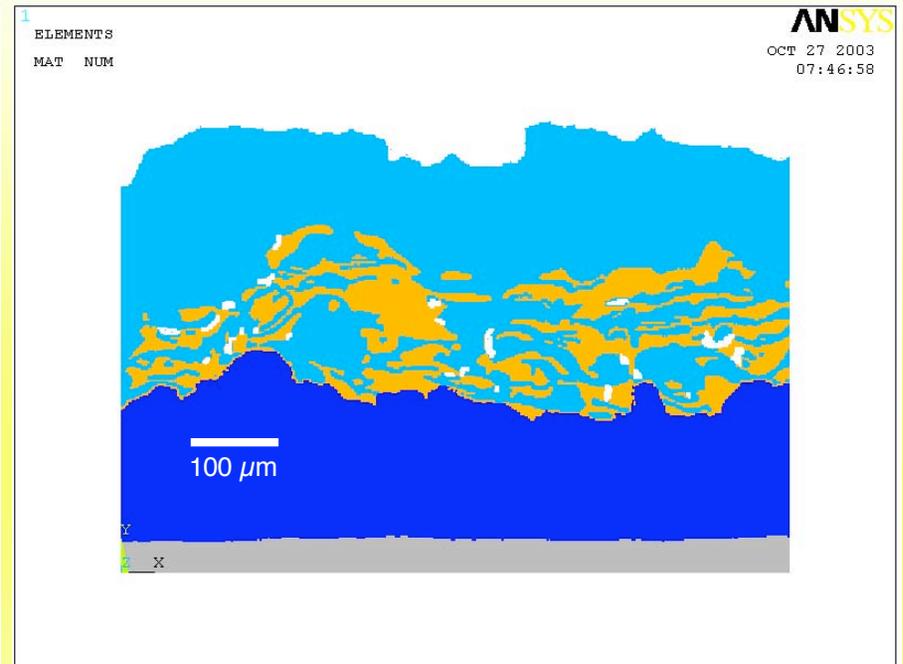
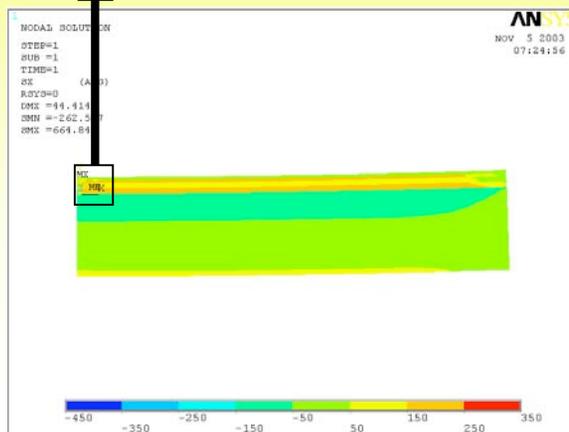
Case 1: σ_x Residual Stress Field Only

σ_x Stresses

σ_x Stresses in Whole Model

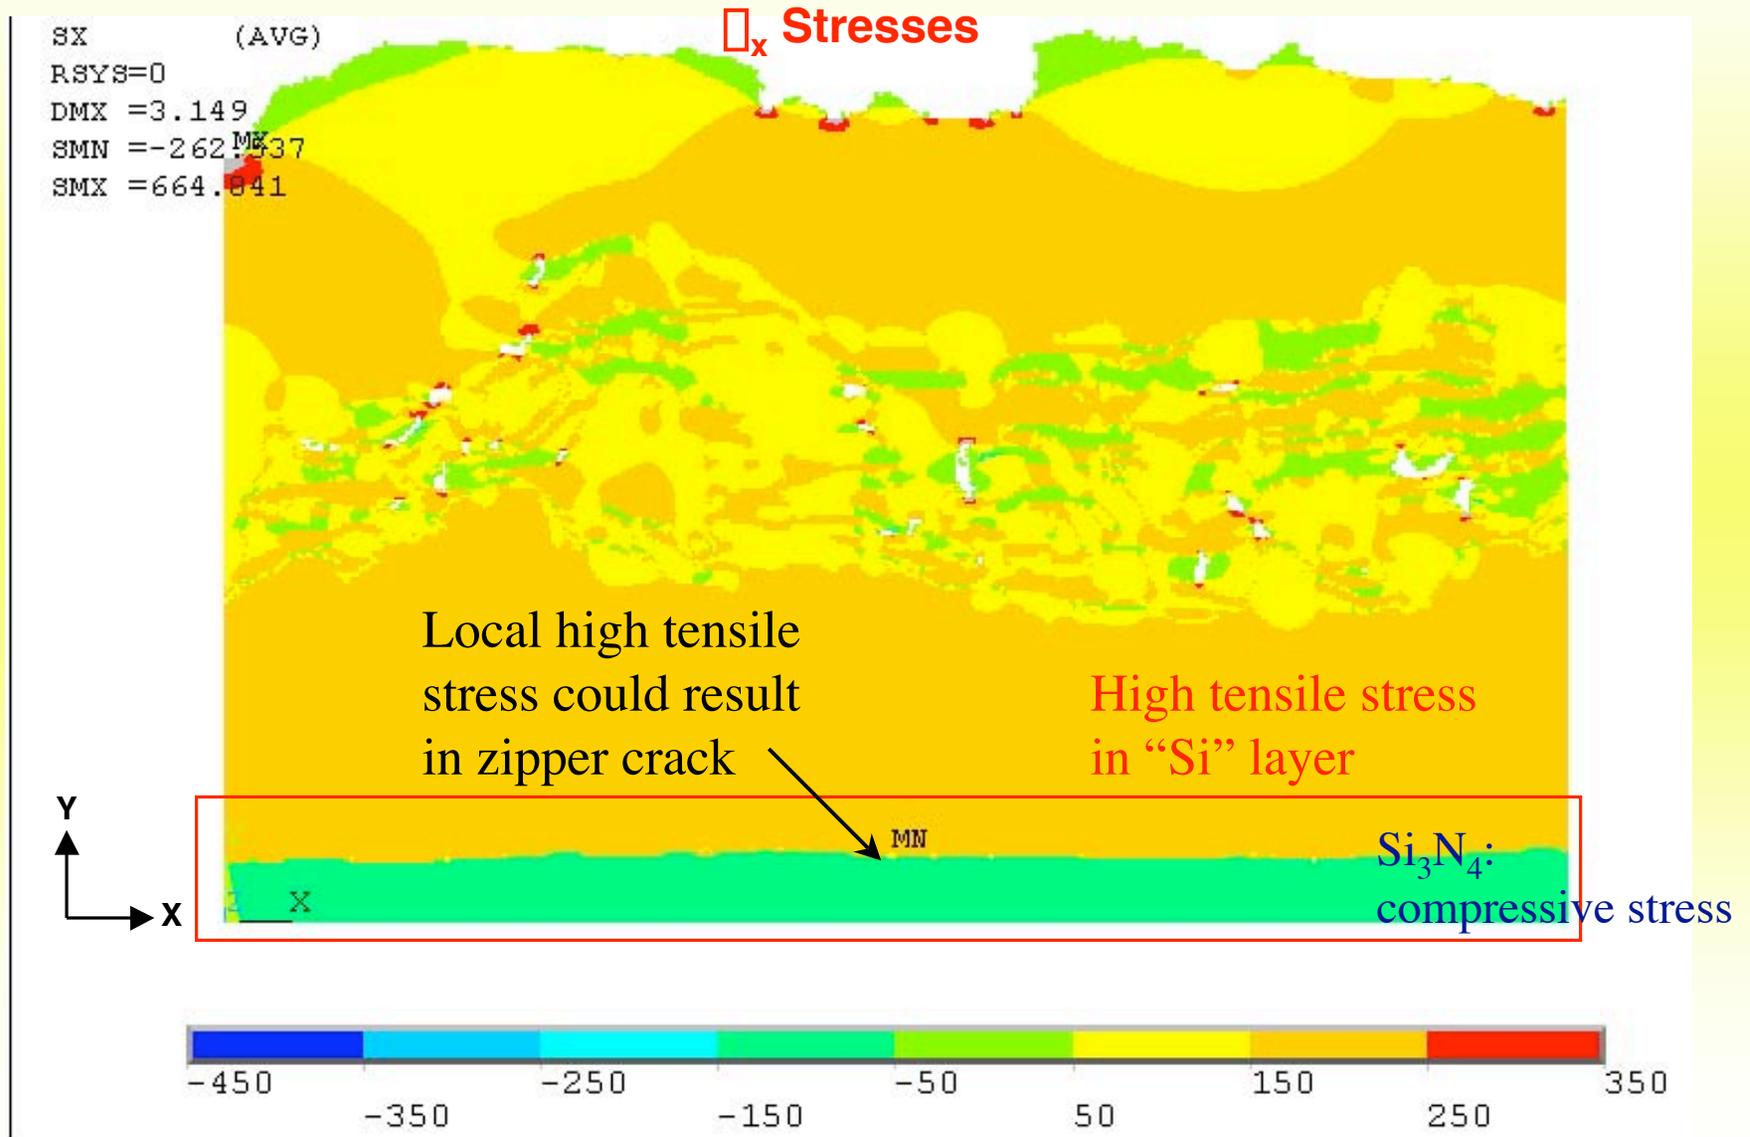
High Stress Concentration Observed at Si/Si₃N₄ Interface
