Effect of Material Parameters on Mechanical Performance of Environmental Barrier Coatings

*H. T. Lin, A. A. Wereszczak, M. K. Ferber, and
T. P. Kirkland*

Ceramic Science and Technology Group
Metals and Ceramics Division
Oak Ridge National Laboratory
Oak Ridge, TN 37831-6068

Study was Motivated by Fracture of EBC-SN282 Nozzle During Thermal Shock Proof Test at Solar Turbines

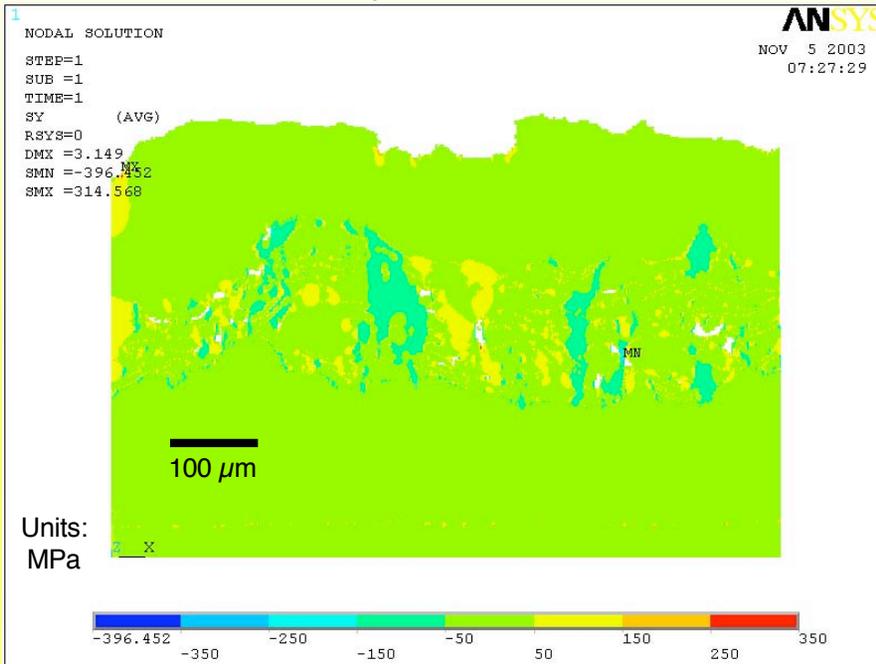
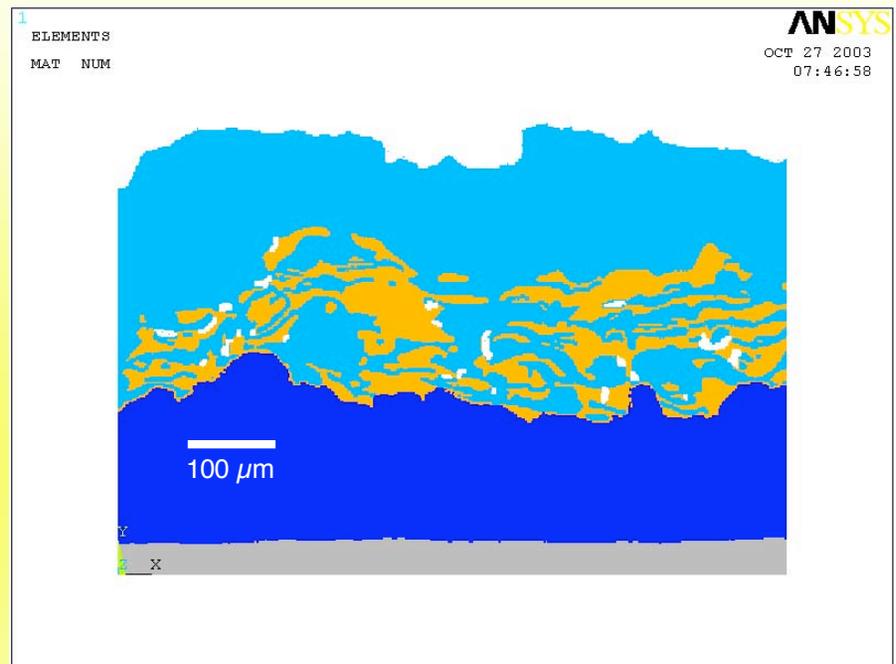
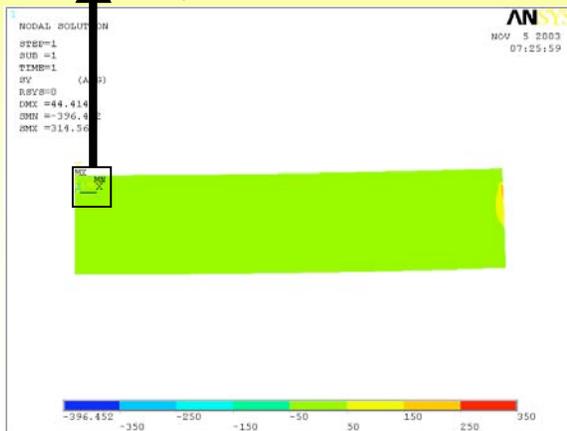
Case 1: σ_y Residual Stress Field Only

σ_y Stresses

σ_y Stresses in Whole Model

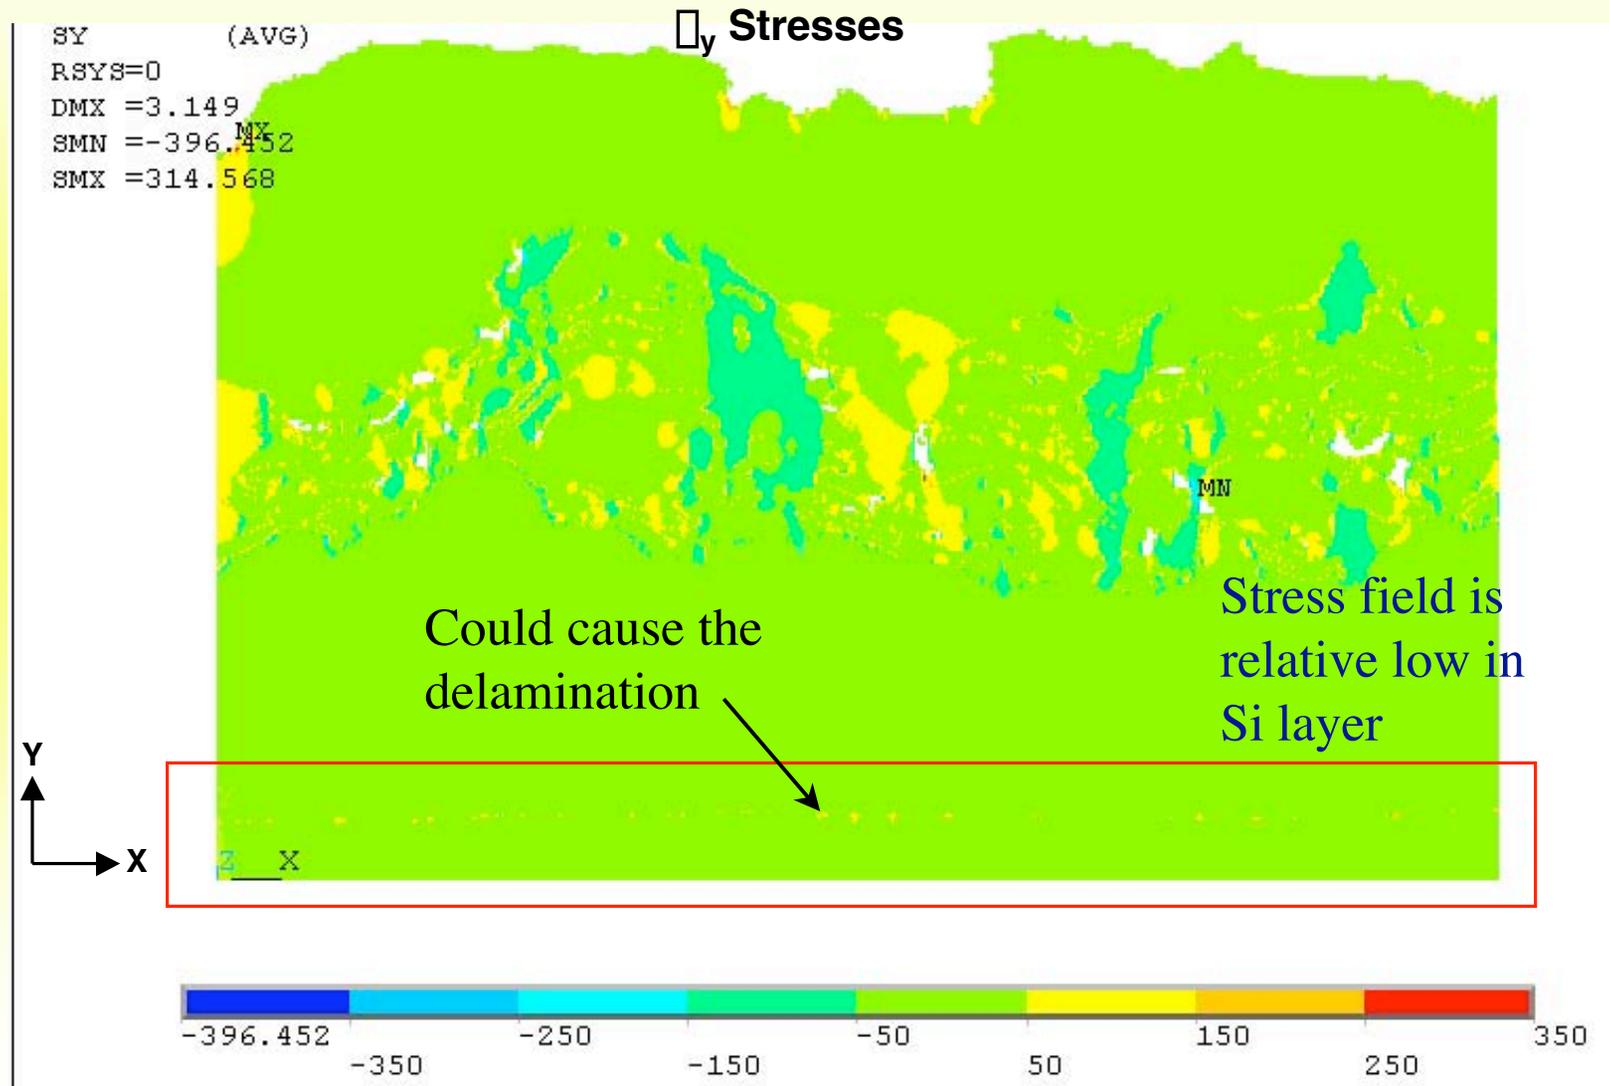
High Stress Concentration Observed at Si/Si₃N₄ Interface

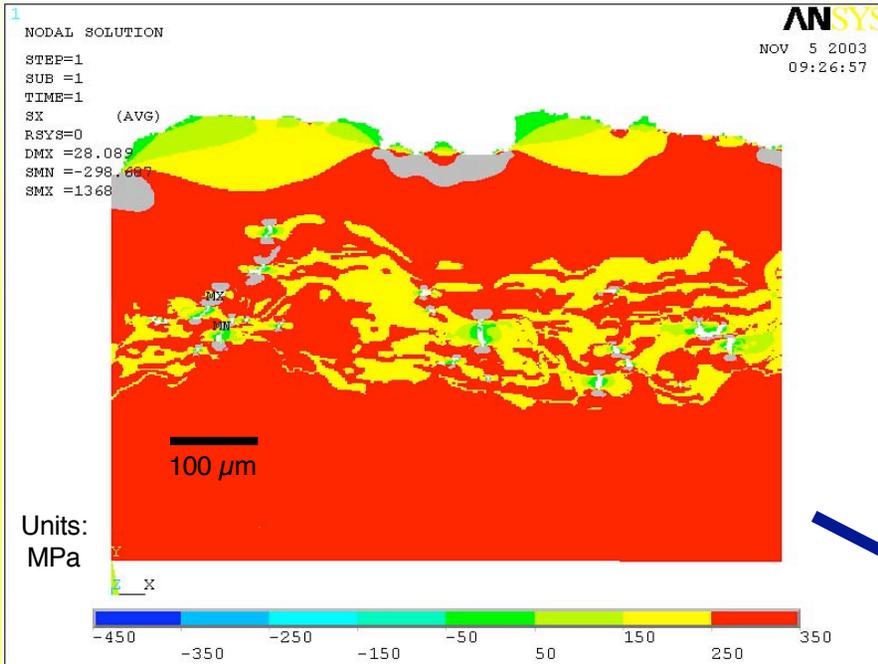
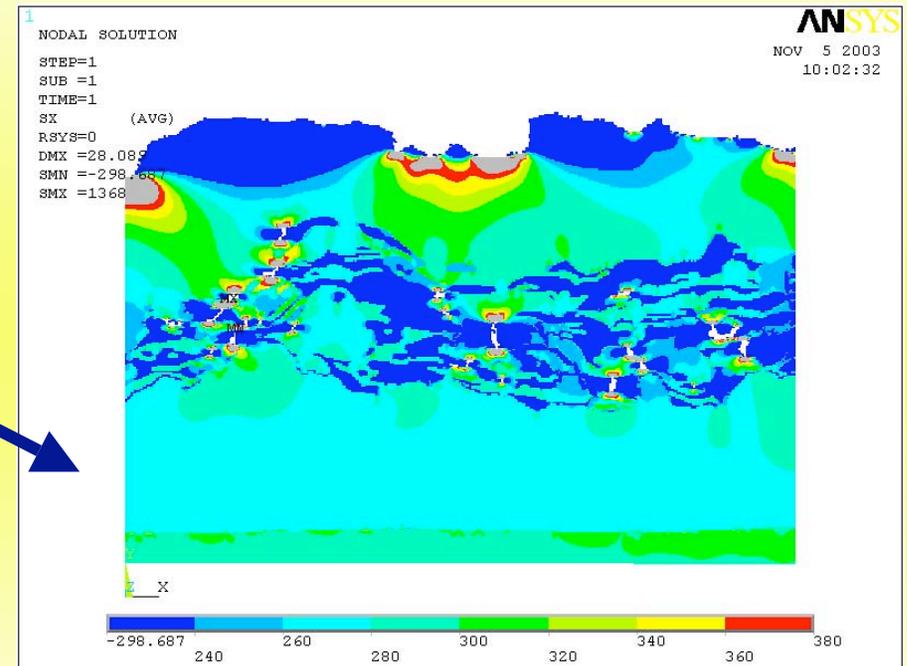
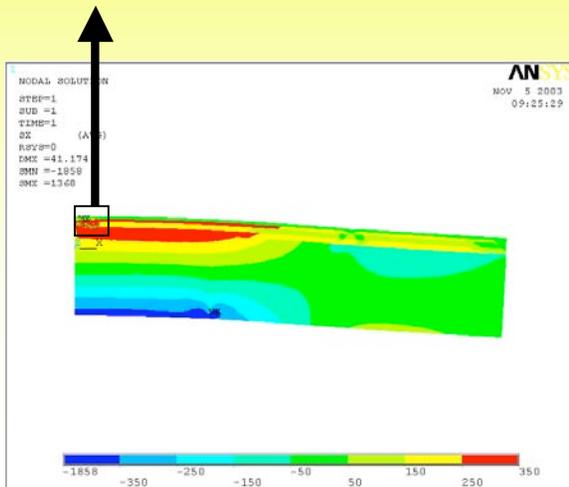
Case 2: Sum of σ_x Residual Stress Field + σ_x Bend Stress

σ_x Stresses

Refined View of σ_x Stresses

$\sigma_{\text{app}} = 270 \text{ MPa Bend Stress}$

σ_x Stresses in Whole Model

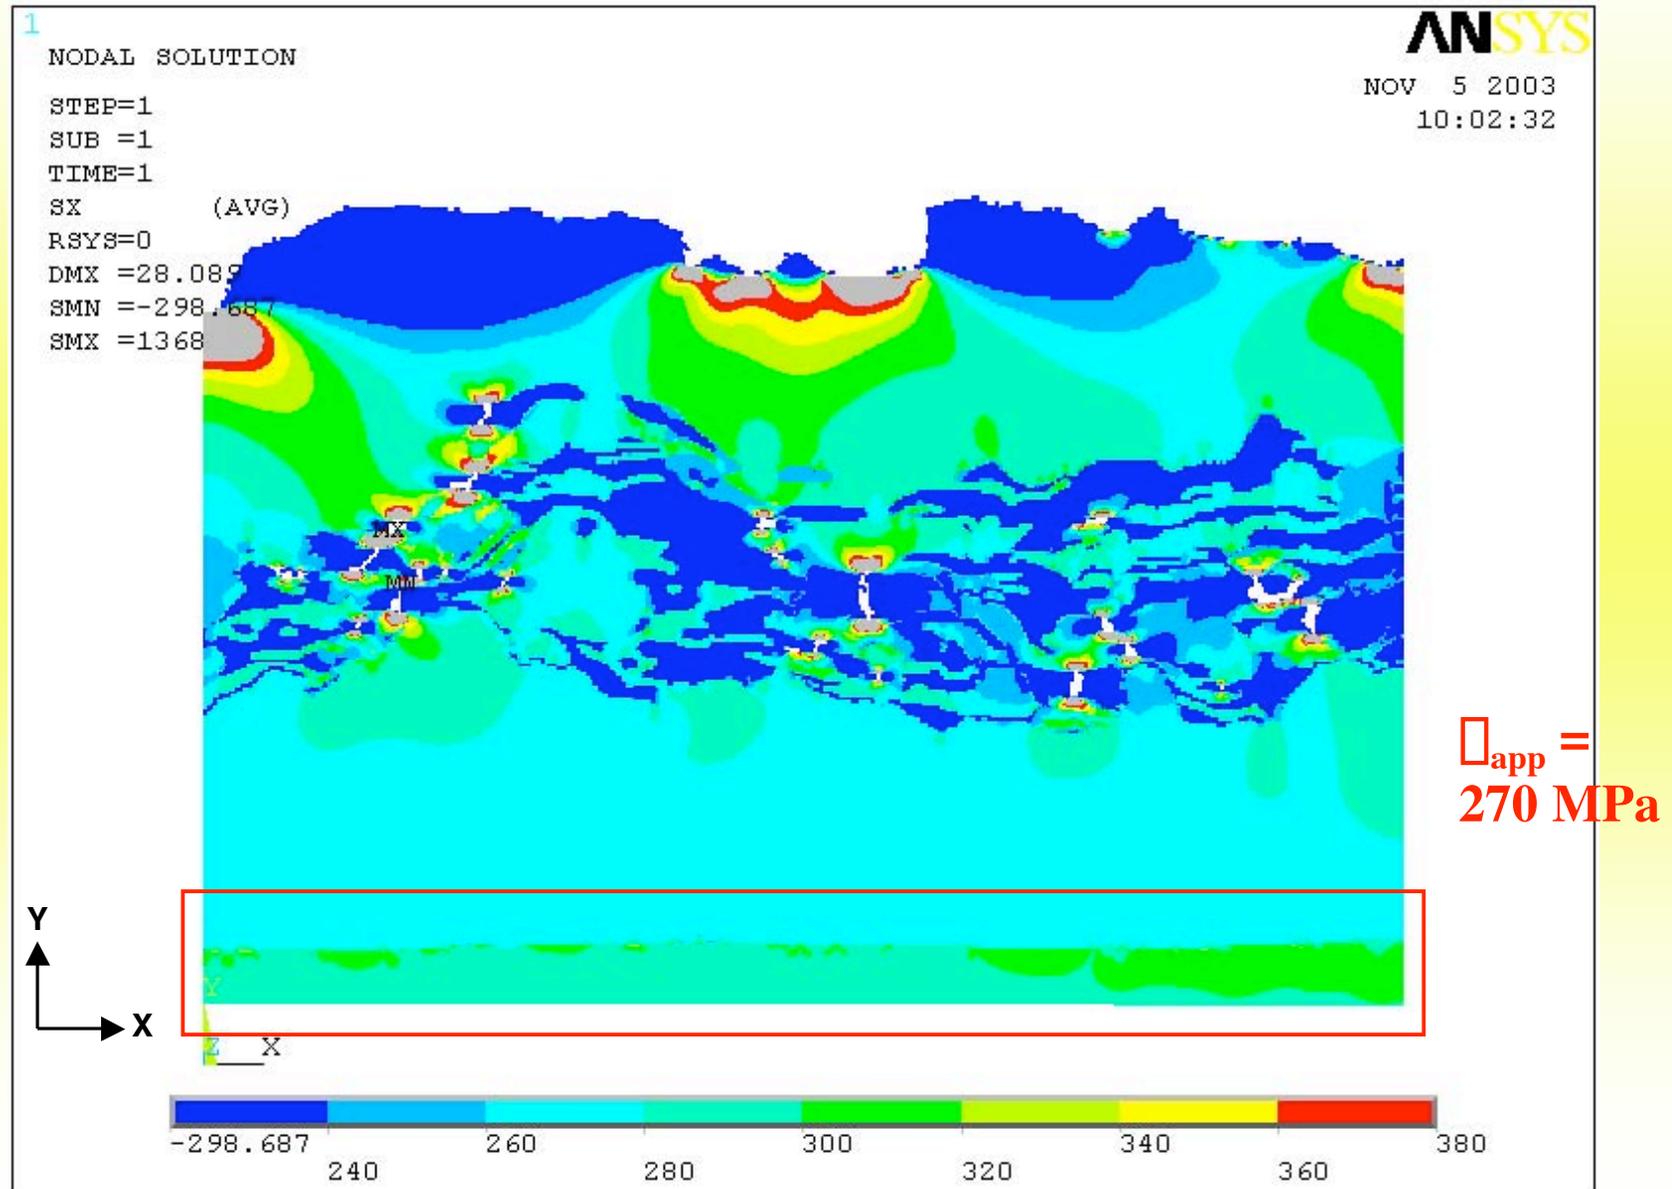
Externally Applied Stress Augments the Residual Stress Field

- Grit blast conditions employed to prepare the component surface could impact the mechanical performance of materials (especially for low toughness ones).
- The biaxial disks and flexure MOR bars with EBC exhibited 67-75% low strength than those obtained from non-coated samples. Subsequent test and analysis suggests that strength degradation is less dependent on the thickness as well as surface roughness of Si bond coat.
- Observations of zipper cracks evident in Si_3N_4 substrates, suggestive failure initiation (and strength degradation) could be possibly associated with CTE mismatch between EBC and Si_3N_4 substrates.
- □-FEA results showed high residual stress field present in Si bond coat (~150-250 MPa) and Si/ Si_3N_4 interface (~50-150 MPa).
- Externally applied stress would augment the residual stress field and cause the premature fracture of ECB samples.

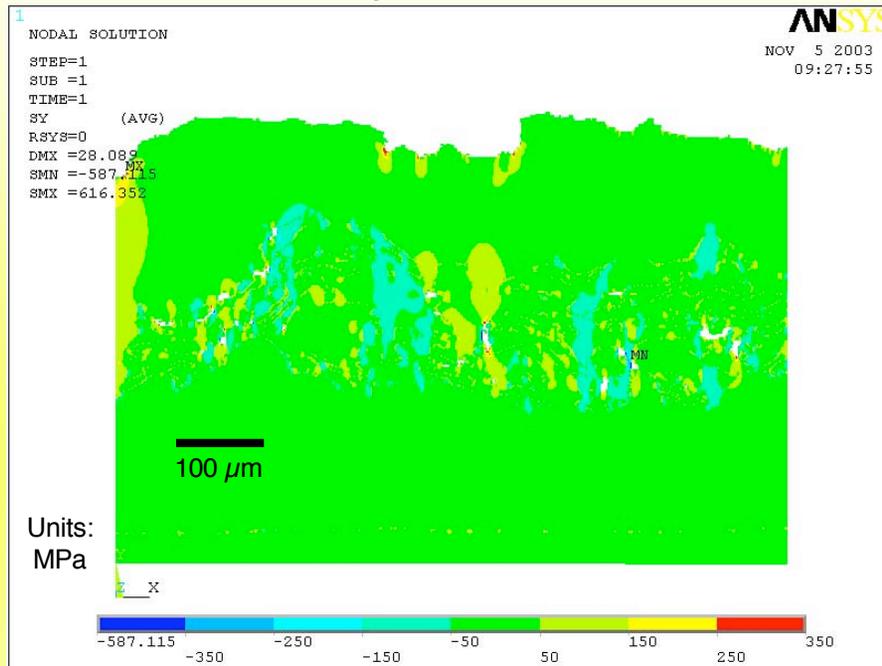
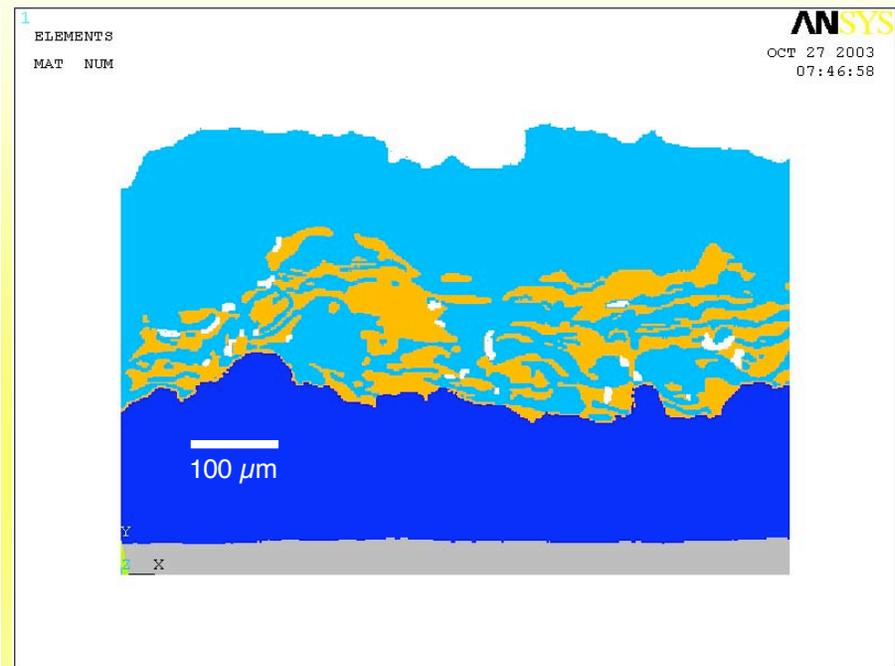
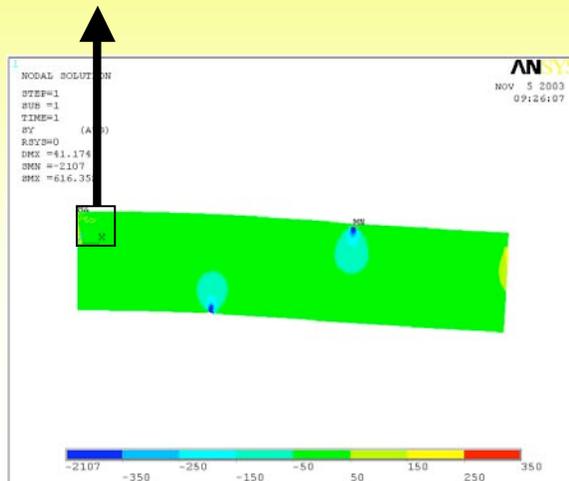
Case 2: Sum of σ_y Residual Stress Field + σ_y Bend Stress

σ_y Stresses

σ_y Stresses in Whole Model
