MATERIAL CHARACTERIZATION OF CANDIDATE SILICON BASED CERAMICS FOR STATIONARY GAS TURBINE APPLICATIONS

Vijay M. Parthasarathy, Jeffrey R. Price, William D. Brentnall
Solar Turbines Incorporated
San Diego, California

ABSTRACT

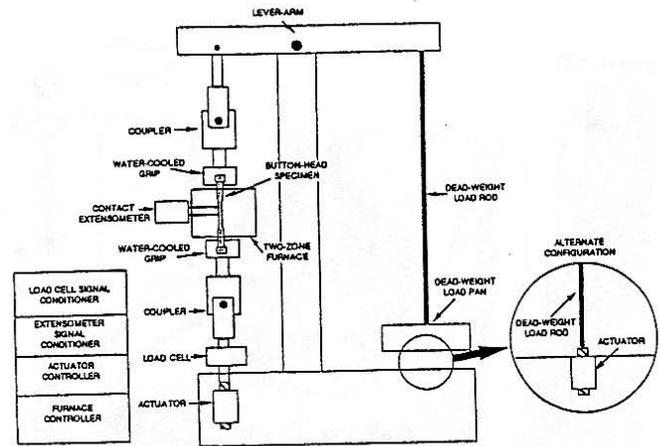
FIGURE 1. SCHEMATIC REPRESENTATION OF THE STRESS RUPTURE MACHINE AT ORNL

Figure 1 is a schematic representation of the creep/stress rupture test machine that will be used by ORNL. The test frames at Solar and UDRI are very similar to this machine. The primary differences are that ORNL uses a contact extensometer, Solar uses laser extensometers and UDRI uses a customized laser speckle interferometer system to measure strain. Solar also uses an MTS hydraulic system for flexural and cyclic fatigue testing.

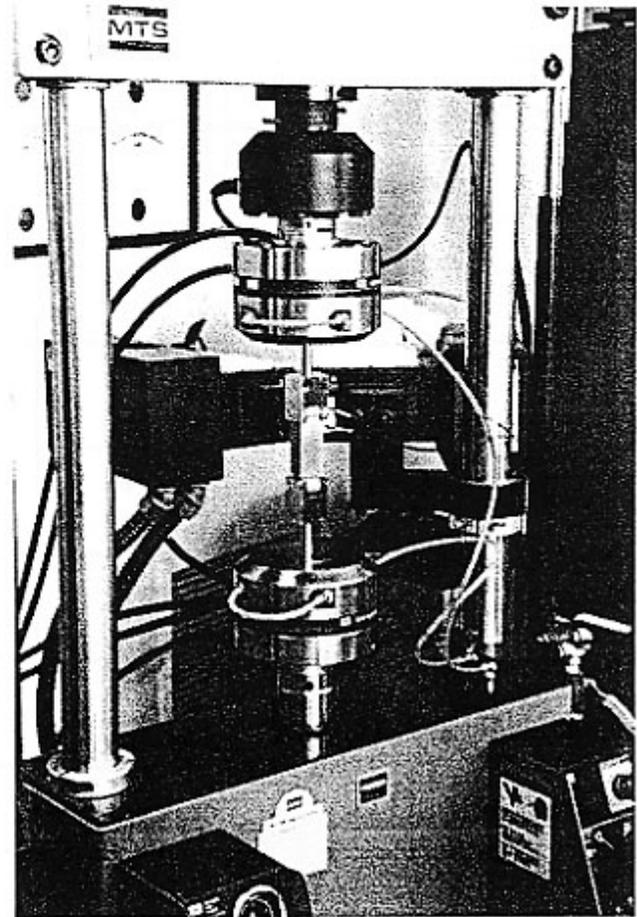
FIGURE 2. PINNED ROOT ATTACHMENT TEST IN PROGRESS

Dovetail root and pinned root attachment specimens were supplied by AlliedSignal Ceramic Components (GN-10), Kyocera Industrial Ceramics Corporation (SN-253) and Norton Advanced Ceramics (NT-164) for testing in an Instron tensile testing apparatus. The grips for the attachment specimen testing were constructed from Waspalloy, which is the disk material that will be used for actual engine testing. Figure 2 shows a pinned root attachment specimen test in progress. The attachment testing is being conducted at loads representing full CF load conditions, cyclic temperature and CF load conditions, and room and elevated temperature failure loads. The behavior of various compliant layer configurations for the dovetail blade attachment specimens at these conditions is also being evaluated. Prior to each test, the specimens are inspected dimensionally and visually at 40X magnification. Following each test the specimens are carefully examined both visually and microscopically to determine the failure origin and mechanism for failure.

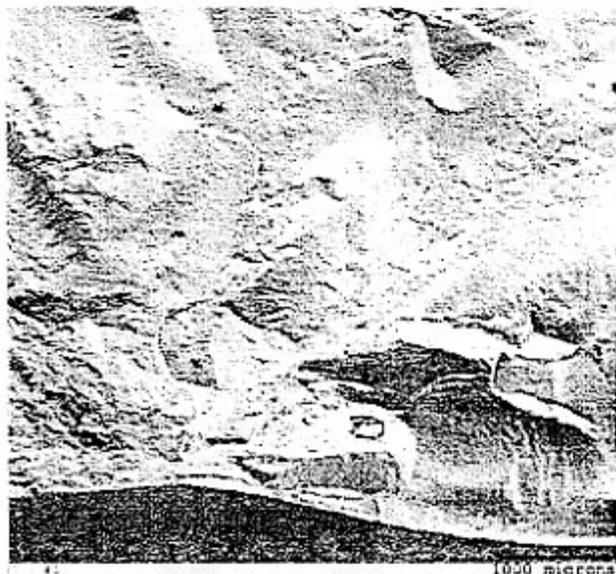
FIGURE 6. FAILURE ORIGIN OF DOVETAIL ATTACHMENT SPECIMEN

Table 5 summarizes the results of attachment testing for the dovetail root design to-date. At room temperature the dovetail specimens failed at stresses 3-4 times the nominal design stress. Figure 6 shows the failure origin of a failed dovetail attachment

specimen. A thin (0.13 mm/0.005 in.) nickel compliant layer material was used for room temperature testing in order to simulate the behavior of the actual compliant layer material (nickel based alloy) at the elevated blade root temperature in actual service. The nickel compliant layer provided any deformations during loading which would identify uneven loading of the specimen during testing. The nickel based alloy is used for testing at 760° C (1400° F) which is the approximate steady state temperature of the blade root in service. Testing to date has shown that the selected compliant layer material has performed well under the blade root conditions.

A single test was performed at the steady state blade root temperature. The failure load in this test was markedly lower than in the room temperature test, but was over 2 times the design stress at actual engine operating conditions. Some locking up of the blade attachment specimen and compliant layer material in the metallic grip was observed in the test. This was partly due to opening of the dovetail grip (-0.006 in.) at the high load and elevated temperature. Minor evidence of contact stress was seen in the failed specimen and compliant layer material.

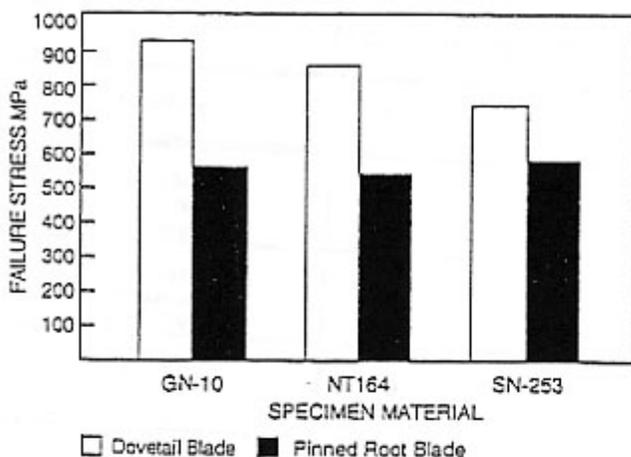
FIGURE 8. COMPARISON OF DOVETAIL AND PINNED ROOT ATTACHMENT SPECIMENS

A comparison of the dovetail and pinned root attachment specimen testing at room temperature from each of the three suppliers is shown graphically in Figure 8. The room temperature failure stress of the dovetail root attachment specimens was considerably higher than the pinned root attachment specimens.

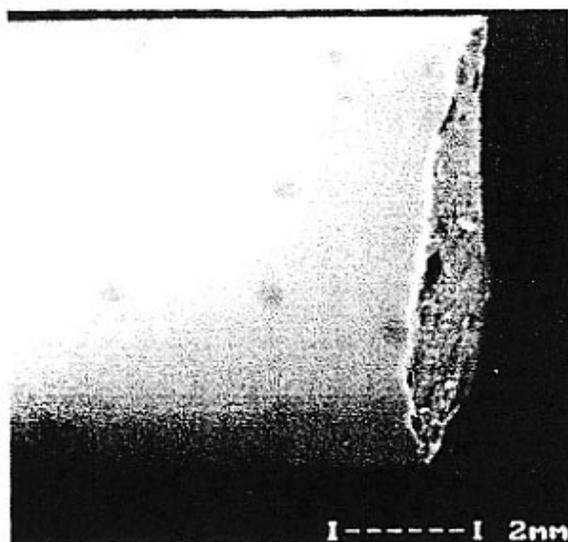
FIGURE 9. SPOTTED SURFACE ON TENSILE SPECIMEN SURFACE TESTED AT SLOWER CROSSHEAD SPEED (1288°C -2350°F)

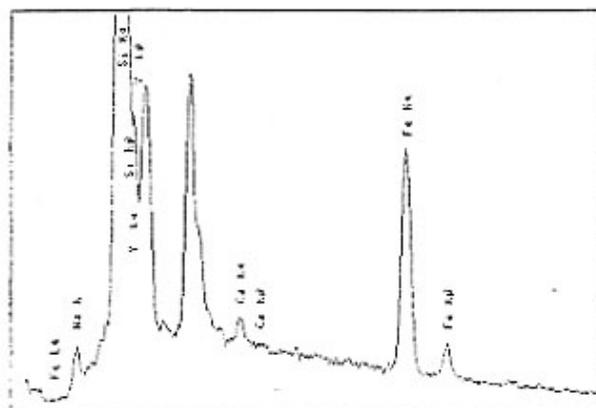
FIGURE 10. EDS OF SPOTS SHOWING HIGH CONCENTRATION OF SODIUM

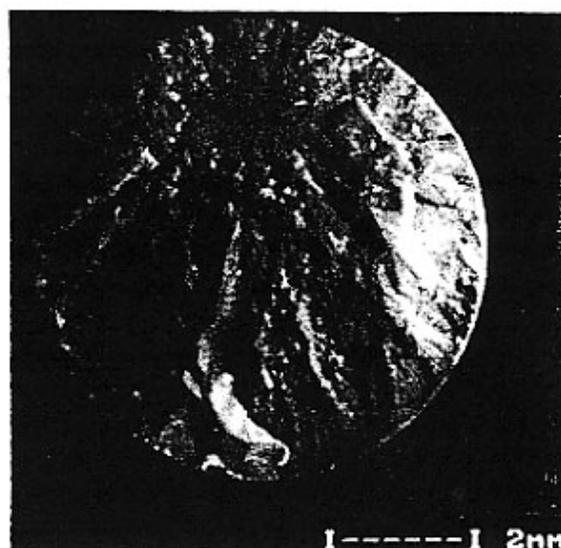
FIGURE 11. TYPICAL VOLUME INCLUSION INITIATED SURFACE. INCLUSION USUALLY HAS HIGH IRON CONCENTRATION

The NT 164 strength was considerably lower (103-138 MPa or 15-20 ksi) than data obtained for a similar NT 164 under the Ceramic Technology for Advanced Heat Engines (CTAHE) program in the same temperature range. On exposure to 1288°C (2350°F) the NT 164 specimens showed a spotted surface (Figure 9). Light element energy dispersive X-ray spectroscopy (EDS) using an Auger spectroscopy system revealed a relatively high concentration of sodium in this region (Figure 10). Figure 11 shows a volume fracture origin. EDS of this surface revealed an Fe inclusion, which seems to be a major cause of low strength fractures. Therefore the low strength failures appear to be caused both by migration of sodium from the encapsulant glass (used in the HIP process) to the dark surface areas causing premature failures and by the frequent presence of Fe inclusions.
