ORNL/Sub/94-SS112/07

SUPPORT SERVICES FOR CERAMIC FIBER-CERAMIC MATRIX COMPOSITES

Final Annual Technical Progress Report

November 2002

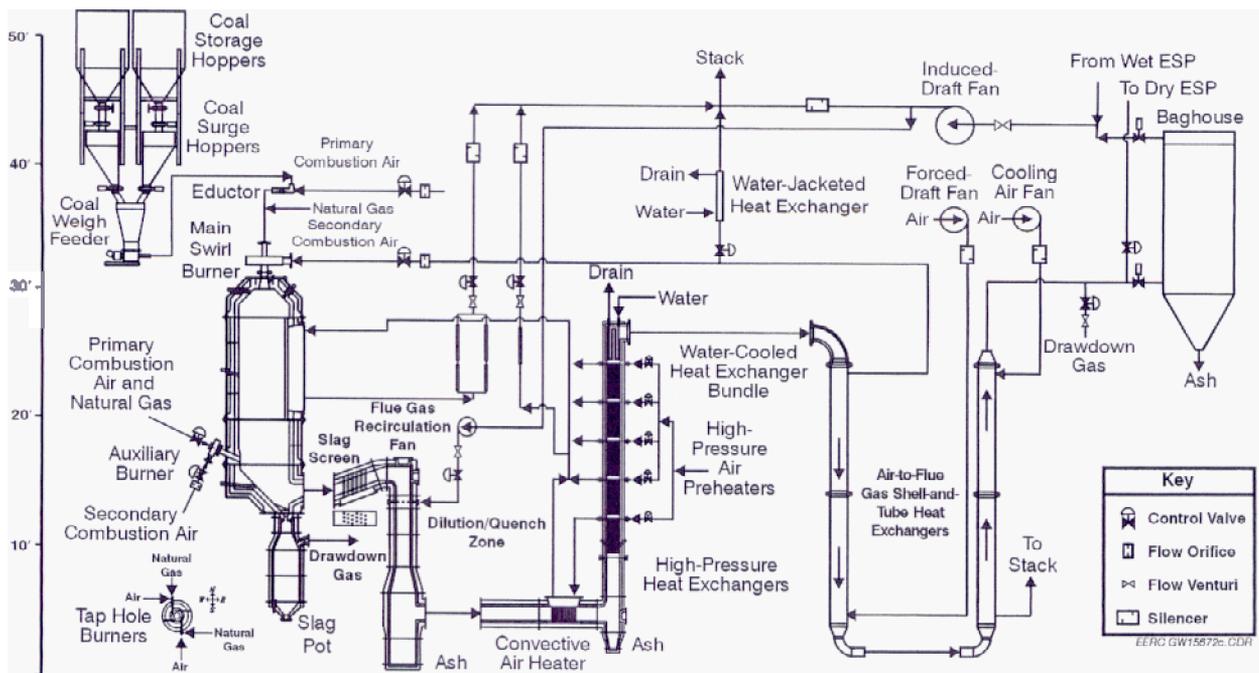
Figure 1. The EERC SFS.

Figure 1 is a simplified illustration of the SFS. It was constructed with funding from the DOE Combustion 2000 Program through a subcontract to the United Technologies Research Center to support testing and development of subsystems to be used in a high-temperature advanced furnace. The illustration consists of eight main components: 1) slagging furnace, 2) slag screen/slag tap, 3) dilution-quench zone, 4) process air preheaters, 5) convective air heater (CAH) section, 6) radiant air heater (RAH) panel, 7) tube-and-shell heat exchangers, and 8) pulse-jet baghouse. The SFS design is intended to be as fuel-flexible as possible, with maximum furnace exit temperatures of 1480° to 1590°C to maintain the desired heat transfer to the RAH panel and slag flow. The furnace has a nominal firing rate of 2.6×10^6 kJ/hr and a range of 2.1 to 3.2×10^6 kJ/hr using a single burner. The furnace design was based on Illinois No. 6

bituminous coal (25,800 kJ/kg) and a nominal furnace residence time of 3.5 s. The EERC oriented the furnace vertically (downfired) so that slag would not interfere with the operation of the burner. Internal dimensions are 119 cm in diameter by roughly 4.9 m in total length. The SFS is lined with three layers of refractory totaling 30 cm thick to minimize heat loss. This insulation keeps the wall surface temperature near that of the gas stream. The inner layer is composed of an alumina castable, developed by the EERC in cooperation with the Plibrico Company, that has been shown in bench and pilot tests to be extremely resistant to slag corrosion at high wall temperatures.

Material sample coupons can be inserted into the system through ports in the main combustor, in the slag screen, or on racks in the convective pass downstream of the CAH. Most samples were included downstream of the CAH. Near that subsystem, gas temperatures are maintained at 980°C, but they drop farther back in the system to approximately 175°C as the gas enters the exit stack. To be included in SFS tests, materials coupons should be no more than 5 cm wide and able to be slipped onto a 1.2-cm-thick Inconel support rod.

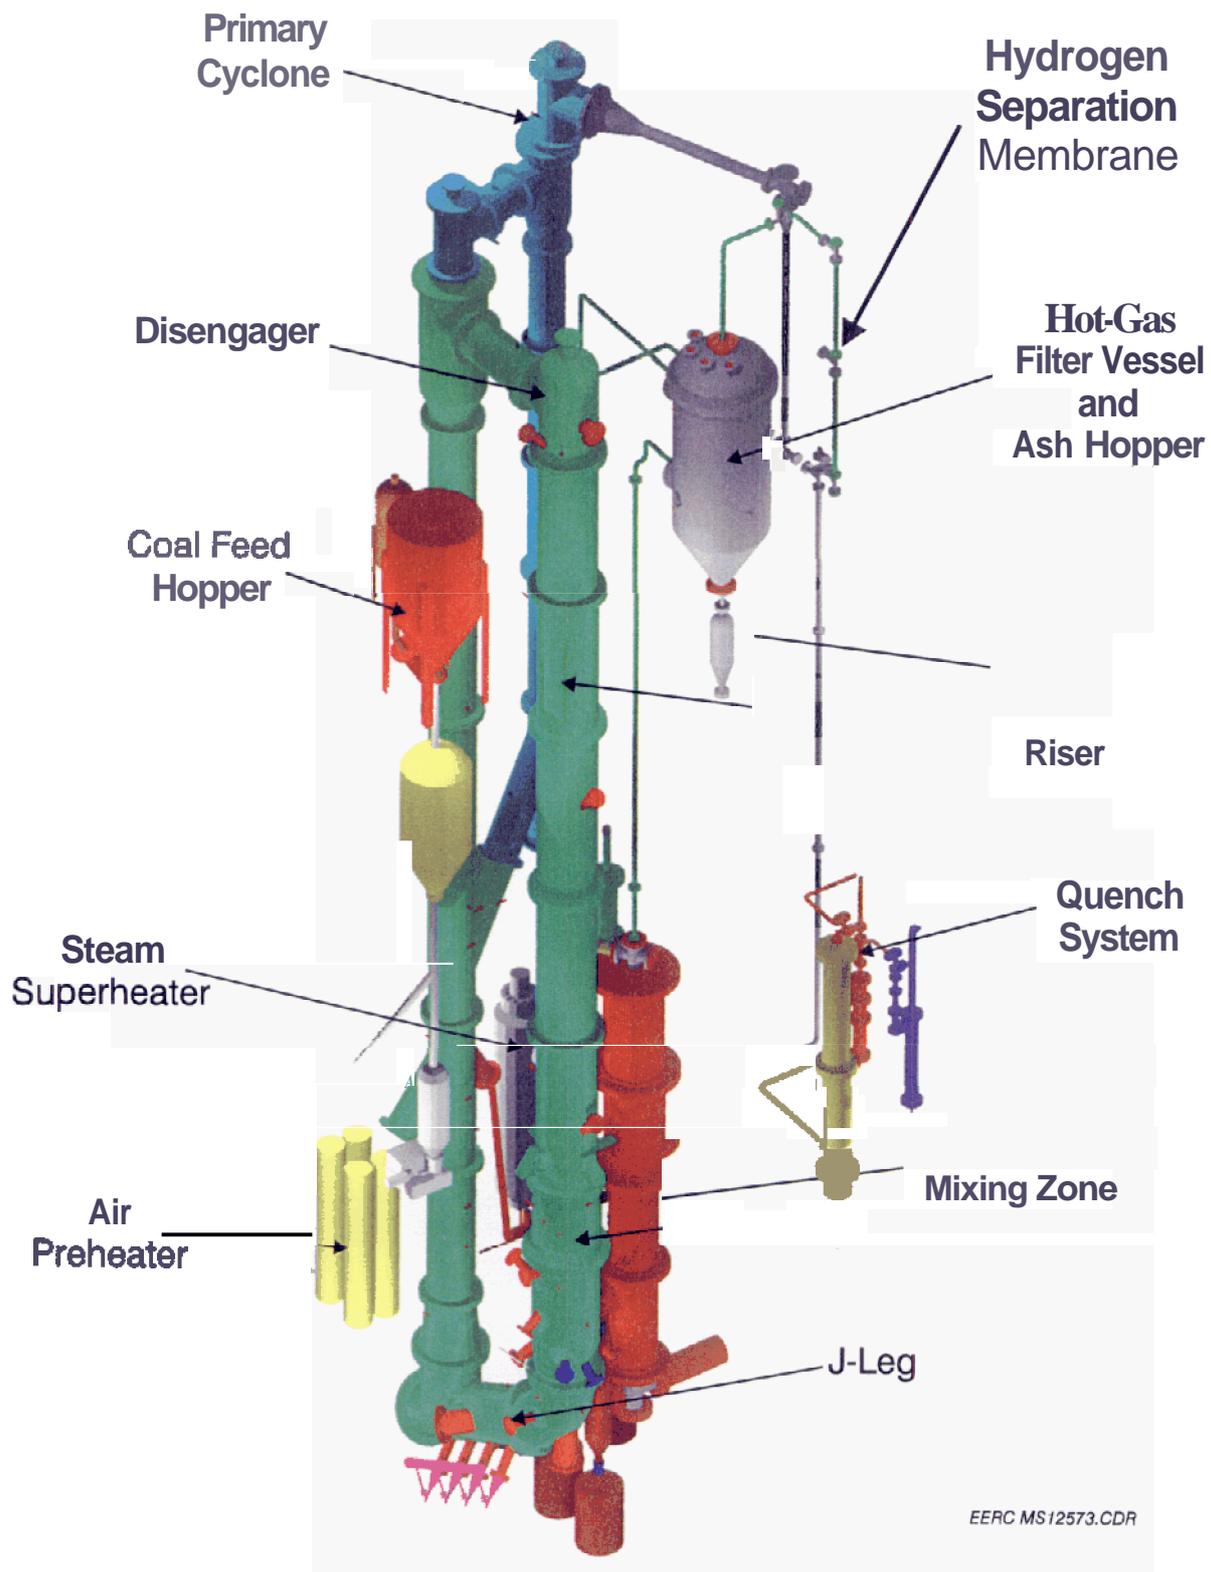
Figure 2. TRDU and HGFV in the EERC gasification tower.

In addition to exposure to combustion conditions in the SFS, material coupons can also be exposed to gasification gas and dust in the hot-gas filter vessel (HGFV) of the TRDU. The TRDU is a 2.6×10^6 -kJ/hr pressurized circulating fluid-bed gasifier similar to the gasifier being tested at the Southern Company Services Wilsonville, Alabama, facility. The system is illustrated in Figure 2. It has an exit gas temperature of up to 980°C, a nominal gas flow rate of 5×10^3 m³/hr, and an operating pressure of 0.93–1.1 MPa. The TRDU system can be divided into three sections: the coal feed section, the TRDU, and the product recovery section. The TRDU proper consists of a riser reactor with an expanded mixing zone at the bottom, a disengager, and a primary cyclone and standpipe. All of the components in the system are refractory-lined and designed mechanically for 1.1 MPa and an internal temperature of 1090°C.

The premixed coal and limestone fed to the transport reactor can be admitted through one of three nozzles that are at varying elevations. Oxidant is fed to the reactor through two pairs of nozzles at varying elevations within the mixing zone. For the combustion mode of operation, additional nozzles are provided in the riser for feeding secondary air. Hot solids from the standpipe are circulated into the mixing zone, where they come into contact with the oxidant and the steam, which is injected into the J-leg. This feature enables spent char to contact oxidant and steam prior to the fresh coal feed. Gasification or combustion and desulfurization reactions are carried out in the riser, as coal, sorbent, and oxidant (with steam for gasification) flow up the riser. The solids circulation into the mixing zone is controlled by the solids level in the standpipe. The bulk of entrained solids leaving the riser is separated from the gas stream in the disengager and circulated back to the riser via the standpipe. A solids stream is withdrawn from the standpipe via an auger to maintain the system's solids inventory at an appropriate level. Gas exiting the disengager enters a primary cyclone that has been modified to provide variable particulate collection performance. Solids from the dipleg of the primary cyclone are collected in a lock hopper. Gas exiting this cyclone enters a jacketed-pipe heat exchanger before entering the

HGFV at approximately 930°C. The cleaned gases leaving the HGFV enter a quench system before being depressurized and vented to a flare.

This vessel is designed to handle all of the gas flow from the TRDU at its expected operating conditions. The vessel is approximately 1.2 m inner diameter (i.d.) and 4.7 m long and is designed to handle gas flows of approximately 550 m³/hr at temperatures up to 980°C and 0.99 MPa. The refractory has a 0.71-m i.d. with a shroud diameter of approximately 0.56 m. The vessel is sized such that it could handle candle filters up to 1.5 m long; however, 1.0-m candles are being used in the initial 540°C gasification tests. Candle filters are 60 mm outer diameter with 10-cm center-to-center line spacing. The total number of candles that can be mounted in the current geometry of the HGFV tube sheet is 19.

Standard TRDU tests consist of 200 hours of operation under gasification conditions with the HGFV operating at temperatures of 540°–650°C, 0.93 MPa. Material coupons are exposed in the system by sliding them over 1.3-cm-diameter stainless steel rods in the free space below the candle filters. Samples up to 5.1 cm wide can be included. The composition of the gas to which the material coupons would be exposed in the HGFV is approximately 8%–14% H₂O, 6%–9% each of CO and H₂, 8%–10% CO₂, and 1.0%–2.5% CH₄, with the balance being N₂ and other trace constituents.

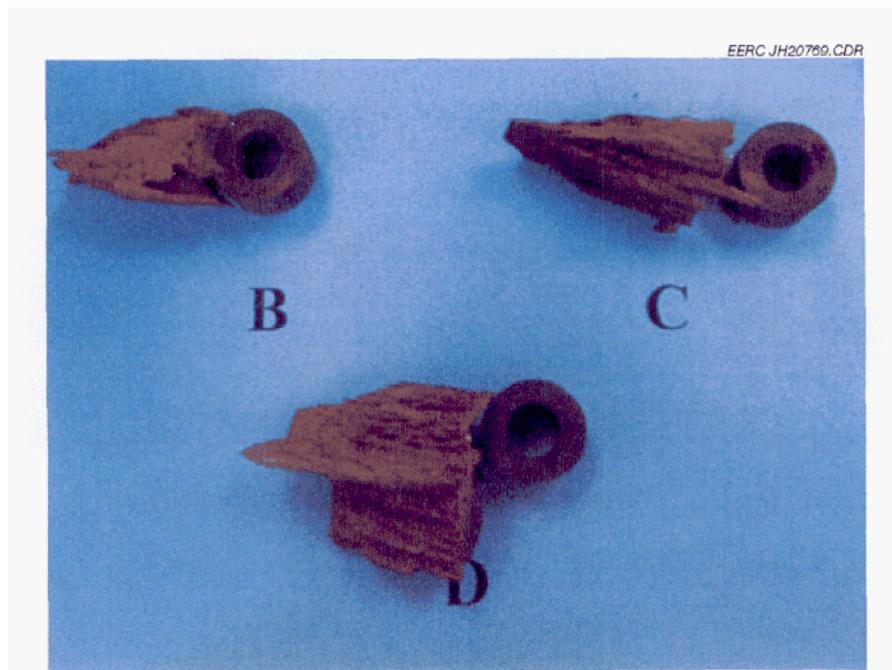
Figure 3. ORNL Cr-Ta coupons after removal from the SFS.

Figure 3 shows the sample removed from the sample holder downstream of the CAH after the November 2001 test run. Flue gas flow across the alloy was from left to right. The ash deposit was easily removed from the alloy, leaving a thin coating of ash. What could be seen of the alloy surface was no longer shiny; it appeared dull dark gray and brown, with no flaking.

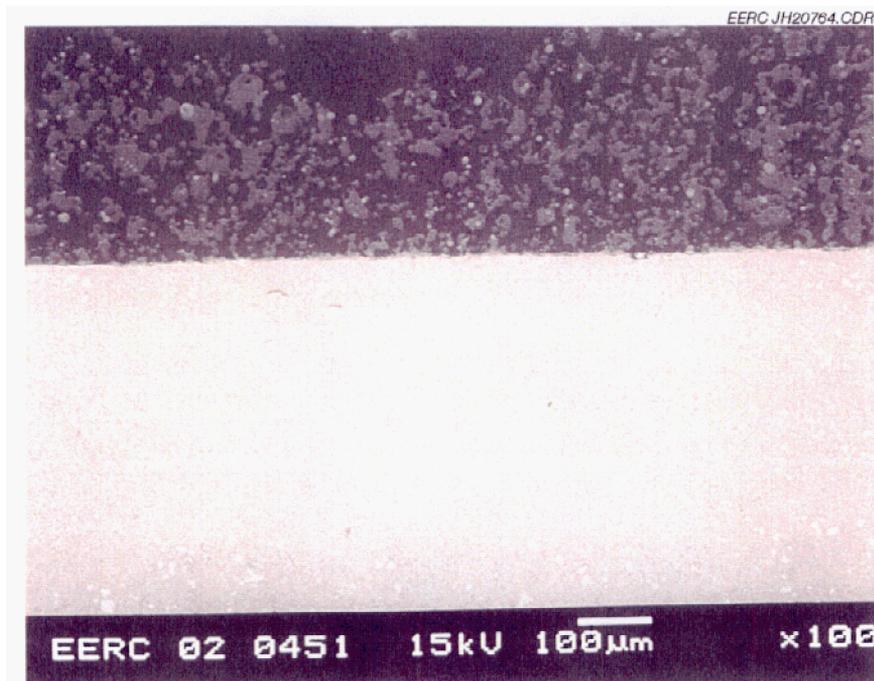
Figure 4. Example of cross-sectioned alloy, corrosion product, and ash deposit at 100x magnification (ORNL Cr-Ta Coupon C).

The alloy was reported to contain 82.75 wt% Cr, 9 wt% Ta, 5 wt% Mo, 3 wt% Si, 0.15 wt% La, and 0.1 wt% Ti. Figure 4 shows a representative example of the cross-sectioned coupon, corrosion product, and ash deposit at 100x magnification. It reveals a dual-phase field of alloy, a typical corrosive intrusion into the sample, and the thin discontinuous oxide layer coating the sample with ash above. A few large cracks were observed, which generally run parallel to the surface of the alloy, were randomly distributed about the sample, and extended several millimeters into the alloy.

The alloy was composed of essentially a chromium matrix reinforced with a Cr-Ta intermetallic phase. A spot analysis of the matrix gave a composition of approximately 92 wt% Cr, 7 wt% Mo, 1 wt% Si, with an intermetallic composition of approximately 47 wt% Ta, 34 wt% Cr, 15 wt% Si, and 4 wt% Mo. The alloy near the surface appeared to be altered. The matrix was slightly enriched in molybdenum, silicon content doubled, and tantalum showed a fourfold increase below the oxide layer. In the same region, the intermetallic phase had a slight reduction in silicon, reduction by half of tantalum, and a threefold increase in molybdenum. Fine porosity was observed to a depth of approximately 15–20 μm . The diameter of the pores was less than 2 μm .

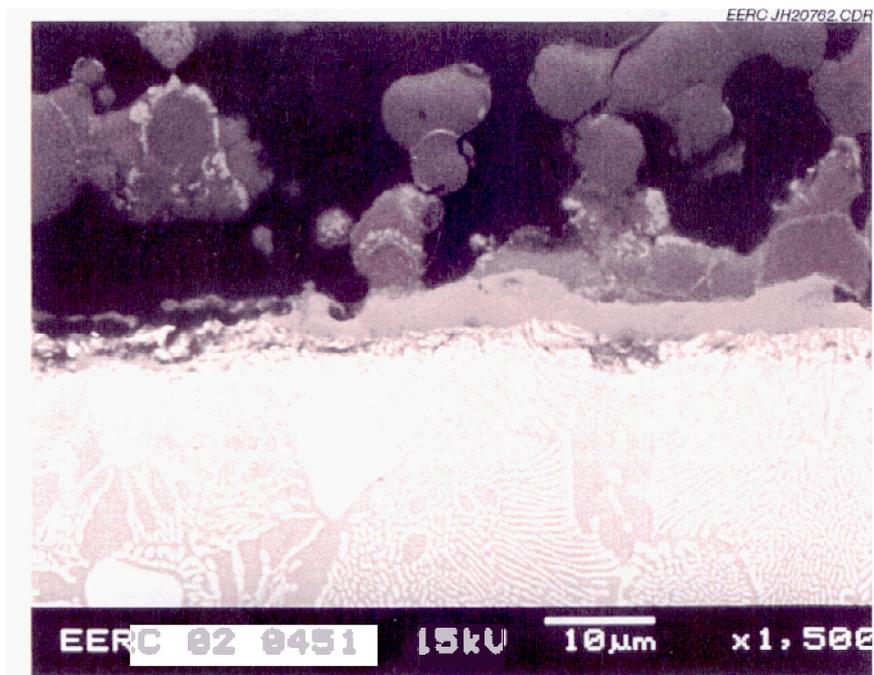
Figure 5. Sample surface at 1500x magnification (ORNL Cr-Ta Coupon C).

Figure 5 illustrates the discontinuous oxide layer with ash deposit attached at 1500x magnification. This figure also clearly shows the Cr-Ta intermetallic phase in a chromium matrix previously discussed. The oxide layer is essentially chromium oxide, which ranges from 2–4 μm in thickness, where present. The layer is enriched with silicon and tantalum at the alloy interface, but tantalum was not detected at the layer surface. However, near the surface, iron, calcium, and aluminum were detected, indicating that the oxide layer reacted with the ash. Chromium was detected in the ash material above the oxide layer in amounts as high as 13 wt%. The alloy surface, both covered with chromium oxide and uncovered, had a 2- μm -thick zone that was highly porous and broken. The corrosion mechanism appeared to be oxidation. Sulfidation, halide attack, or ash constituent interaction directly with the alloy was not detected.

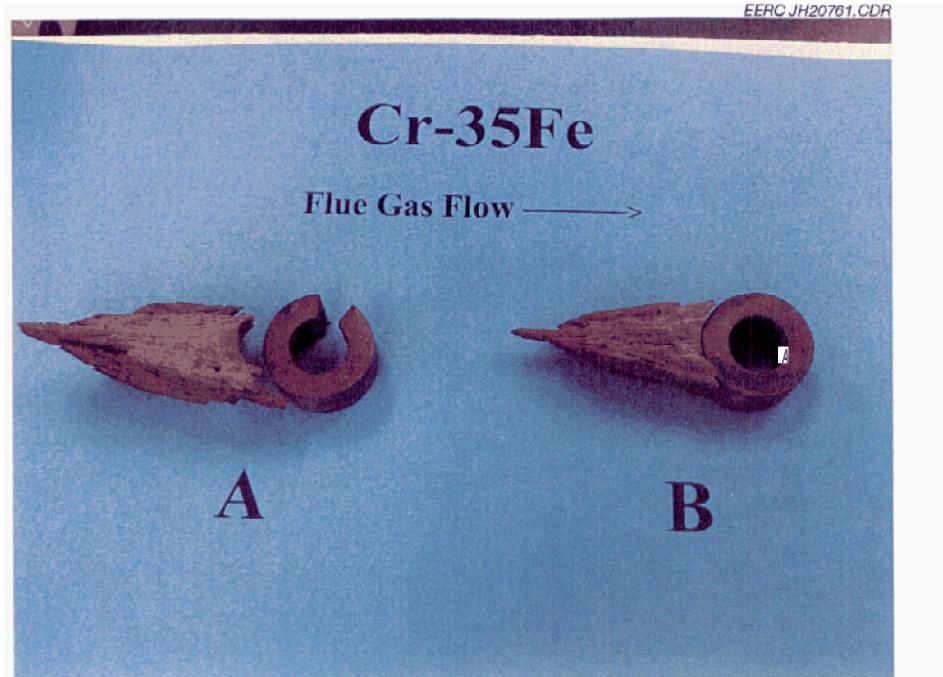
Figure 6. ORNL Cr35-Fe coupons after removal from the SFS.

Figure 6 shows the samples removed from the sample holder downstream of the CAH after the November 2001 test run. Flue gas flow across the alloy was from left to right. The ash deposit separated easily from the alloy, leaving a thin coating of ash. The surface of the alloy was no longer shiny and appeared dark gray to brown, with no indications of flaking.

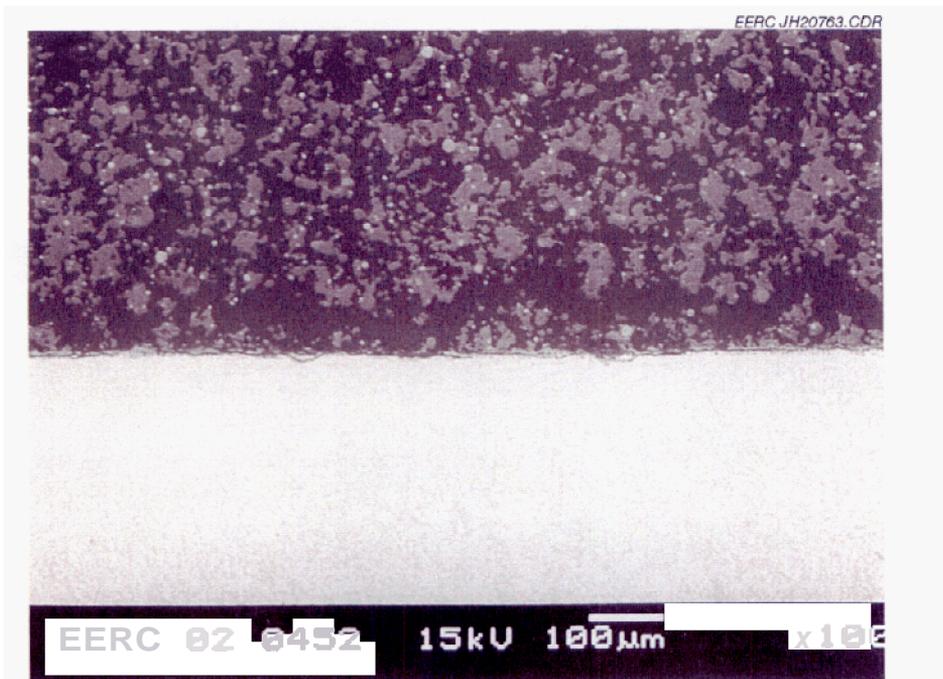
Figure 7. Cross section of alloy showing corrosion and ash deposit at 100x (ORNL Cr35-Fe Coupon A).

The reported composition of this alloy was 54.5 wt% Cr, 35 wt% Fe, 5.5 wt% Ta, 4 wt% Mo, 0.5 wt% Ti, and 0.3 wt% Si. A representative example of the cross-sectioned coupon at 100x magnification is shown in Figure 7. It reveals a dual-phase field of alloy, a typical corrosive intrusion into the sample, and the thin discontinuous poorly attached oxide layer coating the sample with ash above. Many areas showed the beginning of pit formation, and none was observed deeper than 10 µm.

The matrix of the alloy was analyzed as having a composition of 62 wt% Cr, 34 wt% Fe, and 4 wt% Mo. Silicon and tantalum were found in trace amounts. The intermetallic phase was found to have a composition of 44 wt% Ta, 24 wt% Fe, 15 wt% Cr, 13 wt% Si, and 4 wt% Mo. Near the surface matrix, enrichment of iron, tantalum, molybdenum, and silicon was measured. Iron enrichment was only 6 wt% on average whereas the molybdenum content doubled, silicon had a threefold increase, and tantalum was found to have a fivefold increase, Chromium content decreased by 20 wt%. The intermetallic phase near the surface was measured to have a decrease by half of chromium, tantalum, and silicon, with only a slight increase in molybdenum.

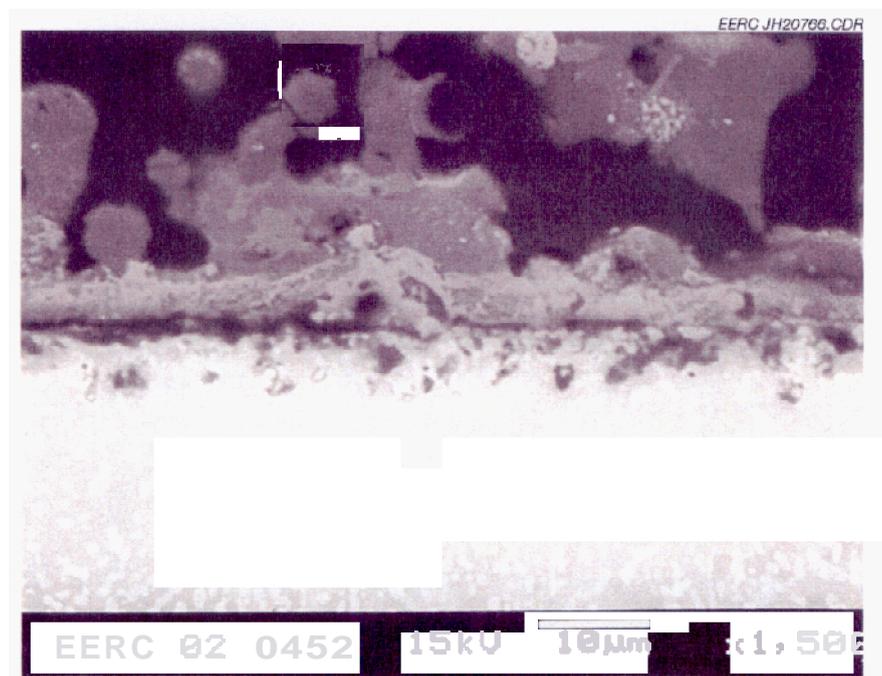
Figure 8. Sample surface at 1500x magnification (ORNL Cr35–Fe Coupon A).

The oxide layer was found to be chromium oxide with a few percent iron and silicon. Thickness was fairly uniform, where present, and was measured to be 5–7 μm thick. The top 5 μm of alloy at the oxide interface was highly porous and broken. Figure 8 illustrates the oxide layer, porous alloy, and ash at a magnification of 1500x. The oxide layer was found to have reacted significantly with the ash. The iron content of the oxide layer was greatest at the metal interface and the ash contact zone. Aluminum was measured at 2–3 wt% throughout the oxide layer. Chromium from the alloy was detected in the ash layer at approximately 2 wt%. Like the previous sample, oxidation was found to be the corrosion mechanism. Sulfidation, halide attack, or ash constituent interaction directly with the alloy was not detected.

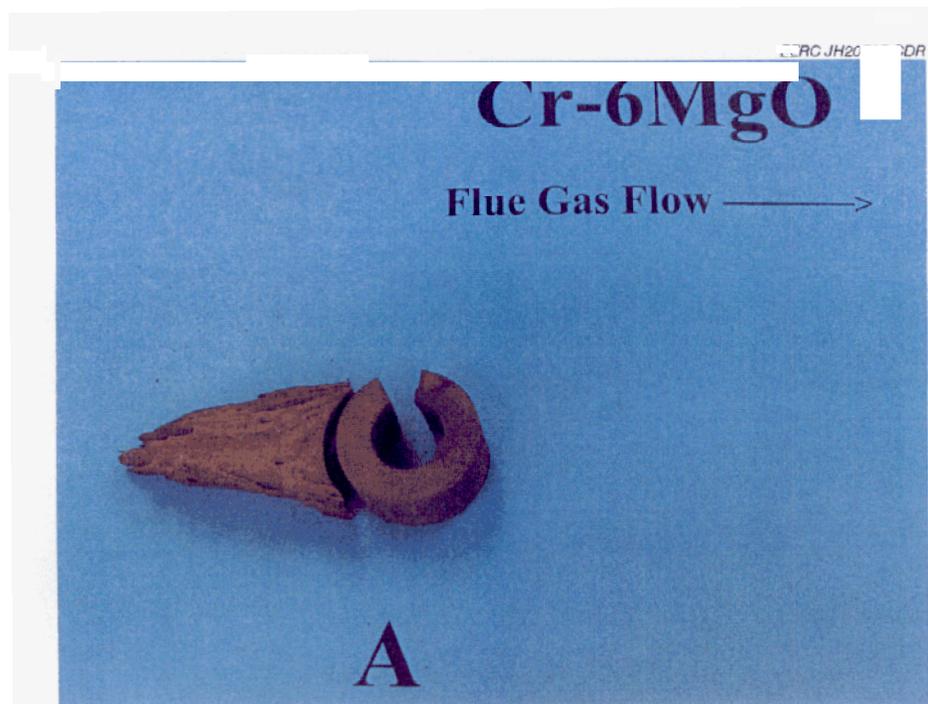
Figure 9. ORNL Cr6-MgO coupon after removal from the SFS.

Figure 9 shows the sample removed from the holder downstream of the CAH after the November 2001 test run. Flue gas flow across the alloy was from left to right. As with the other two samples, the ash deposit was easily separated from the alloy, leaving a thin layer of ash. The alloy surface was no longer shiny. Instead, it appeared dull dark gray to brown, with no visible degradation or flaking of the surface.

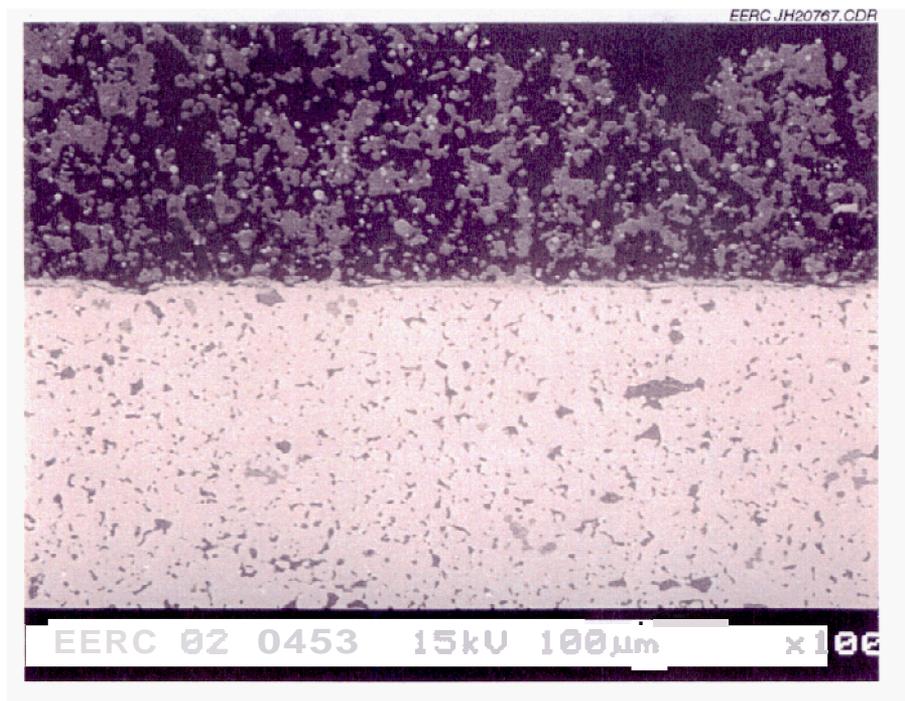
Figure 10. Cross section of alloy at 100x magnification (ORNL Cr6–MgO Coupon A).

Figure 10 shows a typical example of the cross-sectioned coupon at 100x. It reveals a triphase field of alloy, typical corrosion, a discontinuous oxide layer, and the ash above. The reported alloy composition was 93.2wt% Cr, 6 wt% MgO, 0.5 wt% Ti, and 0.3 wt% La₂O₃. Indications of pitting directly under the oxide layer were noted but no evidence of cracking was observed.

The alloy is composed of a chromium matrix with a La-rich phase and a Mg-rich phase. The La-rich phase was analyzed and found to contain 63 wt% La, 22 wt% Ti, 13 wt% Cr, and 2 wt% Mg. The Mg-rich phase was found to contain 21 wt% Mg, 48 wt% Cr, and 31 wt% Ti. Near the surface of the alloy, the lanthanum could only be detected in trace amounts. The Mg-rich phase near the surface was found to lose all but a few percentage of titanium and chromium.

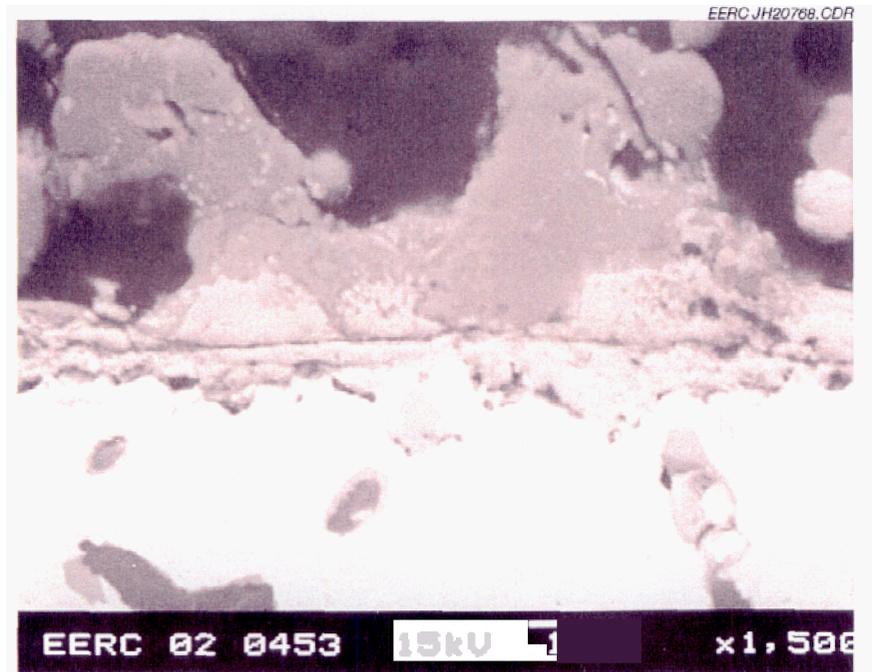
Figure 11. Alloy, oxide layer, and ash deposit at 1500x magnification (ORNL Cr6-MgO Coupon A).

The oxidation layer was irregular in thickness and broken in areas. An average thickness was measured to be 5 μm . The layer also appeared to be poorly attached to the alloy. Figure 11 shows an example of the oxide layer and ash on the alloy at a magnification of 1500x. Iron was found in the oxide layer grading from “not detected” at the alloy interface to as high as 8 wt% at the ash interface. Trace amounts of aluminum and silicon were also detected in the oxidation layer. Chromium was found as high as 5 wt% in the ash above the layer. The ash layer was well adhered to the oxide layer. Evidence of sulfidation or halide attack could not be detected. Oxidation appears to be the corrosion mechanism for this alloy as well, with some interaction of iron from the ash with the oxide layer and some dissolution of the chromia into the ash deposit. Sulfidation, halide attack, or ash constituent interaction directly with the alloy was not detected.
