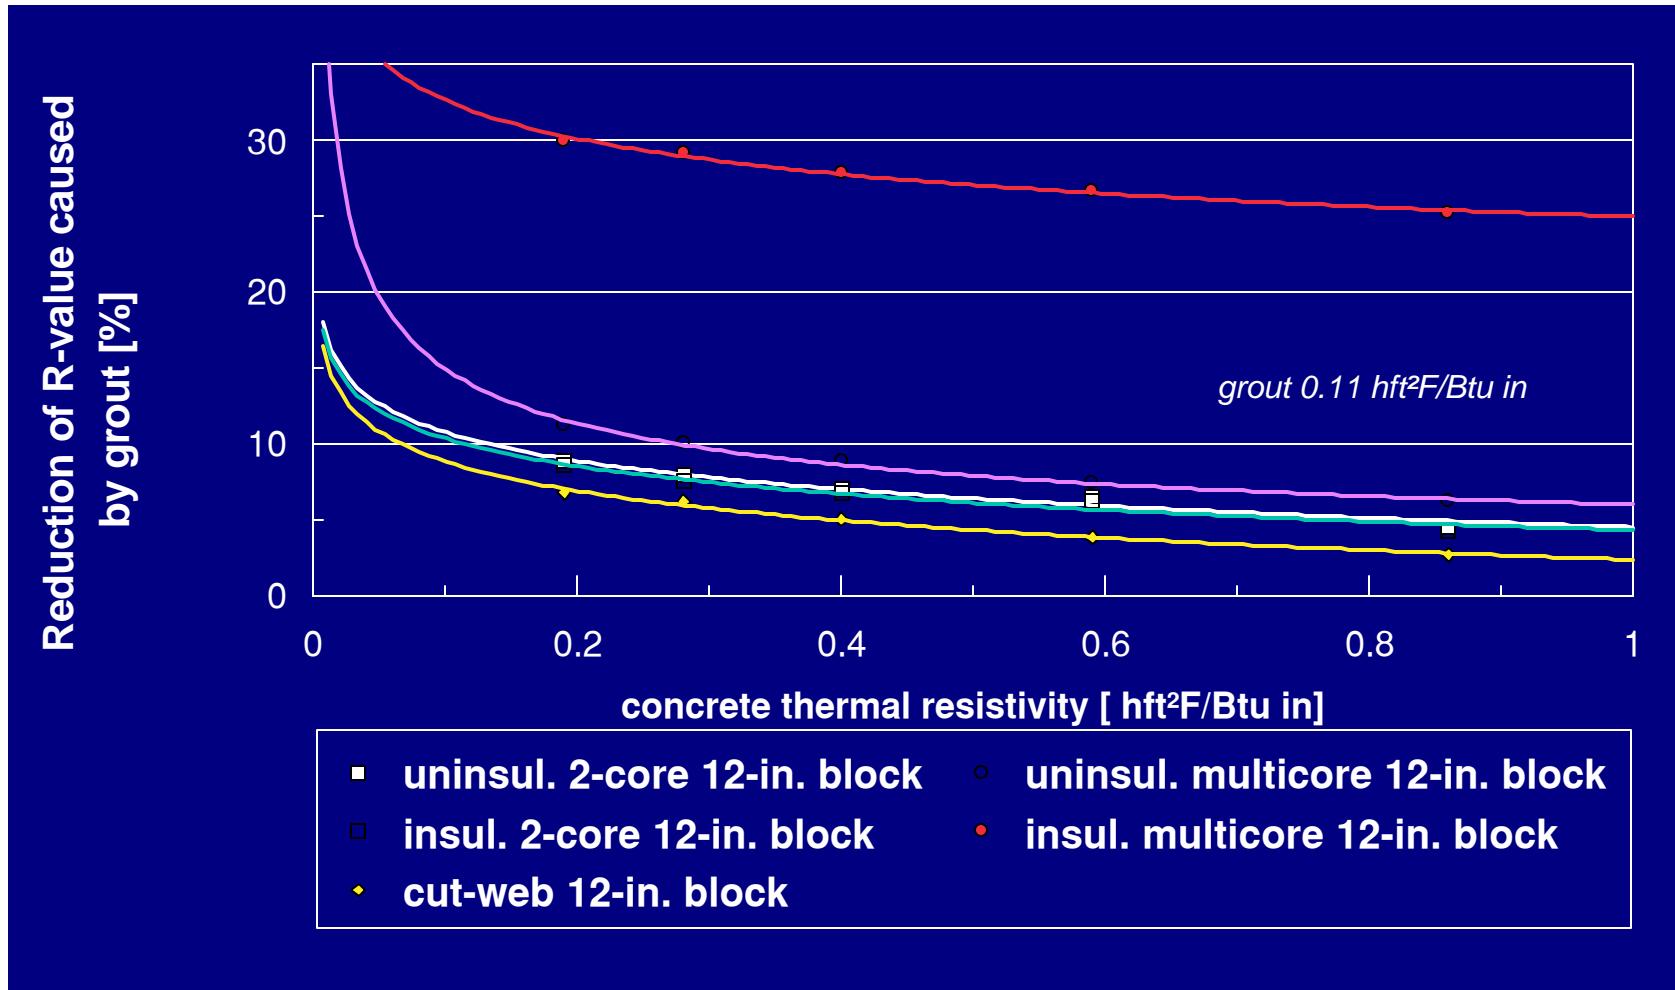
Fig.6. Reduction of masonry wall R-value caused by grout.
