Energy-Efficient, Flood-Damage-Resistive Residential Envelope Systems Testing

Robert Wendt,
Oak Ridge National Laboratory, Oak Ridge,
Tennessee.

Heshmat Aglan, PhD,
Tuskegee University, Tuskegee, Alabama.

Investigate impact of flood water on performance of traditional and flood-damage-resistant residential envelope systems.

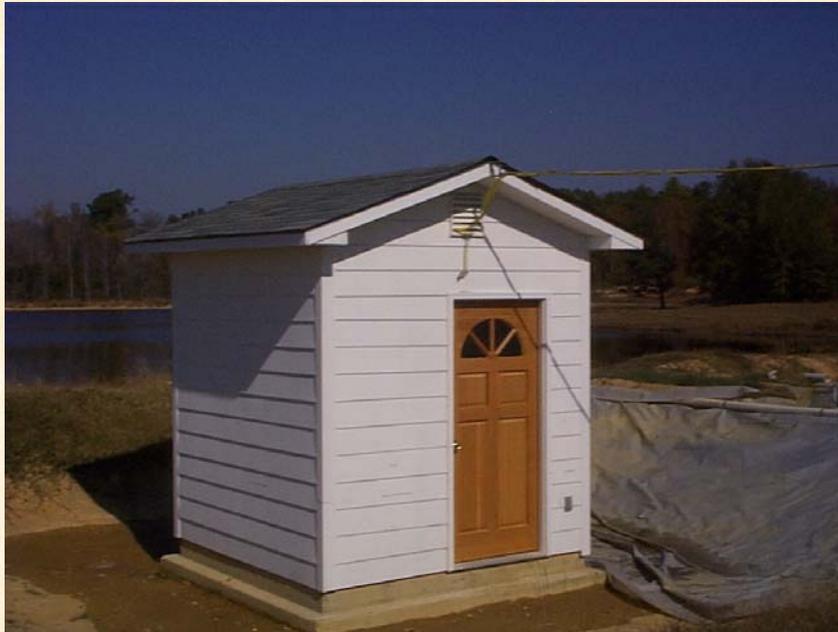
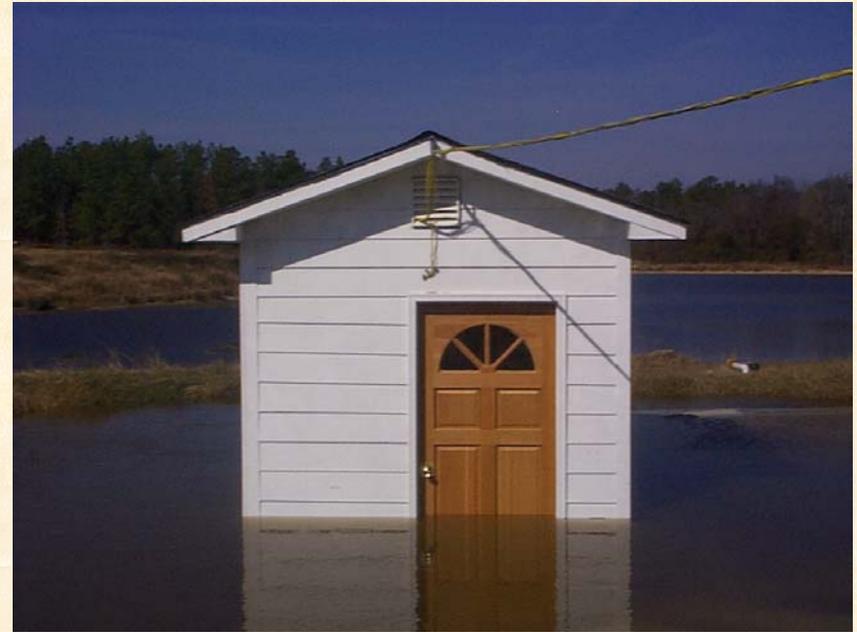
Slab on Grade Test Module

Before and After Flooding

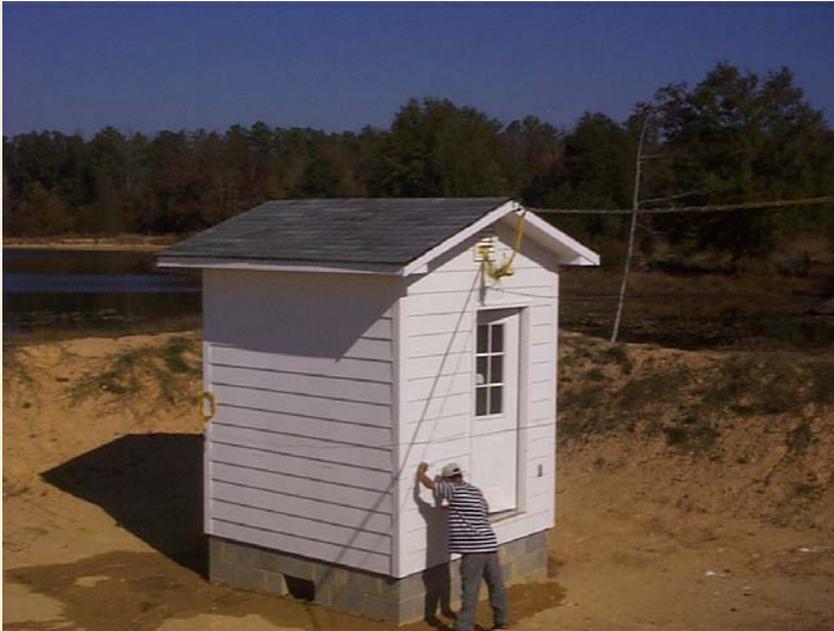
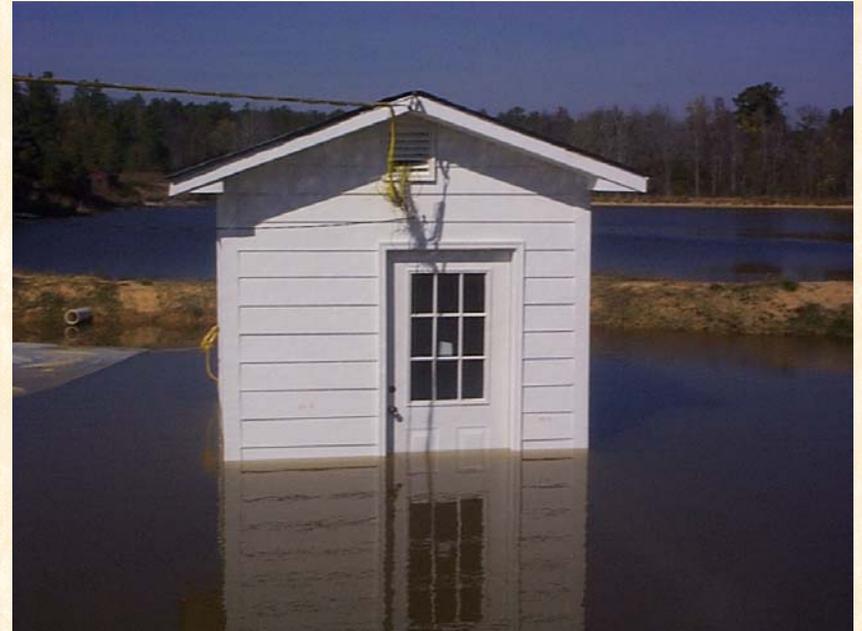
Crawl Space Test Module

Before and After Flooding

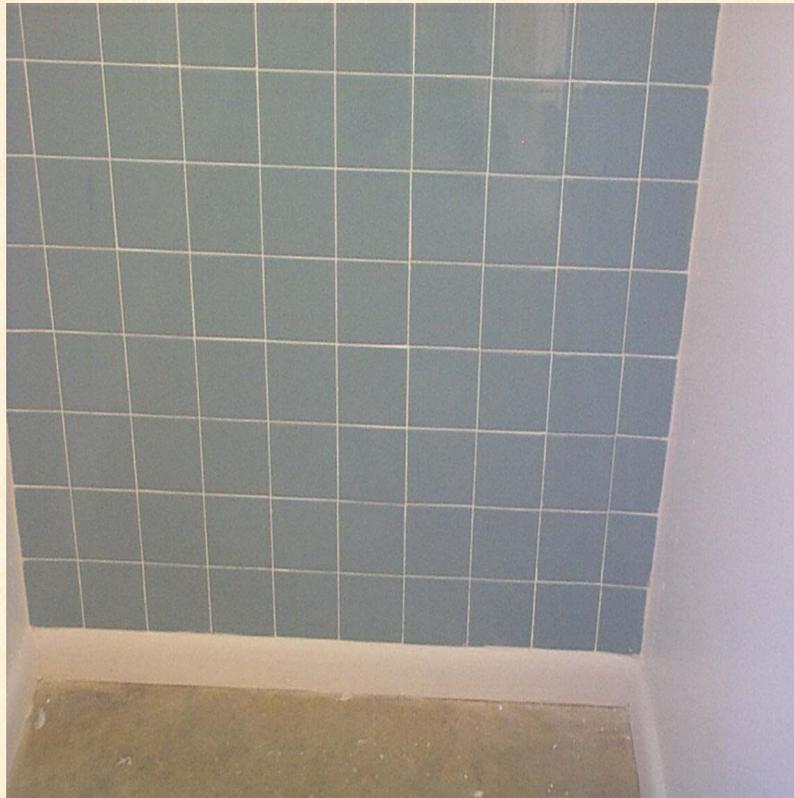
Wall 2 from Room S-102

Pre-flood

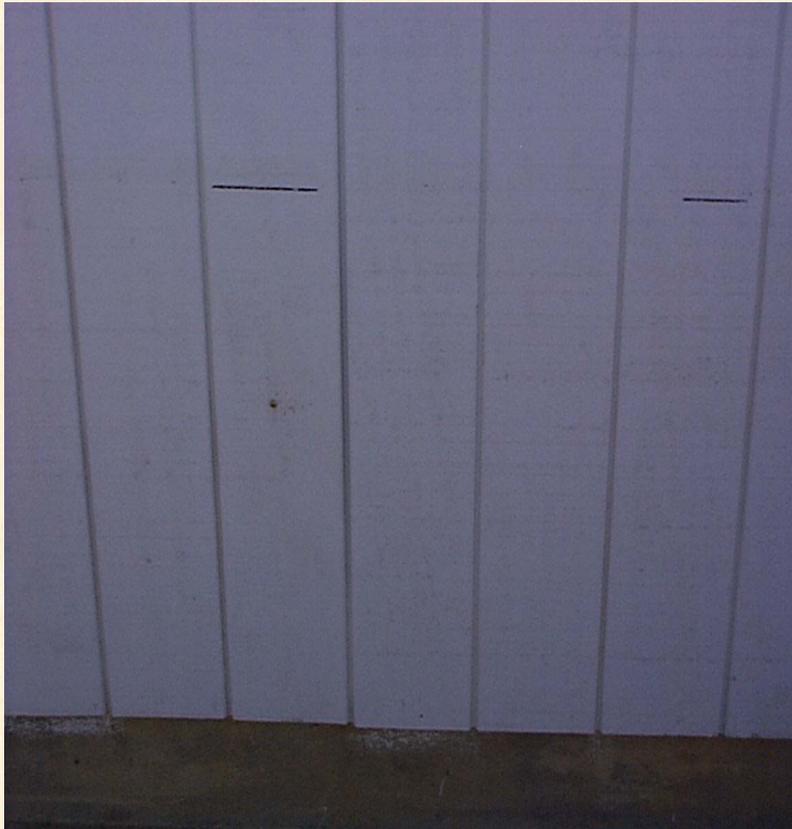
Exterior Wall 2

Post-flood (5 days before washing)

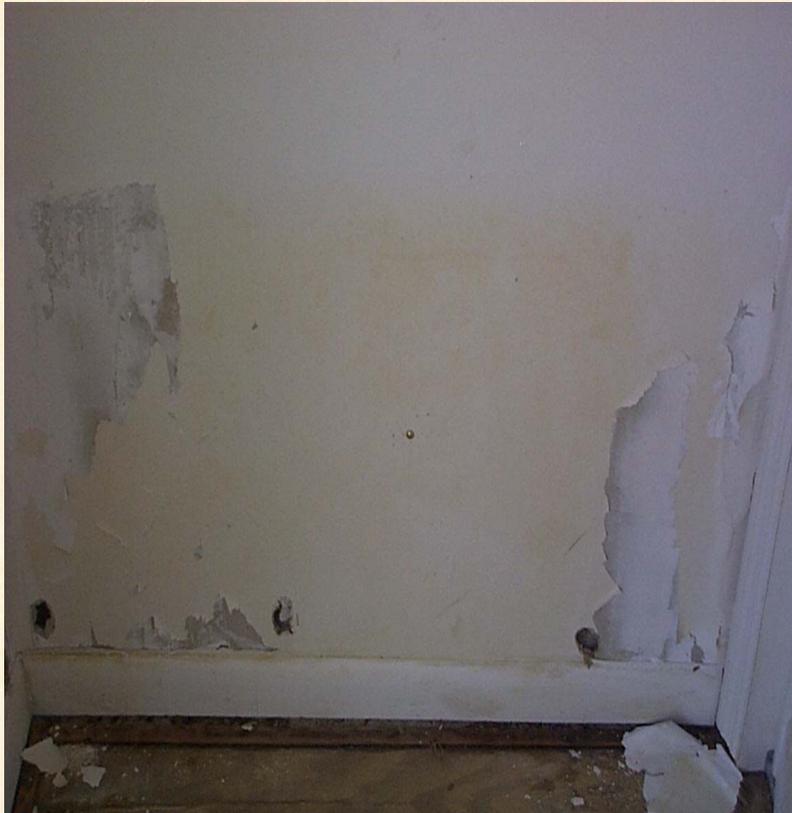
Wall 4 from Room C-101

Post-flood (12 days)

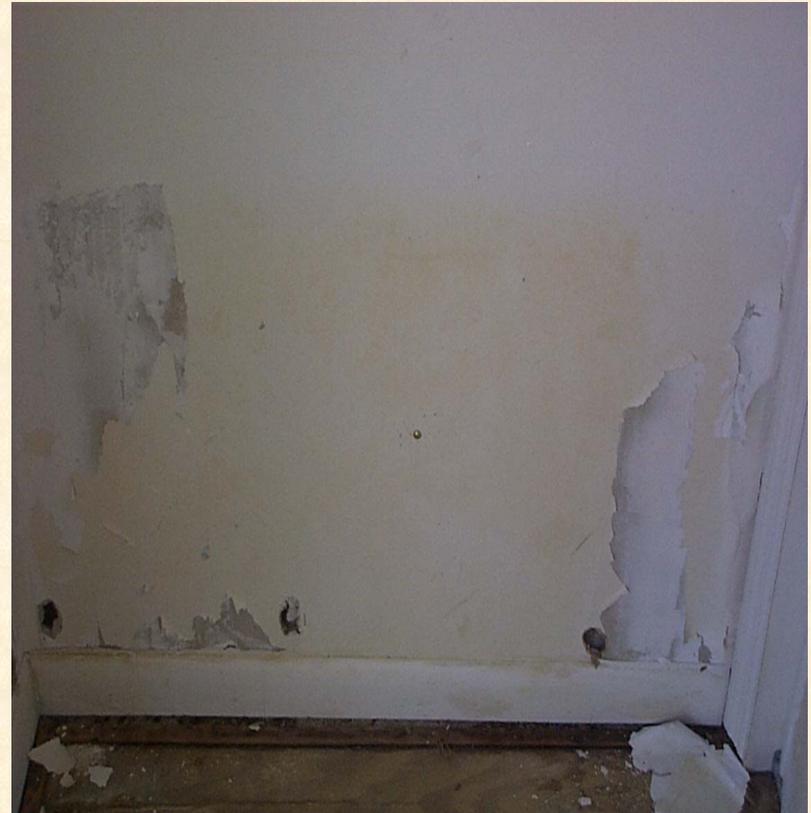
Post-flood (26 days)

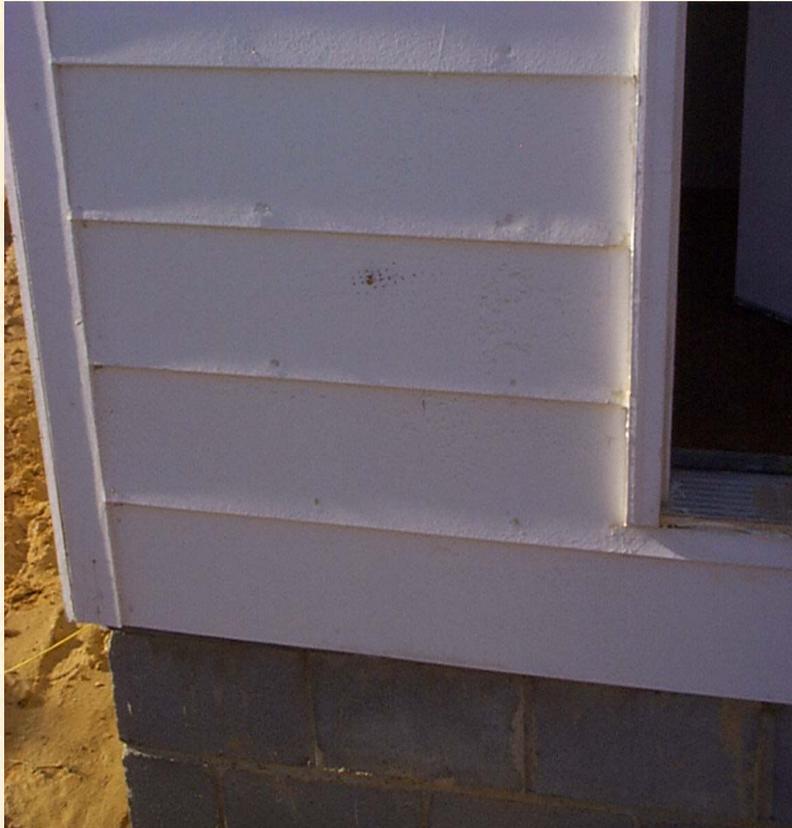
Exterior Wall 3

Post-flood (5 days – before washing)

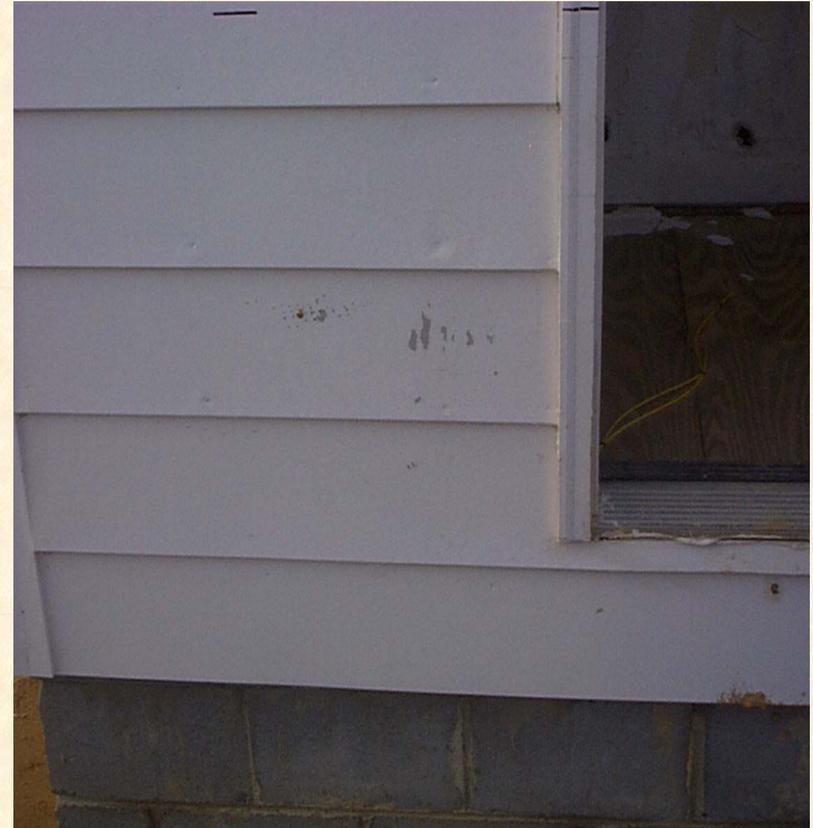
Post-flood (12 days)

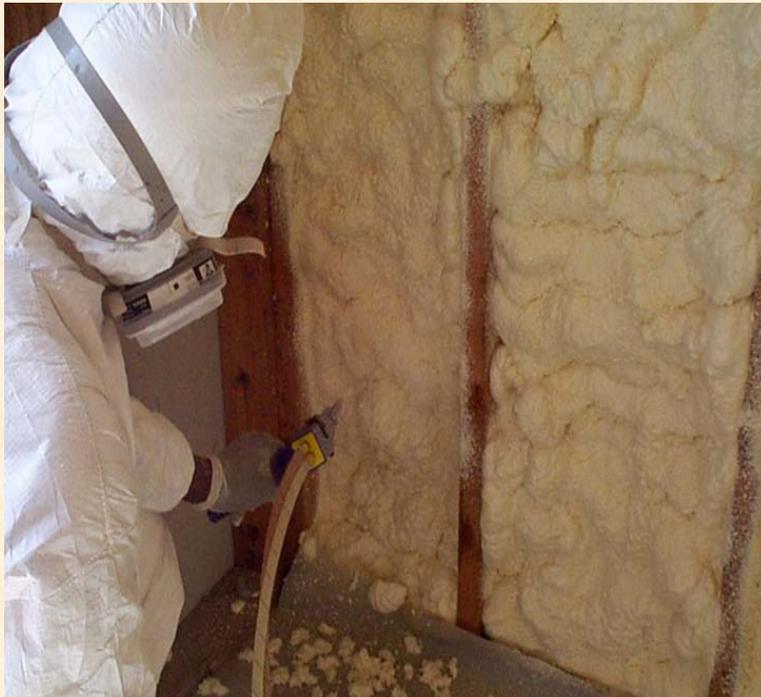
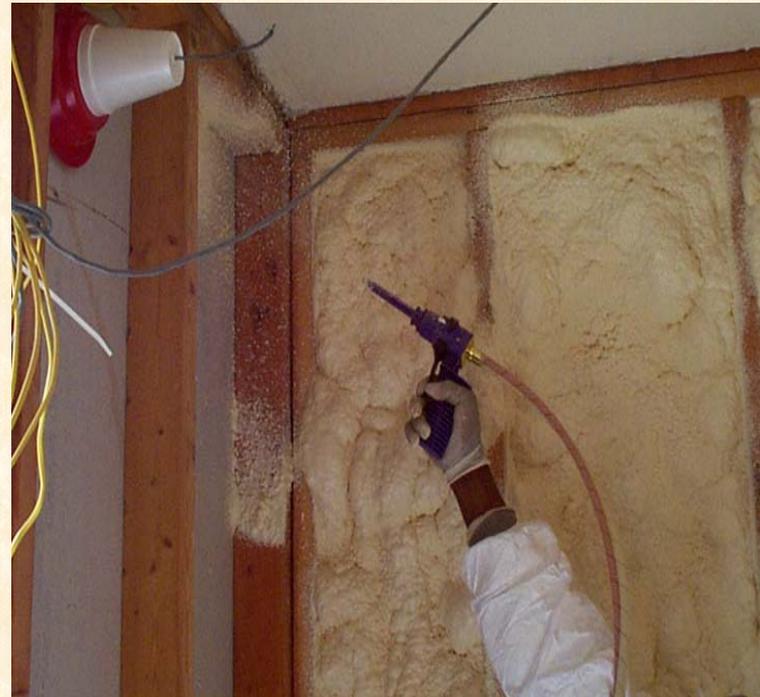
Spray Polyurethane Foam (SPUF) Insulation being installed

Energy Performance: SPUF, R-19; Fiberglass, R-11
