Flood-Damage Resistive Residential Envelope Systems

Ed Laatsch, FEMA

Robert Wendt, ORNL

The ORNL/Tuskegee Field Test

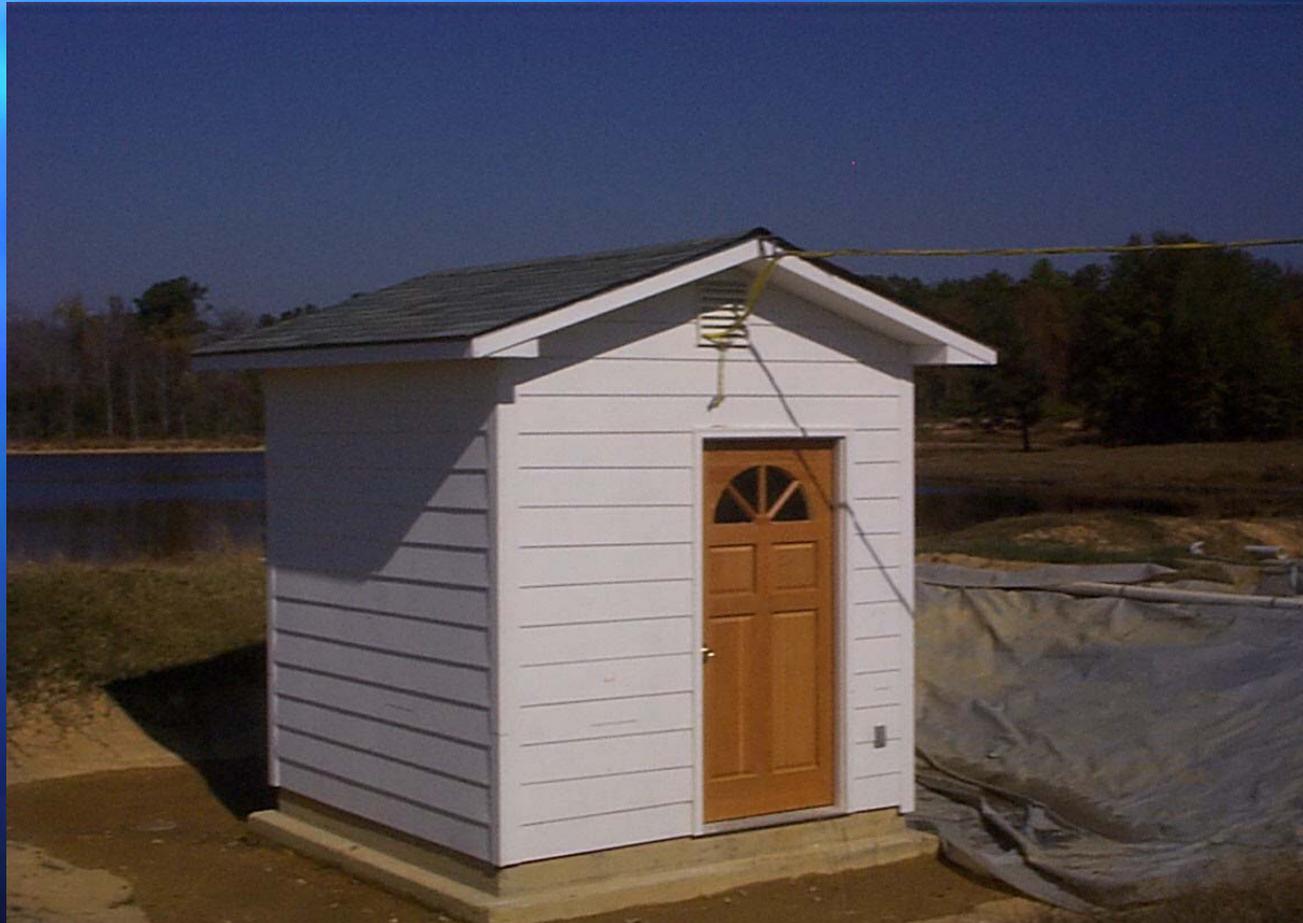
First Slab-On-Grade Module

- Siding - plywood and hardboard lap
- Sheathing - OSB and plywood
- Insulation - fiberglass batt, exterior walls
- Interior - gypsum board with paper joint tape
- Flooring - one room, carpet on pad and one room, concrete with sealer, no covering
- Interior Walls - one room, latex flat white and one room, latex enamel on 3 walls and ceramic tile on 4th wall

- Exterior door – solid wood, panel
- Interior door - hollow core interior grade
- Windows - double pane, aluminum
- Electrical - typical duplex electrical outlets and wiring installed above floor (below flood level)
- Ceiling - gypsum board, 2 coats interior latex paint
- Attic - wood framed, plywood roof decking
- Roofing - asphalt shingles

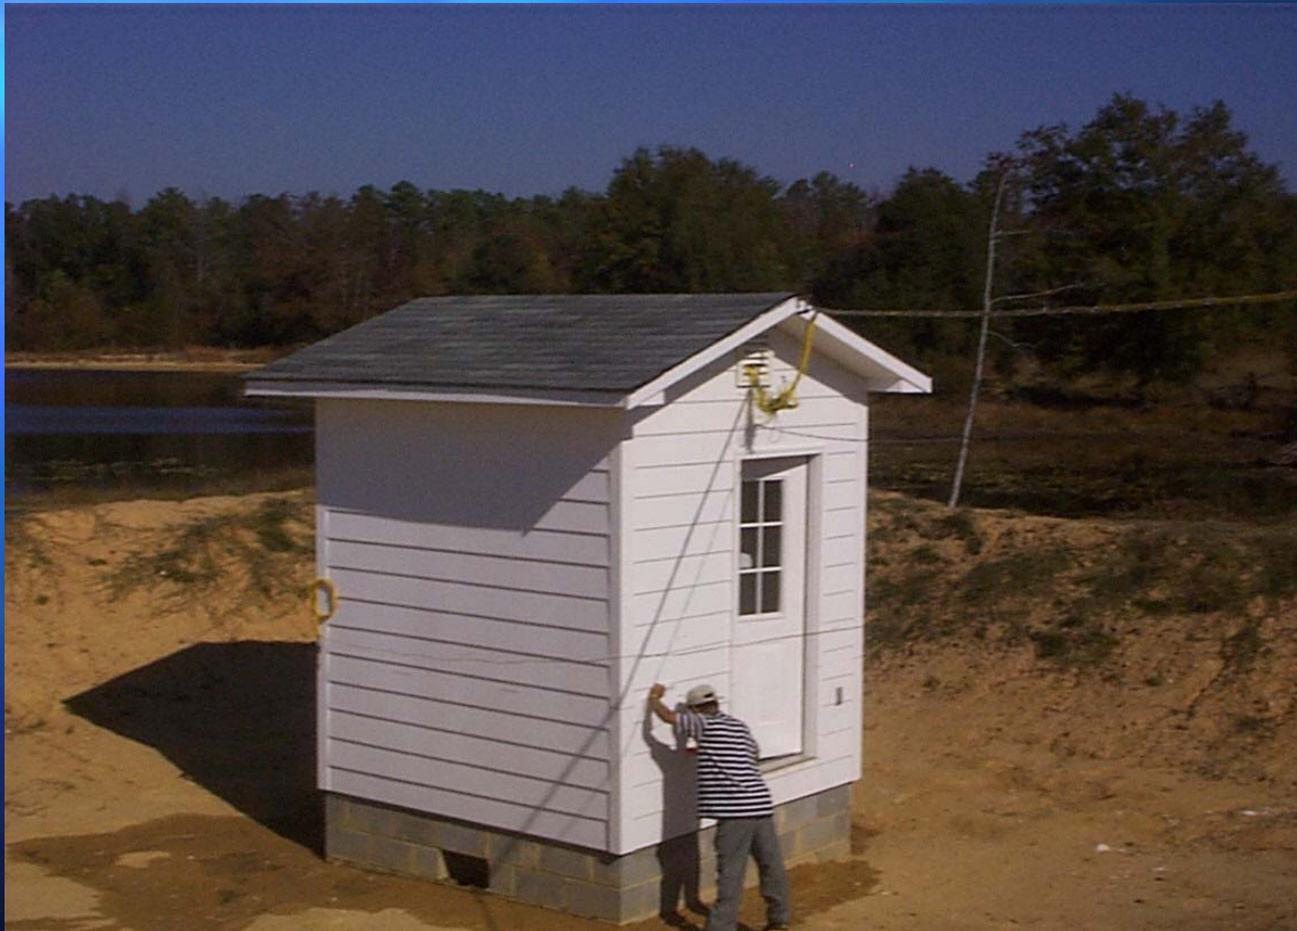
First Crawlspace Module

- Siding - plywood and hardboard lap
- Sheathing - OSB and plywood
- Insulation - fiberglass batt, exterior walls
- Interior - gypsum board with paper joint tape
- Floors - wood joists, plywood subfloor
- Flooring - one room, carpet on pad and one room, sheet vinyl
- Interior Walls - one room, latex flat white and one room, vinyl wall covering on two walls, white latex enamel on two walls

- Exterior door - steel w/ ½ light
- Interior door - hollow core
- Windows - double pane, aluminum
- Electrical - typical duplex electrical outlets and wiring installed above floor (below flood level)
- Ceiling - gypsum board, 2 coats interior latex paint
- Attic - wood framed, plywood roof decking
- Roofing - asphalt shingles

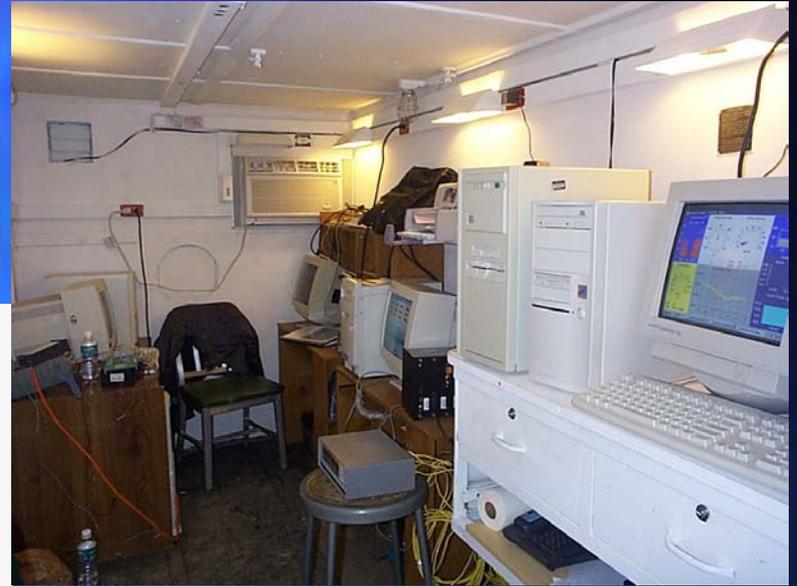
Instrumentation

- RH
- Temperature
- Moisture

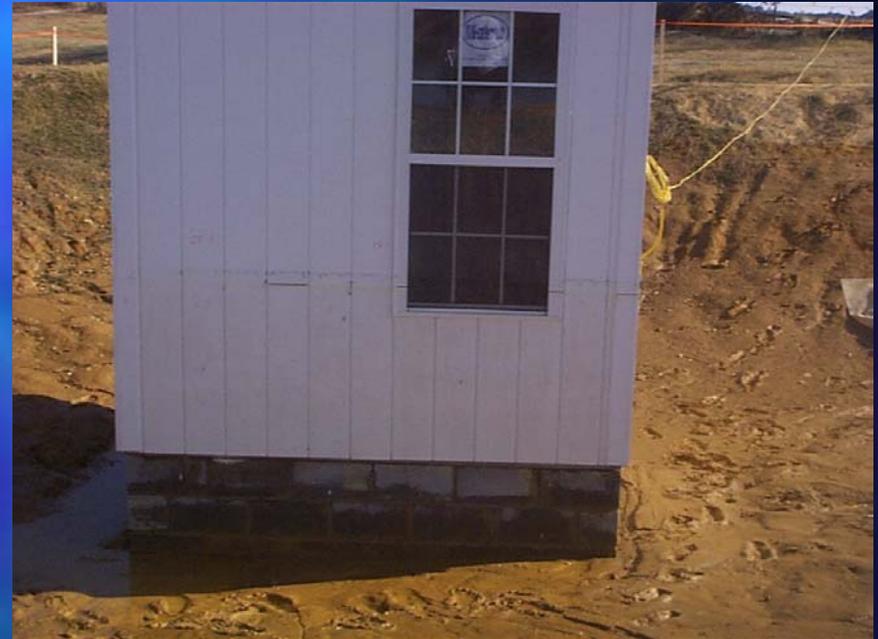
- Exterior walls were stained below flood level
- Plywood siding was warped
- Hardboard siding was OK
- Cracks in wood corner trim boards
- Exterior door was stained and more difficult to open

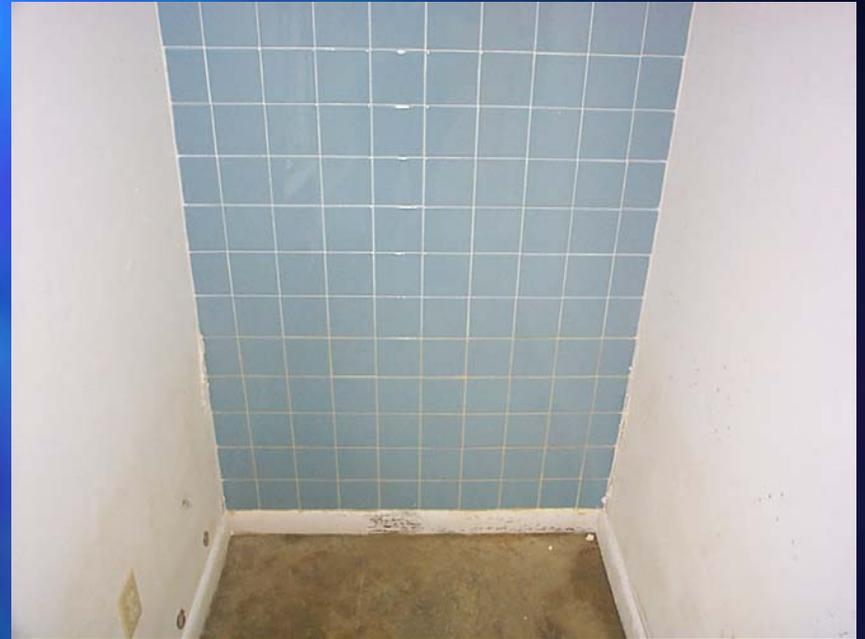
- Strong musty smell
- Waterline on gypsum board walls above the waterline
- Carpet was saturated and muddy
- Interior doors stained and split at bottom
- No mildew or mold until Day +10, minor growth thereafter

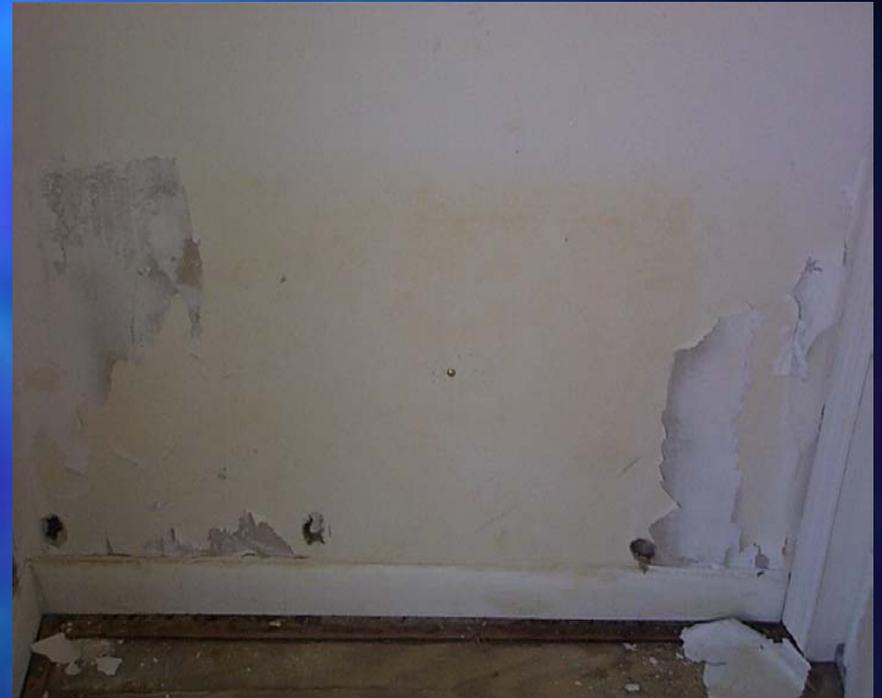
- Paper drywall tape peeling off walls
- Paint blistering (semi-gloss peeled less than flat)
- Ceramic tiles on floor and walls firmly affixed (grout slightly deteriorated and discolored)

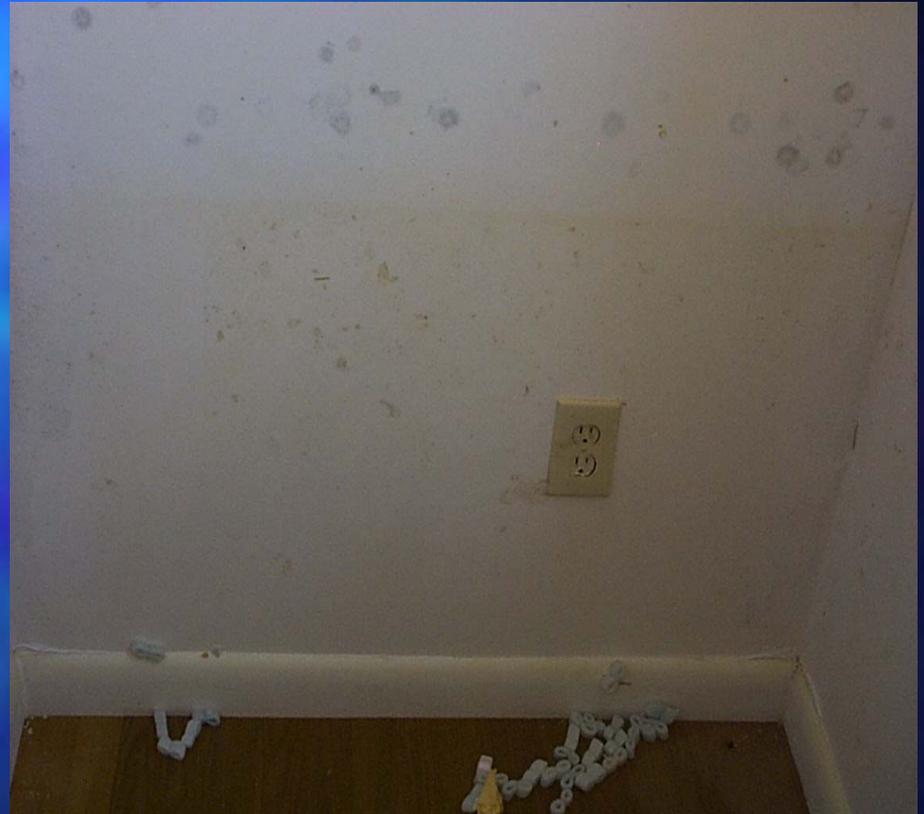
- Strong musty smell upon entry
- Walls stained below water line
- Major mildew and mold growth concentrated in a 20" band above waterline upon entry

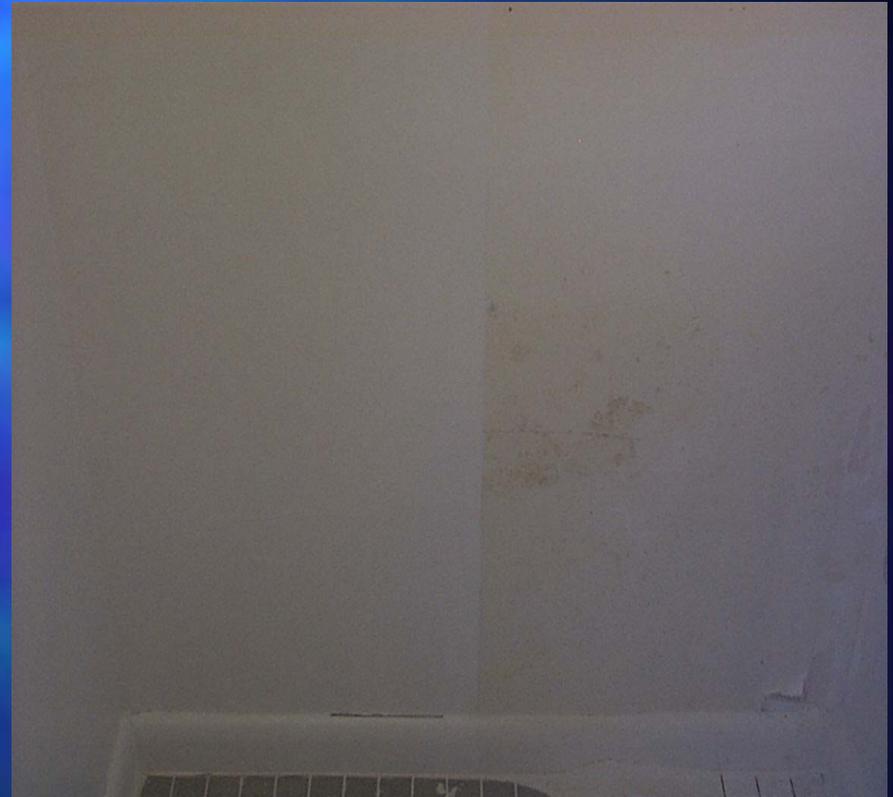
- Loose paint and joint tape removed, walls sanded, and re-painted, passed – like new
- Exterior door sanded and re-painted, passed – like new
- Interior HC door removed, failed - to be replaced
- Interior 6 panel door refinished, failed - due to staining
