HYBRID JOINING IN AUTOMOTIVE APPLICATIONS

Vlastimil Kunc
Oak Ridge Associated Universities
Oak Ridge, TN 37830

Donald Erdman, Lynn Klett
Oak Ridge National Laboratory
Oak Ridge, TN 37831

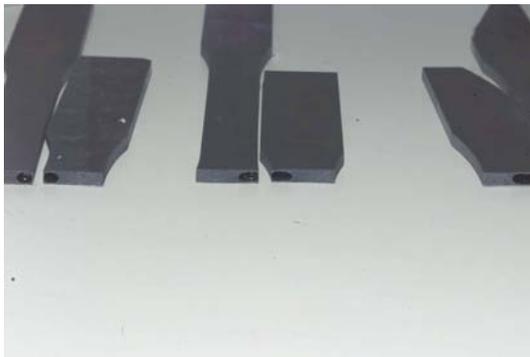
Figure 3. Internal bubbles/voids on tensile specimen fracture surfaces attributed to inaccuracies and scatter in material properties.

specimens. After assessing the results of a set of tensile tests, severe inconsistencies were found in the data. Examination of the fracture surfaces for suspect specimens, which exhibited lower than average strength and/or stiffness measurements, often had large voids attributed to trapped gasses introduced during the molding process. These voids are easily discernible with the naked eye as shown in Figure 3. These bubbles provided crack starter sites, and effectively reduced the cross-sectional area of the specimen, resulting in the aforementioned inconsistencies. To eliminate the voids, a new procedure was developed to deposit the highly viscous adhesive onto the molding platens after centrifuging to remove any air introduced in the mixing process. Any manipulation of the adhesive, which would result in shearing or tensile forces, was eliminated and only compressive forces were used to distribute the adhesive to fill the mold. The specimens machined from the plaques molded in this manner were significantly more homogenous and void free. Furthermore, post-test examination of the fracture surfaces indicated failure of the material that was not initiated from voids in the material, resulting in much more consistent stress-strain behavior as depicted in Figure 4 with the corresponding material properties shown in Table 1. This processing technique was adopted for preparing all further adhesive tensile and creep test specimens.

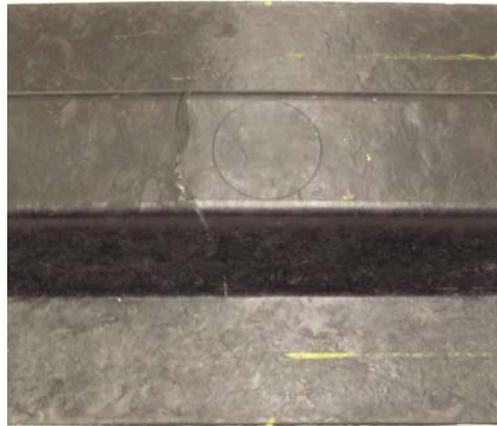
Figure 14. Adhesively bonded specimen after quasi-static test with hat in tension exhibiting off-center failure.

For the hat in tension specimens, catastrophic failure occurred at the top of the hat section and remained solely in the composite material. The crack was often located away from the longitudinal center of the specimen where the bending stresses were maximum, likely because of the property variation in the Quantum material (Figure 14). Hence, the specimen failed at a location where the stresses were lower, but where the material strength was also lower. Unlike for swirled glass hats, there was no difference between the failure mechanism for specimens with different joints. Only two specimens sustained significant push-through damage from contact stresses of the rollers initiating cracks starting at the flange and influencing the load-displacement behavior.

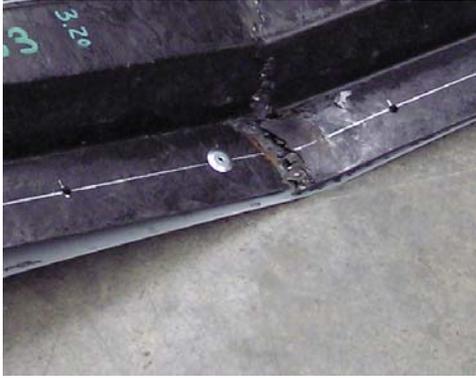
Figure 15. Broken and missing rivets in riveted specimen that failed after 43,200 cycles at 70% of static ultimate load with the hat in compression.

This failure behavior can be explained by the large variation in strengths and stiffness observed in the Quantum material. When the highly stressed areas of the specimen coincided with weak material areas in the composite hat, the hat failed in these regions in a manner similar to the quasi-static tests. When the material in highly stressed areas of the hat was strong enough to sustain the fatigue loading without immediate failure, other components of the structure failed and re-distributed the stresses enabling the structure to sustained a much greater level of damage prior to collapse. Examples of these types of extensive damage are shown in Figures 15 and 16 where numerous rivet pullouts and extensive cracking of the metal base can be readily observed.

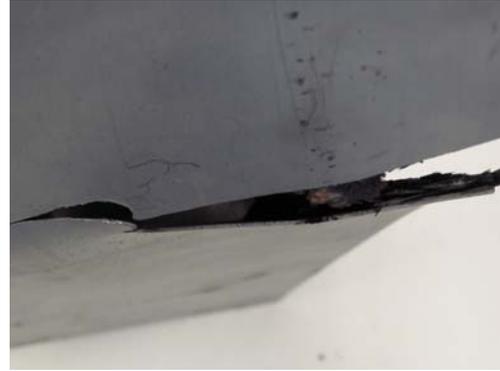
Figure 16. Cracking of steel during fatigue test for adhesively bonded specimen that failed at 307,100 cycles at 70% of static ultimate load with hat in compression.

Results for specimens tested with hat in compression are more consistent. All three specimens with adhesive only developed cracks in the metal. The cycles to catastrophic failure were 481,100, 307,100, and 175,700. Crack initiation and propagation can be detected from the global response of the structure as shown in Figures 17 and 18. All specimens with hat in compression with rivets only exhibited rivet failure leading to redistribution of load to the composite hat. Eventually the hat failed in the flanges as well as the sides of the hat at 43,200, 52,600 and 151,100 cycles. At this point, the top of the hat hit the support of the bending fixture indicated by an increase in stiffness since the fixture was effectively carrying the load. Specimens with rivets and adhesive did not fail catastrophically, instead the flanges were torn away from the hat in the same manner as observed in the quasi-static tests. It took 45,000, 45,000 and 92,000 cycles for the flanges to tear enough to allow the top of the hat to reach the support of the bending fixture. One specimen developed cracks in the metal while another developed cracks in the adhesive.
