AN INNOVATIVE TECHNIQUE FOR BI-MATERIAL INTERFACE TOUGHNESS RESEARCH

John Jy-An Wang, Ian G. Wright, Ken C. Liu, Michael J. Lance
Oak Ridge National Laboratory, Oak Ridge, TN 37831-6171
Phone:(865)574-2274, E-mail:Wangja@ornl.gov
Roy L. Xu
Vanderbilt University, Nashville, TN 37235

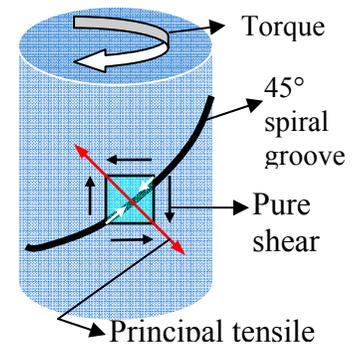
Figure 1. Schematic diagram of SNTT configuration.

The SNTT methodology operates by applying pure torsion to cylindrical specimens machined with a notch line that spirals around the specimen at a 45° pitch angle. The pure torsion loading creates a uniform, equi-biaxial tension/compression stress field on each concentric cylinder, and the grooved line effectively becomes a Mode I (tensile) crack mouth opening, as illustrated in Fig. 1. It is not difficult to visualize that this rod specimen

as a variant of a compact-tension specimen, having a width equivalent to the total length of the spiral notch. Compact-tension testing has an inherent problem, which is lack of a means to uniformly distribute the applied load throughout the entire specimen thickness. This is because the

This is because the stresses at and near the two free surfaces are anomalous, resulting in shear lip formation that often is discernible in fractured specimens. In contrast, the torque load acting on every cross-section along the rod specimen is the same and directly measurable, so that a plane-strain condition is achieved on every plane normal to the spiral groove.

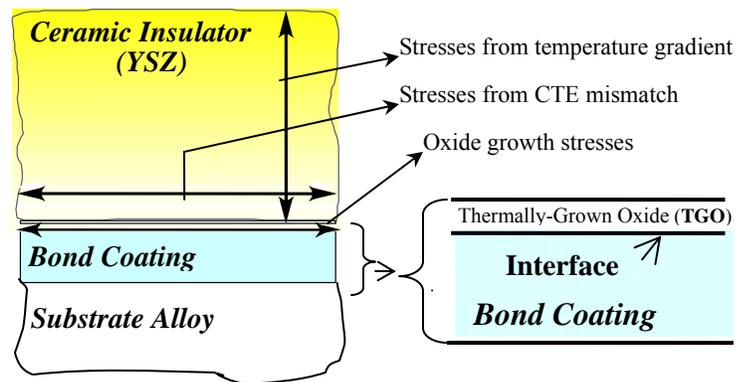
Figure 2. Schematice diagram of interface between bond coating and thermally-grown oxide

generated by the proposed technique would be extremely valuable is that between the metallic bond coating component of a thermal barrier coating, and the alumina scale that is deliberately grown on that bond coating to provide environmental protection, as well as to anchor the outer ceramic thermal barrier layer. Recall that the use of thermal barrier coatings (TBCs) has been pioneered on the airfoil surfaces of advanced gas turbine engines, where they are needed (in conjunction with internal cooling of the airfoils) in order to increase power and/or efficiency of operation, which is achieved by operating at combustion gas temperatures above the melting point of the alloys used for the airfoils,. The failure mode of TBCs typically involves crack propagation near to or along the interfaces between the ceramic and thermally-grown oxide (TGO), or between the TGO and the bond coating. When the characteristics of the ceramic layer are optimized, the weakest link in the TBC system will be at the TGO-bond coating interface. Our research was focused on the fracture behavior and toughness of such an interface, which is illustrated in Fig. 2.

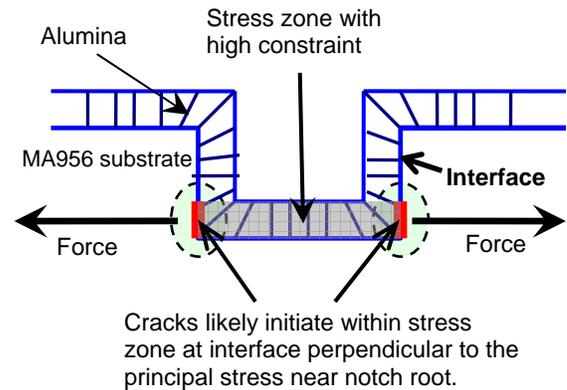
Fig. 4 Schematic diagram of notch root geometry and the associated crack initiation sites by pure torsion loading. The orientation of the crack propagation for the proposed SNTT configuration is material dependent. With (1) thin film alumina scale of high hardness compared to that of substrate, and the compressive residual stress of the thin film (acting normal to the principal stress), and (2) potential notch root blunting or substrate yielding due to high tensile stress fields near the corner of the notch root, a crack is more likely to initiate from the corner of the notch root, and to propagate upward (in the orientation of Fig. 4) along the interface. After the threshold for crack growth along the interface (vertical in Fig. 4) has been exceeded, the compressive residual stress in the alumina will cause the

The details of notch root geometry and the indicated failure initiation sites of an oxide MA956 SNTT sample are illustrated in Fig. 4. The shaded area of alumina scale indicates the region of thin film that is capable of transmitting resultant force of the principal stress induced

unsupported portion of alumina scale to buckle (due to the lack of lateral support from the substrate).

This hypothesized SNTT failure mode was confirmed from SEM examination of tested SNTT thin film samples. Thus, for a non-precracked, oxidized SNTT MA956 sample, cracking was expected to initiate at the corner interface (at the bottom of the groove), and to grow upward along the interface, before it penetrates down into the substrate.

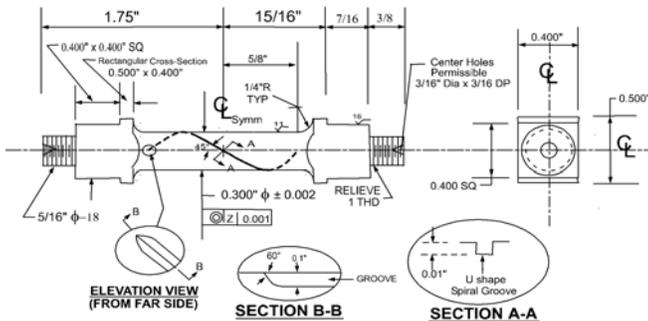
Fig. 5. SNTT thin film specimen design configuration

SNTT specimens were fabricated to the design shown schematically in Fig. 5 from a rod, 1-1/2-in. diameter, of alloy MA956, and from a 1/2" by 2" cross-section plate of a higher-Al variant (MA956HT, heat WBD0667).

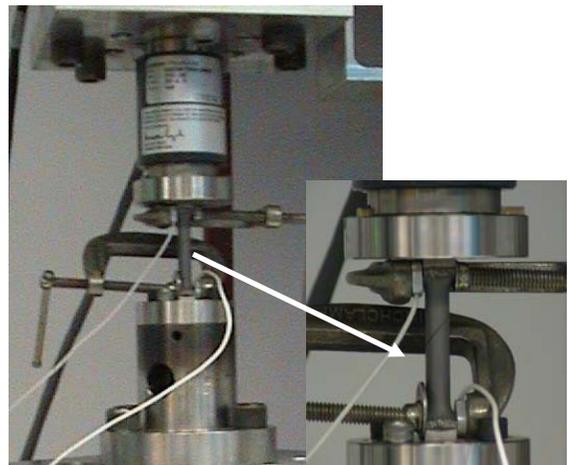
Fig. 6. Experimental set-up with acoustic emission sensors attached to the specimen.

Torsion tests were performed using a closed loop-controlled, electro-hydraulic, biaxial testing system, shown in Fig. 6. Test specimens were subjected to pure torsion controlled by LVDT and RVDT, in association with a high-sensitivity, biaxial load cell to maintain a zero

axial load. In order to capture the onset of crack initiation, an acoustic emission device was used. Precracking for baseline MA956 specimens was accomplished by cyclic torsion, using the Haver sine wave form. The maximum torque used in precracking varies with materials and must be determined experimentally; normally 60~80% of the torque that generates the maximum shear stress around the specimen diameter will suffice. We did not use compliance to monitor the fatigue crack growth; instead, an approximate compliance function was used to estimate crack growth under loading and unloading sequences in torsion. To date, the closed-form solution for torsion compliance has not been developed. An exploratory procedure estimating load-displacement (or stress-strain) slope change at different phases of fatigue loading was adopted to estimate fatigue crack growth. The fatigue crack growth was measured by postmortem examination. In general, precracking was not needed for a brittle SNTT specimen, such as a ceramic. Also, for investigating interface cracking of an oxidized MA956 SNTT specimen, the precrack was considered to be redundant due to material discontinuity being a natural stress riser. However, in order to provide a comparison between the precracked baseline sample and the oxidized sample, two sets of SNTT baseline samples were prepared, one with a precrack and one without a precrack.

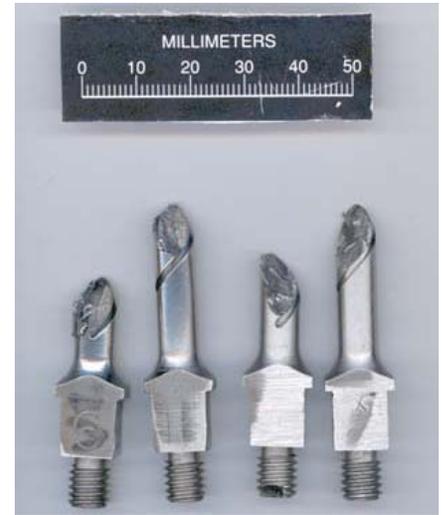
Fig. 7 Fractured SNTT samples.

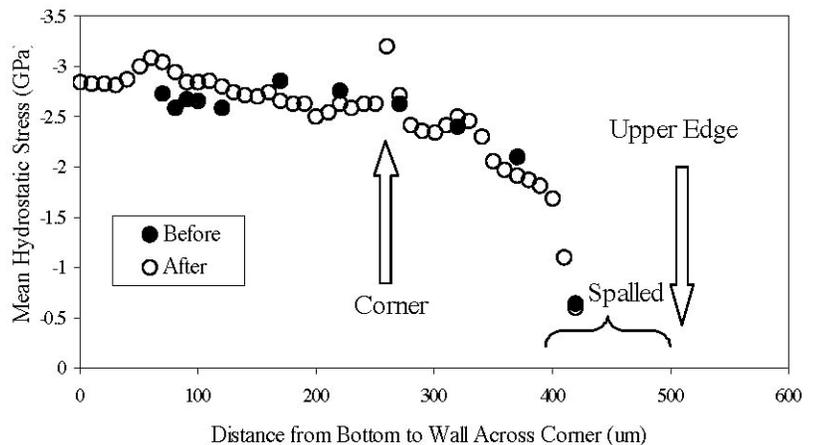
Figure 8. Residual stress profile across U-groove from Specimen No 7 before the torsion test, and from Specimen No. 3 after the torsion test.

Table 2 shows the average hydrostatic stress collected from the thermally-grown α -Al₂O₃ scale from both the bulk (far away from the groove) and within the groove. The bulk stress varies slightly between samples which are due to different heating conditions. Average measurements collected within the groove show less stress and more stress variation than the bulk measurements which is most likely caused by the alumina scale spallation and interfacial cracking in this area.

the majority of the thin film is still intact after the torsion test. The estimate residual stress from the bulk and side of the U-groove of Specimen No. 3 was used as input for the boundary condition of the SNTT finite element model analysis.

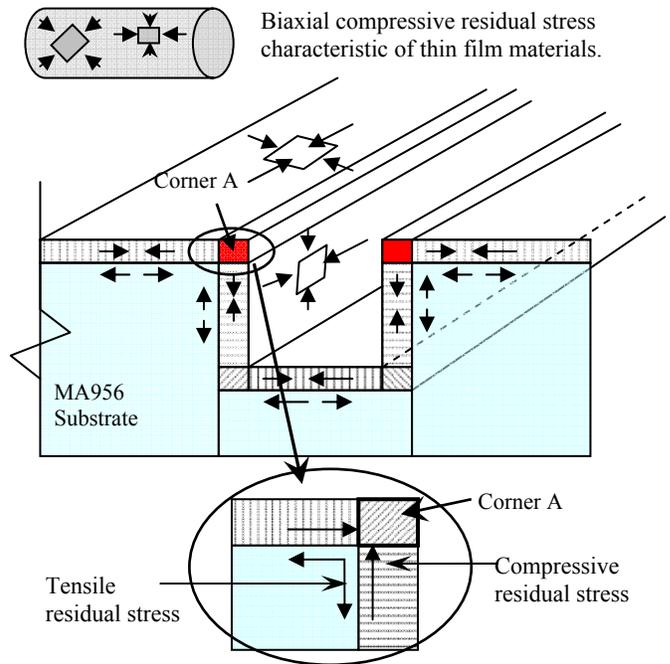
Fig. 9 Schematic diagram of residual stress fields near the U-groove site.

oxidation treatment of the SNTT samples. It appeared that the alumina scale at the top corner (see Fig. 9) of the V- or U-groove sites were all spalled, while the alumina scale remained intact on the rest of the SNTT samples. The residual stress distribution near the U-groove site is shown schematically in Fig. 9. For a thin, thermally-grown oxide, normal stress is not usually a concern except at the sites near delamination, such as at free edges. As indicated above, biaxial compressive residual stress fields exist within such films as a result of growth stress, and stress induced by CTE mismatch, which is a function of temperature and cooling rate, film thickness, etc. The out of plane normal stress typically does not exist, or is very small, for a flat plate with a relatively thick substrate. The stress fields of a thin film can be characterized as equal bi-axial stress fields, and estimated from hydrostatic pressure obtained from a nondestructive evaluation, such as Cr^{3+} fluorescence piezospectroscopy technique. As for the case considered here, a circular rod with notch may present a different problem compared to a flat surface. However, the above condition can still be hold for a curved surface with a curvature that is much larger than the thin film thickness. In our specimen design with a 0.15 inch diameter, the correspondence curvature is much larger than the film thickness at 10 μm range. Thus, the issue regarding residual normal stress still holds for a majority of the cylinder surface, except at the U-groove. Due to lack of information regarding spallation in real time, the possible cause of the alumina spallation at the top corner of the U-groove are listed below, with reference to Fig. 9.

It is well known that the free edge of a thin film can act as a site for delamination. In Fig. 9, Corner A is adjacent to two perpendicular thin film layers. The top corner of the substrate does not possess the characteristics of a free edge. From the point of a physical singularity and the surface slope discontinuity at a corner, it will be difficult to form a thin film with a well organized and orientated columnar structure, and subsequently to maintain the integrity of the thin film and its bonding with substrate during cooling. Furthermore, considering the residual stress distribution during cooling, as illustrated in the lower portion of Fig. 9, the tensile residual stresses of the substrate will have a tendency to pull the corner of the substrate away from its original position in a diagonal direction, while the compressive residual stress in the film has a tendency to push the alumina film away from the top corner of the substrate, also in a diagonal direction. It is not difficult to visualize that, with increasing residual

stress during cooling, the combined effect of tensile and compressive residual stresses at the corner will eventually detach the alumina film at the top corner of the U-groove.

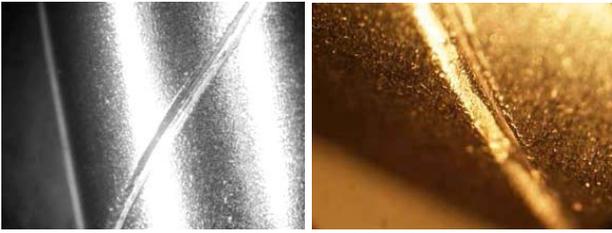
Fig. 10. Typical as-machined V-groove (Specimen No. 1).

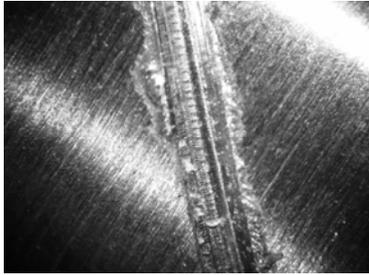
Figure 11. V-groove cutting flaw sites in specimen No. 5.

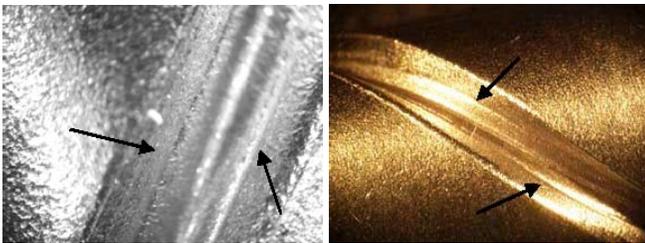
Figure 12. Cutting discontinuity (arrows) on both as-machined V-groove walls (Specimen No. 2)

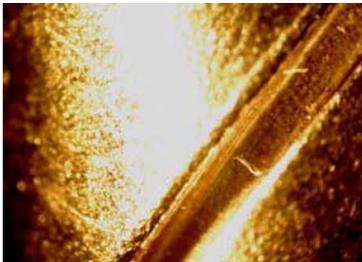
Figure 13. Typical appearance of as-machined U-groove (Specimen No. 9).

Surface images of typical U-groove sample (Specimen No. 9) are shown in Fig. 13. U-grooves seem to have less machining damage compared to that of V-grooves.

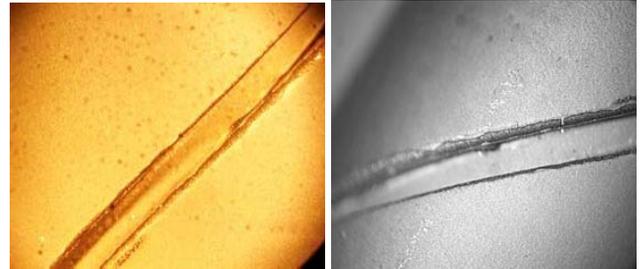
Figure 14. Views from south and north edges of U-groove on Specimen No. 3 (not pre-cracked).

Plan views of the surfaces of oxidized U-groove SNTT specimens Nos. 3, 7, 9 shown in Figs. 14-16, show that the alumina scales had spalled from both the top corners of U-groove. The scale on Specimen No. 9 was thinner than that on Specimen No.3; shiny residues also were visible at the bottom of the groove. The difference of

thin-film thickness between Specimens No. 9 and No. 3 was due to the different baseline materials, MA956 and 956HT, used to manufacturer these two samples. Plan views of the surfaces of oxidized V-groove SNTT specimens also show that the alumina scales had spalled from both the top corners of V-groove.

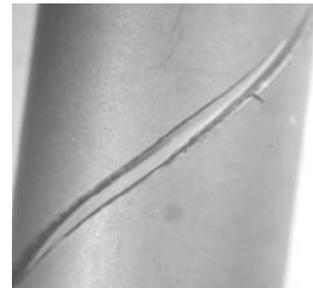
Figure 15. Specimen No. 7 (U-groove, not pre-cracked) after oxidation

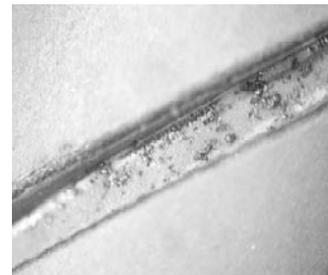
Figure 16. Specimen No. 9 (U-groove, pre-cracked) after oxidation

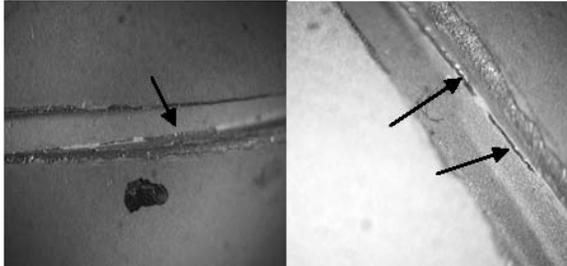
Figure 17. Scale spallation sites after torsion testing (Specimen No. 3)

Figures 17-20 illustrate the fracture and spallation sites of the alumina scale as indicated with arrow marks for specimen Nos. 3 and 7 after torsion testing. The majority of the alumina scale at the bottom of the spiral groove appeared to be intact. A crack along the edge of the

bottom corner of the spiral groove on specimen No. 3 is shown in Figs. 17 and 18(a). A more detailed view of the alumina scale spallation at the bottom corner of the groove is shown in Fig. 18(b). A similar scale cracking and spallation site at the bottom of the groove on Specimen No. 7 is shown in Figs. 19, 20. There was no damage apparent at the bottom of the U-grooves in the as-machined samples, prior to oxidation.

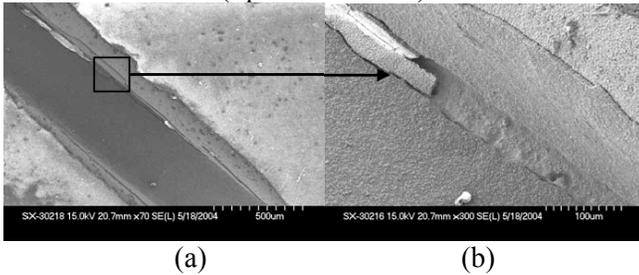
Figure 18. Scale spallation at the bottom corner of Specimen No.3.

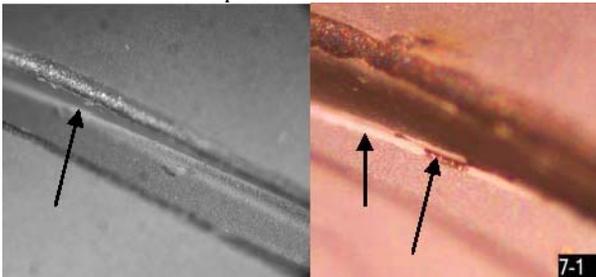
Figure 19. Scale delamination and spallation sites after torsion testing (Specimen No. 7).

No. 9 and No. 7 (not pre-cracked), shown in Figs. 23 and 19, indicates fewer spallation sites on the non-pre-cracked specimen. This delamination on the pre-cracked specimens may have resulted from the development of an oxide wedge at the tip of the pre-crack sites during oxidation. Figure 24(a) shows typical U-groove spallation and crack sites on Specimen No. 9, which are similar to those of non-precracked samples, but more extensive. Details of the alumina scale spallation site at the bottom corner of U-groove are shown in Figure 24(b), and Figure 24(c) shows typical crack sites near the bottom corner of the groove. Figure 24(d) shows the external features of the alumina scale.

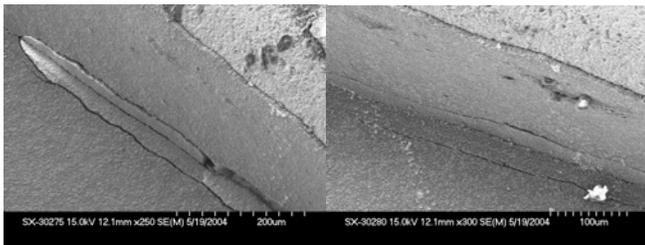
Figure 20. Scale crack and spallation sites along the bottom of the U-groove after torsion testing (Specimen No. 7).

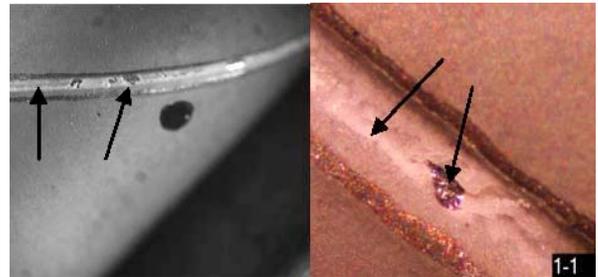
Figure 21. Scale spallation and delamination sites after torsion testing (Specimen No. 1)

In contrast, on the pre-cracked samples (Nos. 1 and 9) a large portion of the alumina scale near the center region of the spiral groove appeared to be delaminated from the substrate. The scale failure sites on Specimen No. 1 are shown in Figs. 21 and 22; the scale appears to be spalled or delaminated in the middle section of the groove. The alumina spallation sites near the center did not exhibit an ‘oxide footprint’ pattern (Figure 22b,d), compared to the spallation sites at the top corner of the U-groove, suggesting that the oxide was not in contact with the alloy at the conclusion of the oxidation treatment. The wide spread damage was most likely attributable to the pre-cracking of the samples. Figure 22(b) shows a large cavity beneath the alumina scale, possibly associated with an original machining defect in the groove.

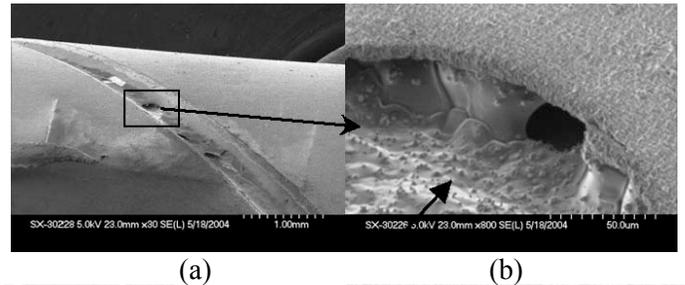
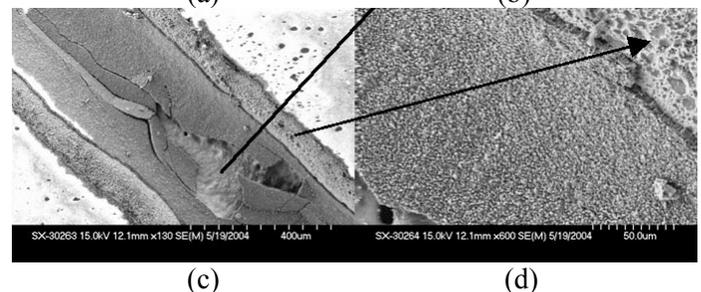
Figure 22. Unusual features at spallation sites in the U-groove on pre-cracked Specimen No. 1, after torsion testing

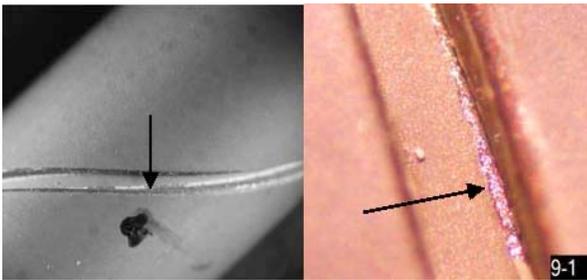
Figure 23. Scale spallation in groove after oxidation (Specimen No. 9, pre-cracked).

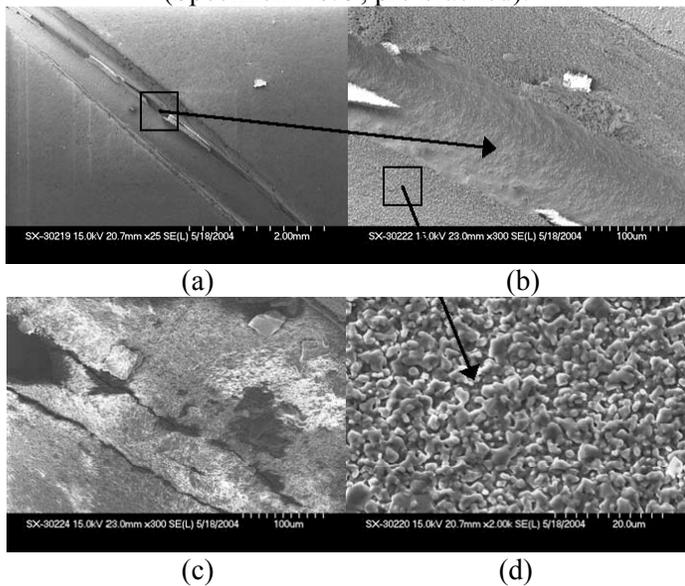
Figure 24. Spallation sites (a) top view and (b) bottom corner, (c) alumina crack sites at bottom corner, and (d) plan view of adherent scale (Specimen No. 9).

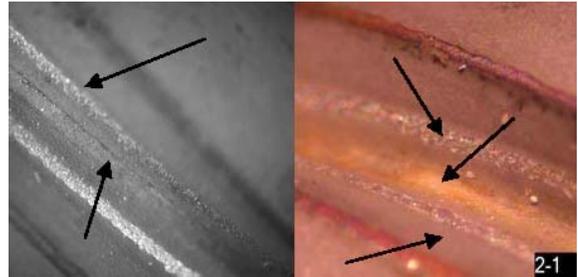
Figure 25. Fracture site (left) and spallation and delamination sites (right) after torsion testing (Specimen No. 2; pre-cracked).

Two parallel spallation lines were observed on pre-cracked specimen No. 2 (Fig. 25), which are consistent with the flaw sites identified on the baseline sample. Also, in Fig. 25a crack line can be seen near the root of the V-groove, and some scale delamination sites also are

visible near the bottom of the spiral groove (Figs. 25b and 26). Figures 27 and 28 illustrate a scale spallation pattern on pre-cracked specimen No. 5 that corresponded to the rough, as-machined surface shown in Fig. 13, and demonstrates the detrimental effects of poor initial surface quality on the structure and adhesion of the oxide scale.

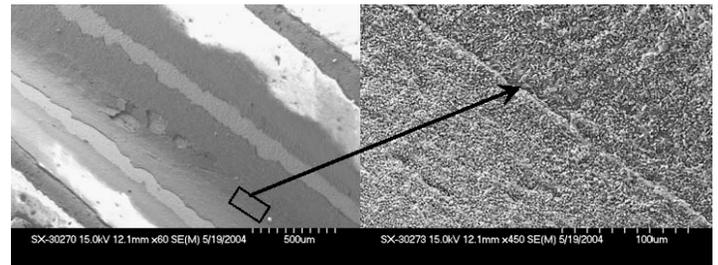
Figure 26. Scale spallation and crack sites on Specimen No. 2.

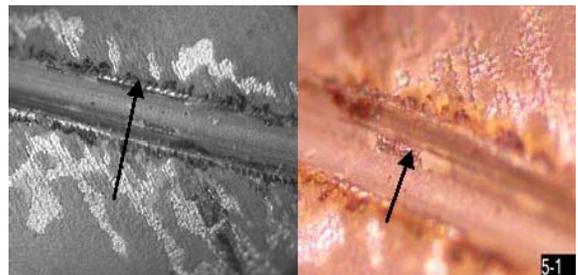
Figure 27. Scale spallation site of precracked Specimen No. 5 after torsion testing

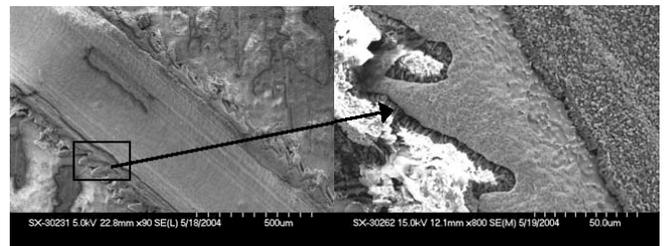
Figure 28. Irregular alumina formation near the edge of V-groove due to machining flaw at the edge of the spiral groove on Specimen No. 5.

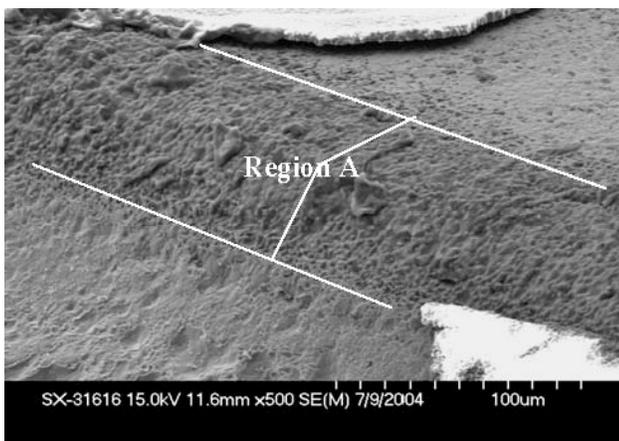
Figure 29. Scale spallation sites at near the edge of groove on pre-cracked Specimen No. 1.

Figure 29 shows alumina spallation sites near the top edge of the spiral V-groove from the fractured Specimen No. 1. The scale over region A in Fig. 29 apparently was not in contact with the alloy (lack of ‘oxide footprints,’ so that spallation occurred during cooling following oxidation. The remaining spallation sites in Fig. 29 apparently formed during the fatigue fracture test, since the alloy surface exhibits extensive ‘oxide footprints,’ signifying an adherent oxide. Figures 30-31 show details of spallation sites at the bottom of the spiral groove. The oxide appears to have bridged areas containing deep voids; the lack of ‘oxide footprints’ on the flat surface between the voids, and the smooth contours of the voids themselves indicate that these constituted a very large cavity beneath the original scale. The fact that the oxide was in contact only with the tops of the ‘pillars’ shown in Fig. 30 (Region ‘B’) and Fig. 31, and yet grew with the expected columnar grain structure to a uniform thickness is surprising, and suggests that transport of Al vapor species across the cavity was faster than oxygen diffusion through the oxide. This spallation site is near the location of the fatigue pre-crack that was formed at the bottom of the U-groove prior to oxidation.

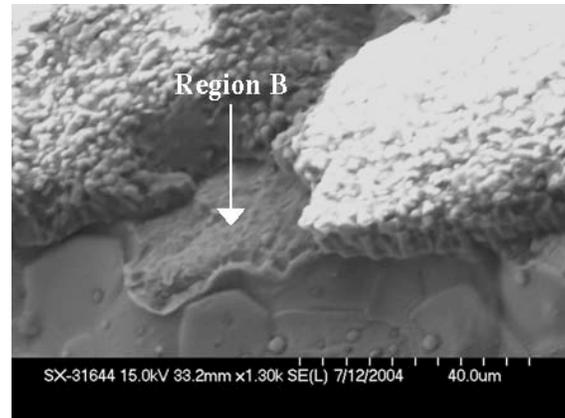
Figure 30. Region B reveals a location where the alumina scale was adherent at temperature (Specimen No. 1).

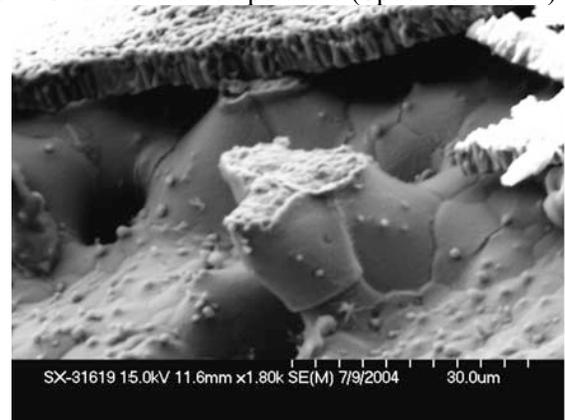
Figure 31. A pillar-like structure near the fatigue pre-crack site on Specimen No. 1.

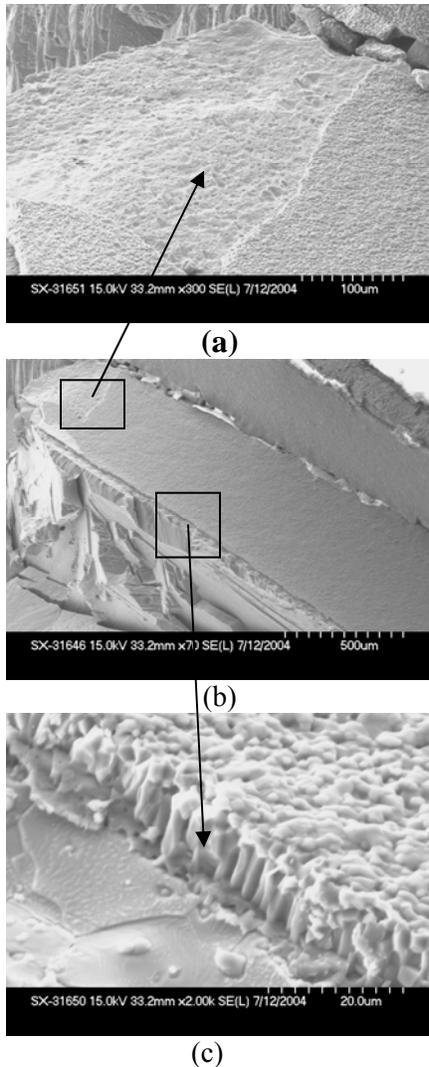
Figure 32. Details of spallation sites at the bottom and bottom corner are shown in (a) and (c); corner/ edge of U-groove bottom as shown in (b); (Specimen No. 7; not pre-cracked).

Figure 32 illustrates scale spallation sites on right side wall and the bottom portion of the U-groove on Specimen No. 7. Spallation typically was focused at the intersection of the side-wall and bottom of the U-groove (Fig. 32b). The scale on the rest of the side-wall and bottom of the groove remained intact, indicating that good bonding between the alumina scale and the substrate still remains even after numerous torsion fatigue cycles.

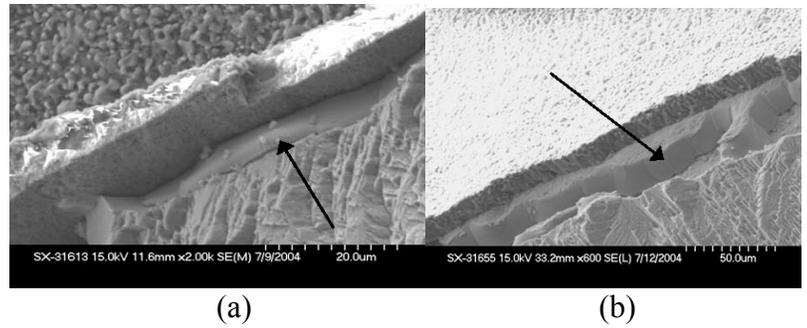
Figure 33. The fracture reveals a distinct, unidentified layer between the alumina scale and the substrate as indicated arrows in (a) the view from underside of the bottom flat of U-groove and (b) view from the top of the bottom corner edge of U-groove (Specimen No. 7).

Figure 33 shows two views of the fracture faces of the adherent scale on the bottom flat portion of the U-groove, near the site of the overall fatigue failure. The cross section of the oxide appears typical of the normal scale grown on this alloy. However, there is also a distinct layer of different appearance from the oxide and alloy located between the alumina scale and the substrate, as indicated by the arrows. Further examples of the layer from the corner between the wall and bottom of the groove are shown in Fig. 34, where the bottom section of the groove was broken away when the specimen

fractured. The finding of this underlying structure in SEM was purely by chance from the fractured No. 7 SNTT specimen with a proper viewing angle. Since the oxide has grown on this layer in the expected way, the layer is clearly MA956. The proximity of the layer and the structures that resemble the ‘pillars’ noted earlier (Fig. 31) suggests some connection: the smooth sides of the ‘pillars’ and the ‘fracture face’ of the layer, and the absence of ‘oxide footprints’ around the base of the ‘pillars’ further suggest the presence of a larger cavity between the unidentified layer and the alloy during the oxidation process. Possibly, the layer may be associated

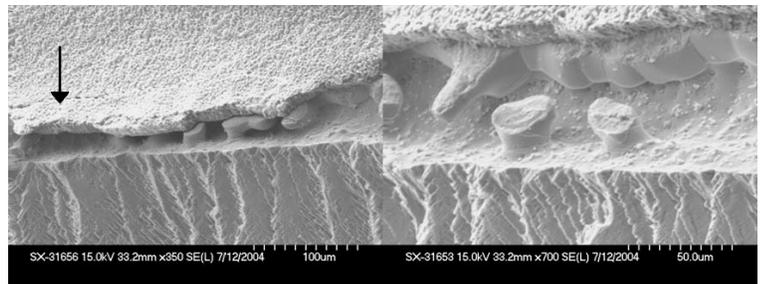
Figure 34. Complex defect sites at the bottom corner of U-groove from the fractured Specimen No. 7

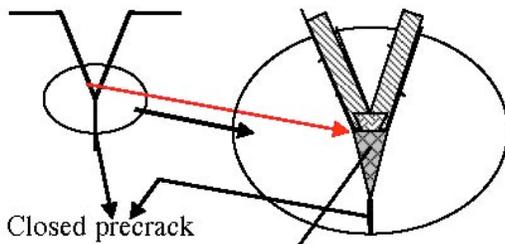
Figure 35. Schematic diagram of the formation of an oxide wedge.

A schematic diagram of the formation of such a wedge is illustrated in Fig. 35, where the precrack was initially closed, but reopened during oxidation. Consequently, the alumina scale grew into the crack to form an oxide wedge. Upon cooling or loading, this oxide wedge will provide a driving force to extend the crack further into the alloy substrate. This crack growth phenomenon beneath the alumina scale is thought to be the main cause of the observed scale delamination and spallation at the center section of precracked V-grooved SNTT samples.

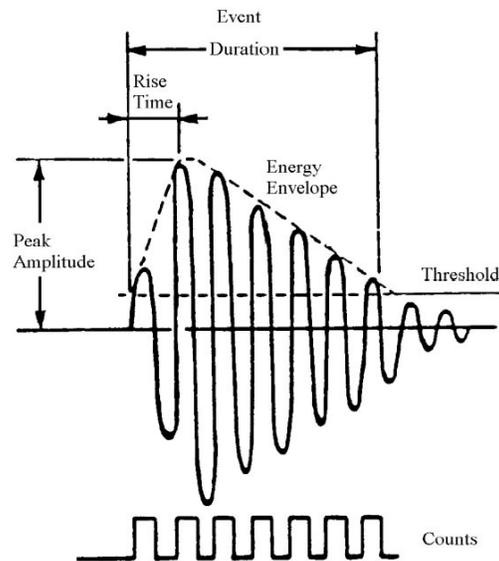
Figure 36. The AE waveform characteristic

by surfaces. An acoustic emission system, LOCAN 320, was used in this research for detecting crack initiation in oxidized SNTT samples under torsional loading. LOCAN 320 is a computerized system that performs AE signal measurements and stores, displays, and analyzes the resulting data in real time. The acoustic signals from the loaded structure are converted into electrical signals by the sensors, amplified to useable voltage levels by the preamplifiers and measured in two-channel computerized modules known as Independent Channel Controllers (ICCs). Each AE source event in a structure may be detected by one, two, or more channels; detection on any one channel constitutes a "hit," so that each event may produce one or several hits. Each AE signal (hit) is described in terms of its features, as shown schematically in Fig. 36, which includes:

- (1) Hit—a burst acoustic emission signal,
- (2) Time—the time of detection signal, in μ sec,
- (3) Rise time—the time from the first threshold crossing to the peak, in μ sec,
- (4) Duration—the time from the first to the last threshold crossing, in μ sec,
- (5) AE Counts—the number of times the acoustic emission signal crosses the threshold,
- (6) AE Count to Peak,
- (7) Energy—area under the signal envelope,
- (8) Average Frequency,
- (9) Threshold level, in dB,
- (10) Peak AE Amplitude—the peak voltage of acoustic emission signal (usually logarithmic), in dB.

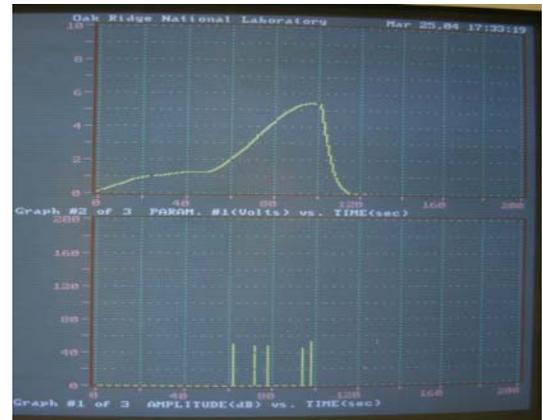
Fig. 37 Torque load (top, in volts) and AE hits (bottom) time histories for Specimen 3.

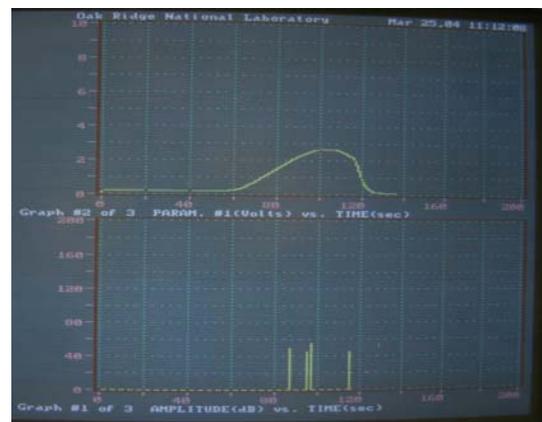
Fig. 38 Torque load (top, in volts) and AE hits (bottom) time histories for Specimen 7.

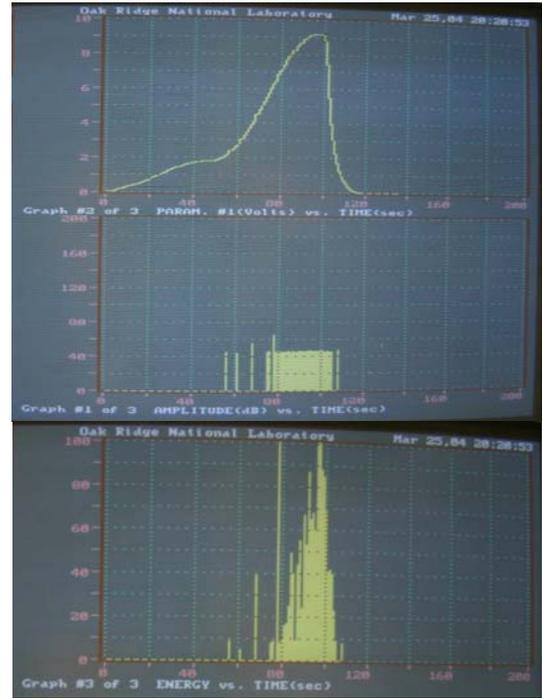
Fig.39 AE hit events from Specimen No. 1

Time-history of AE hit signals from pre-cracked SNTT samples during the torsion tests are shown in Figs. 39-40.

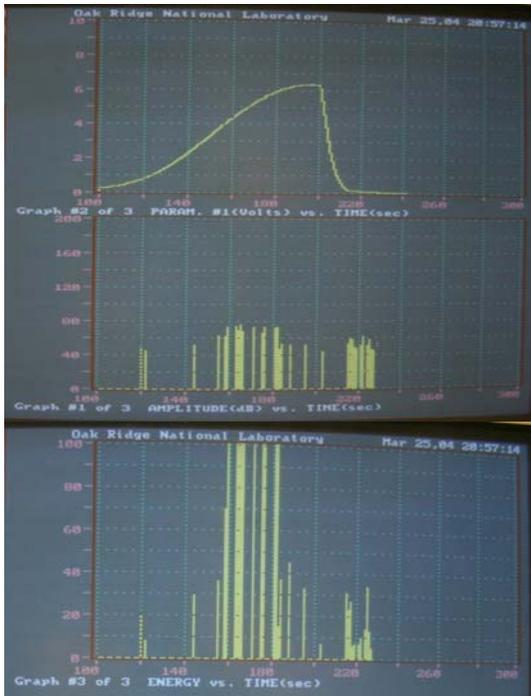
Fig.40 AE hit events from Specimen No. 5
