## **Compatibility Study of Protective Relaying in a Grid-Connected Fuel Cell**

**R. H. Staunton**

Oak Ridge National Laboratory, Oak Ridge, Tennessee

March 2004

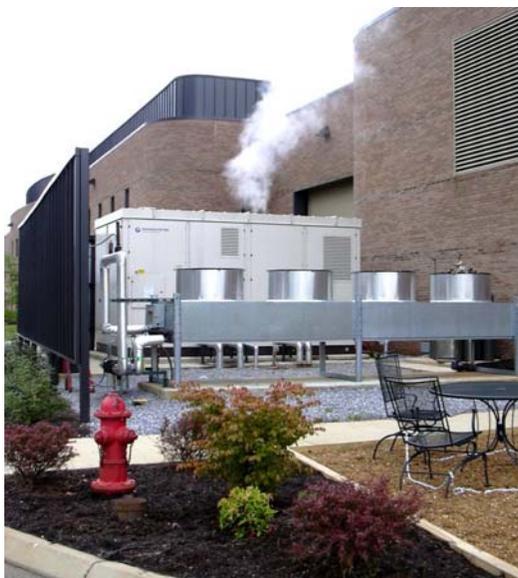
IFC, a United Technologies Company, of South Windsor, Connecticut, manufactured the 200-kW, phosphoric acid Model PC25C fuel cell shown installed and operating at the NTRC in Fig. 2.1. Hundreds of these fuel cell models have been delivered to locations around the world (see <http://www.dodfuelcell.com/>). The near-zero-emissions unit uses natural gas to produce hydrogen ( $H_2$ ) in an internal reformer; and the  $H_2$  and oxygen ( $O_2$ ) chemically react in a catalyst to produce clean, high-quality electric power at an electrical efficiency of 37%. The system is advertised to have a combined electric/thermal efficiency of ~60%.<sup>1</sup>

**Fig. 2.1. Fuel cell in operation at the NTRC in June 2003.**

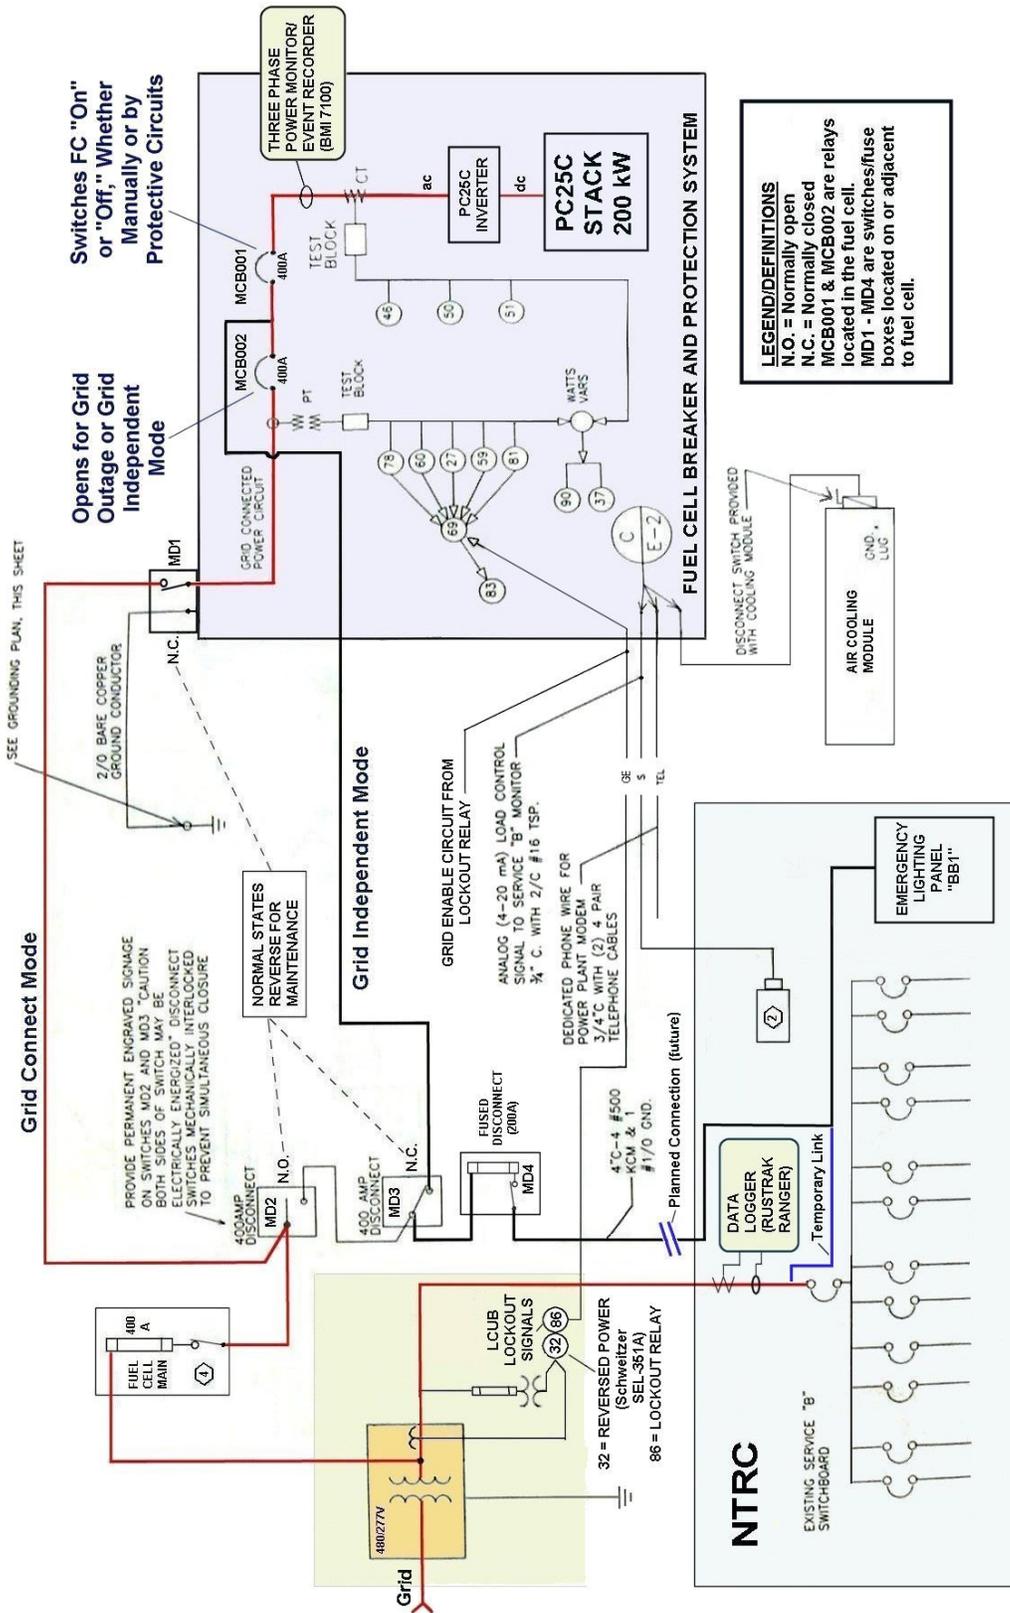
Continuing with Fig. 2.2, power from the fuel cell inverter first reaches the main fuel cell relay, MCB001. This relay is closed in normal operation. The relay switches the fuel cell "on" or "off" by manual commands or by protective circuits. The output of the relay connects via MCB002, switch MD1, and a 400-A fuse to the local electric grid (i.e., transformer secondary). Relay MCB002 is normally closed during grid-connect operation unless there is a EPS outage or the fuel cell is placed in the grid-independent mode. In either of these cases, MCB002 opens, permitting fuel cell power to feed only emergency electric panels (via MD3 and MD4); however, the wiring to the emergency panels was not completed during this study. As indicated by a note, MD1, MD2, and MD3 are in the positions shown unless the fuel cell is turned off and placed into a maintenance mode.

Fig. 2.2. Fuel cell and transformer wiring to the NTRC electrical system.

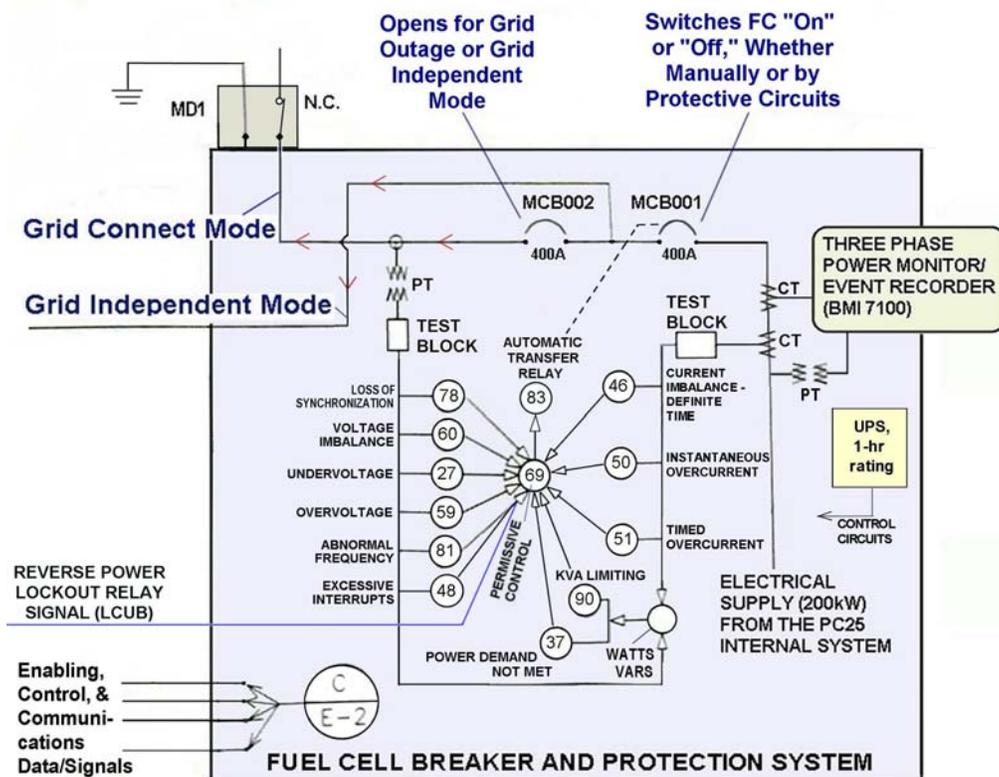
Figure 2.3 is an expansion of the earlier representation of this circuitry with the addition of refinements and additional protective device details. On the right-hand side of the drawing is a rounded rectangle showing one of several monitor/event recorders used in this study. Current transformer (CT) and potential transformer (PT) connections to all three phases provide the necessary data. The monitor is placed at the output of the fuel cell stack and 3-phase inverter before any relaying so that a full picture of power flow from the fuel cell is obtained. Any downstream relay openings can be clearly seen in this current flow.

Fig. 2.3. Fuel cell protective and safety relay circuit.

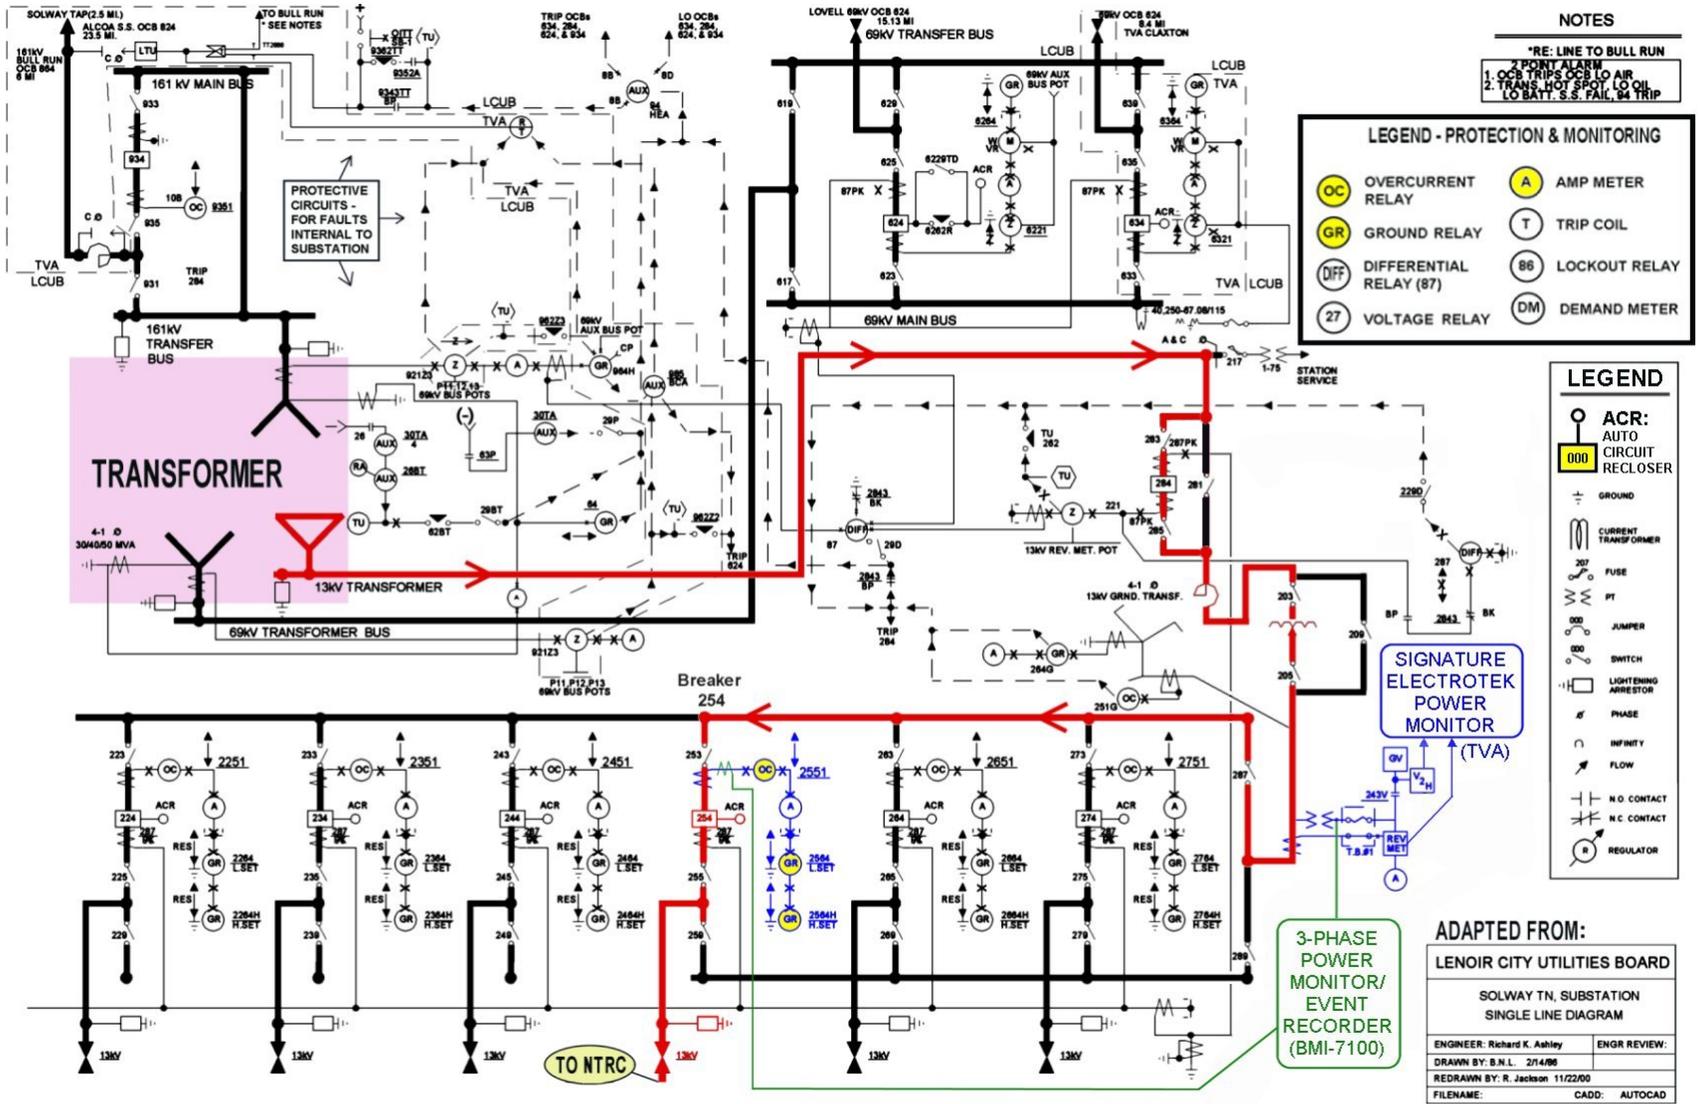
The substation is schematically represented in Fig. 2.4 in a single-line diagram. The red line represents the secondary circuit to the Breaker 254 feed for the NTRC and other customers east of the substation. Two data monitors are shown in the lower right-hand corner of the figure, one installed by TVA for its own monitoring purposes and one installed for this project but seldom used (or needed) to provide insight into interruptions to the fuel-cell-to-grid connection.

Fig. 2.4. Solway substation single-line diagram.

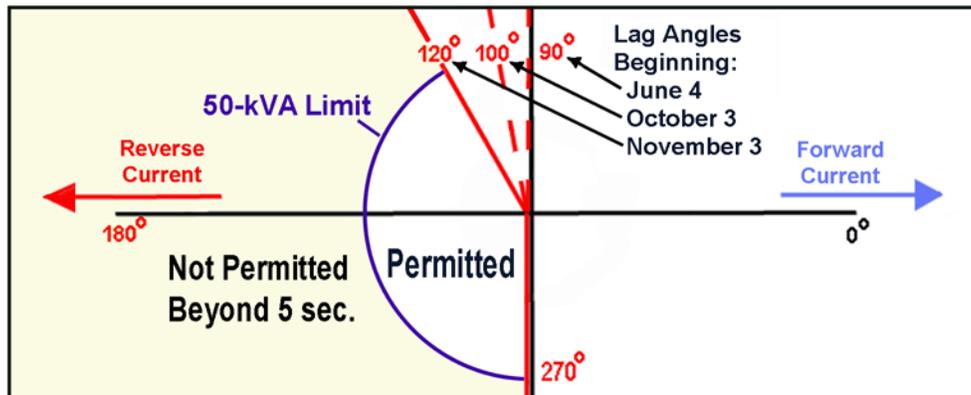
When difficult-to-explain events were encountered with unusually low PF (e.g., below 0.6), ORNL considered whether the Device 32 type of reverse power protection might be helpful. ORNL acknowledged that with a severe lagging current and high fifth harmonic content, there would be reverse harmonic currents that could cause trips even in a Device 32 protection scheme. In consultation with personnel at SEL, LCUB decided not to experiment with what it considered to be a technically inferior protection scheme. Instead, LCUB decided to modify the permissible phase angle in the load-encroachment scheme. At ORNL’s request, LCUB allowed an additional 10° (for a total of 100°) in an effort to reduce the number of unexplained trips, but that did not seem at the time to be quite sufficient. LCUB was hesitant to extend the permissible current phase angle further, since it is under contract with TVA not to allow any customer to generate power onto the grid. As indicated in Fig. 2.5, it was not until early November that LCUB made a further adjustment in the settings to allow a lagging current phase of 120°. The limit of apparent power remained at 50 kVA. In effect, this change created a protective system that not only required >50 kVA reverse apparent power, but also a significant amount of reverse real power (assuming normal levels of reactive power).

**Fig. 2.5. Allowable lag angles in the grid-connected mode at full power generation.**

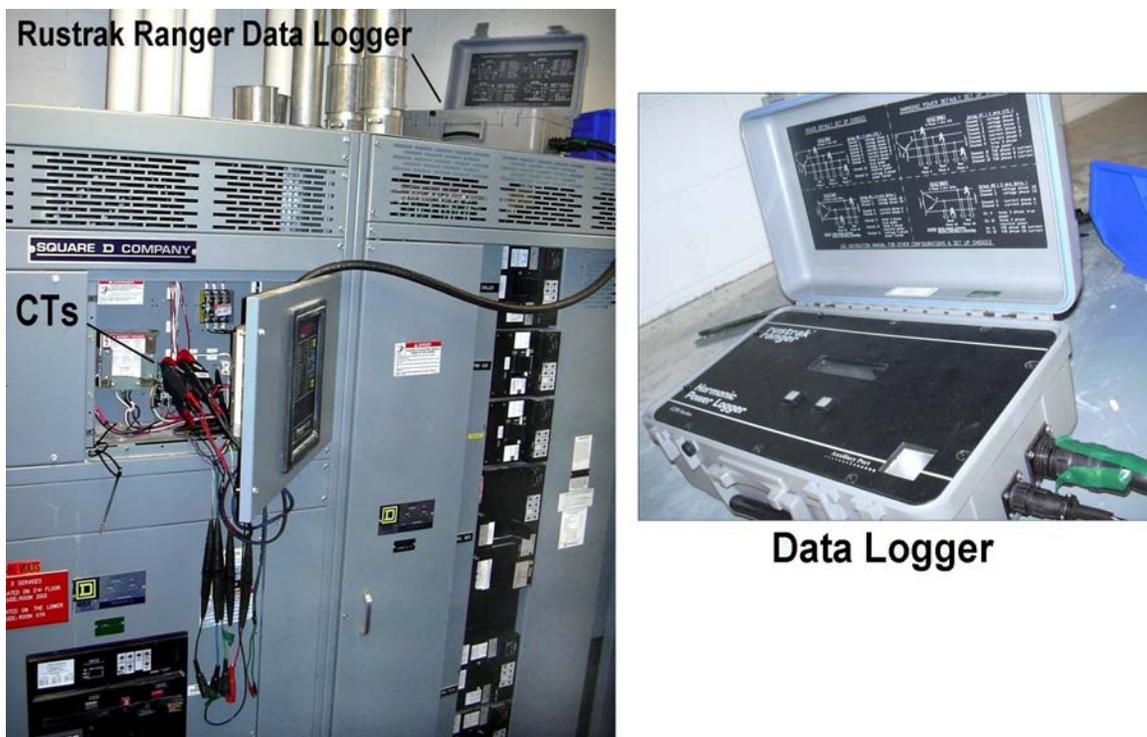
The most important improvement made to the data collection system was EPRI-PEAC's addition of a Rustrak Ranger data recorder to the main Service B breaker panel in the NTRC, as shown in Fig. 2.6. This improvement, made in early July 2003, provided the actual voltages and currents for all three phases, revealed fluctuations in the building loads (unlike the monitor located in the fuel cell), and provided continuous data feedback during the study. From the data, real power, apparent power, reactive power and PF plots were generated for many of the events.

**Fig. 2.6. Main breaker panel for Service B with data logger installed.**

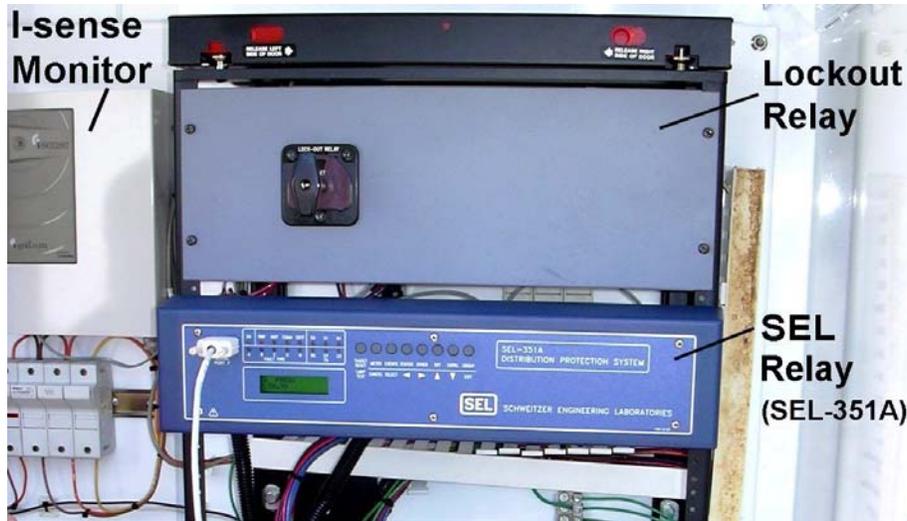
The second most important source of data was the SEL relay's waveform and electrical parameter recording capabilities (hence, the instrument is more than just a "relay"). The SEL relay is shown in Fig. 2.7 mounted in a cabinet adjacent to the Service B transformer. The lockout relay is shown immediately above the SEL relay. The SEL relay provided data only for the events in which it generated the permissive that placed the fuel cell into the idle mode. The instrument captured 3-phase voltage and current waveform data, 3-phase current magnitudes at the time of interrupt, time, and other data. From the waveform data, PF can be estimated.

**Fig. 2.7. SEL relay and lockout relay in cabinet adjacent to the Service B transformer.**

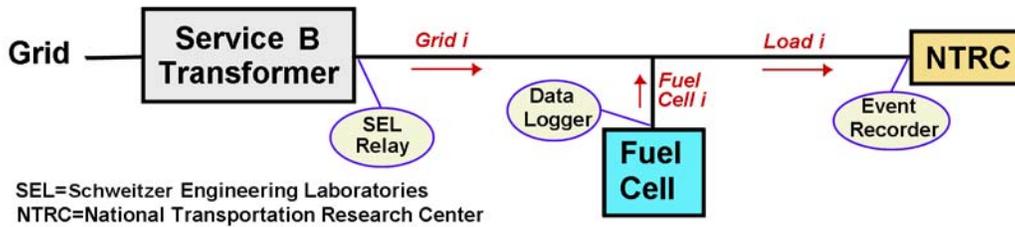
Figure 2.8 shows a block diagram of the electrical system, comprising the grid, transformer, fuel cell, and load in the NTRC. In this section, we will consider how different types of power can affect the PF as viewed by the utility (i.e., at the main Service B transformer).

Fig. 2.8. Major current sources/loads in the grid-fuel-cell-NTRC system.

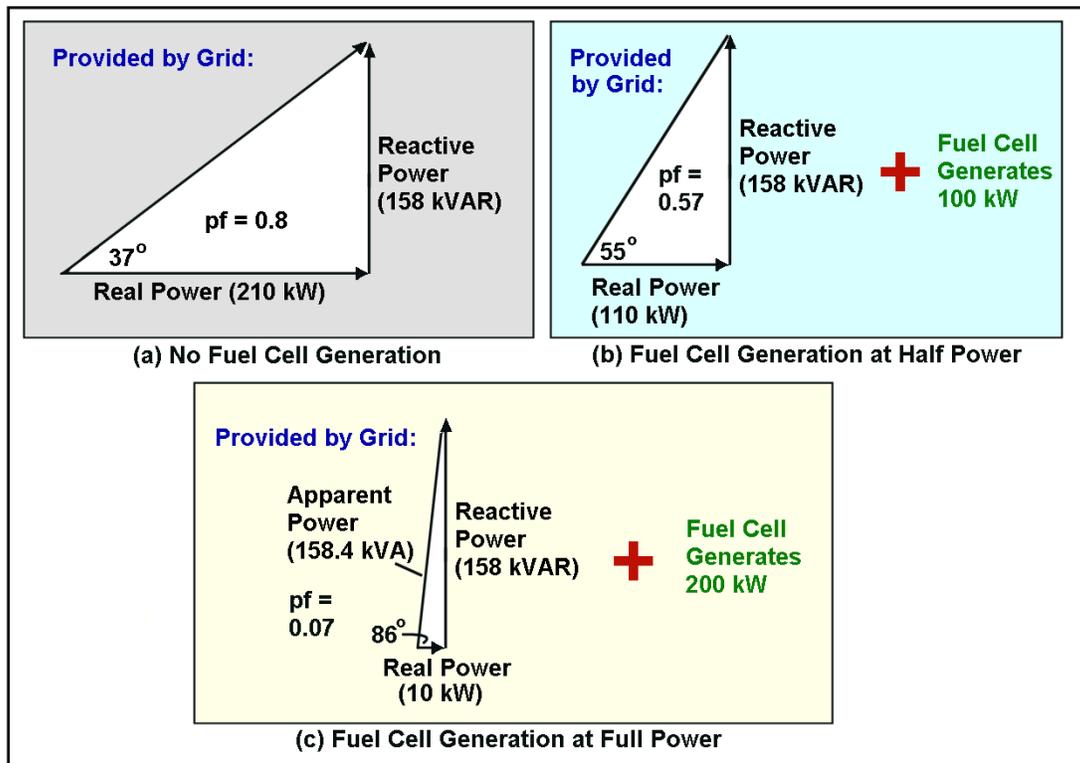
Figure 2.9a shows the general relationship between real, apparent, and reactive power levels in a facility such as the NTRC, where the reactive power level is high. Since the fuel cell is idle, the grid is supplying all real and reactive power. Figure 2.9b shows the same relationship; however, in this case, the fuel cell is contributing 100 kW of real power. Because of this generation, the grid supplies a reduced level of real power, and the grid is now supplying mostly reactive power. Another consequence is that the power factor changed from 0.8 to 0.57 as seen by the grid (i.e., at the building transformer). The corresponding current lag angles increased from 37 to 55°. Taken another step further, if the fuel cell generation level is increased to the full 200-kW level and the real power demand in the NTRC remains very close to the fuel

Fig. 2.9. Effects of meeting real and reactive power demand with a progressively greater fuel cell contribution.

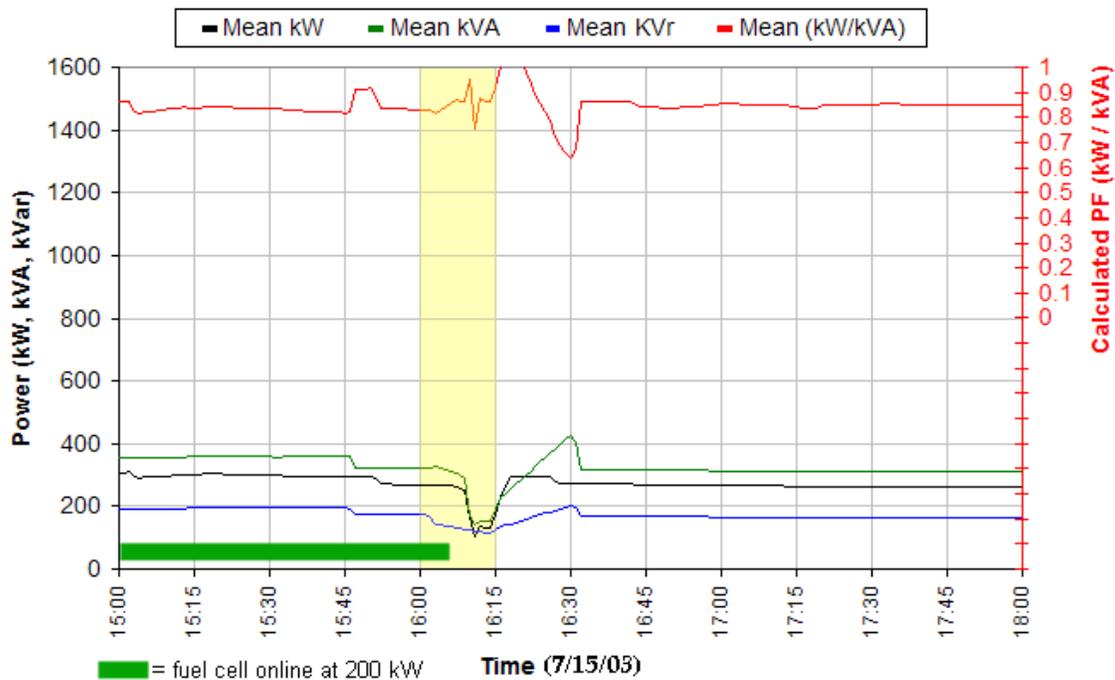
The building power and PF plot from 3 to 6 p.m. (Fig. 3.1) shows that all three power curves (i.e., real, apparent, and reactive power) fluctuated for unknown reasons at about the time of the event. These are postulated to be coincident times; however, one must allow 5 min of clock error between the fuel cell clock and the Rustrak data recorder. The real and apparent power and the PF fluctuated for approximately 15 min following the event.

**Fig. 3.1. NTRC building load and PF data for July 15, 2002.**

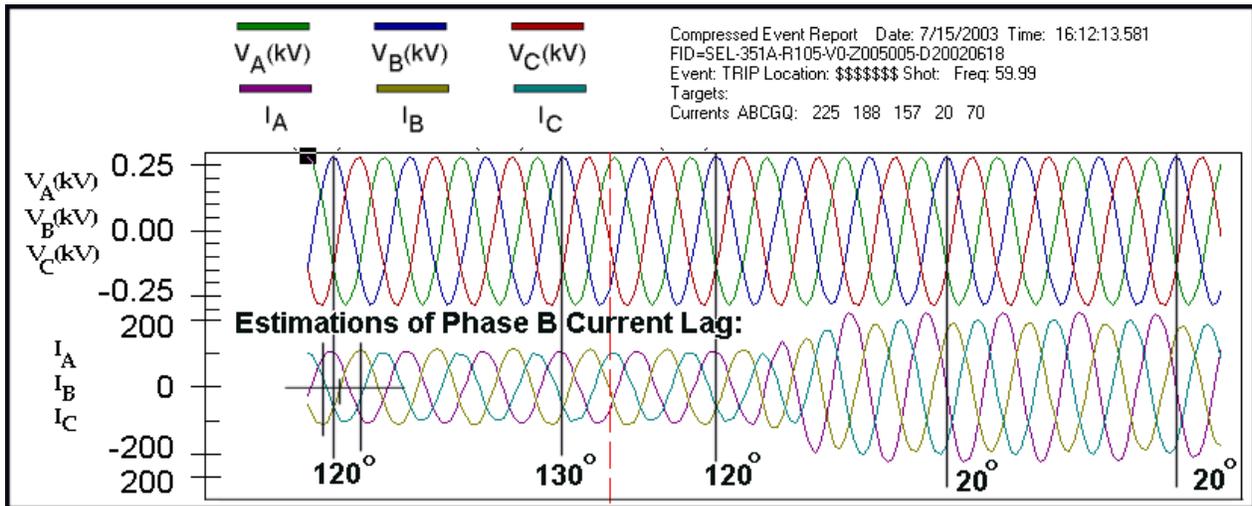
as shown because the grid was assuming the full NTRC load. There was considerable current unbalance (phase C current being 30% less than phase A) that was due to unknown causes.

Fig. 3.2. SEL relay data showing voltage and current waveforms at time of trip.

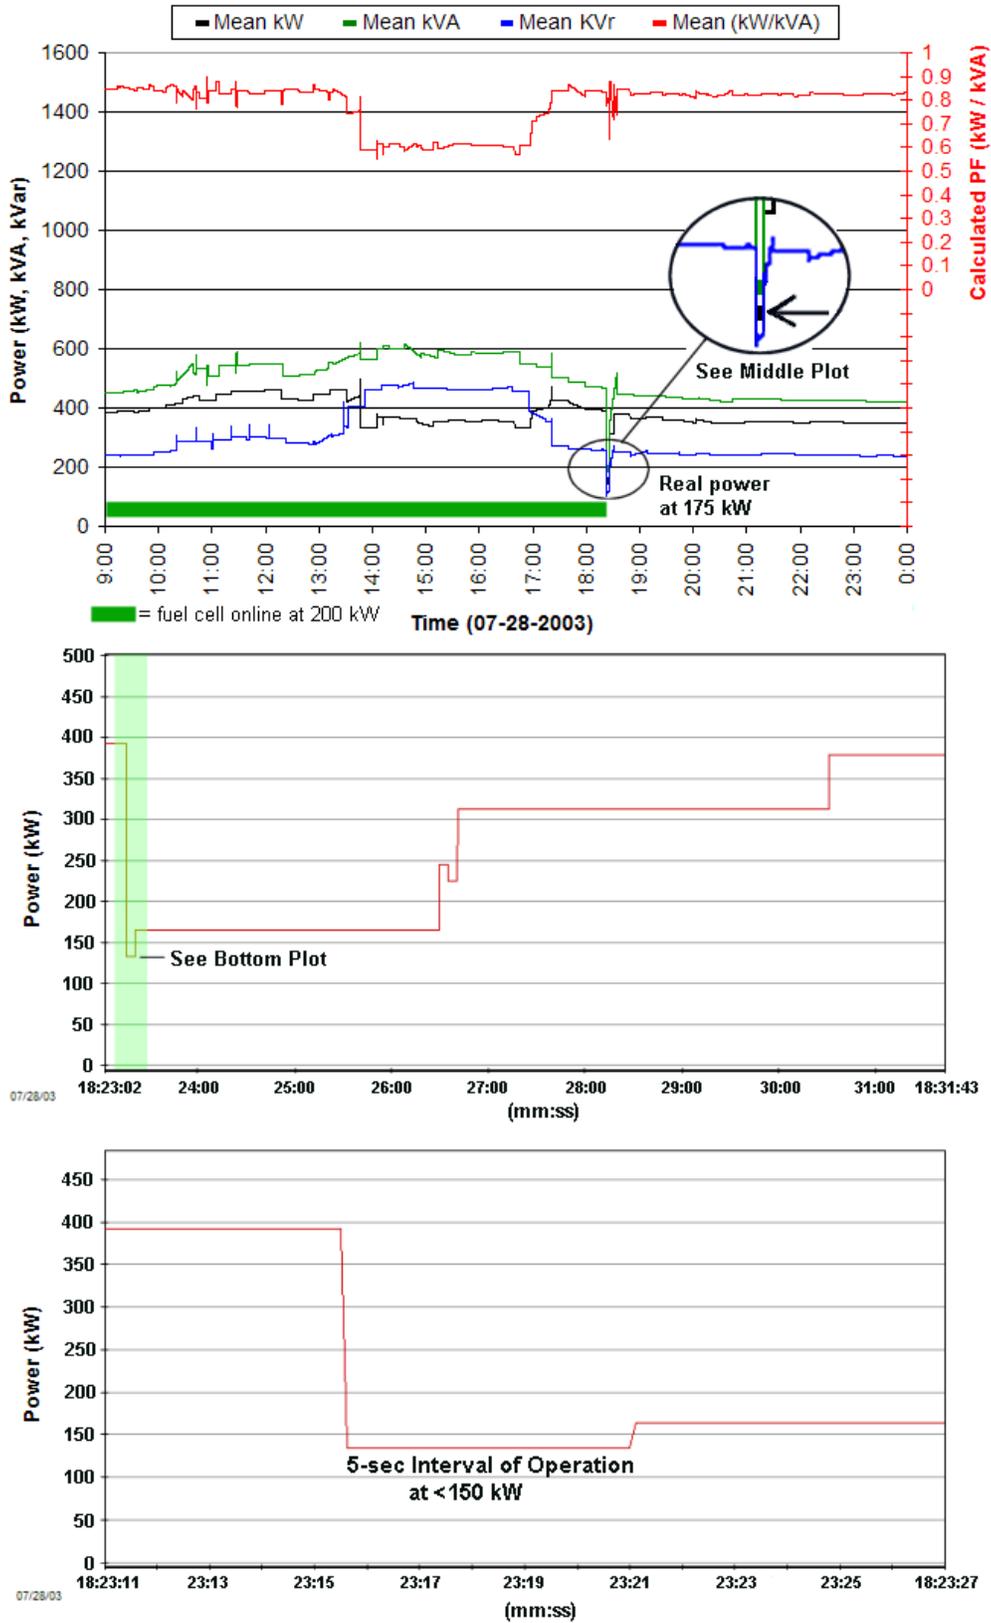
Fig. 3.3. NTRC building load and PF data for July 28, 2002.

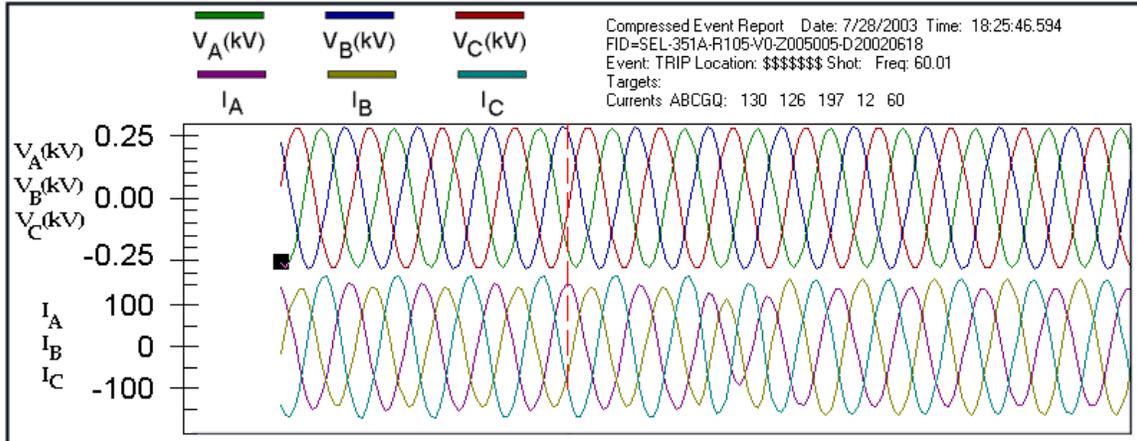
**Fig. 3.4. Waveform data for the July 28 event provided by the SEL relay.**

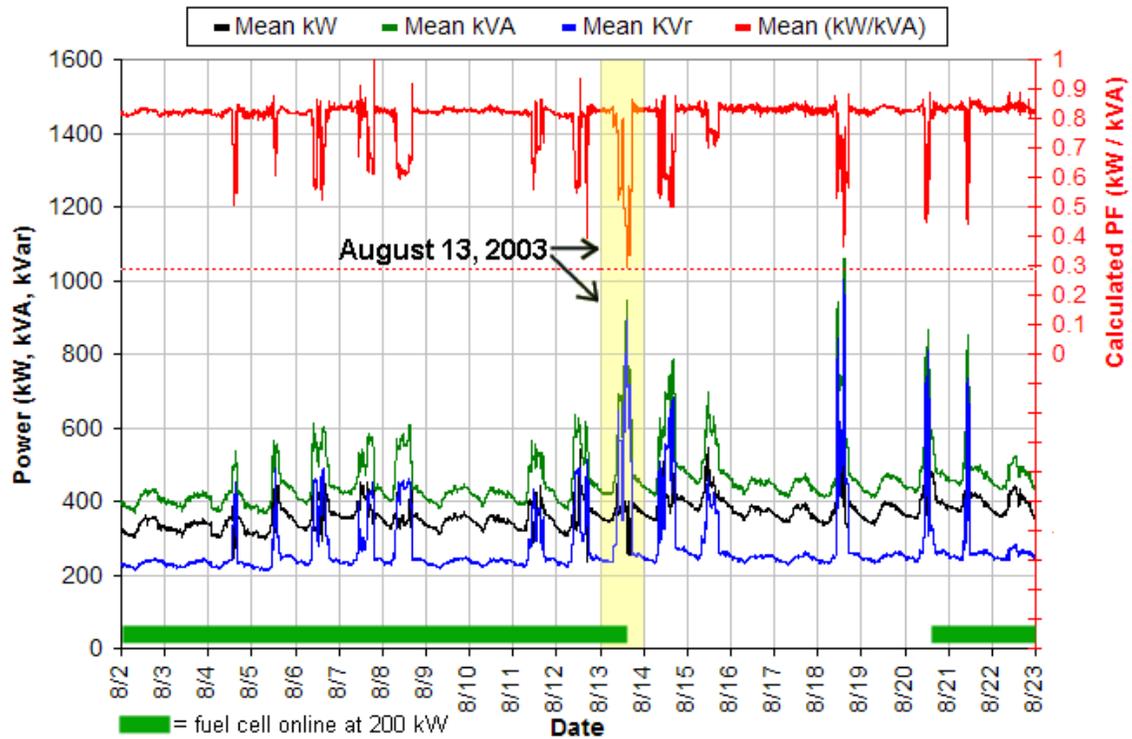
Fig. 3.5. NTRC building load electrical data (August 2003).

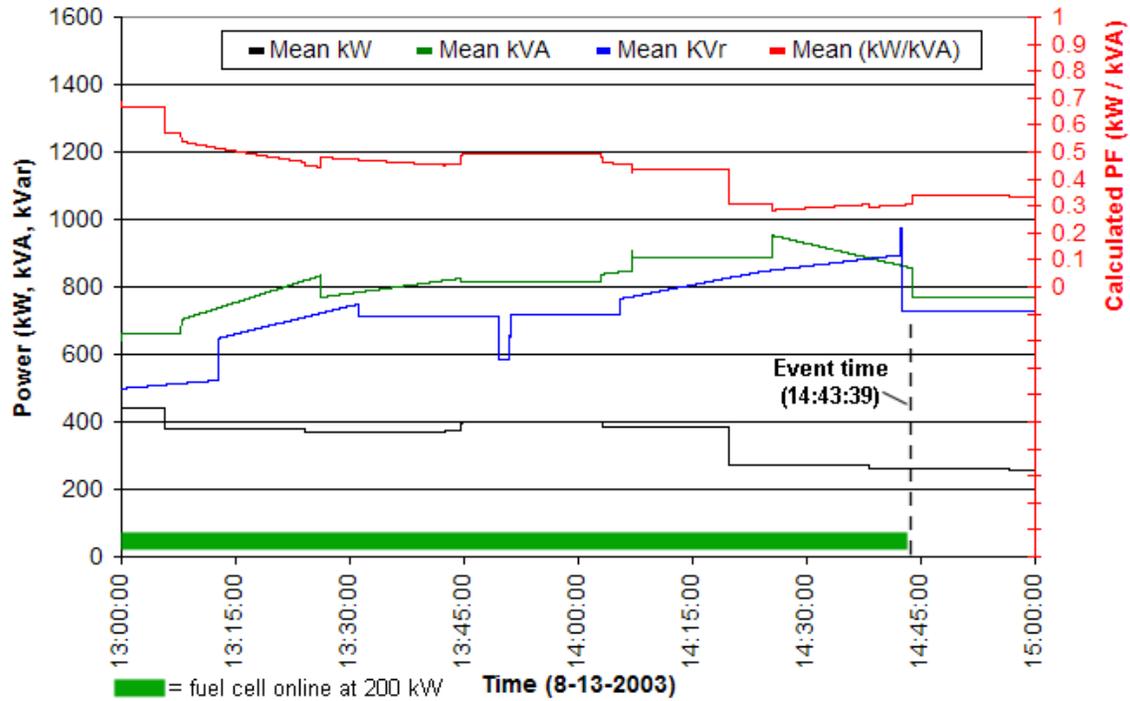
Fig. 3.6. NTRC building load electrical data for 2-hr period on August 13.

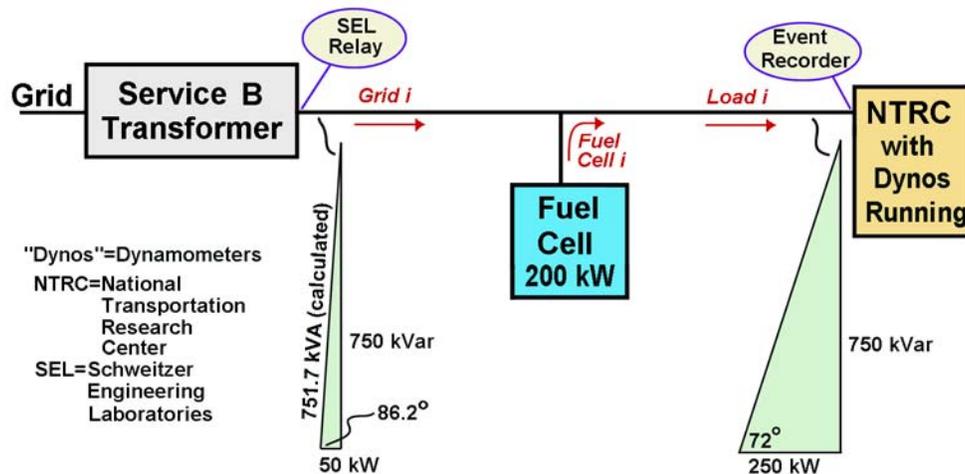
Further analysis can be aided by looking at the overall system (Fig. 3.7). The power plot showed that the reactive power level was 750 kVar at the time of the event. Although measured at Panel B, it also applies to the transformer location, because the fuel cell supplies only real power. The building was consuming 250 kW, of which the grid was supplying only 50 kW. This produces lagging current phase angles at the transformer and NTRC of 86.2° and 72°, respectively. Another effect of dynamometer operation is the production of very high levels of harmonic distortion (especially the fifth harmonic). Thus it is postulated that the SEL relay trip occurred because the monitor made an ~4° phase error for 5 sec because of the harmonic currents and interpreted the 86.2° lag as a ~90° lag. This solves the problem of the high reverse currents that the fuel cell could not have produced; they were actually forward currents, and they were high because of the high levels of reactive power during dynamometer operation.

Fig. 3.7. System view of the August 13 event during high reactive power demand.

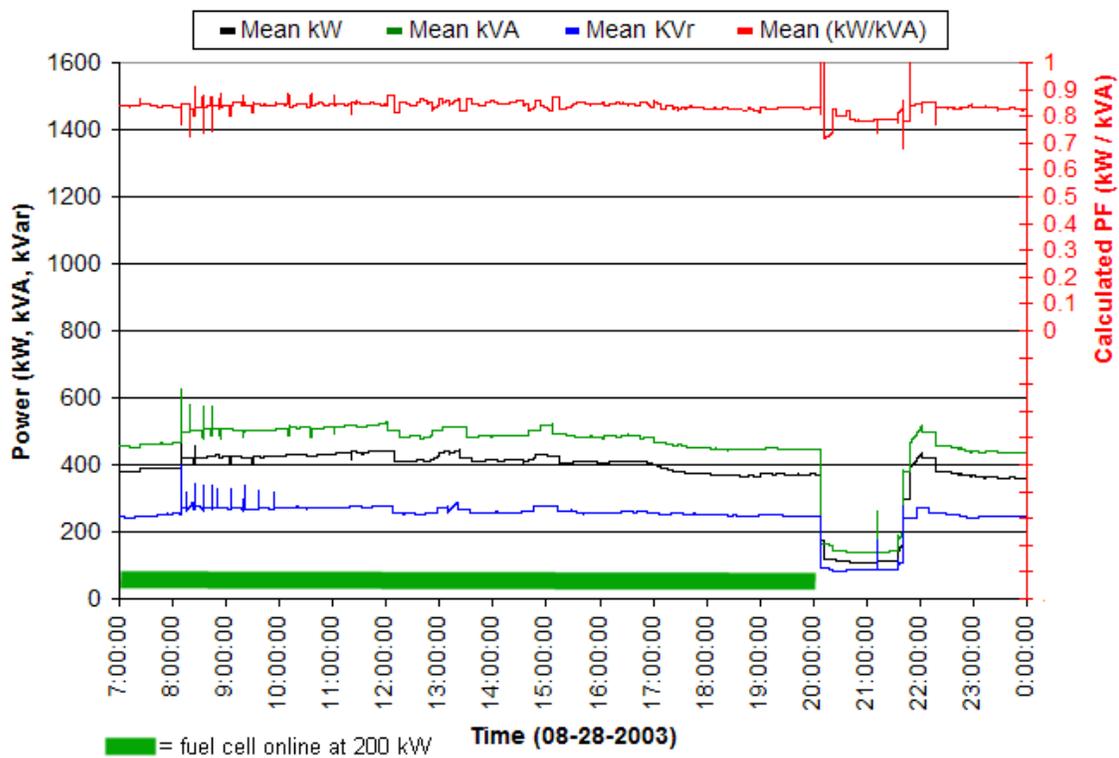
Fig. 3.8. NTRC building load electrical data for 17-hr period on August 28.

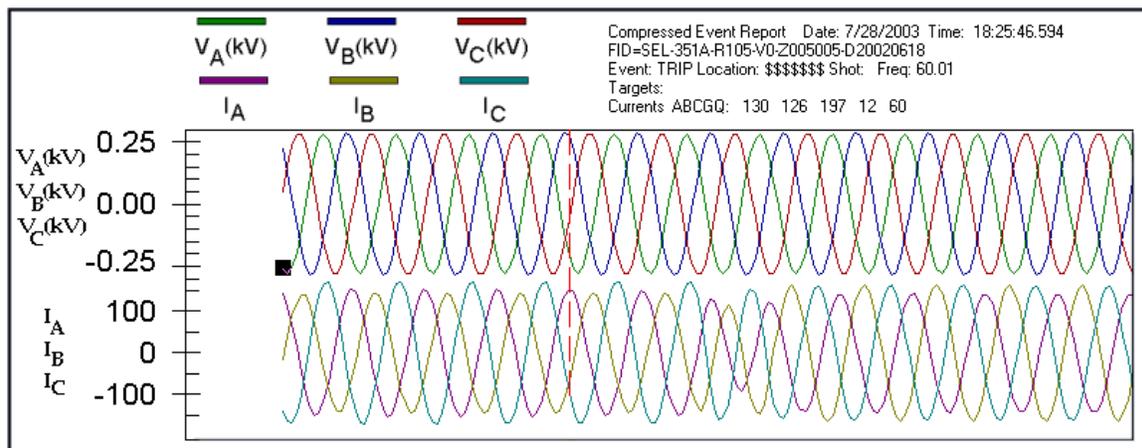
The SEL relay produced waveform data (see Fig. 3.9) at the end of the 5-sec timed interval showing that the phase differential between the voltage and the current (as viewed at the Service B transformer) was >90°. The phase differential was due to the fuel cell’s real output power level, which more than offset the real power demand of the NTRC loads. Thus, the excess real power flowed back into the LCUB distribution system.

Fig. 3.9. Waveform data for the August 28 event provided by the SEL relay.

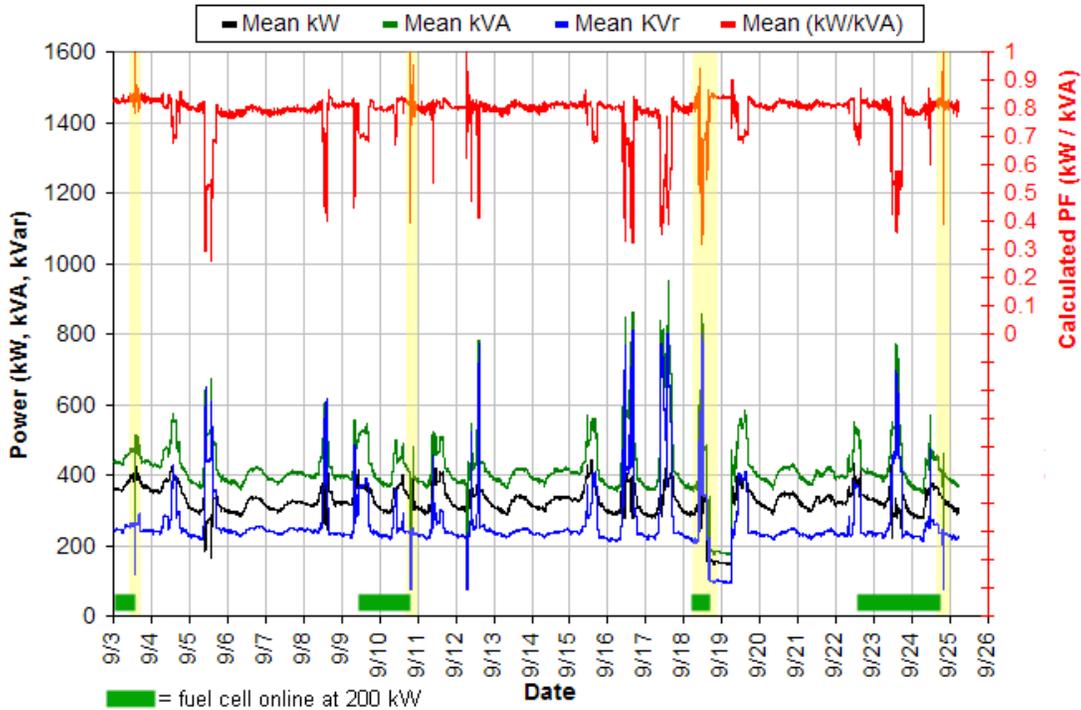
September was an eventful month in which there were a number of severe PF excursions and severe drops in NTRC power levels, as indicated in Fig. 3.10. Note that, as expected, the low-PF excursions correspond to high peaks in apparent and reactive power. The four disconnect events for the month are highlighted in yellow. As indicated by the green bar at the bottom of the plot, the percentage of the month when the fuel cell was grid-connected and producing 200 kW was small. This situation was due to delays in getting a reset of the SEL and lockout relays from the utility and the continuing setbacks in efforts to get load tracking operable.

Fig. 3.10. NTRC building load electrical data (September 2003).

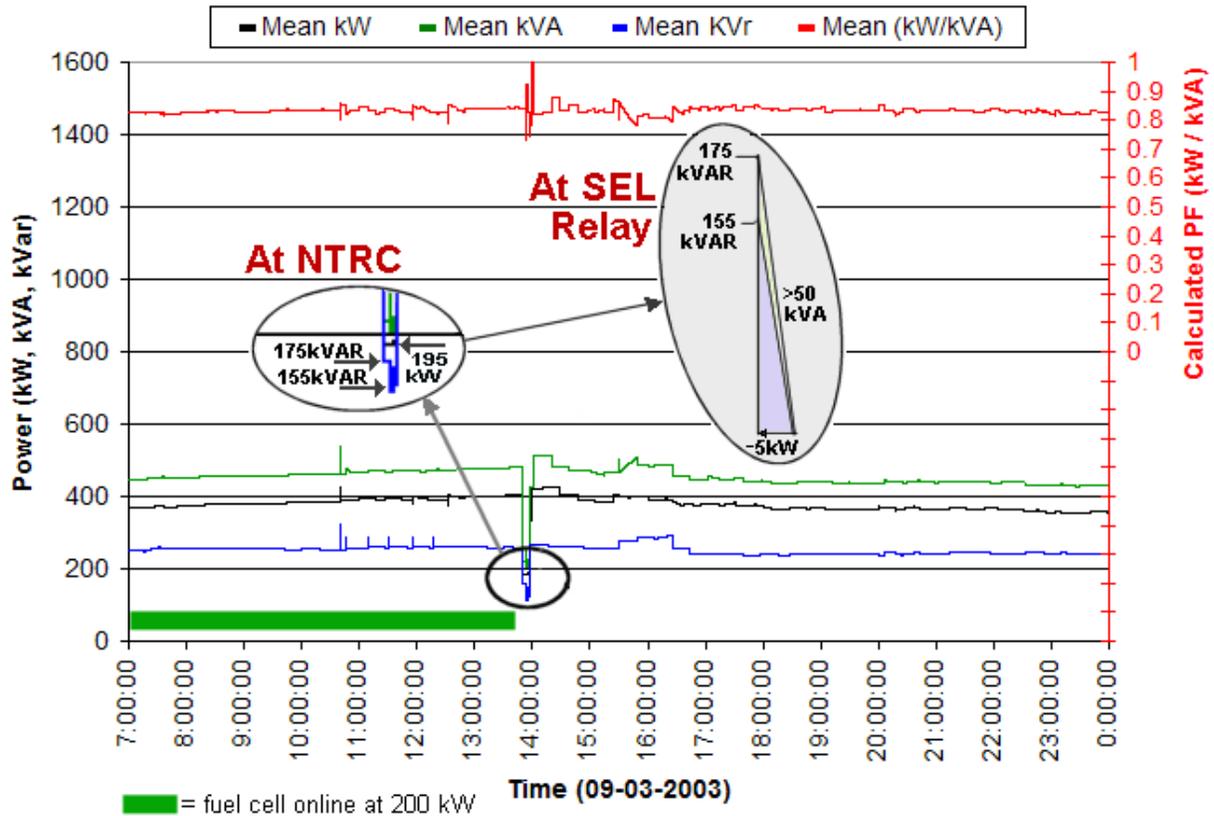
before 2 p.m., the real power, shown in black, dropped from about 400 kW to 195 kW for 10 min. This building load drop, as confirmed in a detailed review of the data, did not involve apparent power dropping any lower than 200 kVA but real power dropped to 195 kW which would have caused a small amount of reverse real power flow. As detailed in Fig 3.11, the SEL relay at the Service B transformer would have seen this small reverse power flow and a much higher amount of reactive power. By inspection, the diagram makes clear that the apparent power was over the 50 kVA trip limit by more than a factor of 3. Hence the power, time, and phase angle requirements were all met for a RPR trip.

Fig. 3.11. NTRC building load electrical data for 17-hr period on September 3.

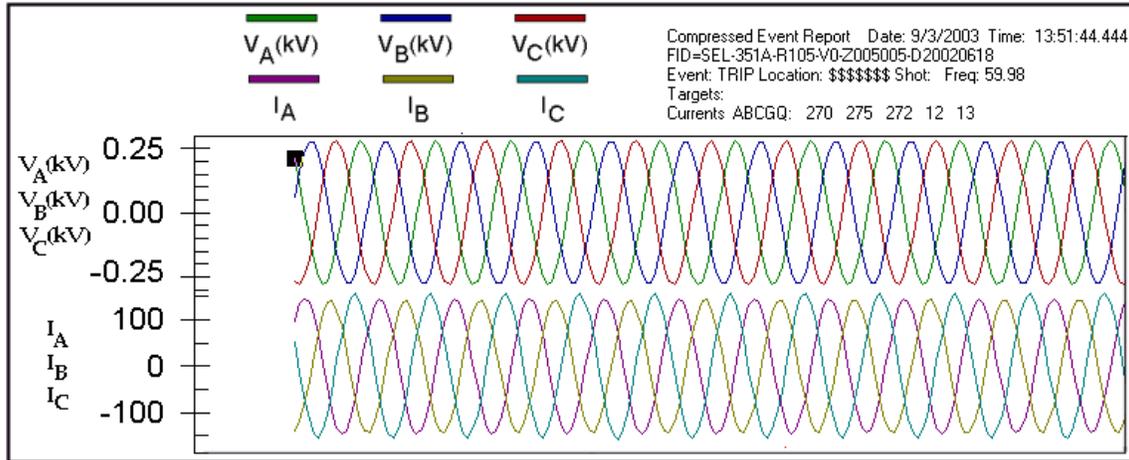
This event is of special interest since it clearly shows how conditions were met for a trip based on the SEL load encroachment logic for reverse impedance while the more commonly used Device 32 reverse power function, if set for 50 kW, would *not* have tripped. In IFC’s 25 other installations of its fuel cell where the local utility requires an RPR protection scheme, Device 32 is used. The protection scheme used in this study trips based on an apparent power limit with *no* limit on how small real reverse power may be.

Fig. 3.12. Waveform data for the September 3 event provided by the SEL relay.

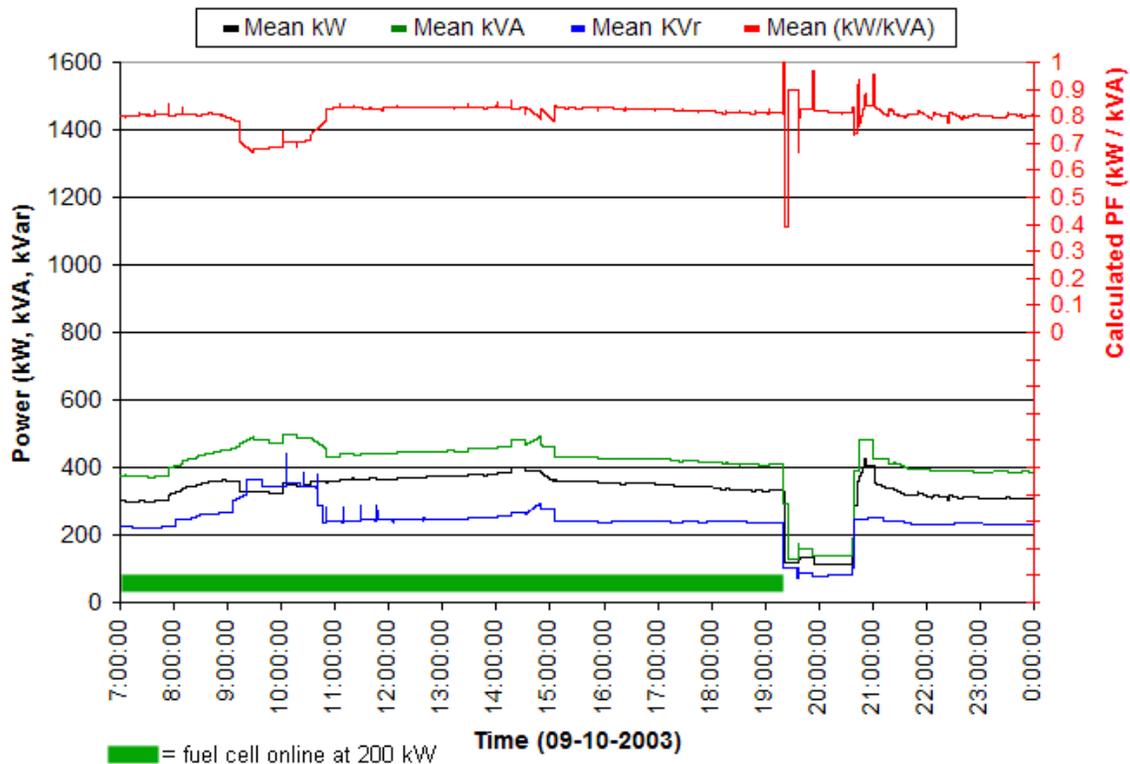
The building load data for September 10 are shown in Fig. 3.13. The fuel cell was programmed to deliver full power. At about 7:13 p.m., the real power, shown in black, dropped from about 330 kW to 110 kW for almost 1.5 h possibly due to trips of the chiller and other building loads (unknown initiating event). The PF briefly dropped to 0.4 at the onset of this event. The drop in building load was sufficient (i.e., to a level <150 kW) to cause a reverse power condition because the fuel cell load tracking was not operable. There was roughly 120 kVA of apparent power in the reverse direction, more than twice the amount needed for a trip. The SEL relay recorded currents in the 3 phases of 241, 248, and 236 A with a 120° lagging phase angle at the end of the 5-sec timed interval. Waveforms appeared normal.

Fig. 3.13. NTRC building load electrical data for 17-hr period on September 10.

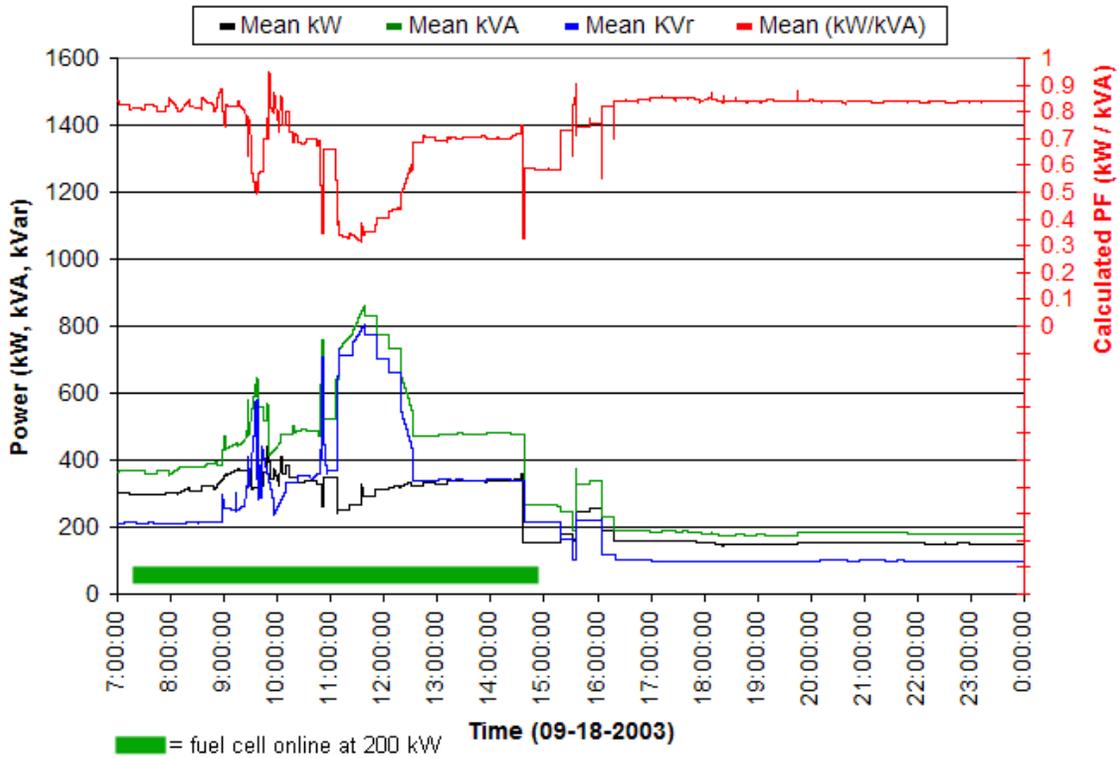
for most of an hour. There was likely some level of dynamometer operation during this hour. The power drop itself was to a low enough level that a >50-kVA reverse power situation resulted. It appears that the fuel cell was not able to load-track (for unknown reasons) and therefore an SEL relay trip occurred during the drop in load.

**Fig. 3.14. NTRC building load electrical data for 17-hr period on September 18.**

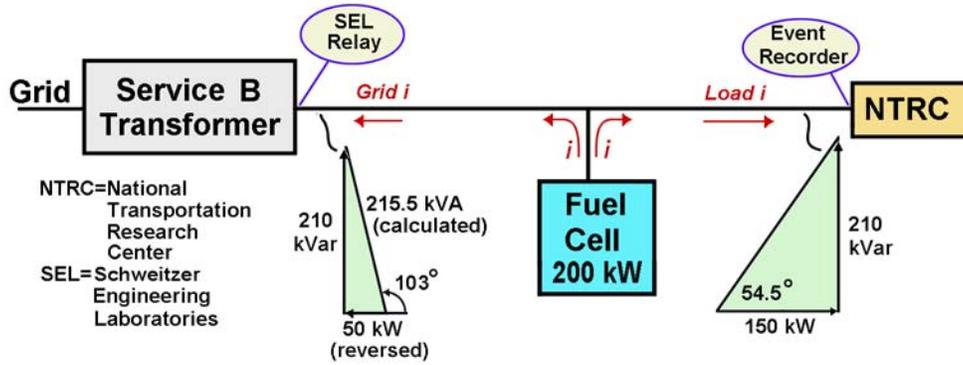
The SEL relay recorded currents in the 3 phases of 296, 296, and 302 A at the end of the 5-sec timed interval. Waveforms appeared normal. Figure 3.15 shows that the reverse power flow at the transformer resulted in a  $103^\circ$  current phase angle lag condition ( $13^\circ$  into the reverse power region). Apparent power is calculated to have been 215.5 kVA at the SEL which is more than 4 times the amount required for a RPR trip. The high reactive power during the event, evident both in the building and at the transformer, was also a likely reason that the reverse current levels were higher than in nearly all other events, but its global applicability is reduced by dynamometer operation (see Sect. 2.3.4).

Fig. 3.15. System view of the September 18 event with reverse power flow.
