## **Compatibility Study of Protective Relaying in a Grid-Connected Fuel Cell**

**R. H. Staunton**

Oak Ridge National Laboratory, Oak Ridge, Tennessee

March 2004

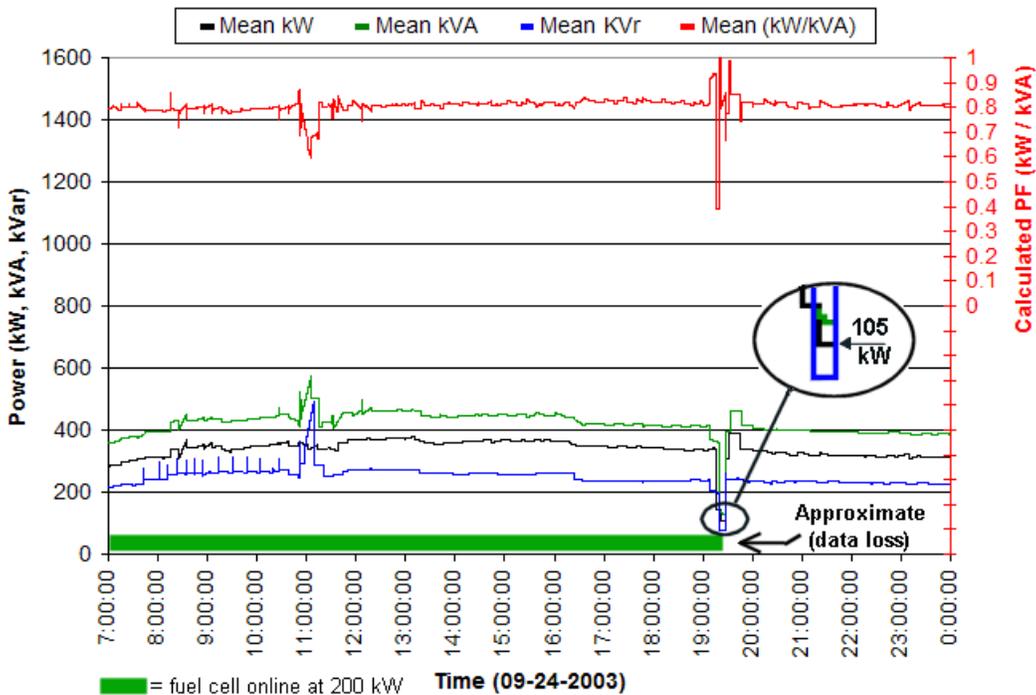
Based on the building load data shown in Fig. 3.16, the event occurred at about 7:15 p.m. when the PF plunged to 0.4 very briefly (i.e., less than 5 sec) and the real, apparent, and reactive power levels fell for a more significant period of time (i.e., about 10 min). During the power drop, the real power fell well below 200 kW, which, in the absence of load tracking, would have caused a reverse power situation. The apparent power remained above 100 kVA, easily satisfying the power requirement for the SEL relay trip.

Fig. 3.16. NTRC building load electrical data for 17-hr period on September 24.

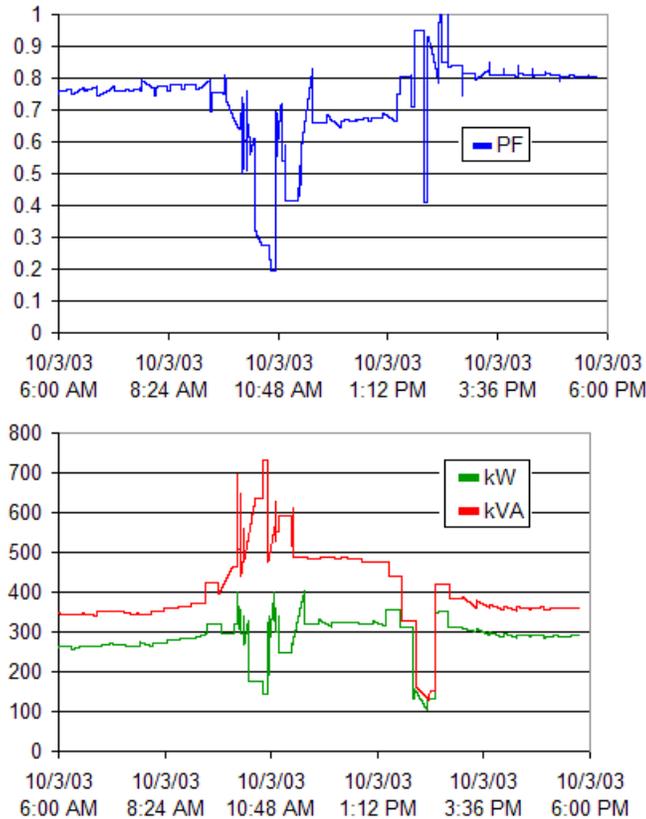
**Fig. 3.17. NTRC electrical data for October 3, 2003.**

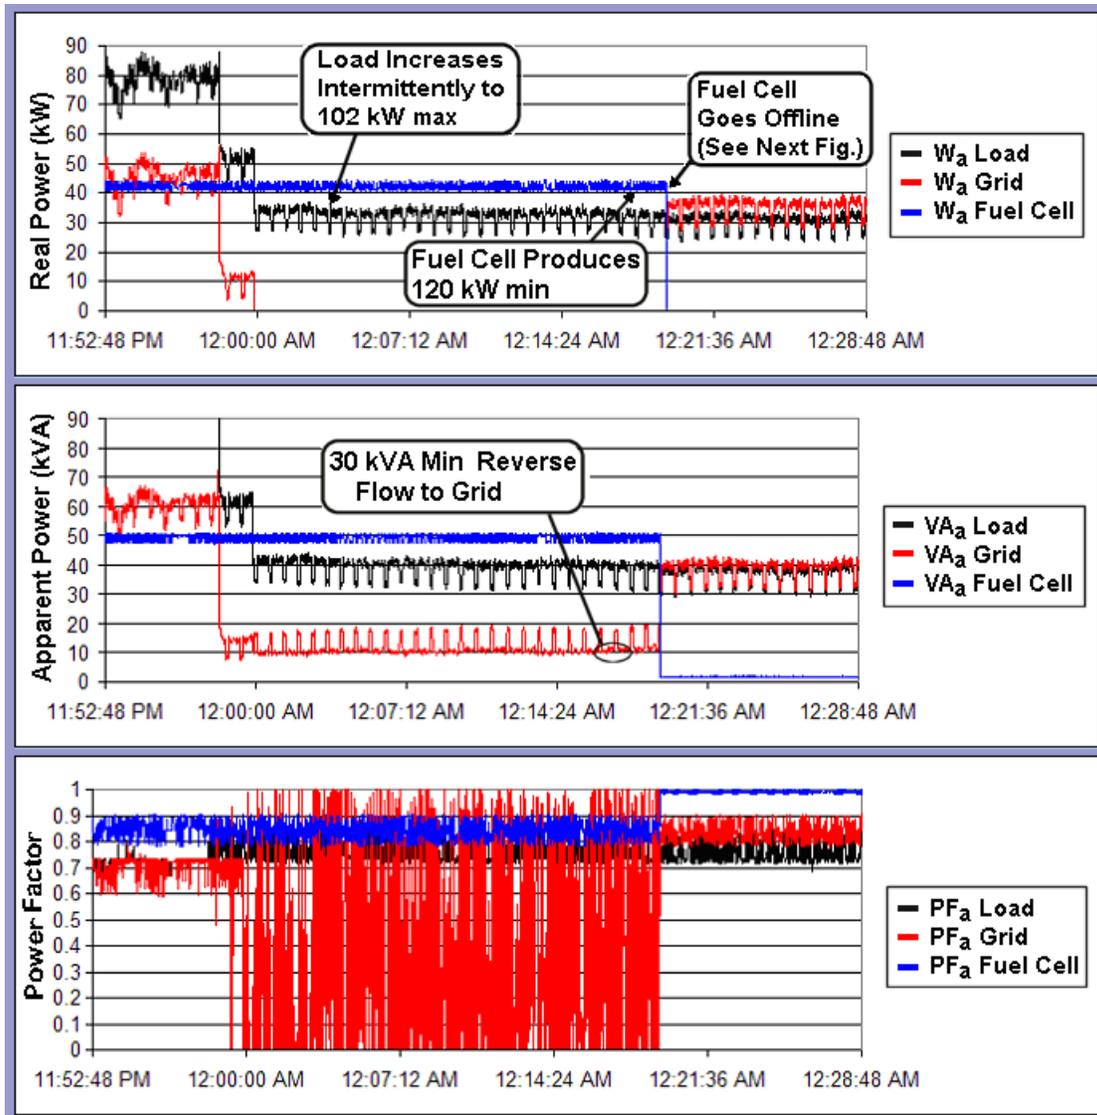
Figure 3.18 shows the plots of real power, apparent power, and PF at the time of the November 14 event. Note that the times indicated by the data logger are 1 h later than actual because the logger had not been updated from EDST to EST. The building load level (black plot line) dropped from ~80 kW to ~30 kW per phase (phase A being shown in the plots) because the building chiller was set to cycle off via a timer switch during the month of November. Once the building load dropped to ~30 kW, another device in the

Fig. 3.18. November 14 event plots of real and apparent power and power factor.

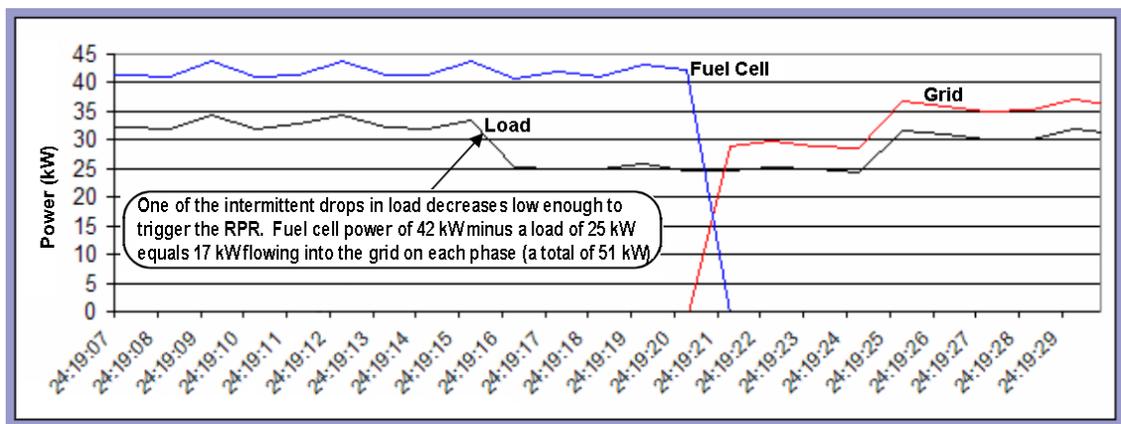
Figure 3.19 is a zoomed-in portion of the first plot of Fig. 3.18 showing the precise real power conditions at the time when the reverse power trip limit was reached. The fuel cell was operating at a fixed output of 125 kW. It appears that a trip *may* have occurred even if Device 32 protection set at 25 kW was used.

**Fig. 3.19. Precise seconds at which the reverse power limit was reached.**

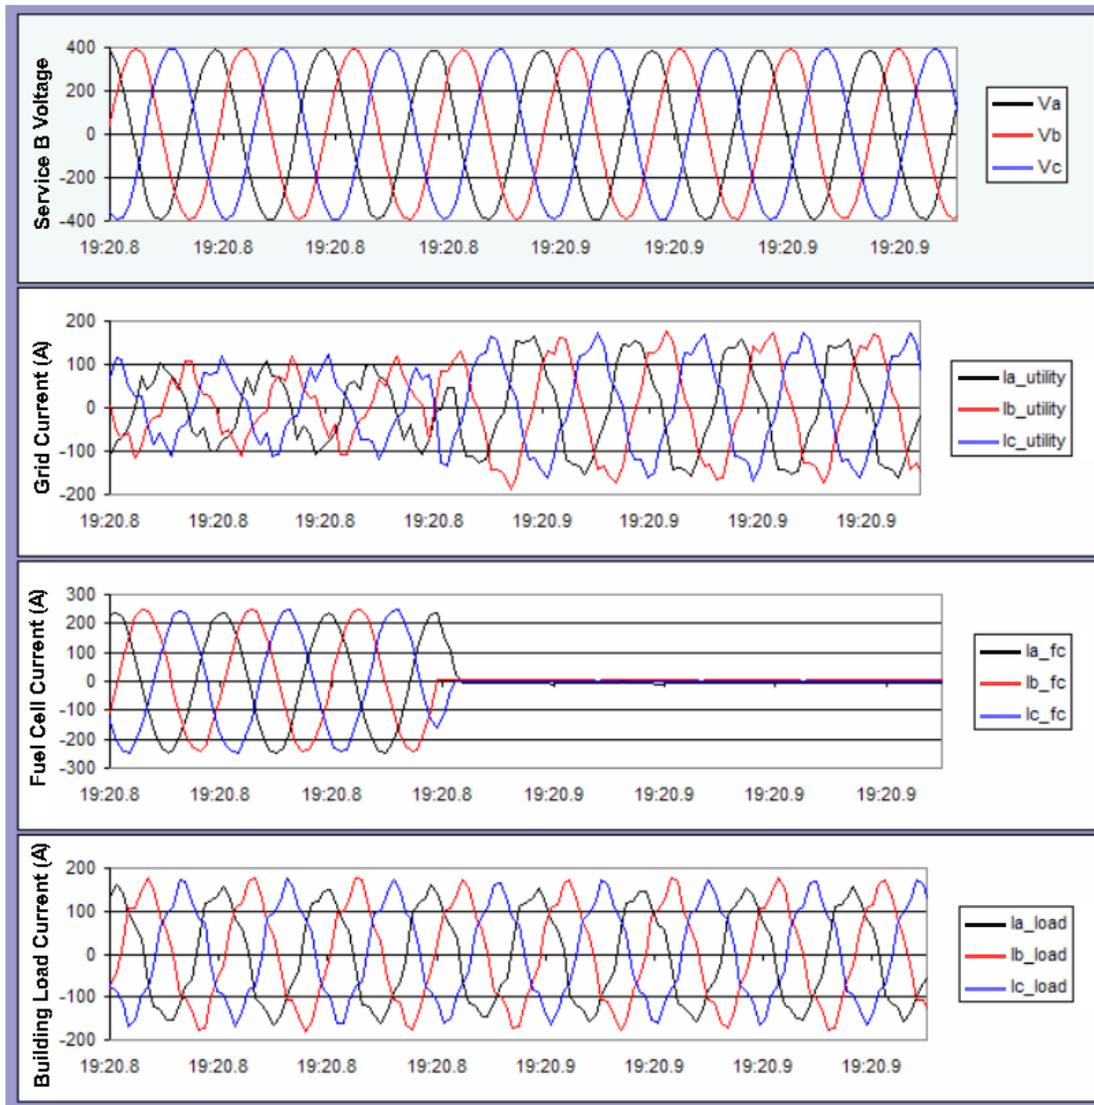
Fig. 3.20. Time plots of the Service B voltage and three corresponding currents.

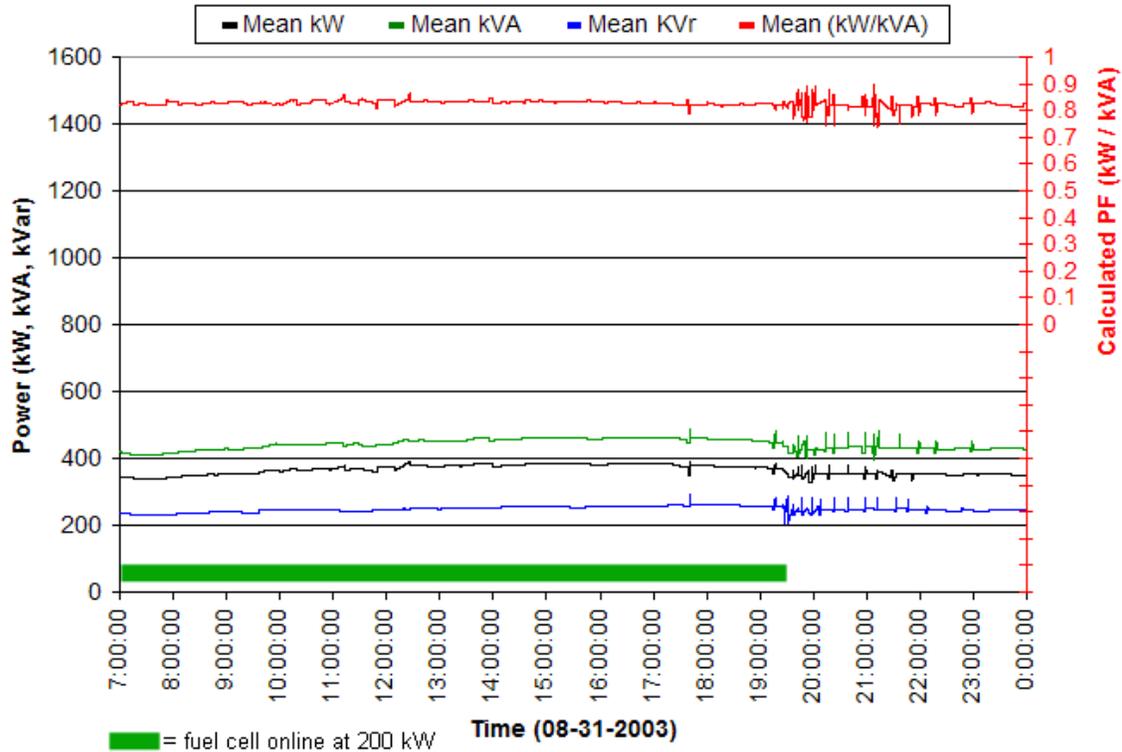
The electrical storm in progress at the time of the event is evident in the building load electrical data plot shown in Fig. 3.21. Based on the figure, it appears that the event occurred near the beginning of a series of electrical transients lasting at least 3 h.

Fig. 3.21. NTRC building load electrical data for 17-hr period on August 31.

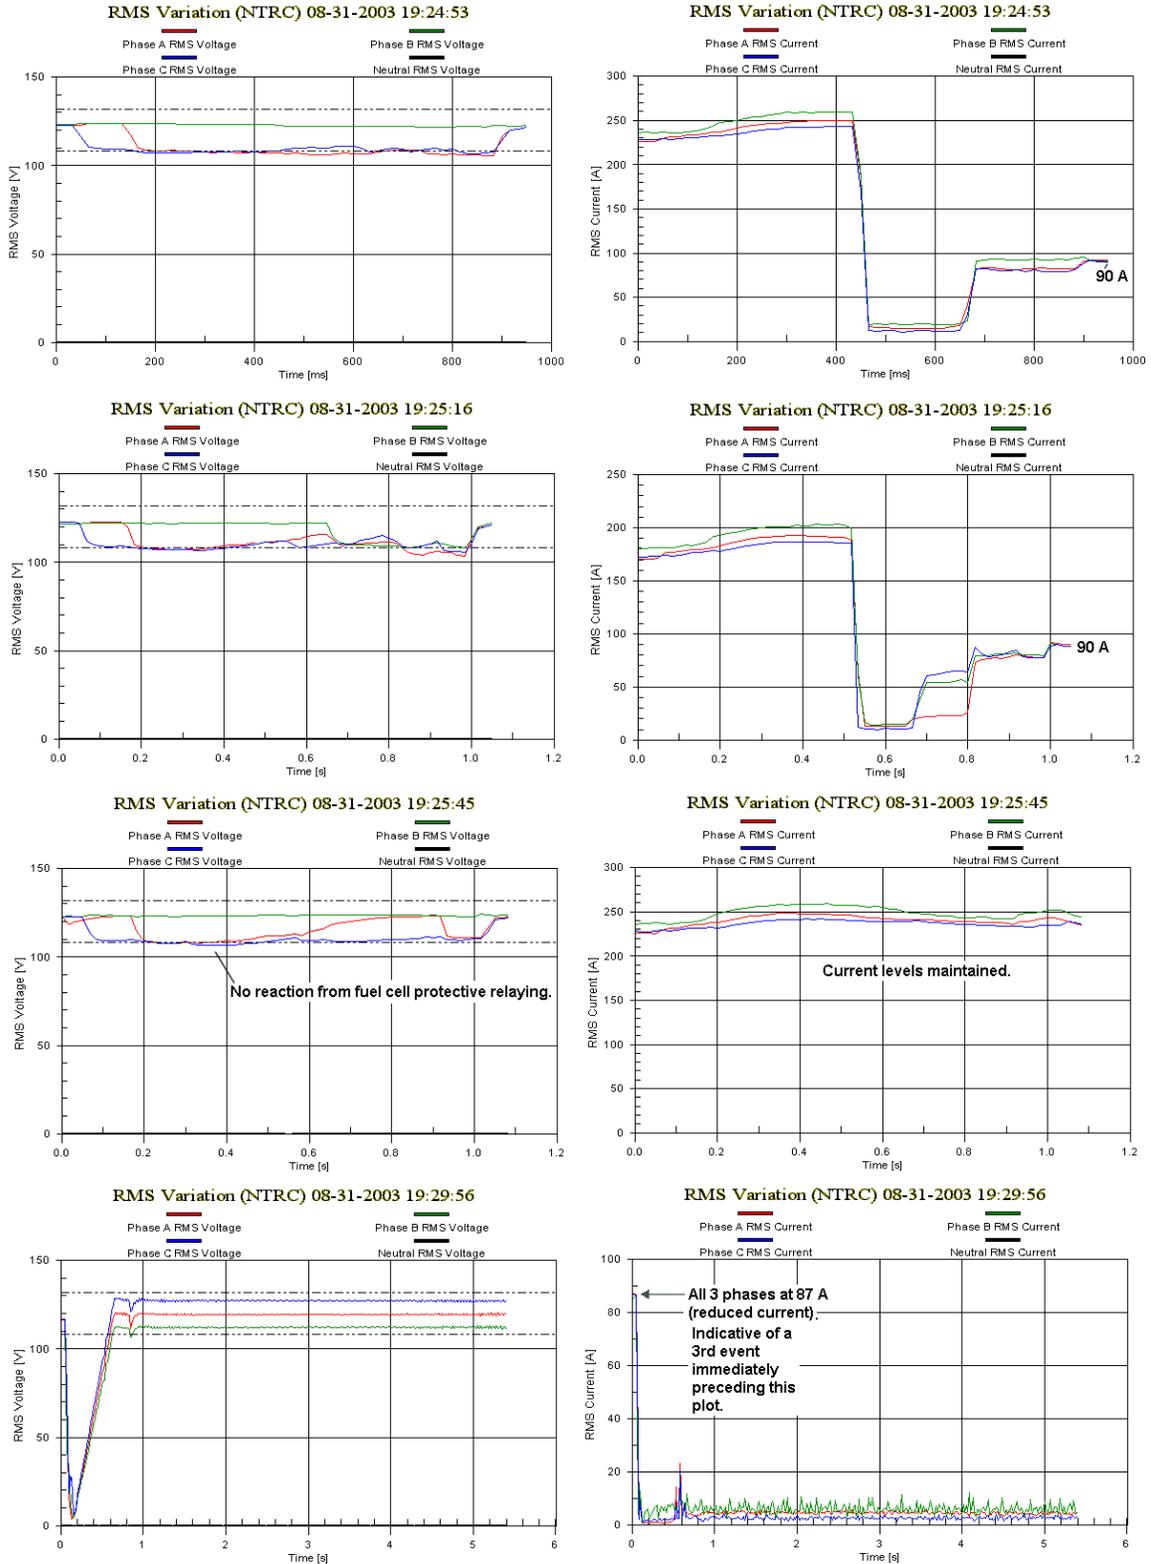
Fig. 3.22. Event data from fuel cell monitor showing three voltage unbalance events (left column) and shutdown. Corresponding current data shown on right.

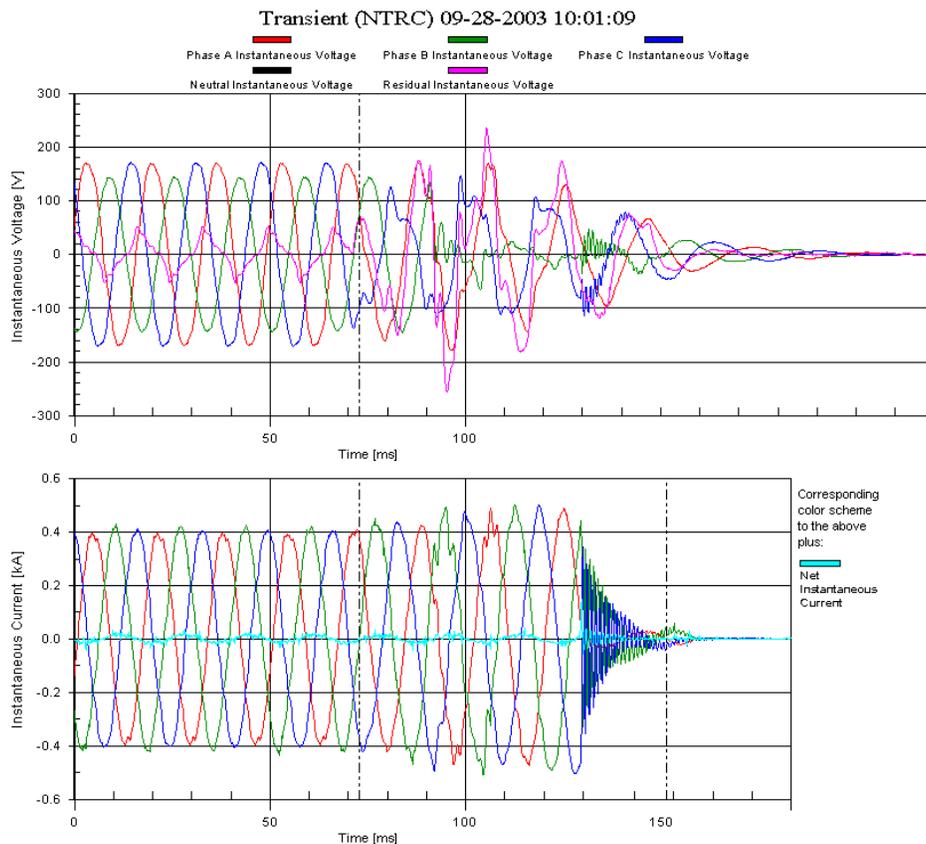
Figure 3.23 shows the inverter output waveforms recorded during shutdown as captured by the event recorder located in the fuel cell cabinet. These plots, as dramatic as they are, are provided only to emphasize the contrasting, continuous-power condition that prevailed in the NTRC. Events such as this one that occur with a normal grid are entirely *seamless* to the NTRC occupants and operations, since the grid picks up the load instantaneously.

**Fig. 3.23. Shutdown event V and I waveforms resulting from UPS inverter failure.**

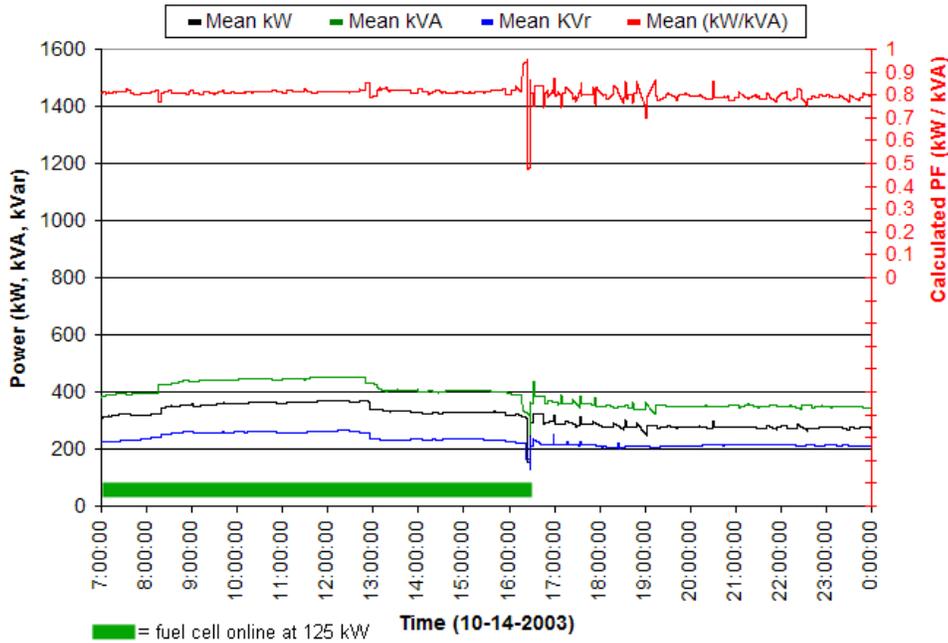
The October 14 event was one of a very few during which the interruption to fuel cell operation coincided with a noticeable flickering of the lights in the NTRC. It was the first outage since the UPS replacement, quarterly maintenance, and the beginning of operation at reduced power (i.e., 125 kW). Wind gusts and a storm system were in the general area. The interruption to fuel cell operation occurred during a grid voltage variation and during resulting grid-induced drops in power and PF, as shown in the building power and PF plot in Fig 3.24.

**Fig. 3.24. NTRC building load electrical data for 17-hr period on October 14.**

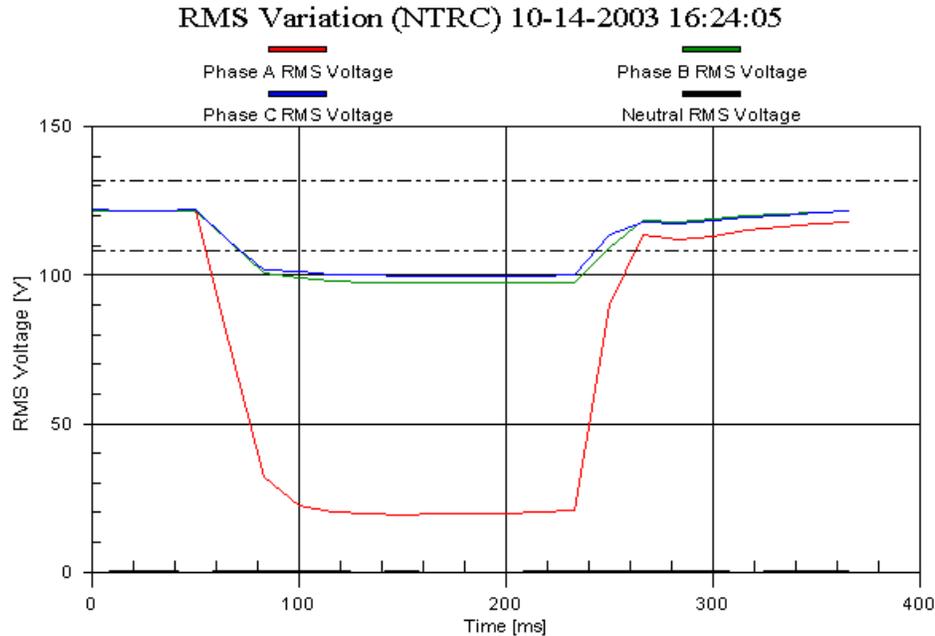
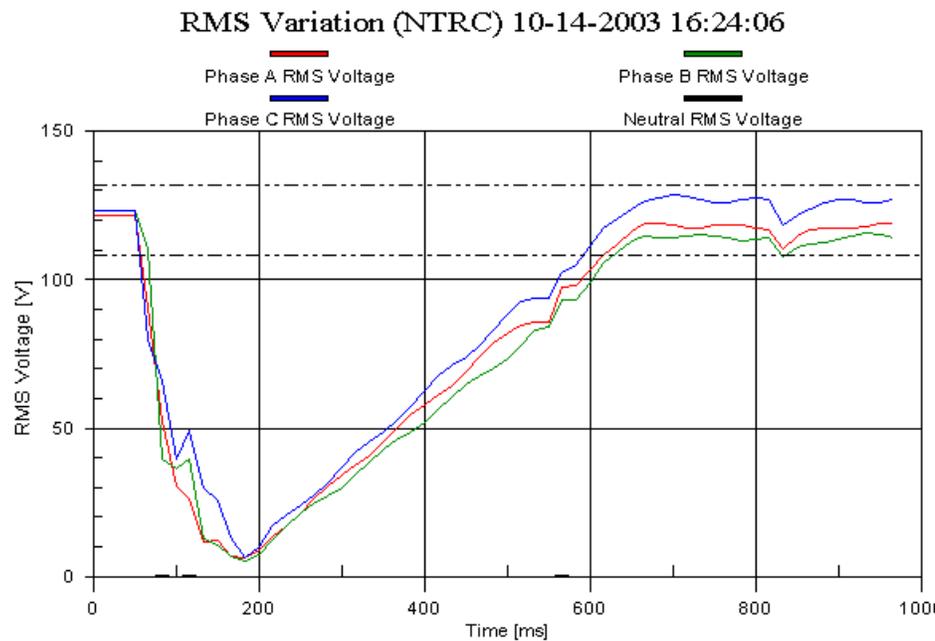
Figure 3.25 shows that a single-phase voltage drop occurred in the NTRC grid power at 16:24:05, and the second plot in the figure shows a 3-phase voltage drop 1 sec later. Thus the entire event was over in approximately 2 sec. Data obtained from an i-sense voltage sensor located near the Service B transformer cabinet also indicated that the event occurred within 2 or 3 sec.

Fig. 3.25. NTRC building voltage data for October 14.

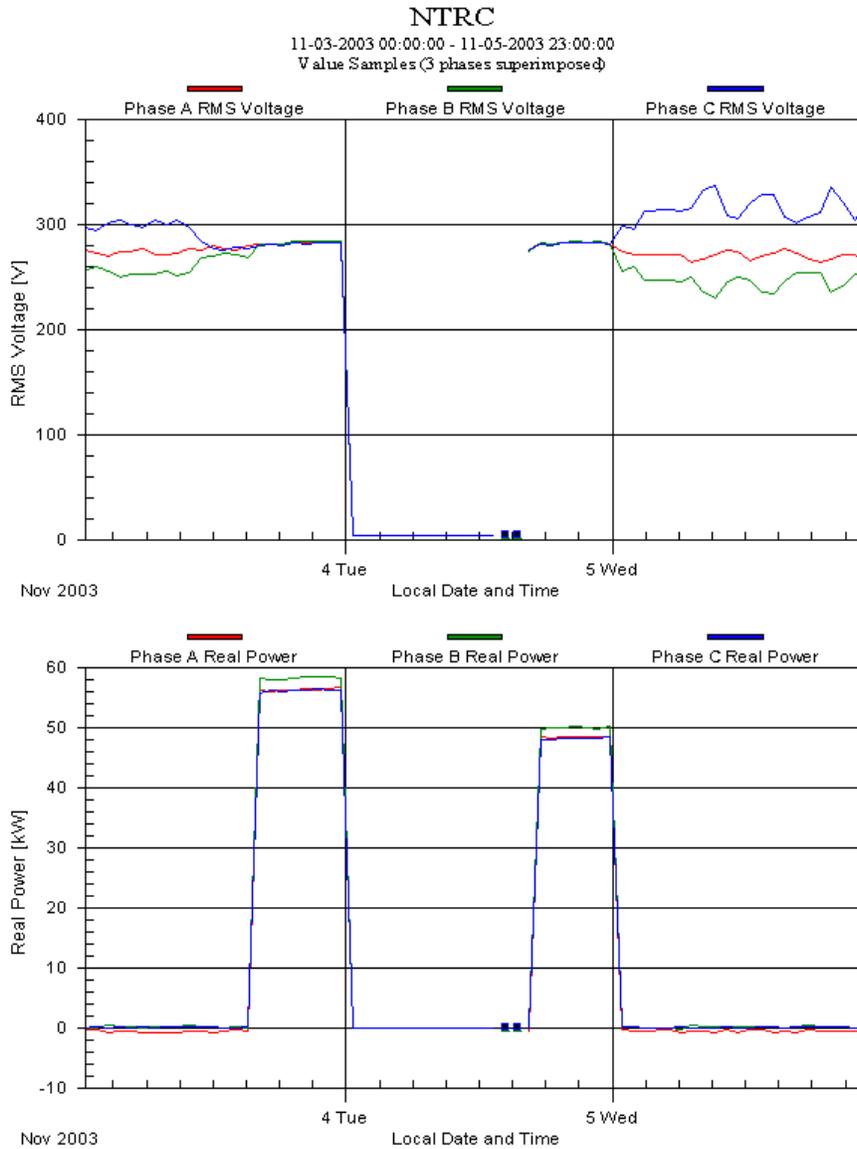
Figure 3.26 shows the low-resolution voltage and real power plots from the fuel cell monitor (inverter output) indicating the loss of generation only minutes into November 4. It also shows another outage late in the day that was an SEL relay trip event (see Sect. 3.2.12).

**Fig. 3.26. RMS V and real power generated from fuel cell on November 3–5.**

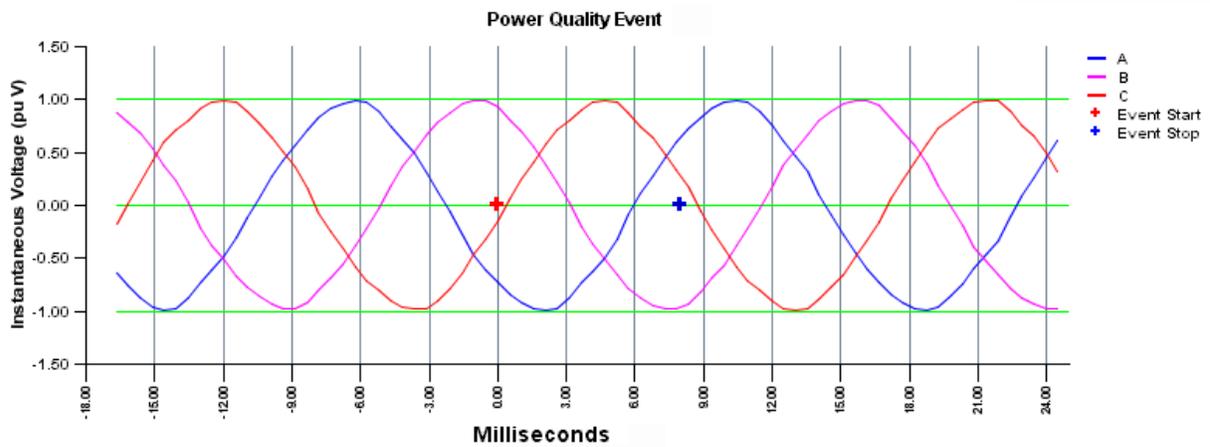
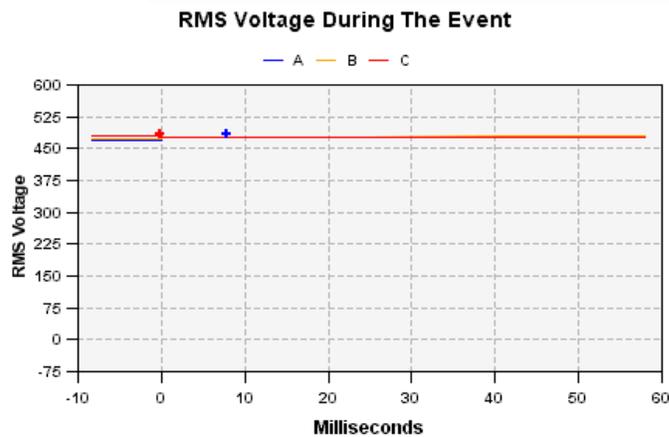
Channel	Min	Max	Worst Case RMS as % of Nominal
1	469.1	479.1	97.7%
2	472.2	478.1	98.4%
3	474.7	479.2	98.9%

Fig. 3.27. Voltage transient data from i-grid for the first of three transients.

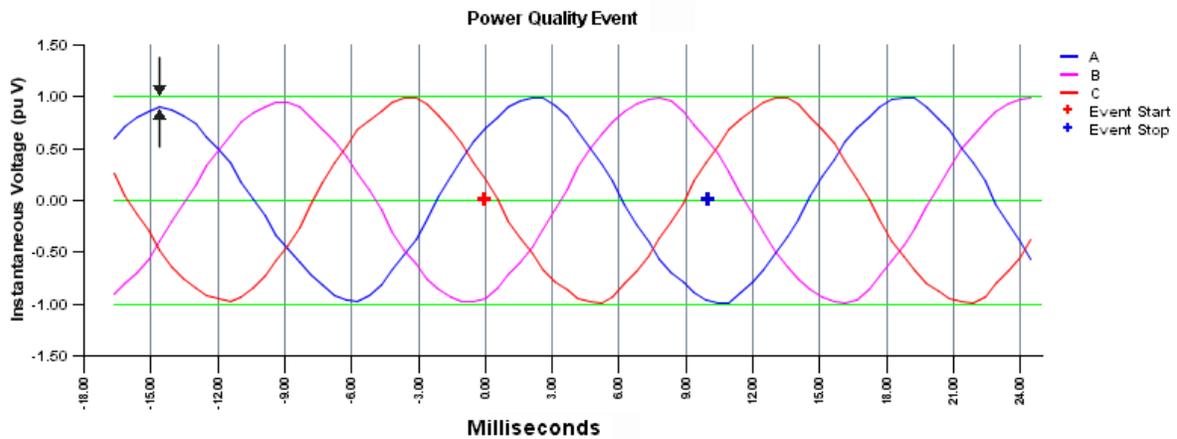
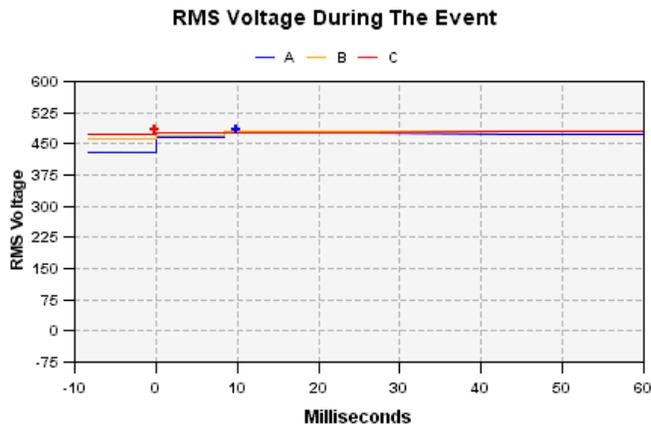
Channel	Min	Max	Worst Case RMS as % of Nominal
1	427.9	479.6	89.1%
2	463.5	479.2	96.6%
3	472.3	478.5	98.4%

Fig. 3.28. Voltage transient data from i-grid for the second of three transients.

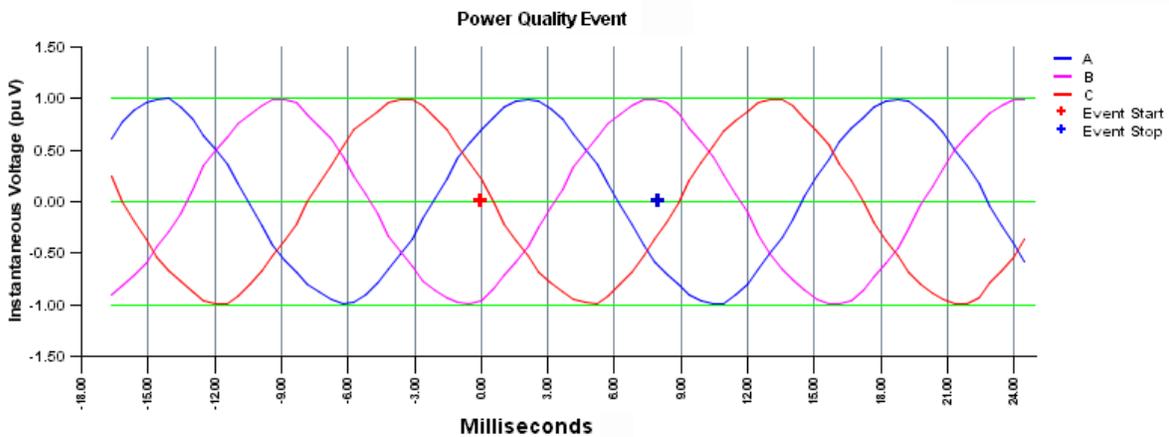
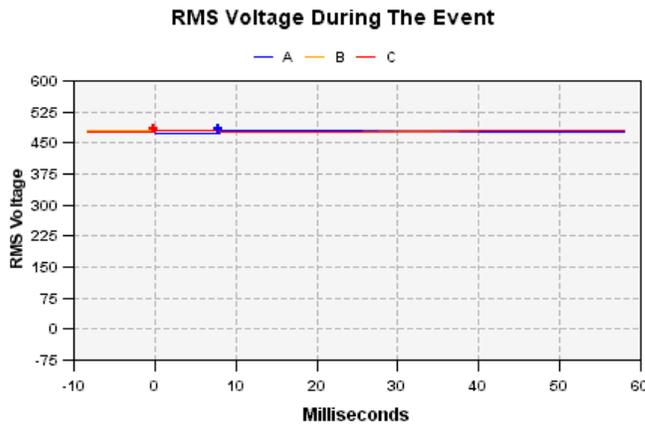
Channel	Min	Max	Worst Case RMS as % of Nominal
1	473.5	478.8	98.7%
2	477.5	479.5	99.5%
3	475.9	481.4	99.1%

Fig. 3.29. Voltage transient data from i-grid for the third of three transients.

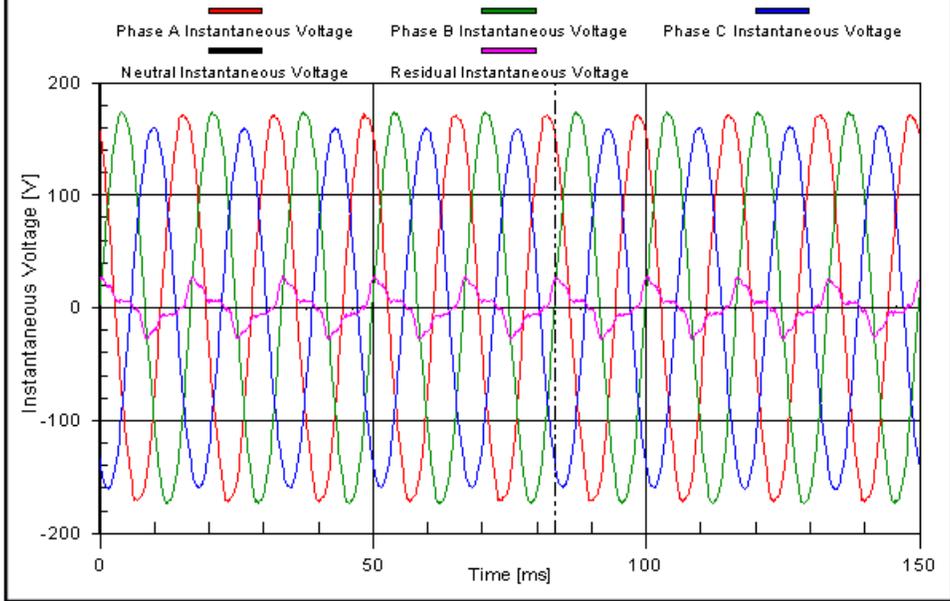
Channel	Negative Peak	Positive Peak	Duration	Rise Time	Principle Freq
Va Inst	-171.81	172.44	3.99 Cyc	6.2500	180.0
Vb Inst	-173.83	174.67	3.99 Cyc	3.5156	300.0
Vc Inst	-161.46	161.88	3.99 Cyc	1.5625	180.0

Fig. 3.30. Partial example of a December 14 voltage unbalance transient.

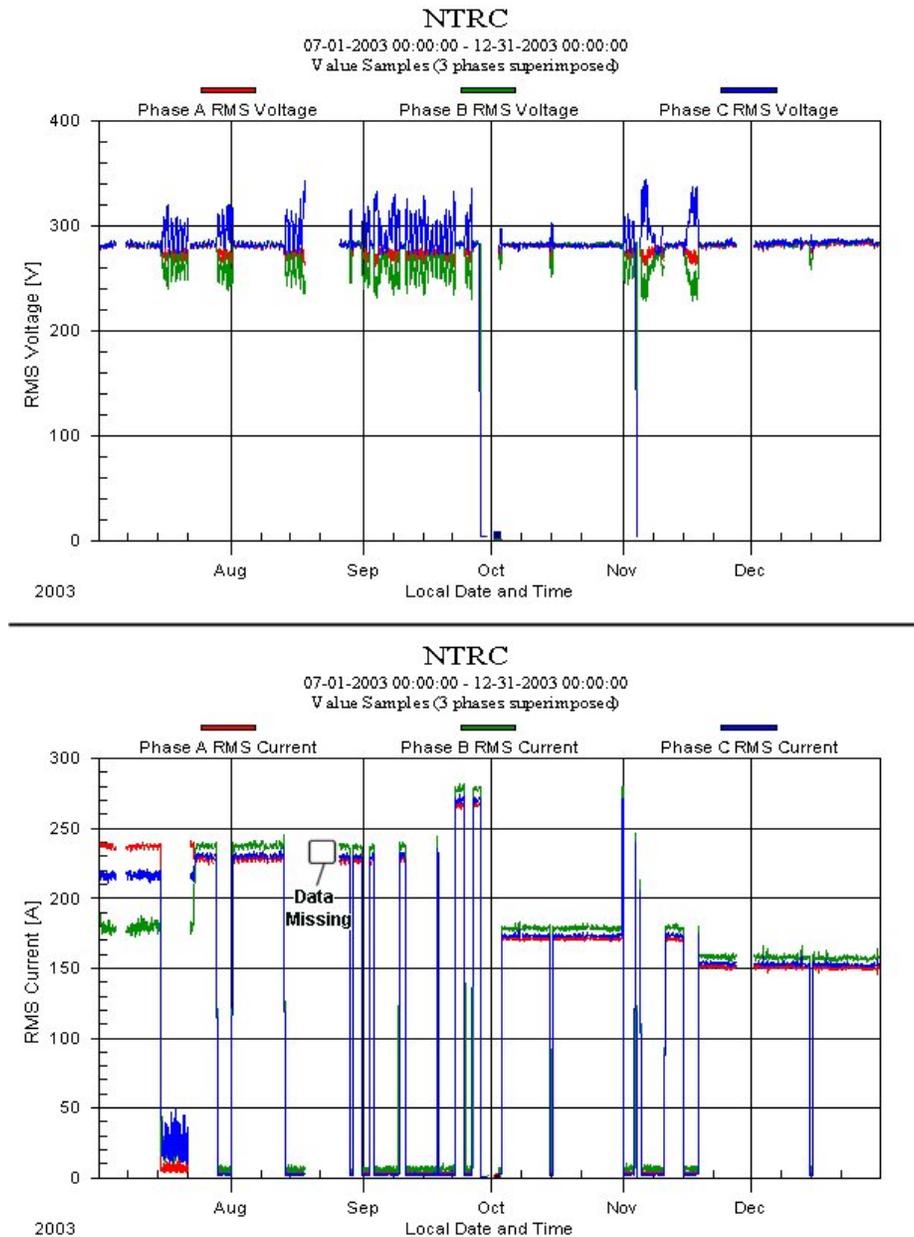
Fig. A-1. RMS V and I fuel cell generation plots for the six-month test period.

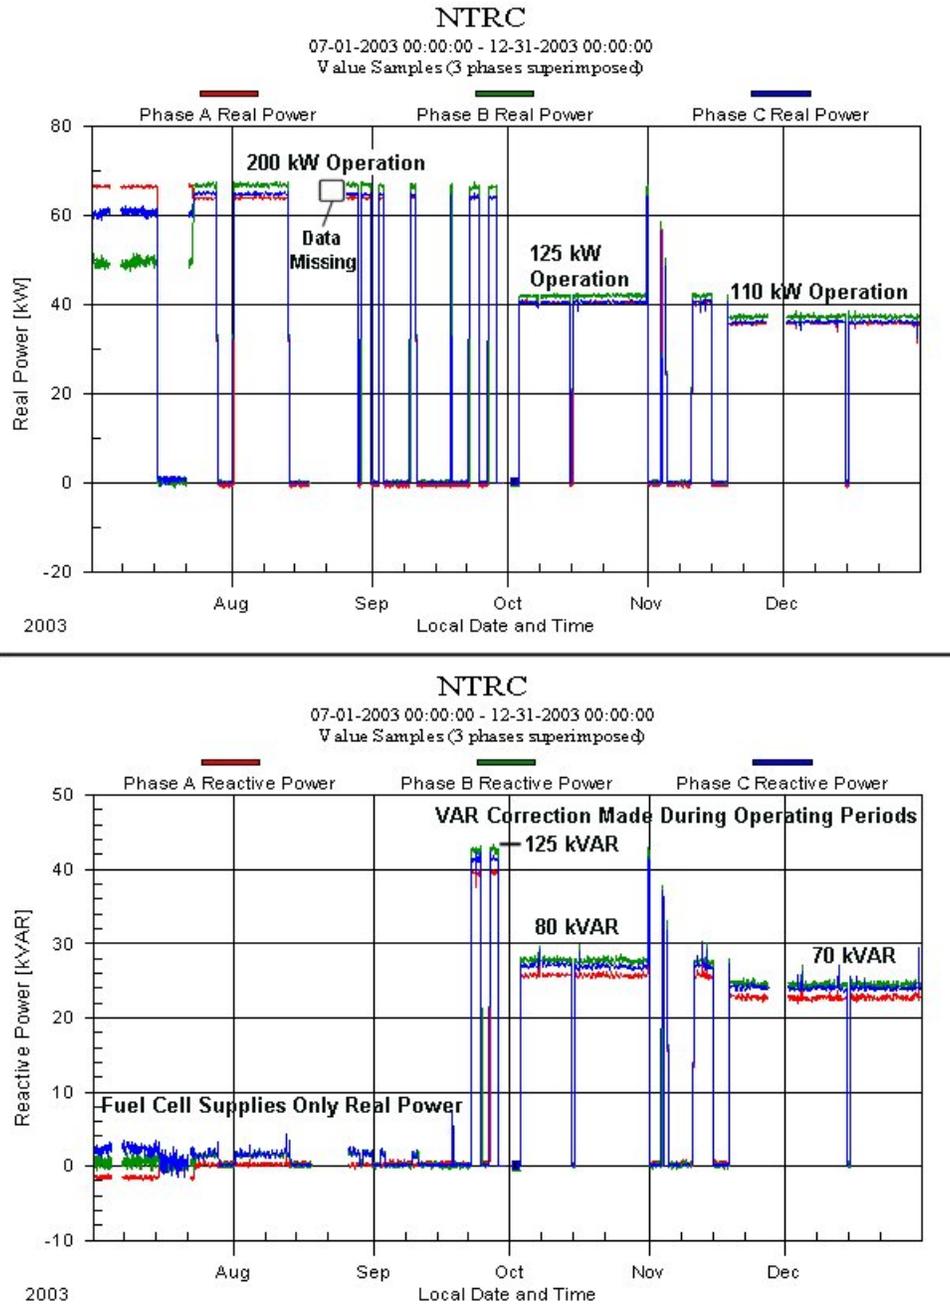
**Fig. A-2. Real and reactive fuel cell power plots for the six-month test period.**
