# **Heat Pump Water Heater Durability Testing – Phase II**

**May 2004**

Prepared by  
OAK RIDGE NATIONAL LABORATORY  
P.O. Box 2008  
Oak Ridge, Tennessee 37831-6285  
managed by  
UT-Battelle, LLC  
for the  
U.S. DEPARTMENT OF ENERGY  
under contract DE-AC05-00OR22725

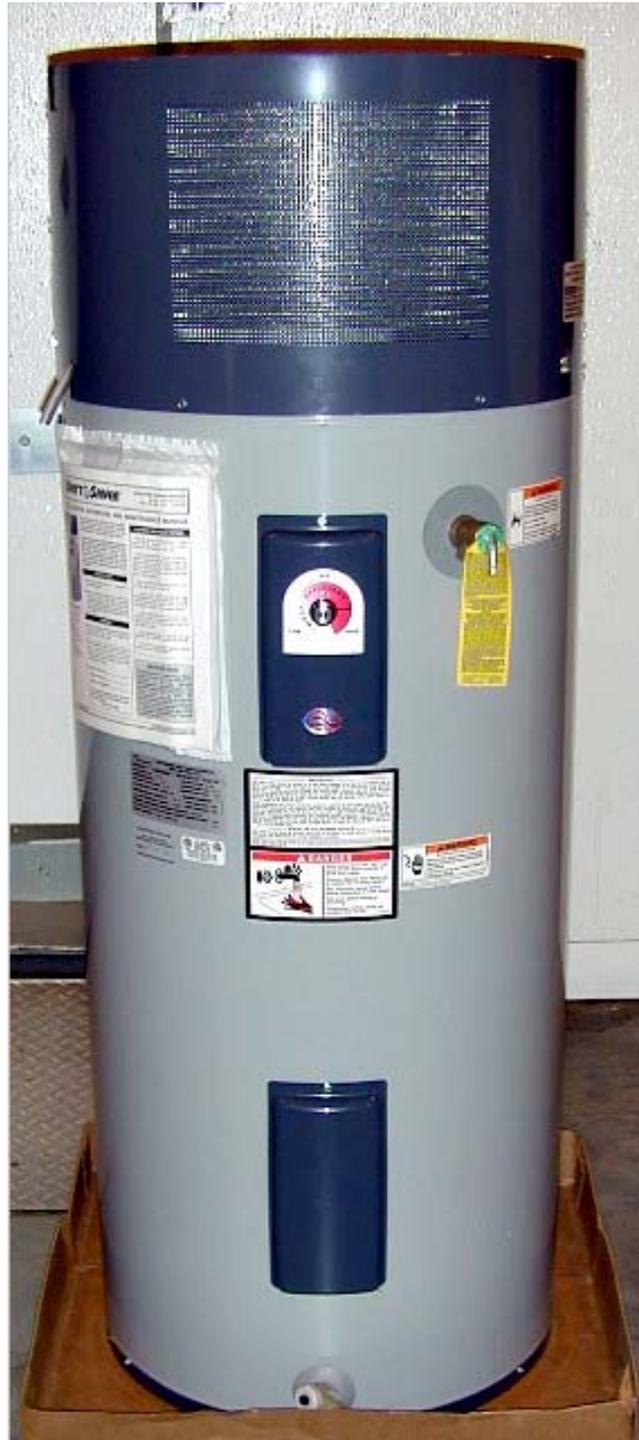
**Figure 1.1** – Photograph of the integral, “drop-in” type heat pump water heater (HPWH) unit evaluated in this durability test phase.

The integral HPWH examined in this study was intended to be a “drop-in” replacement for conventional EWHs. It is pictured in Figure 1.1 and is shown in schematic cut away view in Figure 1.2. As used in this report, “drop-in” means that the HPWH can be installed virtually anywhere an EWH can be installed utilizing essentially the same installation procedures. It is likely that most HPWH installations will require slightly

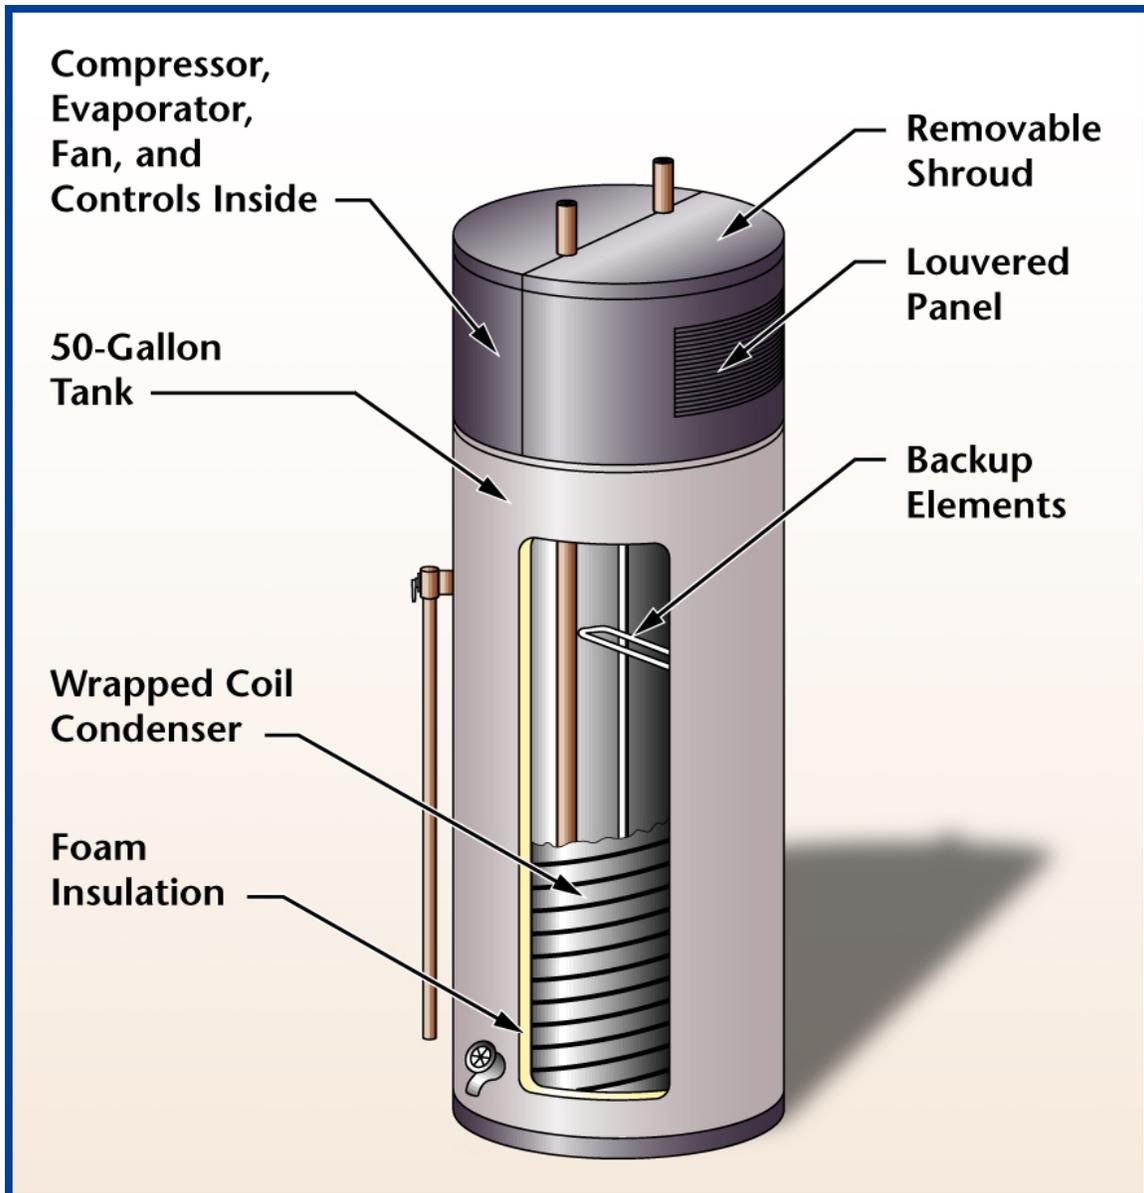
**Figure 1.2** – Cutaway schematic view of the integral HPWH.

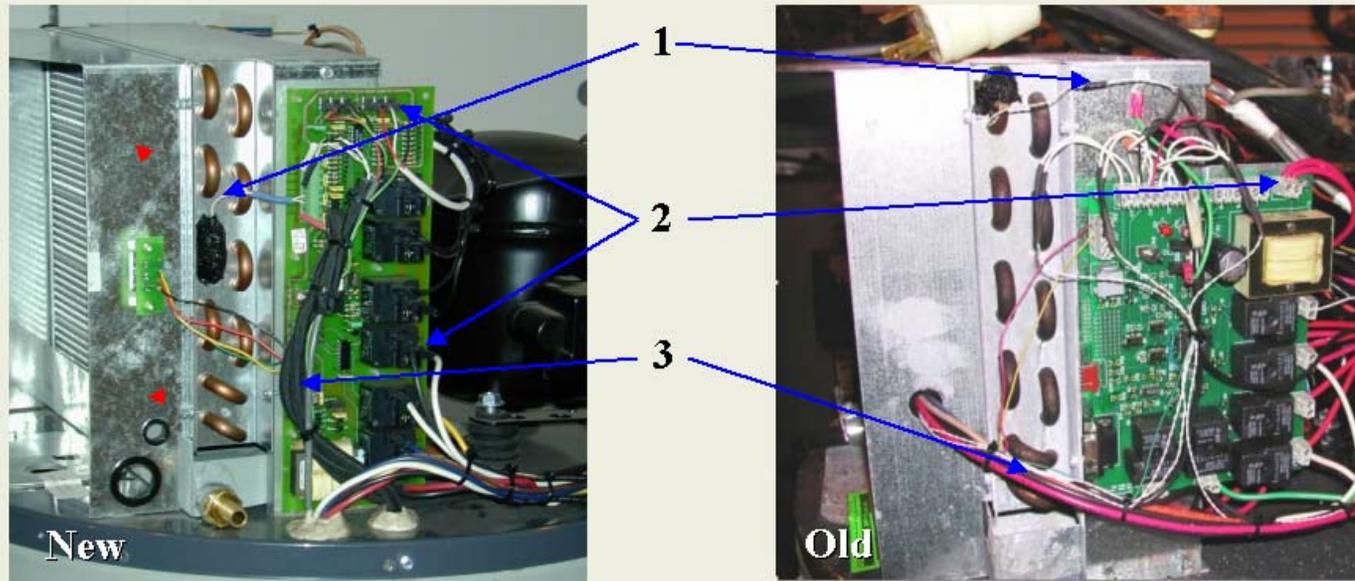
- 1** – New; splices eliminated from thermistor lead wires
- 2** – New; wires connected to board with slip-on, spade lugs
  - easier, more reliable connection than screw terminals on old board
- 3** – New; thermistor leads separated from power leads & shielded
  - eliminate electrical-noise-induced signal variations

**Figure 1.3** – New vs. old integral HPWH control board showing changes made in response to previous durability test findings.

- The thermistor sensors were upgraded to a more rugged (heavier) model with heavier gauge lead wires, and splices eliminated from the sensor leads.
- Sensor cables were rerouted away from the high voltage power wiring.
- A new control board design was implemented, primarily to reduce manufacturing costs, but also to incorporate features to improve its reliability and to reduce susceptibility to random noise.
- The control program was revised to sample the thermistor and thermostat inputs about 32 times and make control decisions based on the average value. This helps to offset the impact of a single aberrant reading.
- A more vigorous factory quality assurance (QA) program has been implemented to eliminate or minimize occurrences such as unsecured thermostats, control boards, and similar items.

Figure 1.3 illustrates changes that the manufacturer has made to the integral HPWH control board as noted above.

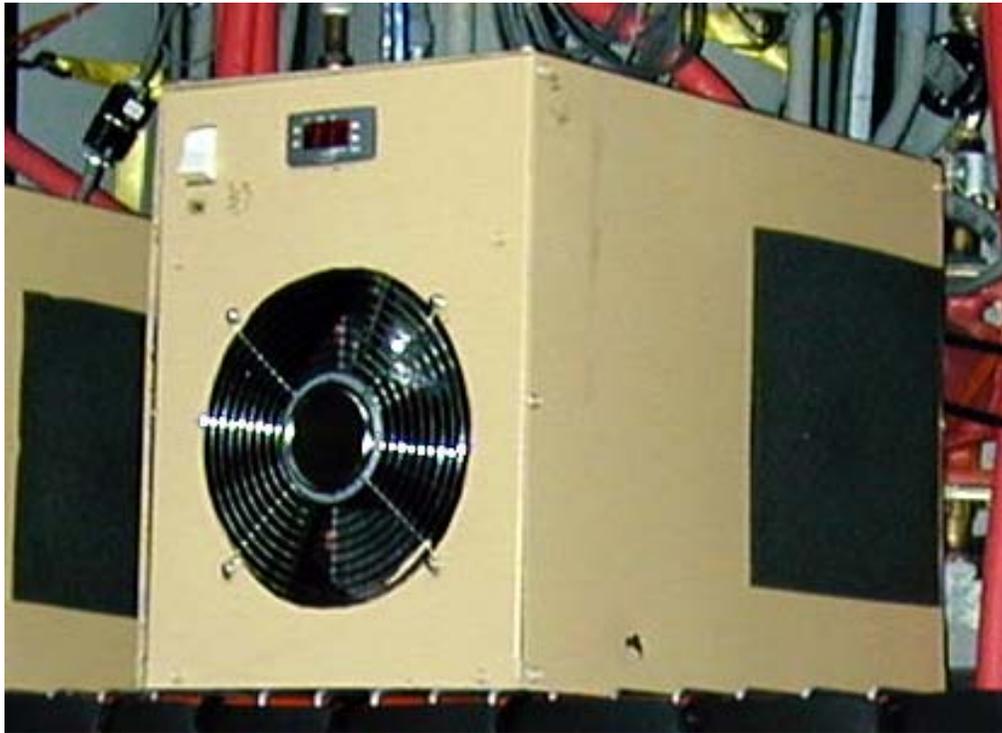
The add-on HPWH consisted of a relatively compact package (about 12.5 in. wide, 16.5 in. high, and 21 in. deep) containing the compressor, evaporator, evaporator fan, refrigerant-to-water condenser, a circulating pump, and a control unit (Figure 1.4). Water connections on the back of the package are piped to a storage EWH tank via a coaxial

**Figure 1.4** – Add-on HPWH package.

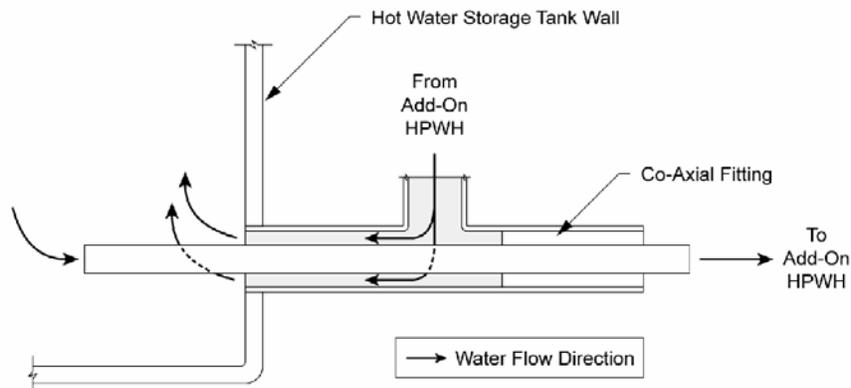
fitting installed in the bottom of the tank where the tank drain valve is normally located. Water is circulated from the storage tank to the HPWH condenser and back through this fitting as illustrated in Figure 1.5. Refrigerant and water streams in the condenser are in a counter flow arrangement for efficient heat transfer. The unit is designed for use with a standard residential 115V circuit and is equipped with a grounded plug for connection to a typical house outlet. The manufacturer's installation instructions recommend that the upper thermostat of the EWH be set at whatever temperature the user desires and that the bottom element be disconnected or its thermostat set to the minimum value to maximize HPWH utilization and efficiency. We set the tank bottom thermostats to the minimum for our durability tests.

**Figure 1.5** – Schematic of tank water fitting used with add-on HPWH units.

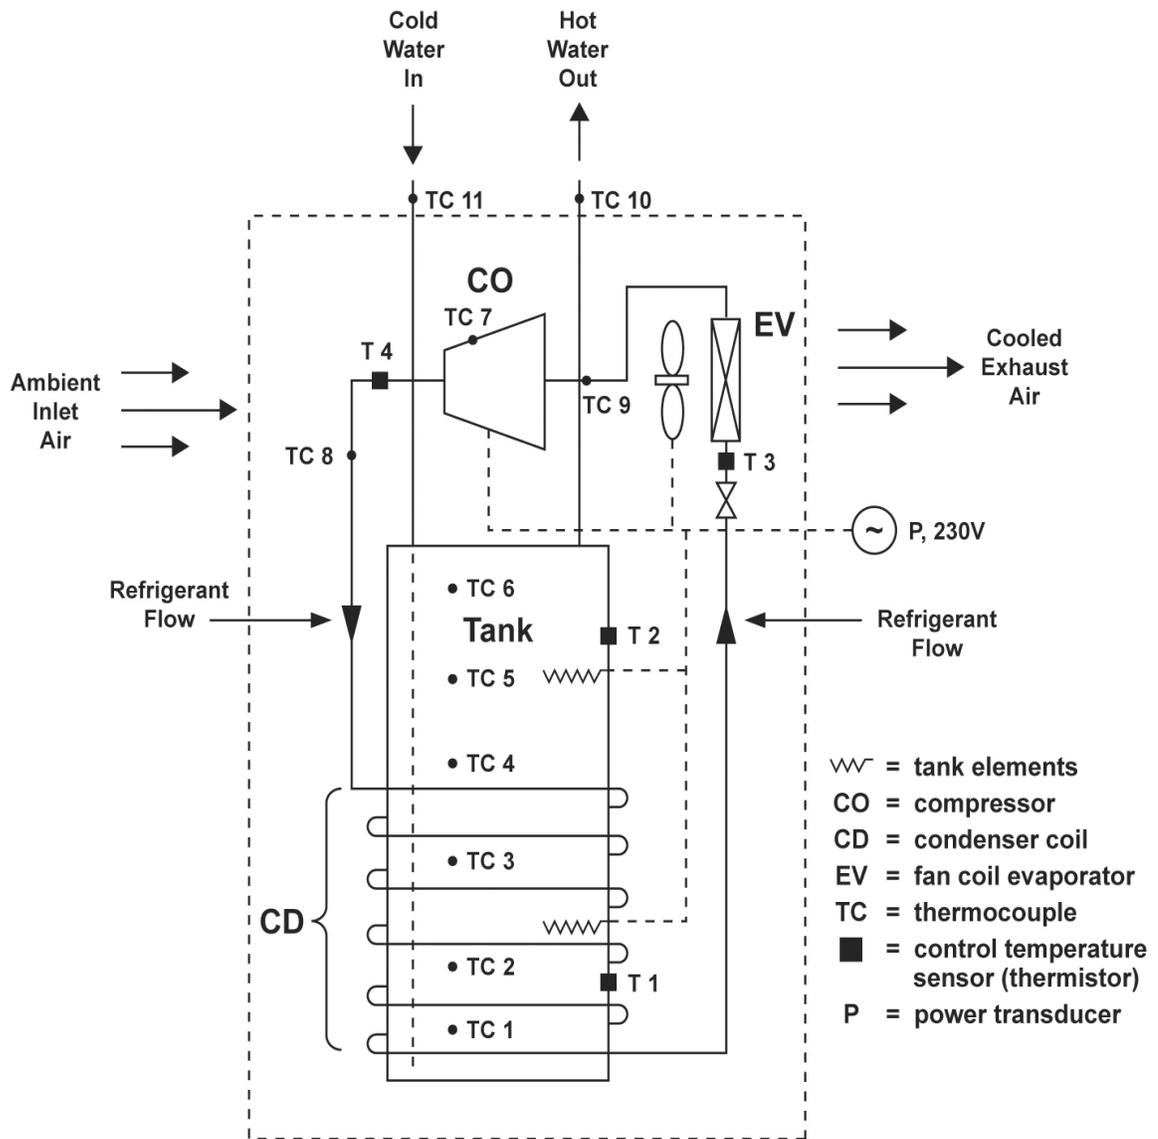
**Figure 2.1** – Schematic of integral HPWH test setup showing data instrumentation locations and control thermistor (T1-T4) locations.

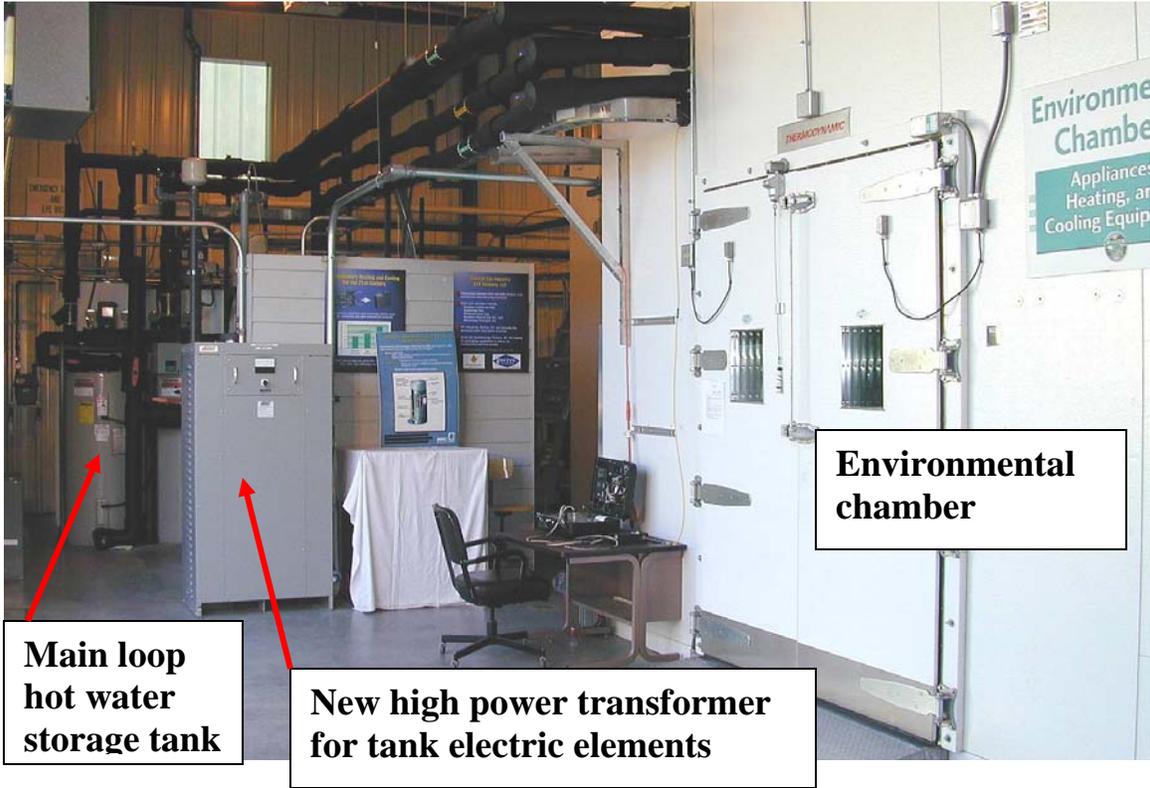
**Figure 3.1** – Overall view of HPWH durability test facility.

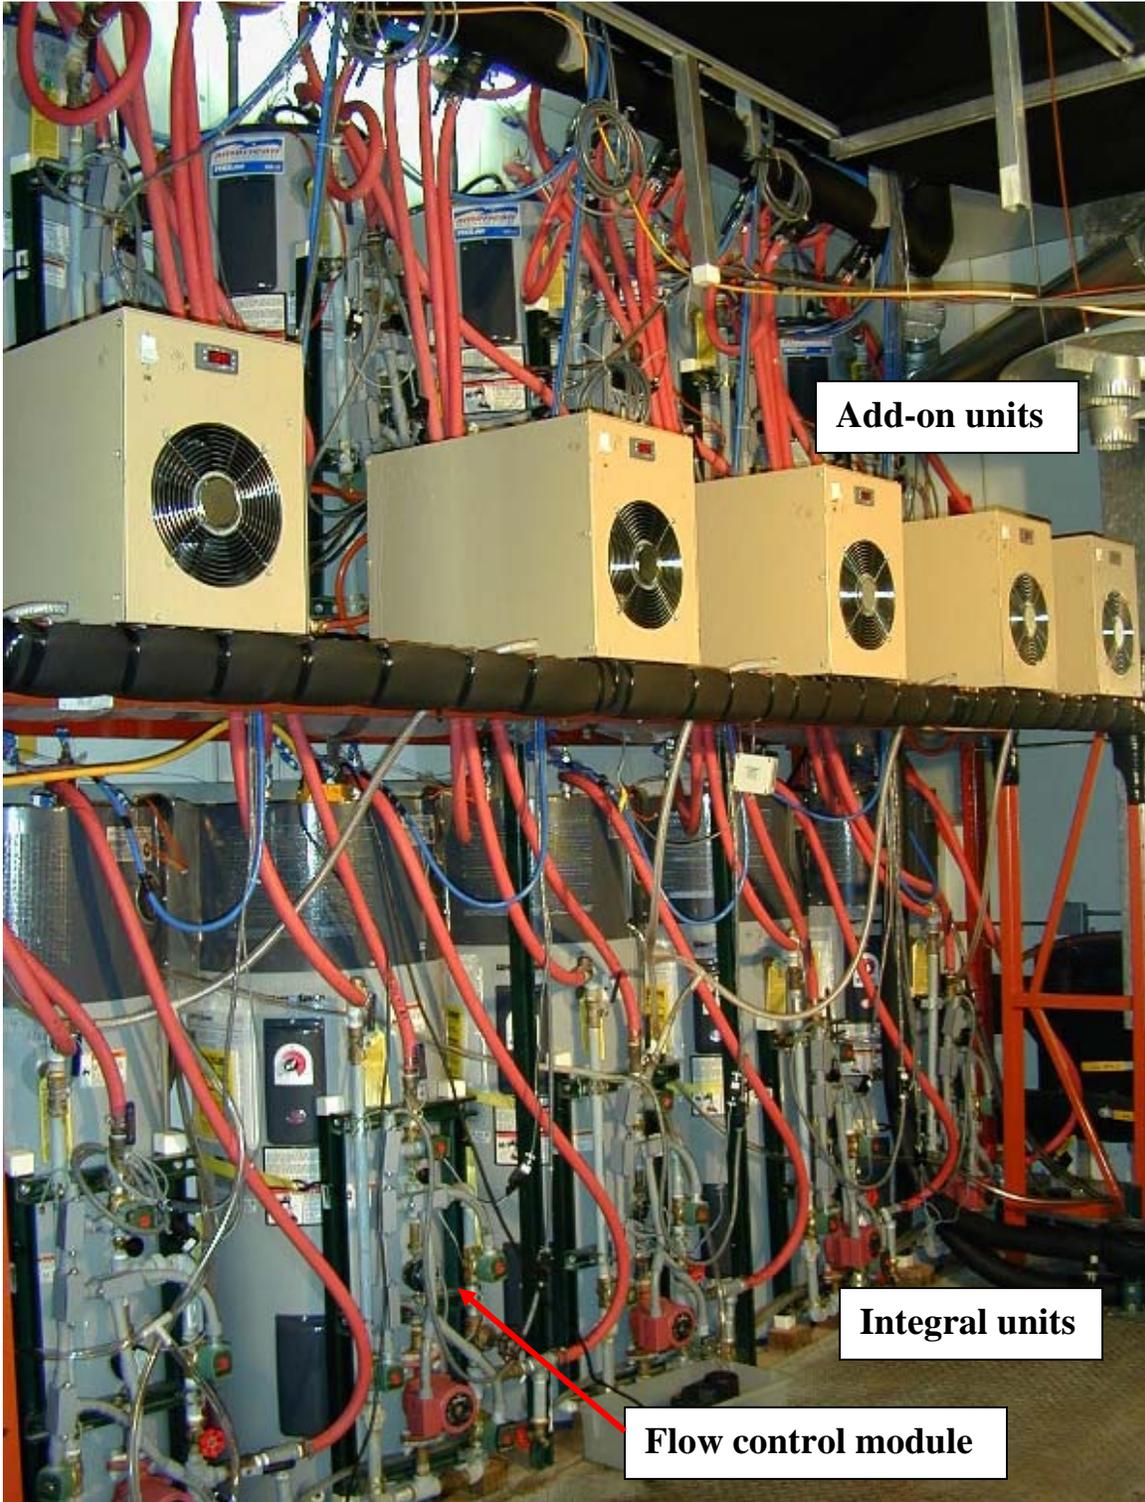
**Figure 3.2** – Installation of HPWHs inside environmental test chamber.

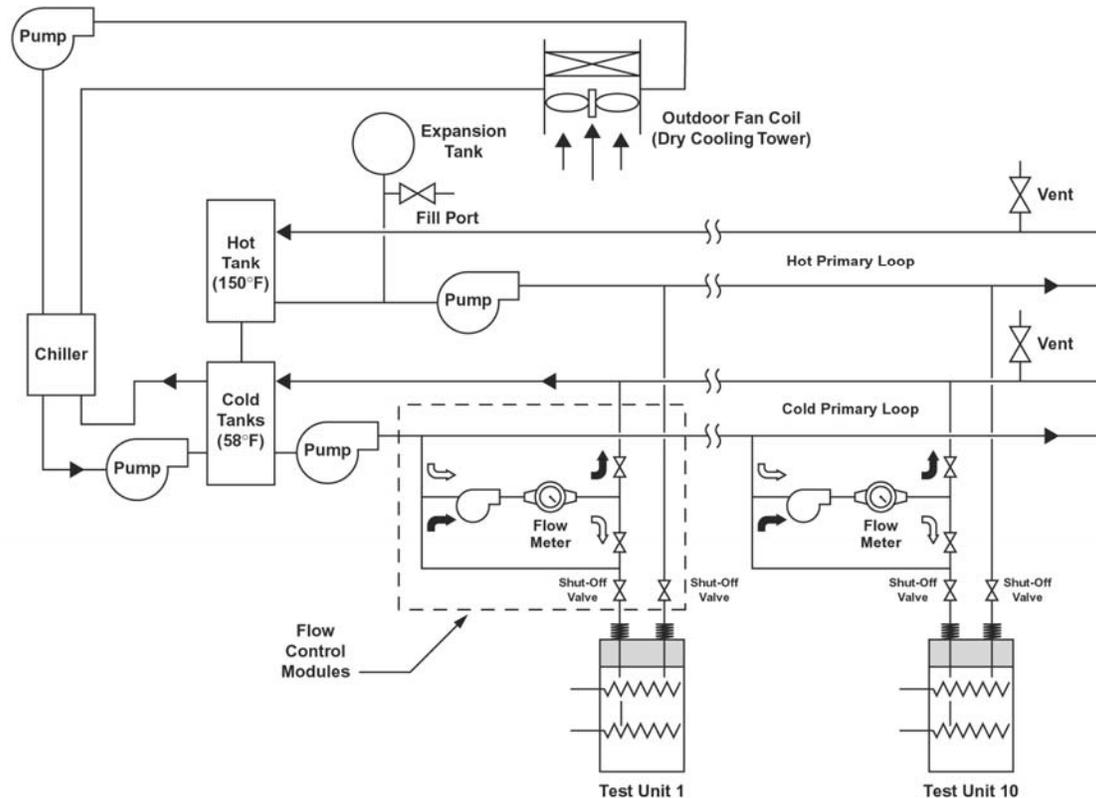
Figure 3.3 shows a schematic of the test stand used for the durability tests. A primary/secondary loop approach was used for providing cold and hot water to each test unit according to its individual demand. This approach was chosen so that each test unit could operate independently of the others. For clarity, Figure 3.3 shows only two HPWH units each with secondary piping. However, the two primary loops (hot and cold) were connected to each of the ten secondary loops.

**Figure 3.3** – Schematic of HPWH test facility plumbing connections.

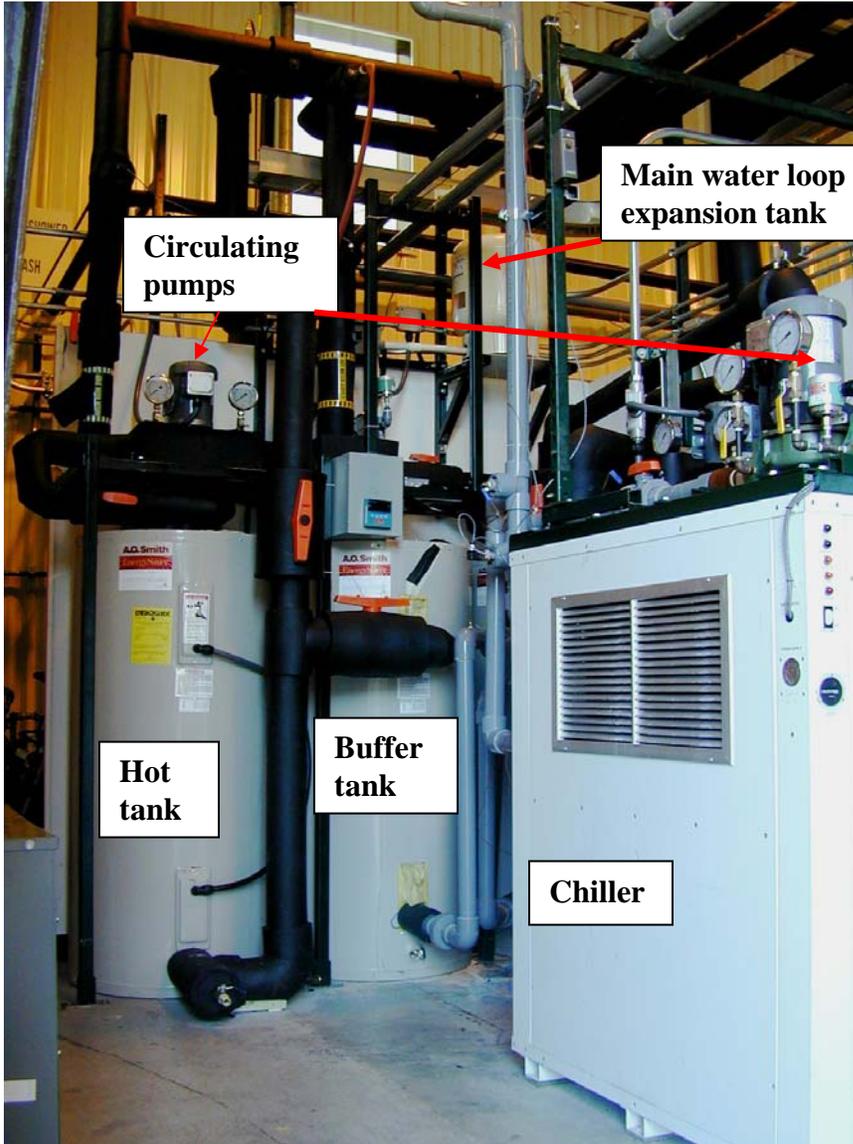
**Figure 3.4** – Photo of HPWH test facility chiller and primary water storage tank section.

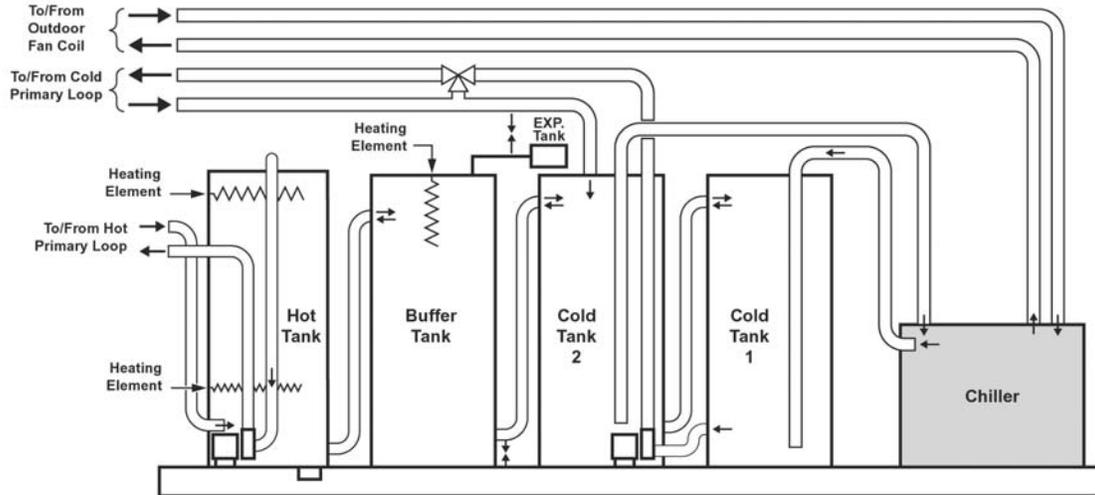
**Figure 3.5** – Schematic of HPWH test facility chiller and primary water storage tank section.

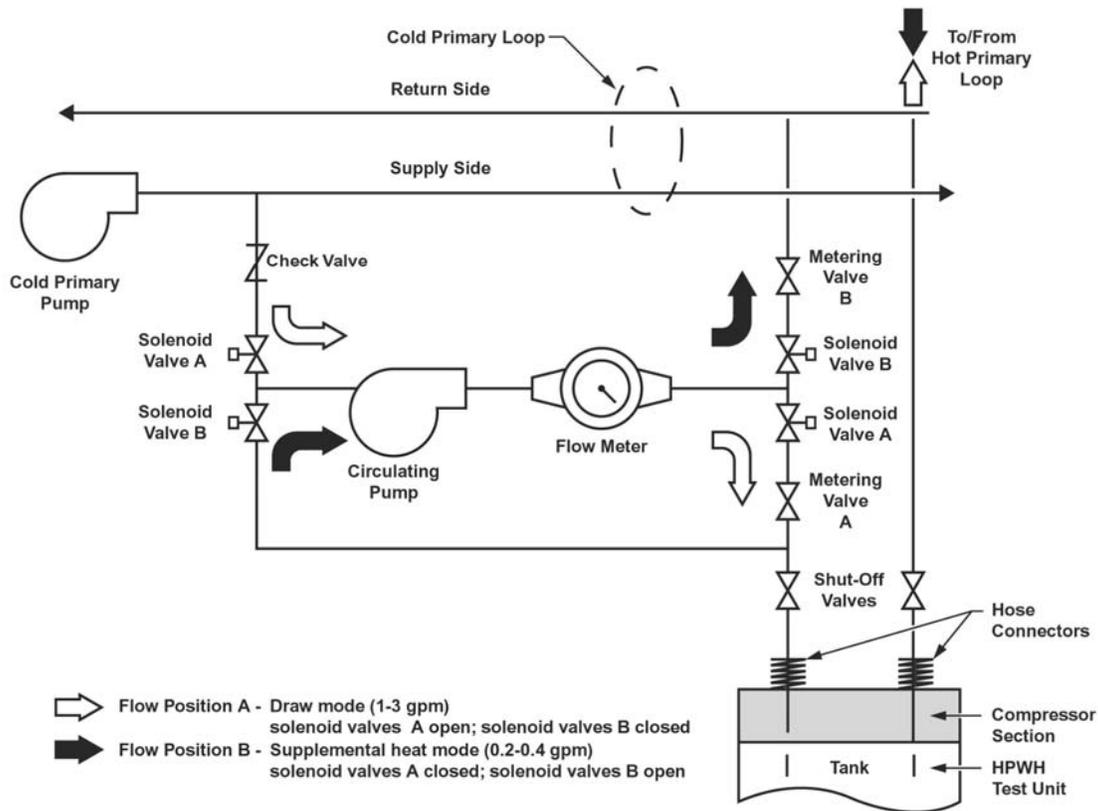
**Figure 3.6** – Schematic of secondary loop flow control module.

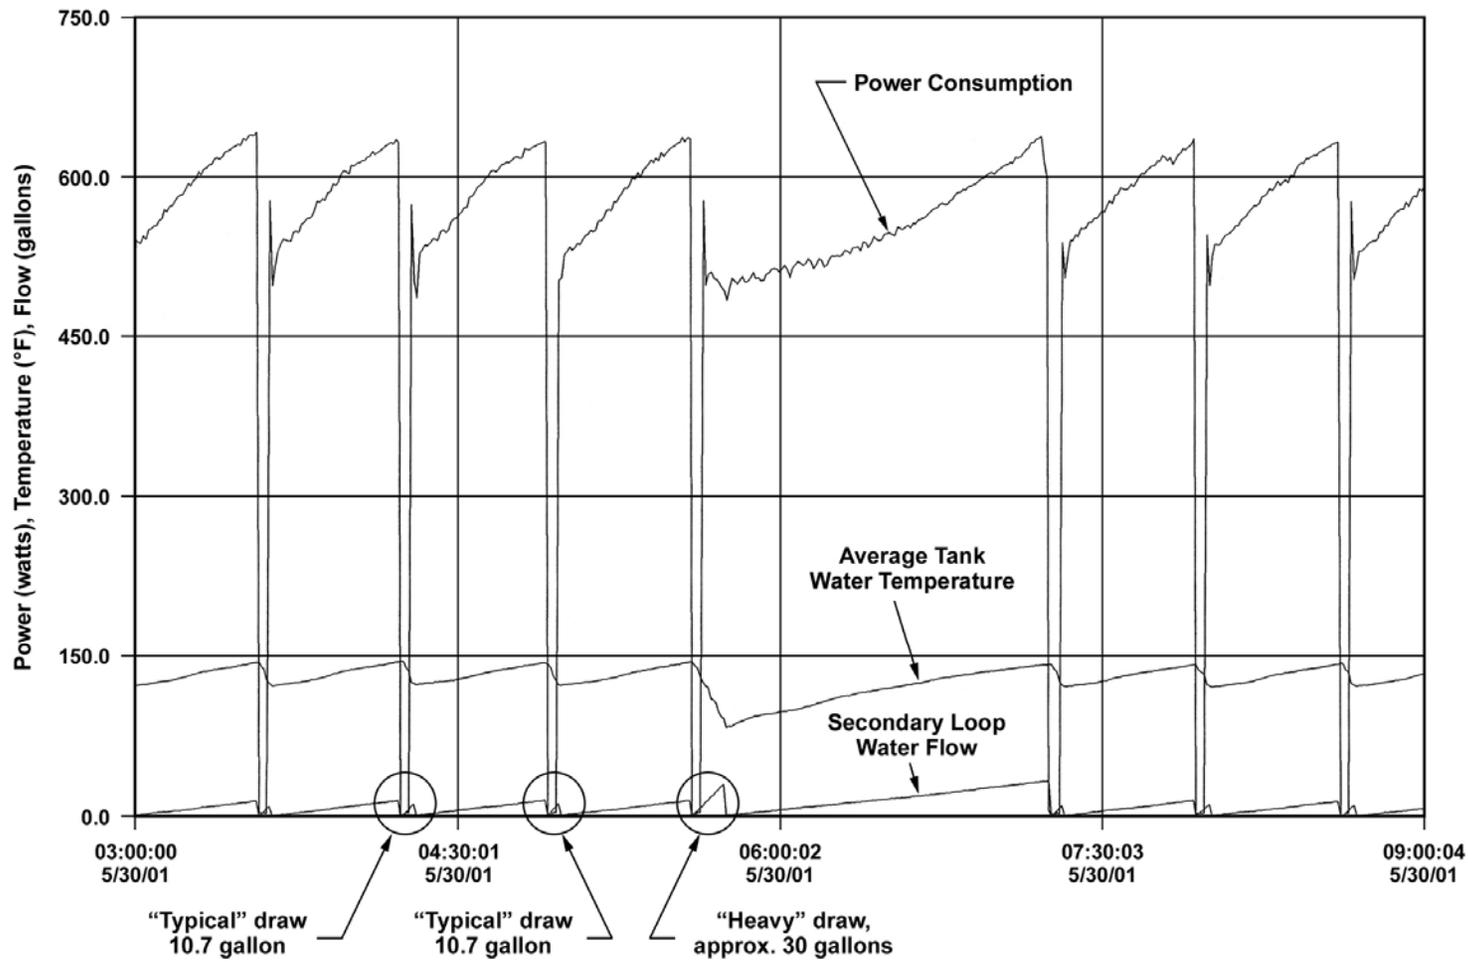
**Figure 4.1** – Representative cycling behavior over 6-hour time period. Power consumption, average tank water temperature, and secondary loop total flow vs. time shown. Cycling rate was approximately 32 cycles/d on average.

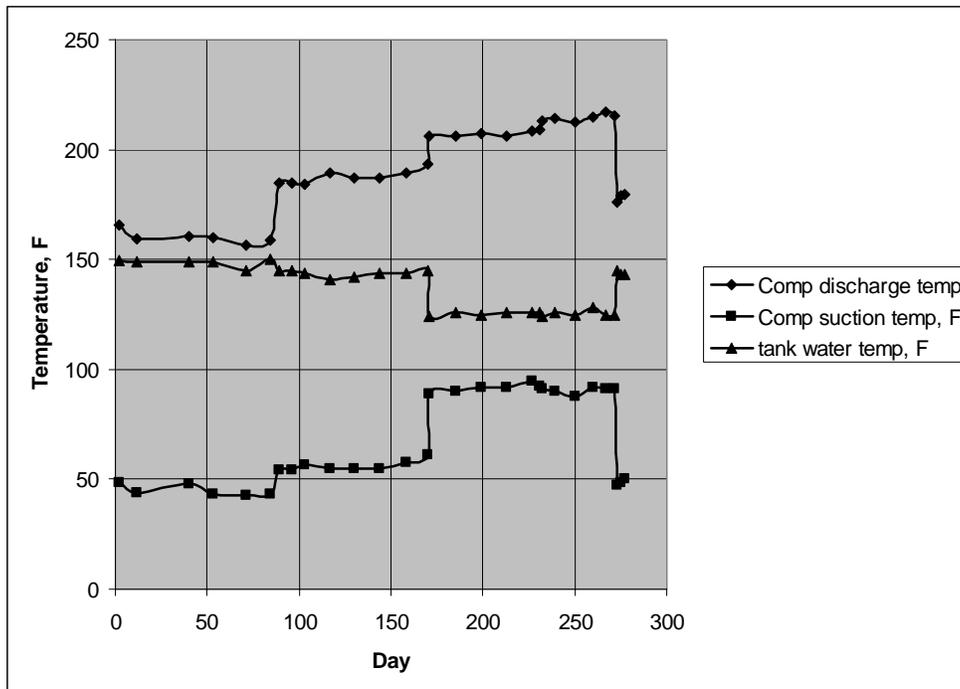
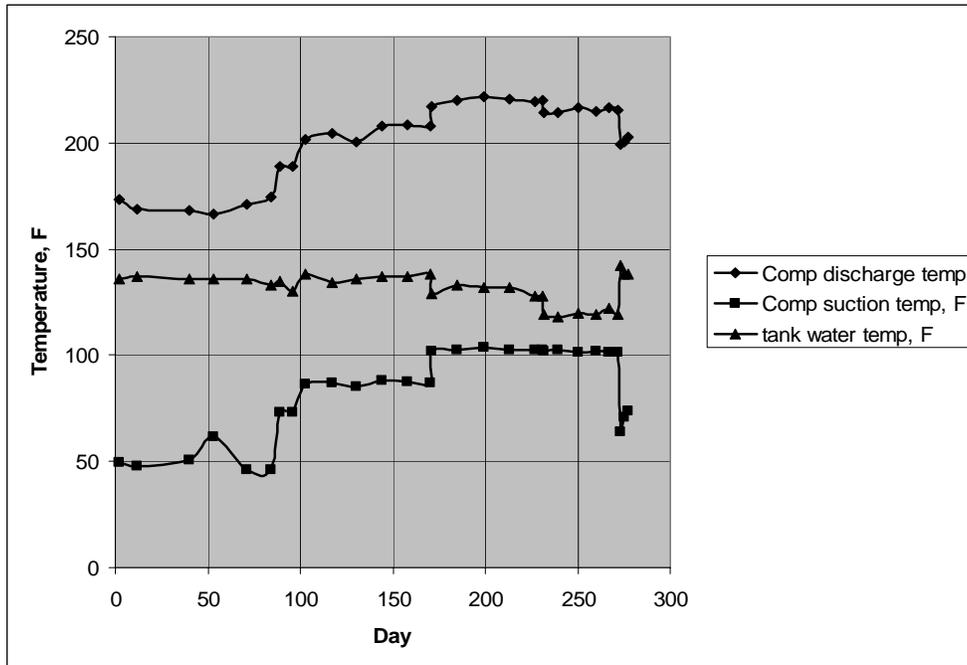
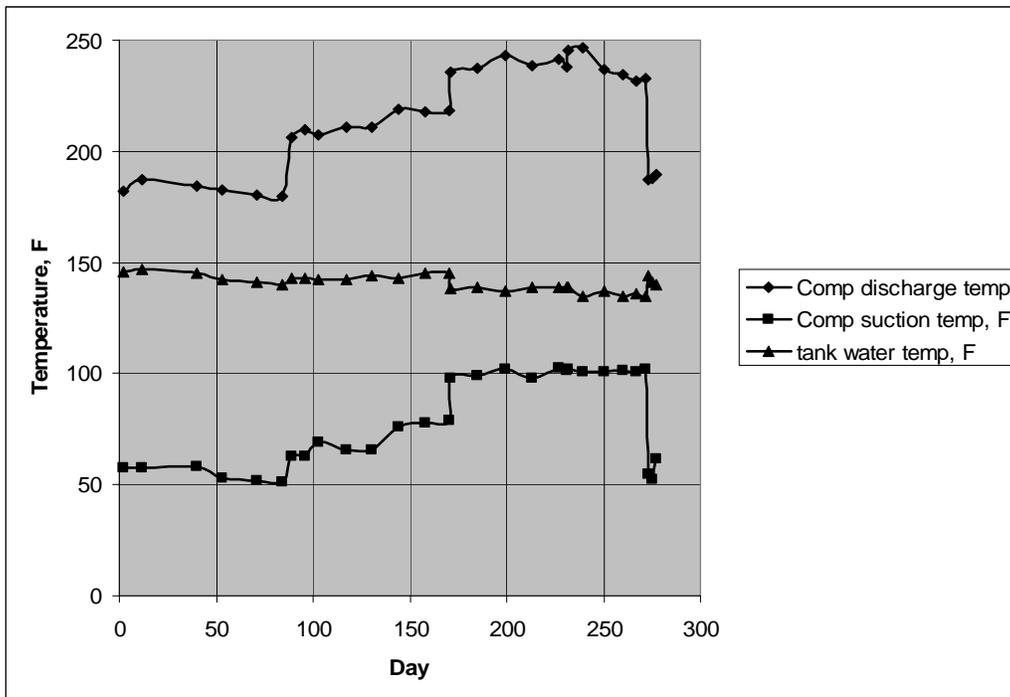
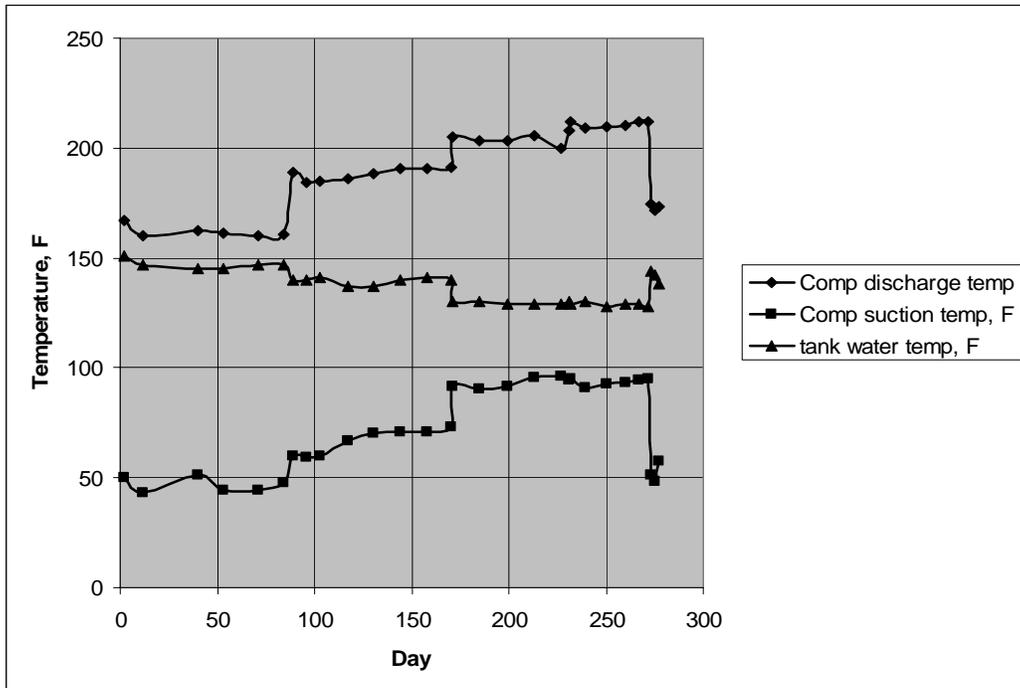
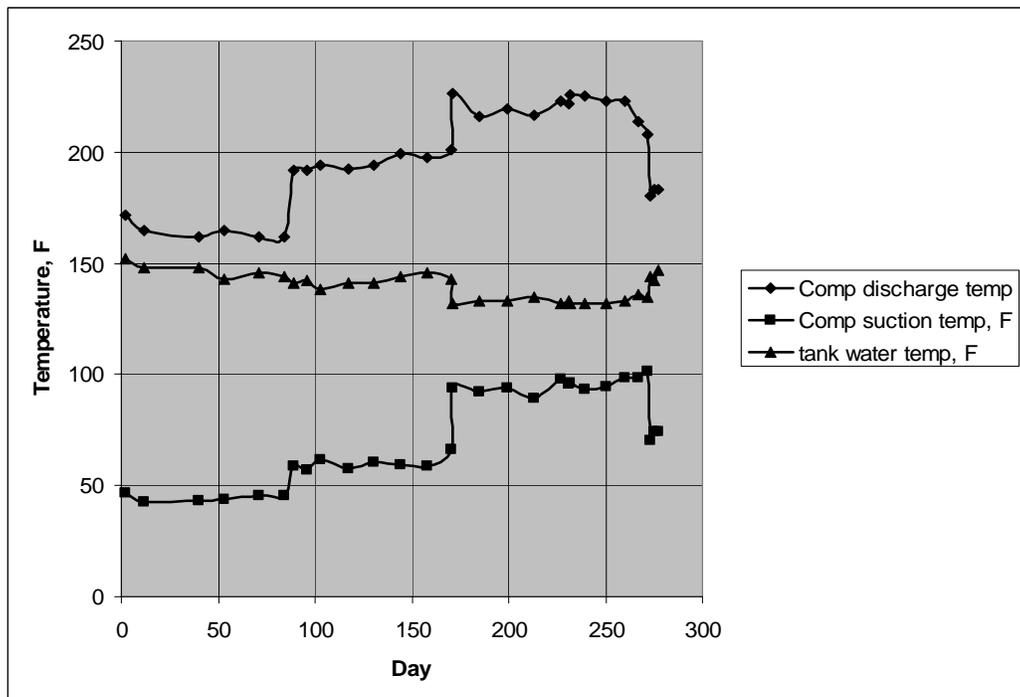
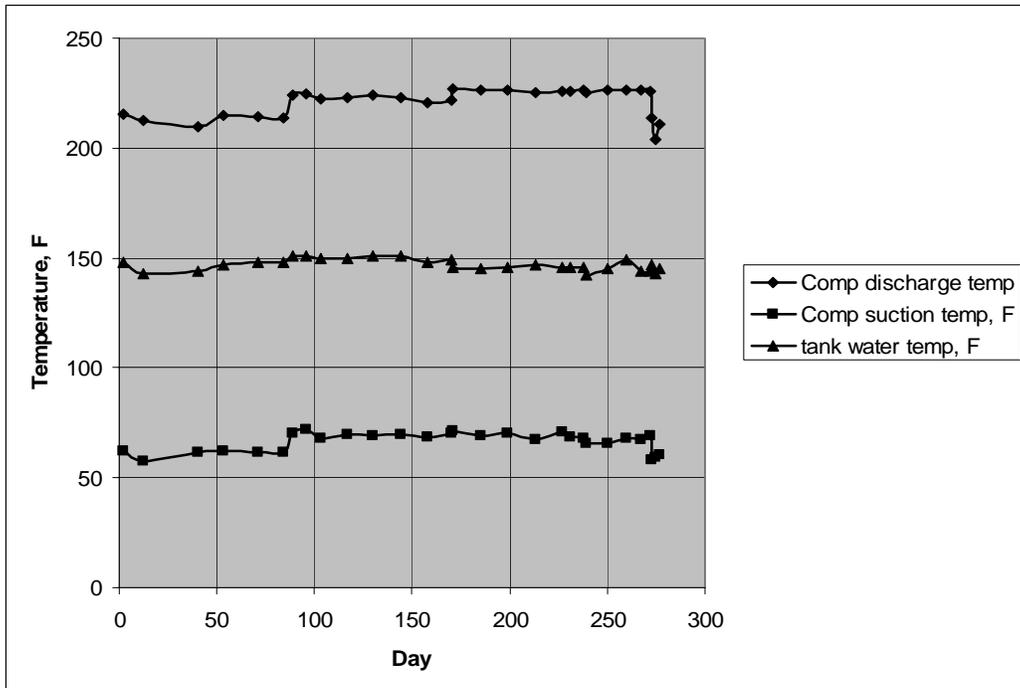
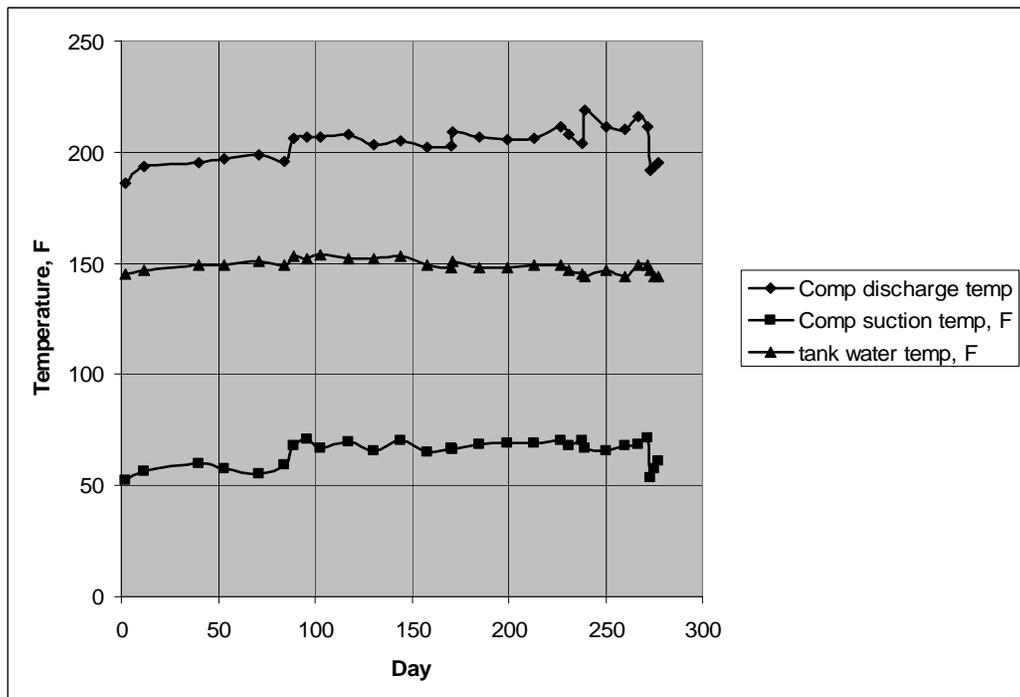
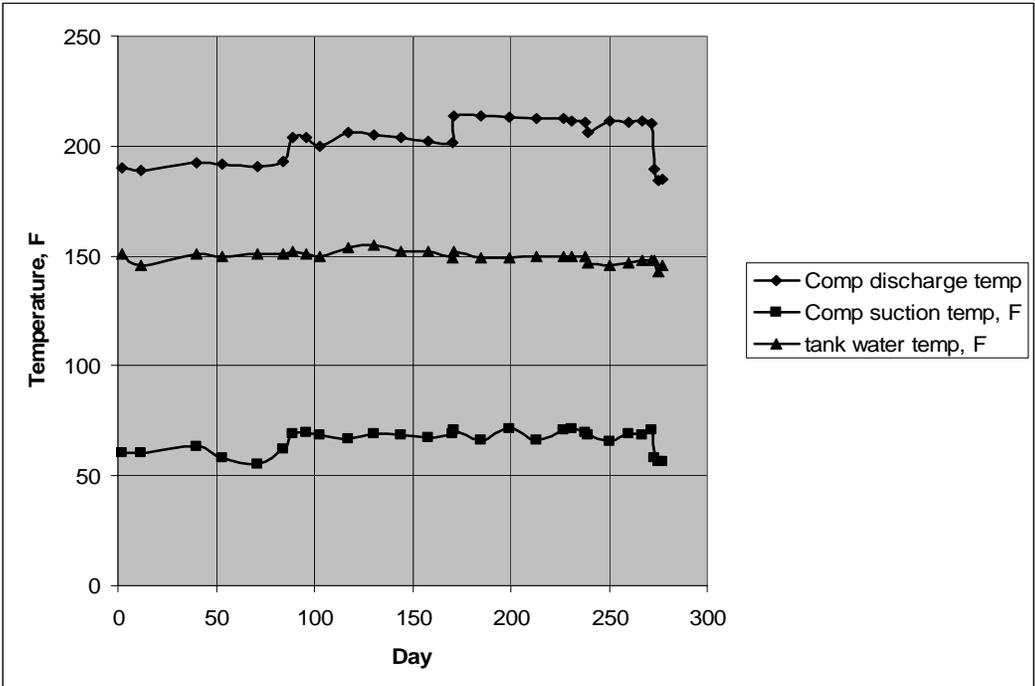
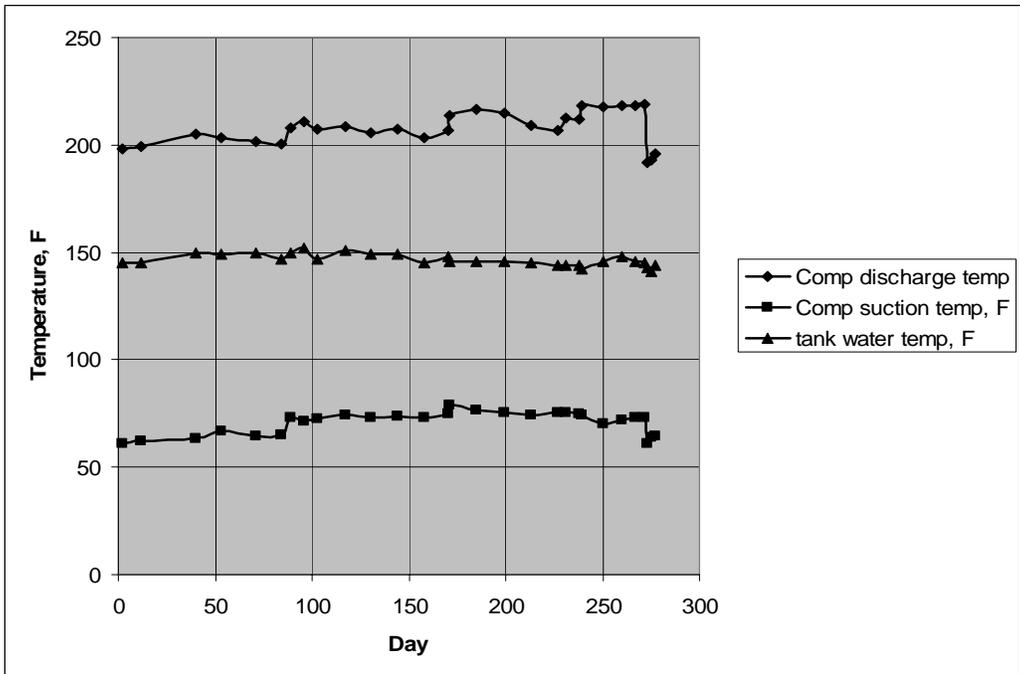
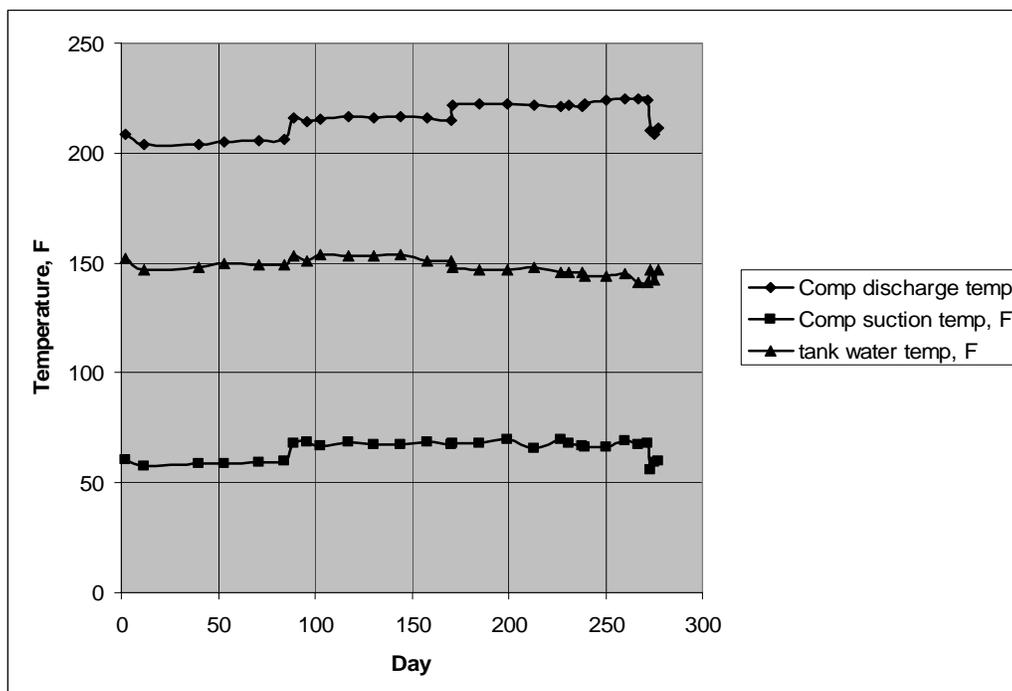
**Performance characteristics over time.** Figures 4.2 through 4.11 show end-of-cycle trends of discharge and suction temperature and tank water temperature for each test unit. The thermostats for each test unit were all set at the beginning of the durability test to achieve upper tank water temperatures of about 145 °F. All units except unit 2 (Figure 4.3) maintained this water temperature during Stage 1 of the testing (ambient conditions typical of indoor locations). As noted above, unit 2 ended each cycle via a trip of its high pressure control. In Stages 2 and 3 with increased ambient temperature and humidity, tank temperatures achieved by the add-on units (Figures 4.2-4.6) tended to degrade (by as much as 15-20 °F during Stage 3). The addition of reduced voltage in Stage 4 further reduced the tank temperature levels achieved by Unit 2. This temperature drop did not occur to such a degree in the integral units (Figures 4.7-4.11). All ten units approached Stage 1 conditions during Stage 5 at the close of the durability test run.

**Figure 4.2** – Add-on unit 1 end-of-cycle discharge, suction, and tank temperature history – Stage 1 start day 1, Stage 2 day 89, Stage 3 day 171, Stage 4 day 232, and Stage 5 day 273.

**Figure 4.3** – Add-on unit 2 end-of-cycle discharge, suction, and tank temperature history – Stage 1 start day 1, Stage 2 day 89, Stage 3 day 171, Stage 4 day 232, and Stage 5 day 273.

**Figure 4.4** – Add-on unit 3 end-of-cycle discharge, suction, and tank temperature history – Stage 1 start day 1, Stage 2 day 89, Stage 3 day 171, Stage 4 day 232, and Stage 5 day 273.

**Figure 4.5** – Add-on unit 4 end-of-cycle discharge, suction, and tank temperature history – Stage 1 start day 1, Stage 2 day 89, Stage 3 day 171, Stage 4 day 232, and Stage 5 day 273.

**Figure 4.6** – Add-on unit 5 end-of-cycle discharge, suction, and tank temperature history – Stage 1 start day 1, Stage 2 day 89, Stage 3 day 171, Stage 4 day 232, and Stage 5 day 273.

**Figure 4.7** – Integral unit 6 end-of-cycle discharge, suction, and tank temperature history – Stage 1 start day 1, Stage 2 day 89, Stage 3 day 171, Stage 4 day 239, and Stage 5 day 273.

**Figure 4.8** – Integral unit 7 end-of-cycle discharge, suction, and tank temperature history – Stage 1 start day 1, Stage 2 day 89, Stage 3 day 171, Stage 4 day 239, and Stage 5 day 273.

**Figure 4.9** – Integral unit 8 end-of-cycle discharge, suction, and tank temperature history – Stage 1 start day 1, Stage 2 day 89, Stage 3 day 171, Stage 4 day 239, and Stage 5 day 273.

**Figure 4.10** – Integral unit 9 end-of-cycle discharge, suction, and tank temperature history – Stage 1 start day 1, Stage 2 day 89, Stage 3 day 171, Stage 4 day 239, Stage 5 day 273.

**Figure 4.11** – Integral unit 10 end-of-cycle discharge, suction, and tank temperature history – Stage 1 start day 1, Stage 2 day 89, Stage 3 day 171, Stage 4 day 239, Stage 5 day 273.

**Low voltage impacts.** The principal impact from low voltage operation in Stage 4 was an increase in compressor discharge and shell temperatures for each unit. This caused no unit failures. The integral units, however, did experience an increased frequency of lower element calls caused when discharge temperatures exceeded the maximum limit.

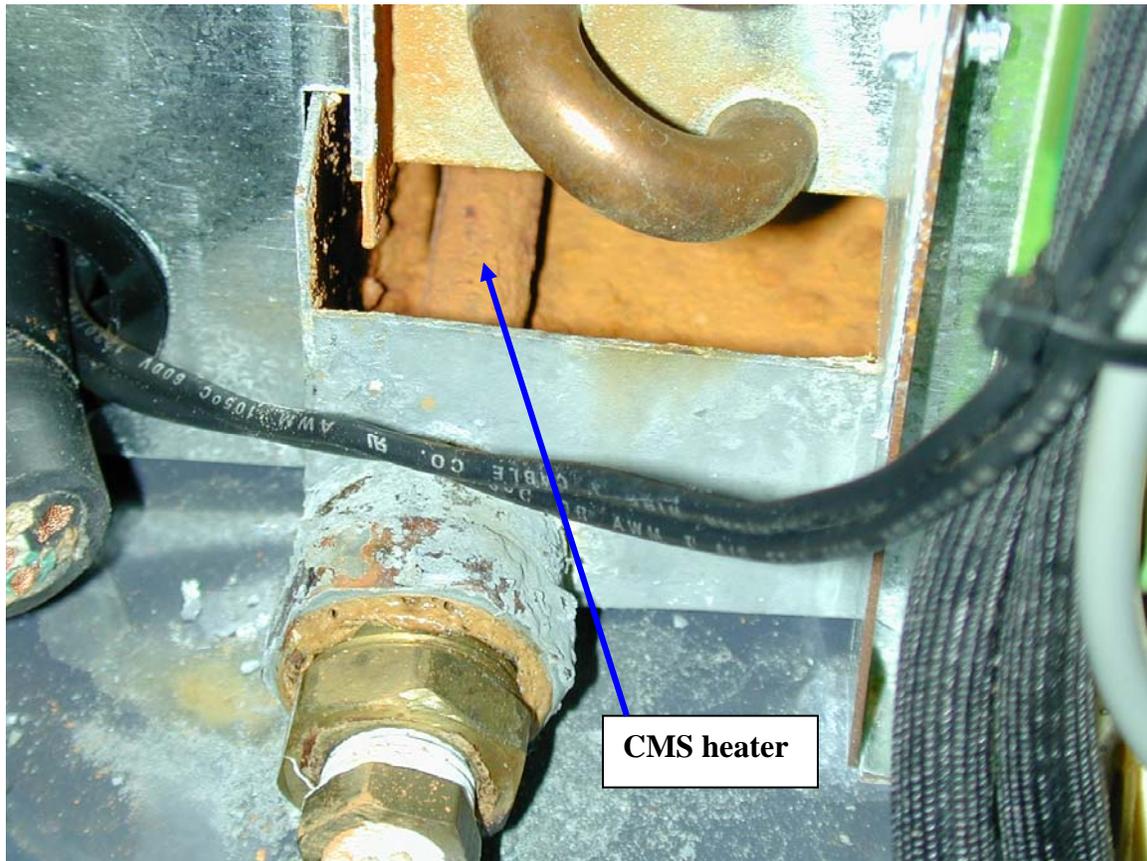
on unit 9. No such deposits were found on units 6, 8, or 10, none of which had the CMS option.

**Figure 4.12.** Drain pan and CMS heater on integral unit 9 after durability test run.
