# **Heat Pump Water Heater Durability Testing – Phase II**

**May 2004**

Prepared by  
OAK RIDGE NATIONAL LABORATORY  
P.O. Box 2008  
Oak Ridge, Tennessee 37831-6285  
managed by  
UT-Battelle, LLC  
for the  
U.S. DEPARTMENT OF ENERGY  
under contract DE-AC05-00OR22725

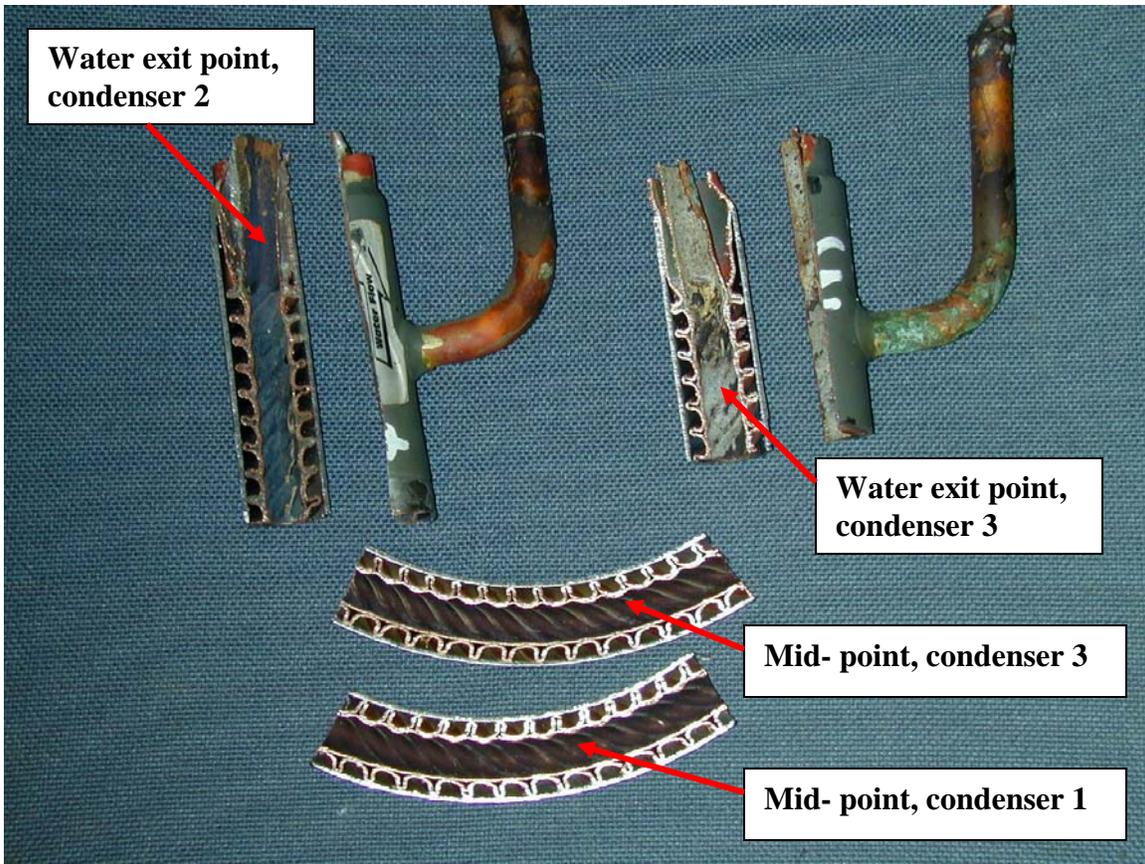
*Add-on units.* Three of the condensers (from units 1, 2, and 3) were sectioned after the testing to check for evidence of fouling. Figure 4.13 shows sections from the condensers that illustrate the range of surface conditions found. The most severe fouling observed occurred at the point where water exits and refrigerant enters (hottest point) the heat exchanger. The condenser from unit 3 showed fairly heavy, whitish deposits at this point. Condenser 2 exhibited a less heavy and darker deposition at this same point. Deposition on condenser 1 surface at this point was whitish but not as heavy as for condenser 3 (see Figure 4.14). On most of the surfaces, only a darkish film deposition was observed. The scale build up was most likely due to calcium carbonate ( $\text{CaCO}_3$ ) precipitation from the water in the test loop. This will likely be a problem for these type tube-in-tube condensers depending upon the hardness of the local water. It can be limited somewhat (but not eliminated) by limiting the maximum hot water set point temperature (perhaps 120 to 130 °F or less). This will limit the water temperature in the condenser and reduce deposition rates. During this durability test water temperatures in the condensers of the add-on units exceeded 145 °F.

**Figure 4.13.** Add-on unit condenser surfaces after durability test run showing surface depositions.

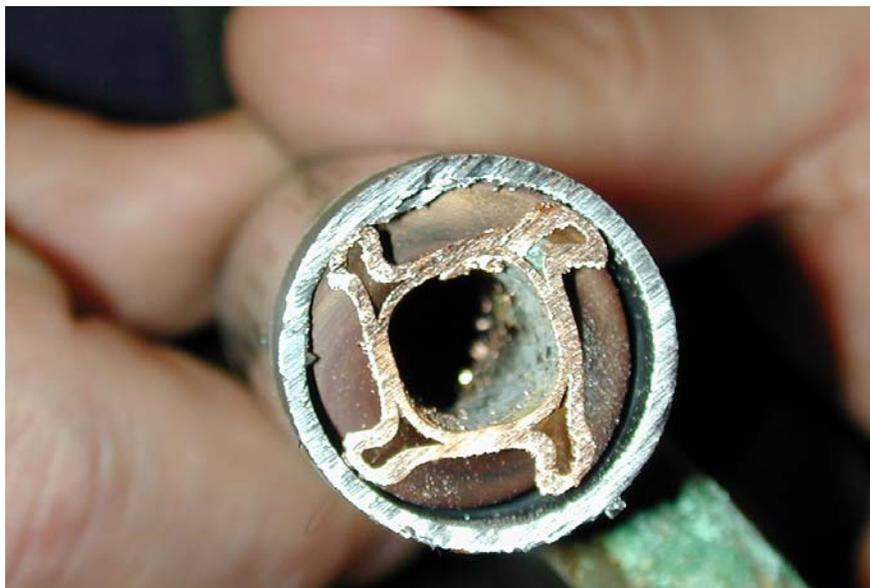
**Figure 4.14.** Cross-section of add-on unit condenser 1 at water exit point.

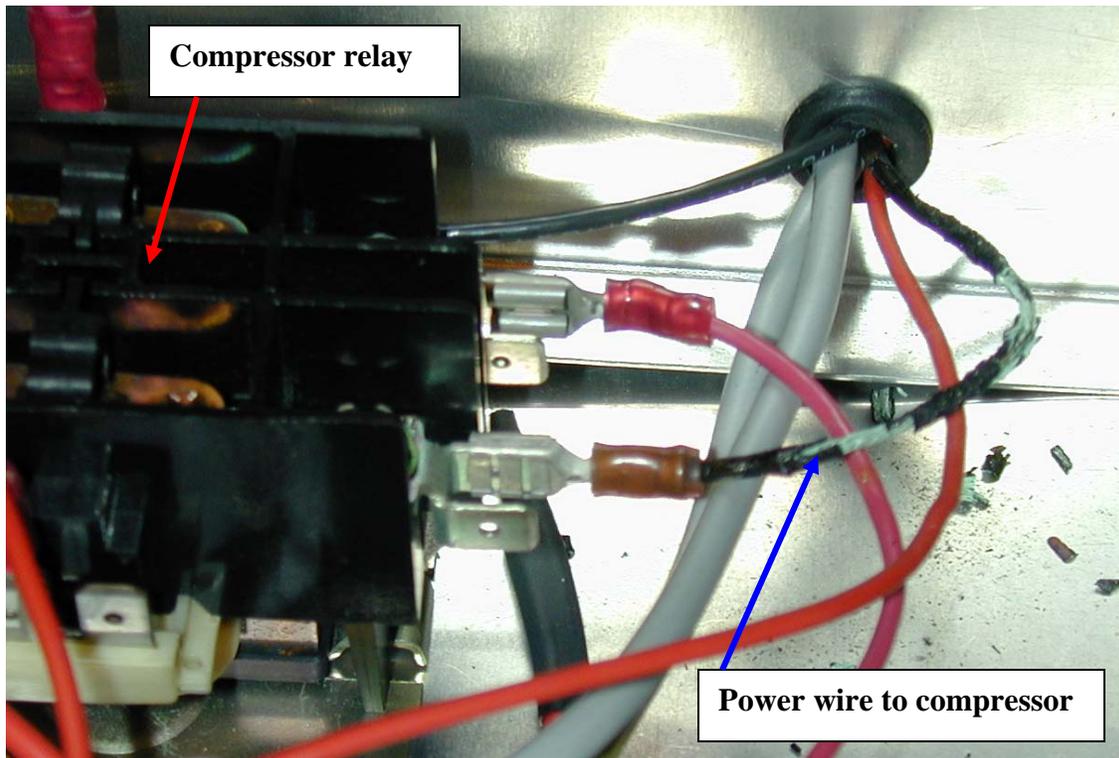
One other thing we noted in the post examination was that insulation on the electric power wire leading from the compressor relay to the compressor had apparently been overheated and in some cases burned off on units 2-5. Figure 4.15 illustrates this condition on unit 3. The insulation is seen to be somewhat charred and some has flaked off. Wire conditions were similar on units 2, 4, and 5. No problem was seen on unit 1. Switching to a wire size capable of greater current capacity would eliminate this problem.

**Figure 4.15.** Add-on unit compressor power wiring; typical of condition found on units 2-5 after durability test.

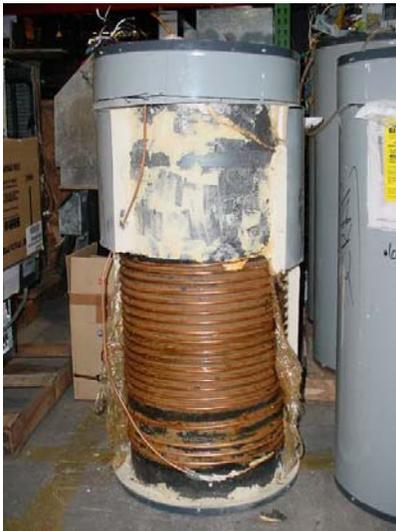
Each tank was dissected, and thoroughly examined for degradation of components and assembly processes. Figure A1 illustrates one of the tanks with metal shell and foam insulation removed to show the condenser wrap.

**Figure A1.** Integral HPWH tank with insulation removed showing condenser wrap.

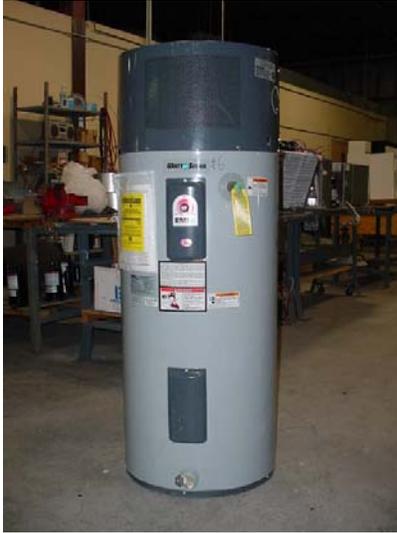
**A2.1.0 External Observations** – Figures A2-A4 are a typical representation of the four units that were returned to EMI. No evidence of condensate leakage, or water infiltration was present inside the element covers or at the electric power connection point (Figures A3 and A4).

**Figure A2.** Integral unit as received by EMI (typical of all four).

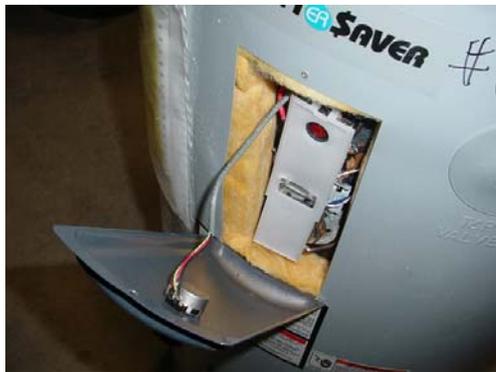
**Figure A3.** View inside upper element access cover.

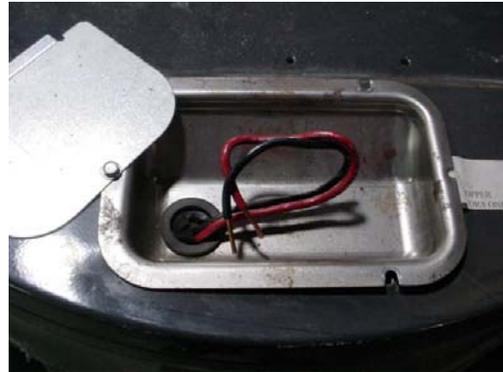
**Figure A4.** View inside power connection cover.

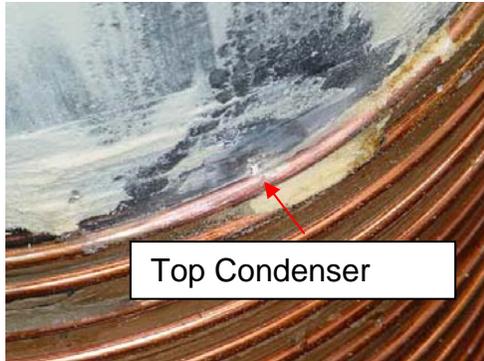
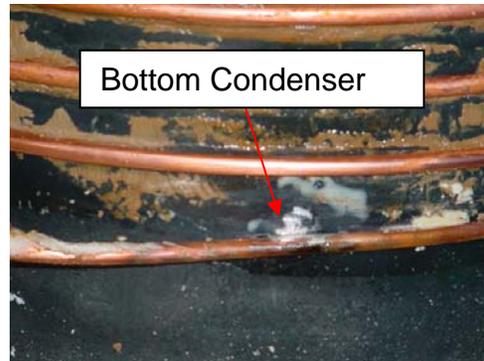
**A2.2.1 Top and Bottom Condenser Brazes:** The condenser coils were found to be tight to outer tank wall on each of the four tanks. No evidence of movement, shifting or kinking. Top and bottom brazes were intact. See Figures A5 & A6.

**Figure A5.** Condenser coil wrap at top braze point.

**Figure A6.** Condenser coil wrap at bottom braze point.

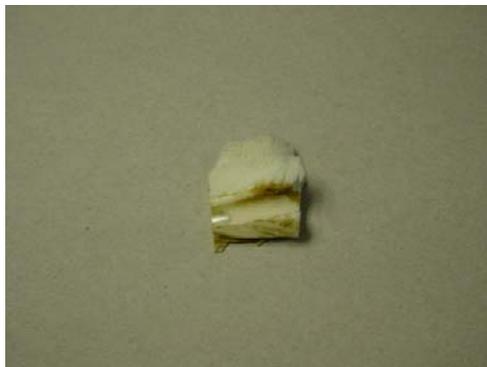
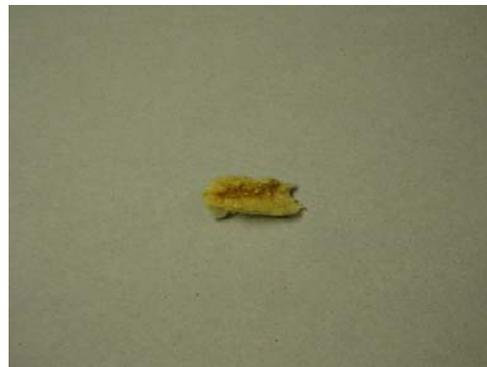
**A2.2.2 Foam Insulation:** No evidence of degradation was found at any point on the tanks. However, some discoloration was observed on foam insulation that was in direct contact with the top of the condenser coil. See Figures A7 & A8.

**Figure A7.** Typical sample of foam insulation around condenser.

**Figure A8.** Foam insulation around the top of the condenser coil.

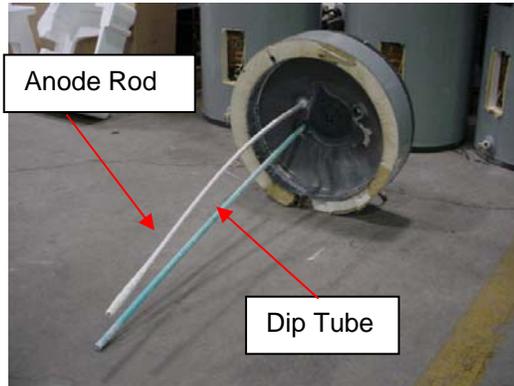
**A2.2.3 Sediment / Scale:** Anode rods on all units were essentially dissolved, with the exception of the steel core, and approximately 6” of anode at the bottom. See Figure A9. The thin (approximately 1/8”) coating of sediment / scale that is shown in Figure A10 is typical of what was present on all tanks

**Figure A9.** Condition of anode rod and cold water inlet dip tube.

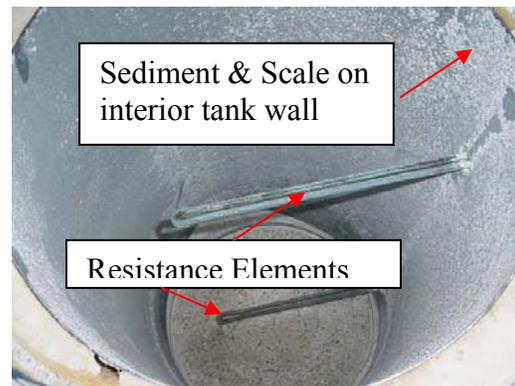
**Figure A10.** Tank interior – condition at end of test.

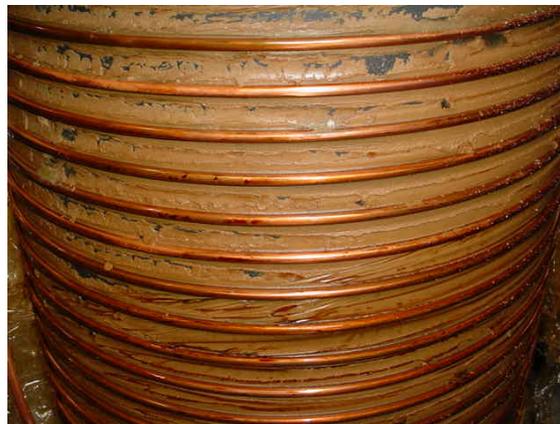
**A2.2.5 Heat Transfer Compound:** This compound is applied between the condenser and tank wall to enhance heat transmission. It was found to be slightly discolored, but remained in place and had solidified to a wax-like texture. See figure A11.

**Figure A11.** Condenser wrap and heat transfer compound.

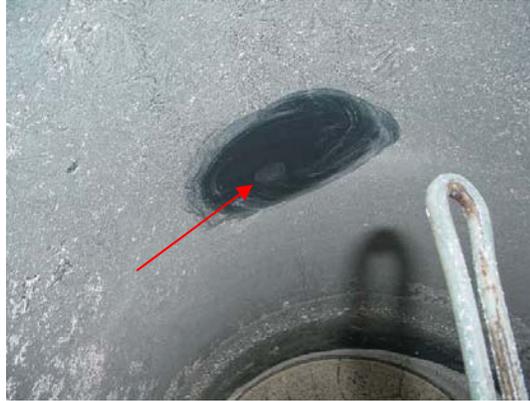
**A2.2.6 Glass Lining:** A slight change in the texture of the glass lining inside the tank was noted opposite the condenser braze points. See the highlighted section in Figure A12. The glass lining did not become separated from the tank wall, and did not show evidence of degradation or corrosion at the braze points.

**Figure A12.** Glass lining opposite condenser braze point inside tank.

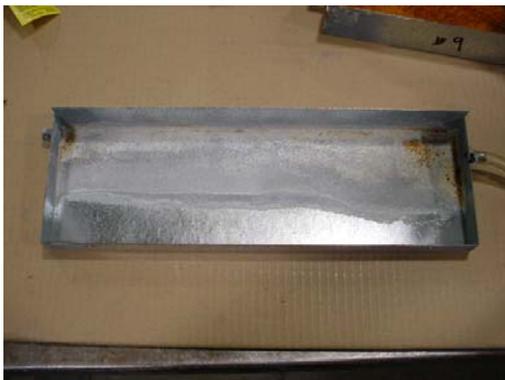
**Condensate drain pan:** Condensate drain pans from units #6 and #8 (gravity drain) had a slight coating of scale, and minor surface rust formation where condensate came in contact. See Figure A13. Condensate drain pans from units #7 and #9 (condensate management system – CMS) had a heavy coating of rust present on the drain pan, and heater where condensate came in contact. See Figure A14.

**Figure A13.** Non-CMS condensate pan condition.

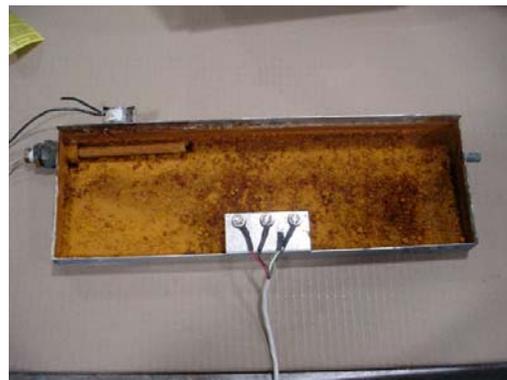
**Figure A14.** Condensate pan from CMS unit.
