Radiation Control Coatings Installed on Rough-Surfaced Built-up Roofs — Initial Results

Thomas W. Petrie, Ph.D.
Phillip W. Childs
Jeffrey E. Christian
Energy Division
Oak Ridge National Laboratory

To be presented and published in the
ASHRAE Symposium Transactions
being held in San Francisco, California
January 1998

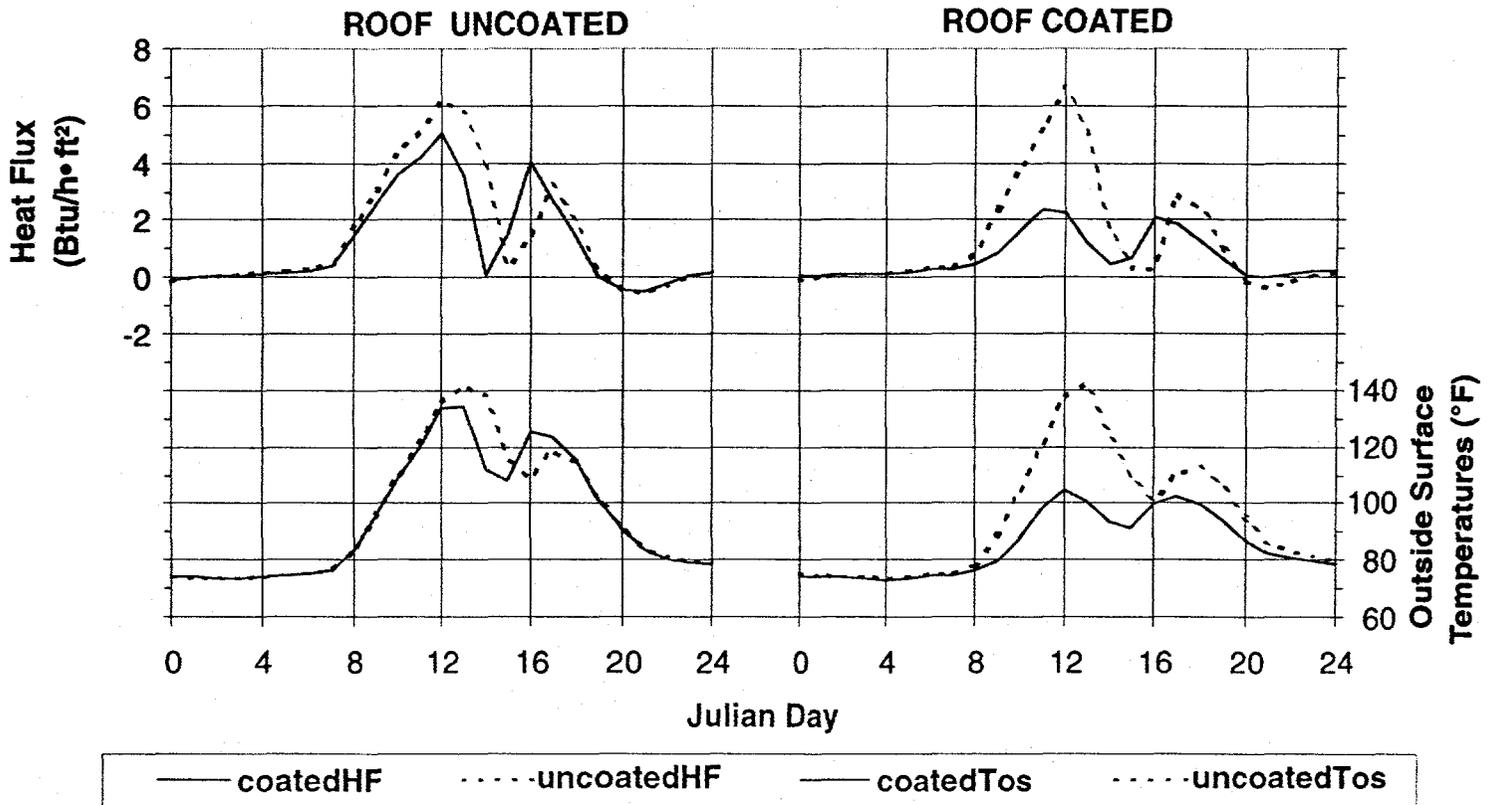
Figure 9

Fig. 9. Hourly outside-surface temperatures and heat fluxes through the insulation for the coated and uncoated locations on the convenience store roof for similar sunny days just before and after the roof was coated.

Convenience Store: June 21, 1996 vs. July 30, 1996

results of applying the simple sunlit criterion to the data for July 30, 1996, the coated roof day displayed in Fig. 9. The percent decreases that are higher than the average, from noon through 2 p.m., are increased by the shading of the coated location. The shading of the uncoated location later in the afternoon causes data with lower percent decreases to be excluded from the average.
